## *Winfield Tainter Gate Cylinder Rod Corrosion*

LRD Annual Maintenance Conference  
Feb 11<sup>th</sup> 2010  
St. Louis, MO

## *Winfield Locks & Dam Red House, West Virginia*

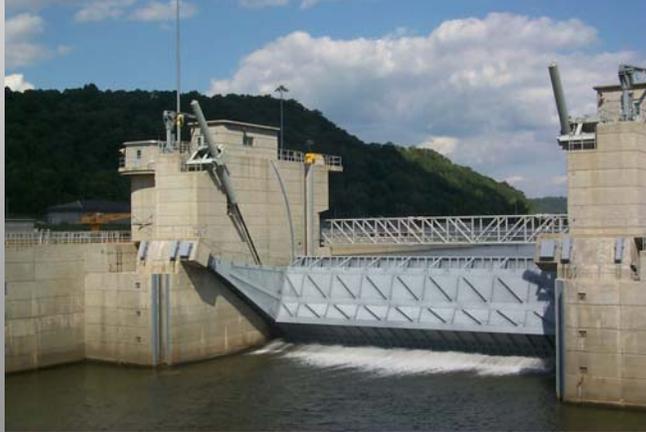
*Newly Commissioned, 1997*

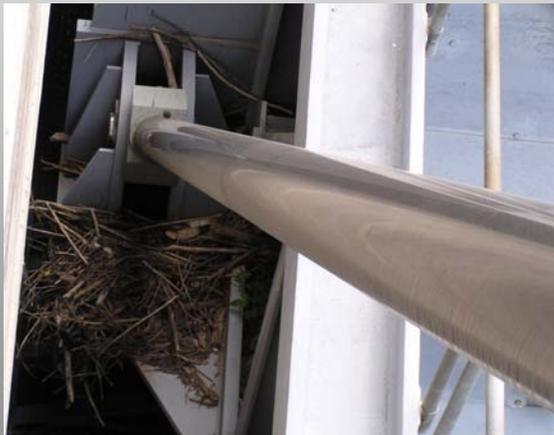
*Rod in May 2005*

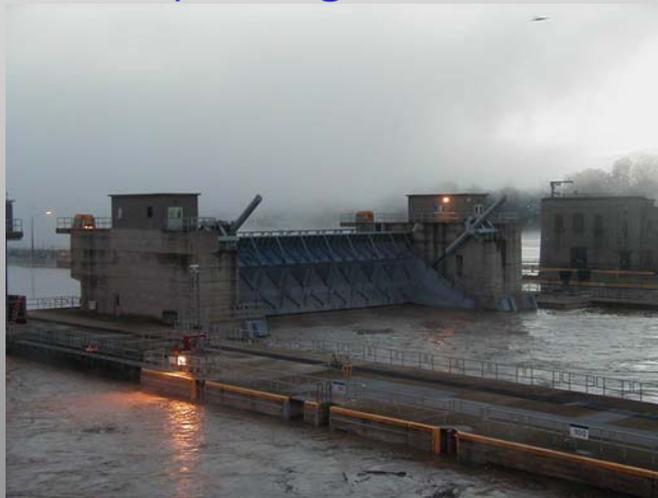
- Small gate operations (1'-2') during flood season every year
- Never Fully Retracted Since 1997

## *Maximum Opening of Gate in 2003*

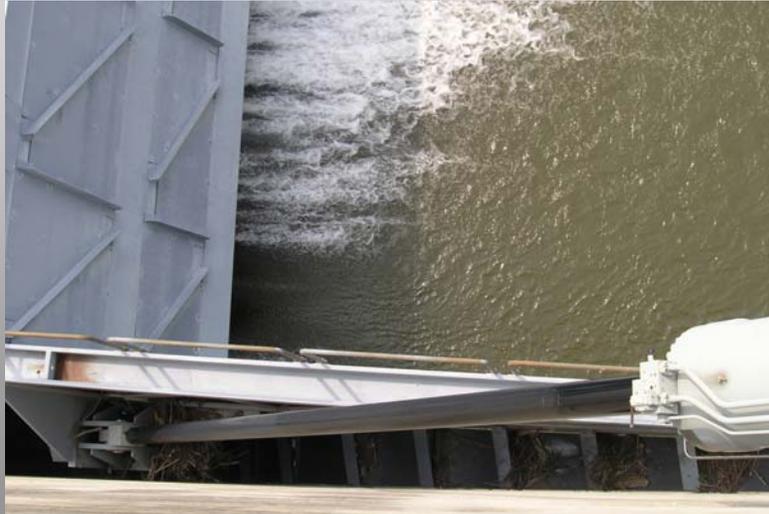
*Rod in May 2005*

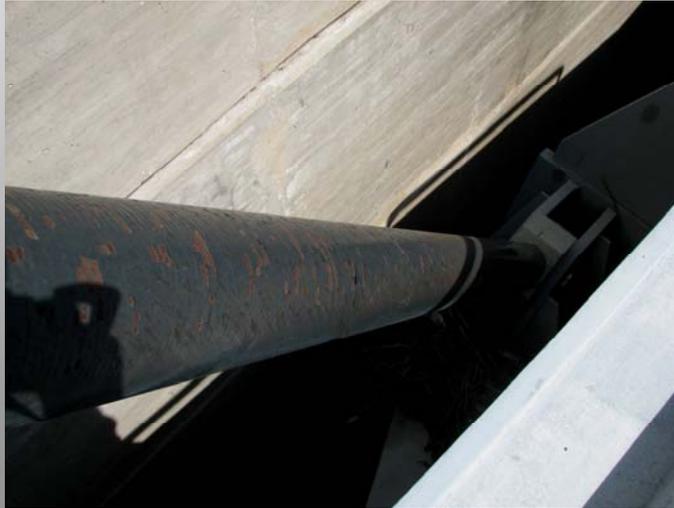
*Rod Condition in April 2008*

- Flaking of Ceramax and Corrosion mostly on top half of the rod
- Begins at just above the end of the rod and extends to about halfway up the rod
- The rod exposed to more sunlight had more severe and extensive corrosion

- Corrosion was caused by water penetration through the porous ceramic coating
- Water penetration occurred after the rod lost its coating of hydraulic oil due to never being retracted
- Contributing factors were sunlight and maybe natural bending of the rod
- The rods are not salvagable

- Periodically coat ceramic coated rods, that are not regularly retracted, with a silicon oil
- Use chrome plated stainless steel or nickel and chrome plated carbon steel rods when possible
- An alternative rod coating for new and existing installations is needed if position sensing is required

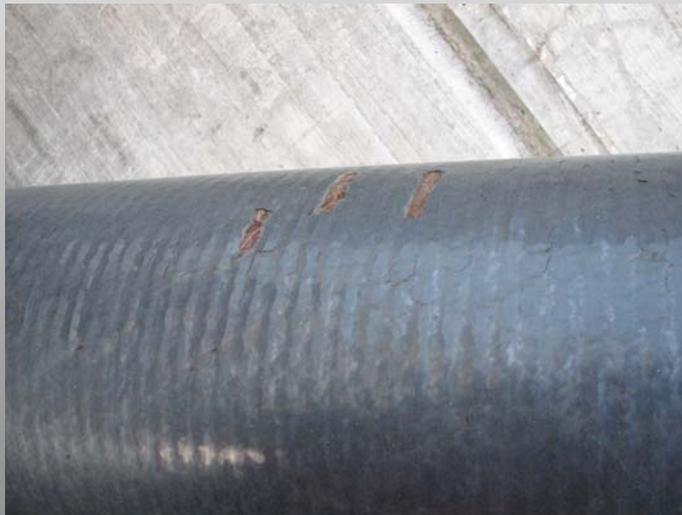
*Rod Condition in April 2008*

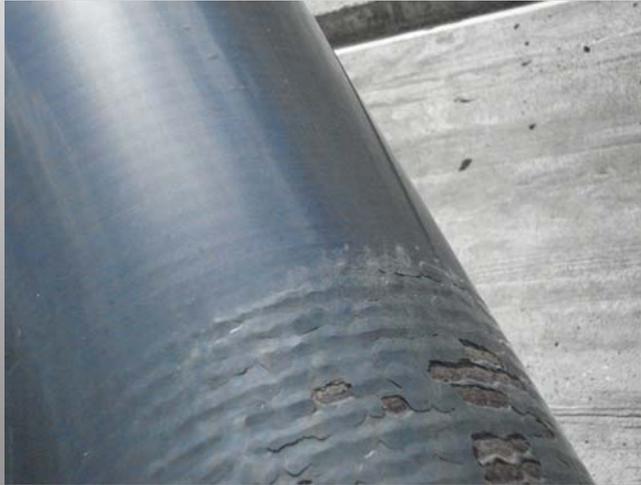
## *Abrupt Transition to Failed Coating*

- Recommends that “ceramic coated piston rods no longer be used at locks and dams for either new construction, or repair or rehabilitation projects” because of coating failures at Winfield and other projects
- Corps guidance and criteria will be revised to remove the option of ceramic coated rods
- All new and repair projects should specify chrome plated stainless steel or nickel and chrome plated carbon steel piston rods
