LOCKPORT POOL MAJOR REHAB

STAGE III CANAL WALL COLLAPSE & RESPONSE

2012 LOCK MAINTENANCE WORKSHOP

28 FEBRUARY 2012

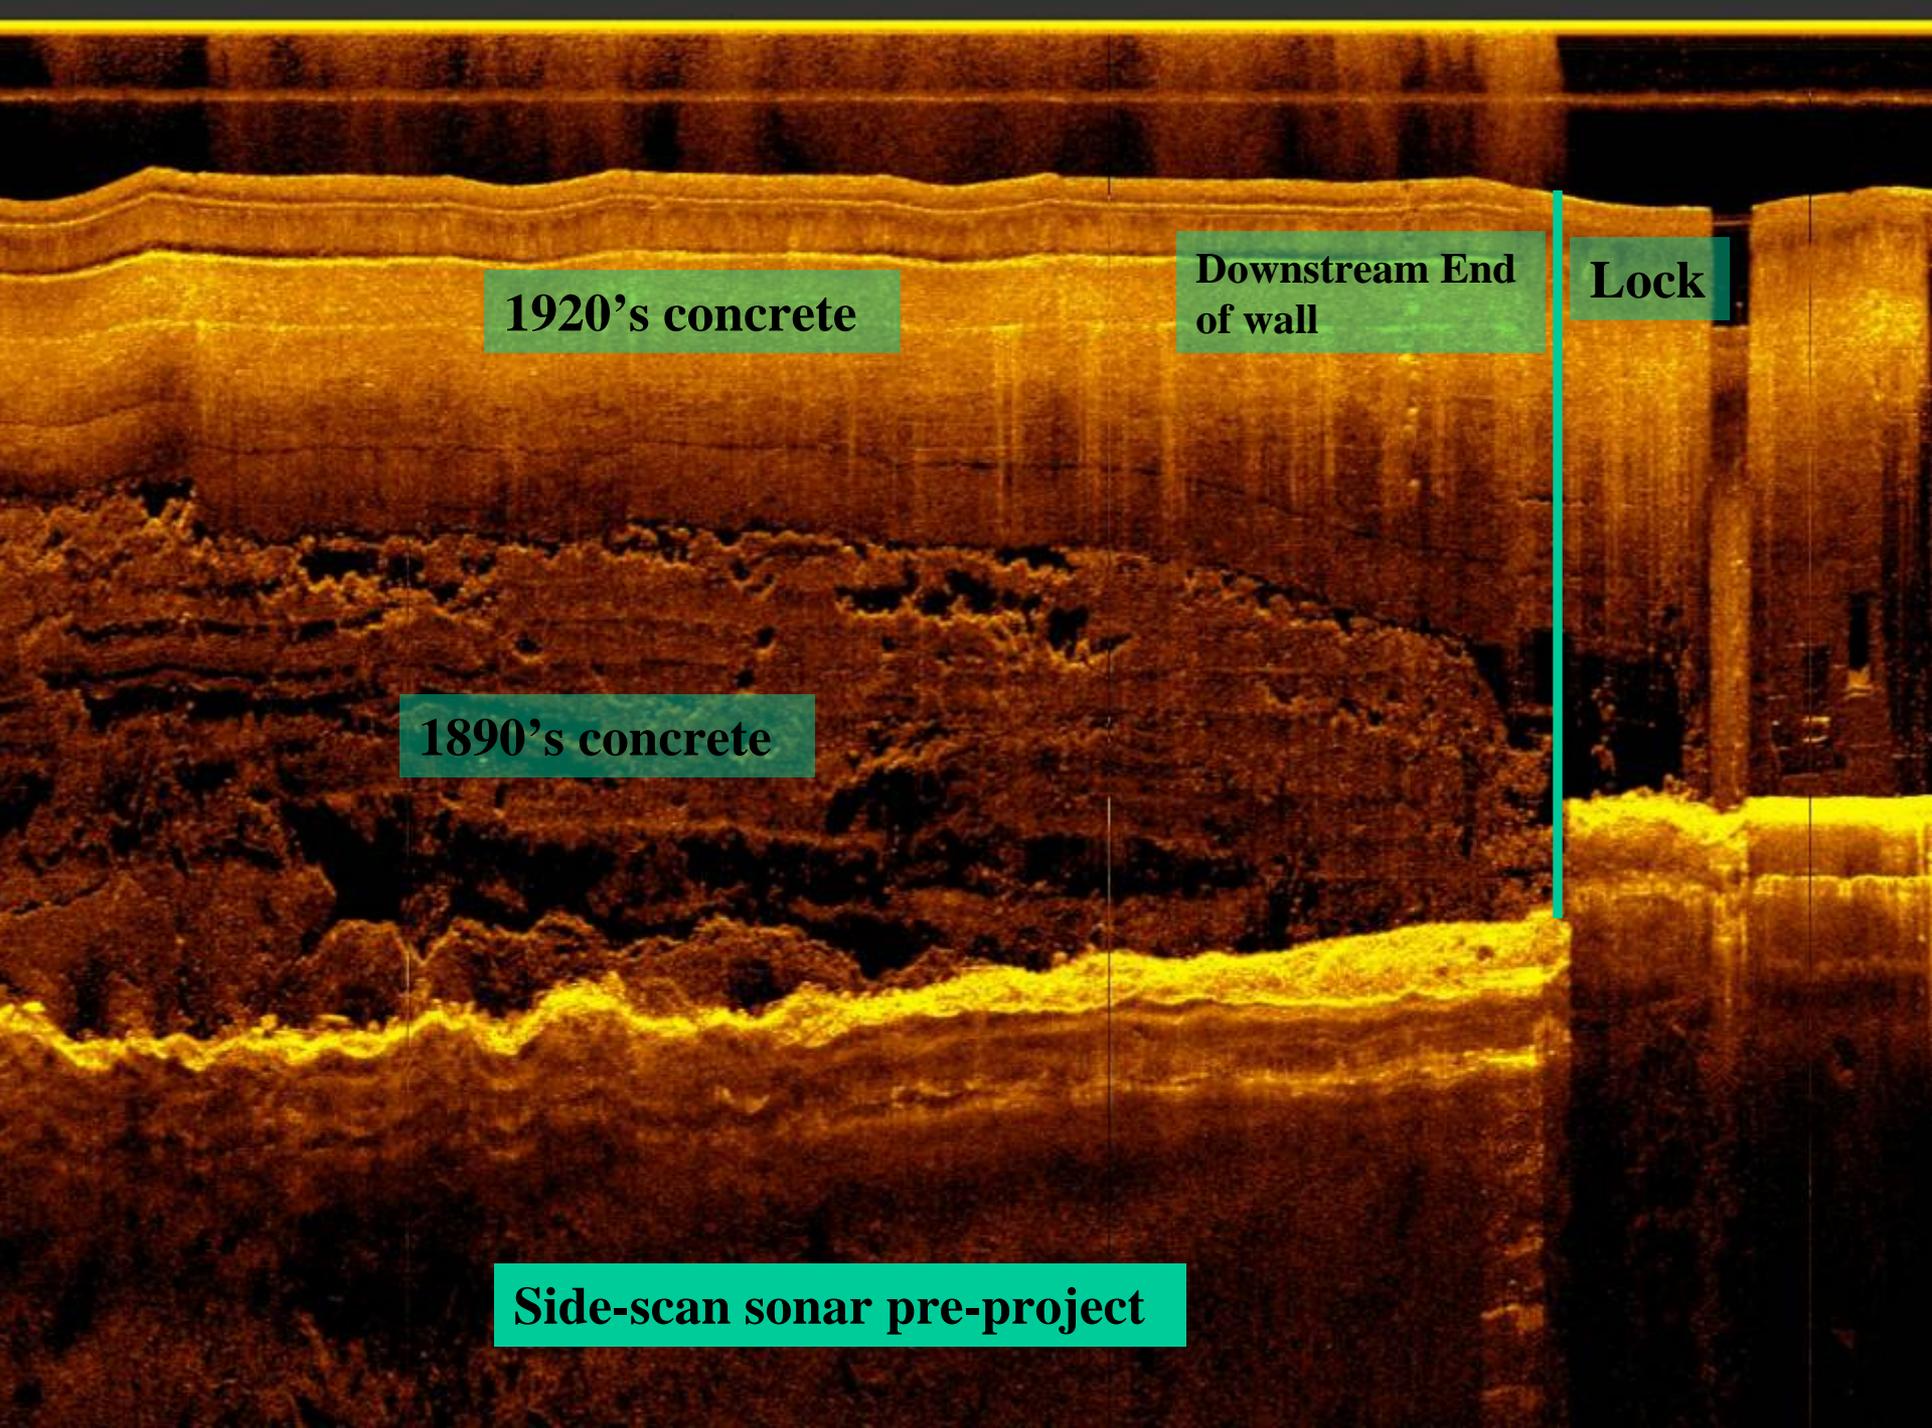
Side-scan sonar pre-project

1920's concrete

1890's concrete

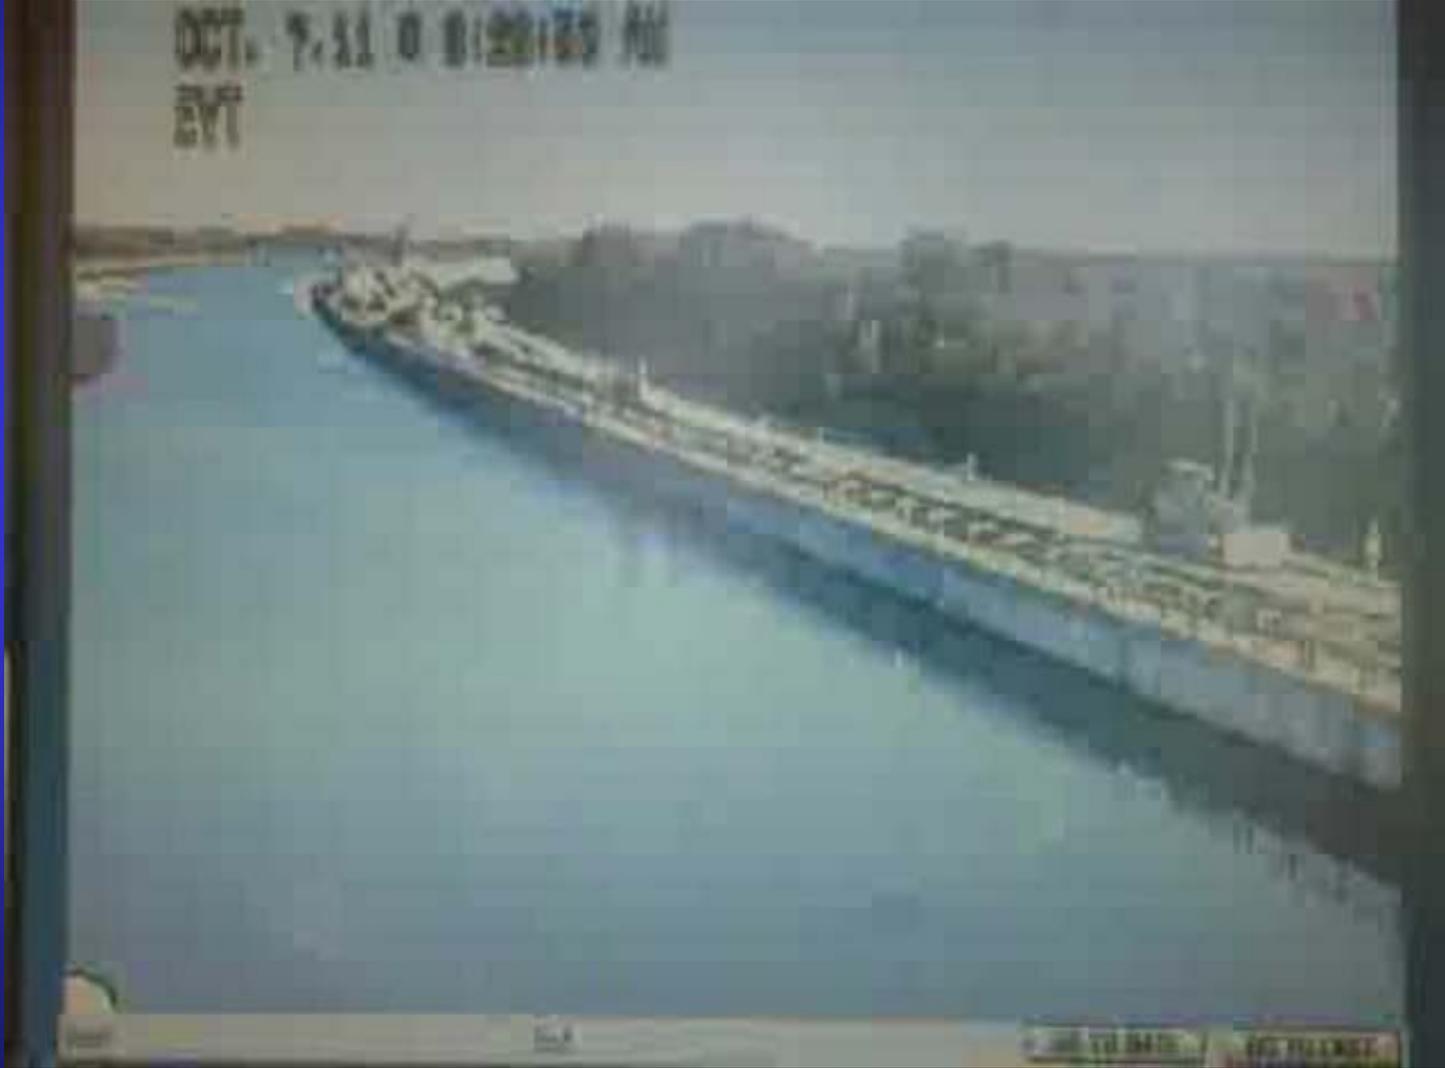
Wall Collapse (Oct 7 2011)

- Through October 2011, over 75% of the new wall was completed without incident
- All work in the canal was on schedule to complete in January 2012
- Site work including earthwork and paving was on schedule to complete by May 2012
- On October 7, 2011, a 280-foot section of existing canal wall collapsed and fell into the canal

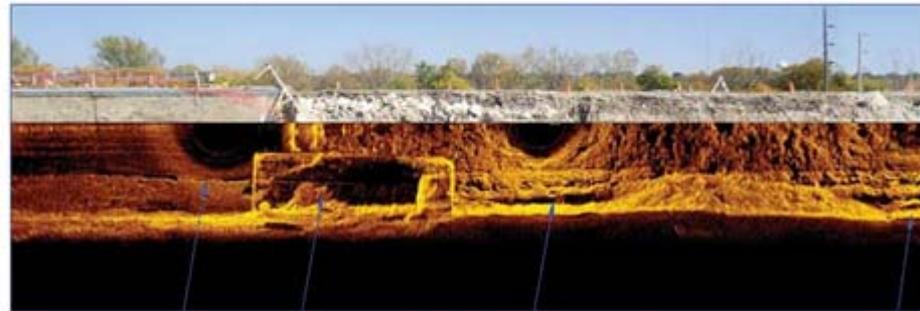
CH 3+00 ft to Ch 1+80 ft (Approximate)

Side scan sonar Post Collapse

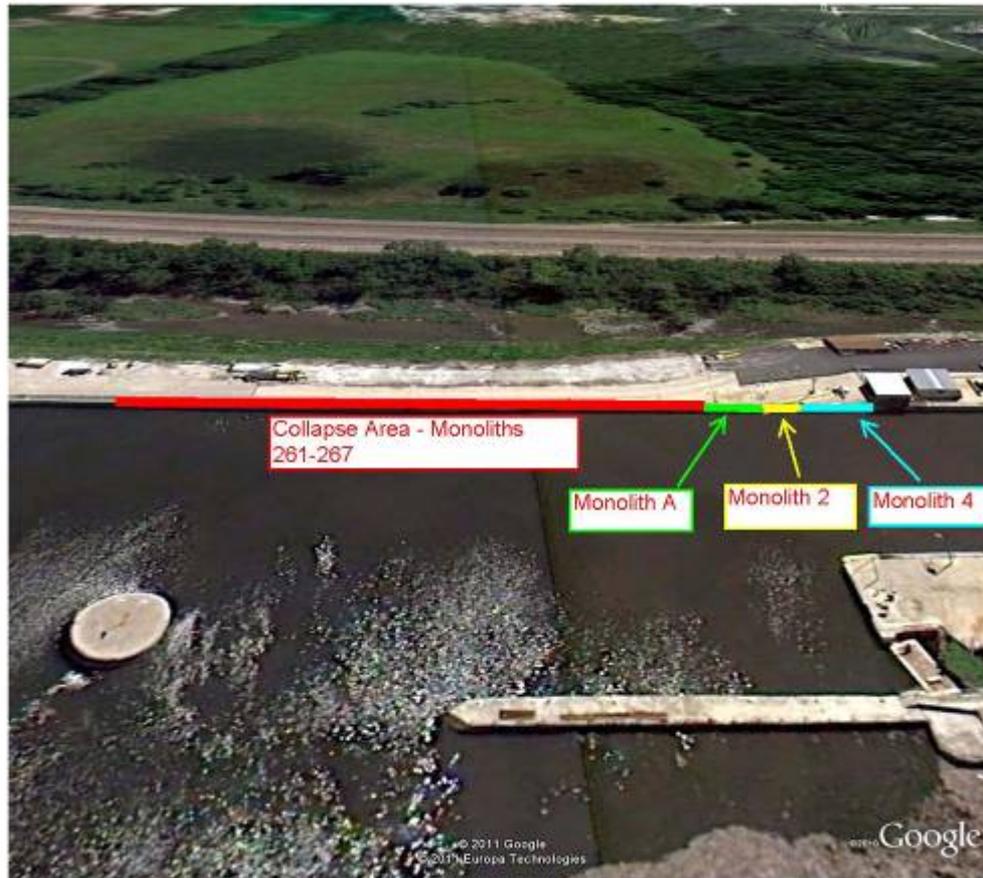
Lock Monolith Repair

- **Completion of original contract work will cost more and take longer**
- **Wall collapse displaced adjacent lock monolith**
 - **Tie-in point for new wall cannot be used**
 - **Landwall lock monoliths must be stable and straight to support normal operations**
 - **Cost to repair damaged lock monolith now part of construction project**
- **Funding needs exceed remaining funds**

- **Stability Berm – to prevent canal breach**
- **Work Platform – to complete wall in collapse area**
- **Helper Boat – to safely pass navigation traffic and protect work in progress**
- **Lock Repair – to return lock structure to pre-wall collapse condition**
- **Debris Removal – to ensure no navigation obstructions in channel**

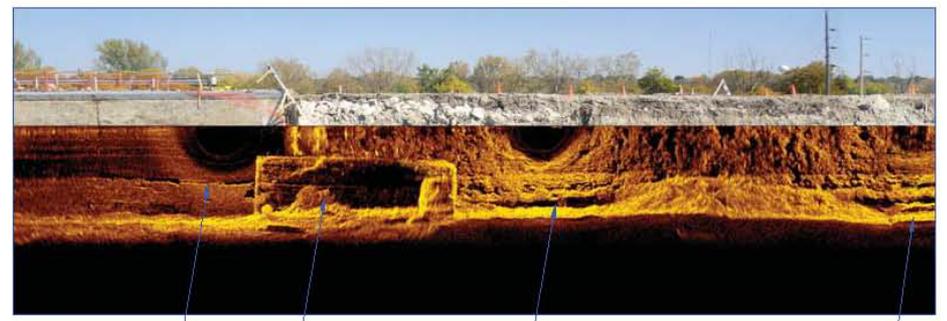
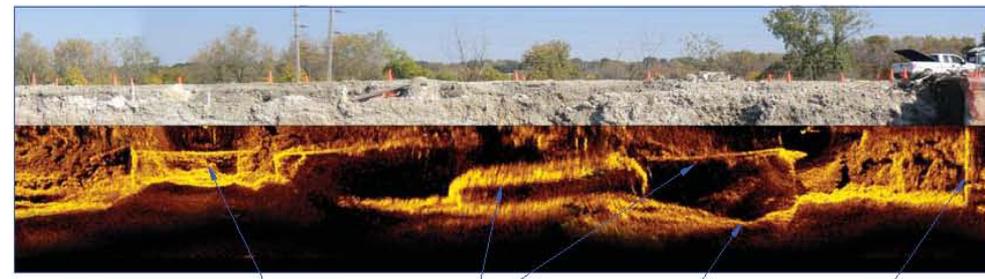
- The wall collapse area coincides with the grouting limits
- It appears that the wall collapse originated at the interface of the 1890 and 1920's concrete

- Grouting hydro-fractured the wall
- The grout curtain equalized water pressure on both sides of the wall reducing the net hydrostatic force
- Extensive deterioration; greater than other reaches of wall as indicated in preconstruction survey
- ▶ Construction methods including demolition and excavation in combination with the condition and age of the wall in this reach
- ▶ The collapse area is upstream of the lock and is subject to more barge impacts than other area of the wall. The wall has experienced barge impacts during construction while the backfill was removed behind the wall. One instance was within 24 hours of the collapse event.
- ▶ The contractor encountered large concrete footings located behind the wall. These footing were removed with large impact breakers subjecting the wall to vibration. Vibration could weaken the interface between the 1890s and 1920s concrete.
