FEBRUARY 29, 2012 / Presented by: Darrin Holt/Mark Cesare

Non Destructive Inspection of Existing Trunnion Rod Anchors

2012 LOCKS MAINTENANCE WORKSHOP

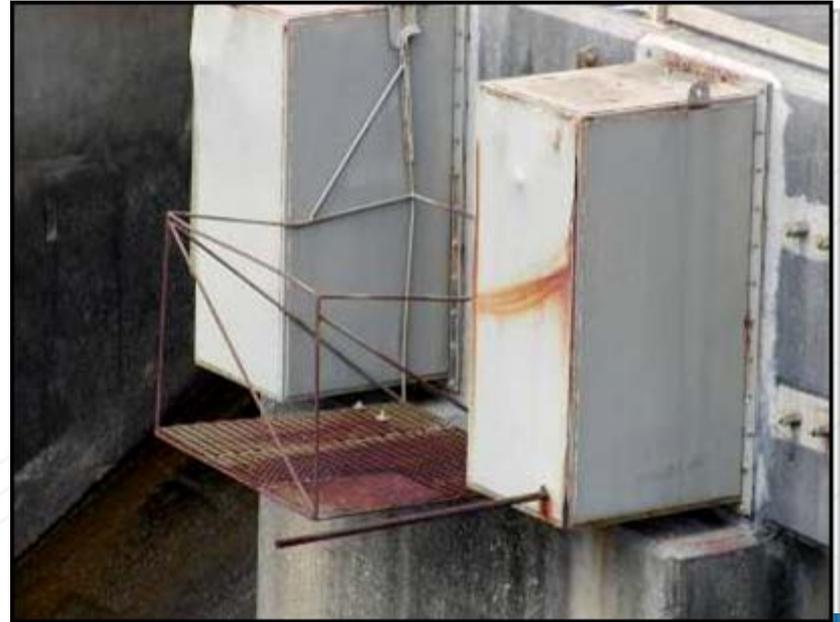
West Point Dam – Rod Failures

- In 2008
 - 5 Failures total
 - 3 on one pier
- Failed rods removed
 - Measured to find failure location
 - Sent for metallurgical testing

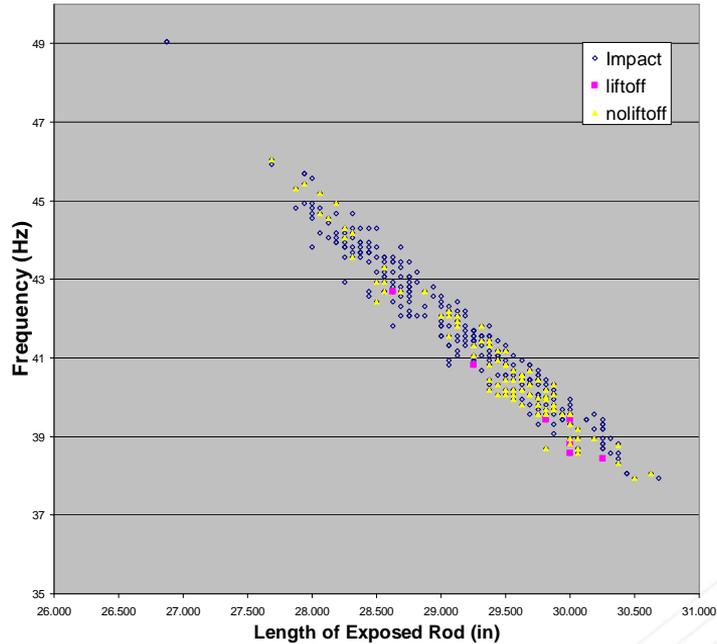
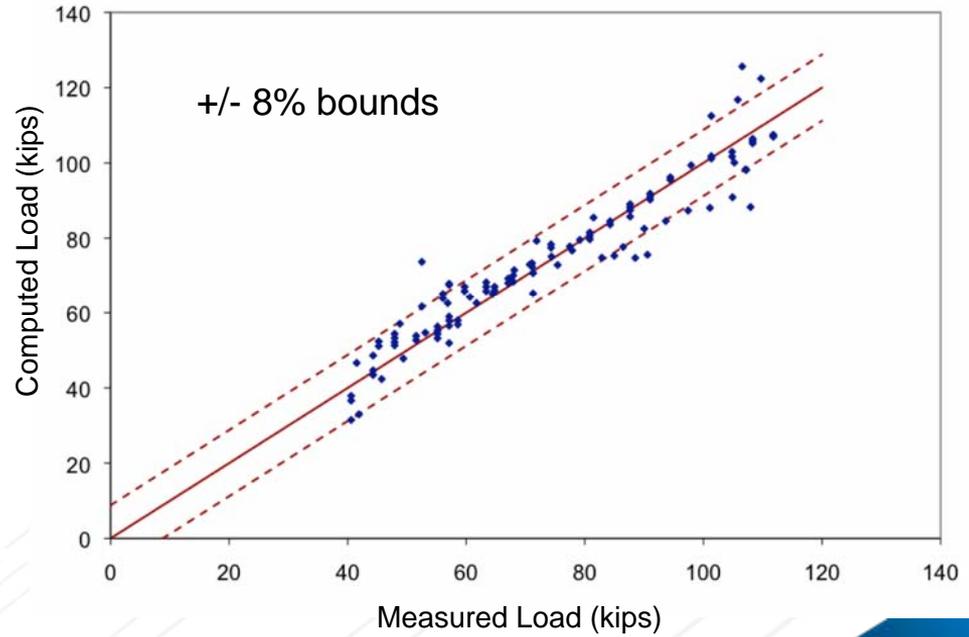
West Point Dam – Dispersive Wave Results

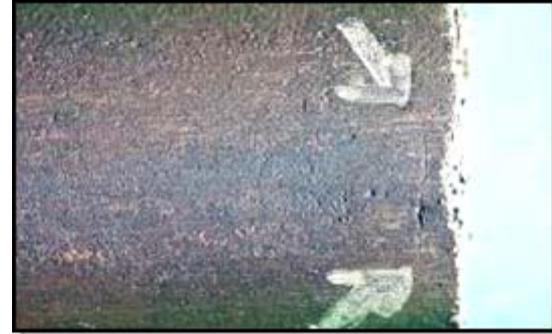
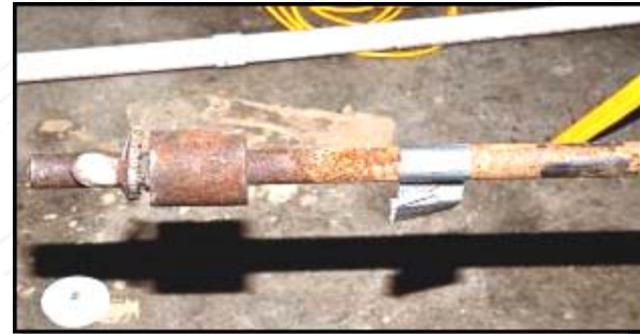
R. F. Henry Dam – Rod Failures

- 4 broken rods found
- Rod removed & sent for testing. Cracks found in material.
- 3 of the failures at threads near Dead End
- 1 rod broke between inspections (a 3 month interval)

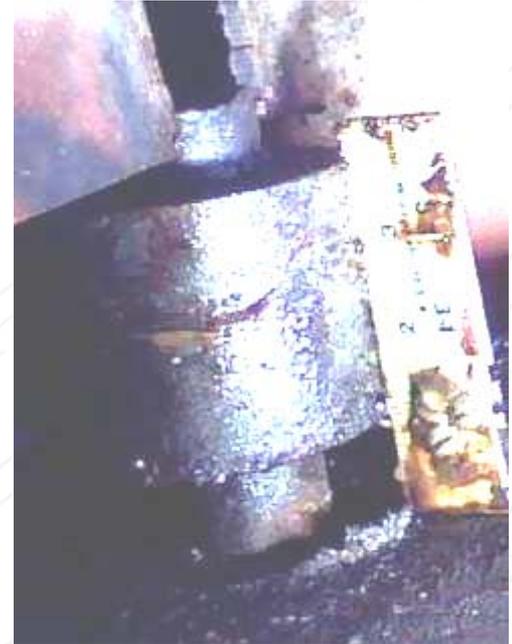
R. F. Henry Dam – Slipped Grip Nut

- 2 Rods found to have slipped Grip Nuts
- Provided good data point for un-tensioned rods
- Rods re-tensioned as part of testing operation

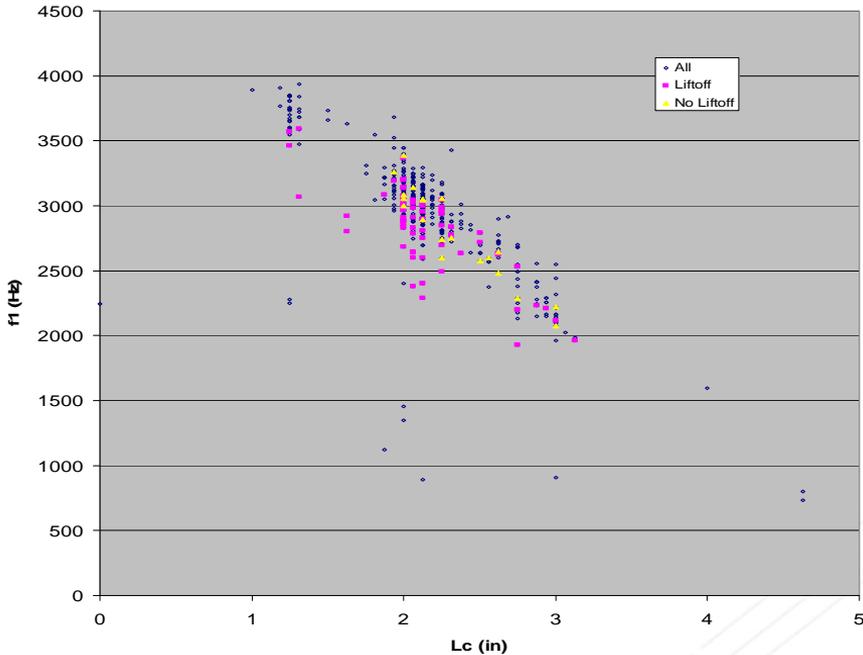
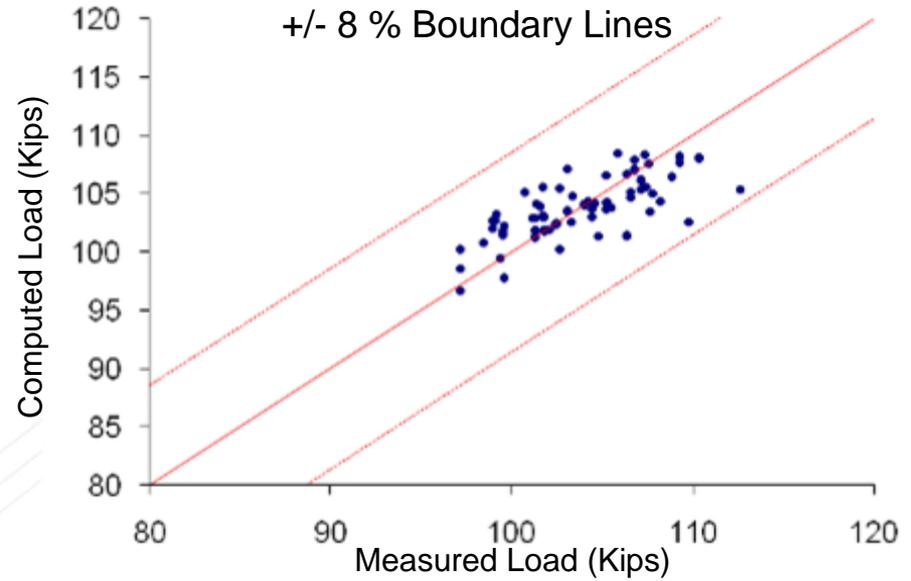
R. F. Henry Dam – Dispersive Wave Results

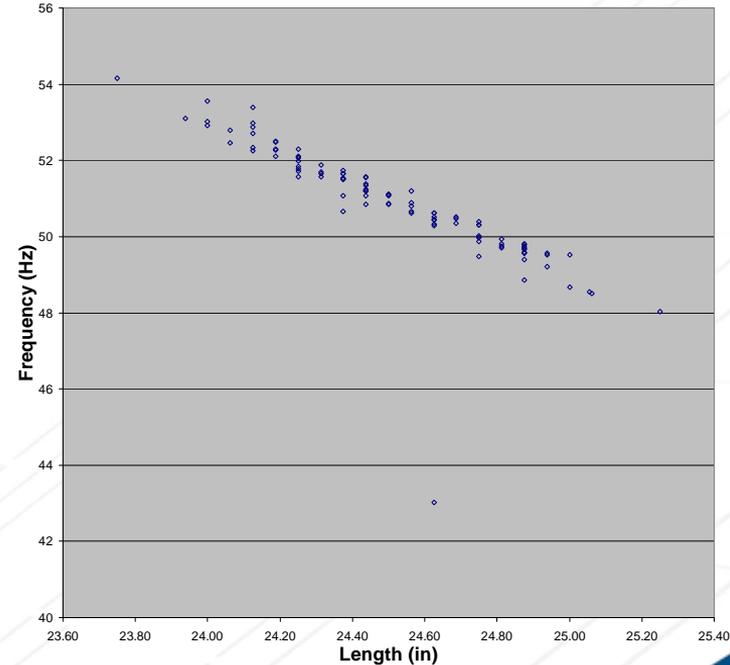
Greenup Dam – Vibration test results

- Broken rod clearly found
- Less scatter than other tests
- Lift-off tests planned but not done yet
- Estimate of tension made by assuming that points near top of this cloud of data are near original lock-off loads

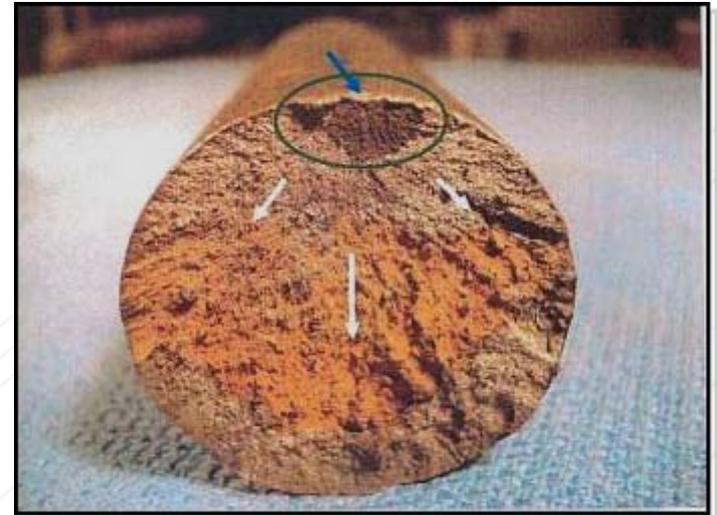
West Point Dam – Rod Failures

- Failures closer to far end but NOT at threads
- Failure Surfaces
 - All showed initial flaw
 - Brittle failure
- Composition within spec

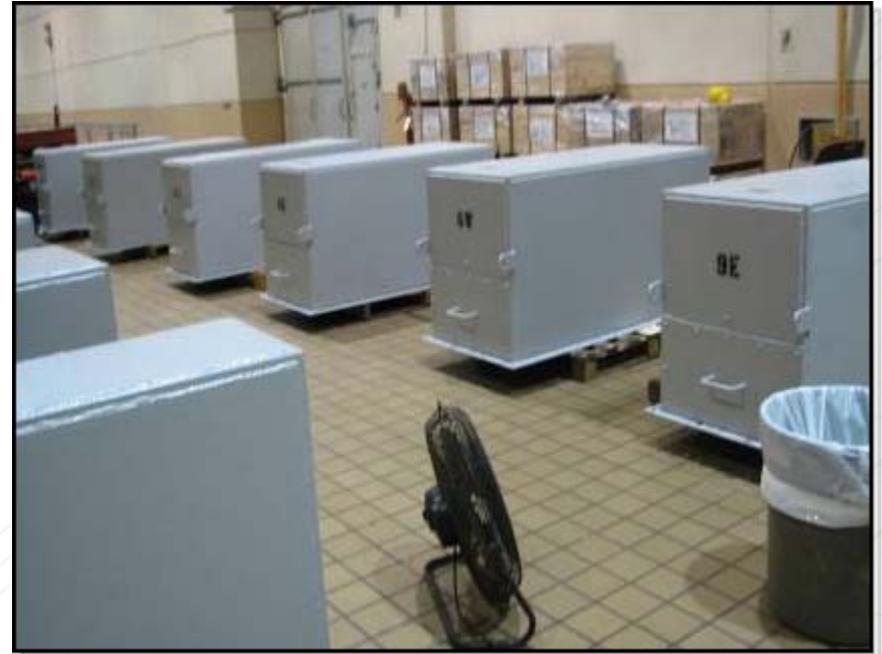
West Point Dam – Cover Boxes

- Cover Boxes were
 - Repaired
 - Cutout for access hatch
 - Painted
 - Numbered
 - Replaced on the dam
