LOCK & DAM 53 REHAB 2012

August 22nd to November 1st

KEITH FLECK & KEVIN VESSELS
PROJECT ENGINEERS
LOUISVILLE DISTRICT

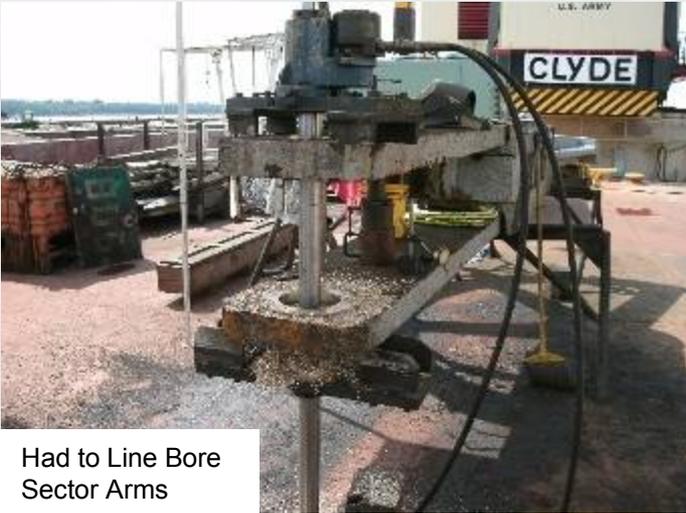
Had to Line Bore Sector Arms

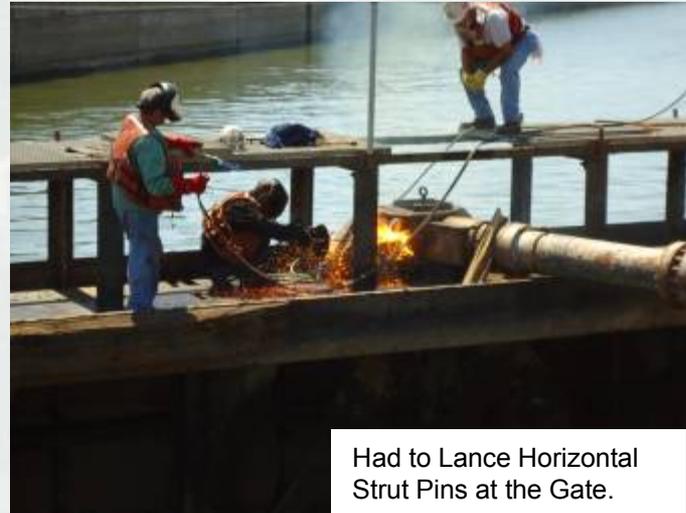
Had to Lance Horizontal Strut Pins at the Gate.

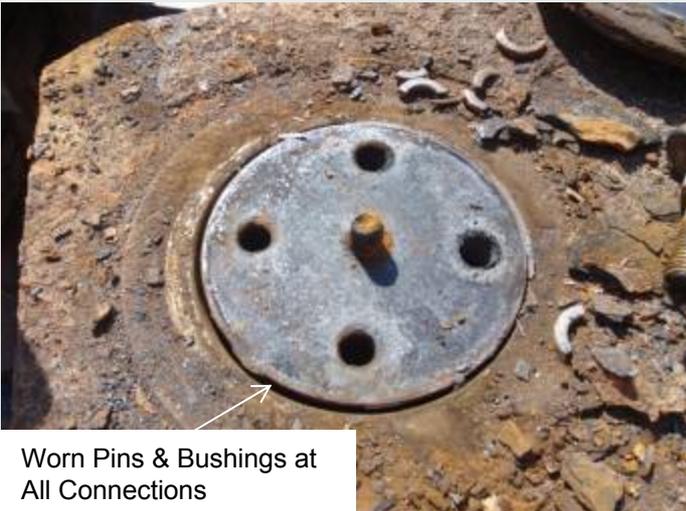
Worn Pins & Bushings at All Connections

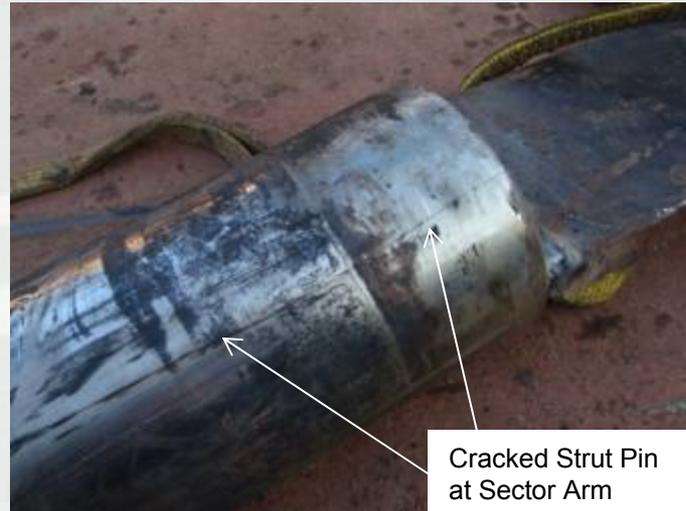
Cracked Strut Pin at Sector Arm

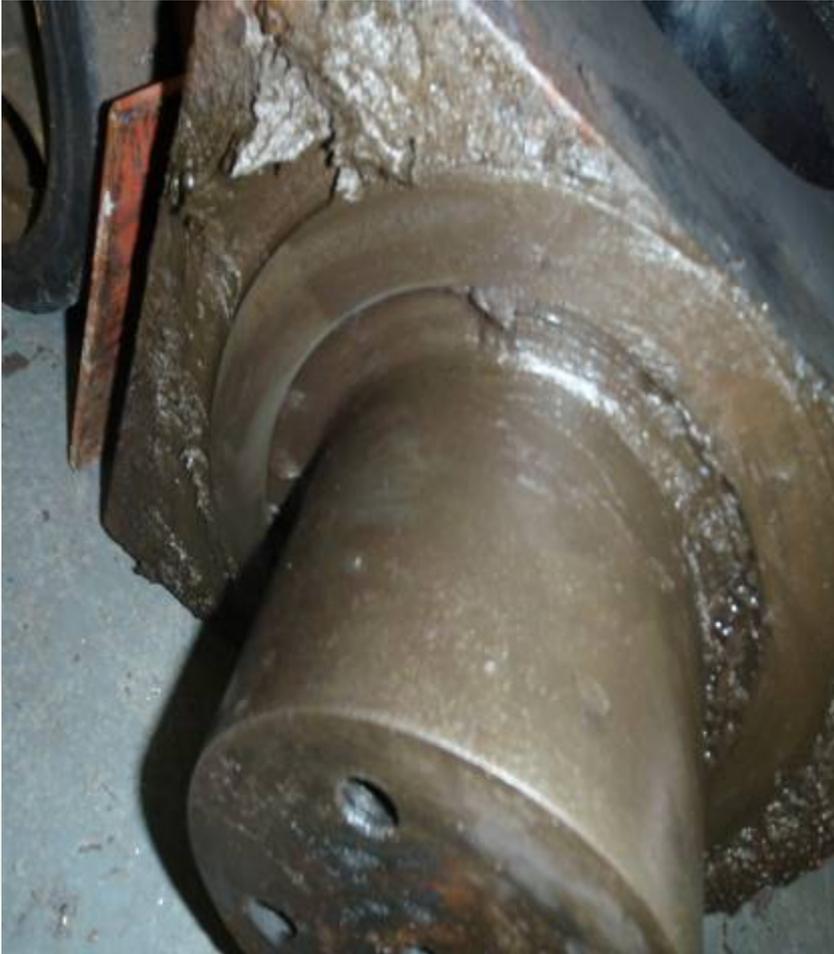
Grease

All four of the Sector Arm Cross Pins in the 1200 machinery assemblies were not greased on the bottom pin.

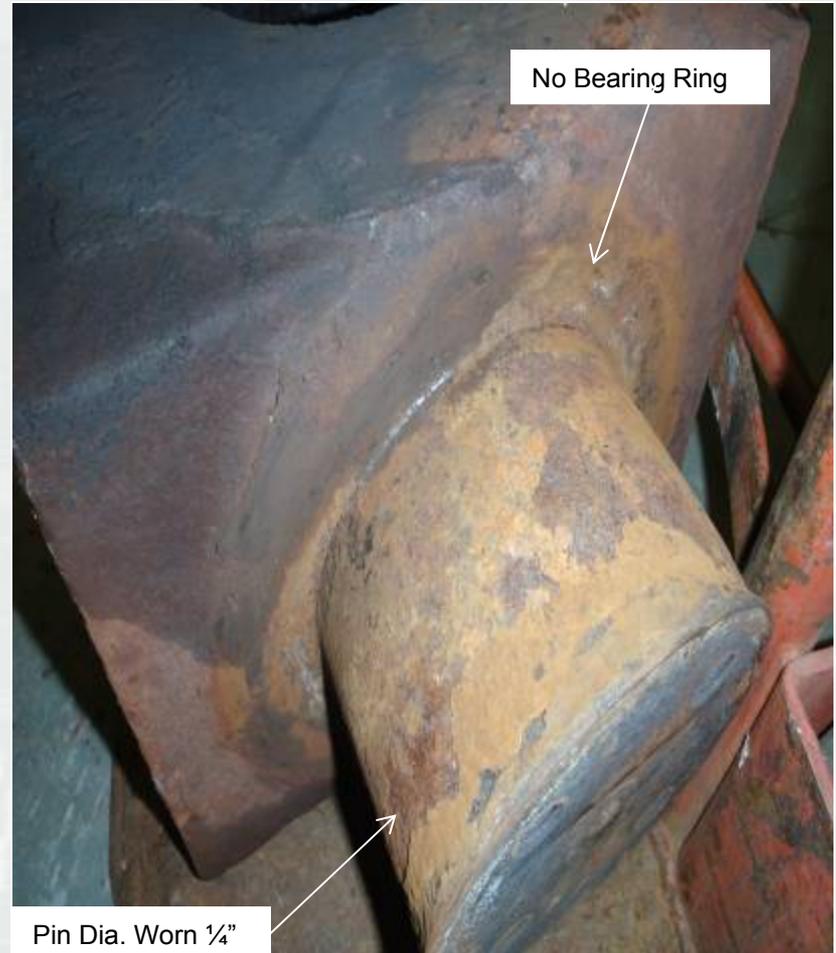
No Grease

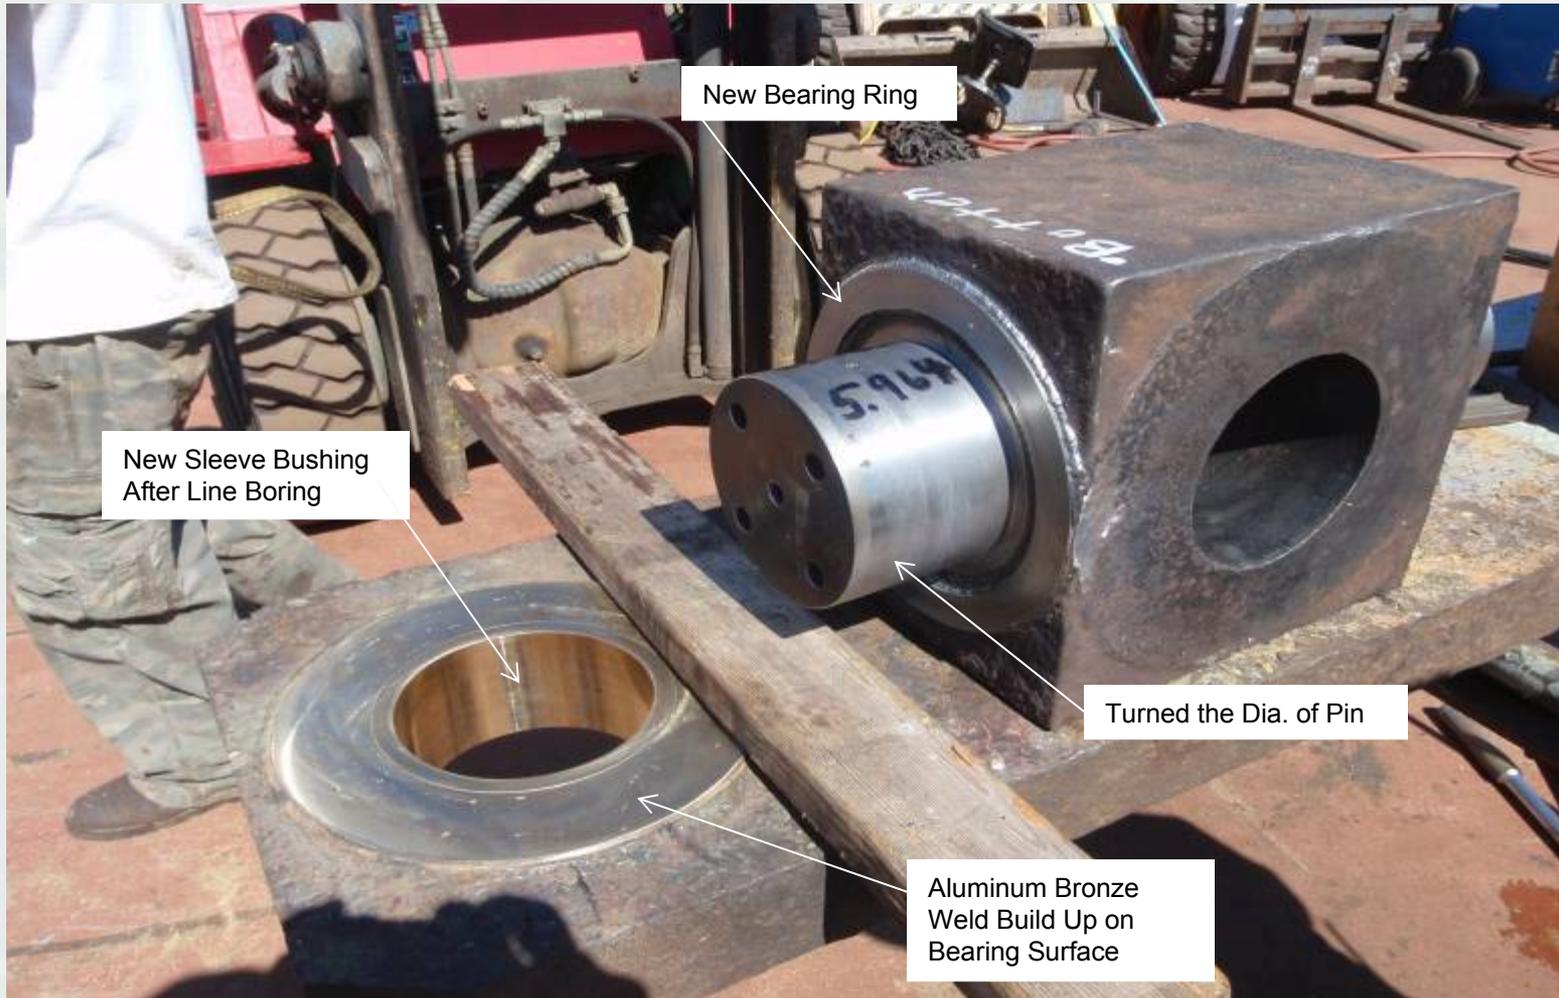
Bottom Sector Arm and Cross Pin after machining

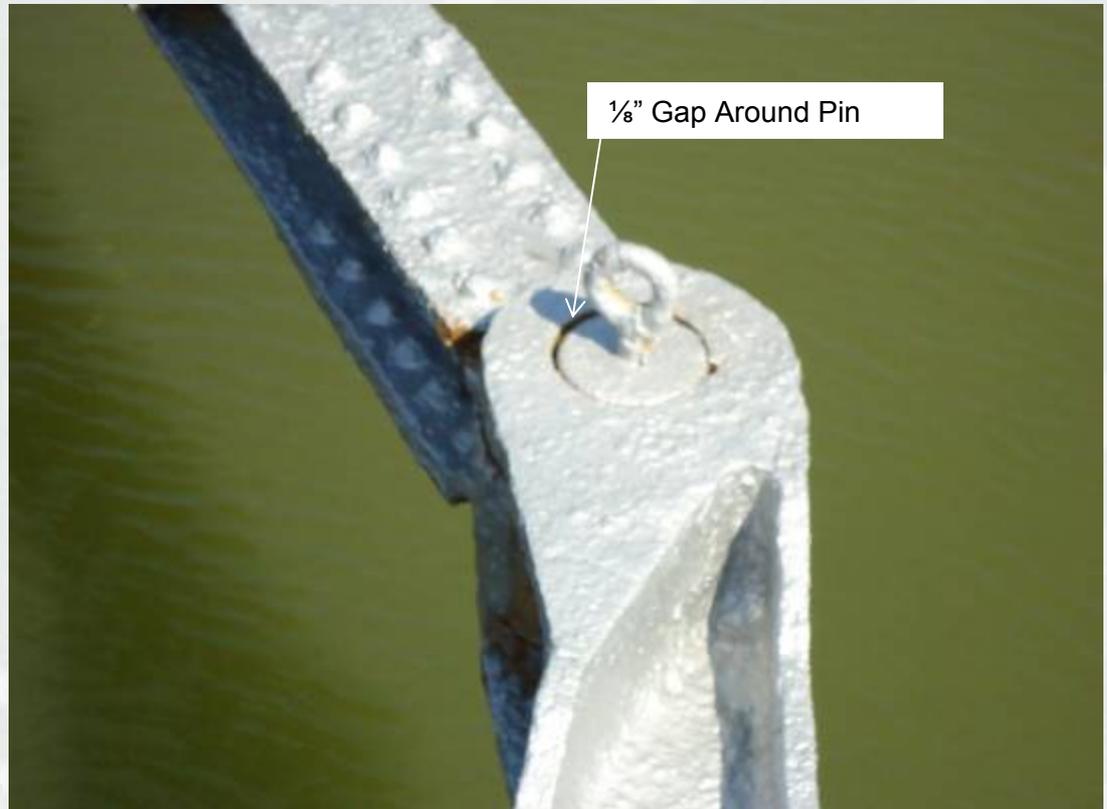
Typical Issues with the 600' Miter Gate Machinery Assemblies

- All pin and bushing connections were worn.
- Strut arm beams had severe section loss and were held together with miscellaneous pieces of metal.
- Rack bar teeth worn causing lots of backlash.
- Sector Bushings, Rollers, and rack bar beam worn causing sector gear and rack bar to rub.

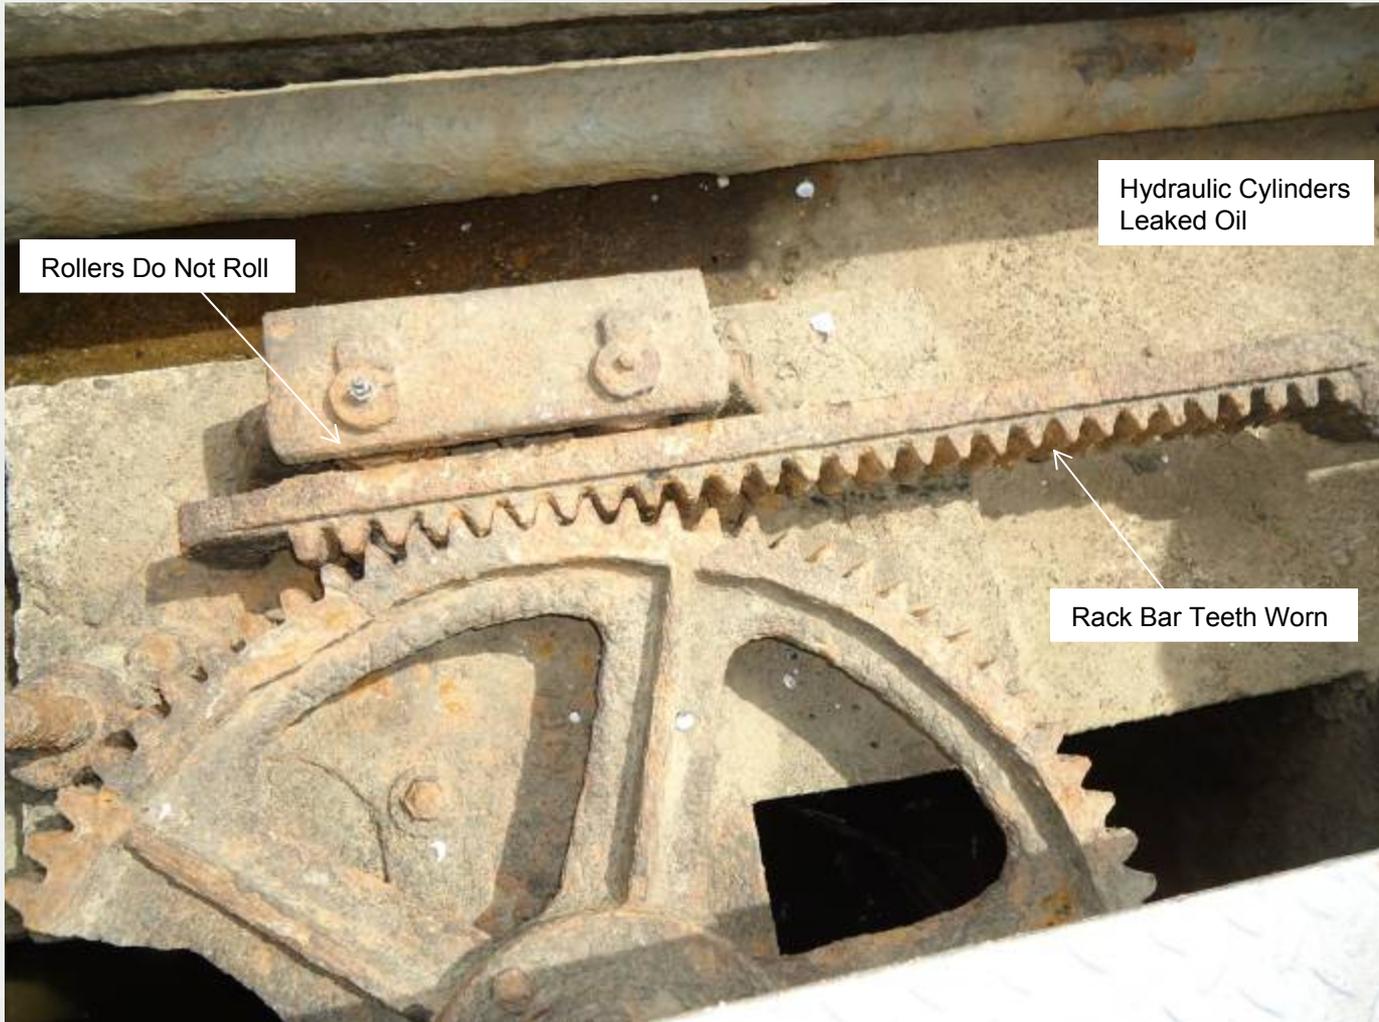
Typical Issues

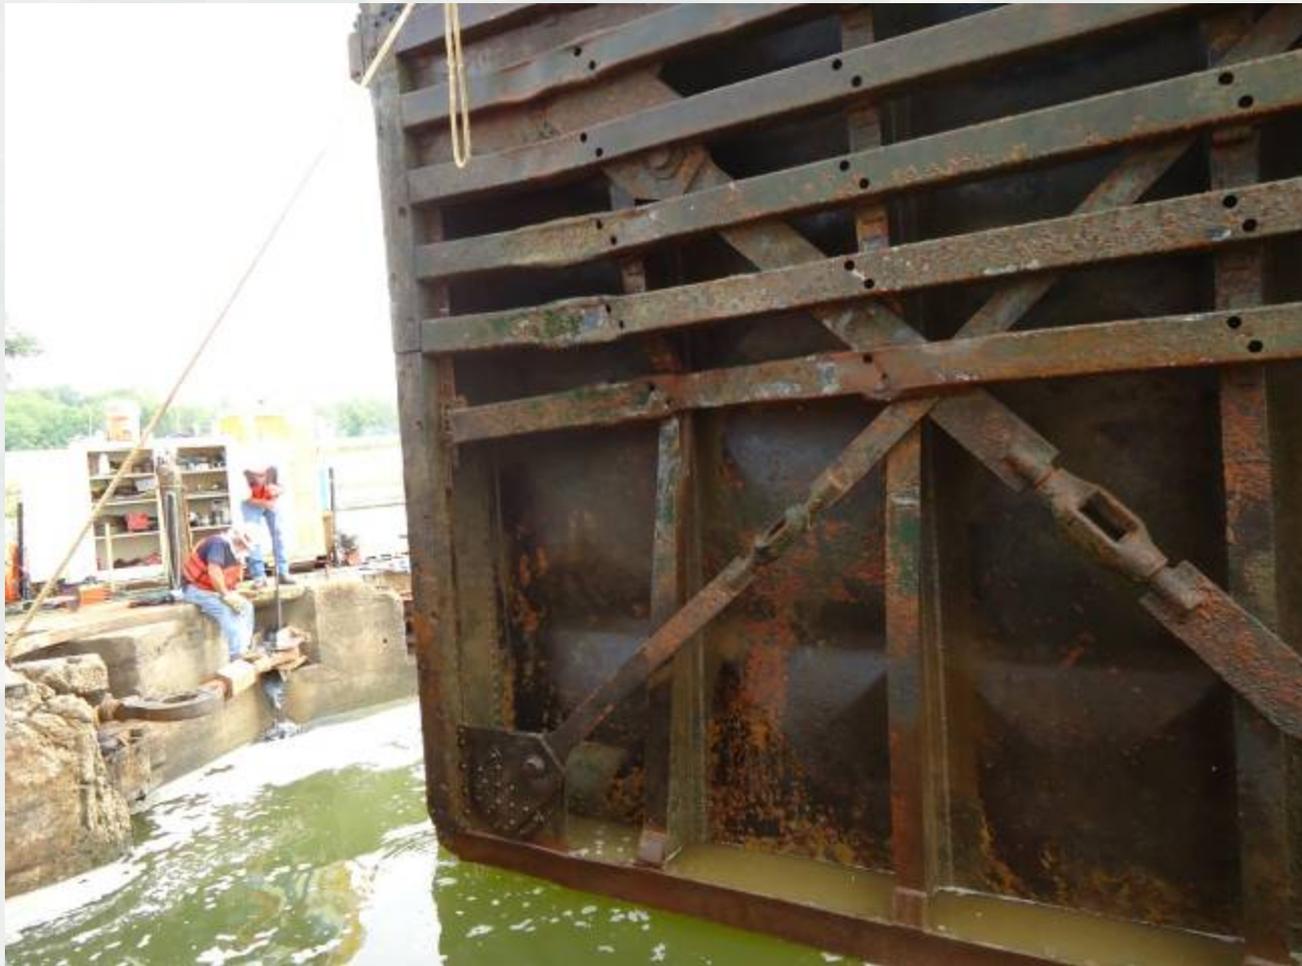
L&D 52 600' Upper Middle Gate Leaf Repair

Tow backed into the gate leaf and damage Vertical Girders 1 and
2

Girder 1 was completely replaced and girder 2 was spliced in the center. The bottom sill plate was also removed and repaired.

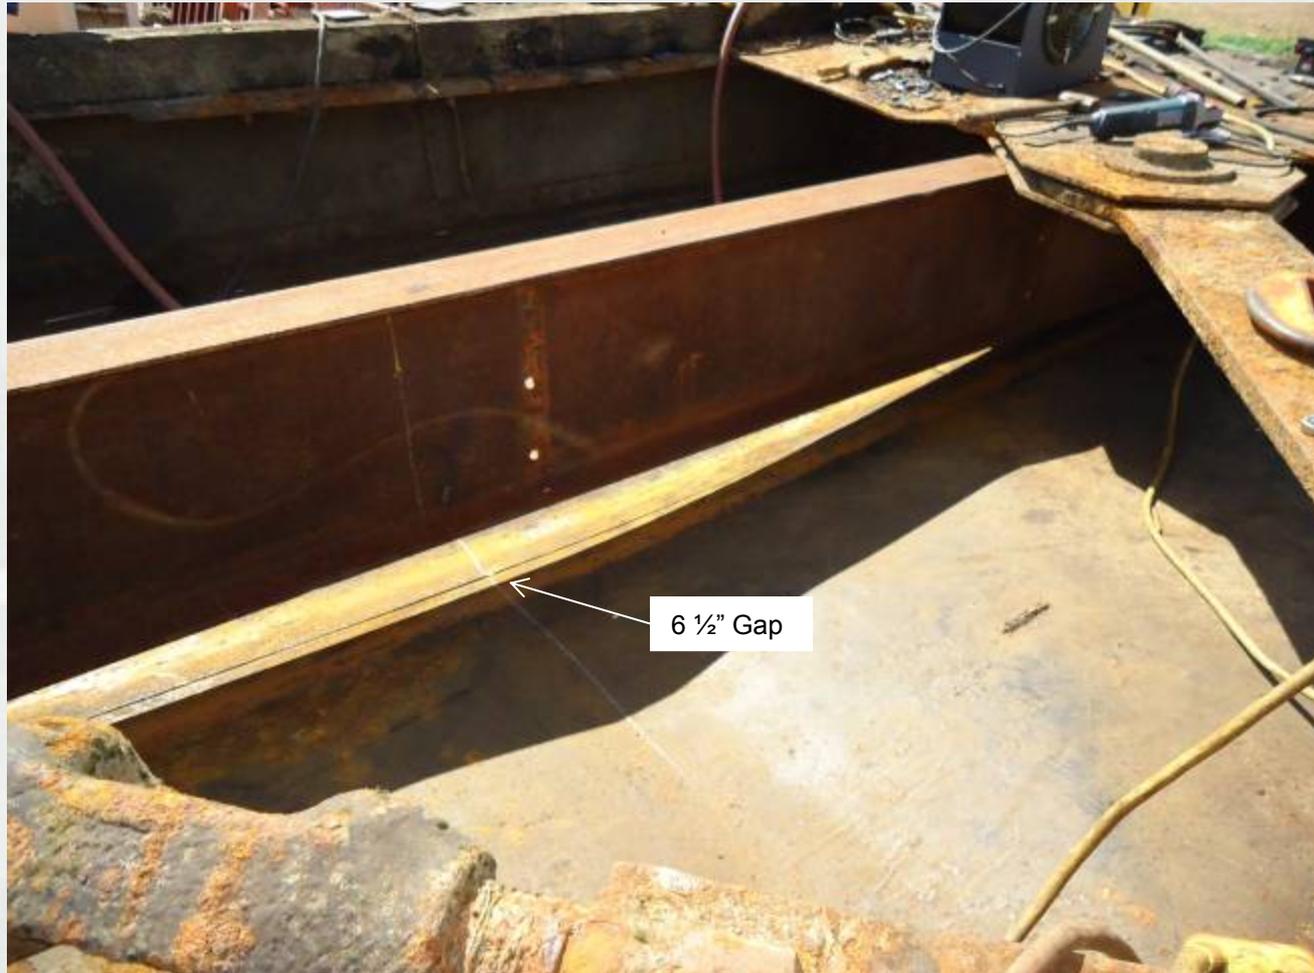
The buckle plate skin sheet had to be pushed back into the original position

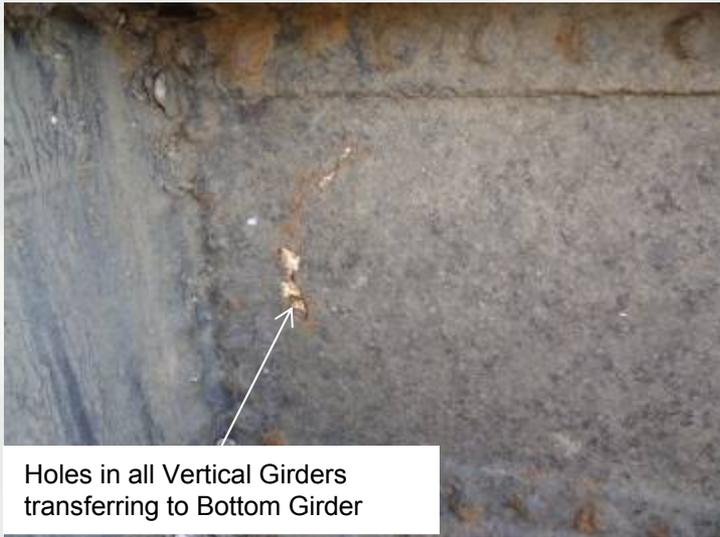
Holes in all Vertical Girders transferring to Bottom Girder

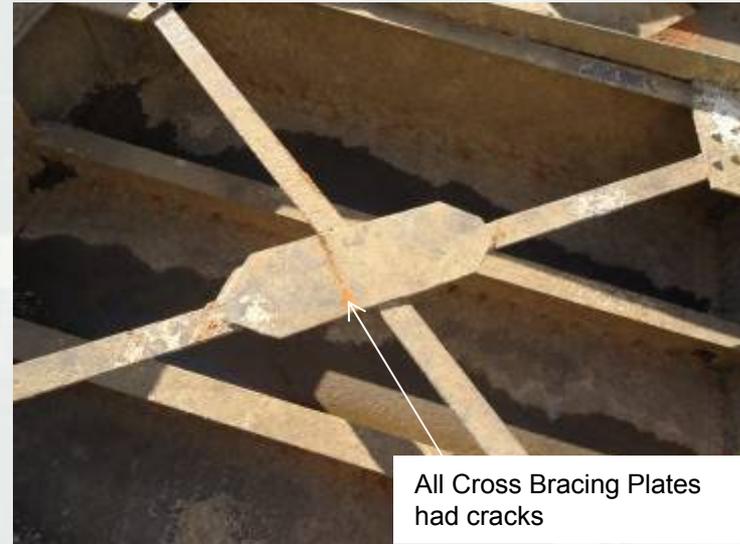
All Cross Bracing Plates had cracks

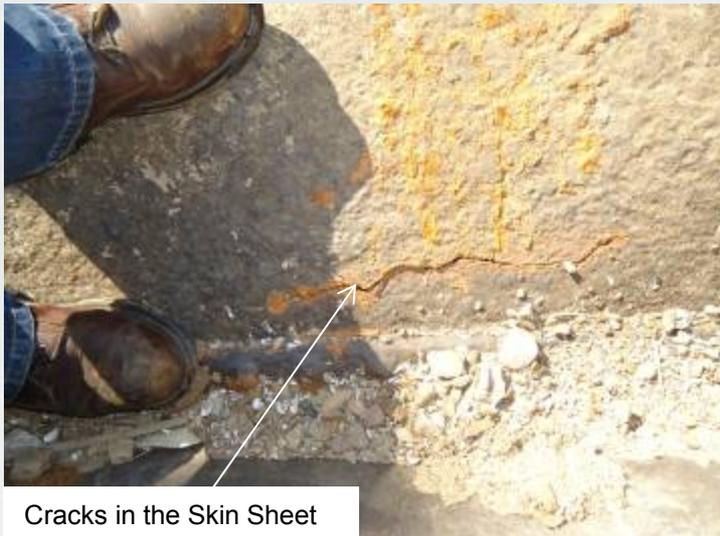
Cracks in the Skin Sheet

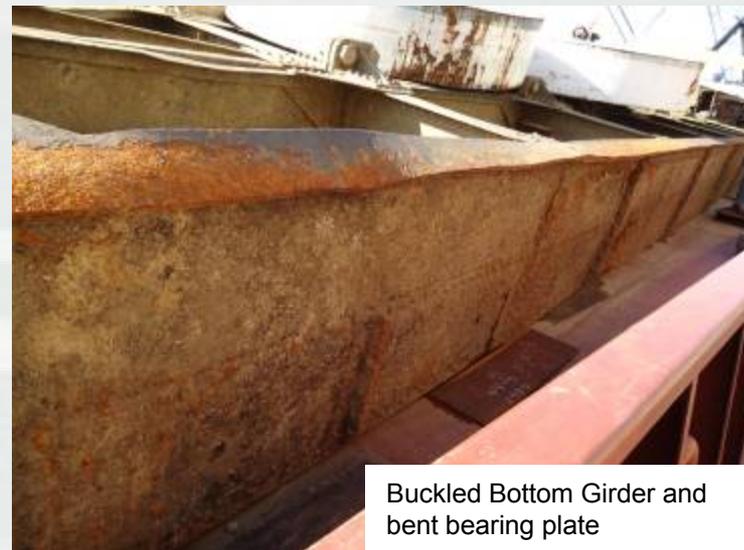
Buckled Bottom Girder and bent bearing plate
