CHICAGO HARBOR LOCK GATES

Replacement, Lessons Learned, Repairs & Successes

Robert (Bob) Ojala

12 February 2013

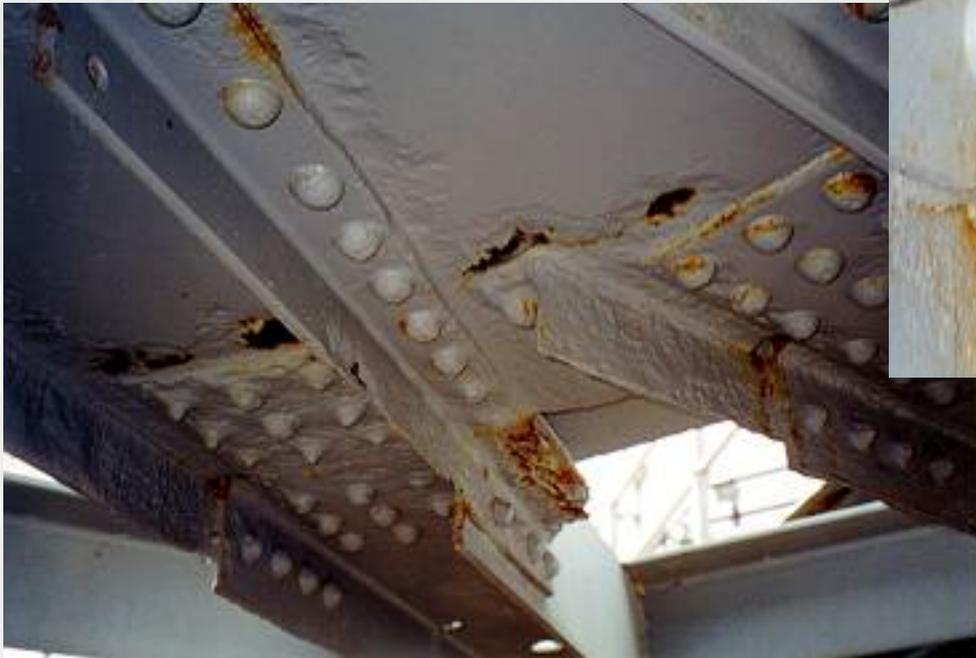
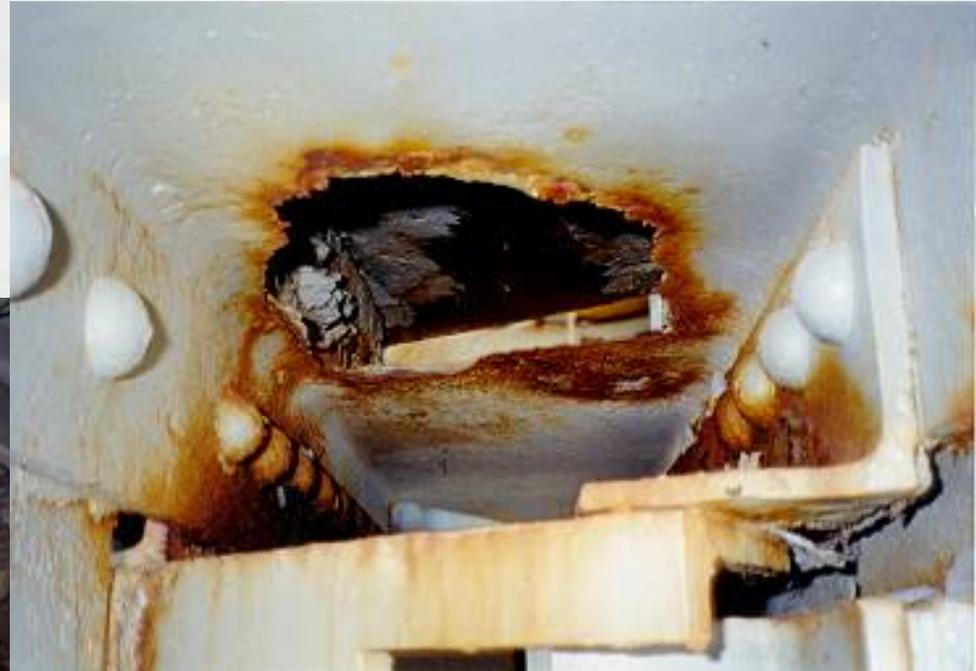
Original Sector Gate Condition

- The original sector gates had sustained quite a bit of damage and corrosion over their 75 year life span

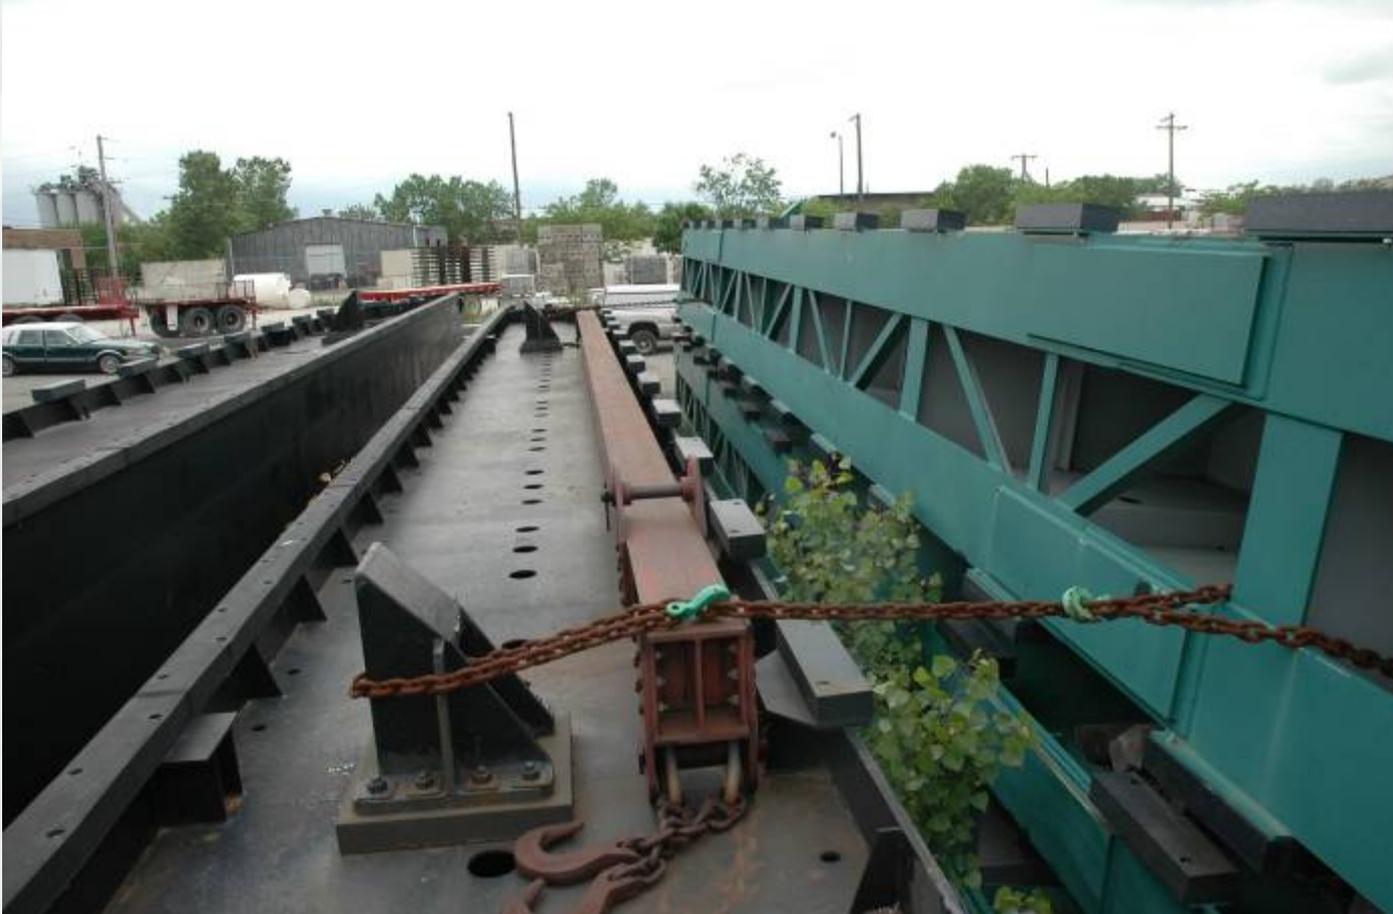
Stop Log Storage Problems

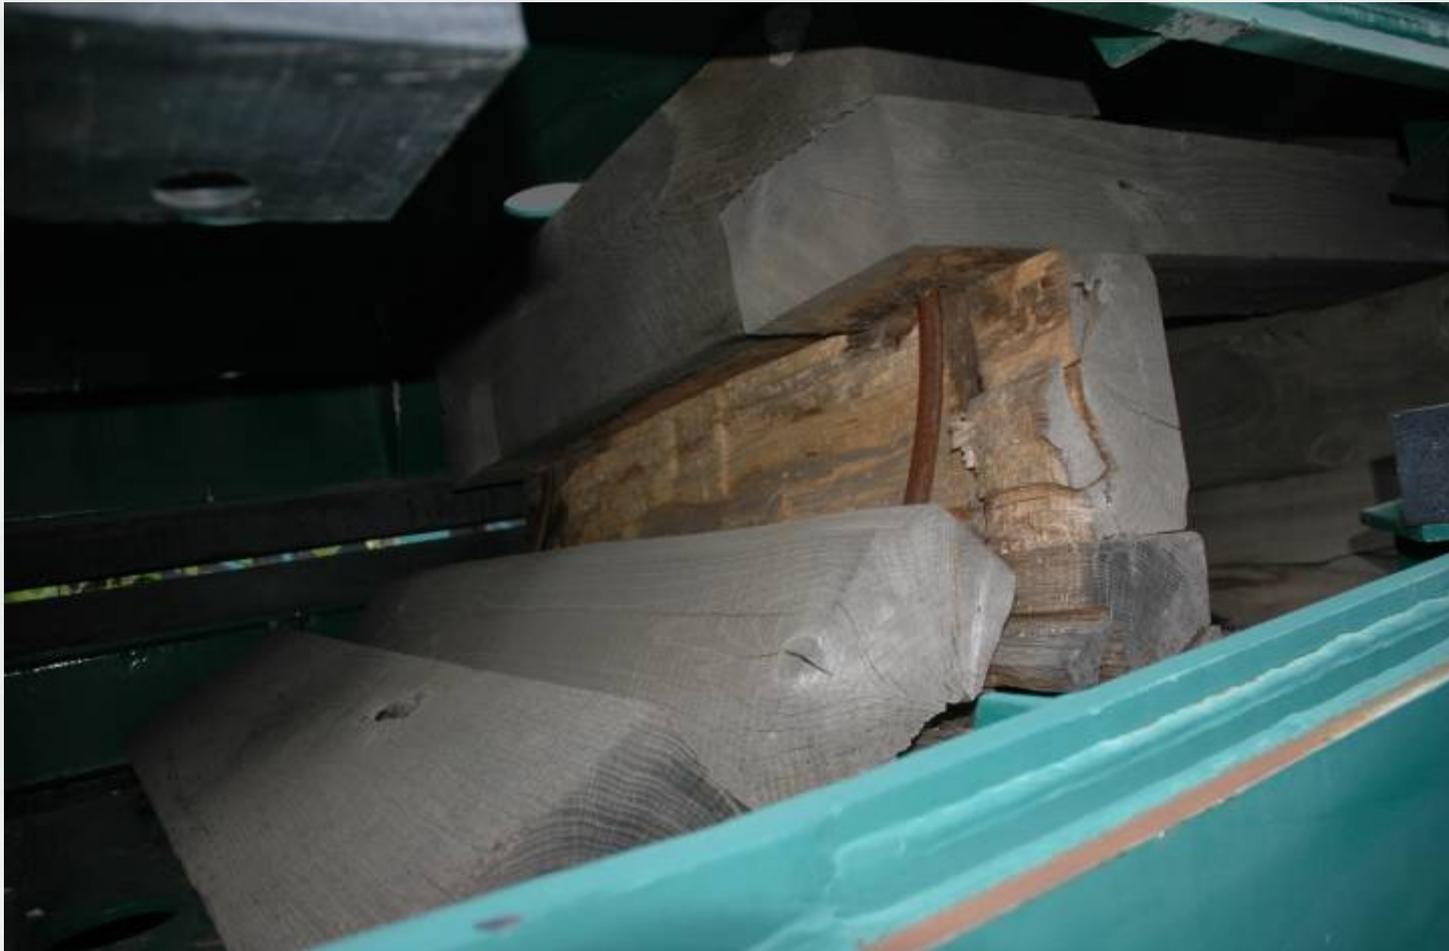
Poor Blocking Design Used

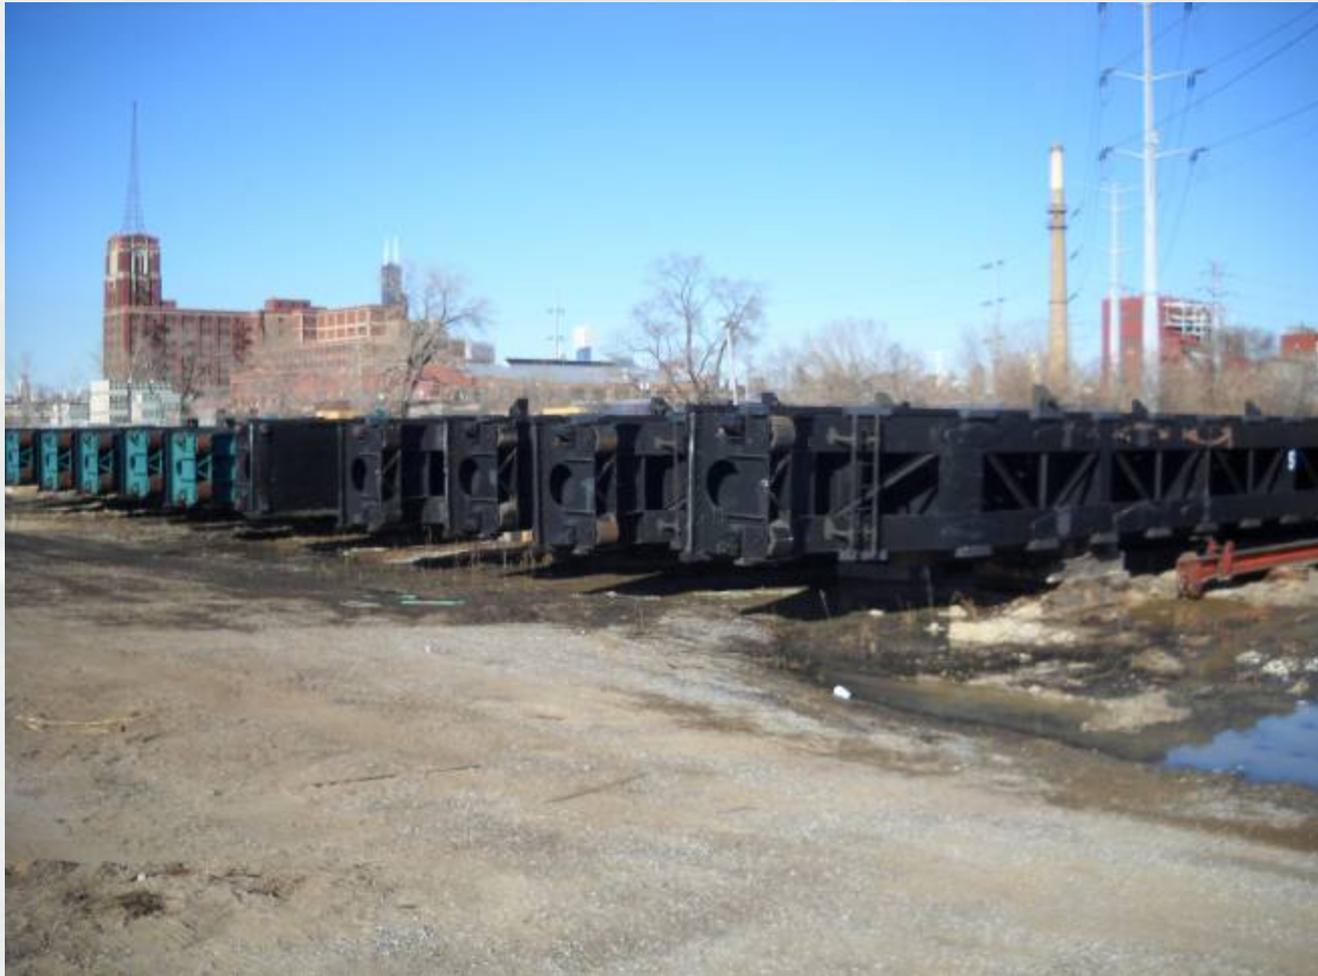
Storage Site Under Water

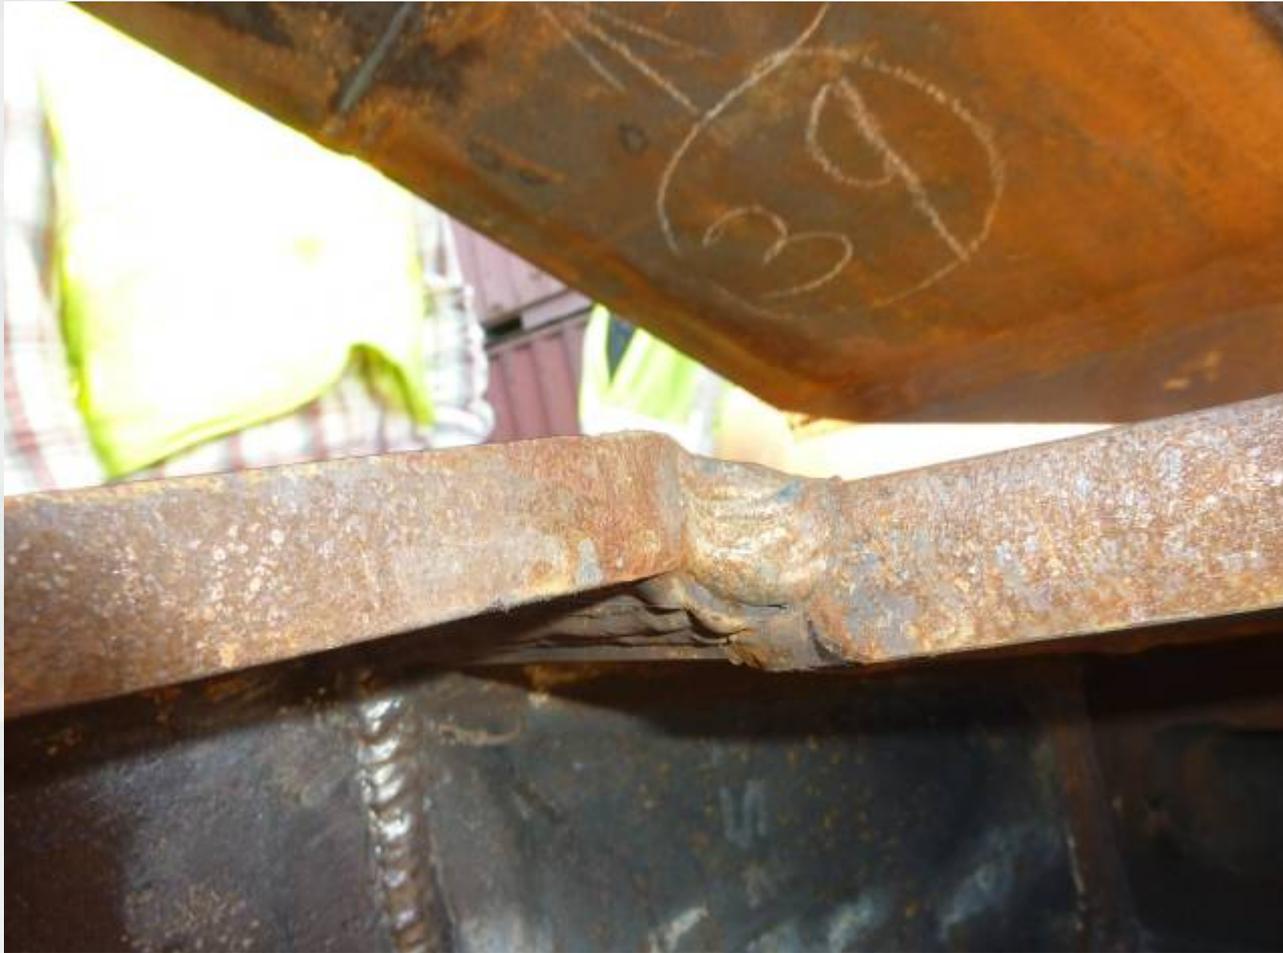
Pintle Built-up section size inconsistencies

Mismatched Member flanges

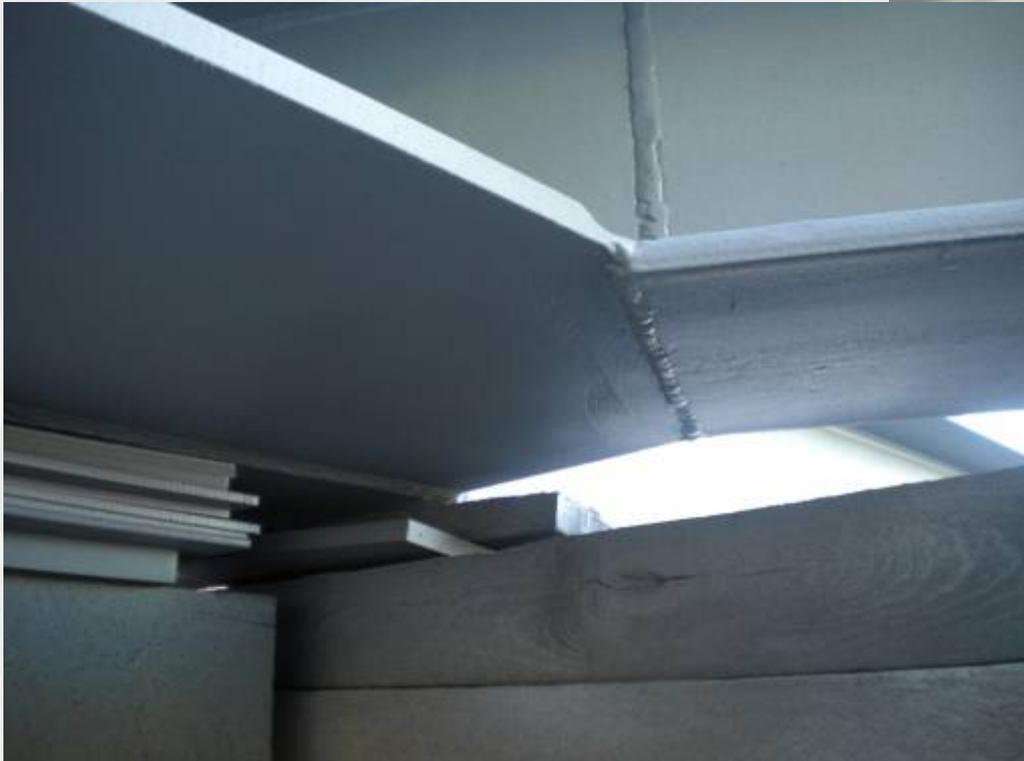
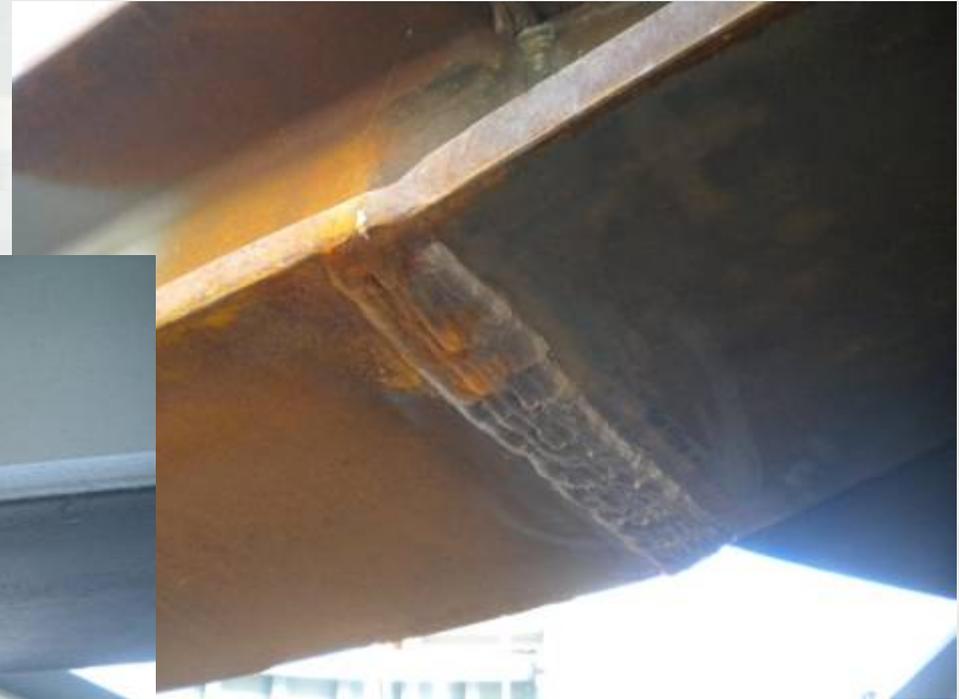
Poor Fit-Up & Alignment

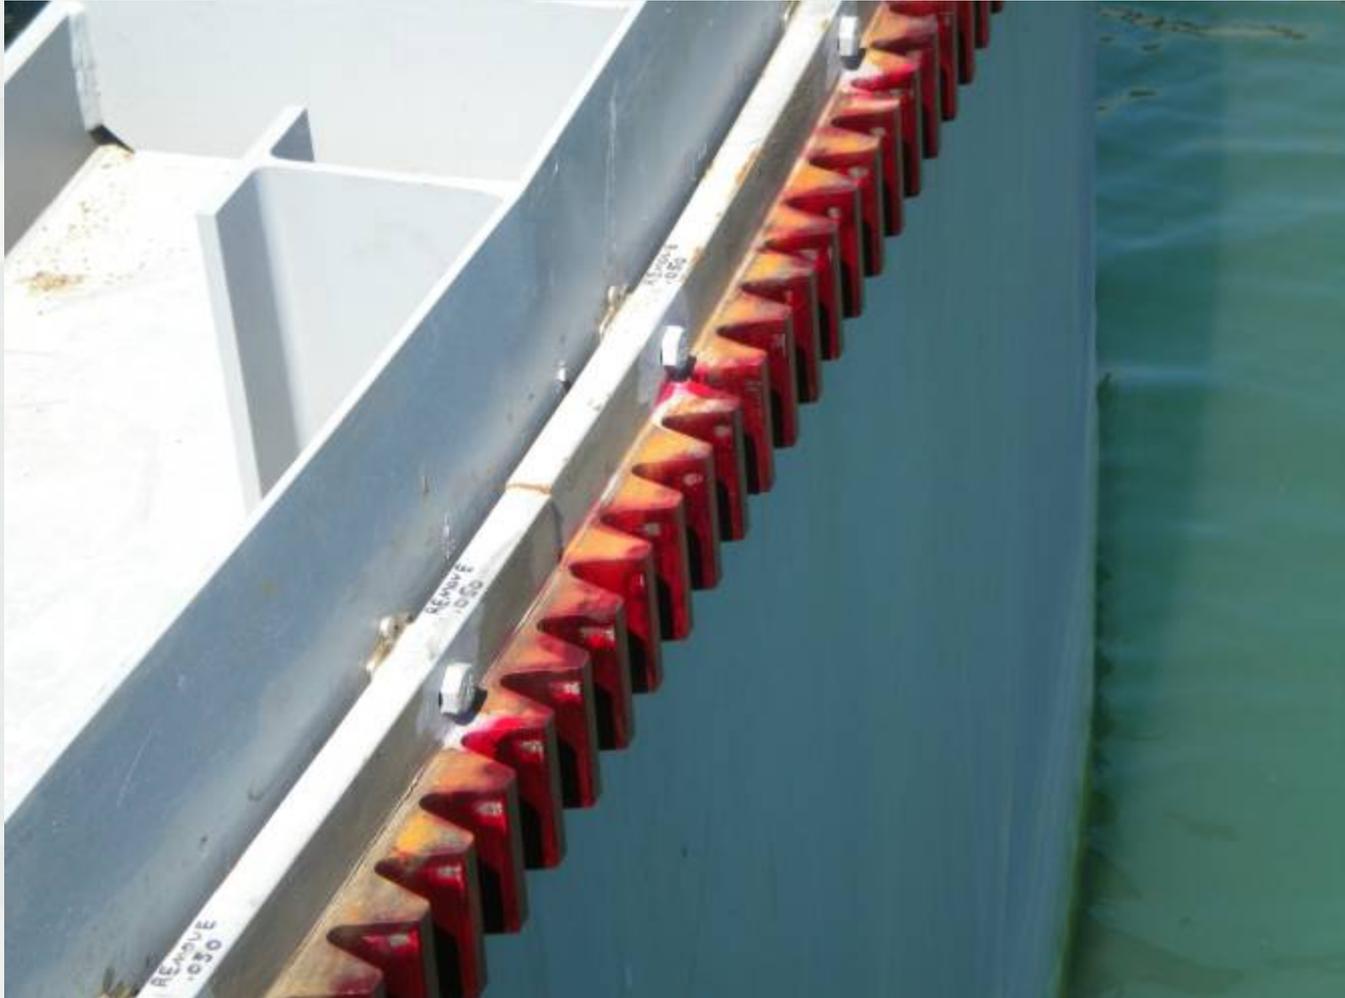
Poor Tooth Contact Pattern Discovered

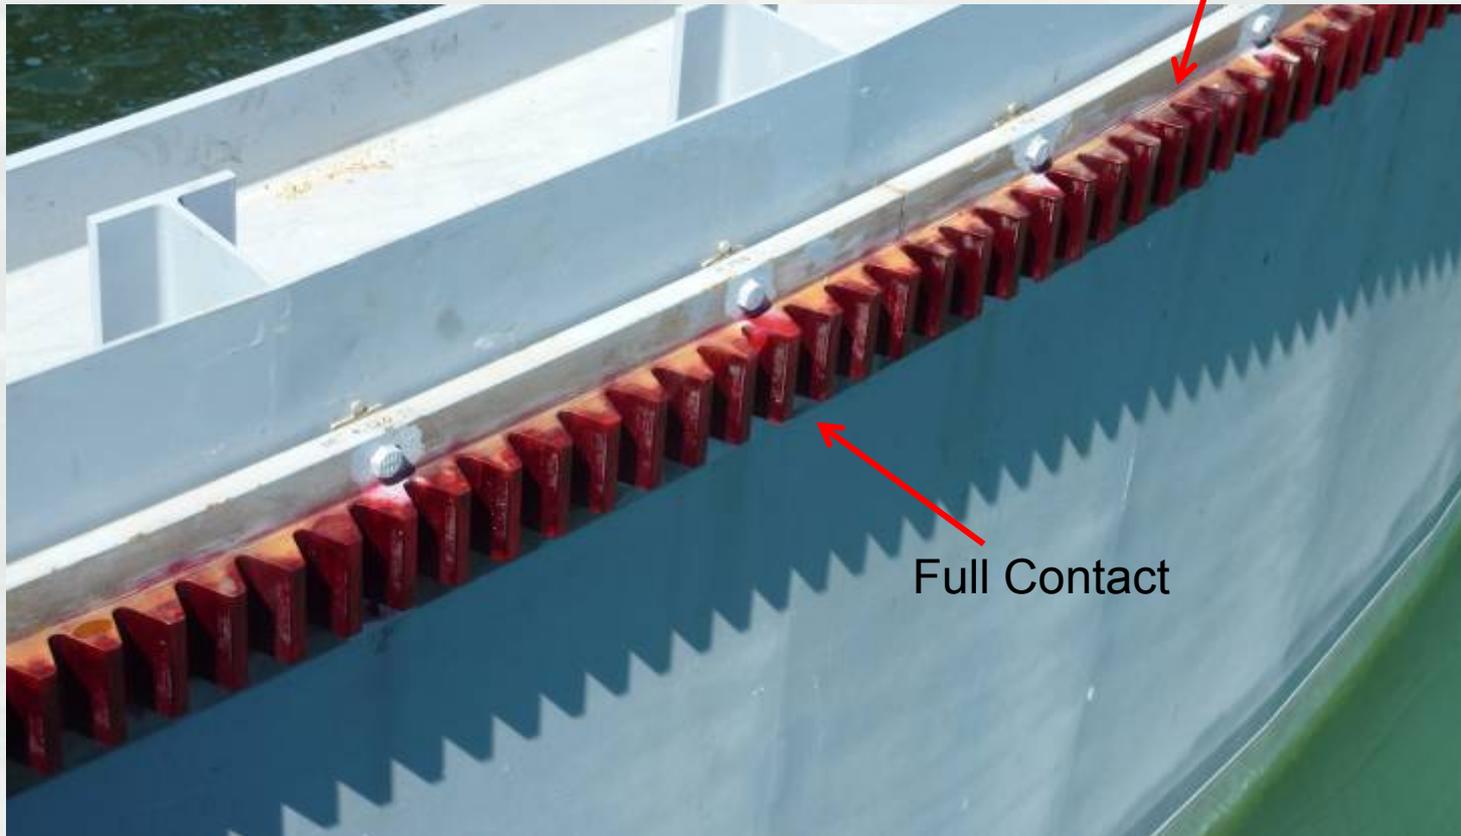
- Dykem Fluid test to determine points of contact

Minimal Contact

Full Contact

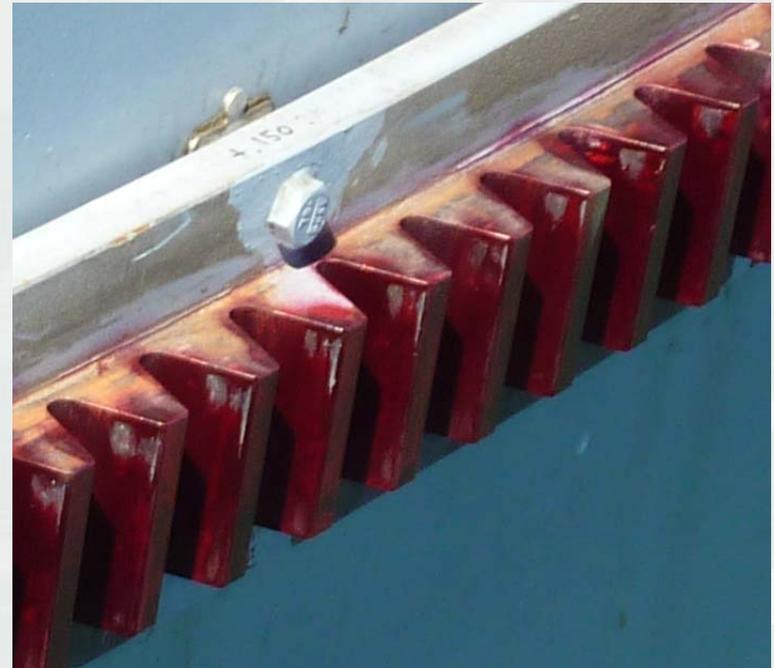
Full Contact at center of rack tooth

Minimal Contact at top of rack tooth

This rack misalignment will cause:

- Variable/ Premature wear
- Rounding of Pinion Teeth
- Potential for gate binding

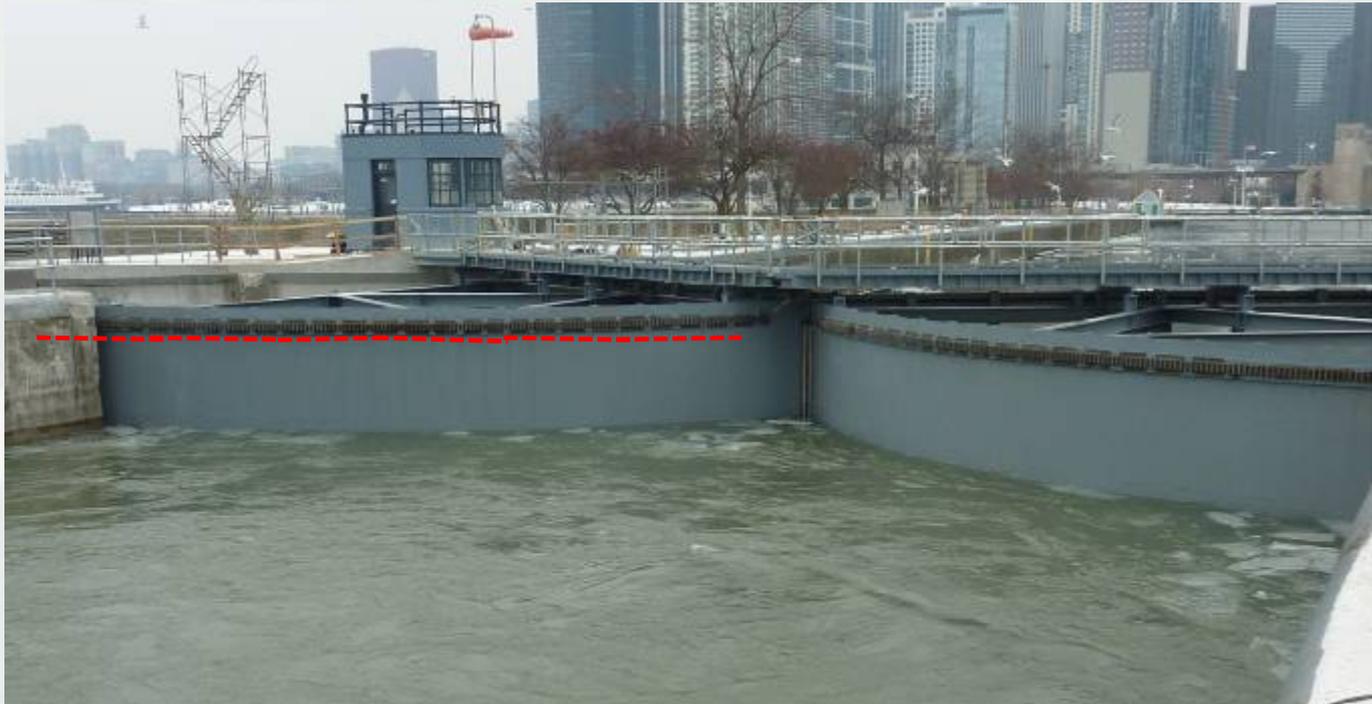
- Large variation in individual rack section installation

Racks not level, plumb, or well aligned at joints

- The plans and specs should have required that field drilling and installation of racks was required. Slotting the holes for field adjustability was also necessary at the worst areas
(Louisville Crew made these repairs)
- Our plans should have specified a tolerance over the entire length of the rack, not just individual sections
- Specs should have required a dye test be performed as a performance test before accepting the gates

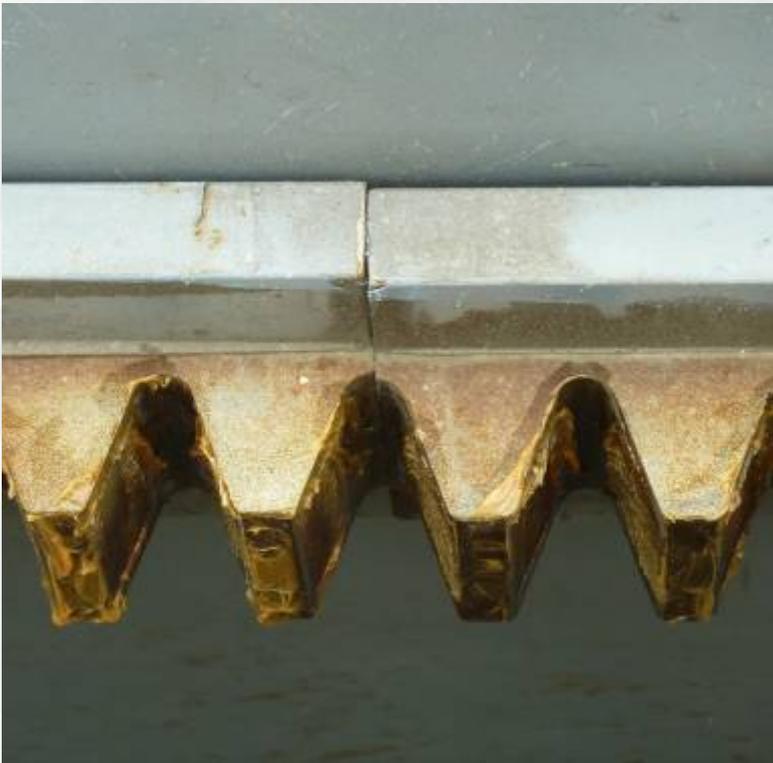
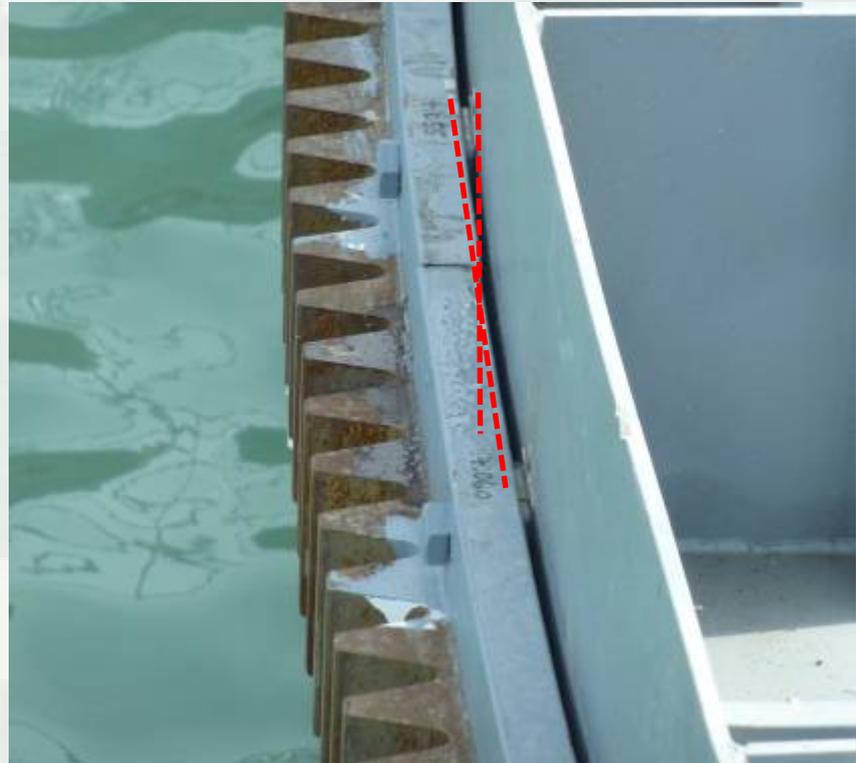
- Large variation in rack pitch

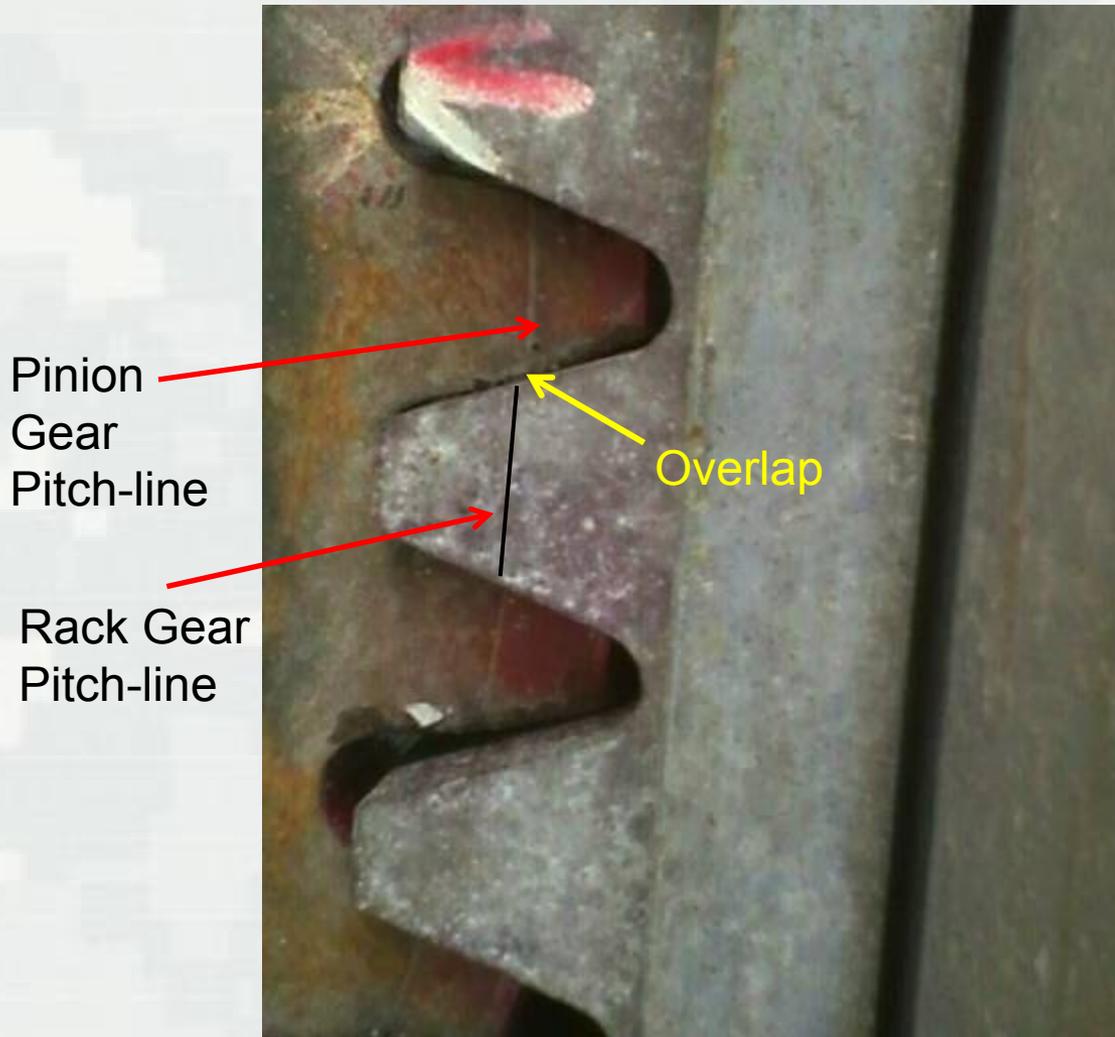
Lessons Learned – HPU Installation/ Pitchline Separation in HOT WEATHER

- Per our plans and specs these pitch lines are to coincide at 140 degrees
- The pitch lines were past overlapping at 80 degrees ambient temperature and low water temperature
- Temperatures reached 97 degrees during the summer of 2011 in Chicago
- **Potential for Binding!**

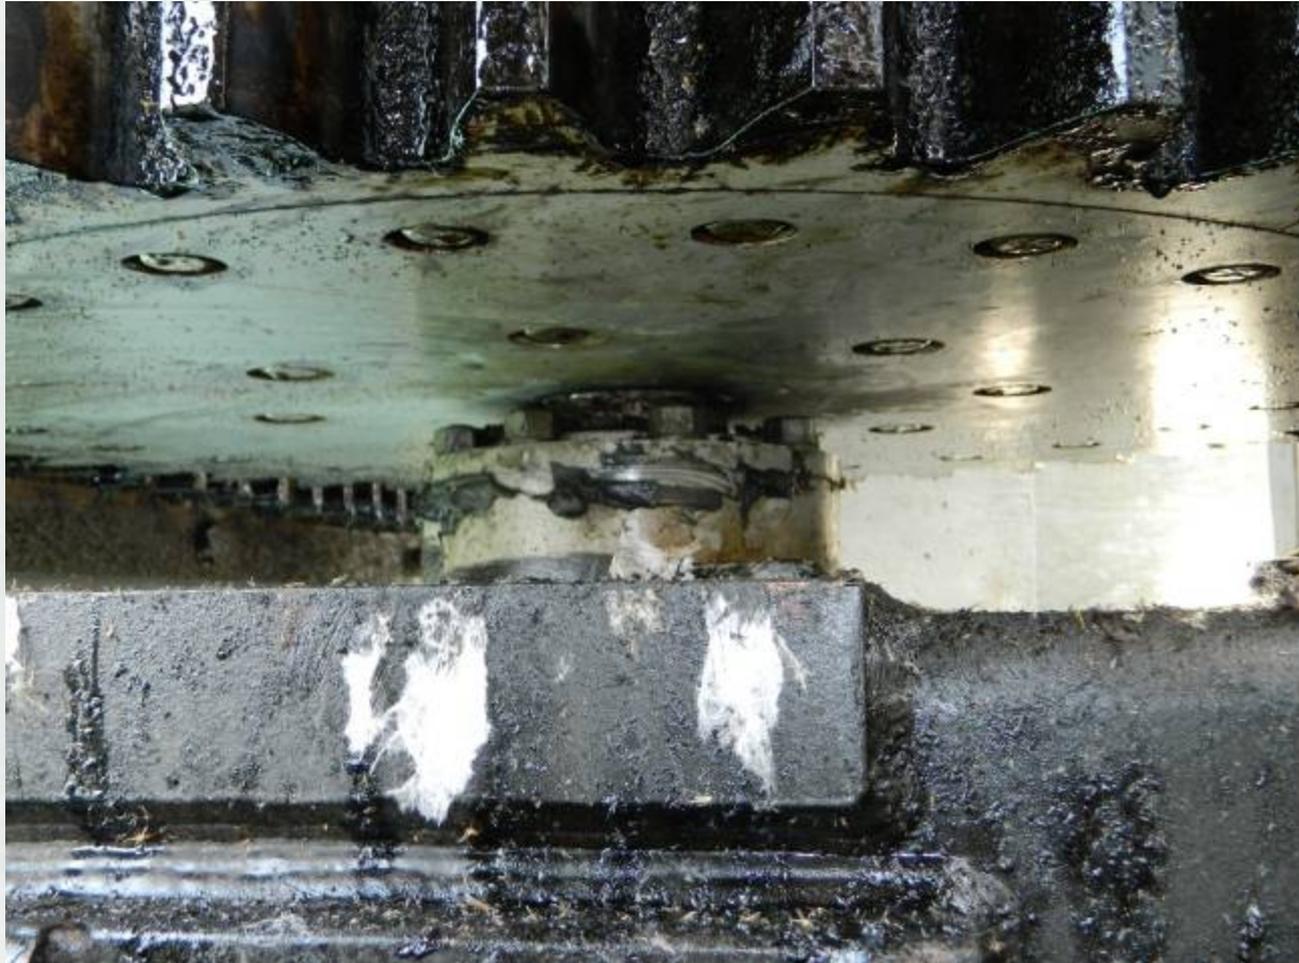
Damage to Pinion Gear Shaft Discovered During High Temperatures

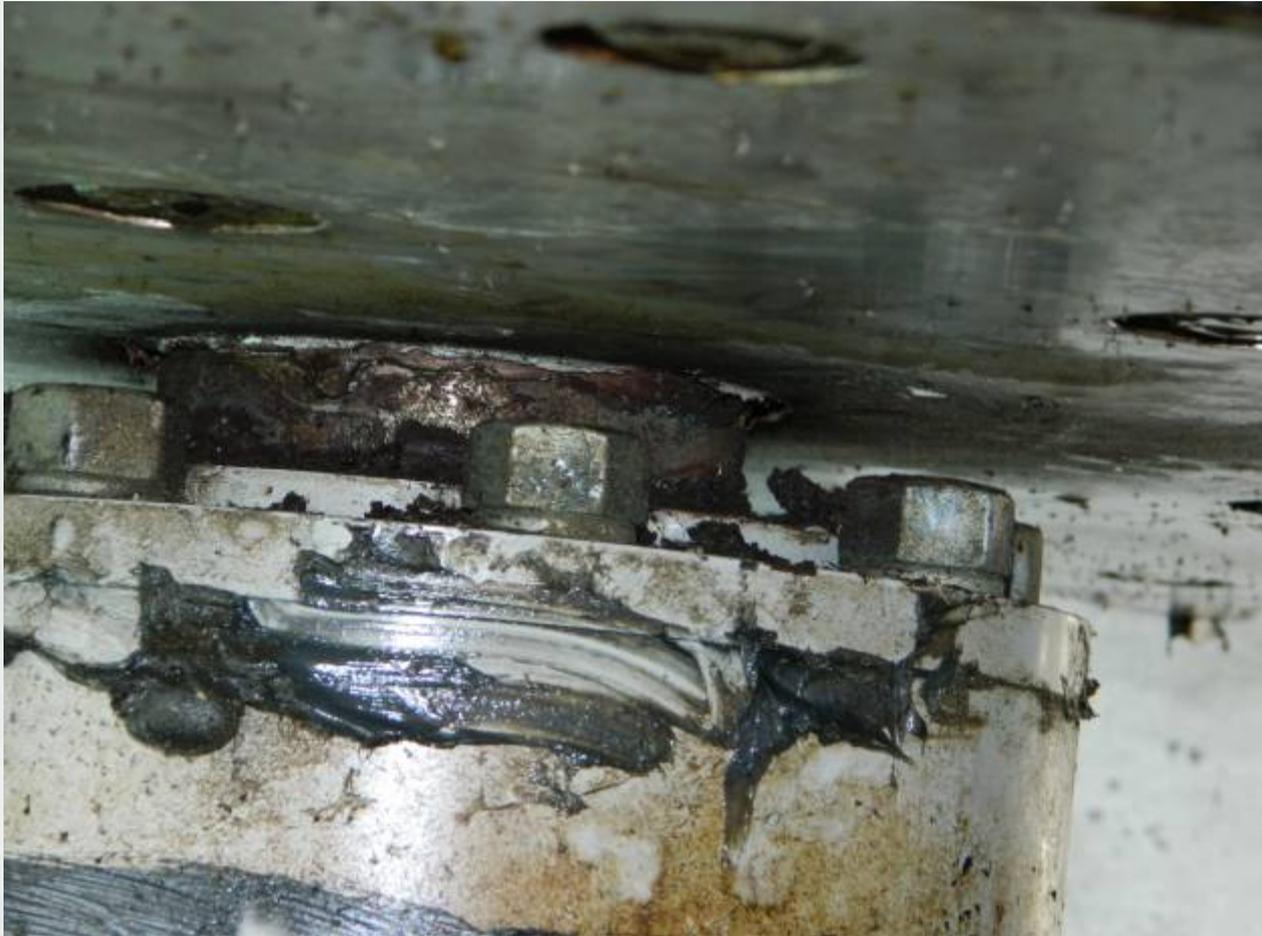
Shaft Weld Broken & Bolts Loose

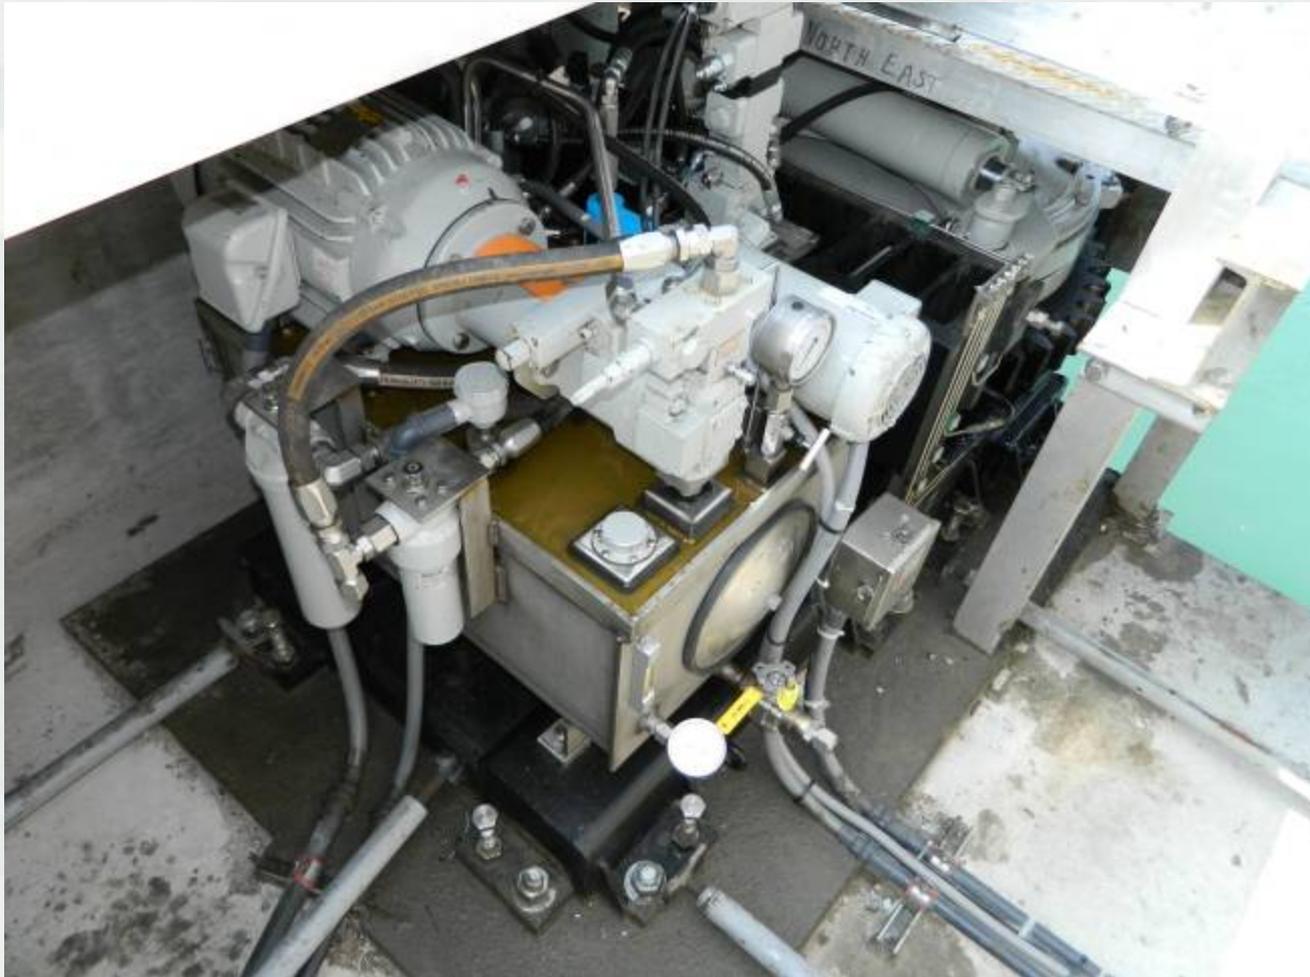
Repetitive, Large Oil Leaks

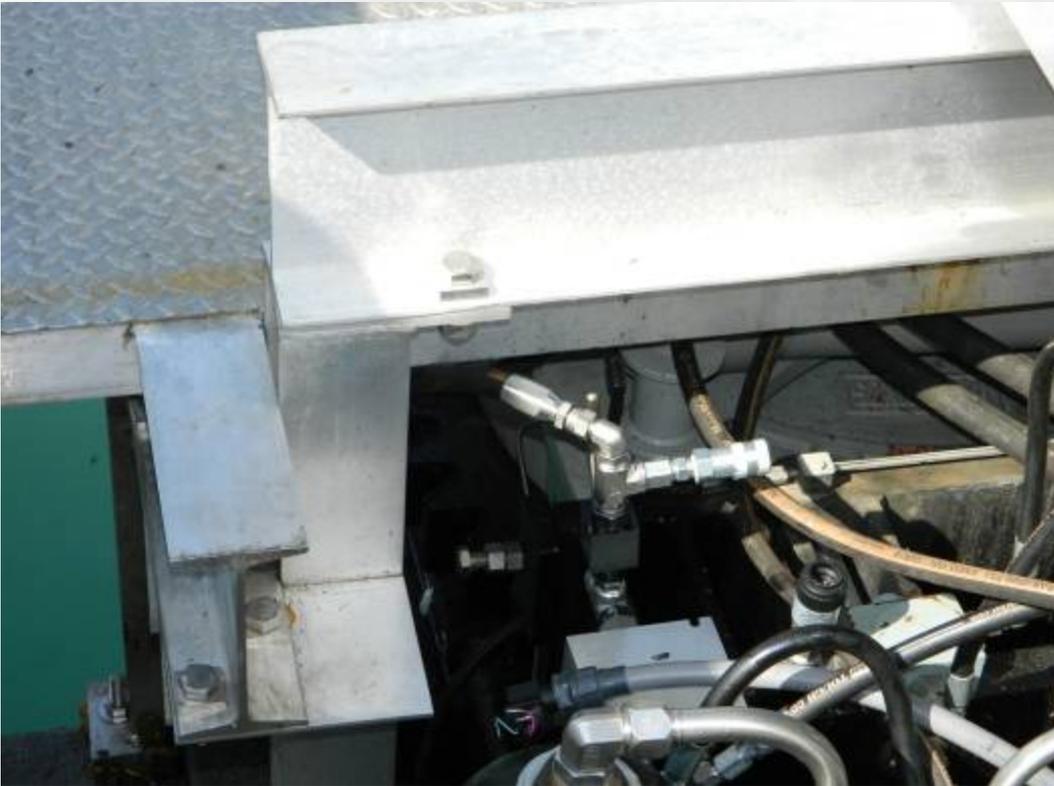
Hose & Fitting Variations Between the four HPU's

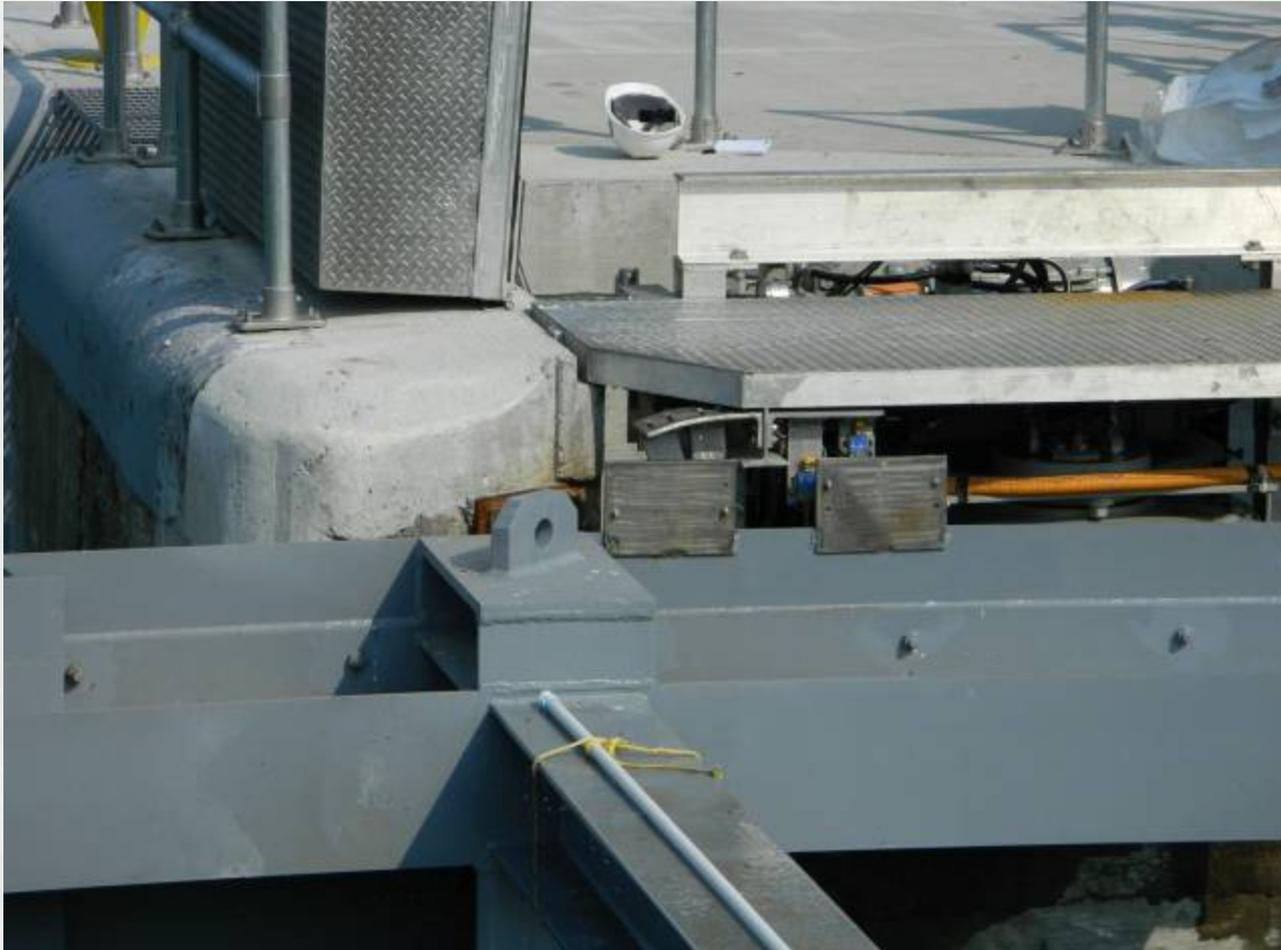
Limit Switch Failures

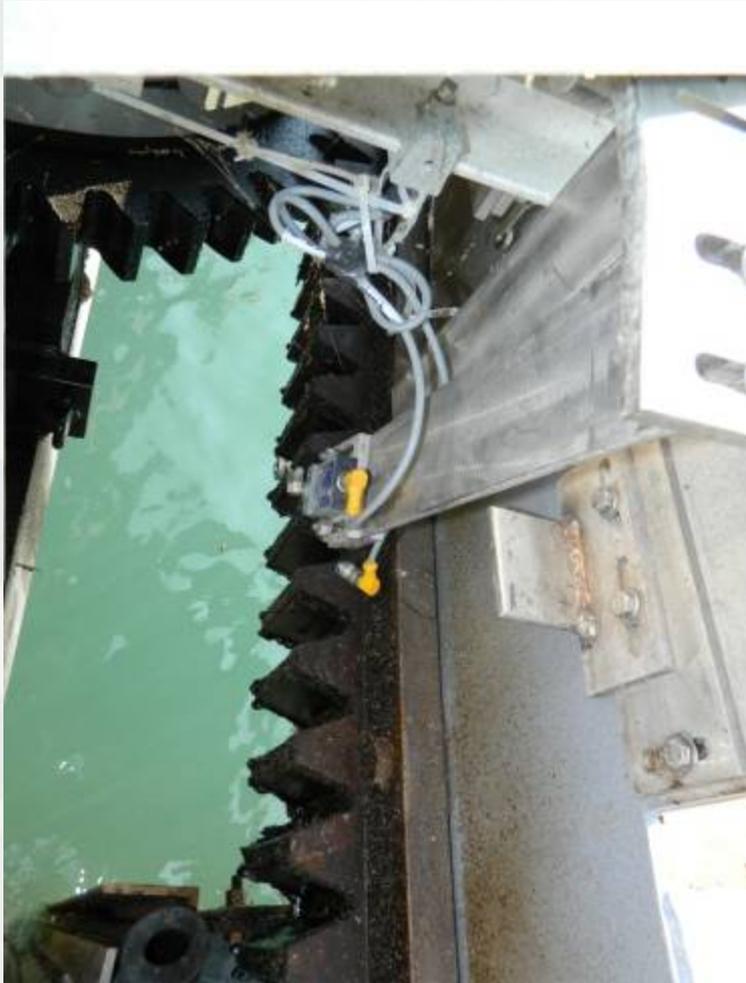
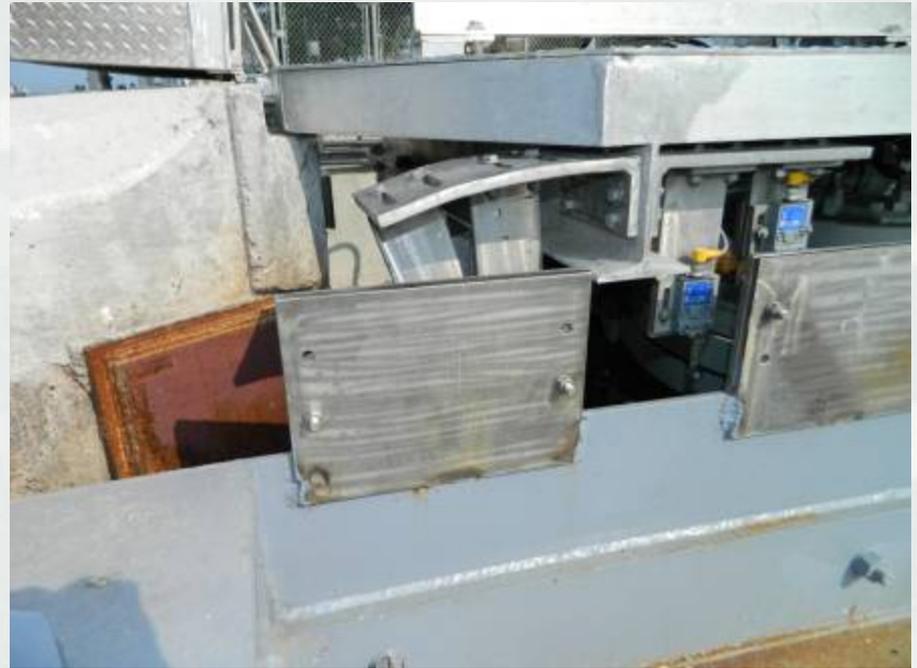
Bent Mounting Brackets and Broken Limit Switches Resulted

Limit Switches hung on walkway structure, causing unwanted movement.

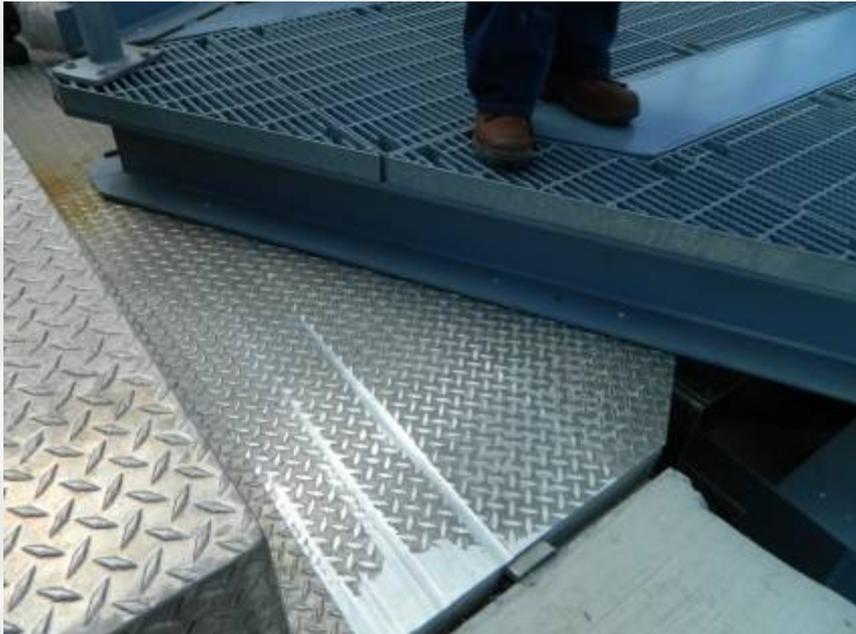
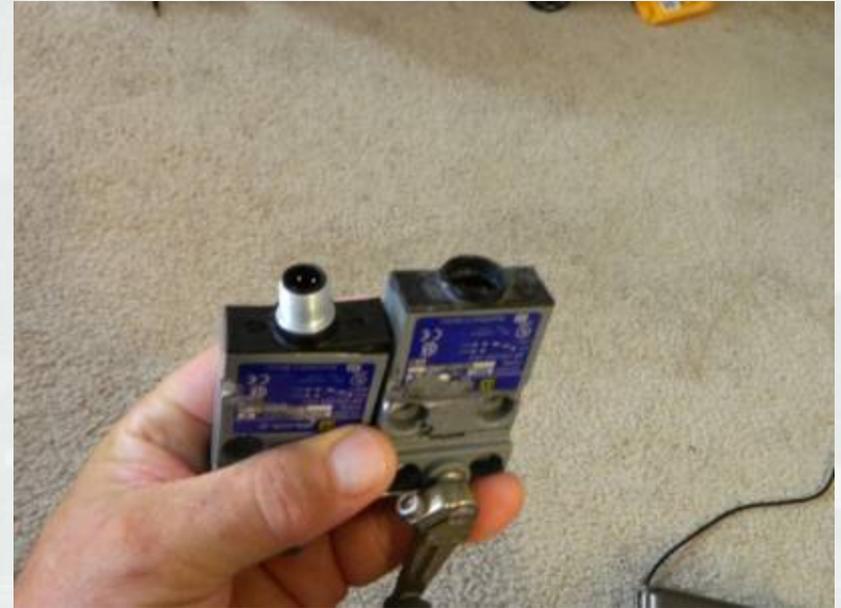
Thermal expansion Caused Racking of Lock Gate Structure and Walkway Supports

Limit Switches struck by Target, and 17 of 24 switches failed in first season
