CHICAGO HARBOR LOCK GATES

Replacement, Lessons Learned, Repairs & Successes

Robert (Bob) Ojala

12 February 2013

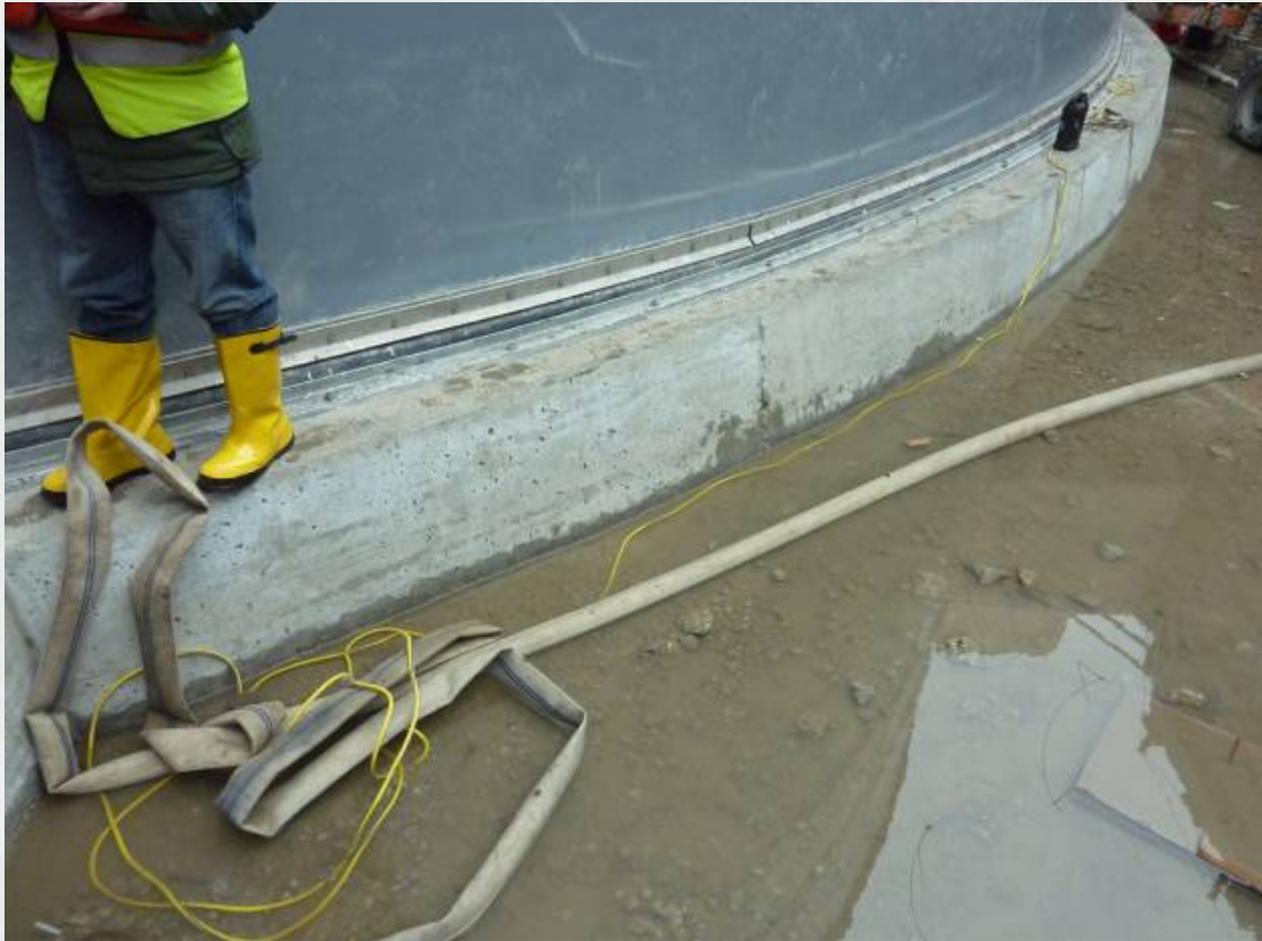
Bottom Seal Too Tight when Structure Racked in Hot Weather

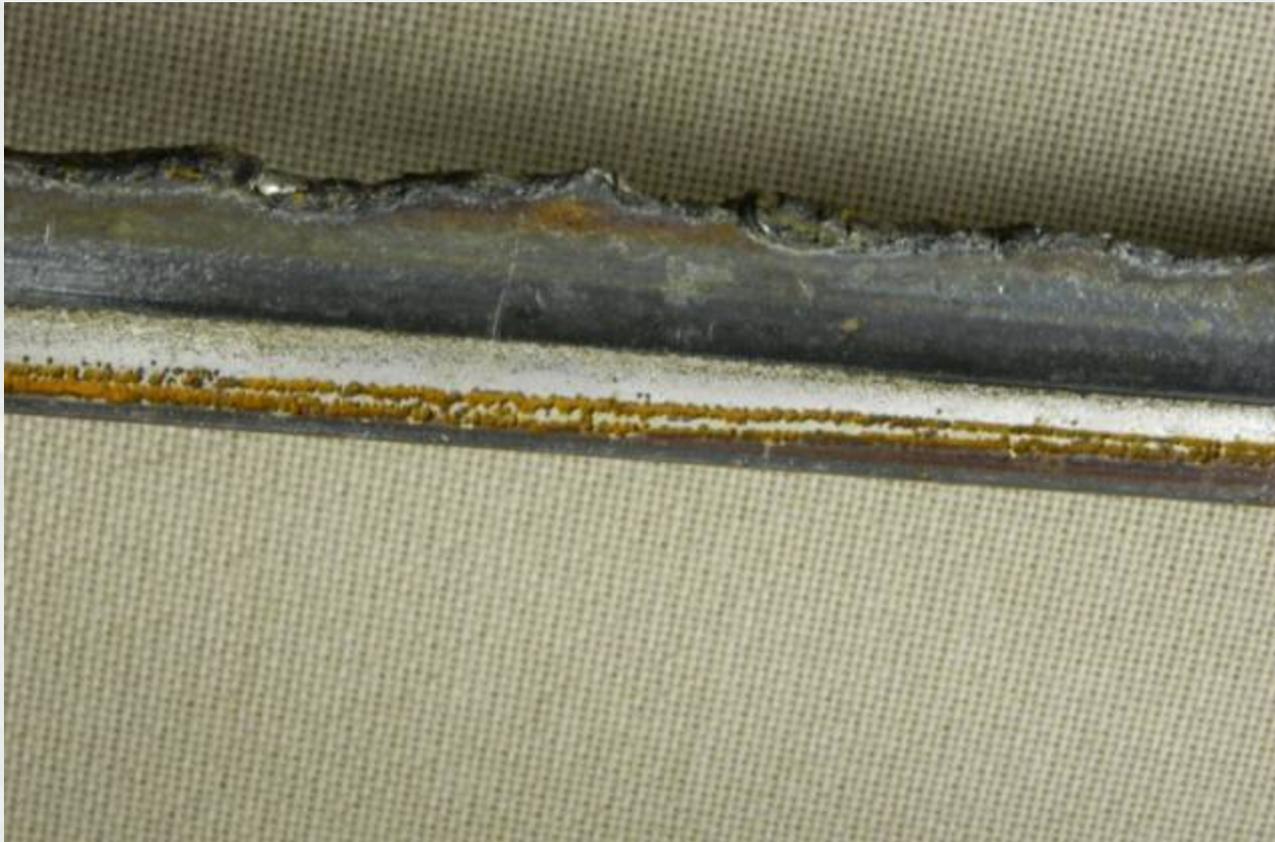
Lower Seal Stainless Angle Iron showed severe pitting and corrosion after less than one year of service.

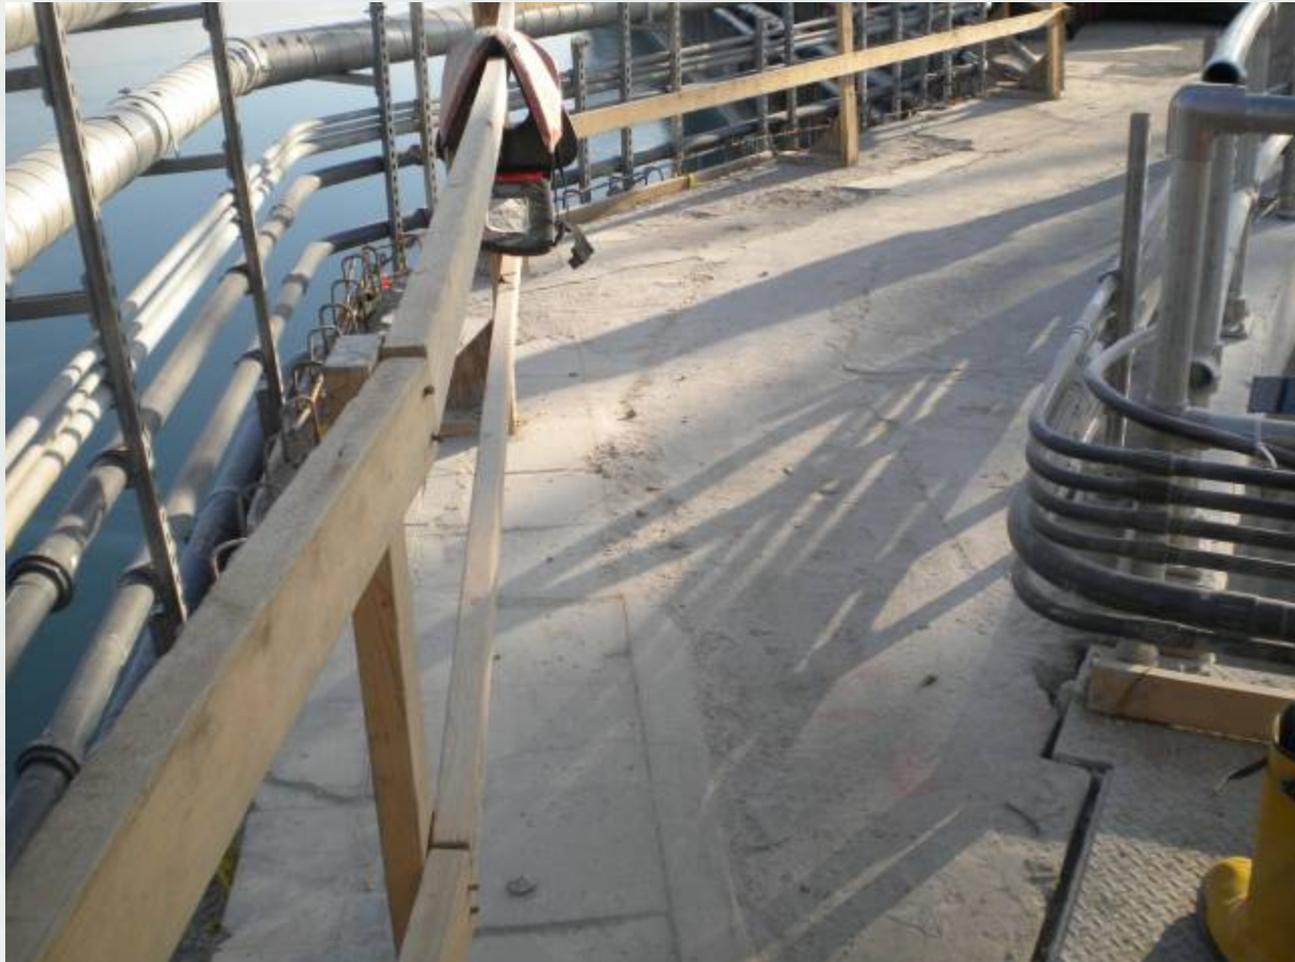
Walkway Pinch Points around Gates Discovered During Construction

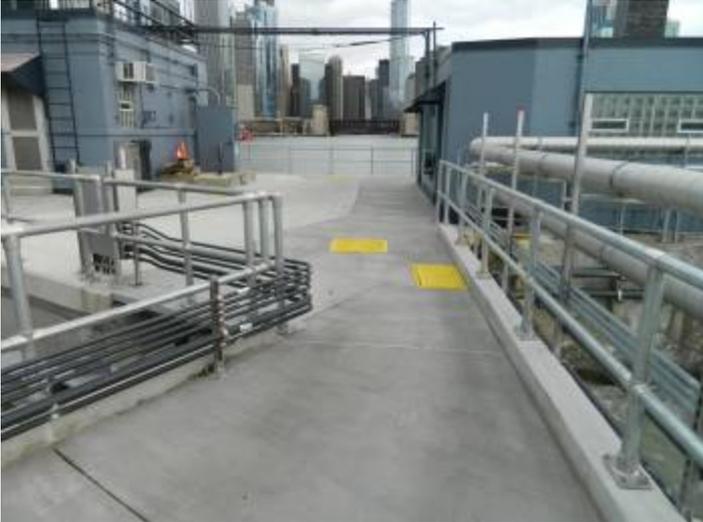
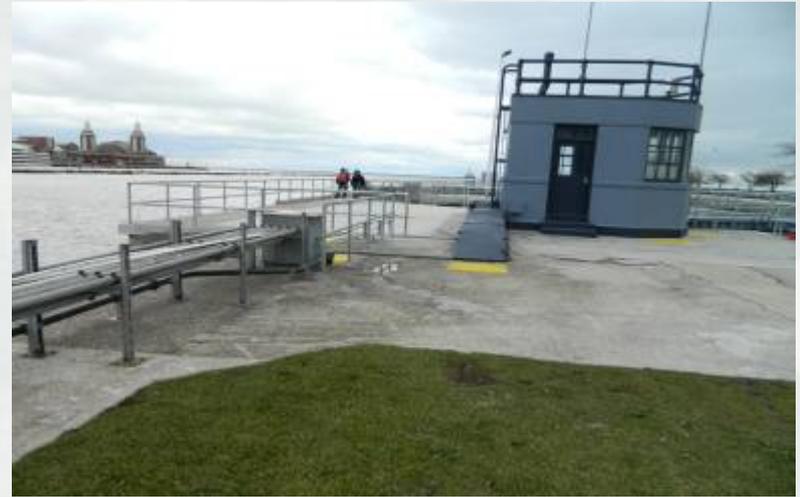
Access Pinch Points Created

#2 – Problem remains

#1 – Contractor made partial repair

#3 Moved Railing

#4 - Removed obsolete building
