Black Rock Lock Bearing Replacement

David Mastriano
Civil Engineer
NY/PA O&M
Buffalo District (LRB)

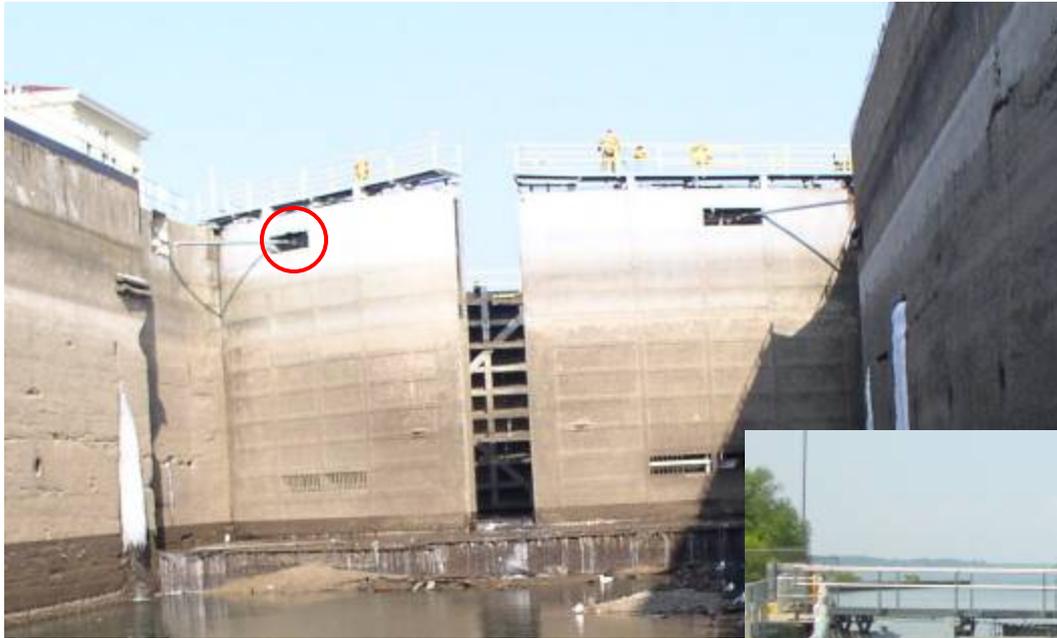
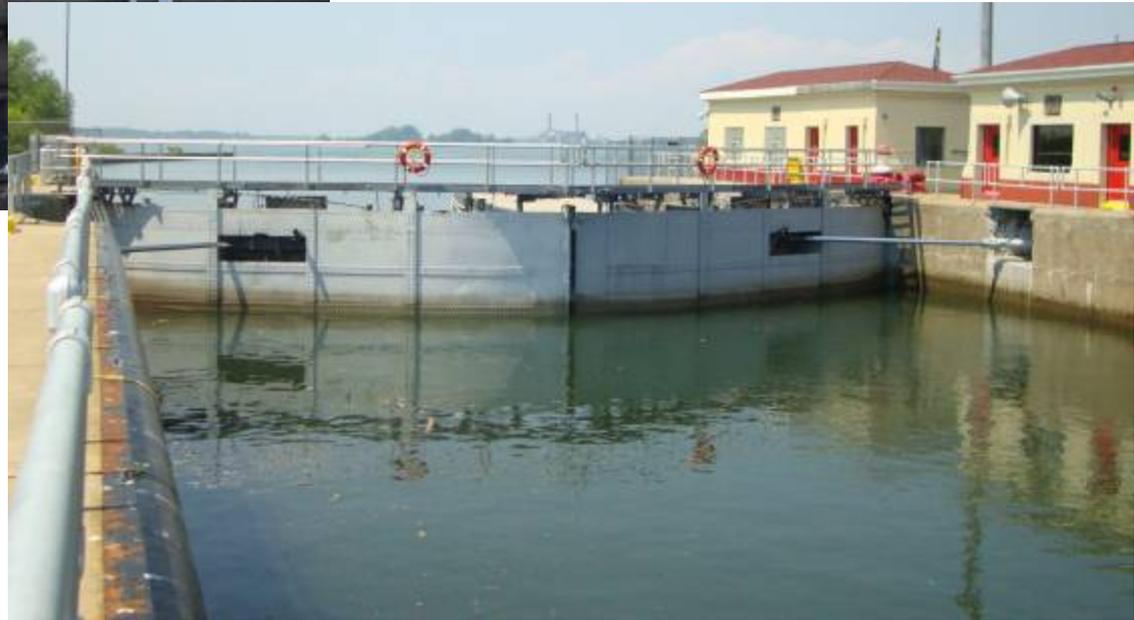
Miter Gate Hydraulic Cylinder Connection Pin

4" diameter clevis pin has been slowly working its way out over the past several years. Pin was only held in place by force fits.

Rod end eye with spherical bearing inside. Can see the slight horizontal rotation/tilt. Bottom cotter pin has been destroyed.

- ▶ New 4” pin shall be a 4XX series stainless steel with min. RC40 hardness and min. surface finish of RA16.
- ▶ Pin shall have FN2 medium force fit to the clevis bracket and FN5 force fit to clevis eye to reduce fretting.
- ▶ In addition, keeper plates will be installed on both ends of the pin to prevent future pin slippage along the longitudinal axis.

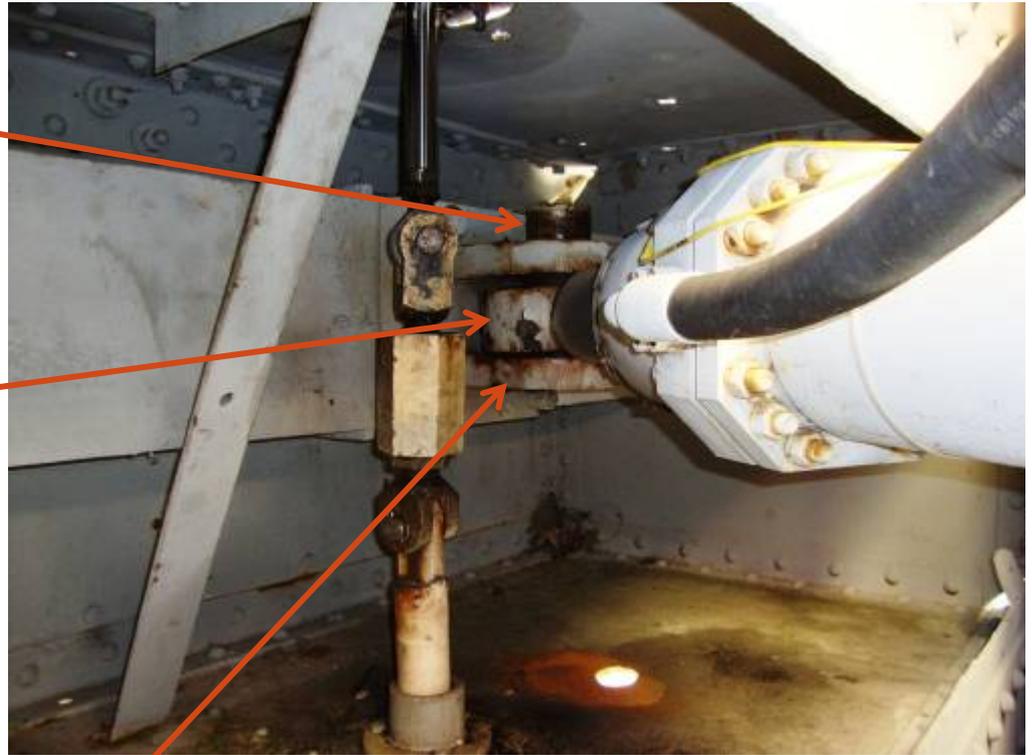
Clevis bracket

- ▶ This is the old identical assembly which was removed in the late 90's and has been exposed outdoors for several years. Attempt at pressing out with 20 tons of force was unsuccessful, which was the limit of the lock's maintenance capabilities.

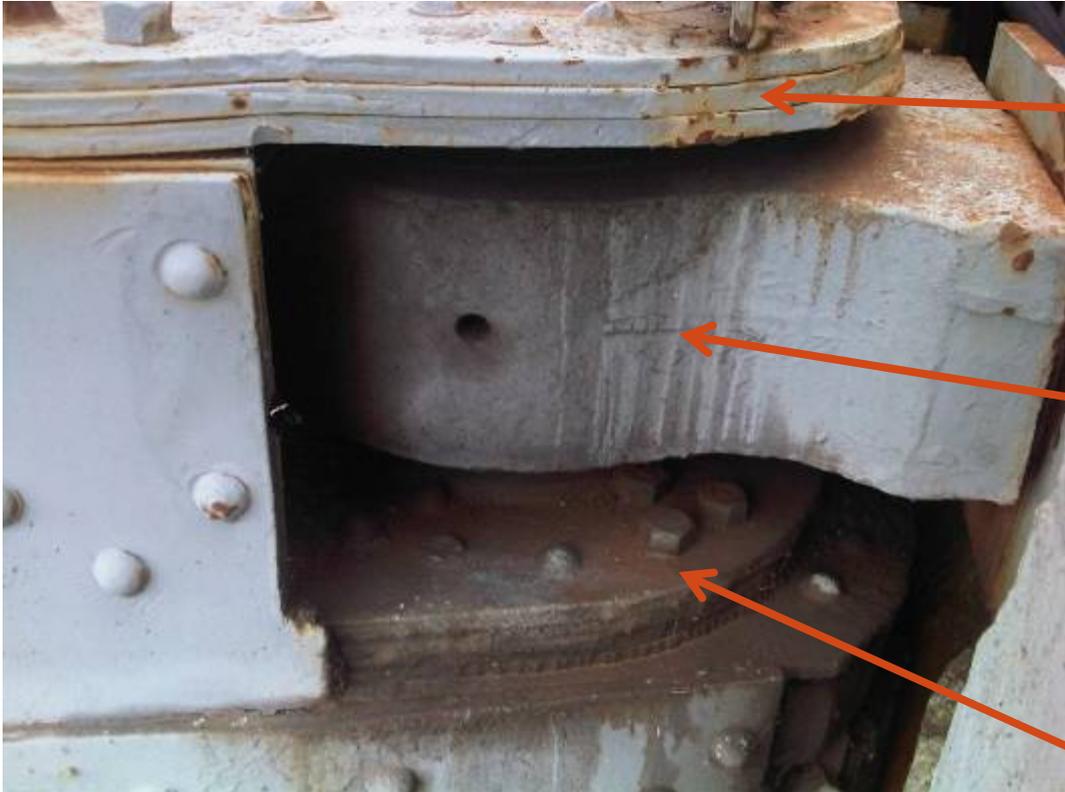
Gudgeon Bearing

Top plate of the lock gate. This piece is 3 cast iron plates riveted together and secures the upper portion of the hinge pin. The pin is welded to this plate.

Casting that houses the bearing. This is connected to the tie bars. Bearing is a TRAXL type bearing, i.e. bronze shell with a thin layer of low friction polymer in the inner bore. Maintenance free, requires no grease.

Bottom plate of the lock gate. This piece is 3 iron plates riveted together and secures the lower portion of the hinge pin. The pin has a slip fit into this plate.

- ▶ The lower east bearing was replaced in Spring 1993.
- ▶ Has been noisy for the past few years, generally during hot weather. (originally noted in the 2005 PI)
- ▶ Inspection had not indicated a problem, however we have continued to monitor this gate.
- ▶ Recently, shavings of bronze have been discovered below the bearing. This indicates that the low friction liner has worn away from the bronze shell that backs the liner. (Traxl type bearing)

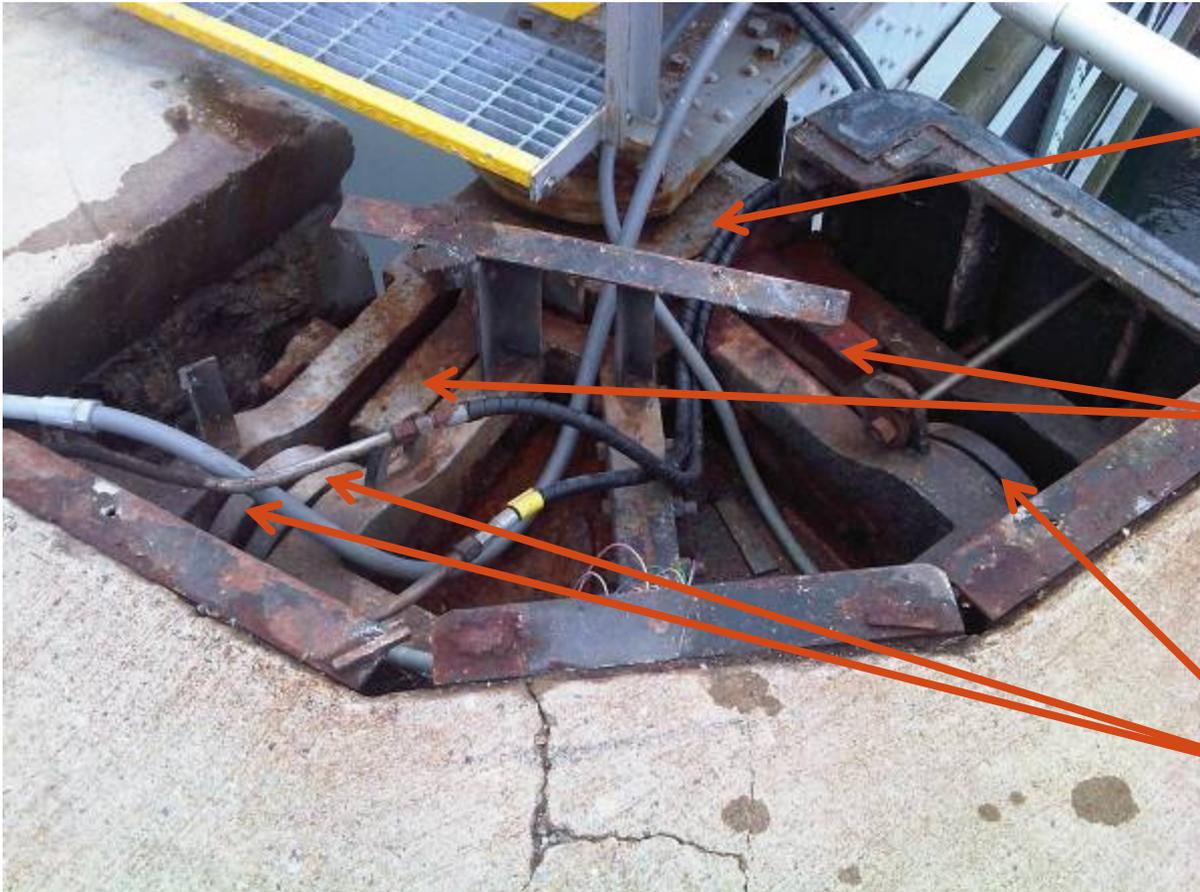
Anchorage Casting

Casting that houses the bearing. This is connected to the tie bars by way of intermediate castings

Casting "ears" that connect to split castings which transmit load to tie bars embedded in concrete

Tie bars transmit load to concrete lockwall

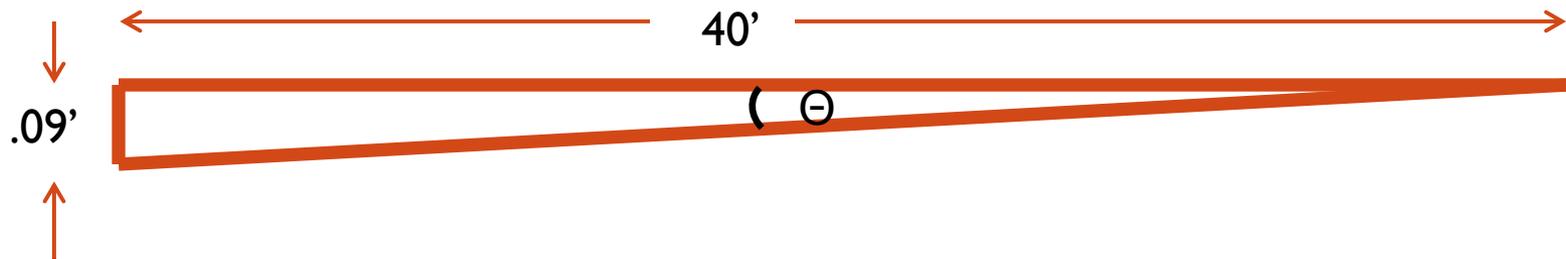
Gate Misalignment

0.09 feet over a distance of 40 feet equates to an angular misalignment of 0.13 degrees

$$\Theta = \tan^{-1} (0.09/40) = 0.13^\circ$$

- ▶ Use casting wedges to raise level of gates so that sag at low pool is minimized and the gates stay closer to the alignment they were in when the bearing and pin was installed (work done during high pool).
- ▶ Use a more misalignment compliant bearing
 - Provide larger running clearance in the bearing
 - Use a spherical type bearing which allows slight tilt of the pin

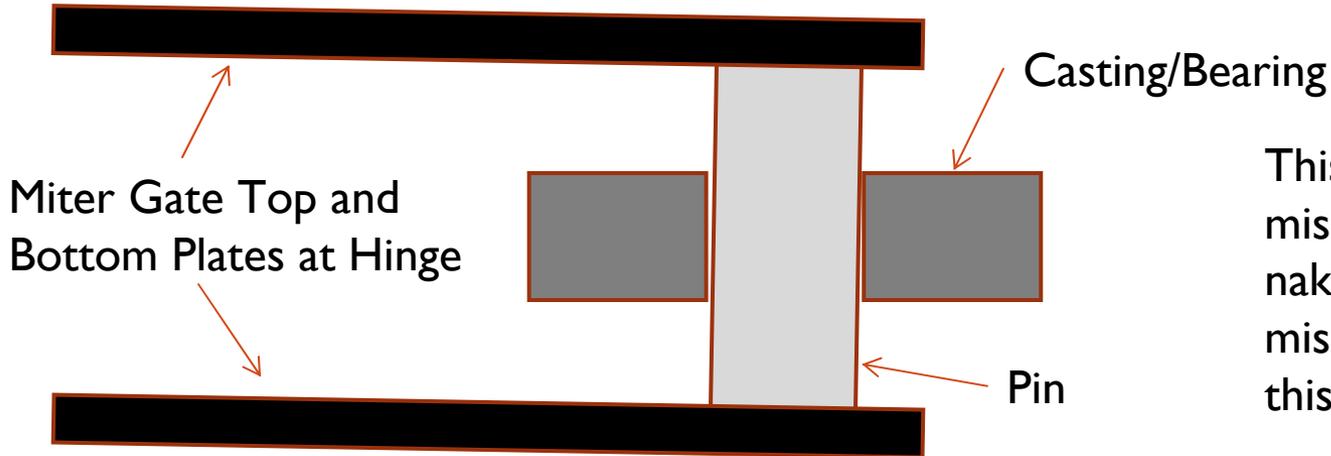
Pin Misalignment

This depiction is a 1 degree misalignment, visible to the naked eye. Actual misalignment is about 1/8 of this.

- ▶ Gate misalignment translates to pin misalignment
 - ▶ Pin “cocked” by 0.018”
 - ▶ Minimum running clearance recommended for 8” shaft by Thordon: 0.010”
 - ▶ Relatively high thermal expansion coefficient, temperature increase = clearance decrease
 - ▶ High ambient temp related to bearing noise as result of gate deformation from iron heating up

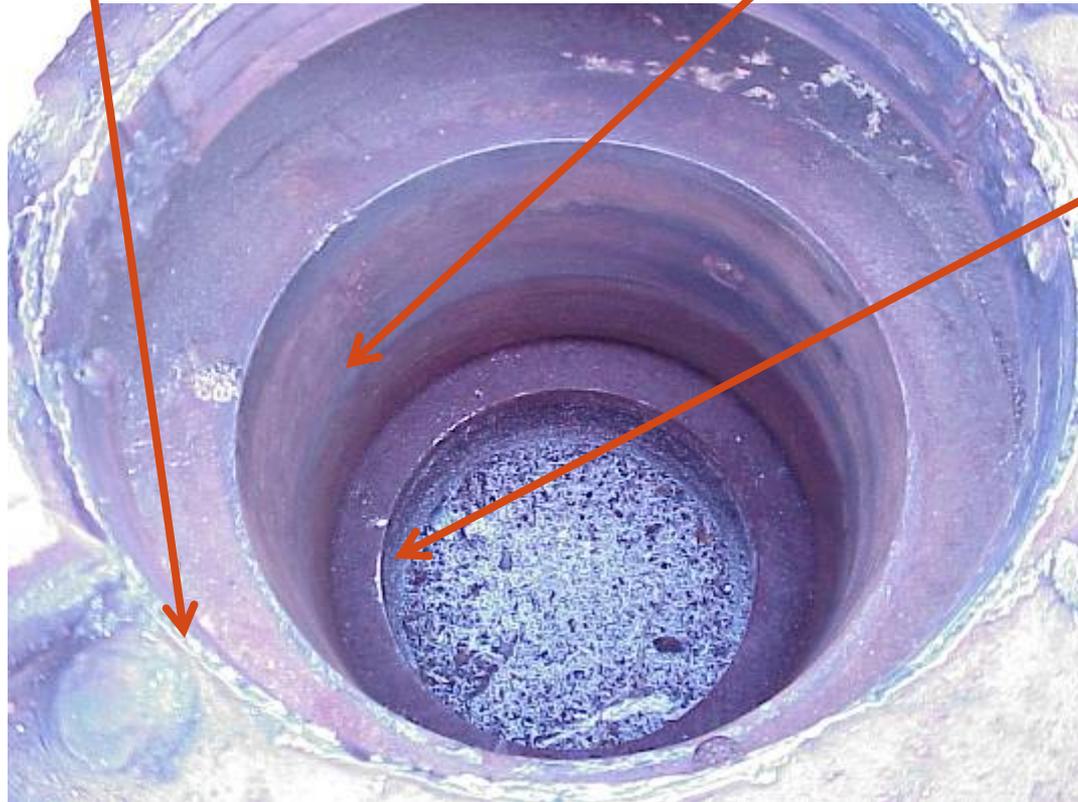
Ready for New Bearing

Inner diameter of top plate cutout

Inner diameter of the casting,
interference fit to new bearing

Inner diameter of bottom
plate cutout where the
bottom of the pin is
located

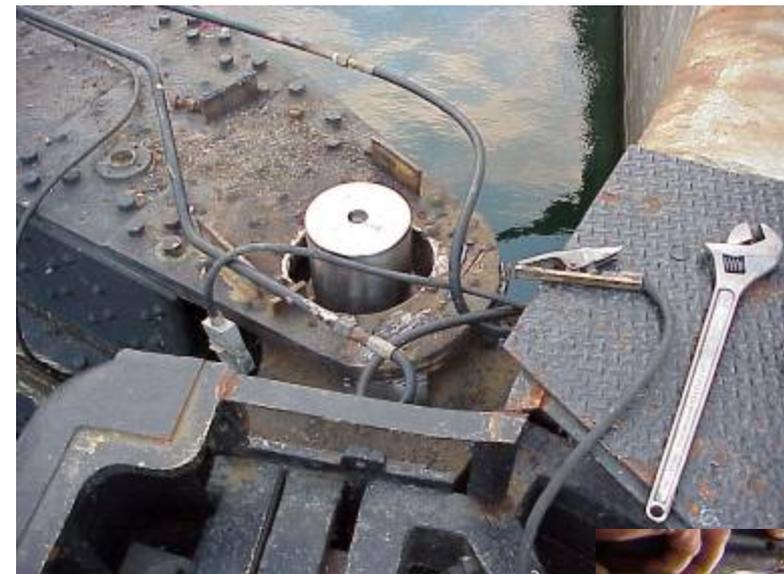
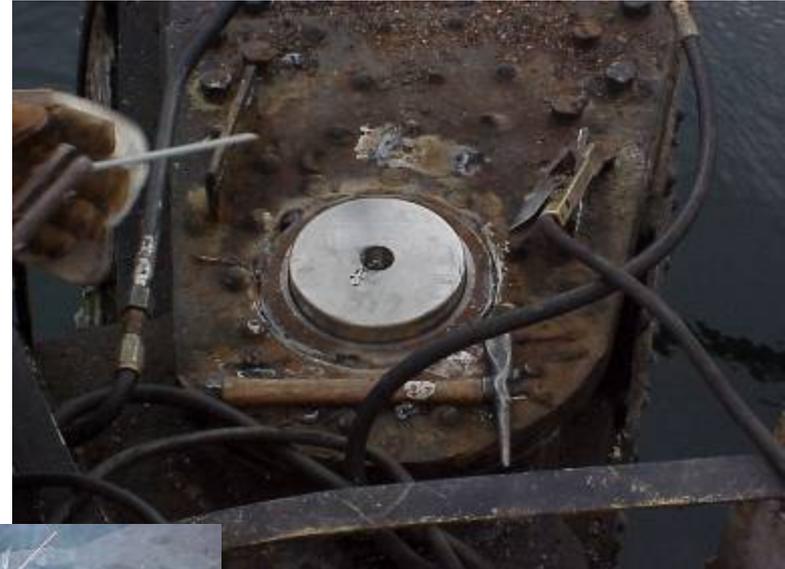
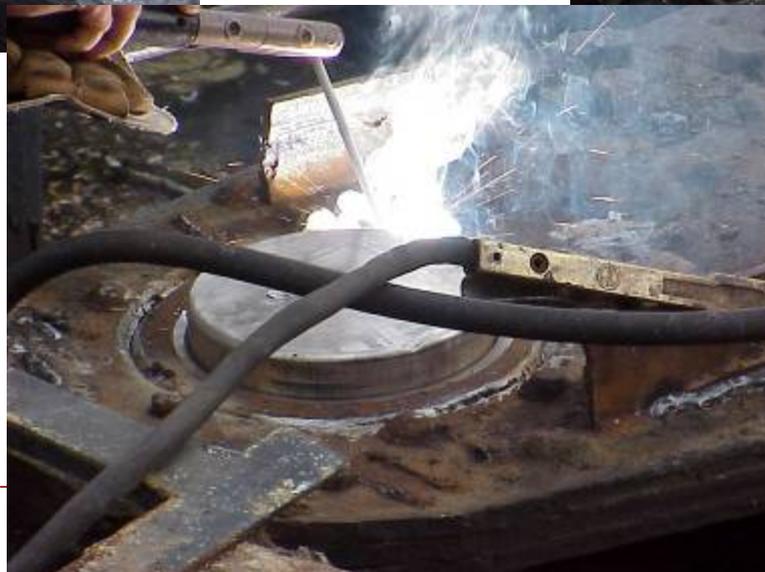
Insertion of Pin to Bearing and Installation of New Top Plate Insert

New pin is type 316L stainless steel, 18" long, nominally 8" in diameter.

Pin is a slip fit to the bottom plate, welded to the top plate insert.
