# Acoustical Imaging for Underwater Inspection

Oct 28, 2014

US Army Corps of Engineers  
**BUILDING STRONG**

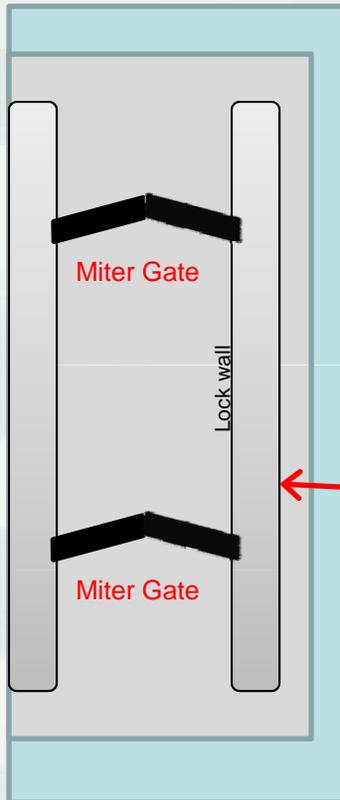
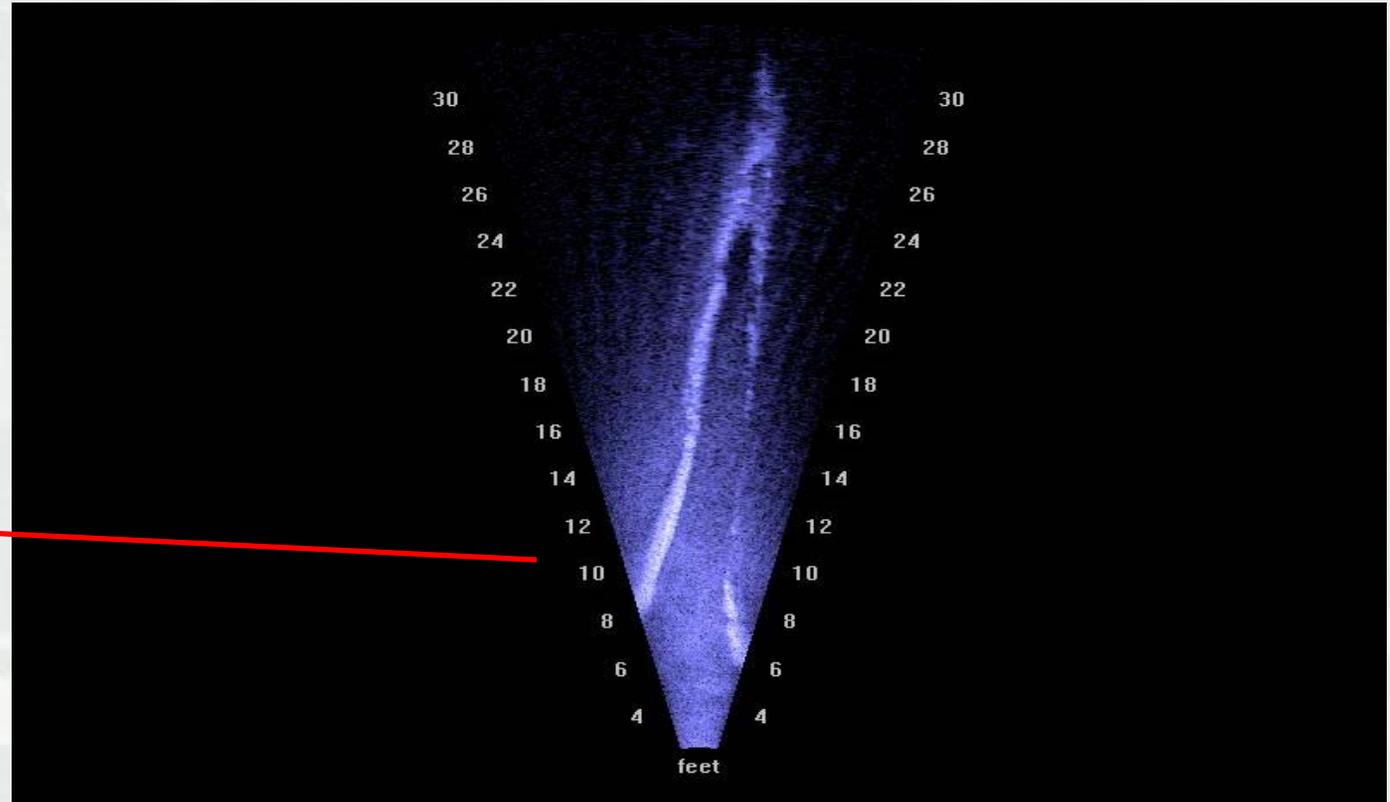
# Acoustical Imaging of Lock and Dam #25

Scour Depth approximately 22 feet from edge of existing cracked concrete edge. Scour Depth estimated at 6 feet but could not be viewed directly as the diver was restricted in distance he could back from the target area. Arrow shows approximate location of this scoured area.

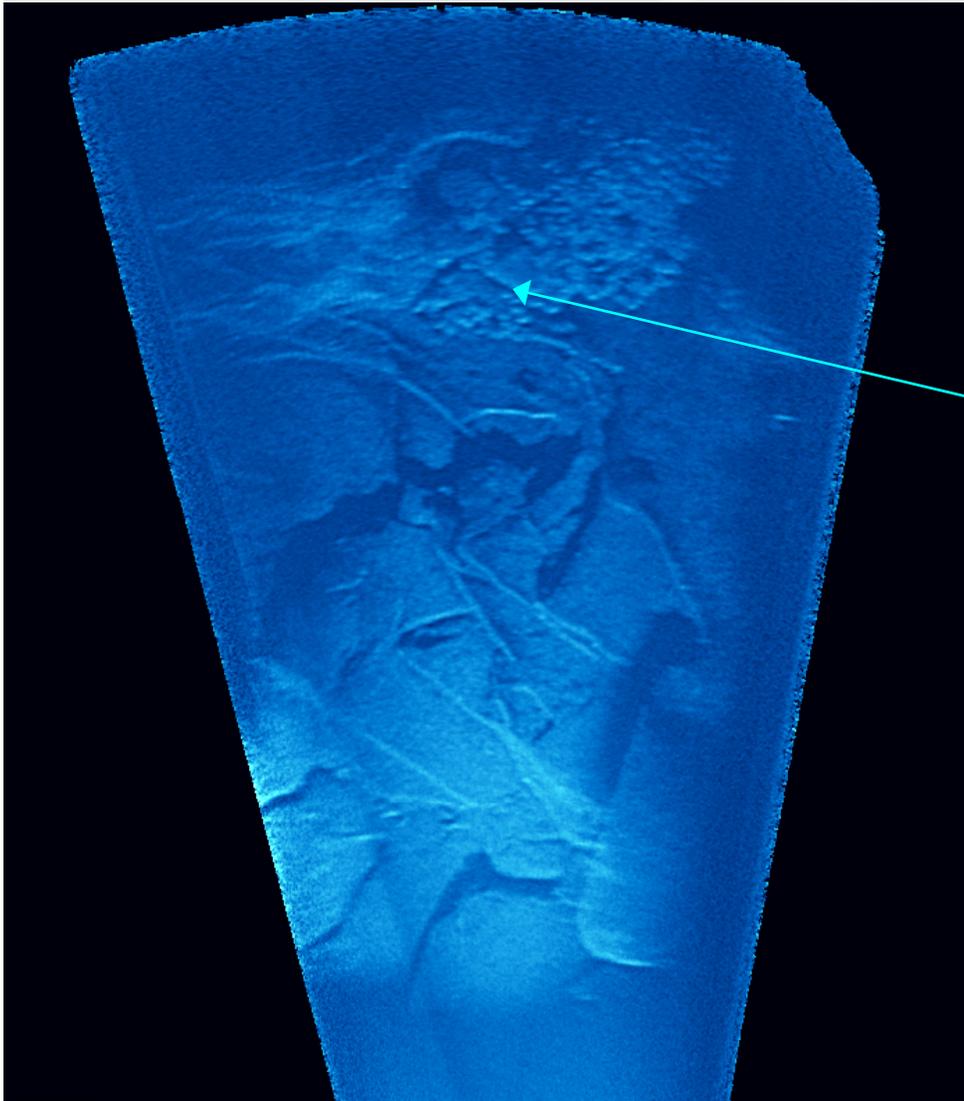
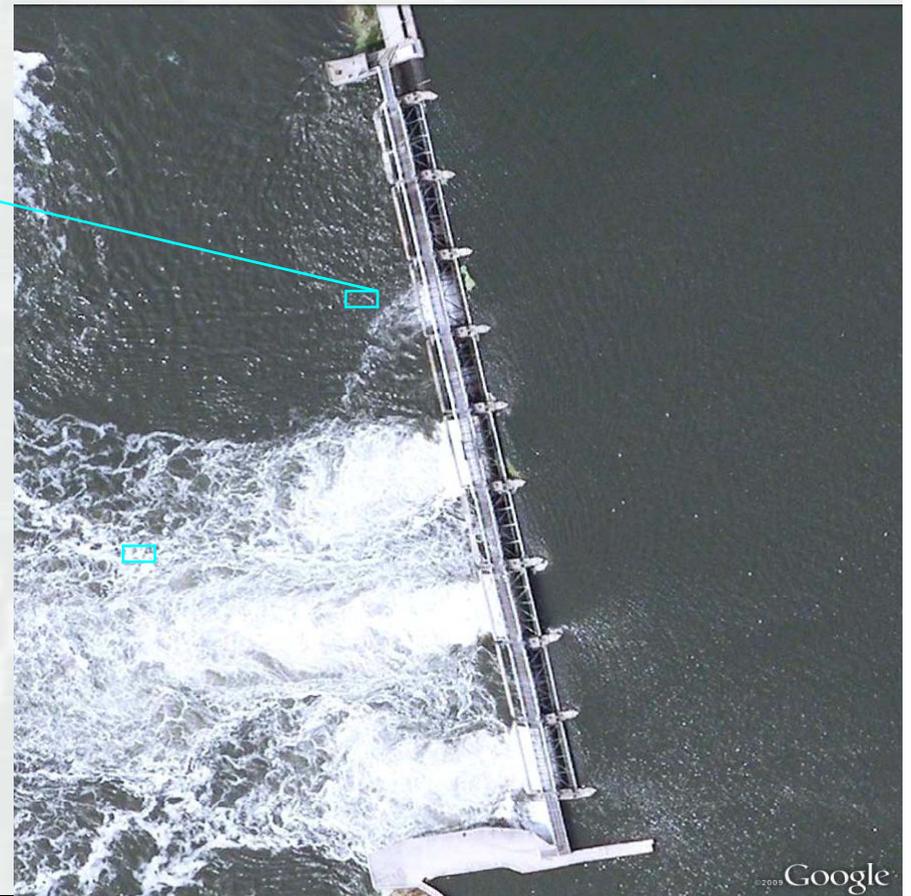
# Acoustical Imaging of Dresden Dam Chicago District

**Scour inspection  
below the dam.**

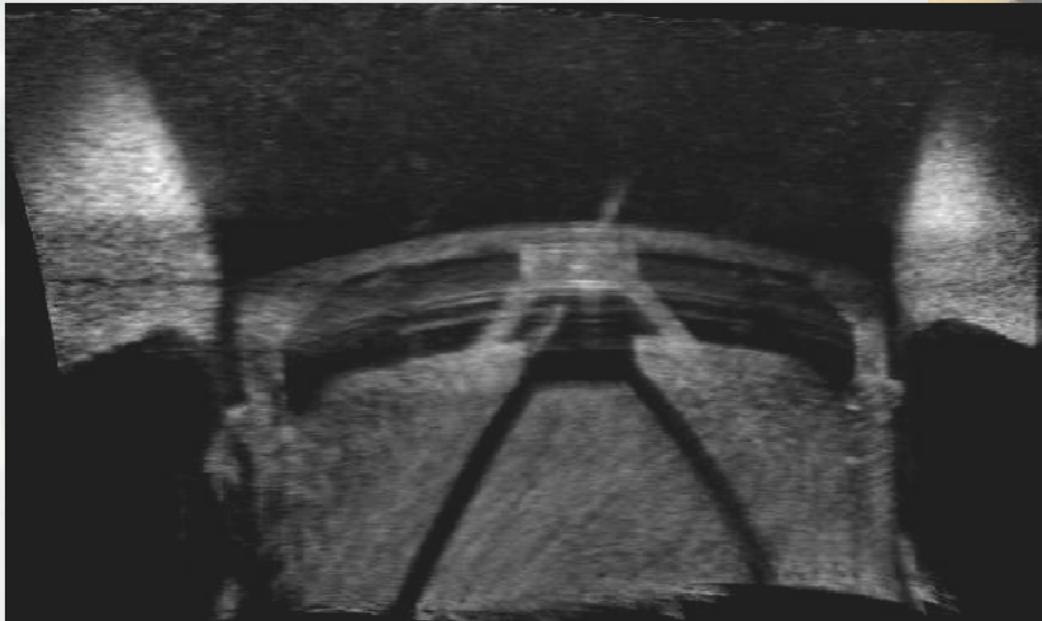
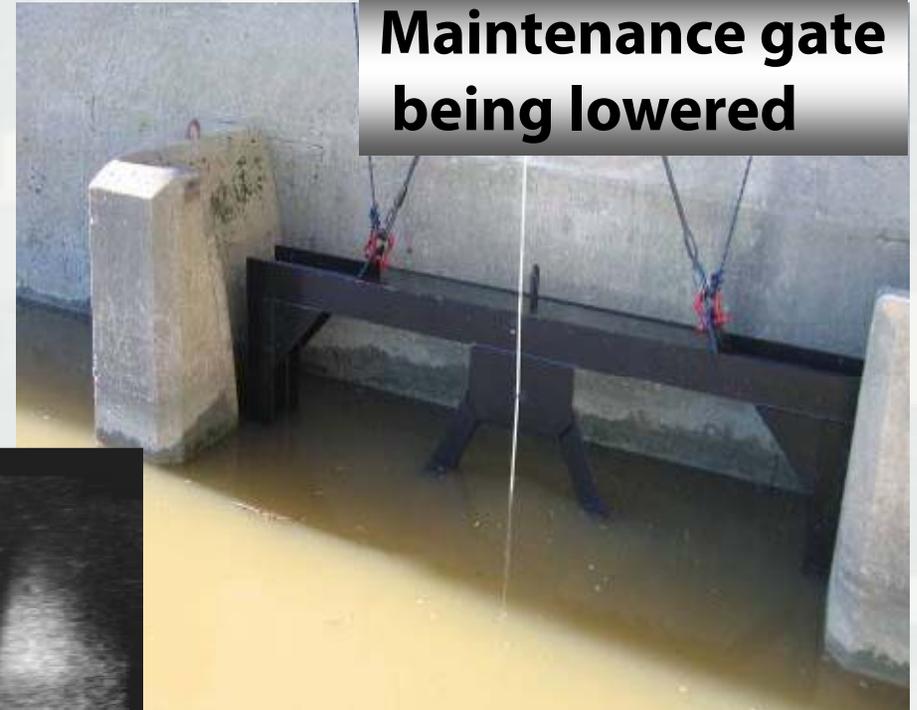
Acoustic Camera was used at Delaware Dam, Huntington District to look for obstructions in the gate slots.

- No slot problems were found.

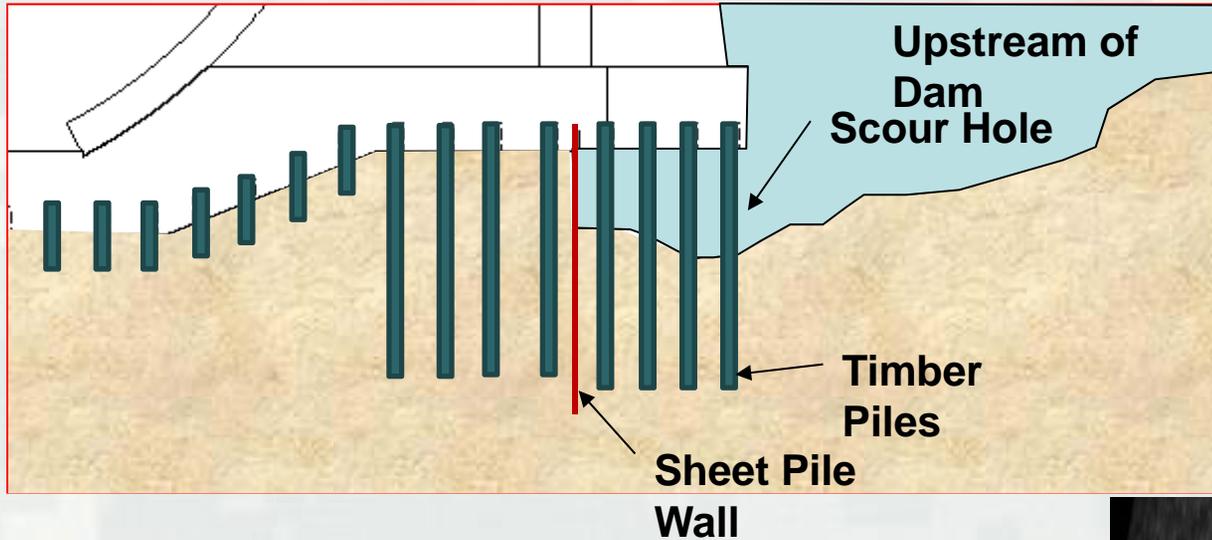
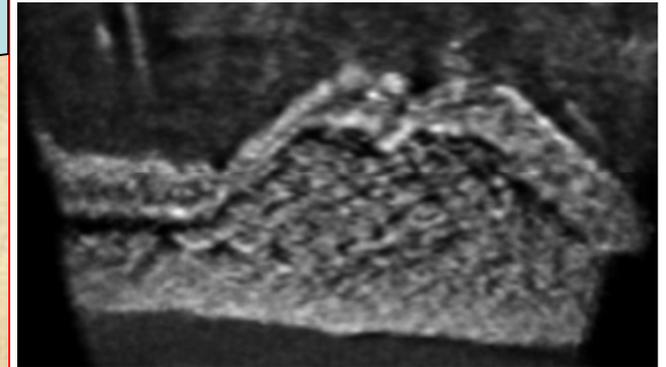
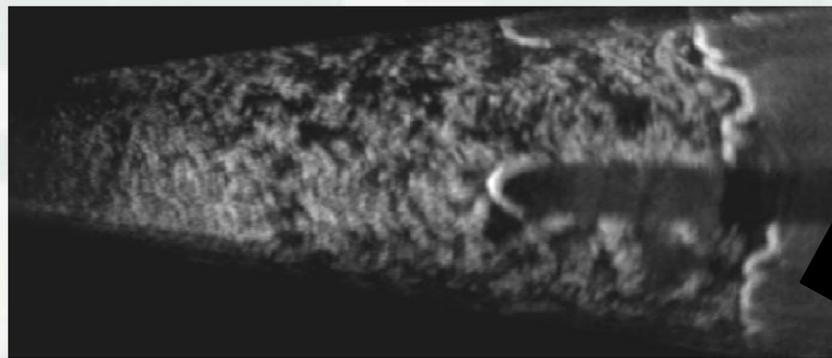
Scour-exposed Timbers

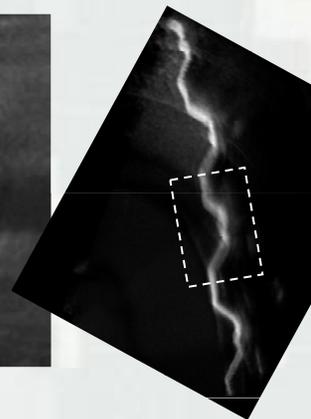
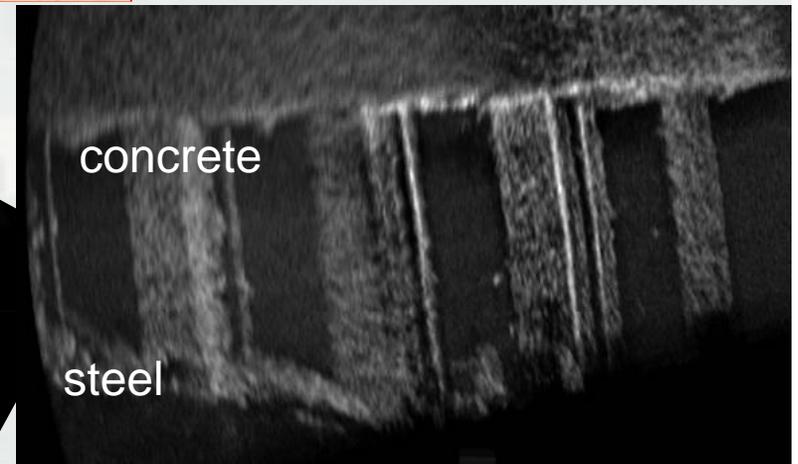
Scour-exposed  
Sheet Piles
