LD-777 Shreve

Accident Investigation Board Report

Headquarters Command Briefing

Findings and Recommendations 2 Sep 2014

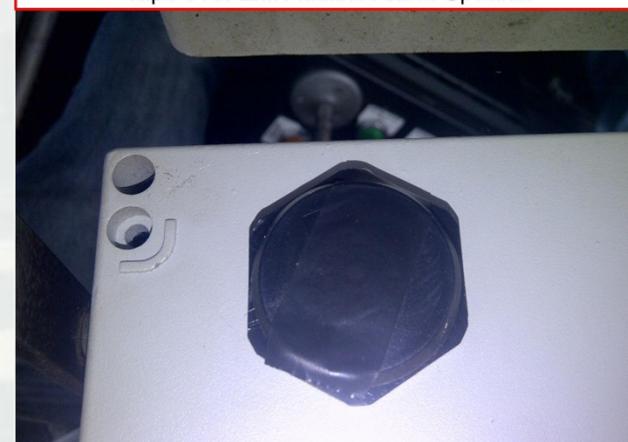
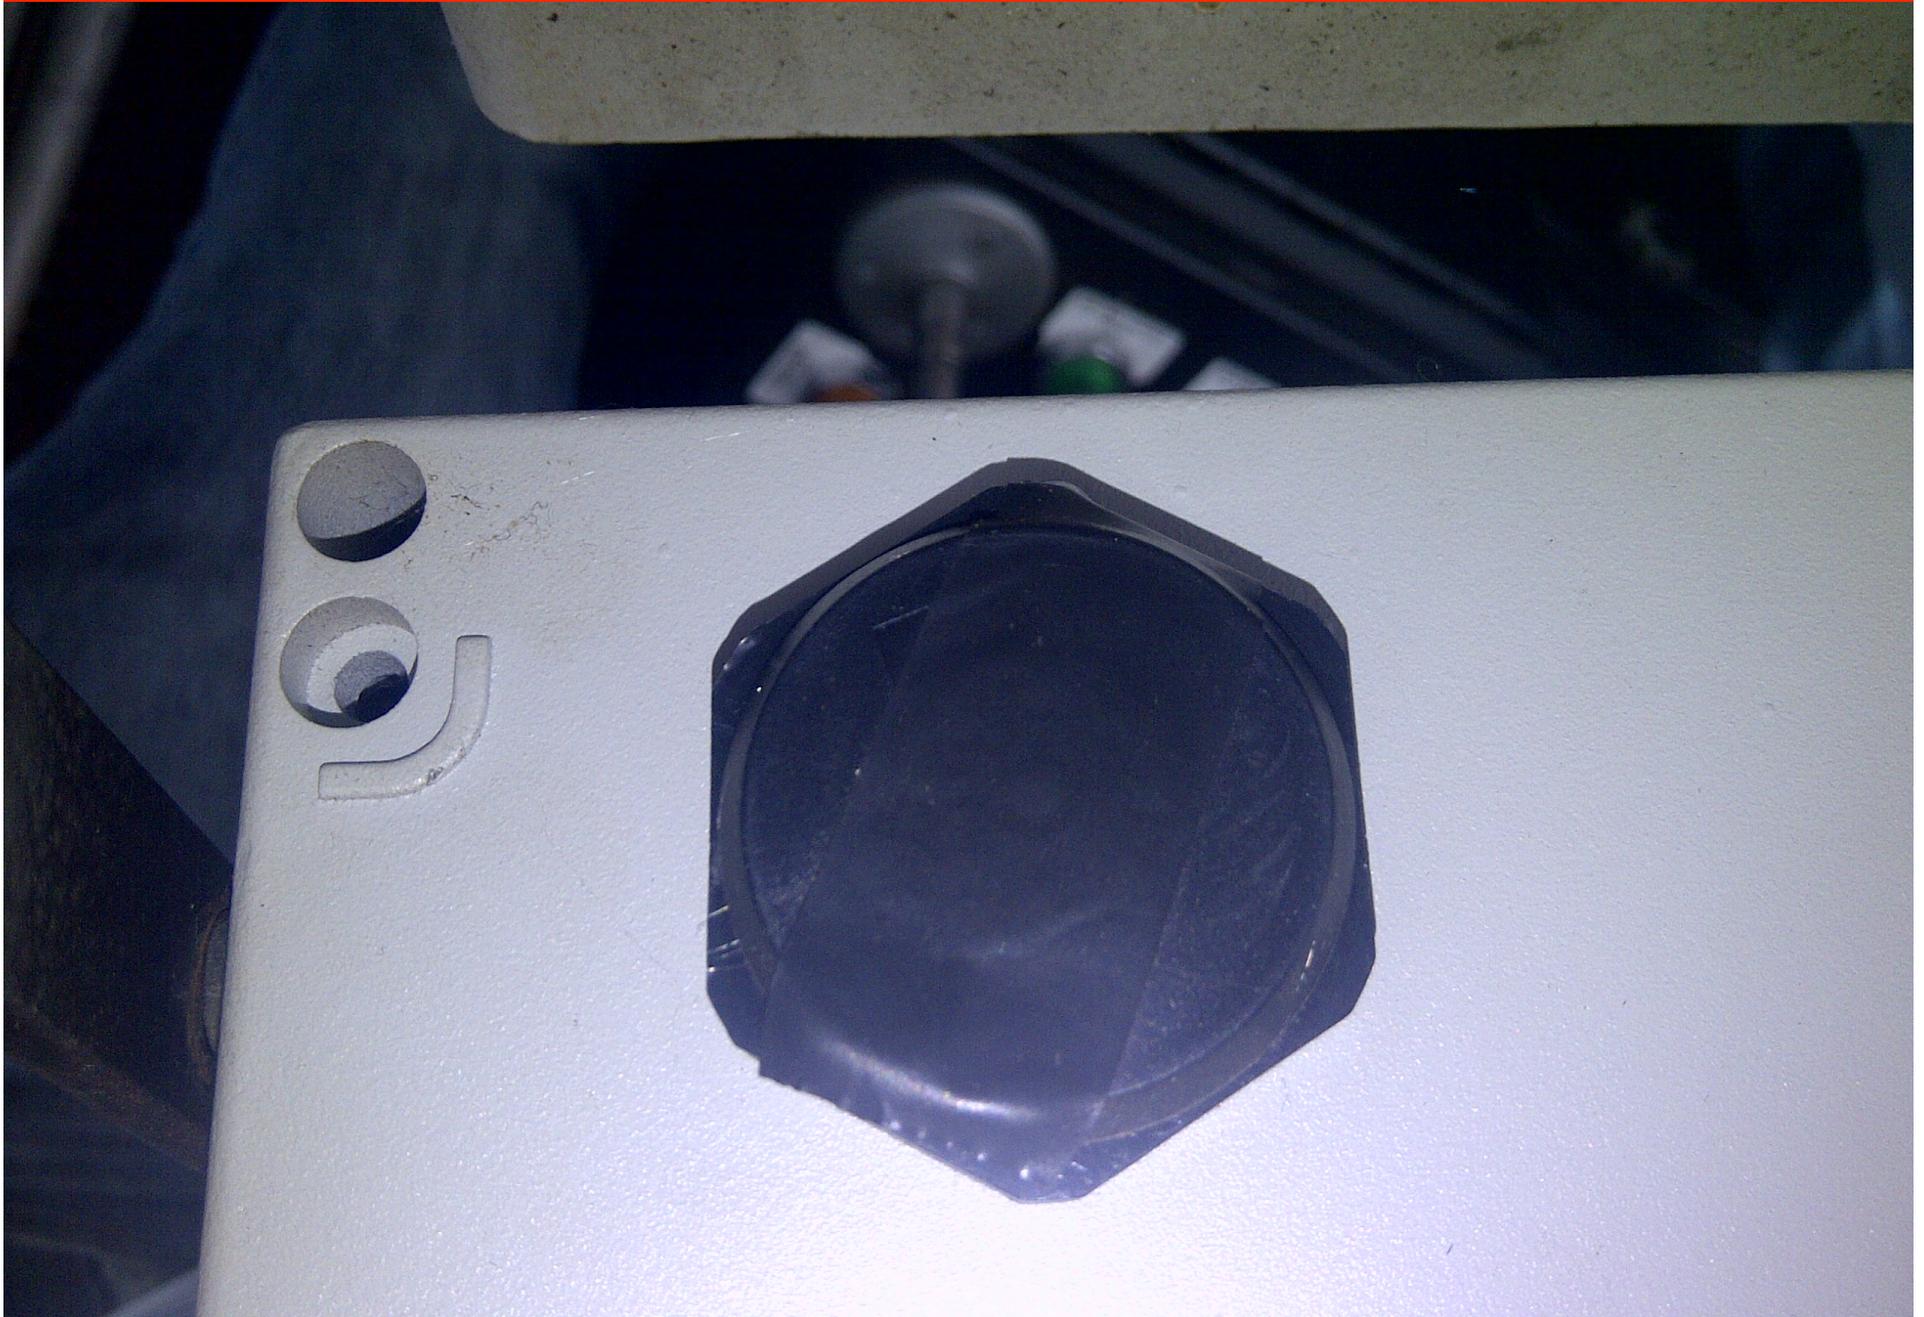
Tape over LMI Audible Alarm Speaker

- Documentation of a current load test, daily and monthly inspections of the crane were not available to demonstrate adequacy and safety of the crane prior to the lift.
- Failure to have the correct load chart in view of the operator
- The load-moment indicator (LMI) failed to alarm or otherwise warn the operator of an overload condition. Audible alarm was taped over.

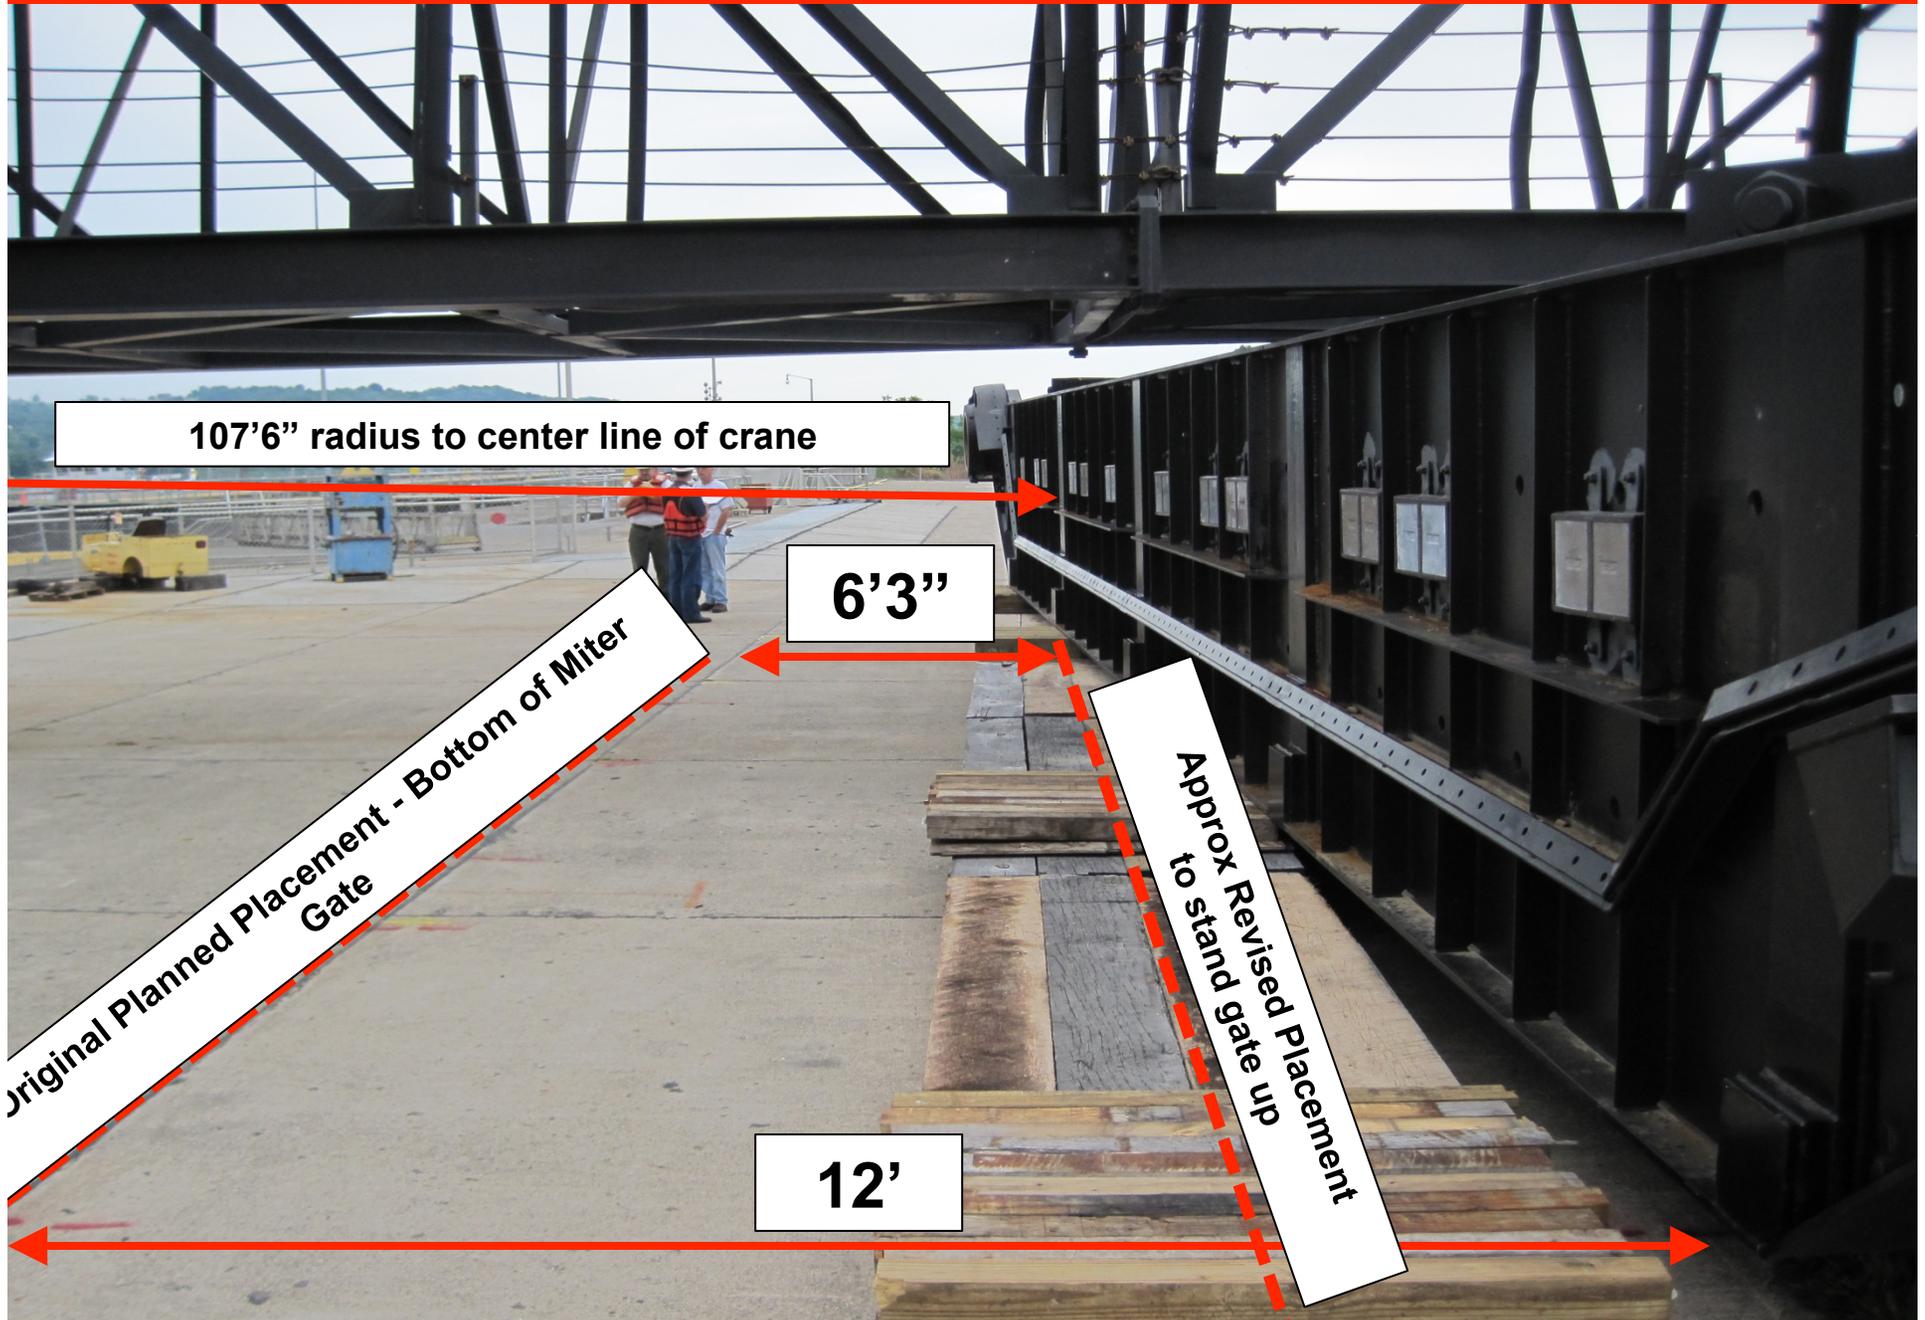
Miter Gate Placement – Planned vs. Actual

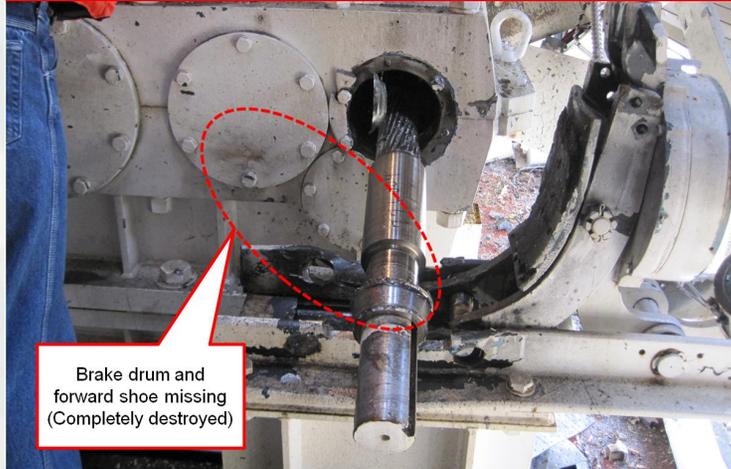
Catastrophic Failure of Boom Hoist Drum Motor Brake and Reduction Gear

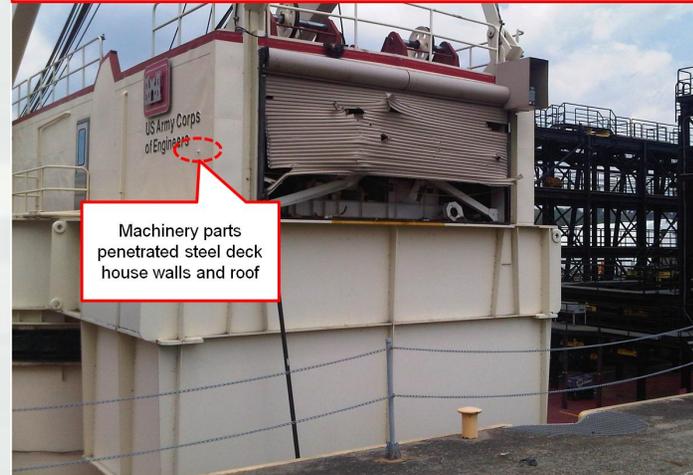
Damage to Machinery House Door from Boom Hoist Drum Brake Explosion

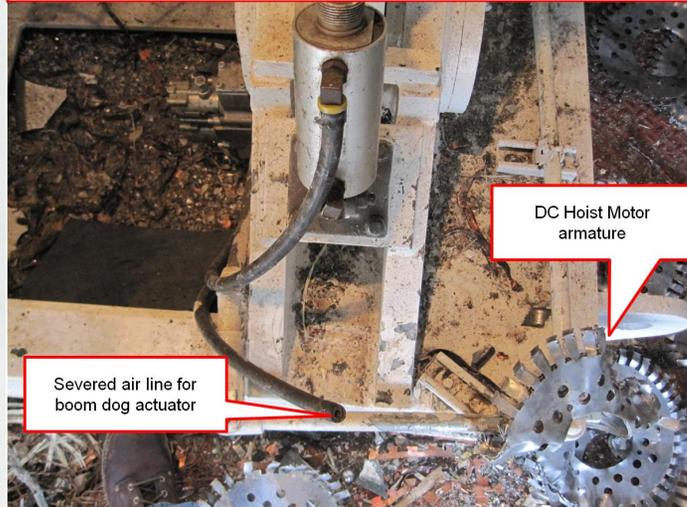
Failed Boom Dog Actuator

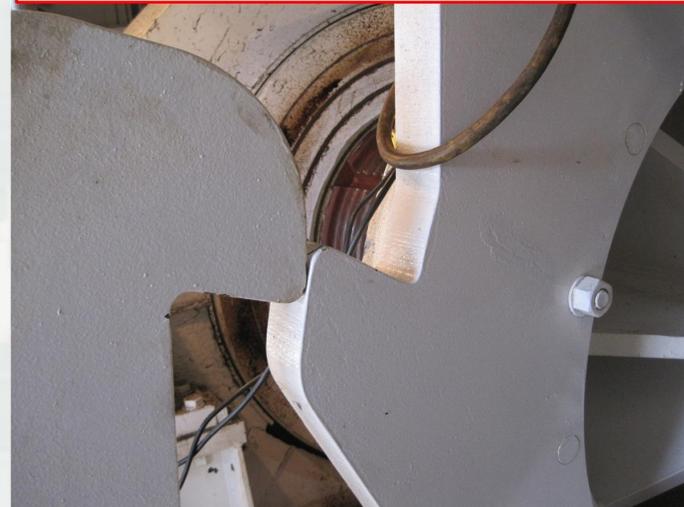
Disengaged Boom Dog

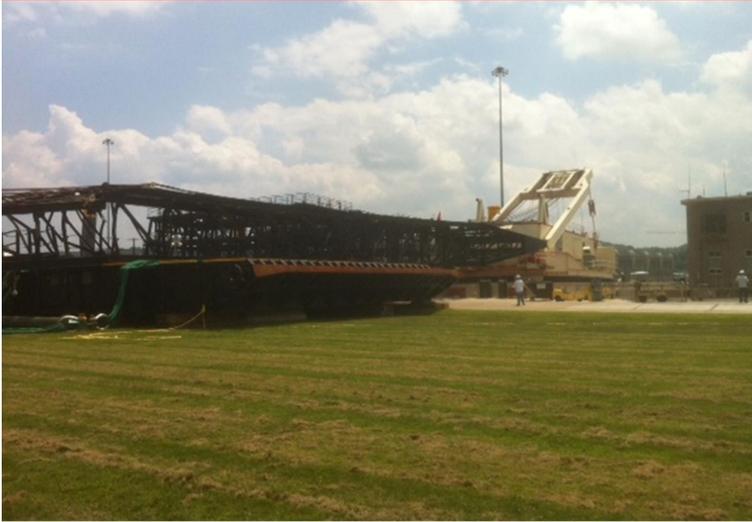
Failed Boom on Top of Miter Gate

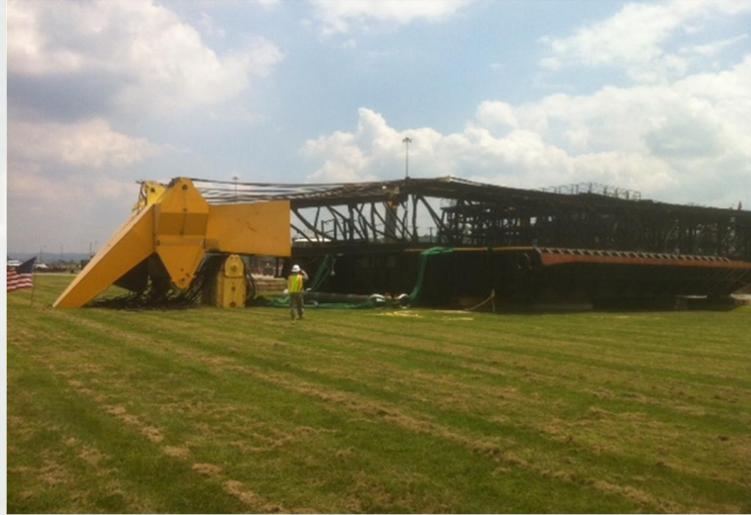
Failed Boom Tip Extending Past the Top of Miter Gate

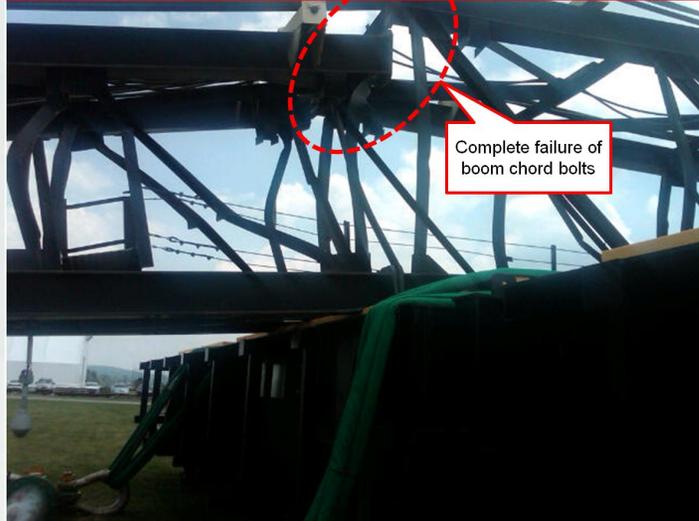
Failed Boom Tip Connection

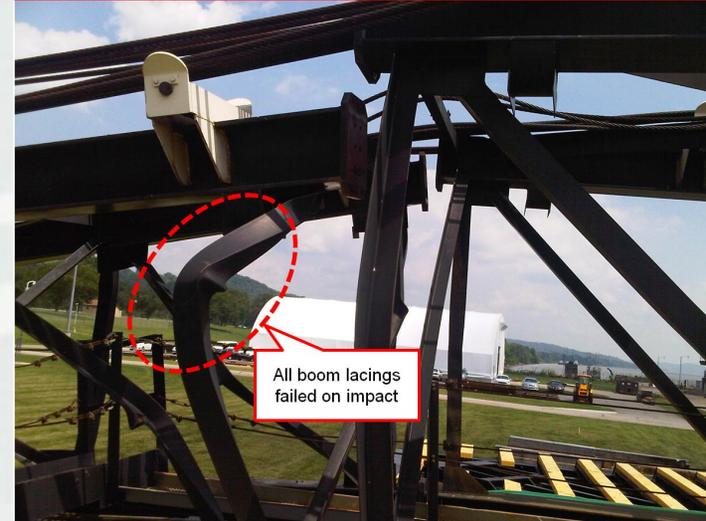
Failed Boom Tip Connection Close Up

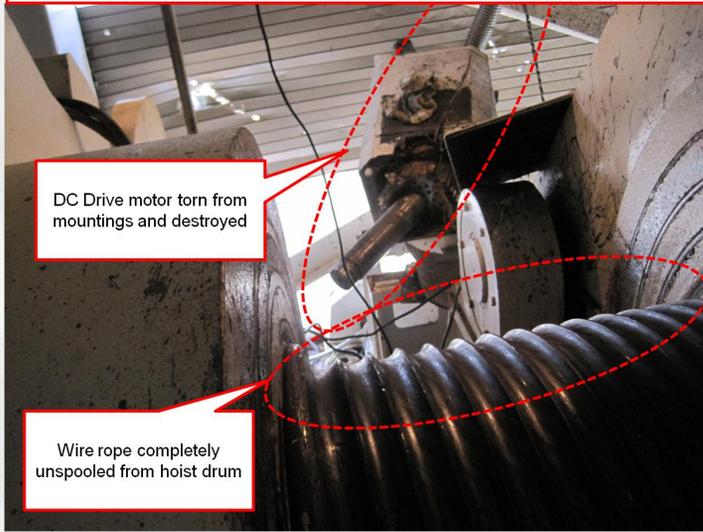
Boom Hoist Machinery Damage

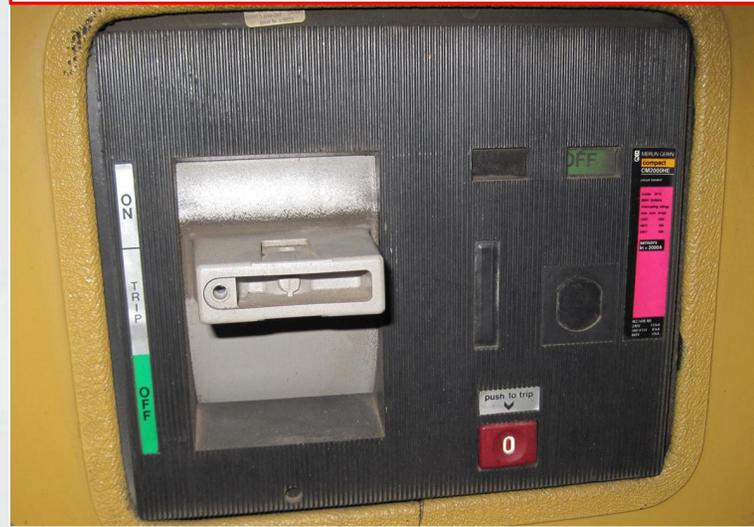
Tripped Circuit Breaker on Main Generator

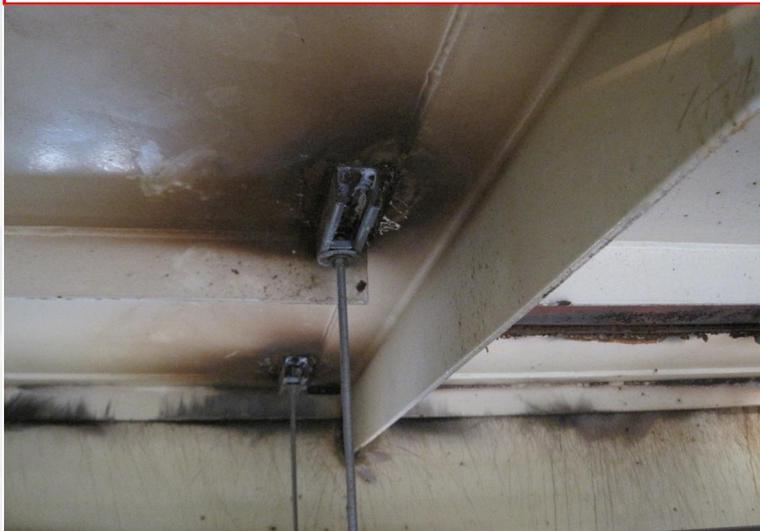
Arc Flash Damage Under the Whirler

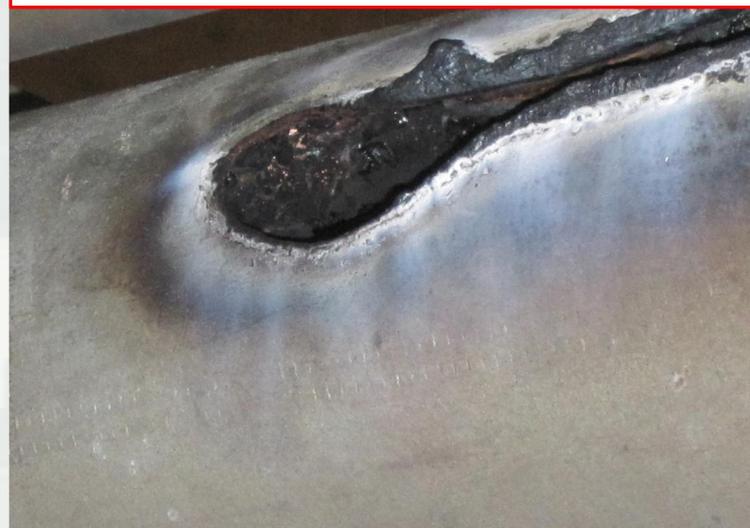
Blown Out Electrical Conduit Under the Whirler

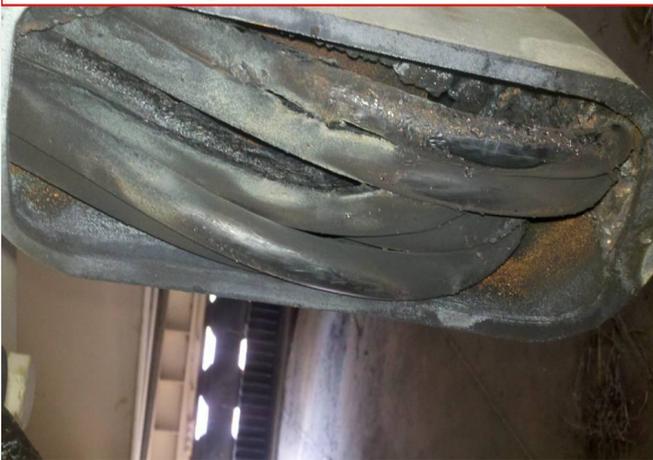
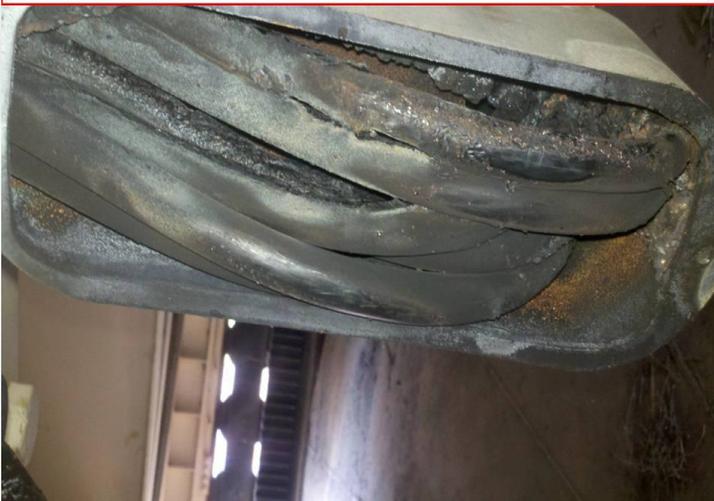
Photo 25: Overpacked Conduit with Unarmored Cables

- The undersized cable conduit did not allow adequate cooling for the generator main cables. Heat degrades insulation over time.

USACE districts should immediately check other electrically powered floating cranes to confirm/deny the presence of Ground Fault Detection Systems. Equipment should be retrofitted if necessary. A periodic megger test program should be considered to ensure electrical systems on heavy lift equipment are fully functional.

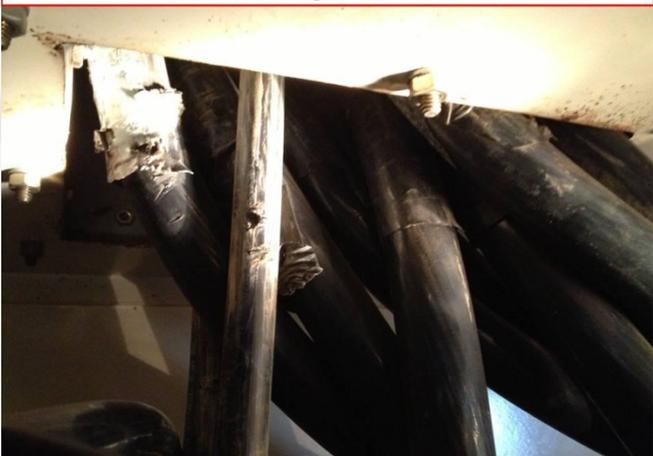
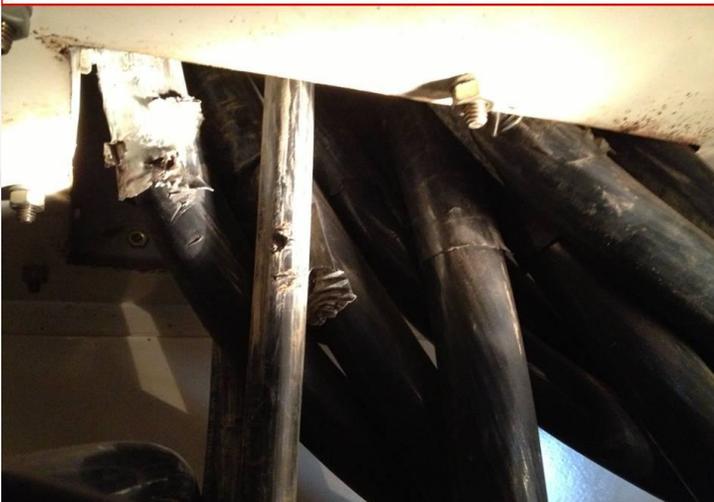
Photo 26: Damaged Cable Insulation

- Damaged insulation from the poor installation provided a start point for insulation break down over time under heat and current.

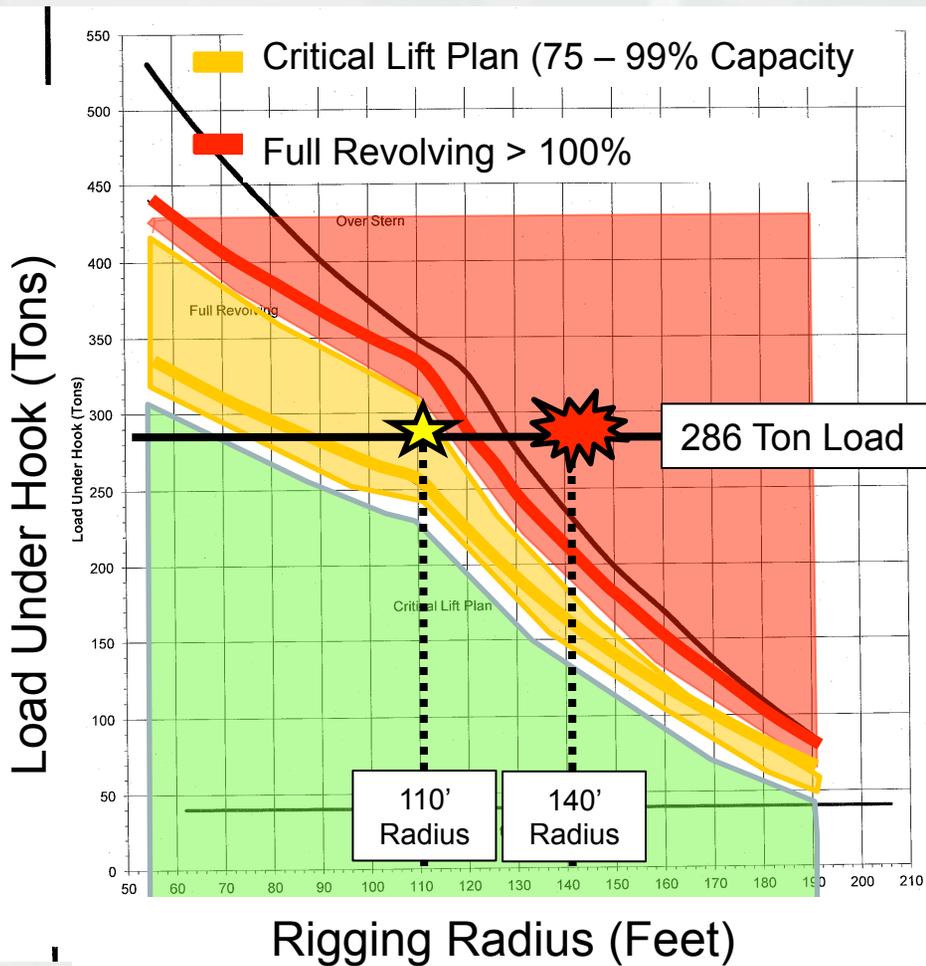
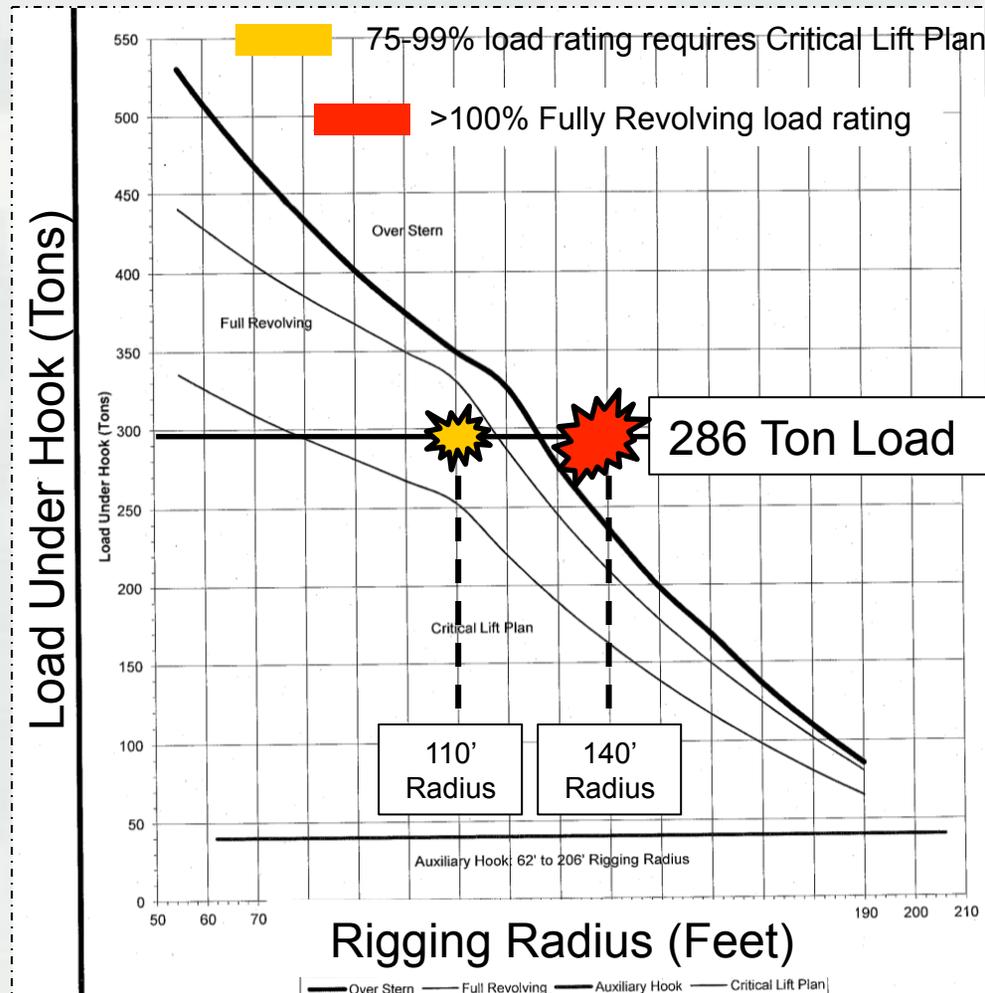
- Operation of the crane outside of its fully revolving load chart eliminated any possibility of the undersized boom brake arresting the load. Under dynamic conditions, the torque created by the load was too great to overcome.

Operation Outside of the Load Chart

- Failure to identify the requirement for critical lift planning
- Failure to physically validate the lift radius
- Improper LMI usage

- All activities should ensure that each crane and derrick has an up-to-date Naval Architectural Analysis.
- A hard copy of the floating service load charts shall be located in the cab of the crane within view of the operator
- The appropriate electronic load charts are loaded in the load-moment indicator (LMI) system

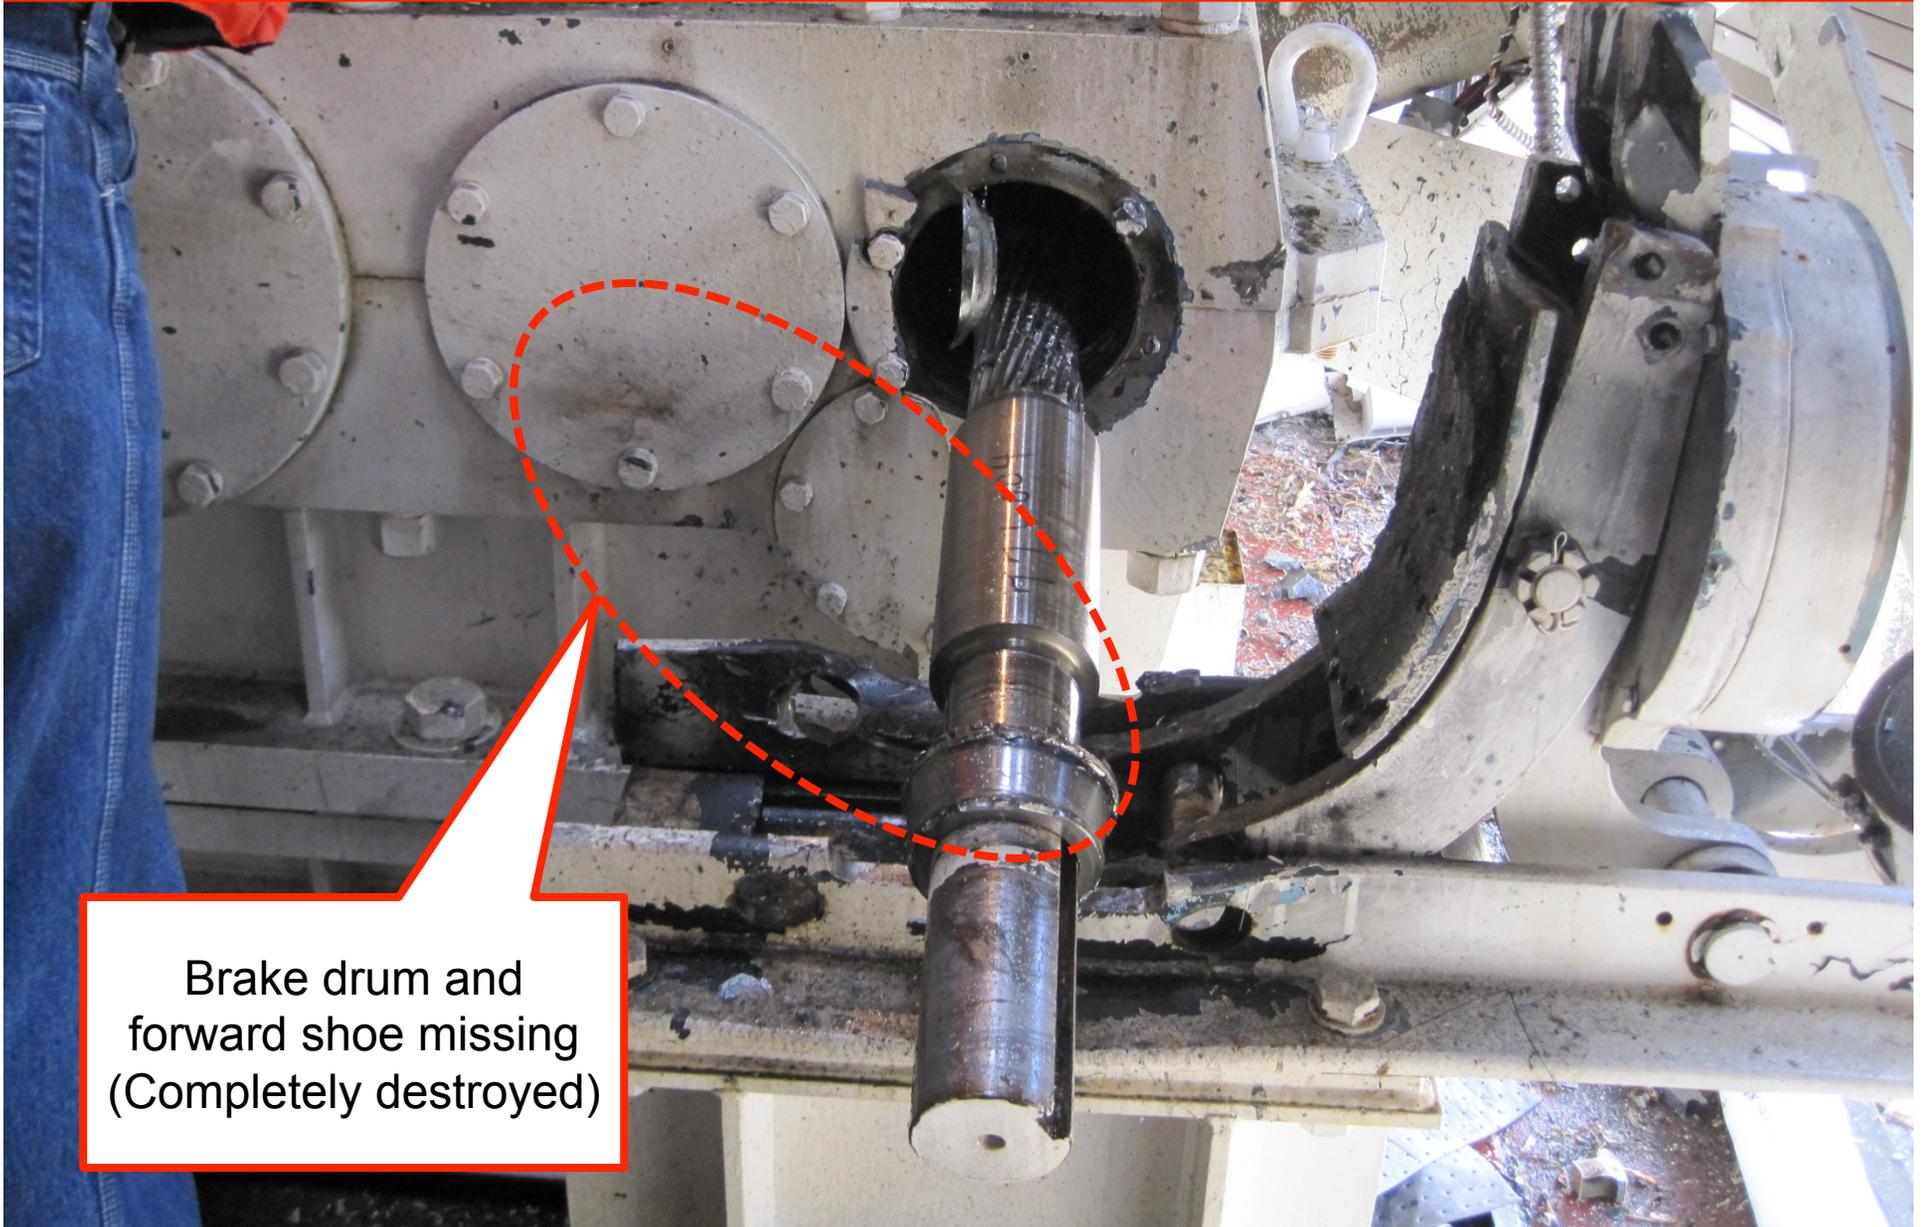
- By design, the boom hoist drum brake automatically locks on to arrest the load.
- Due to a design error, the boom hoist drum brake was undersized and only capable of holding 110% of the crane's rated capacity vice the 125% requirement per ASME B.30.

Catastrophic Failure of Boom Hoist Drum Motor Brake and Reduction Gear

Brake drum and
forward shoe missing
(Completely destroyed)

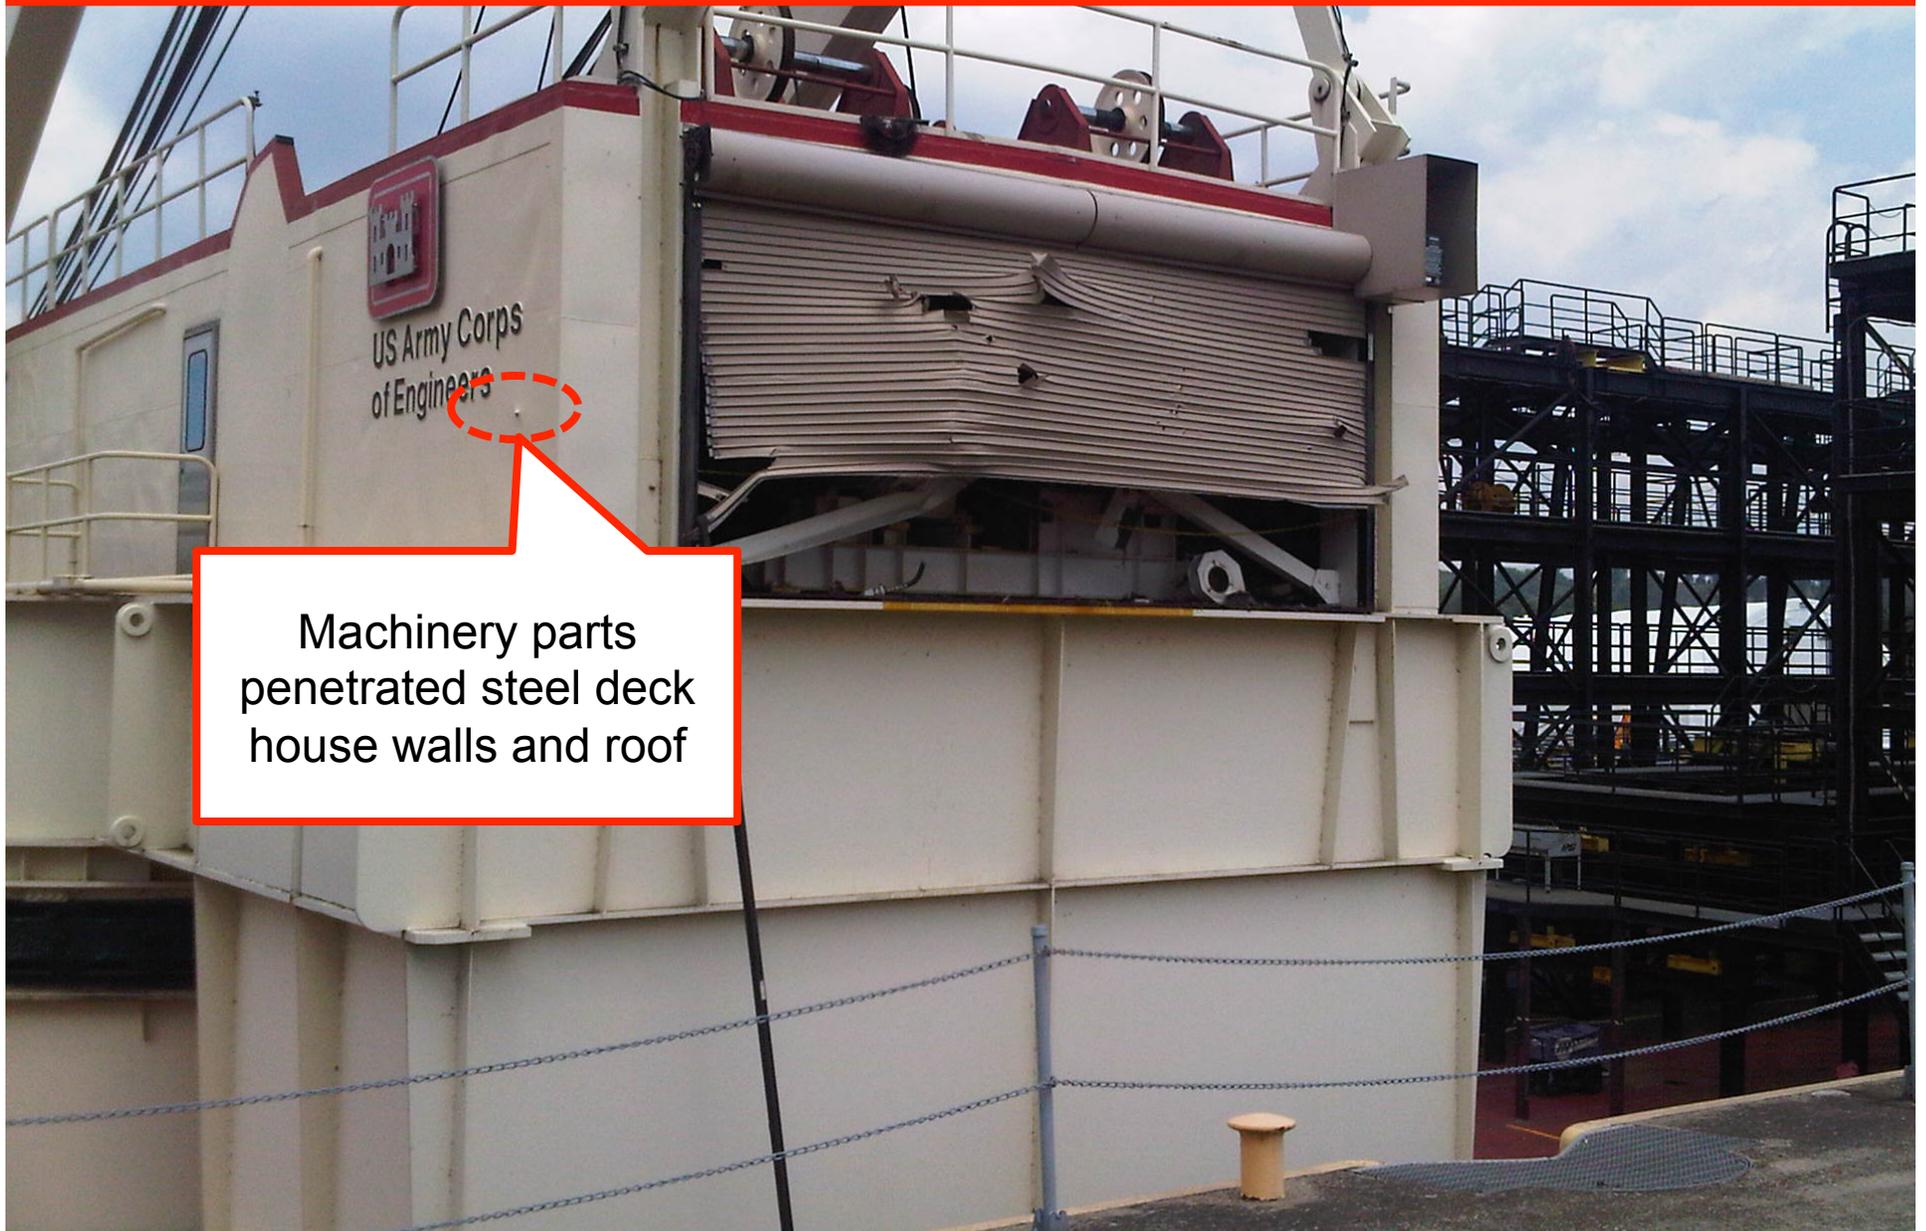
Damage to Machinery House Door from Boom Hoist Drum Brake Explosion

Machinery parts
penetrated steel deck
house walls and roof

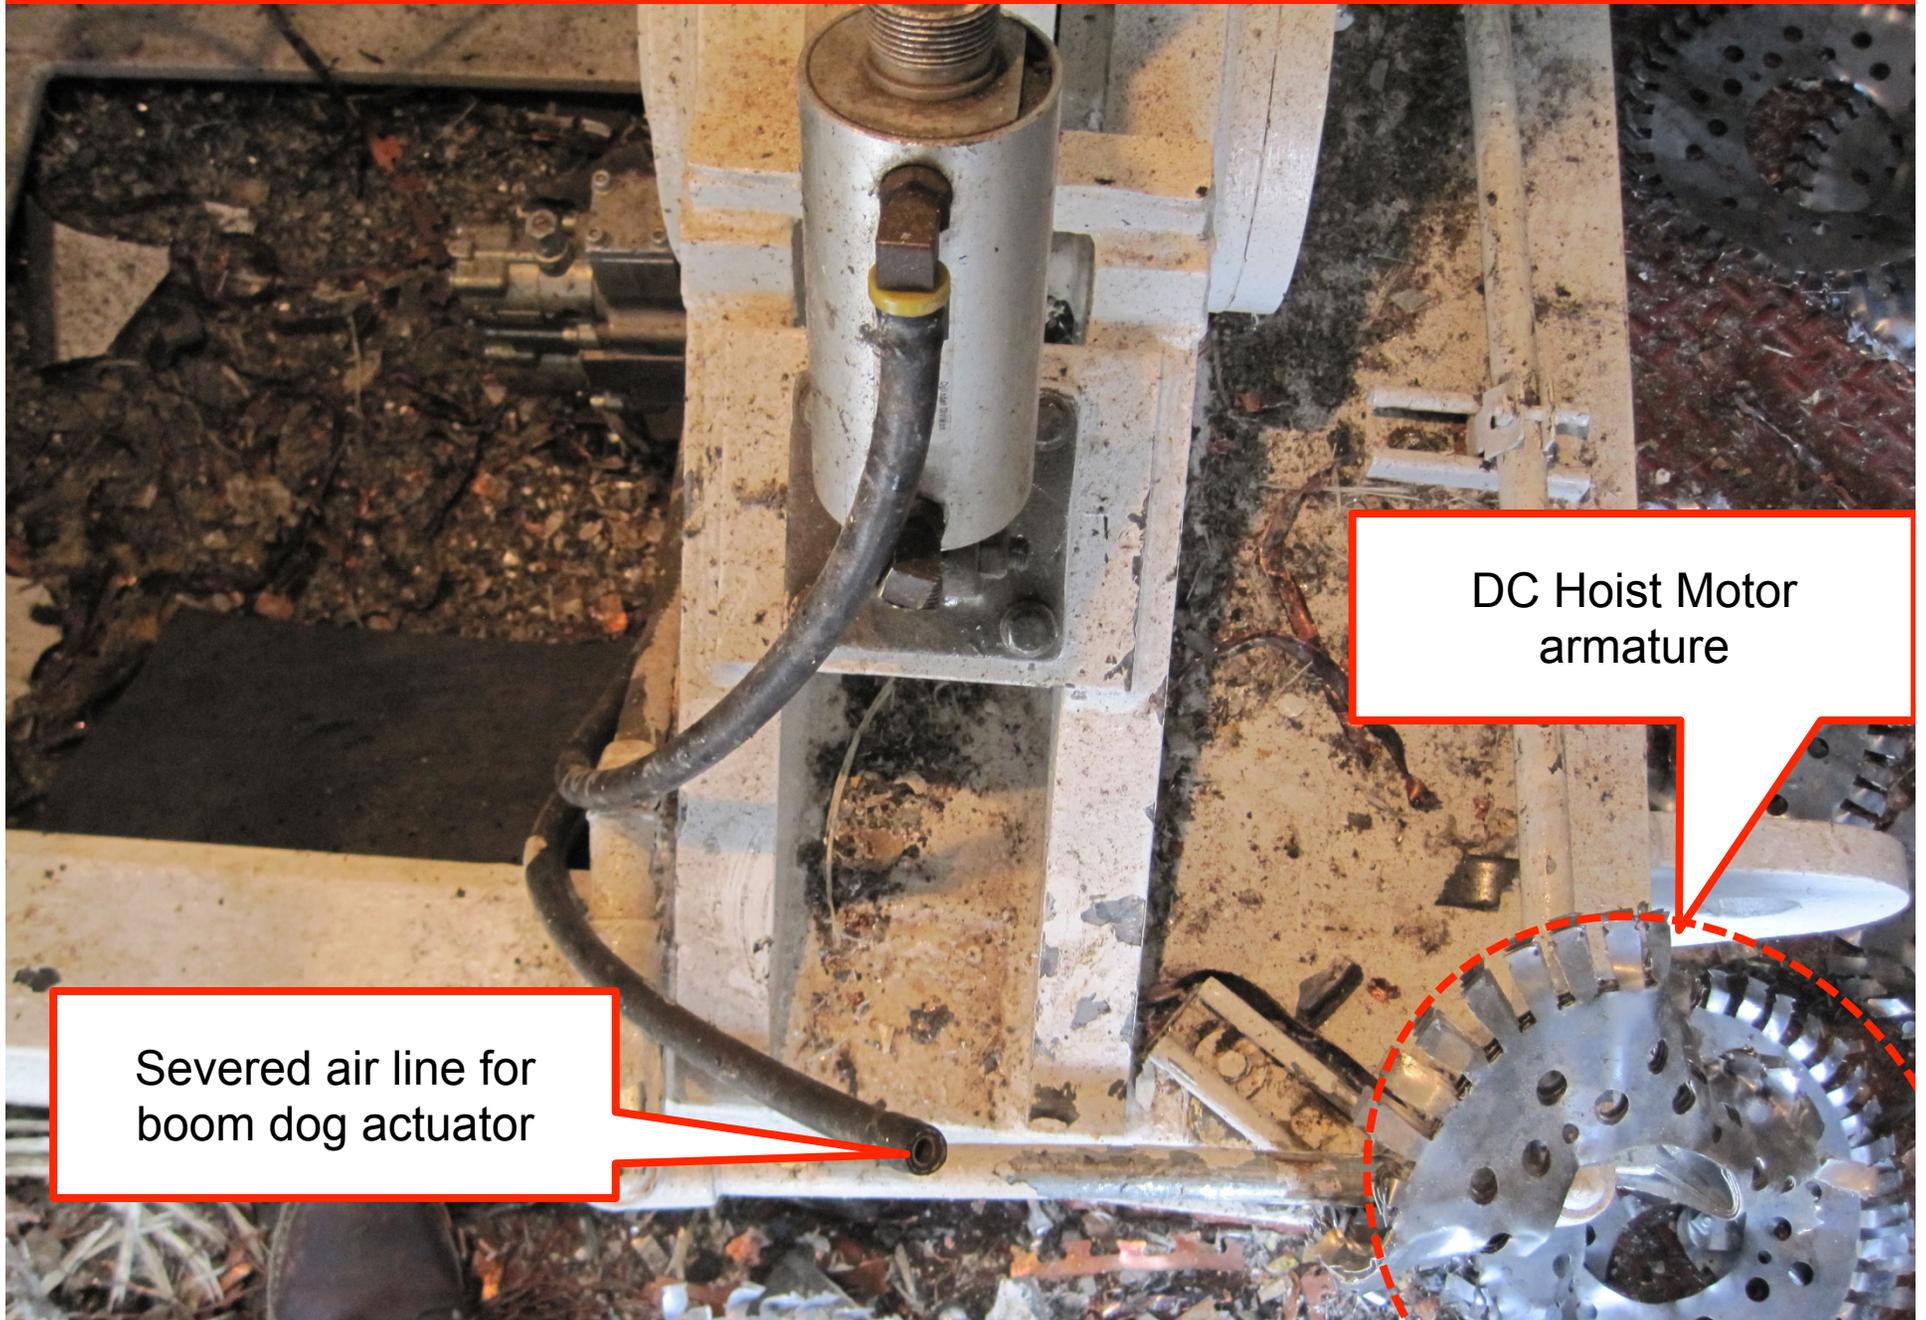
Failed Boom Dog Actuator

Severed air line for boom dog actuator
