LD-777 Shreve

Accident Investigation Board Report

Headquarters Command Briefing

Findings and Recommendations 2 Sep 2014

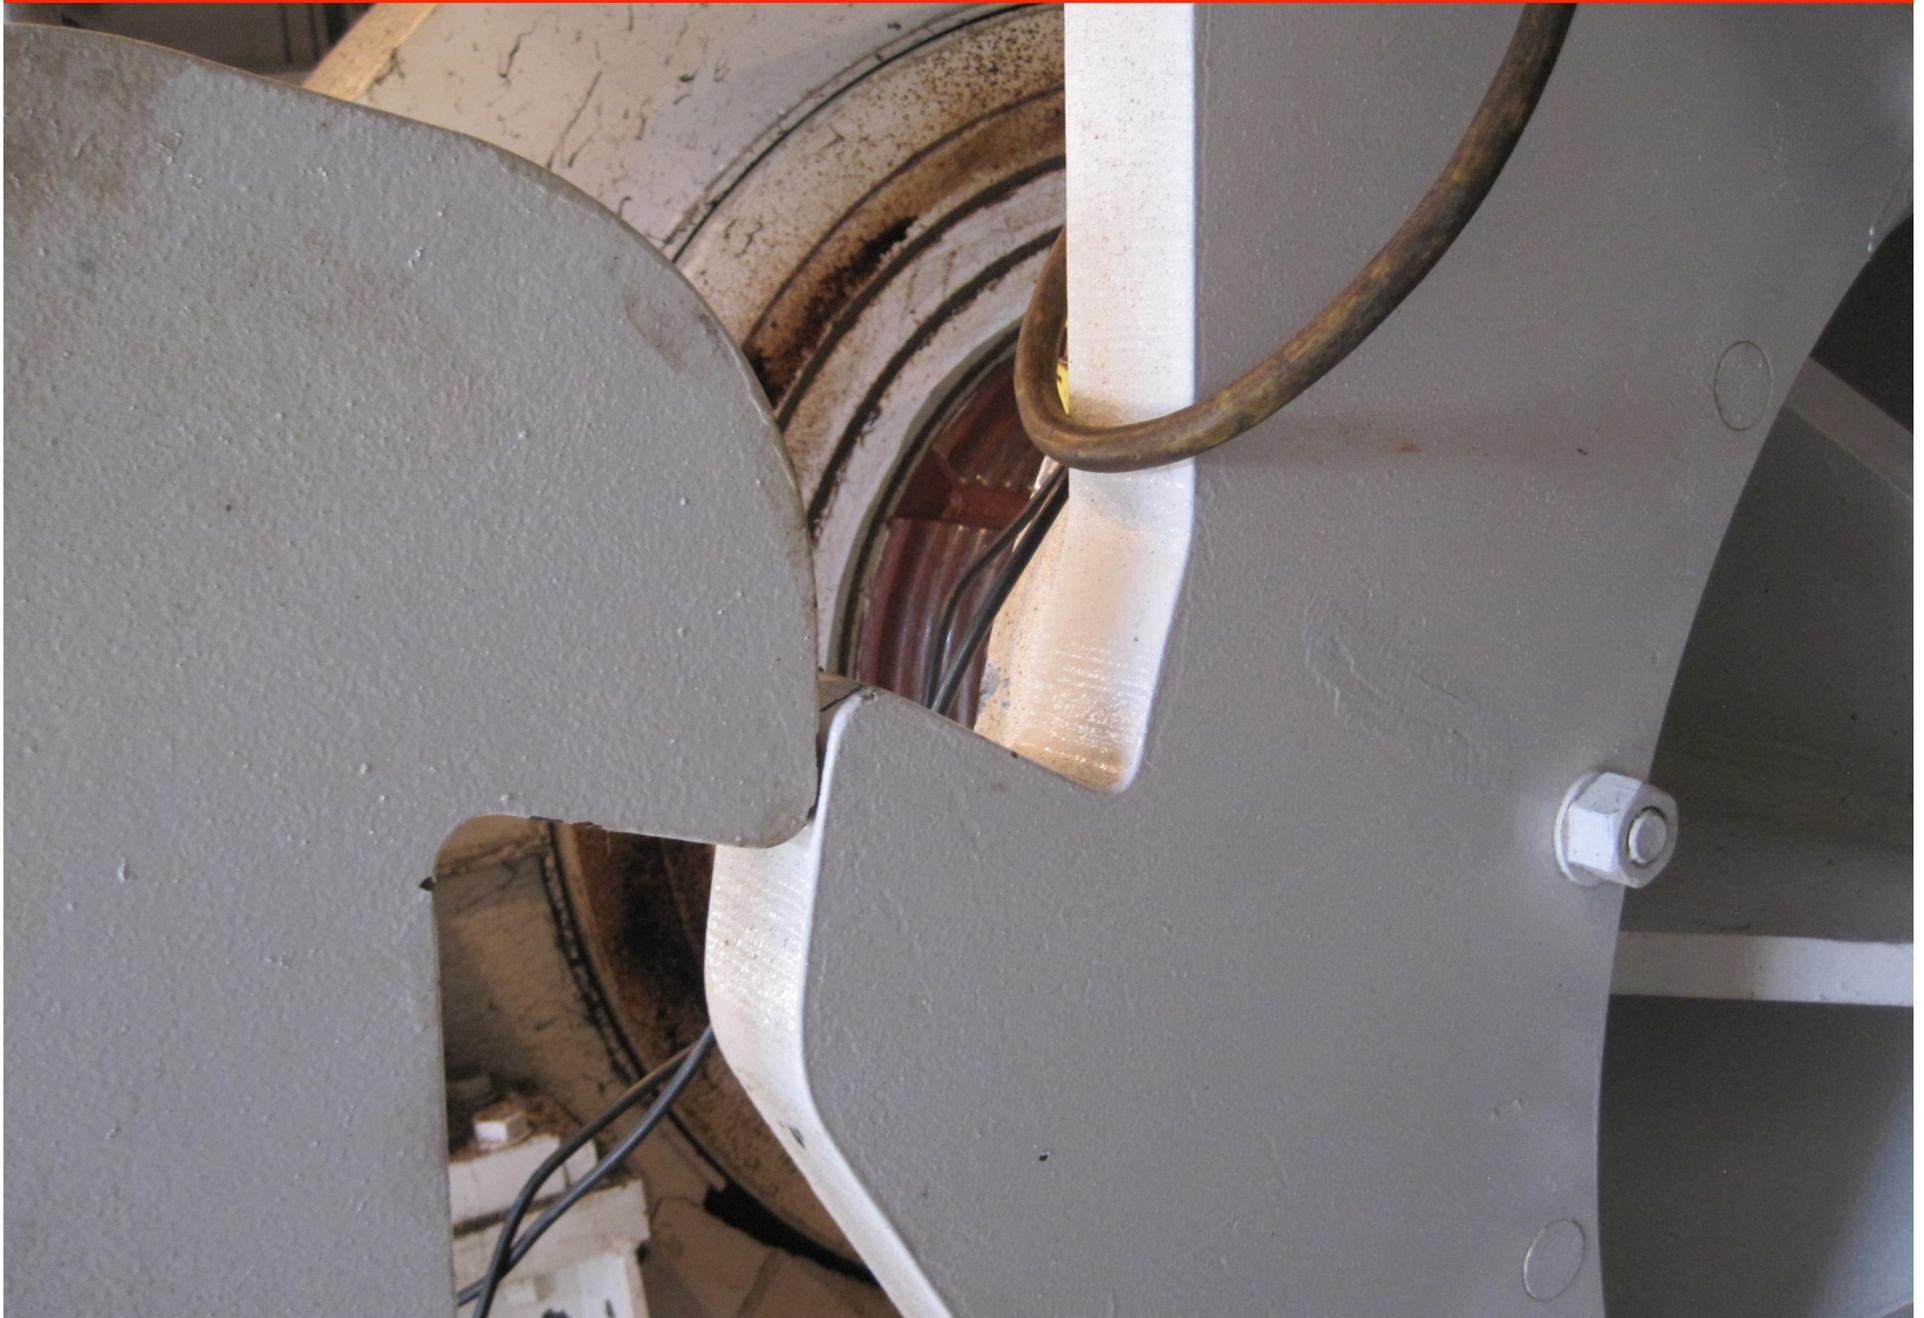
Disengaged Boom Dog

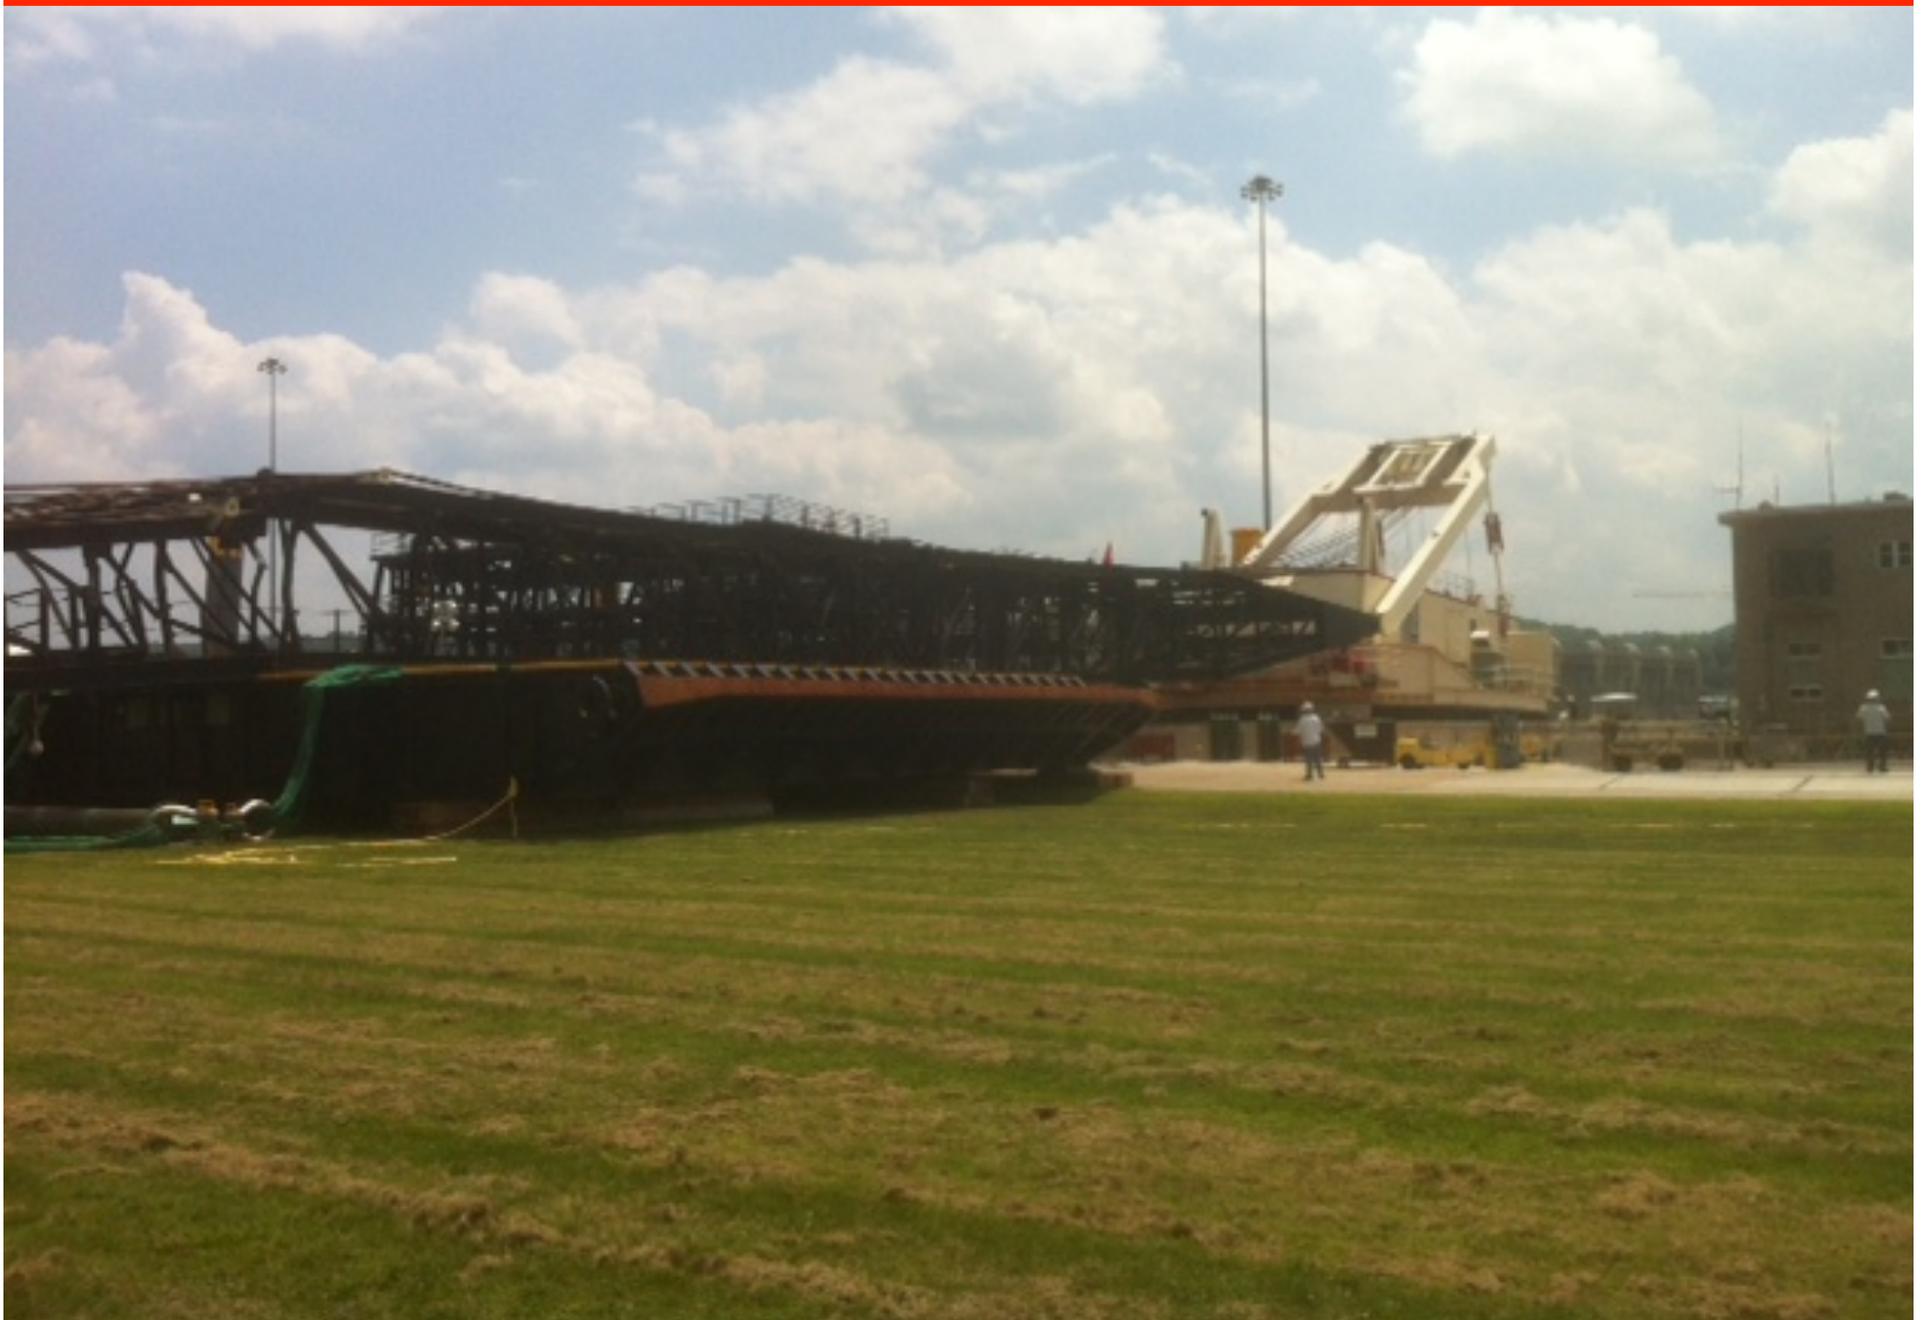
Failed Boom on Top of Miter Gate

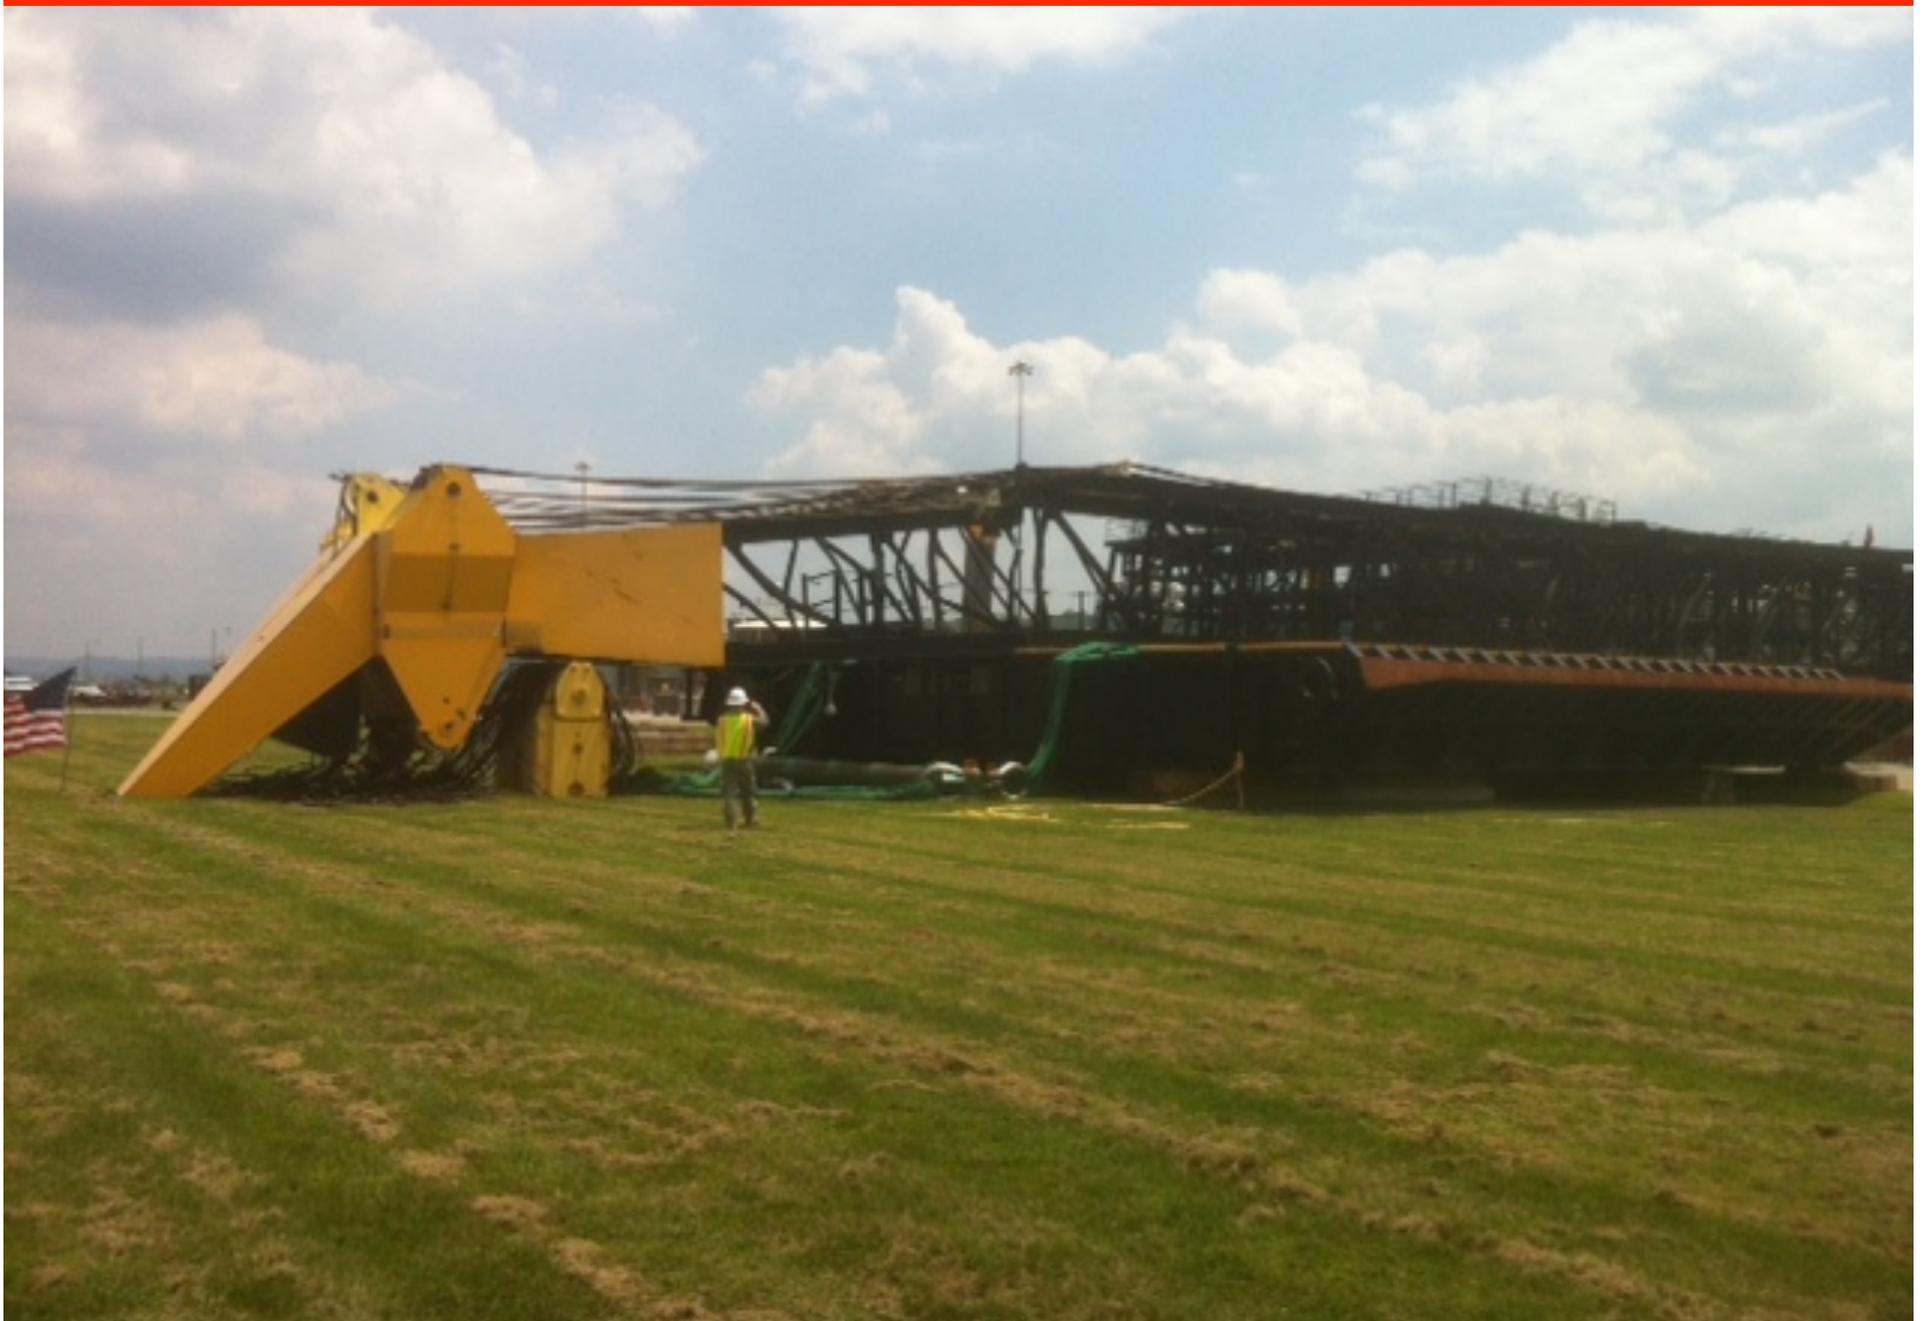
Failed Boom Tip Extending Past the Top of Miter Gate

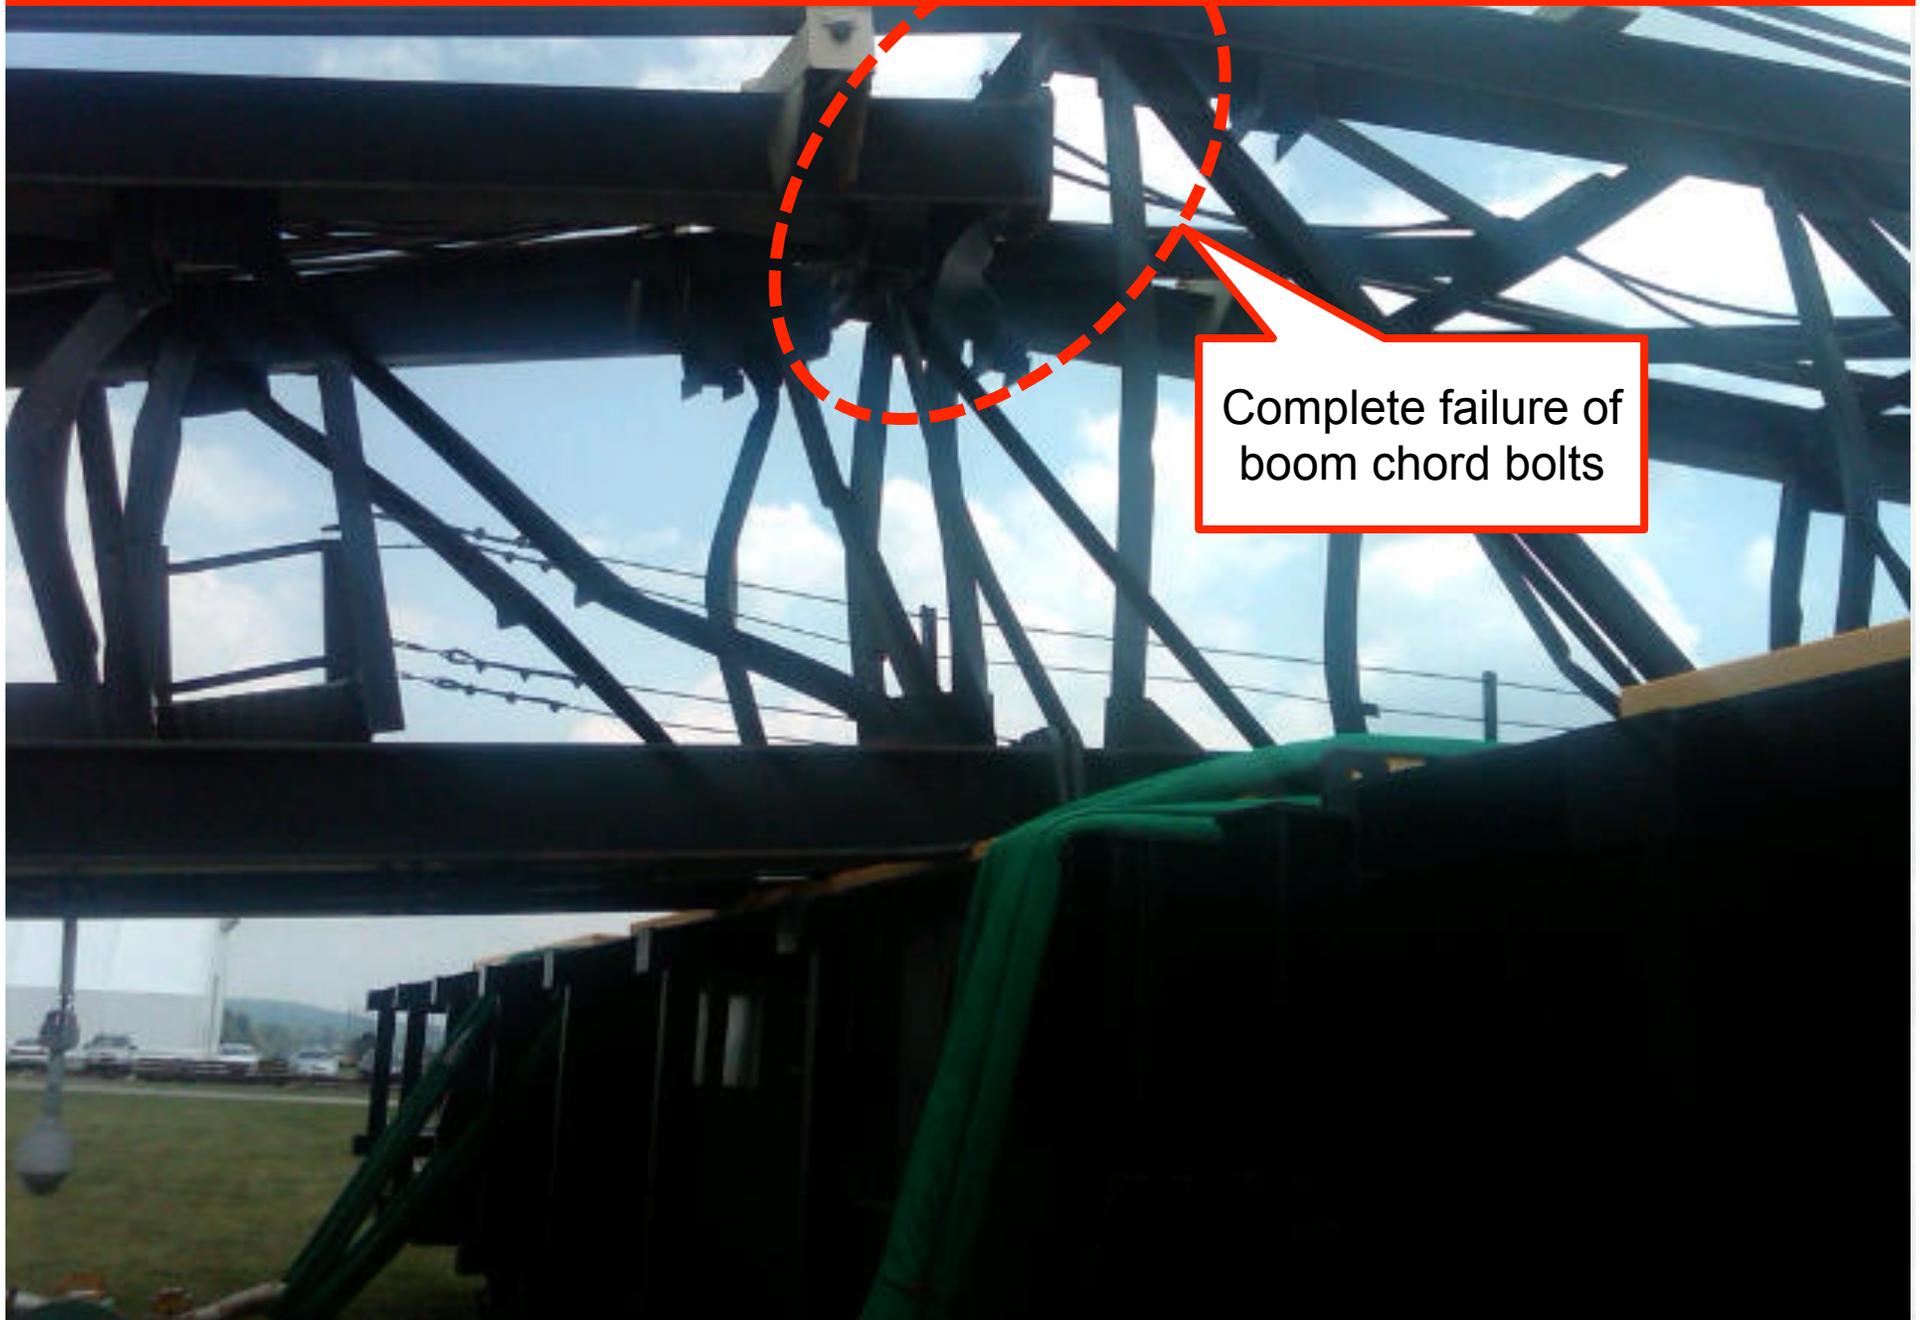
Failed Boom Tip Connection

Complete failure of
boom chord bolts

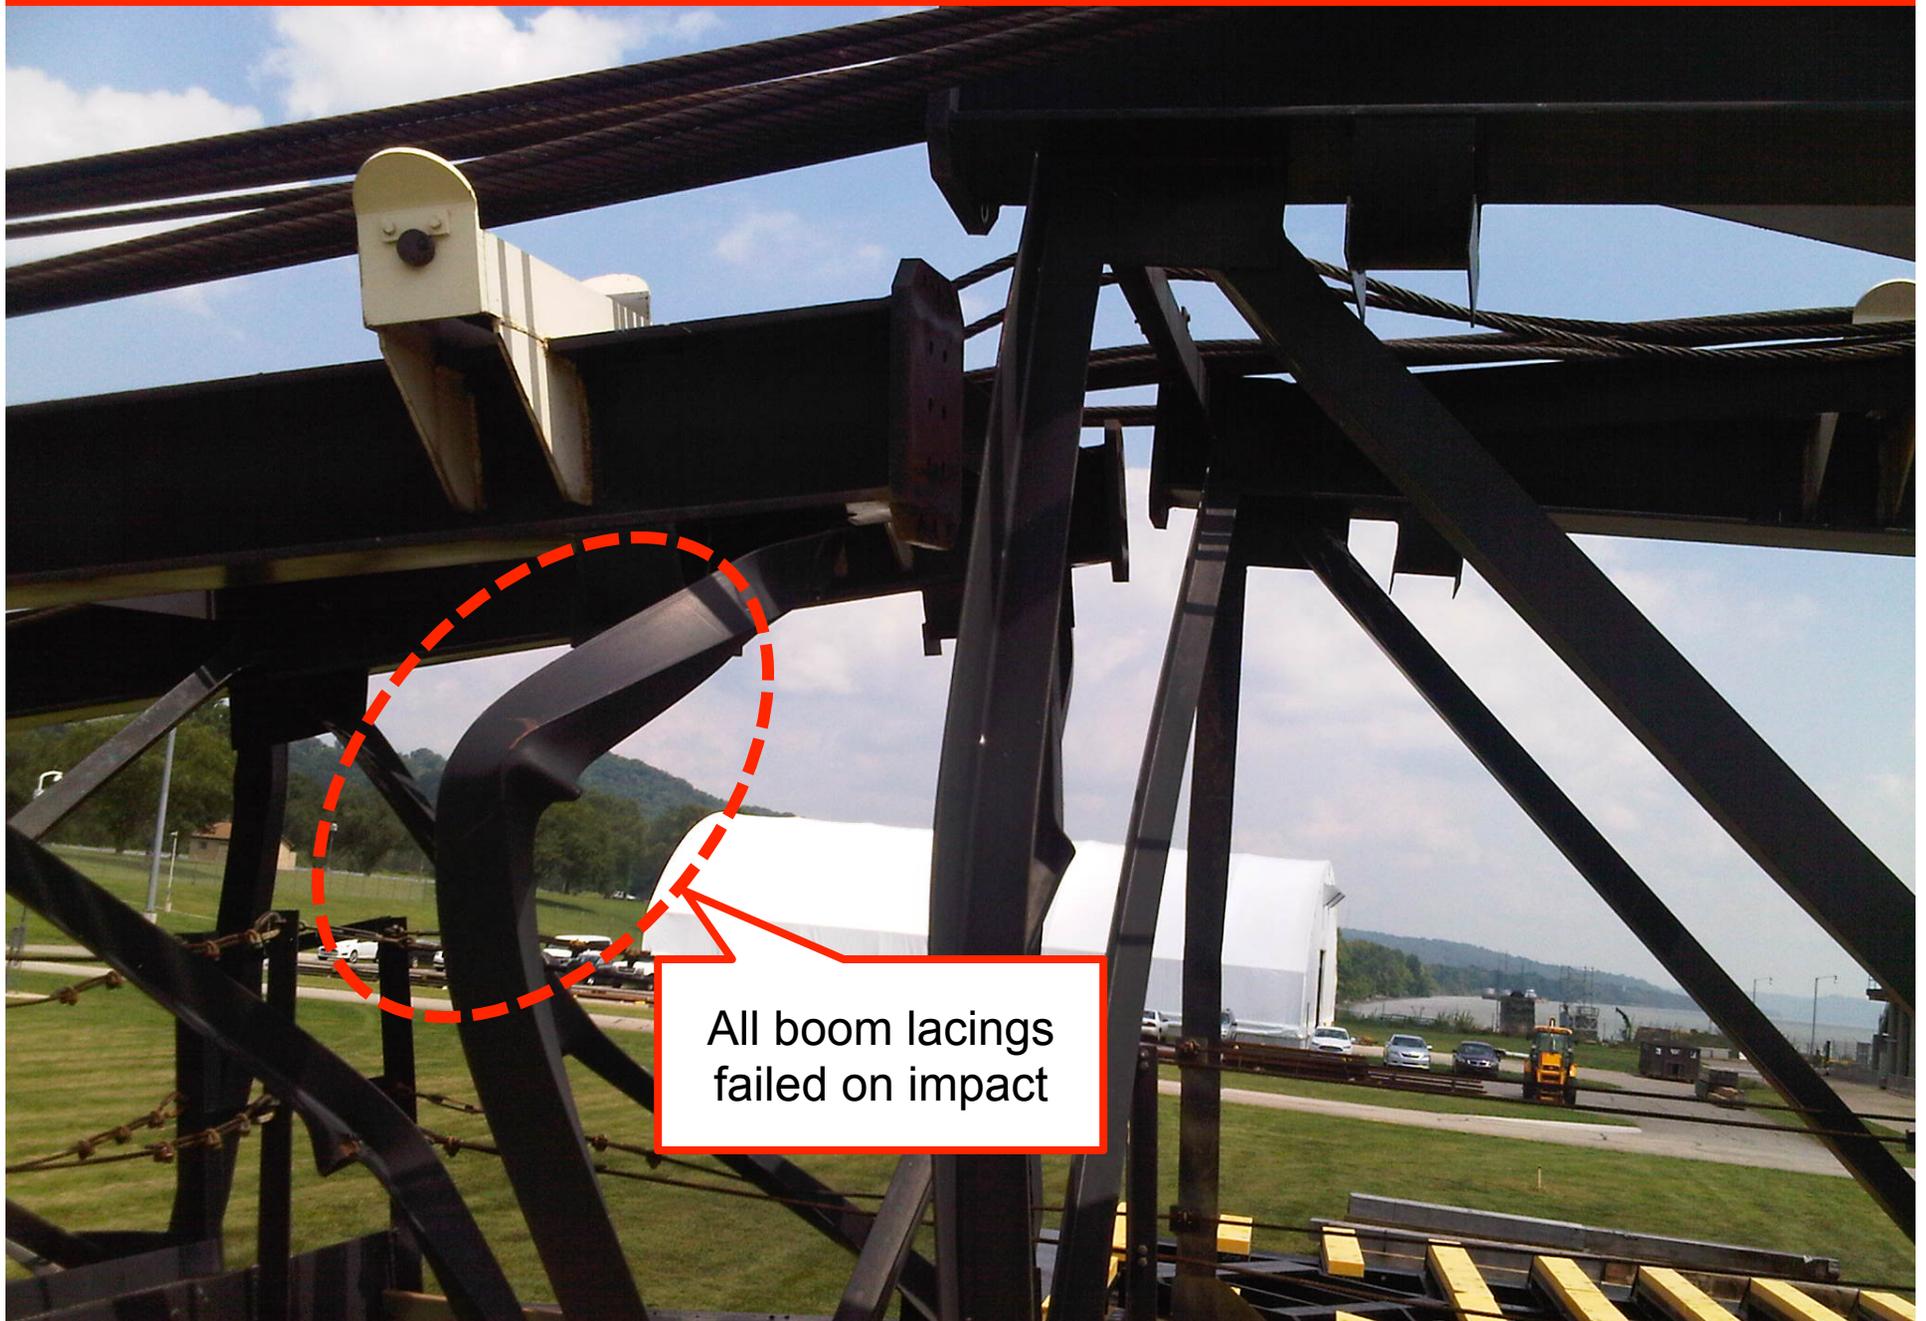
Failed Boom Tip Connection Close Up

All boom lacings
failed on impact

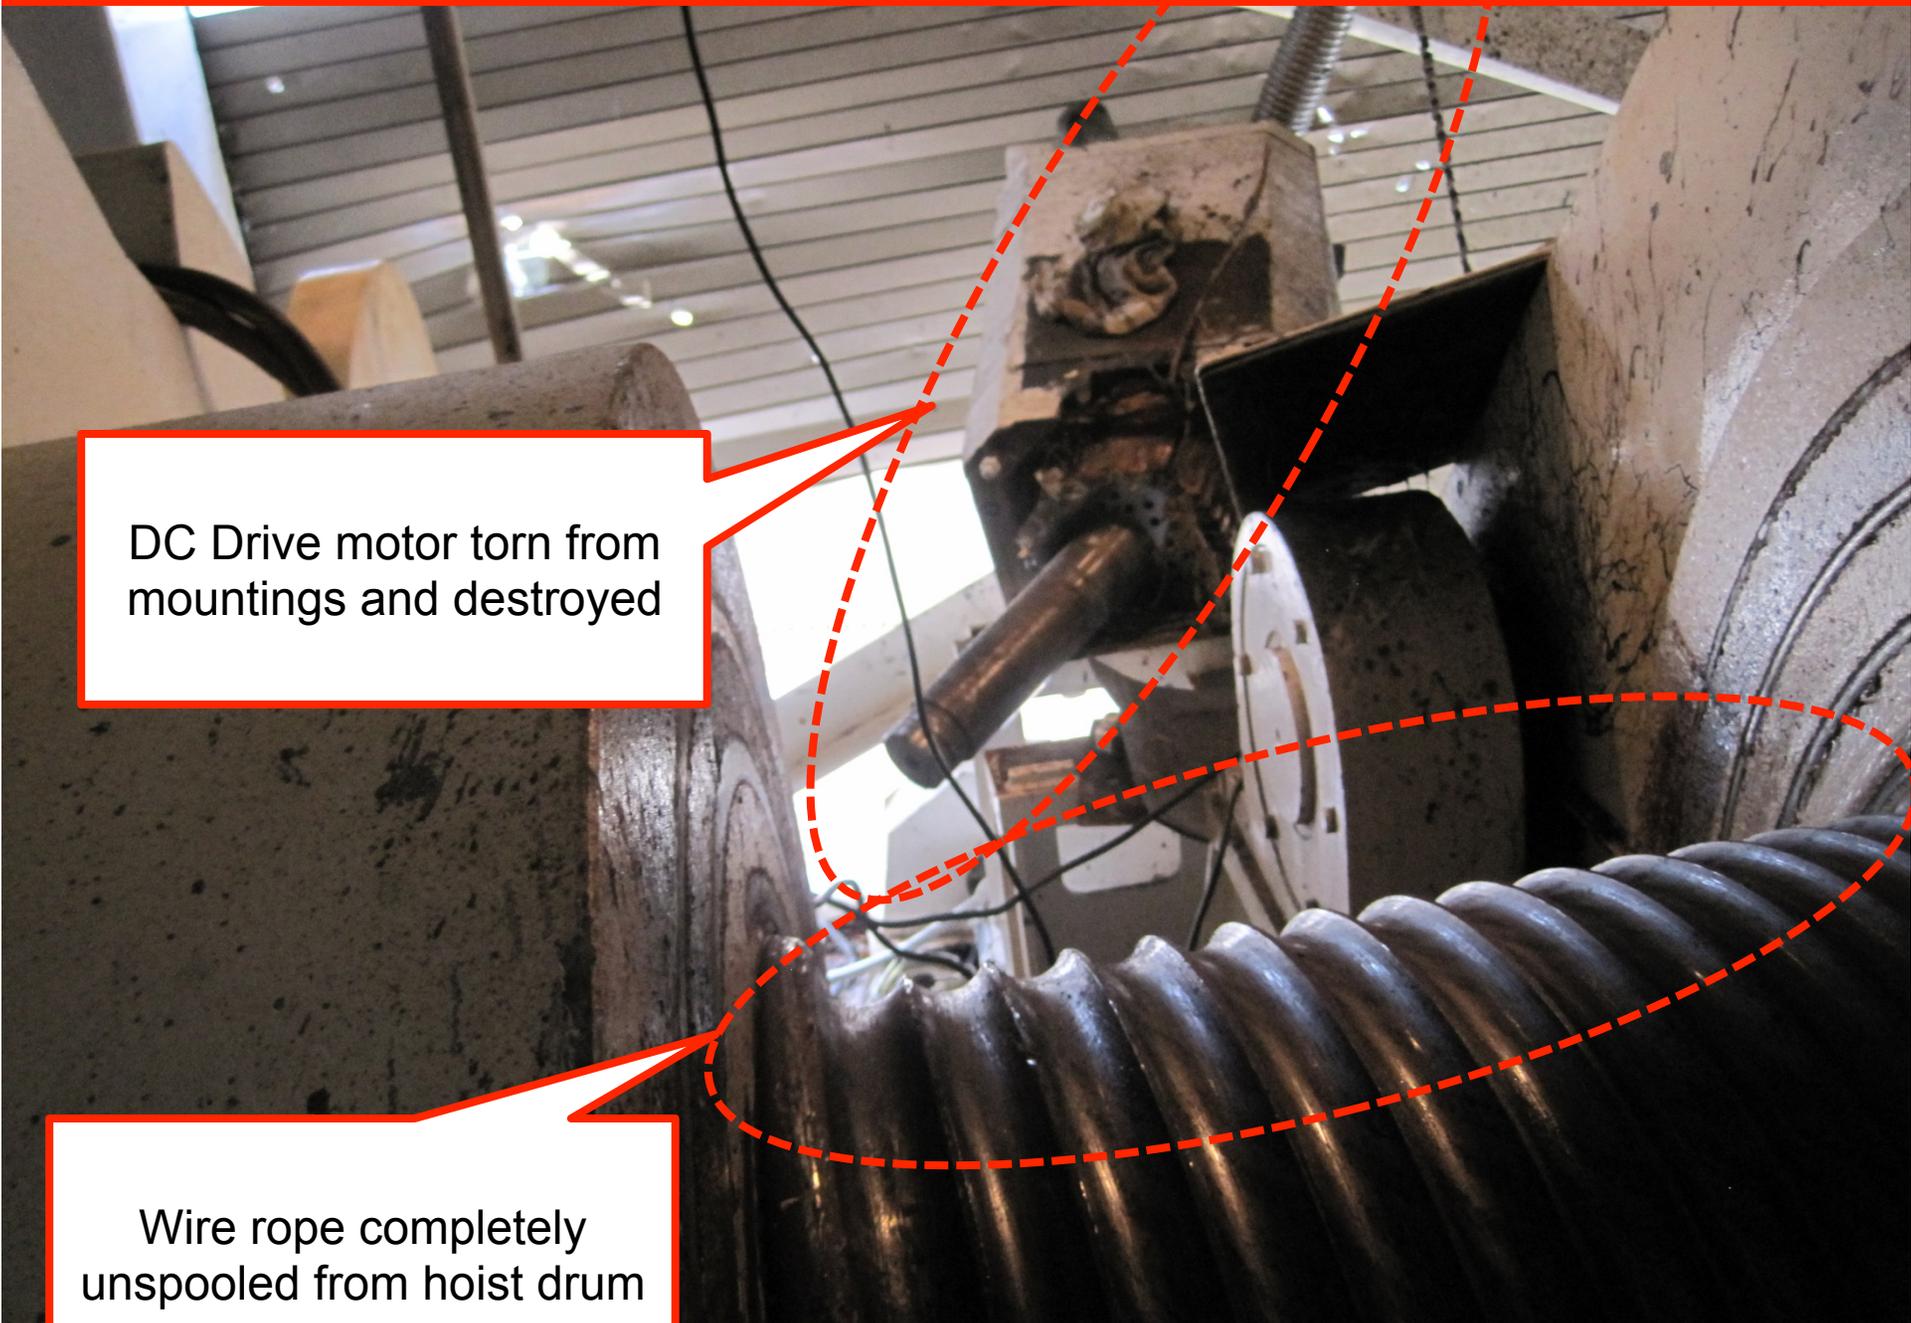
Boom Hoist Machinery Damage

DC Drive motor torn from mountings and destroyed

Wire rope completely unspooled from hoist drum

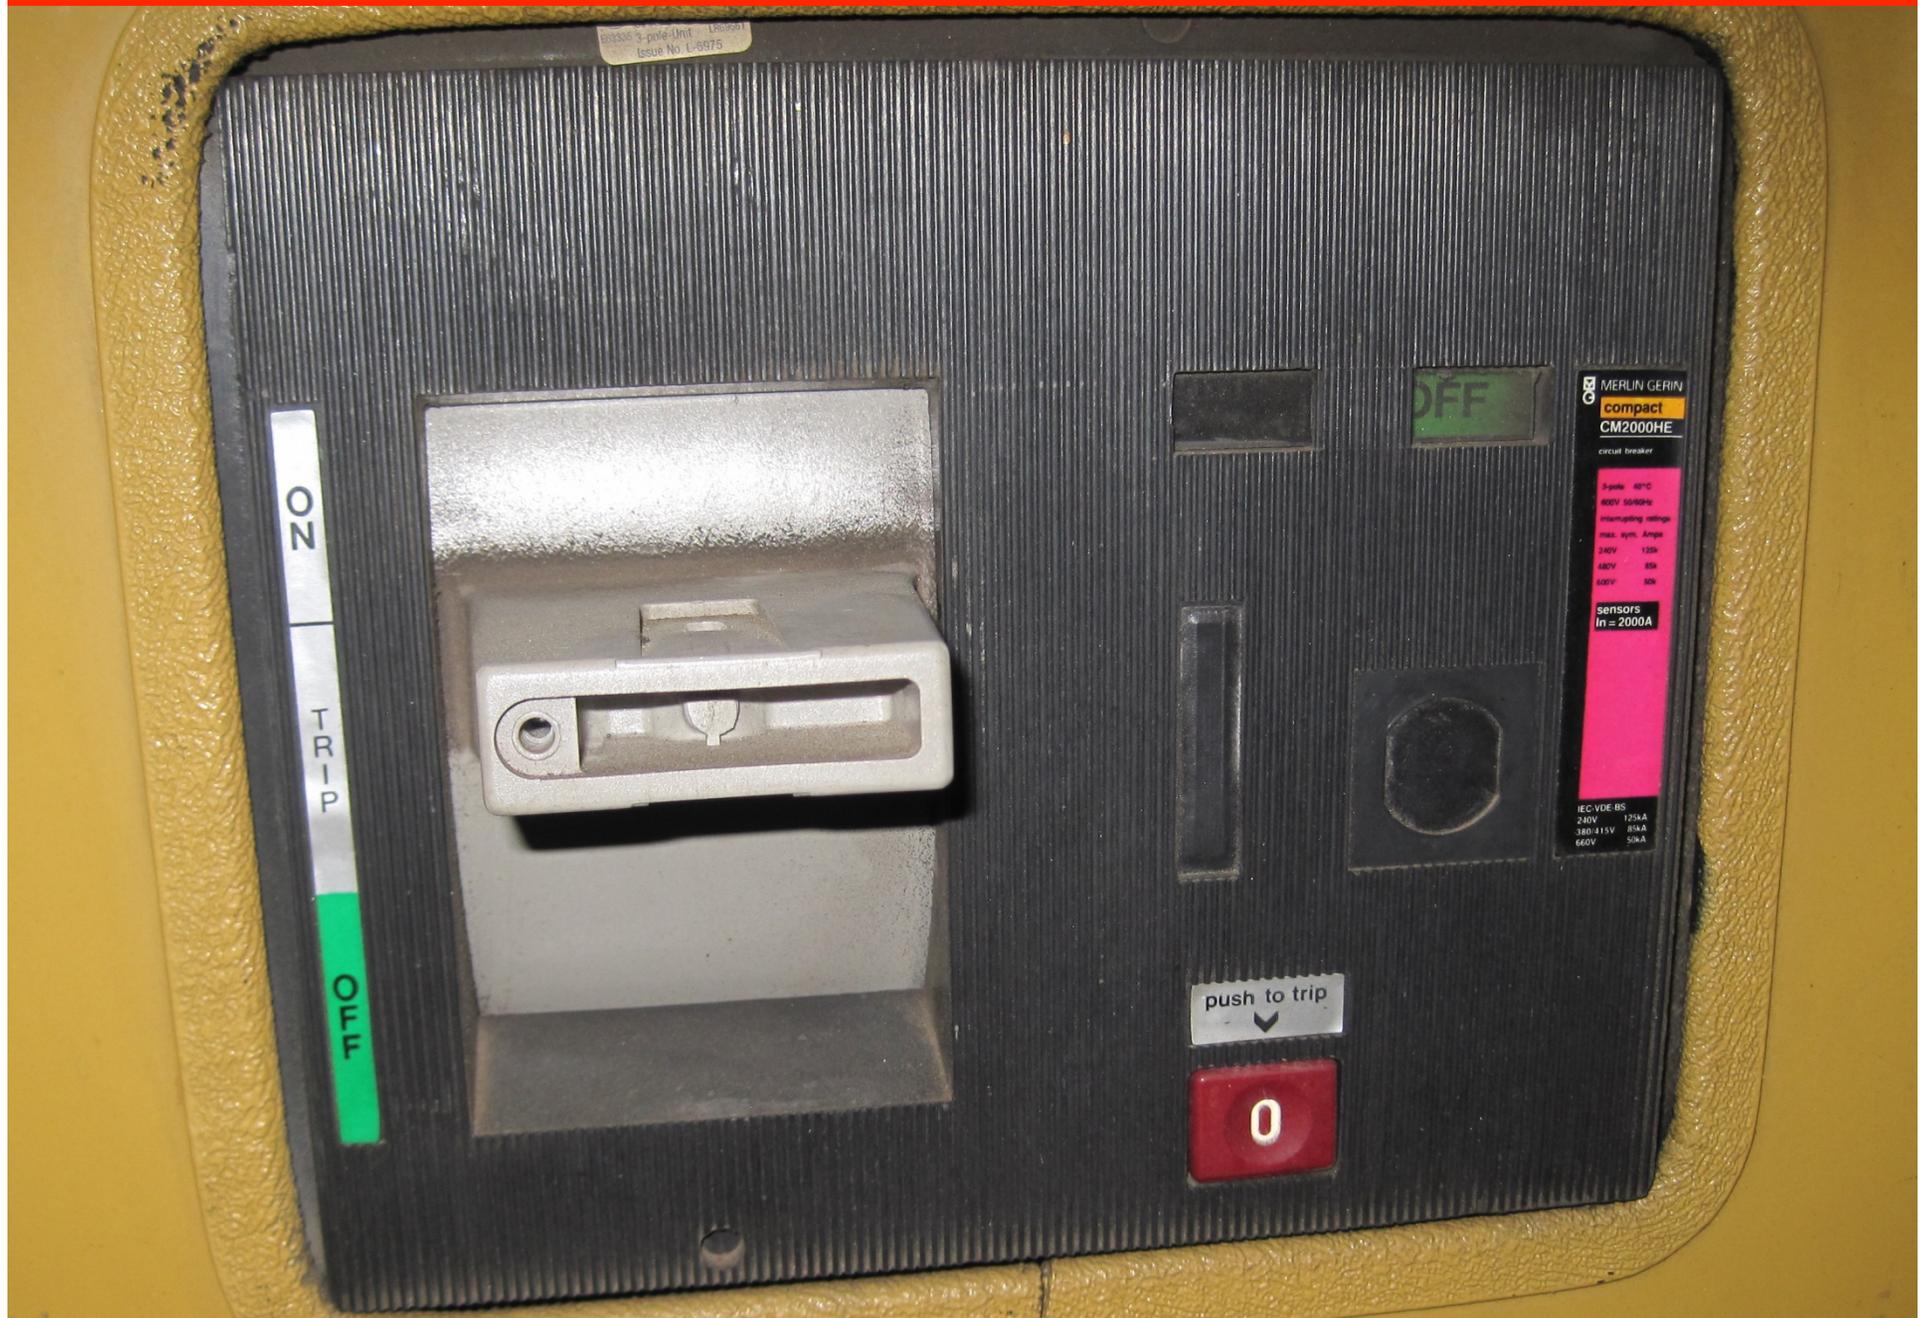
Tripped Circuit Breaker on Main Generator

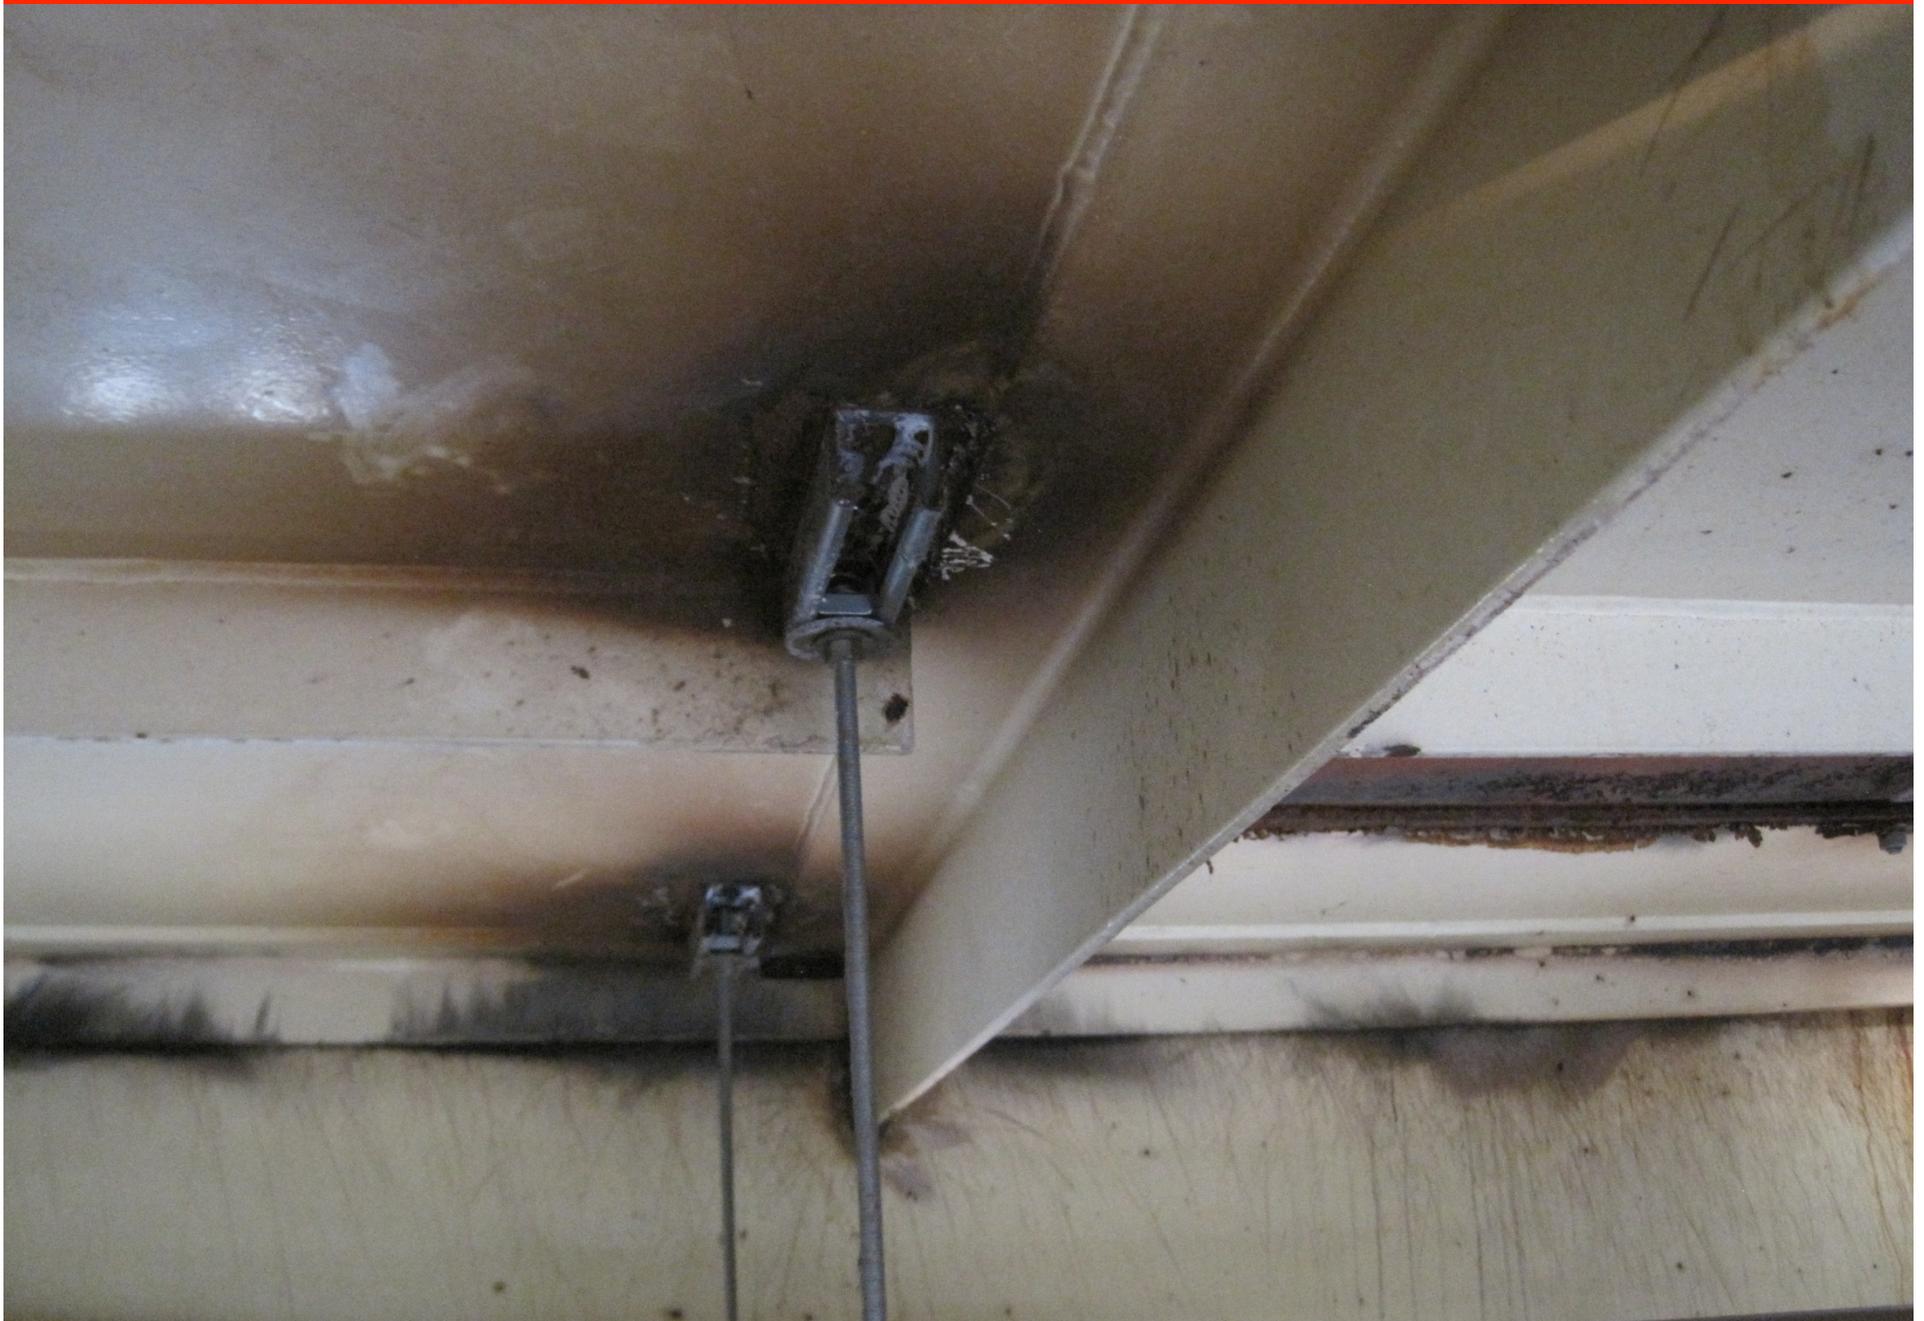
Arc Flash Damage Under the Whirler

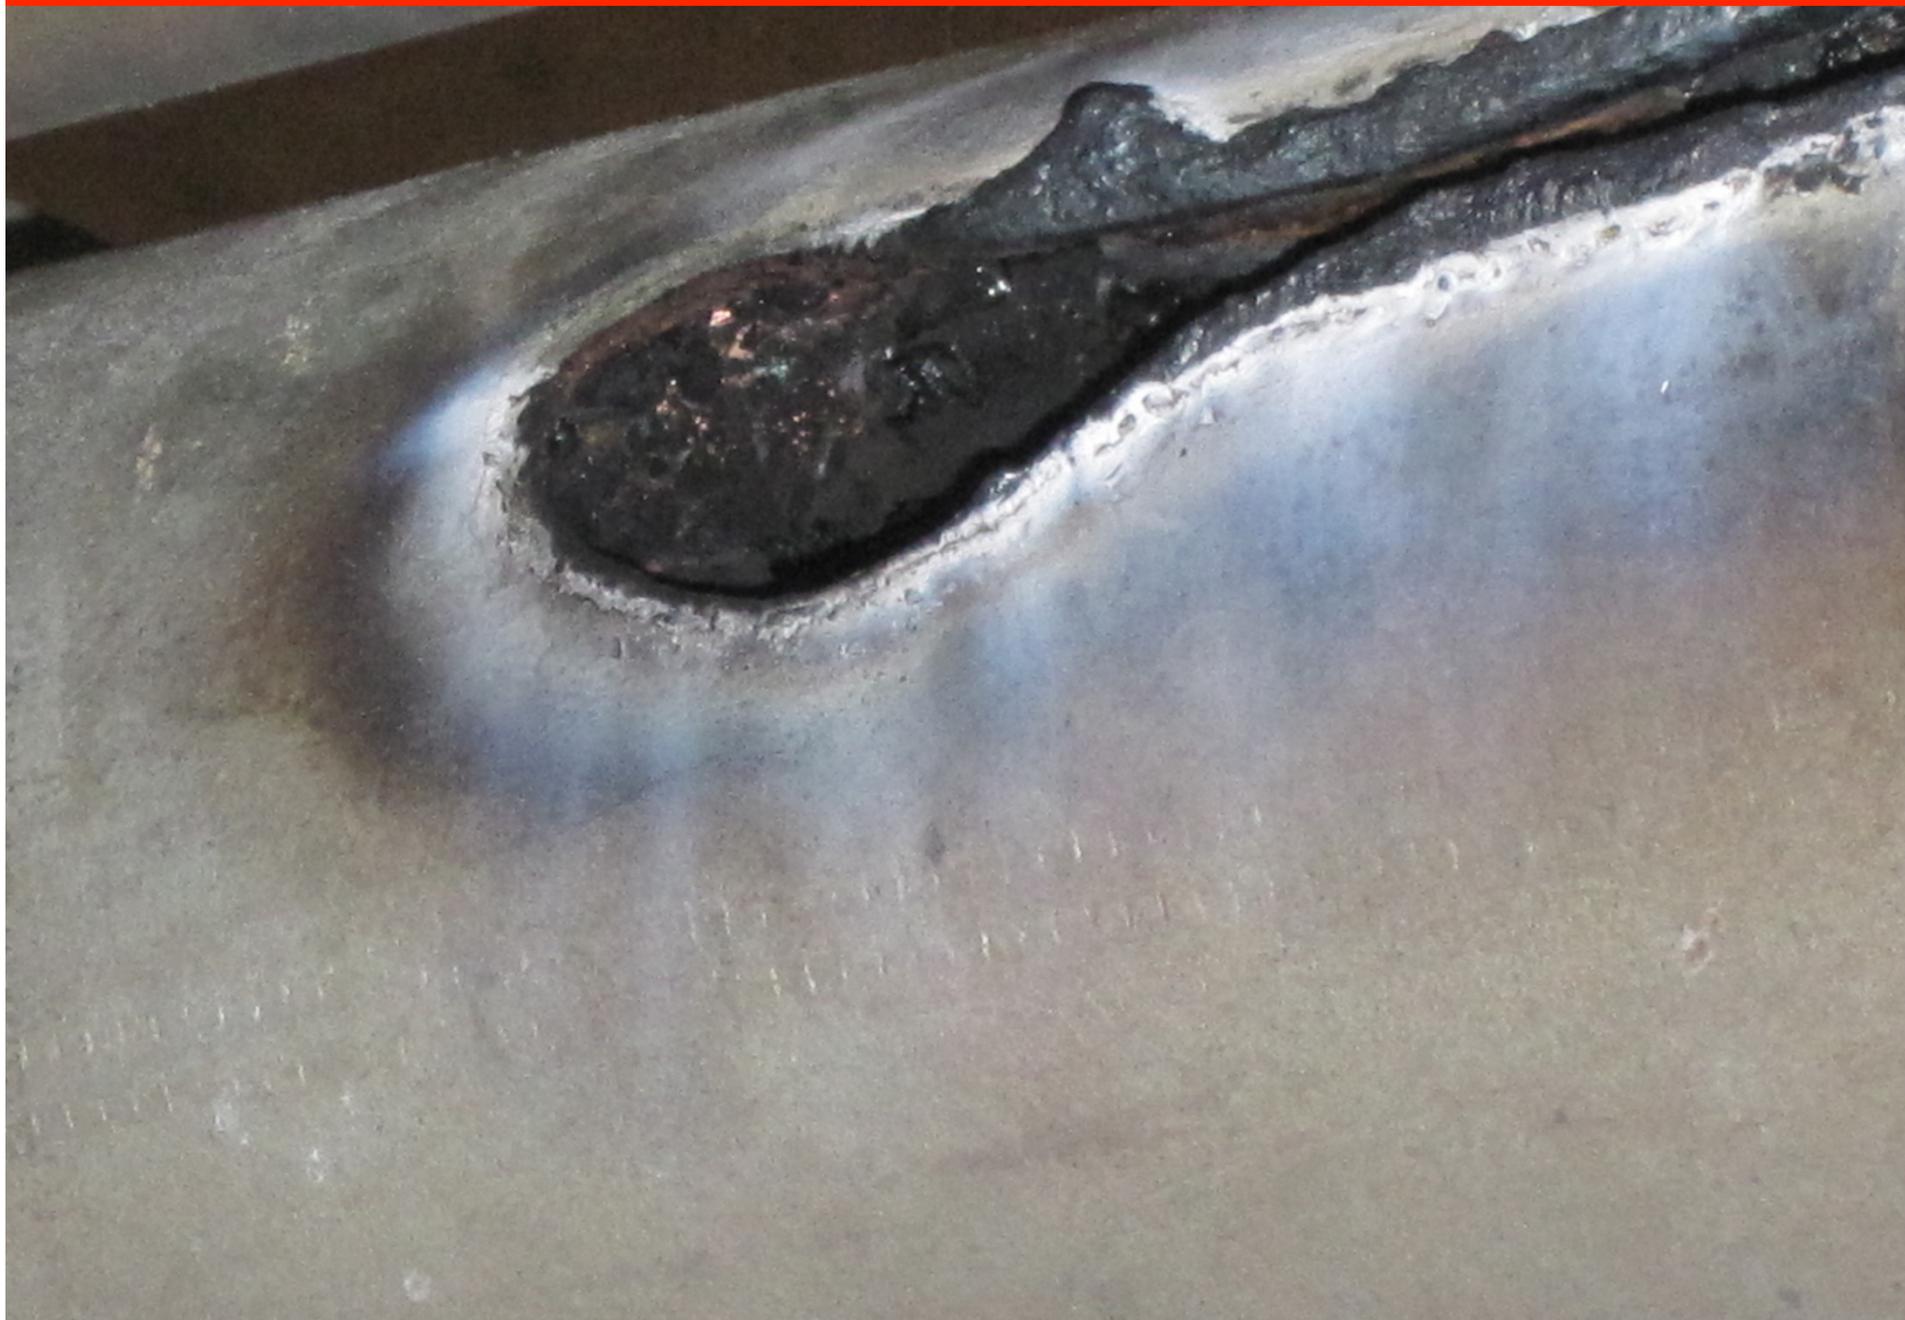
Blown Out Electrical Conduit Under the Whirler
