Panama Canal Gate Seal Problems

USACE 2016
Vicksburg, Mississippi

WILFREDO YAU
Locks Overhaul Engineer

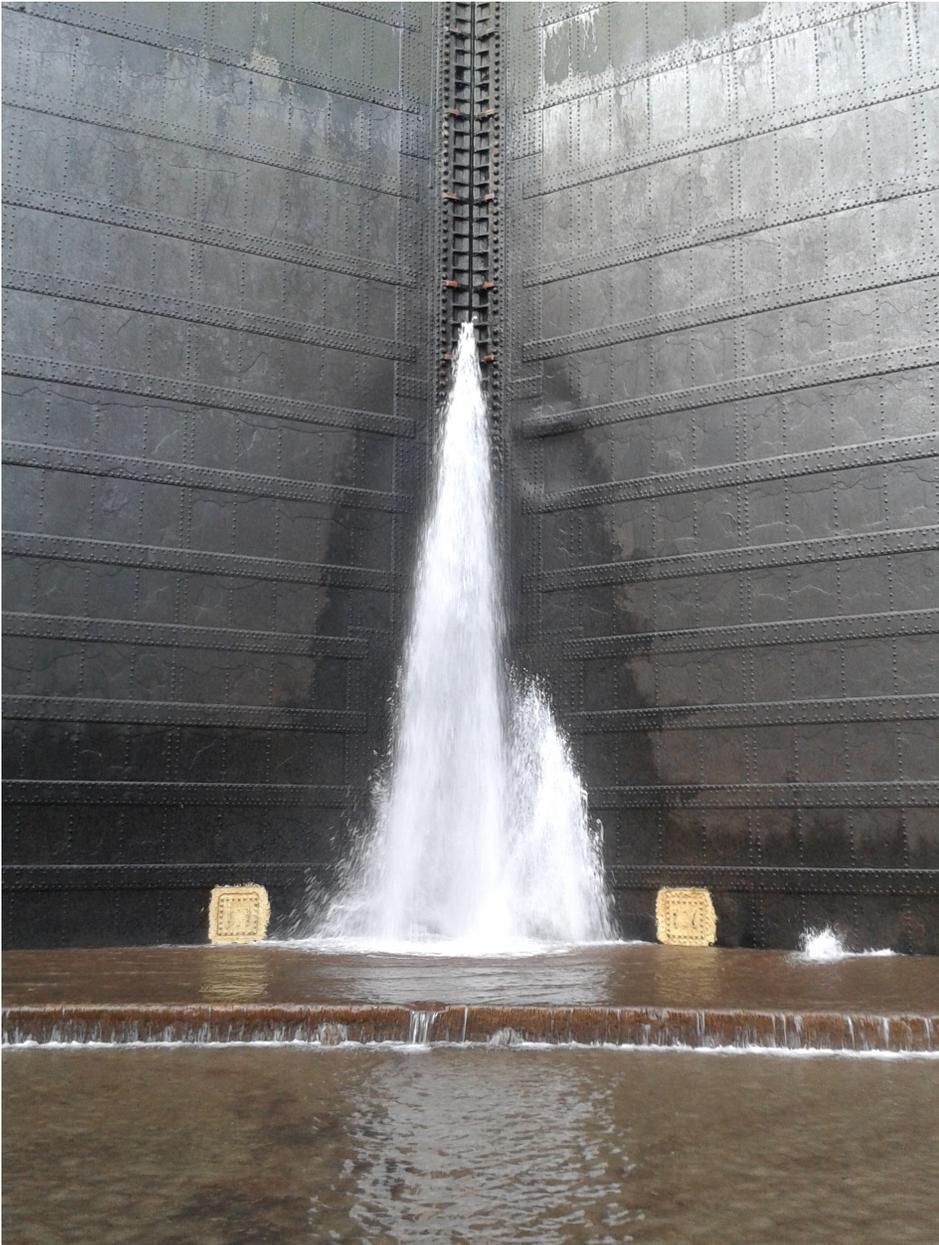
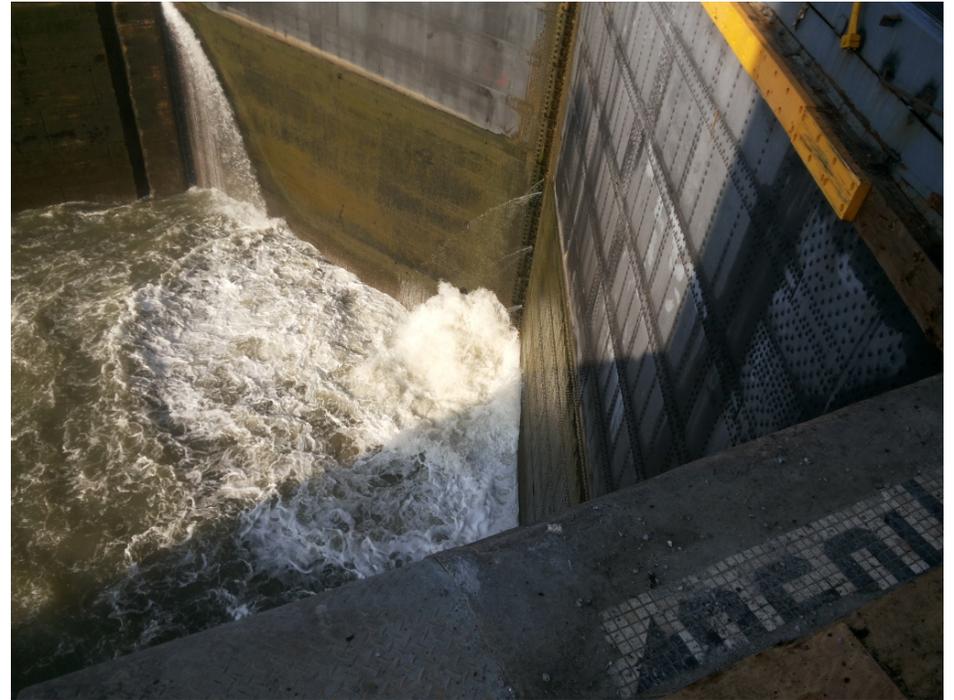
Leaks by rubber seals

Our main problem:
Important leakages on rubber
seals.

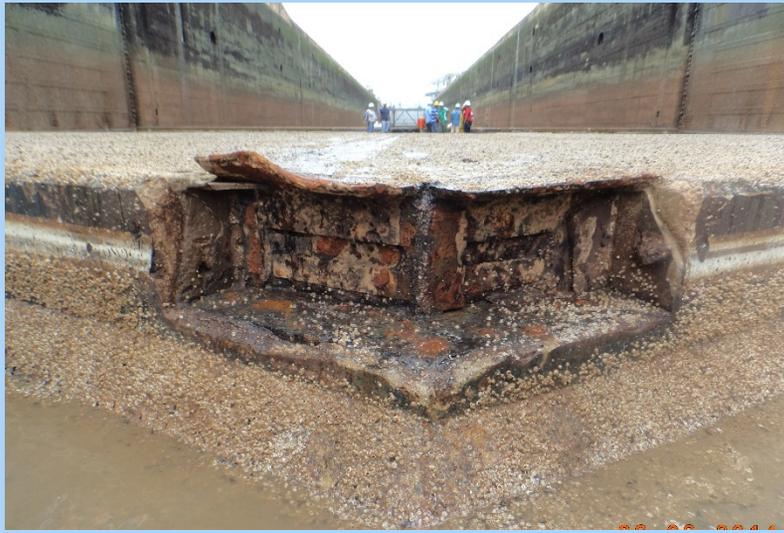
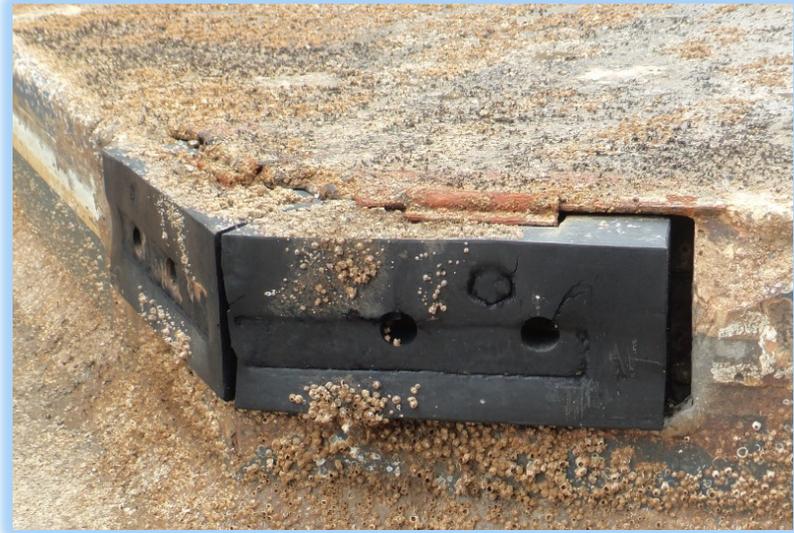
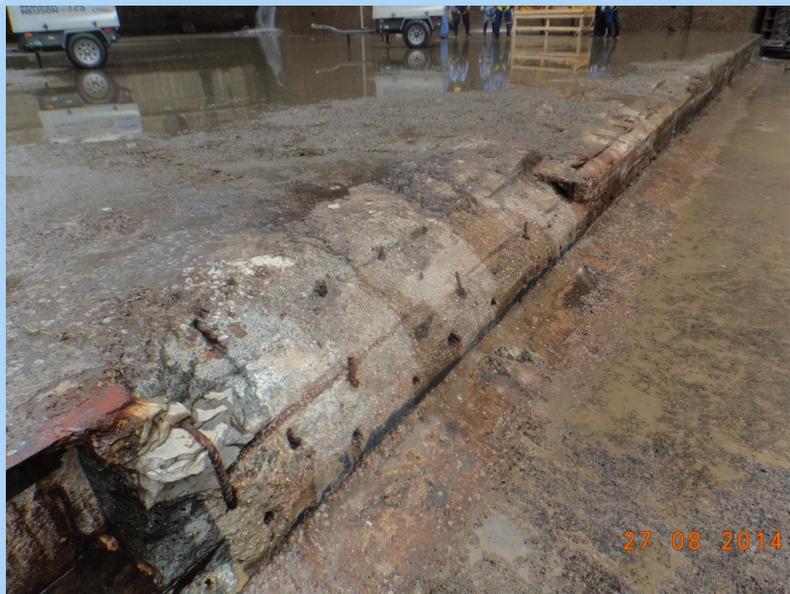
Sill and apex damage exposed during dry chamber works.

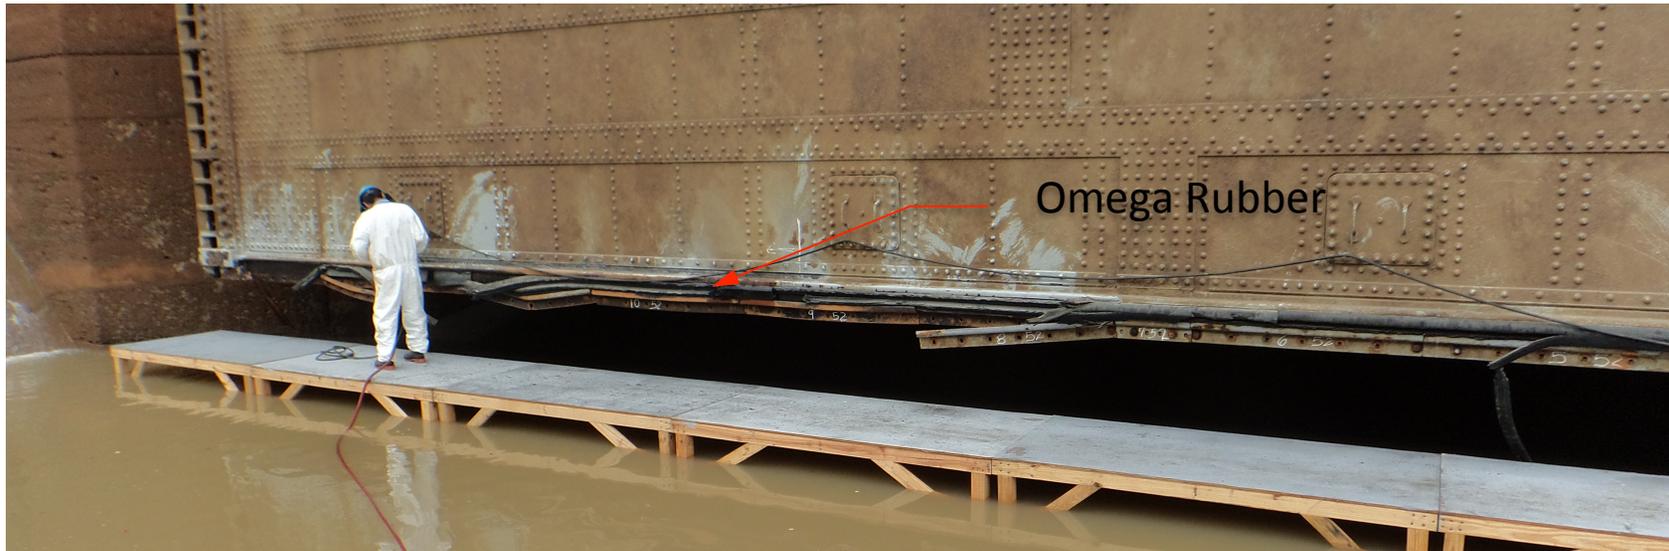
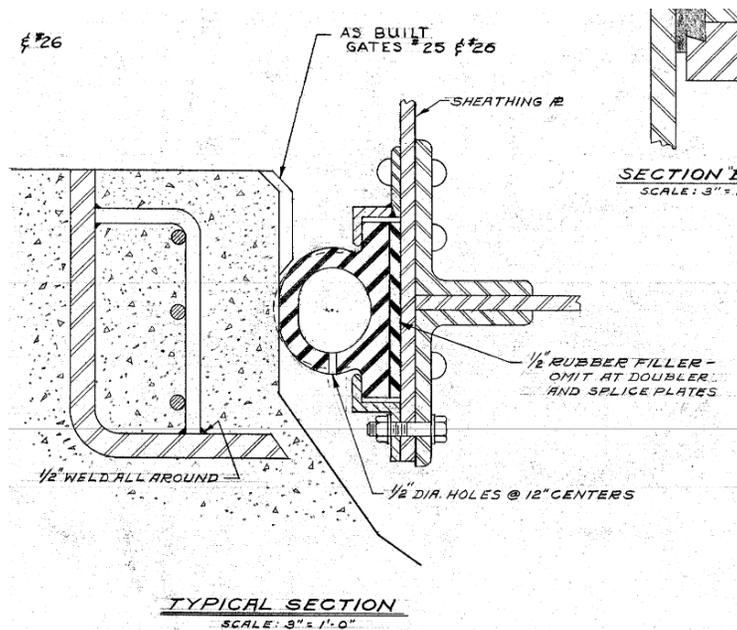
- These are part of the rubber seal installed directly on gate. Works together with Apex.
- Severe damage is presented in some conditions, including the fixing hardware.

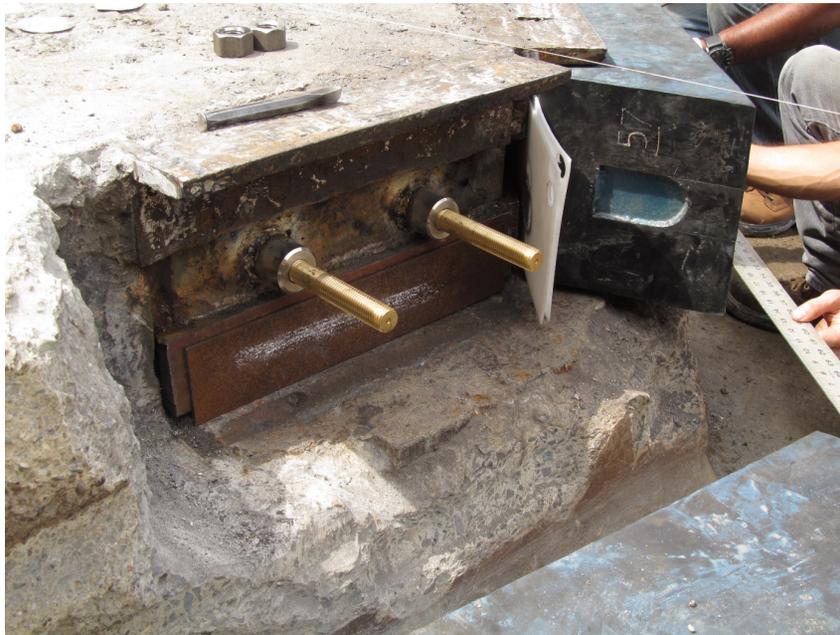
- As per current design, two marine brass bolts were used in each section.
- The modified apex was used for its first time.
- The gate works properly for approximately 3 weeks.
- The bolts failed by shear and a big leakage started.
- No damage on apex.
- New question:
 - Why do we have a shear stress?

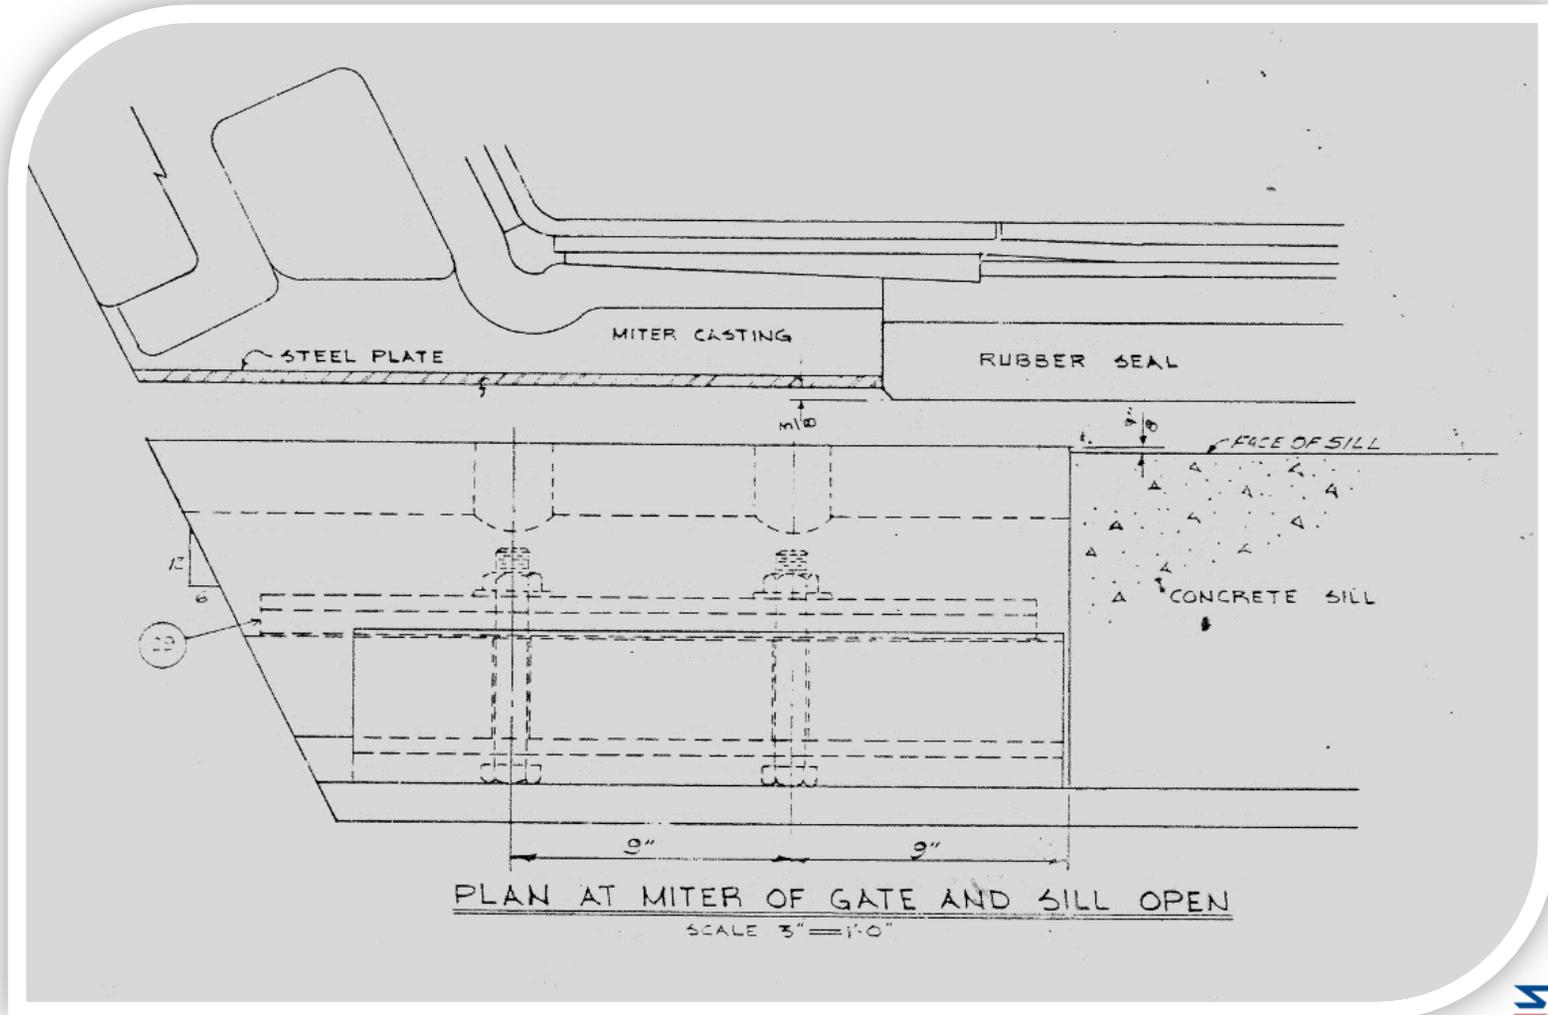
Drawing 5088-222A, 11 Apr 1969, Rev. 1999, 2001

Vertical gate movement = potential shear failure
