# Lock 20 Dewatering

Lock and Dam Maintenance  
Workshop 2016

Rock Island District  
Mississippi River Project  
Matt Thurman

# Lock and Dam #20

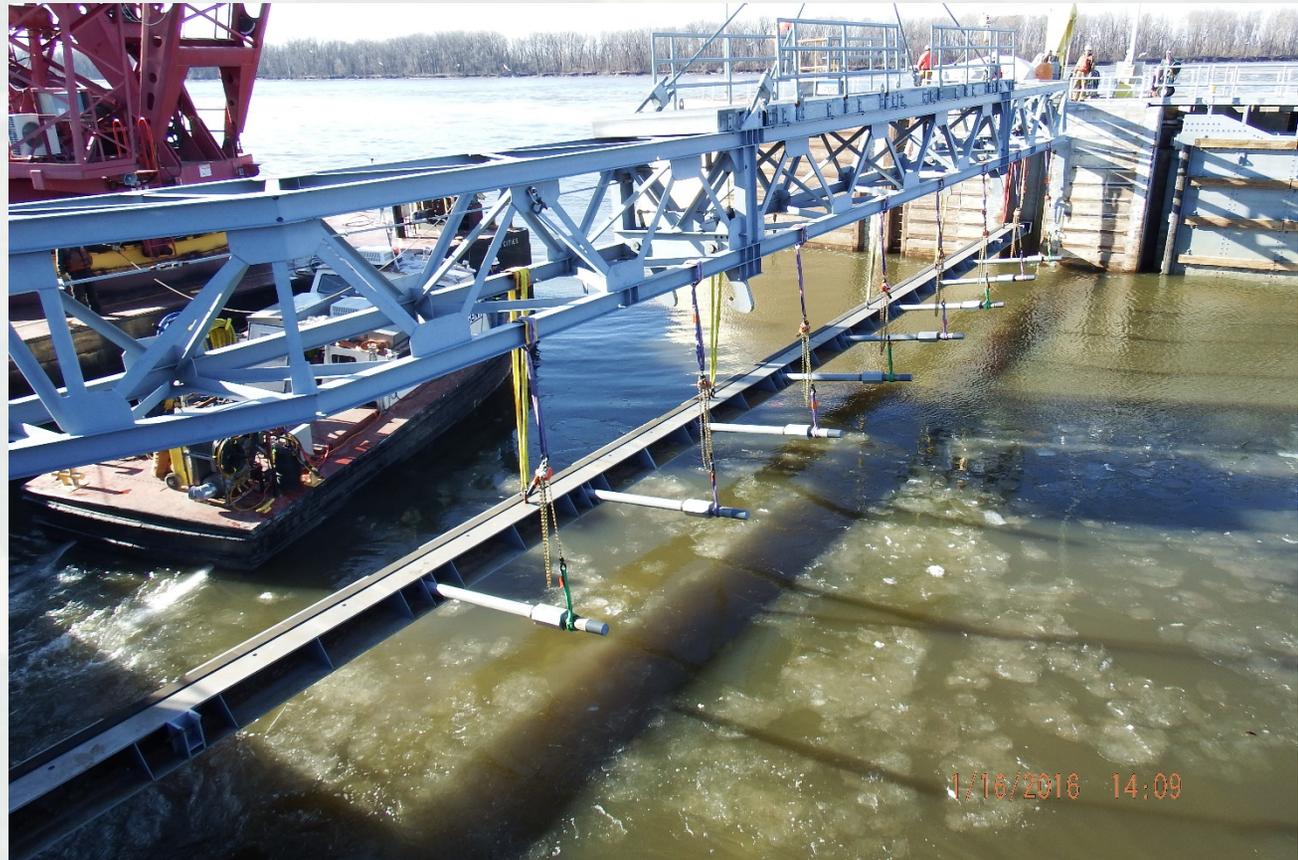
- Weldment with sill plate on top.
- Struts that tie into the poiree saddles.

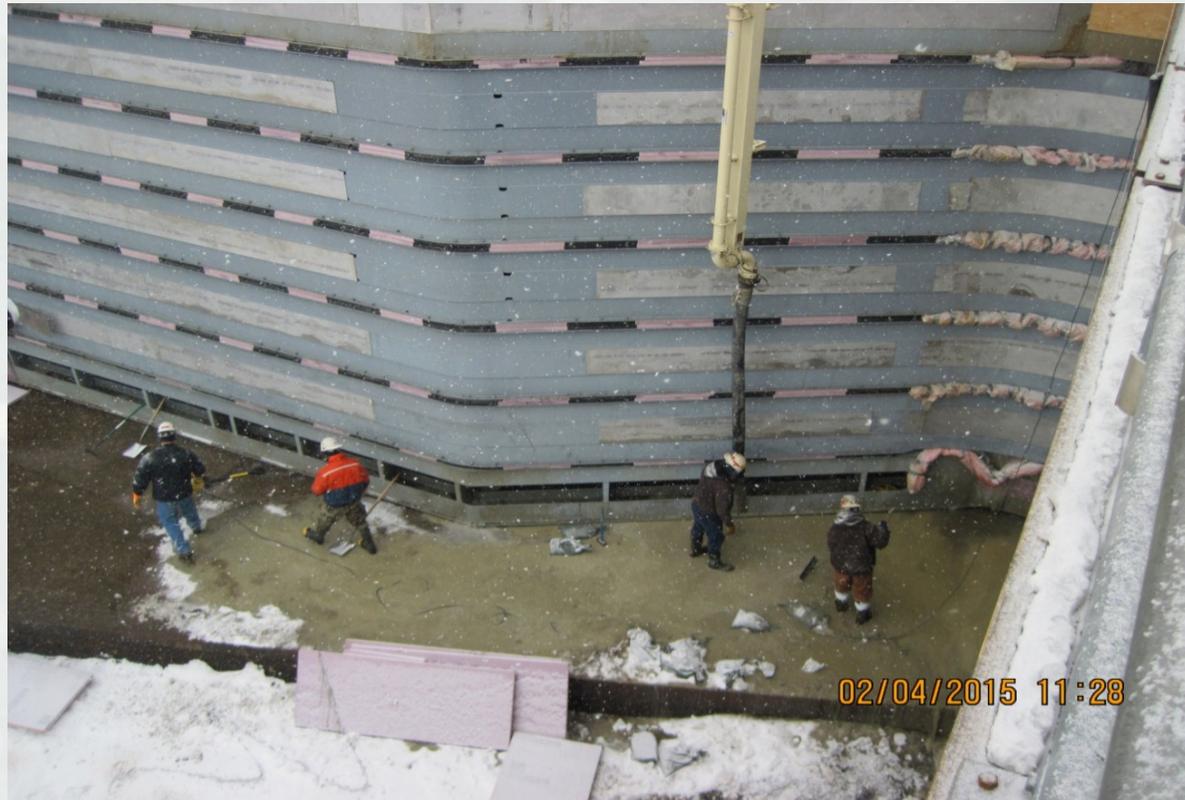
- Placing Concrete around Sill Beam below Bulkhead Stack

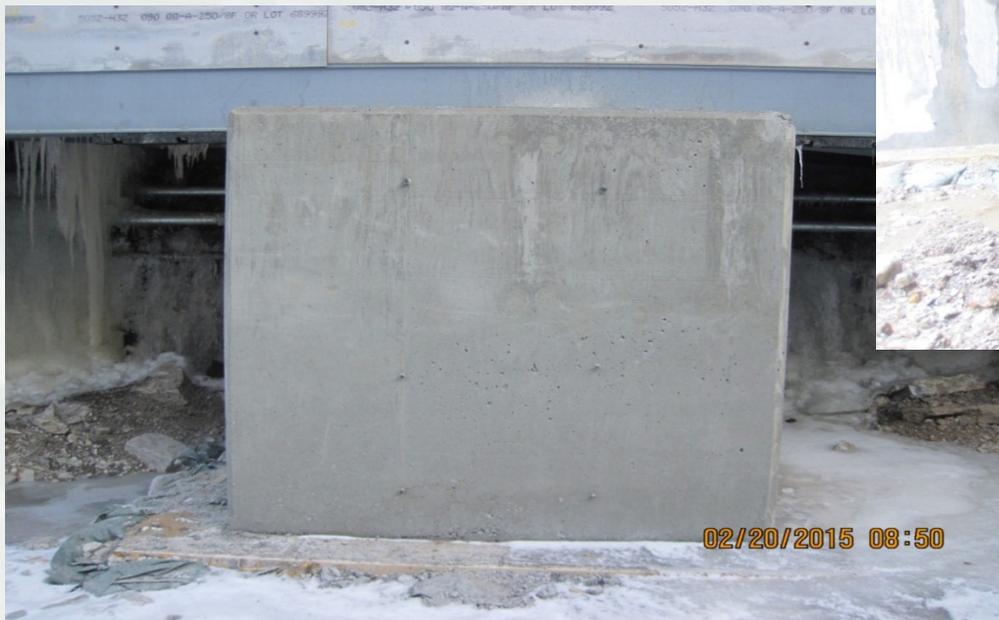
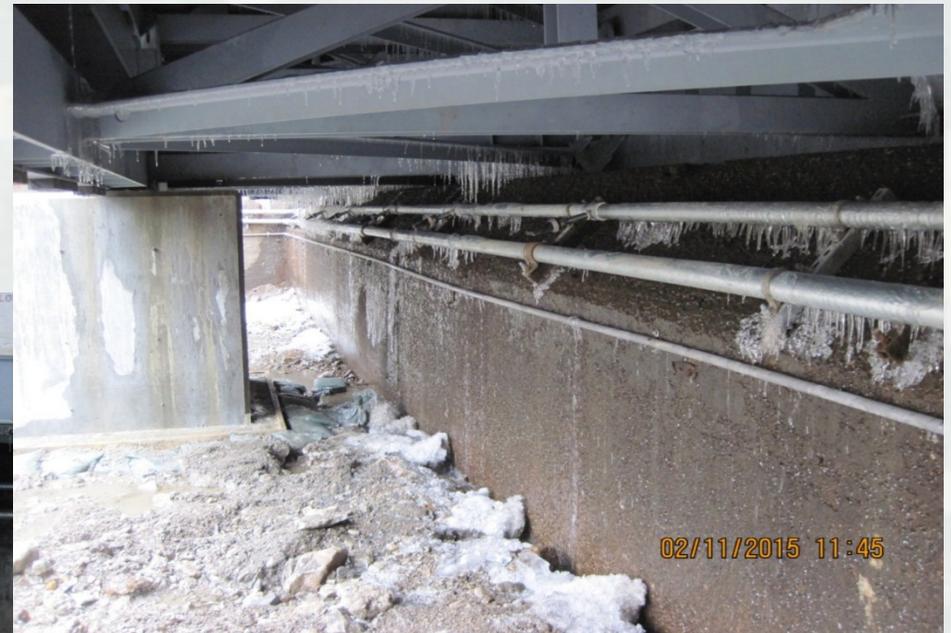
- Concrete Pedestals supporting tension side of Bulkhead

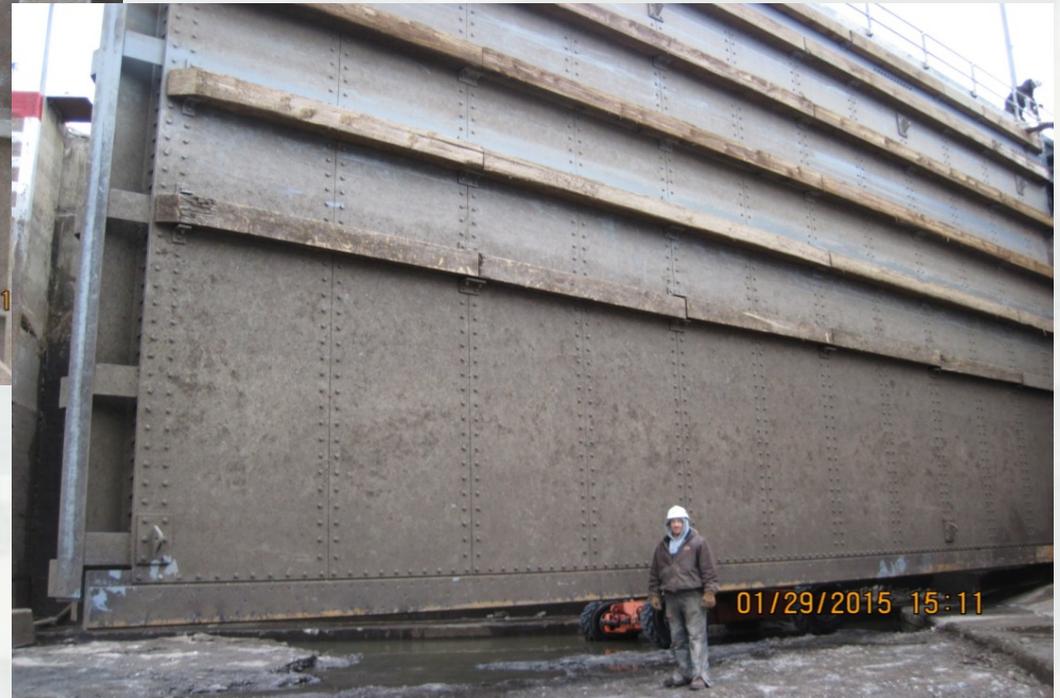
- Typical Vertical framed M/G.
- Air Lines added for debris/ice removal.

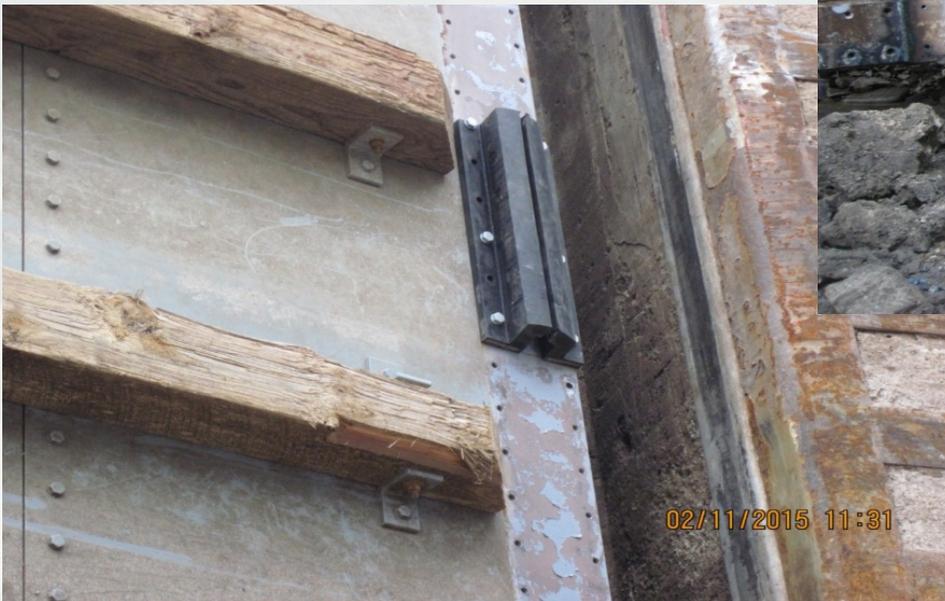
- Omega Seal binding issues at the Quion.

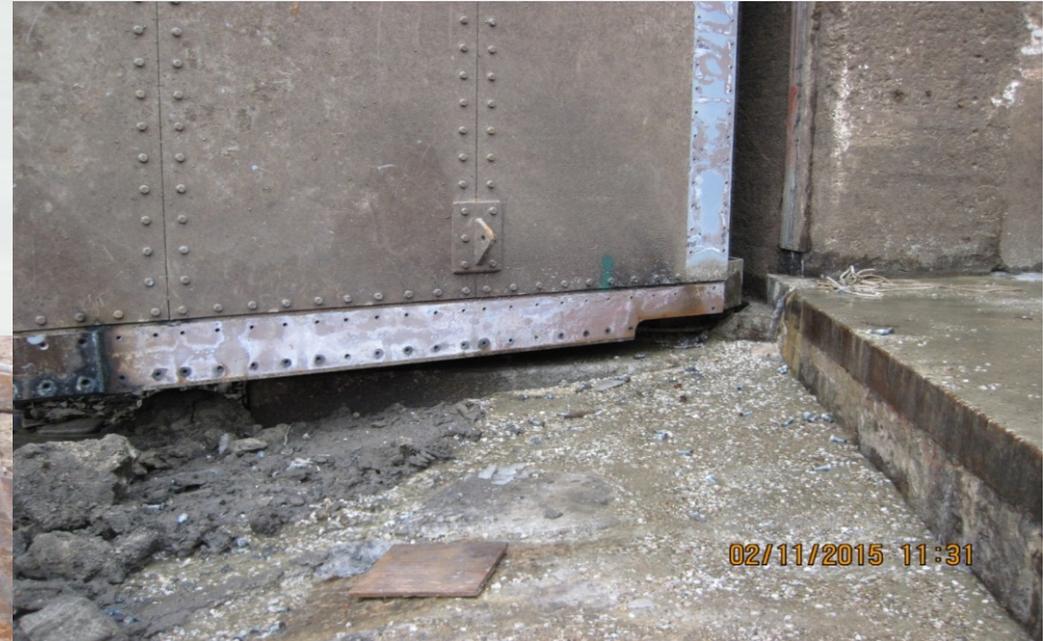
- Thrust Plate Interference with Sill. This was causing #3 M/G to jump.

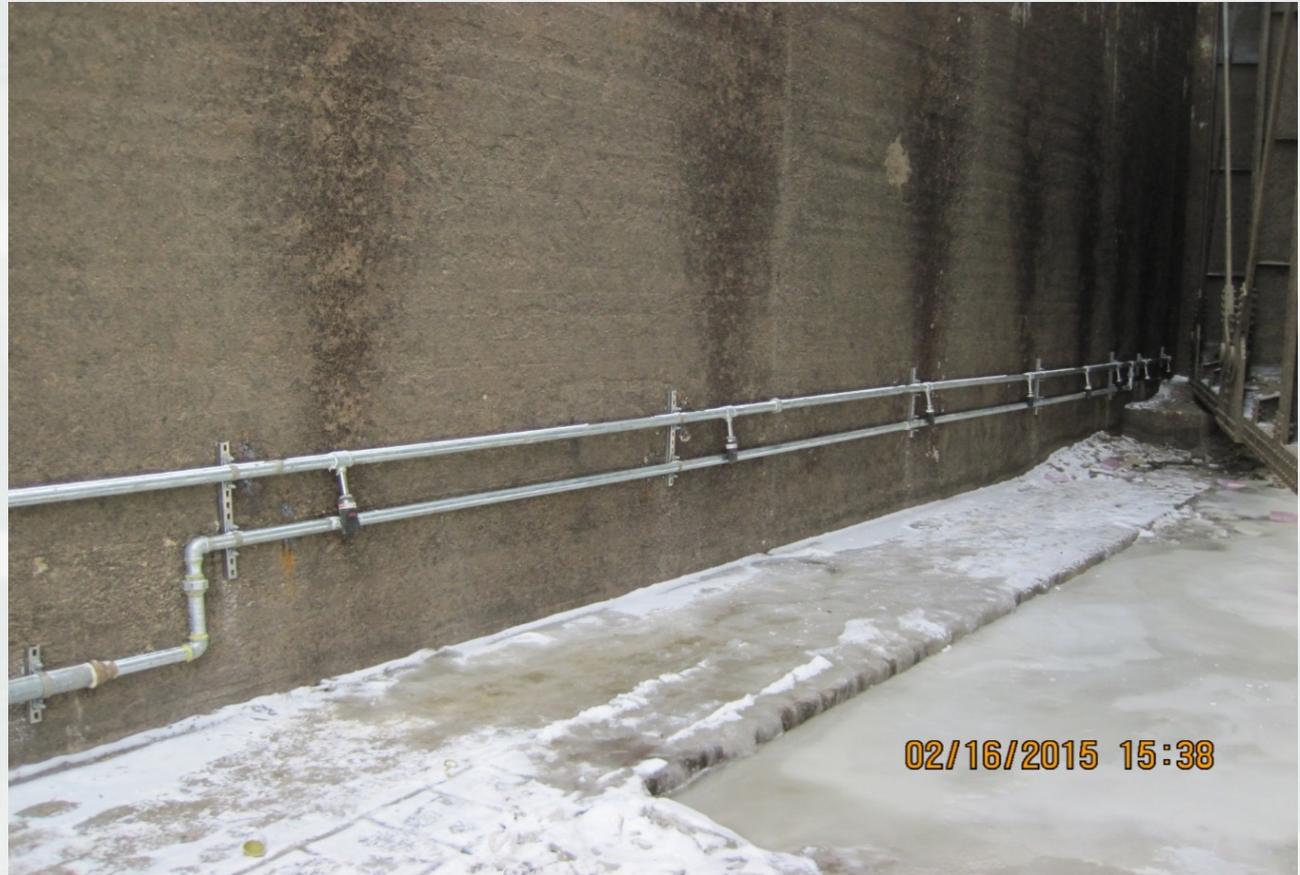
- New SS Bubbler piping in M/G recesses.

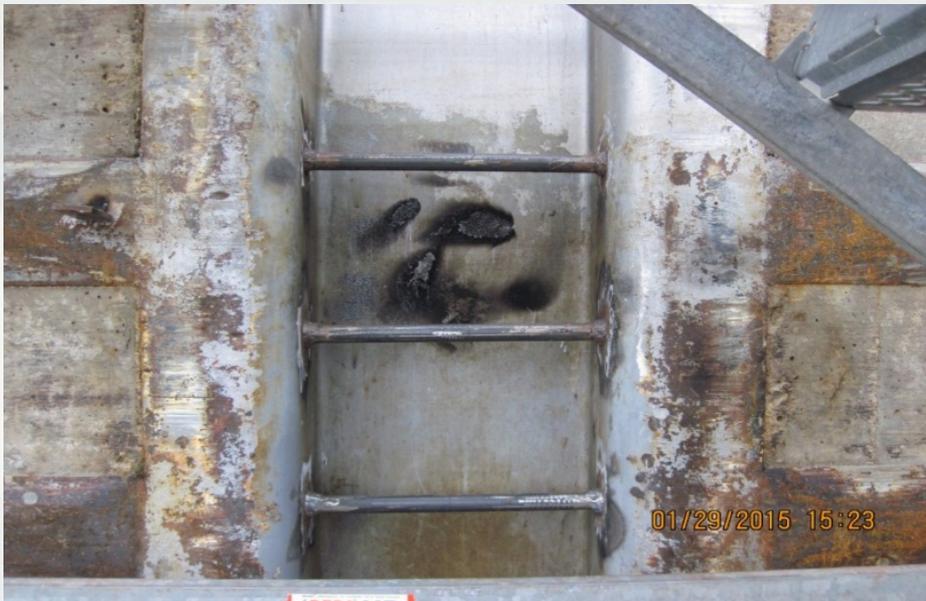
- Ladder Rung Replacement.

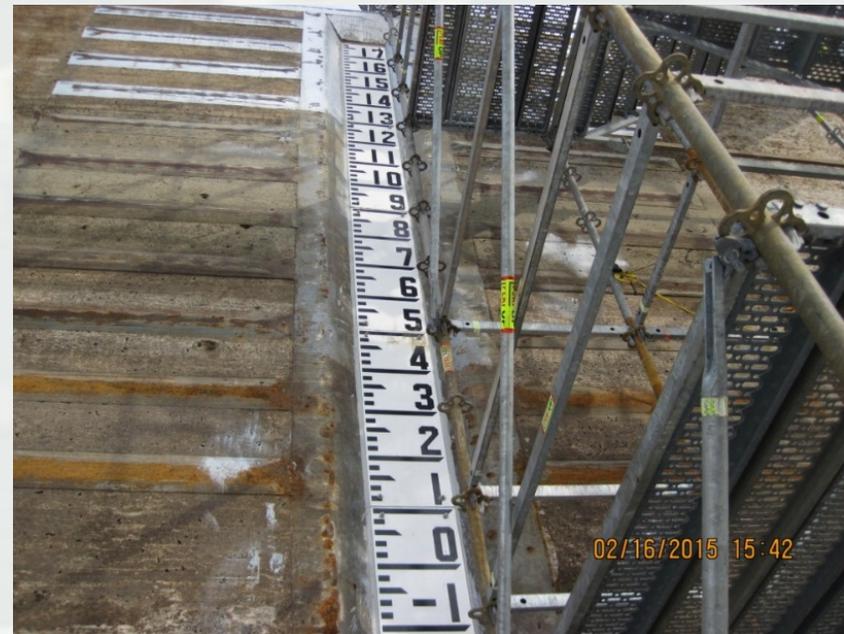
- New Vertical Staff Gage

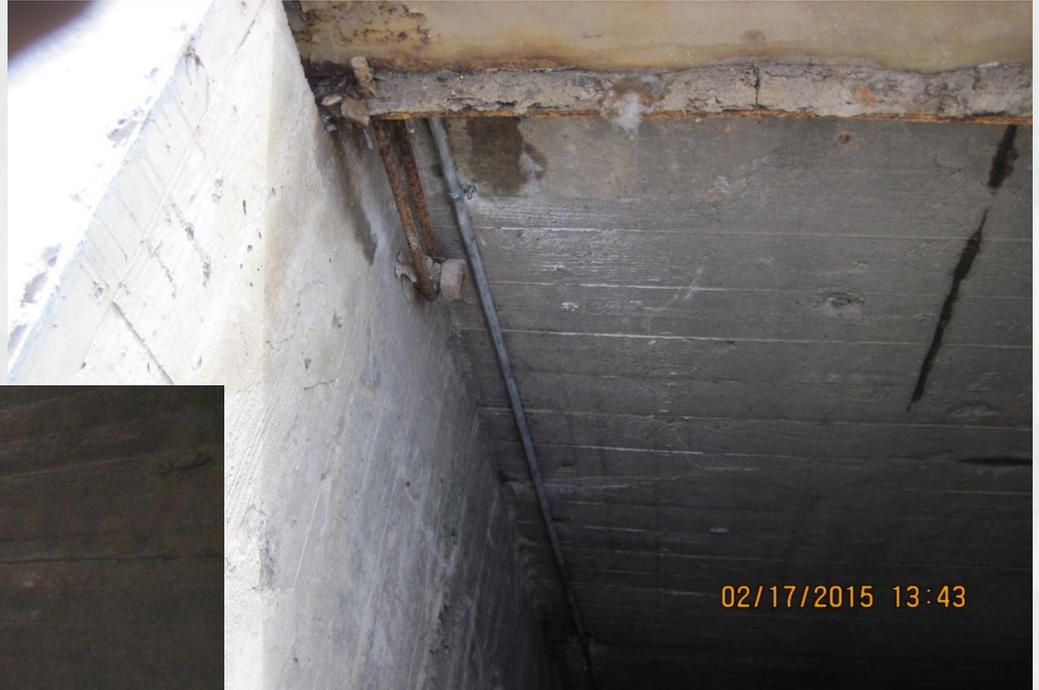
- Trunnion Painting & Inspection.

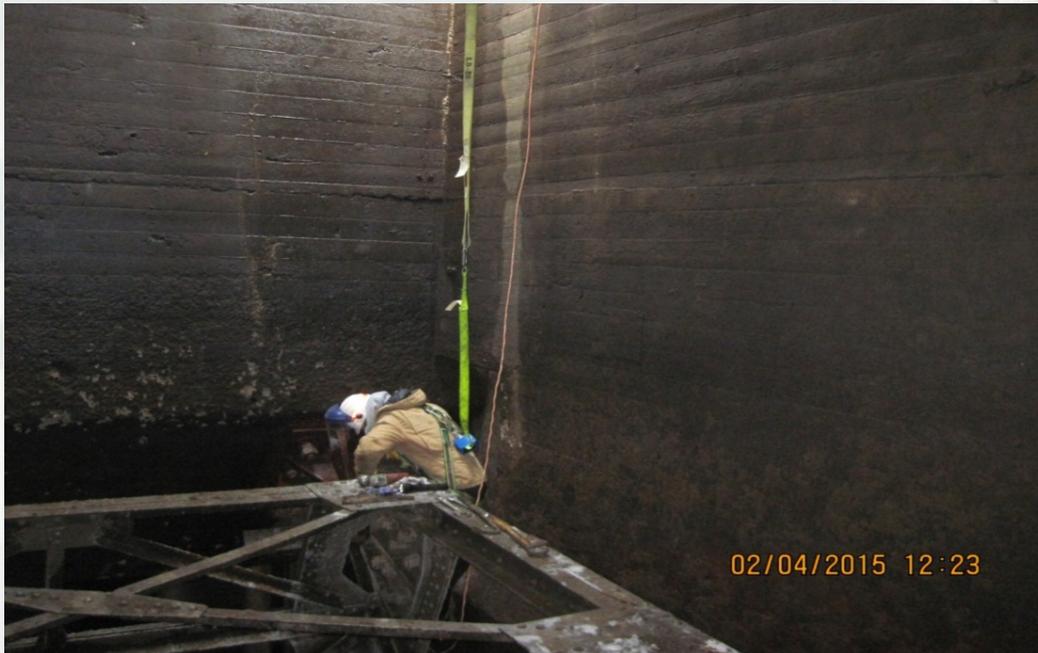
- Replaced all Grease Lines to Valves

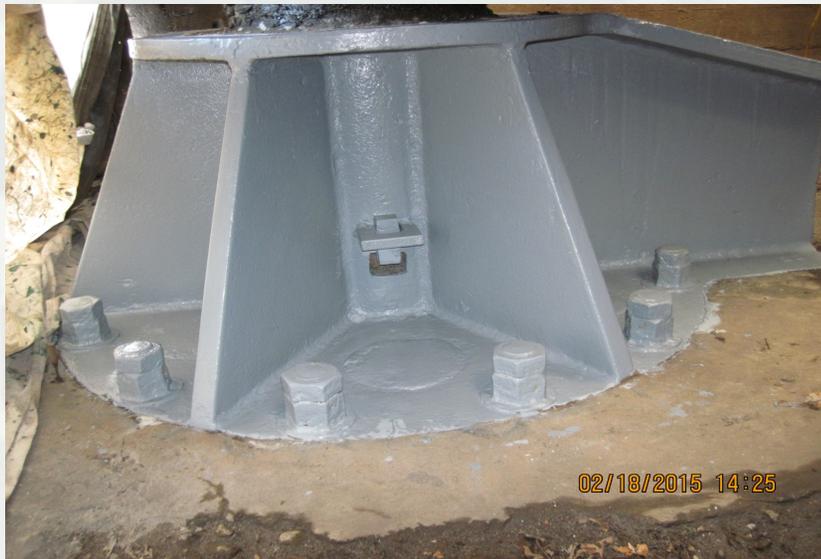
- Sector Gear Base Inspection & Paint.

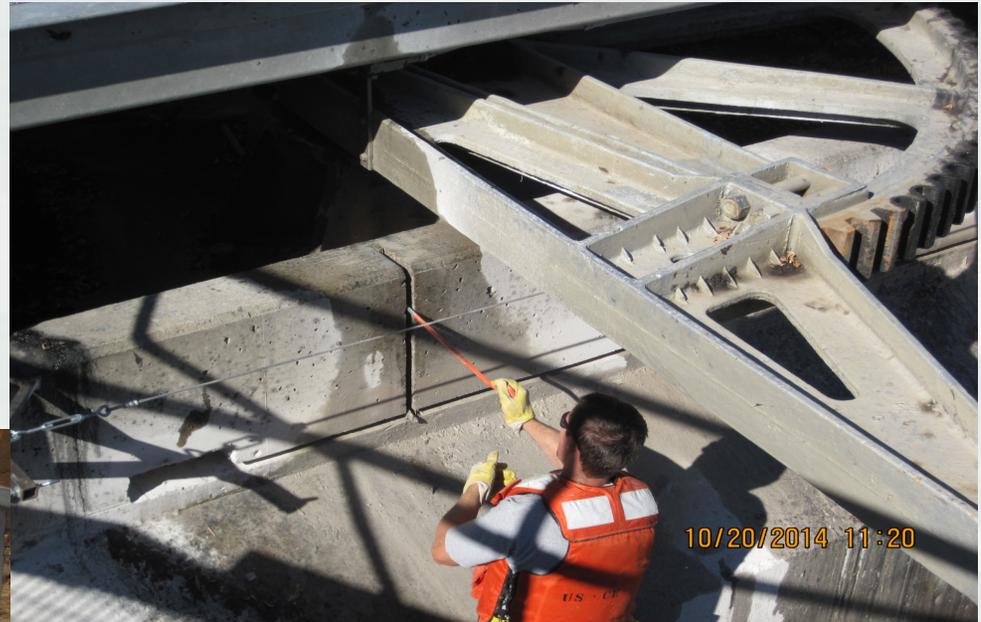
- Parapet Wall Removal – M/ G Machinery Recess.
- Only site in MVR-Miss to have this and causes cleaning issues after floods.
