McAlpine South Chamber Dewatering

Louisville District

Lock Maintenance Workshop

15 February 2011

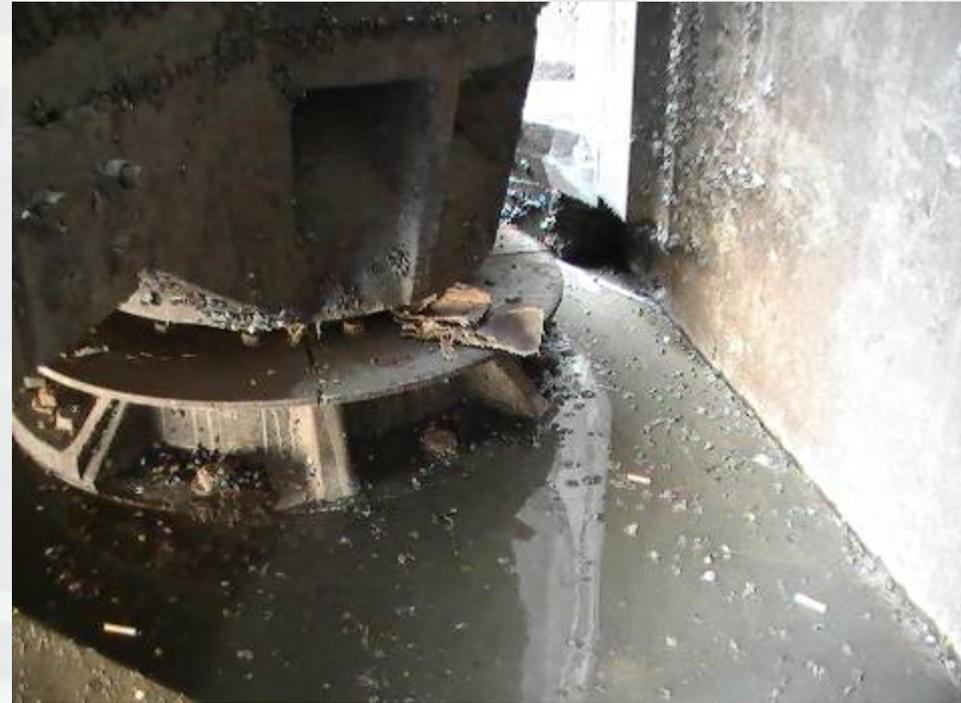
- Material
 - ▶ Tenmat T814 – ¼” thick
 - ▶ C931 Bronze Backing – 1-¾” Thick
- Problems noted with LRW before acceptance

Failed bushing at LMW

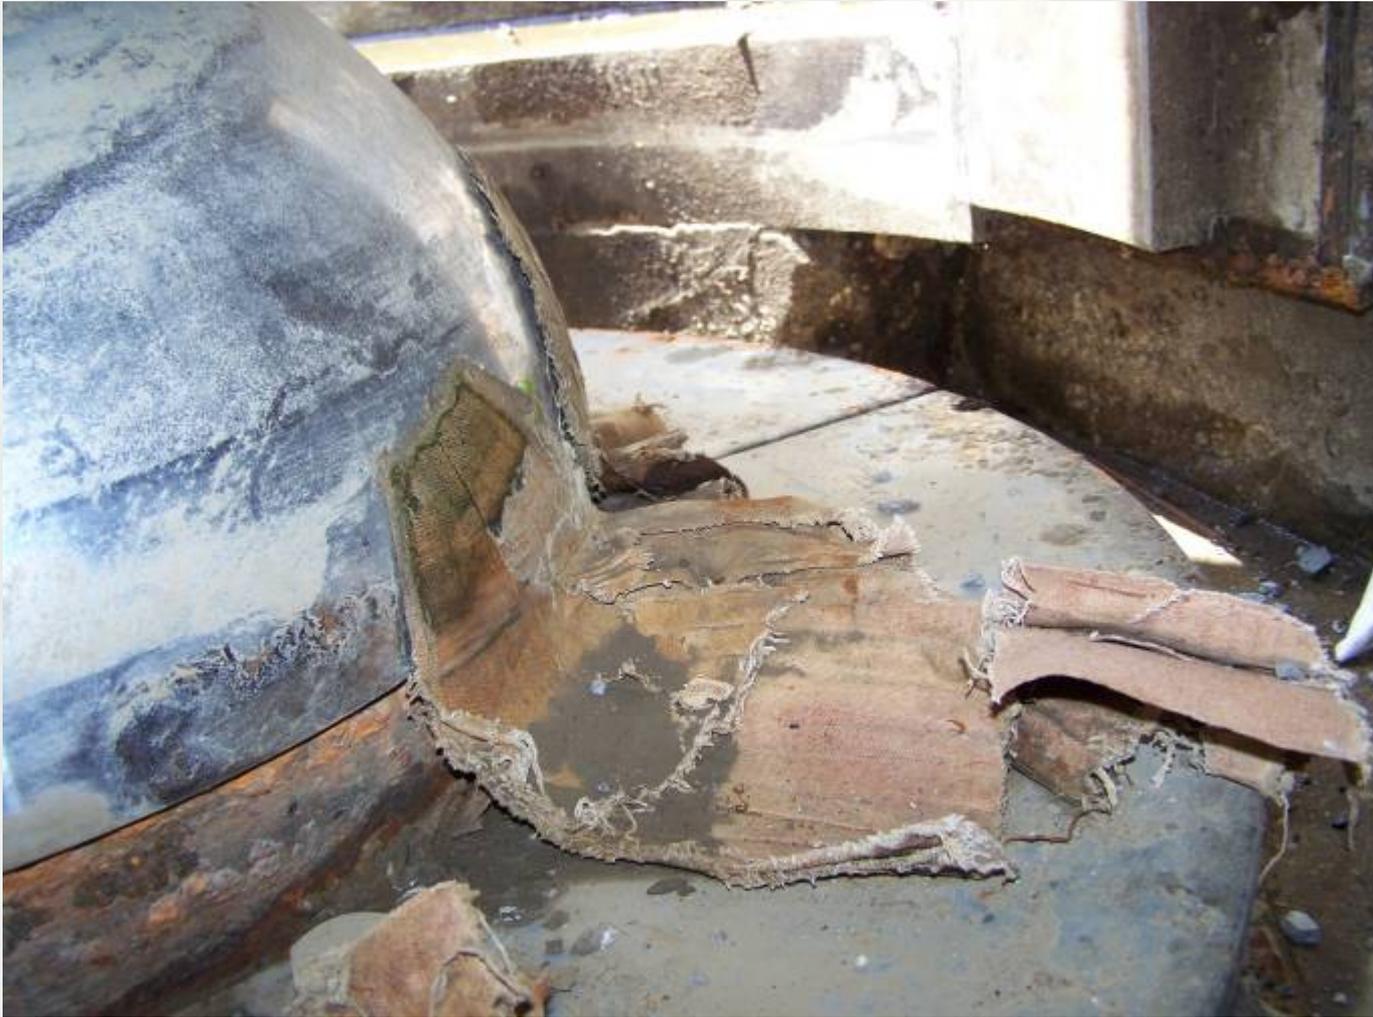
Failed bushing at LMW

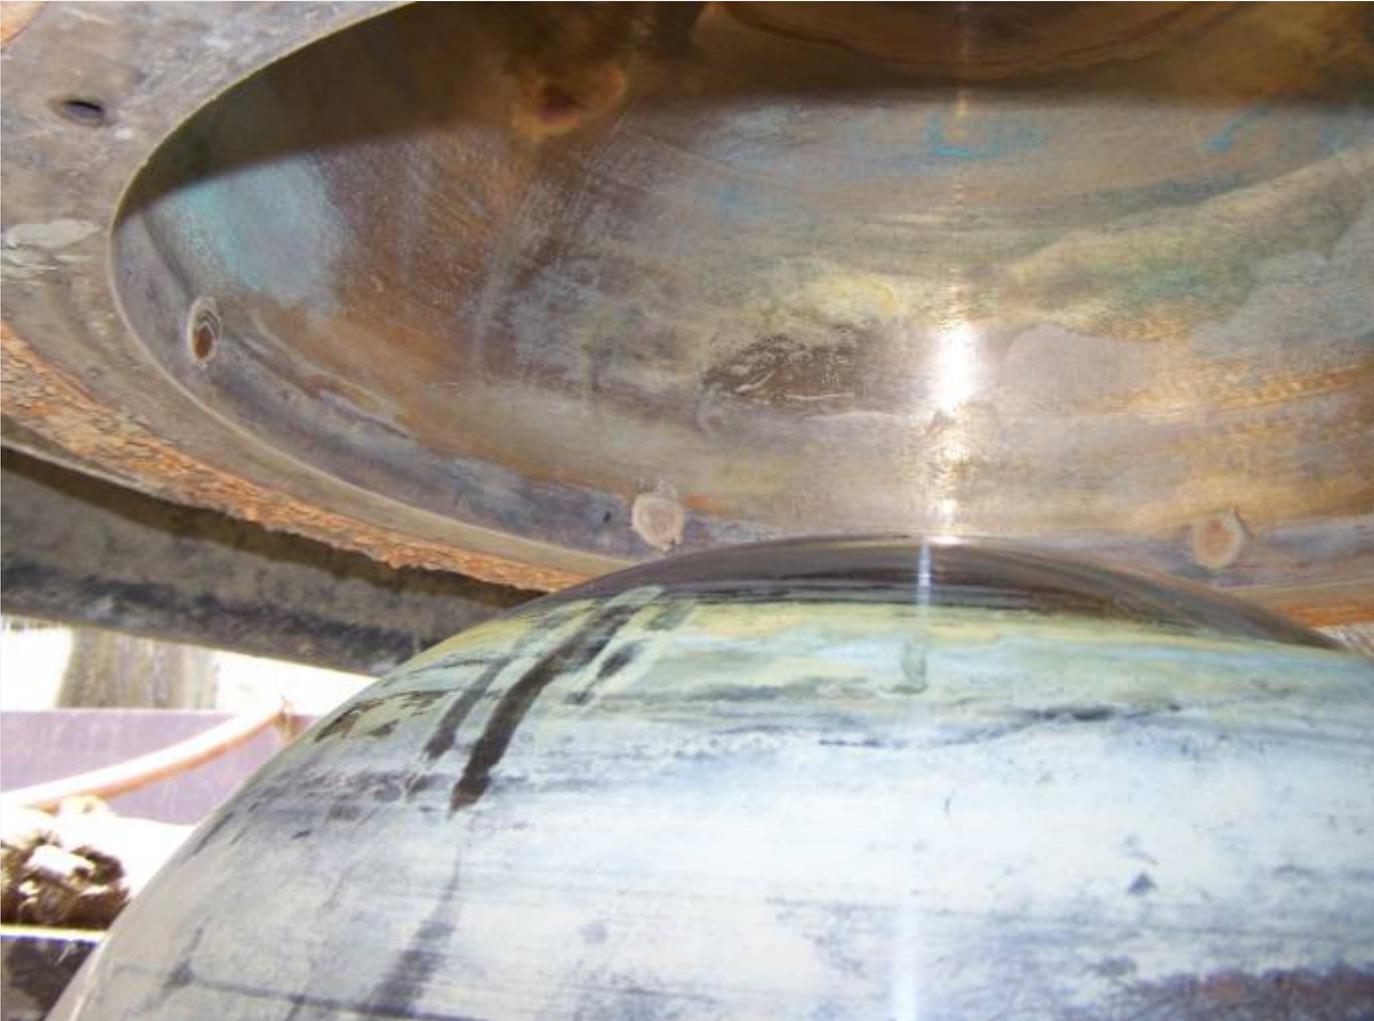
No Tenmat left in bushing at LMW

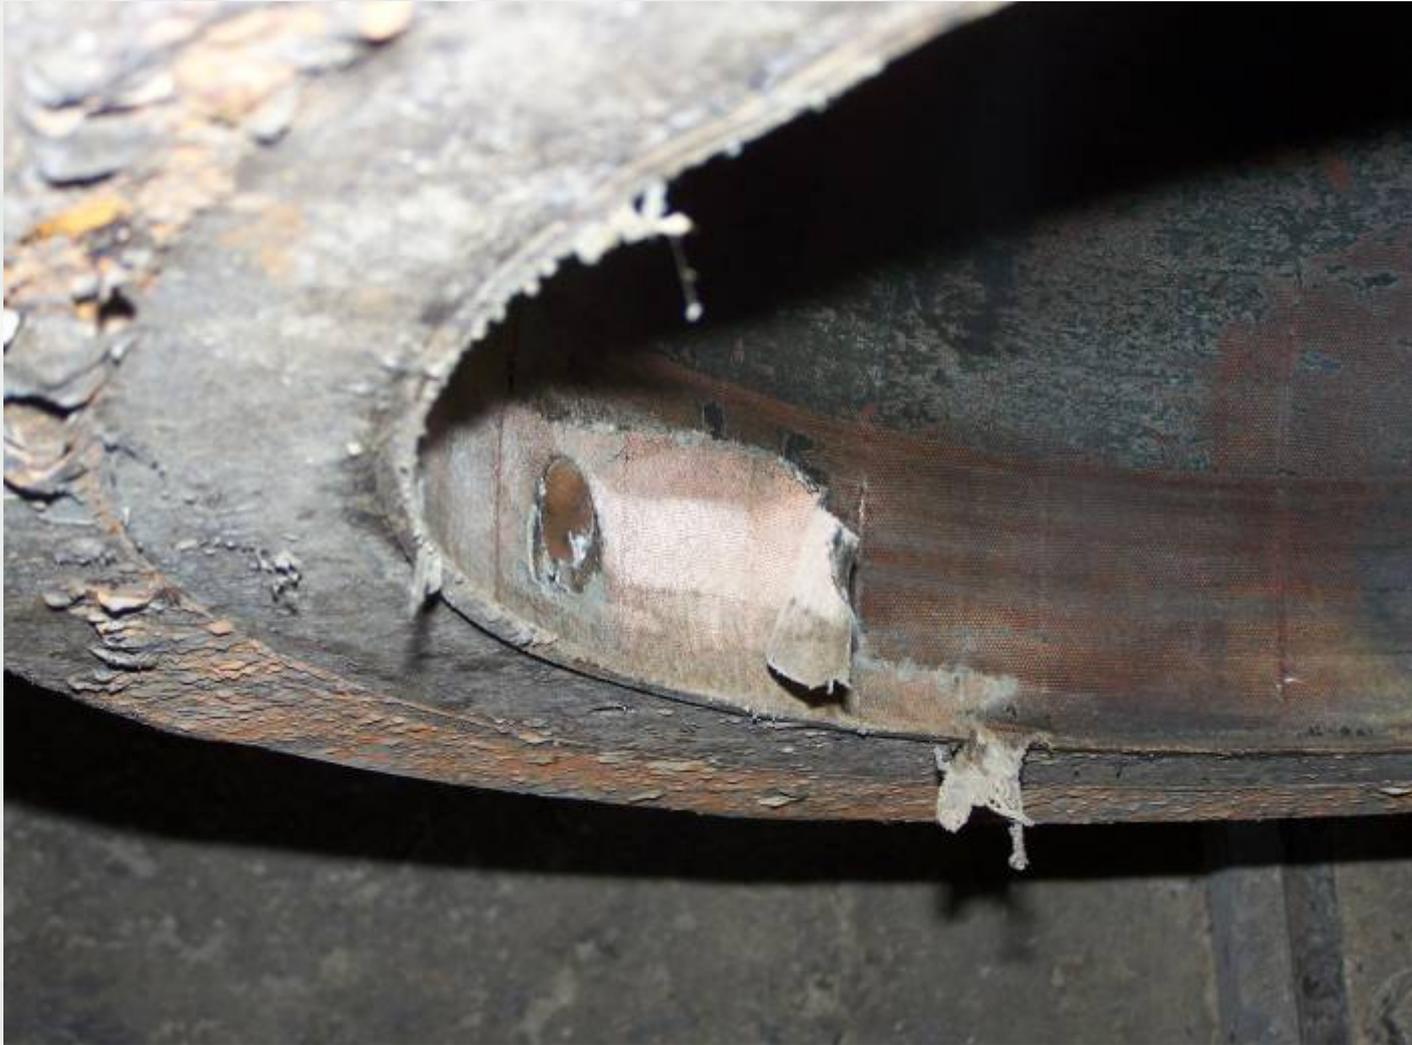
Failed bushing at LLW

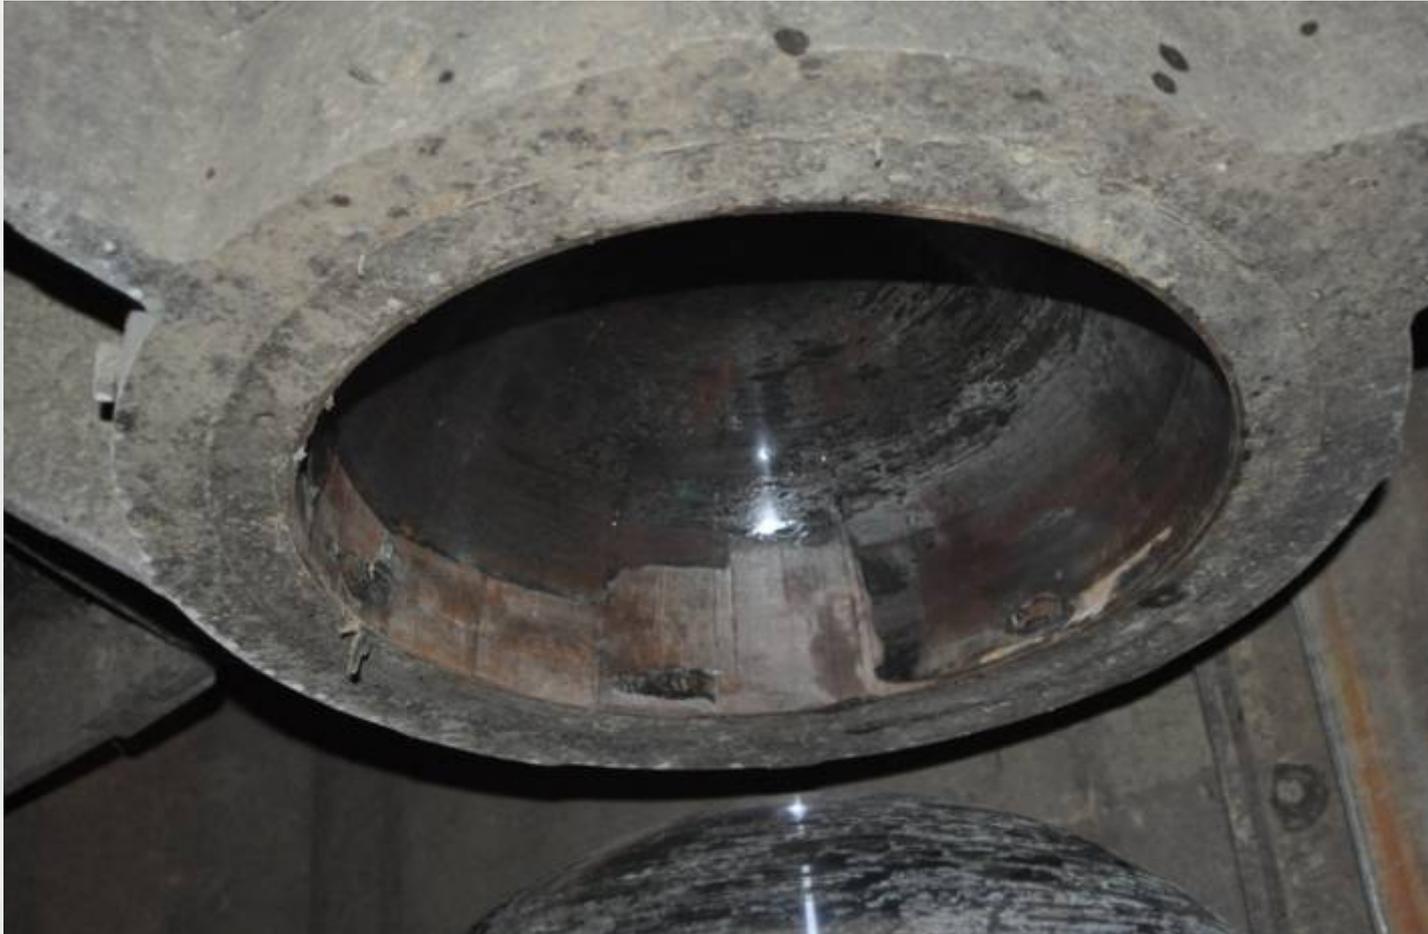
Failed bushing at ULW

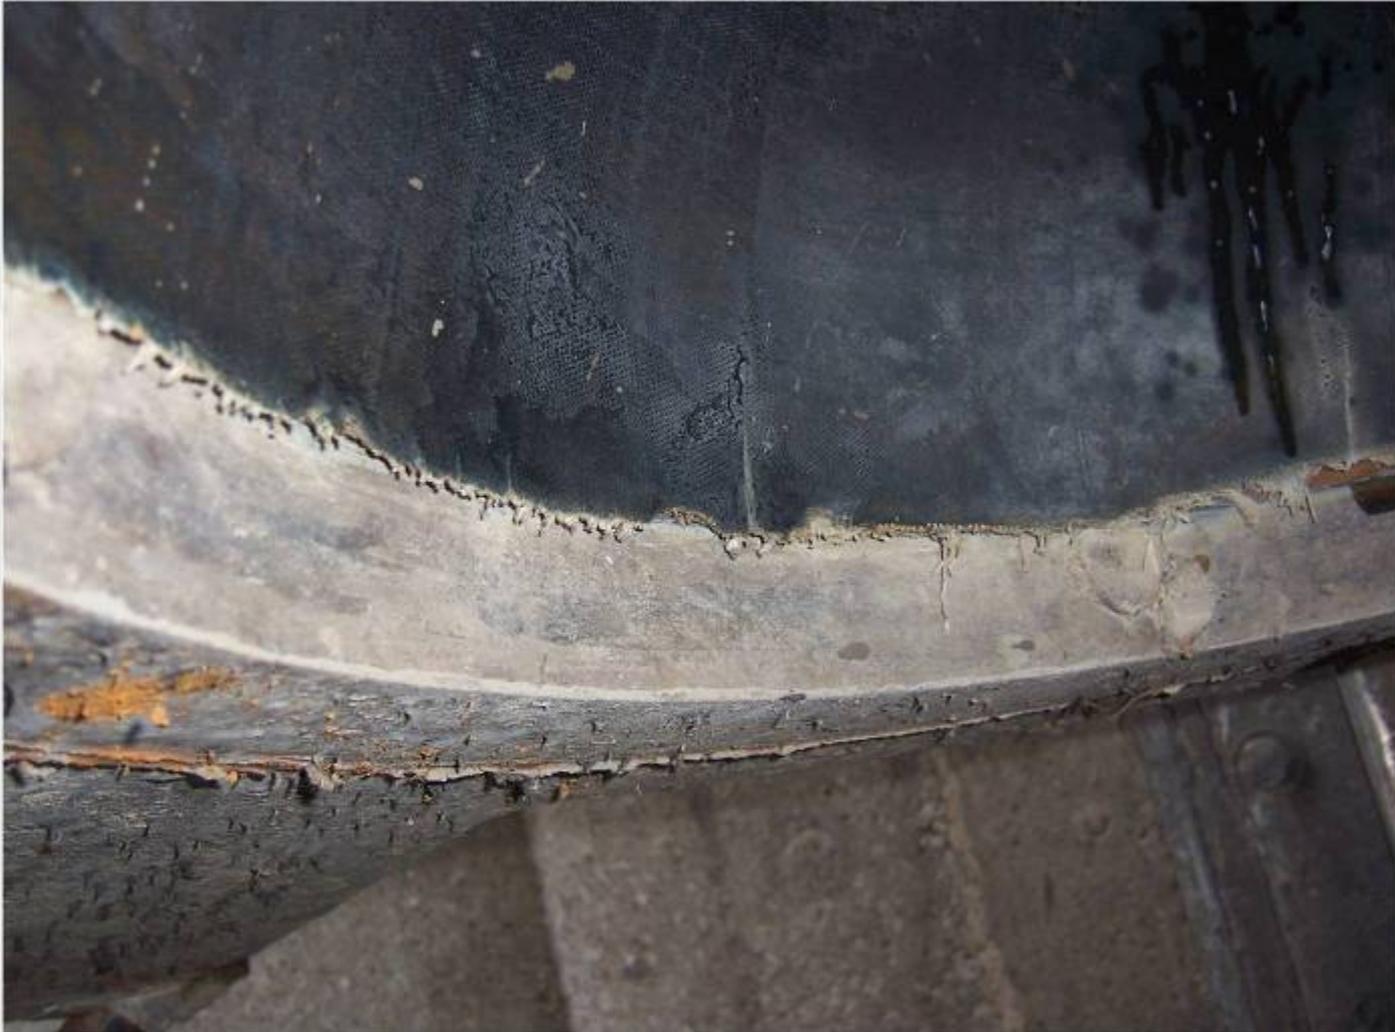
Failed bushing at UMW

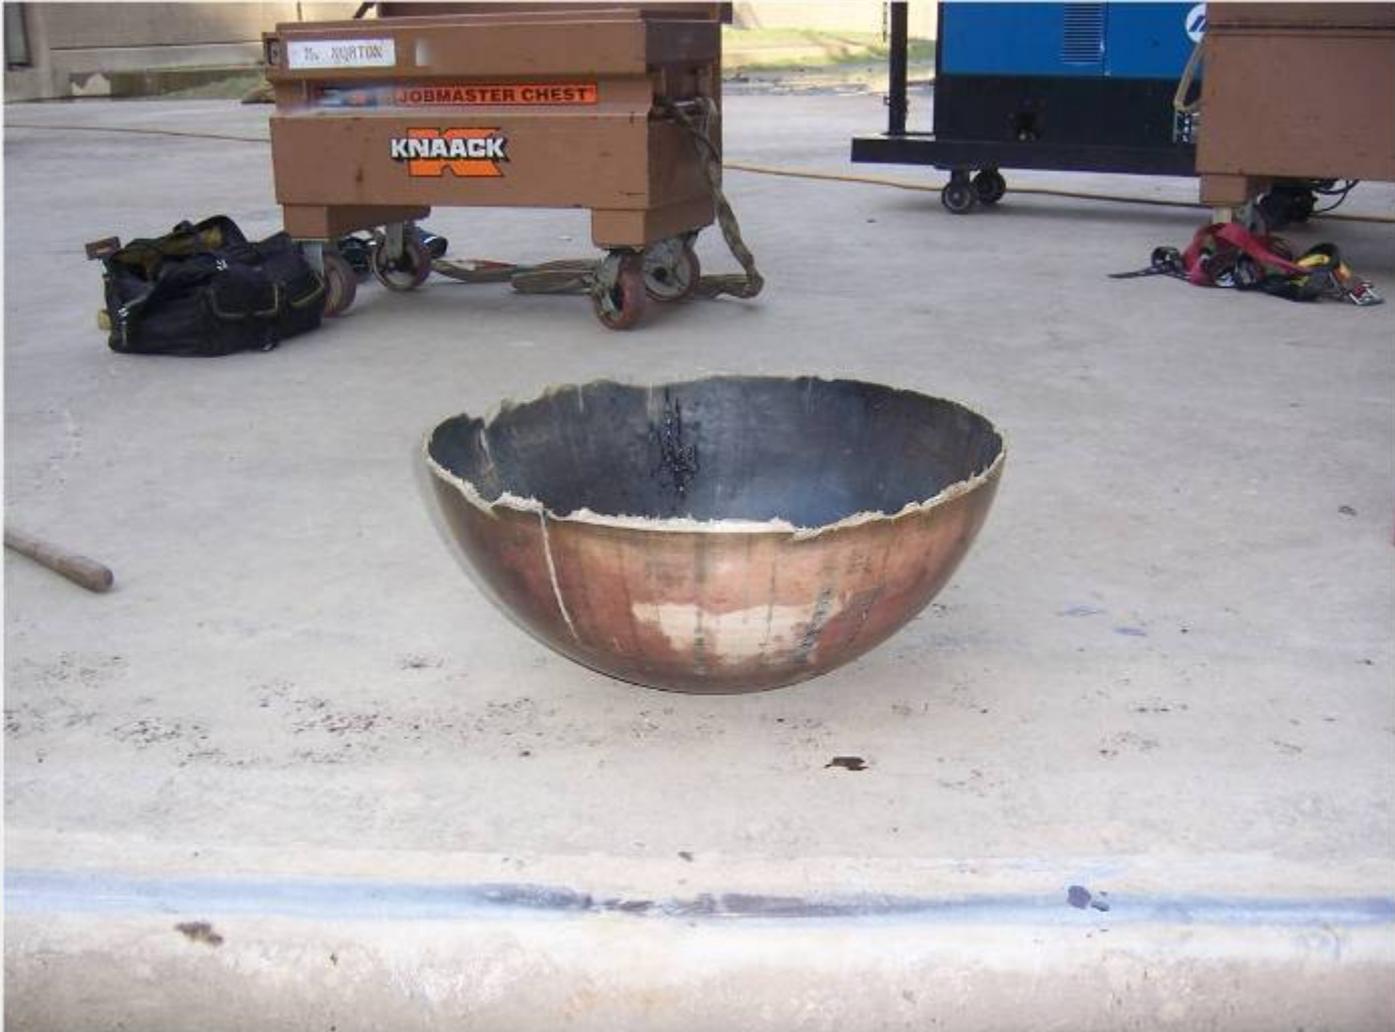
Tenmat liner fell out of bushing at UMW

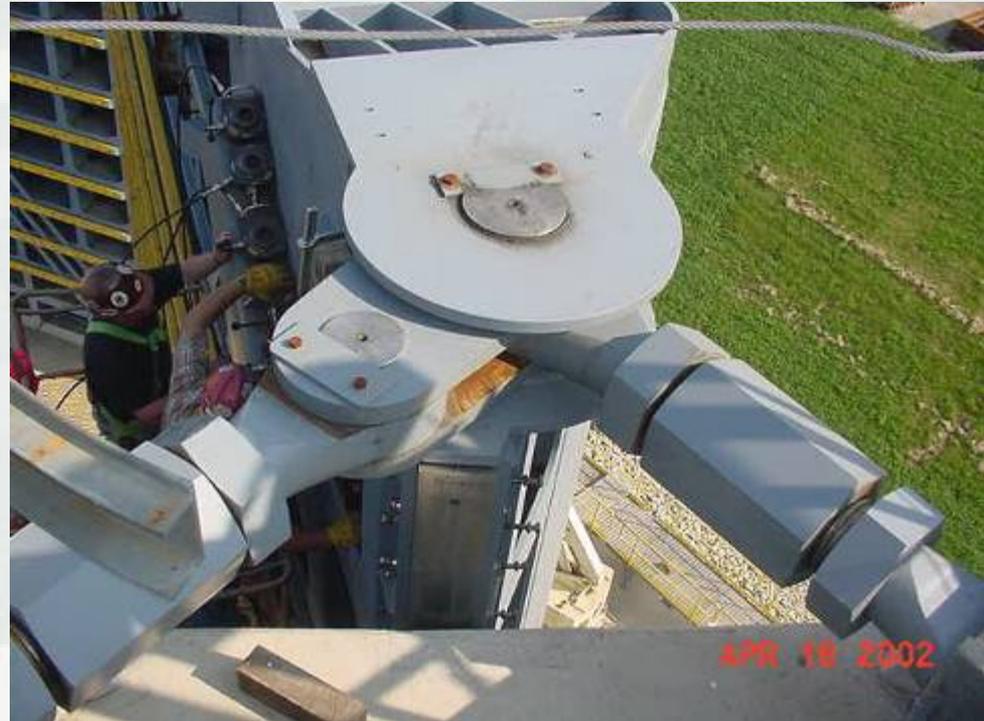
- Material
 - ▶ Tenmat T814 – 1/16" Thick
 - ▶ C932 Bronze Backing – 3/16" Thick
- 1/4" slop in bushing
- Bronze backing very soft

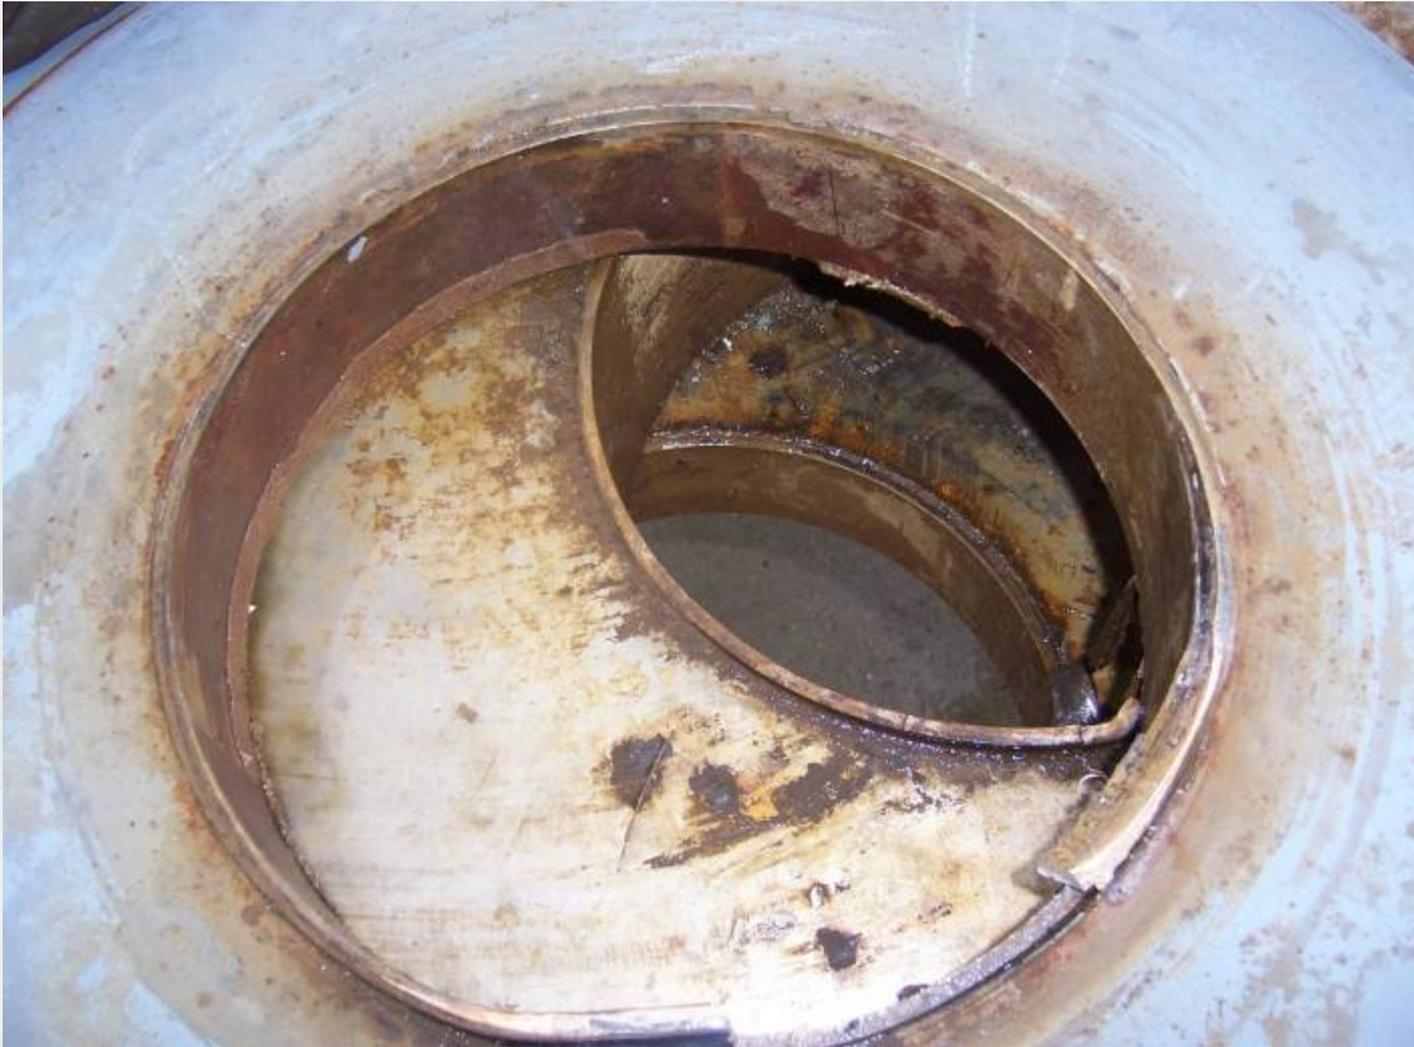
Gudgeon bushing with little Tenmat left in it

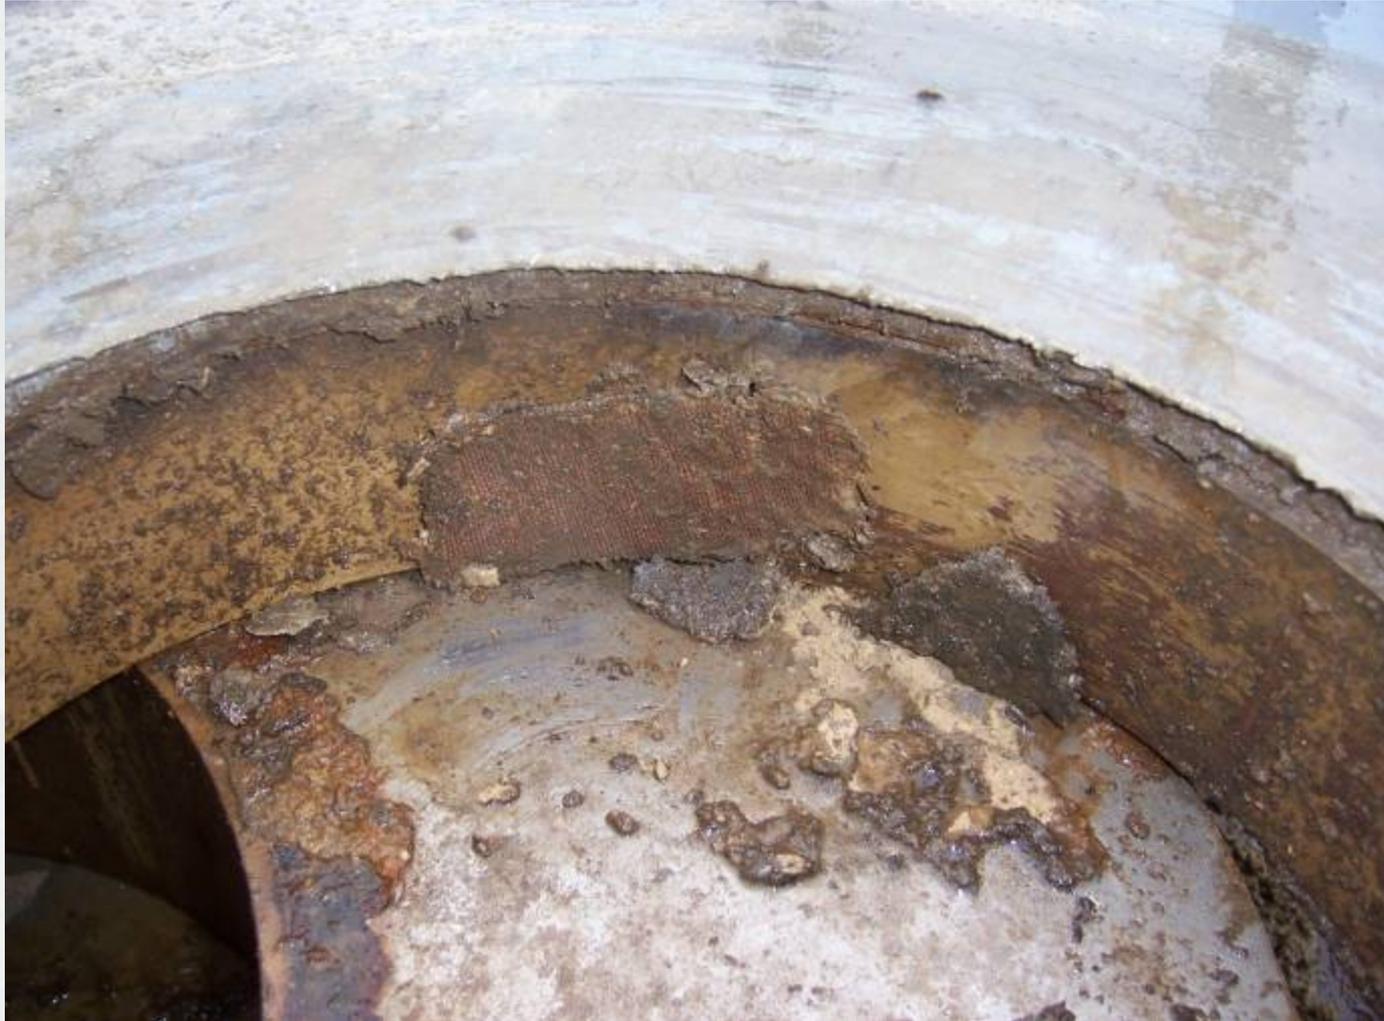
Some Tenmat remaining in bushing

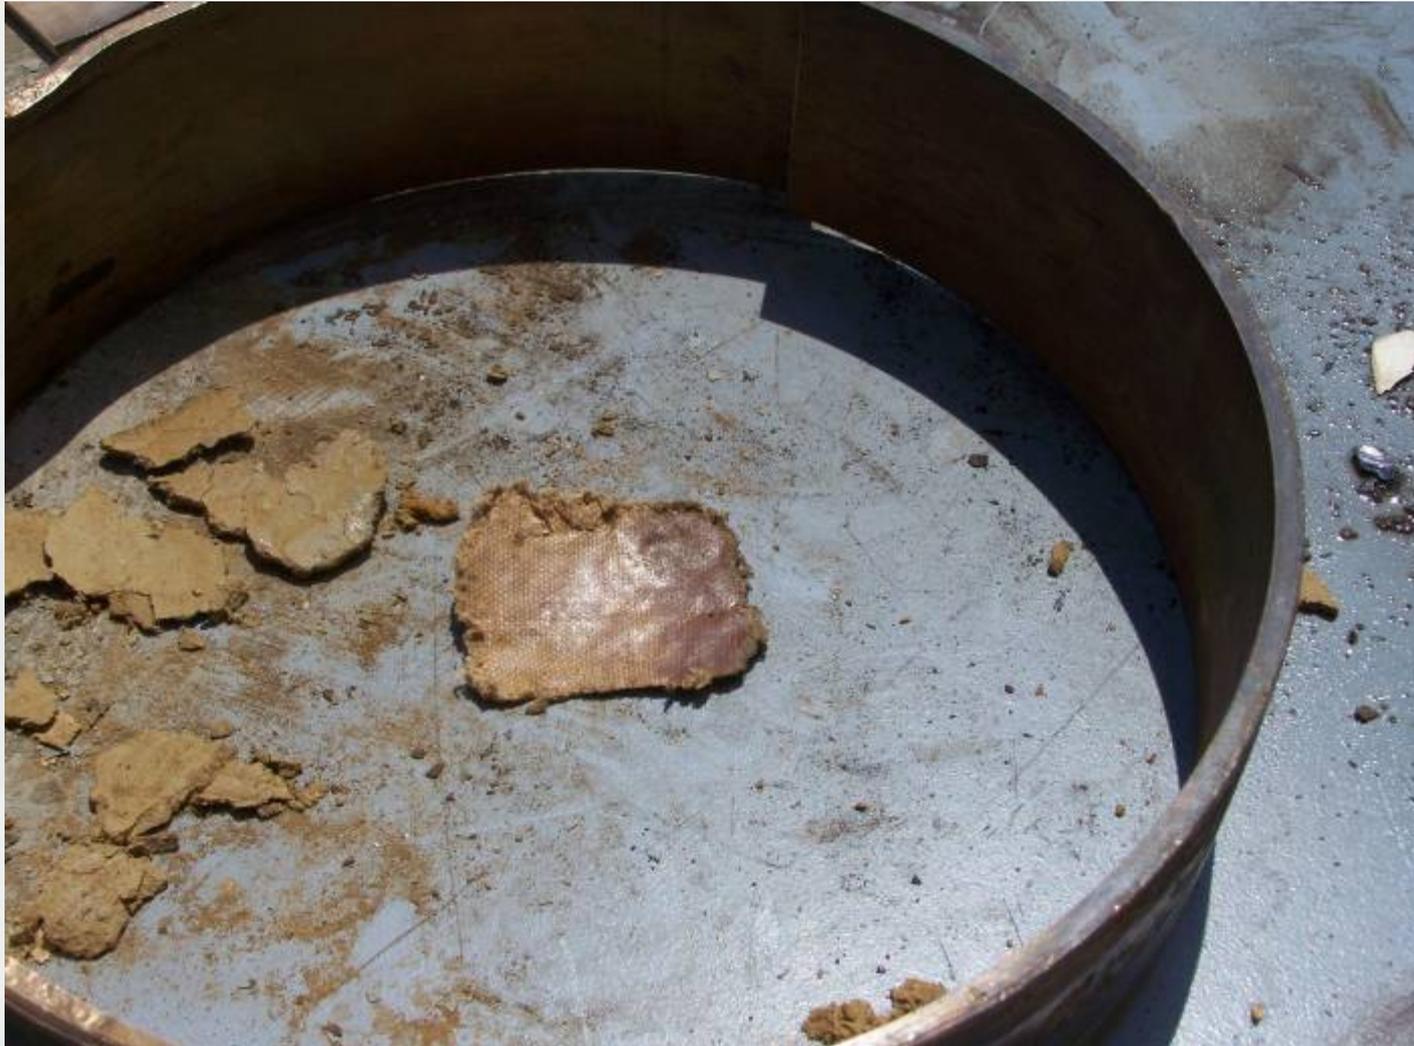
Removed bushing with Tenmat
pieces

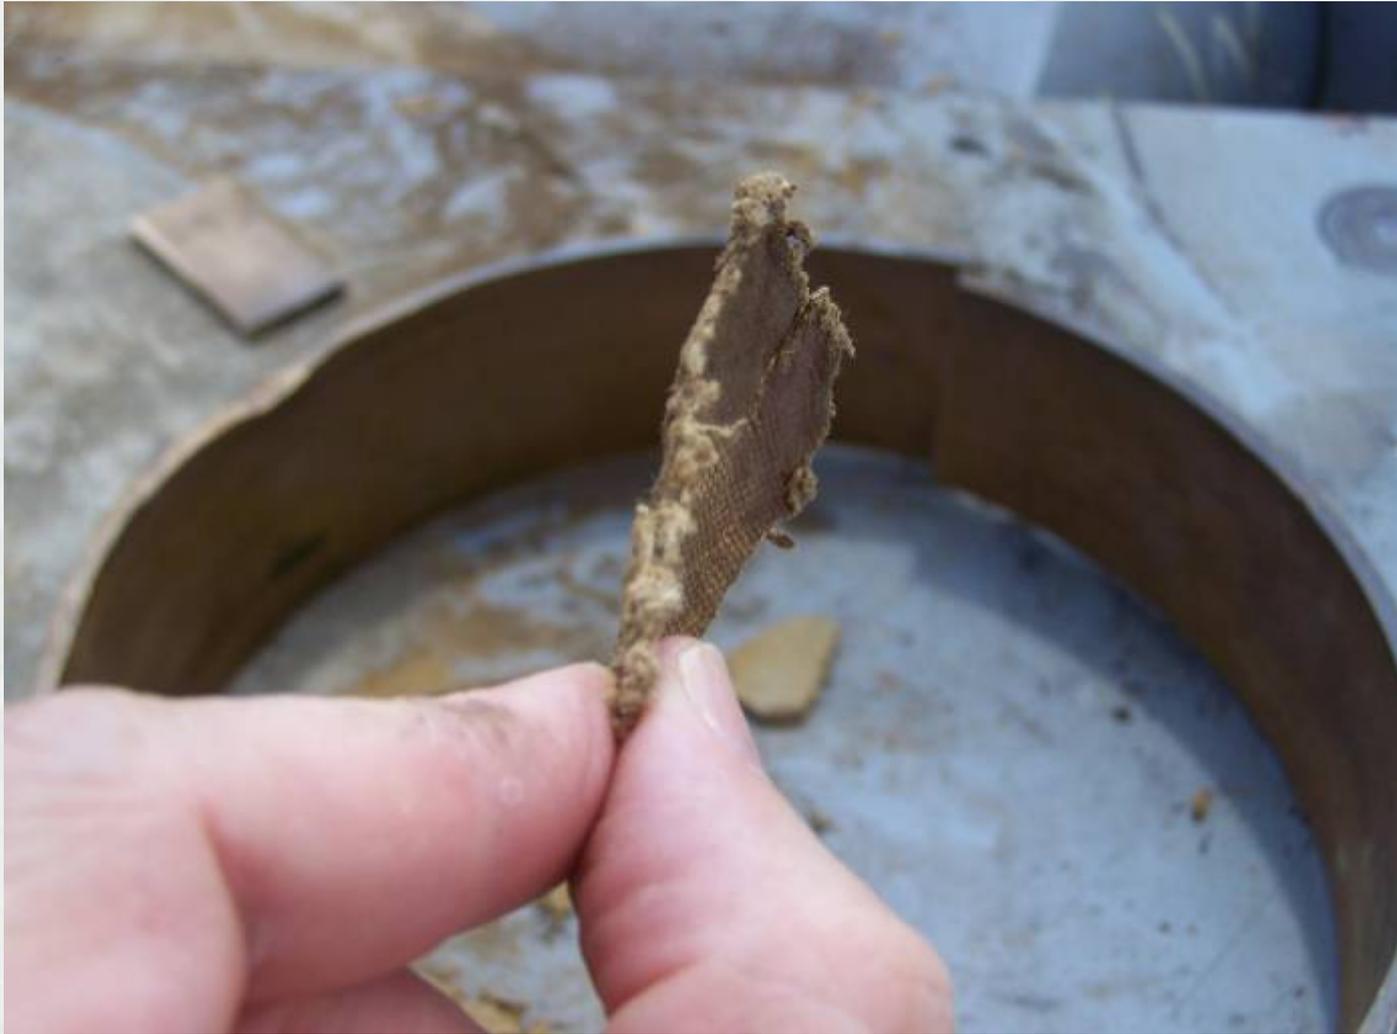
The Tenmat was only 1/16" thick

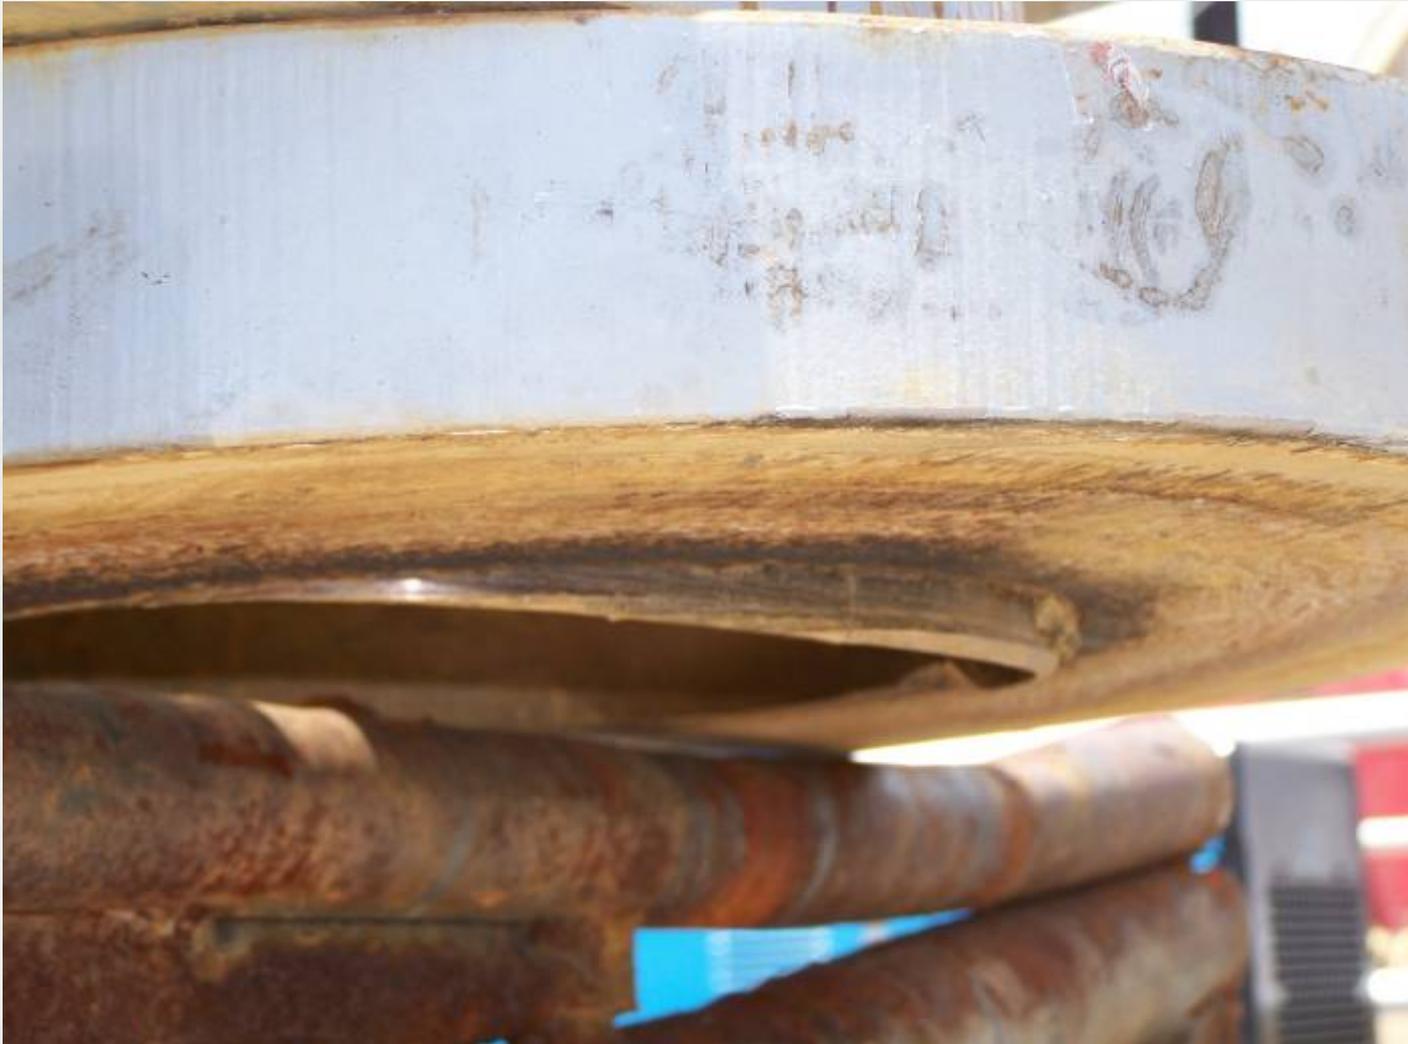
Soft bronze backing extruded past anchor arm

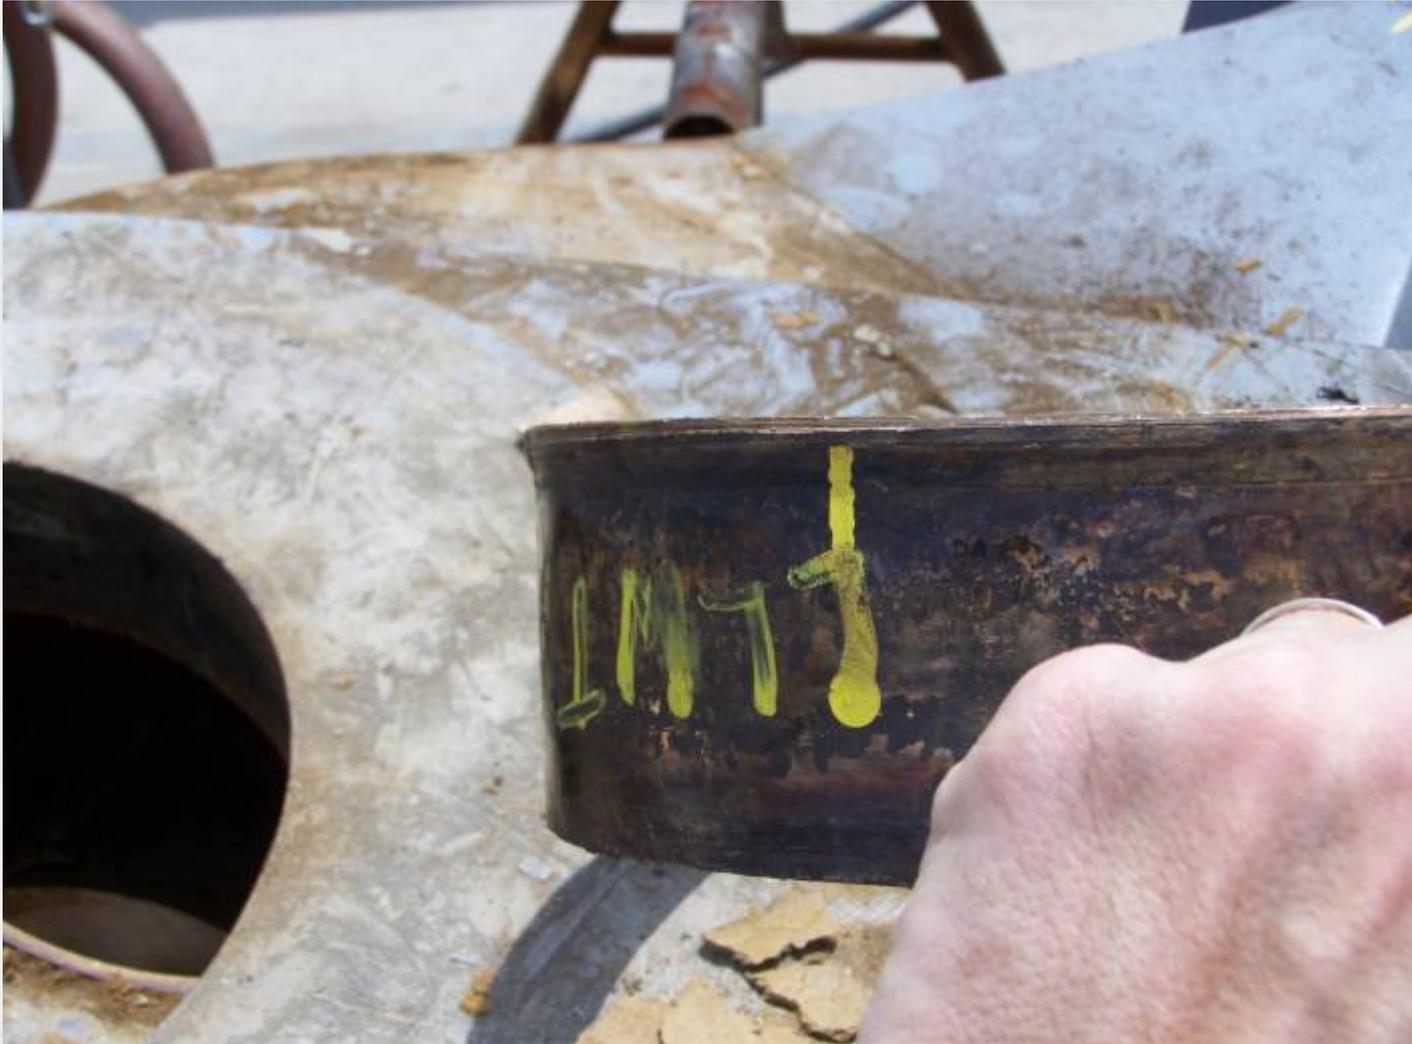
Damaged bronze backing to gudgeon bushing

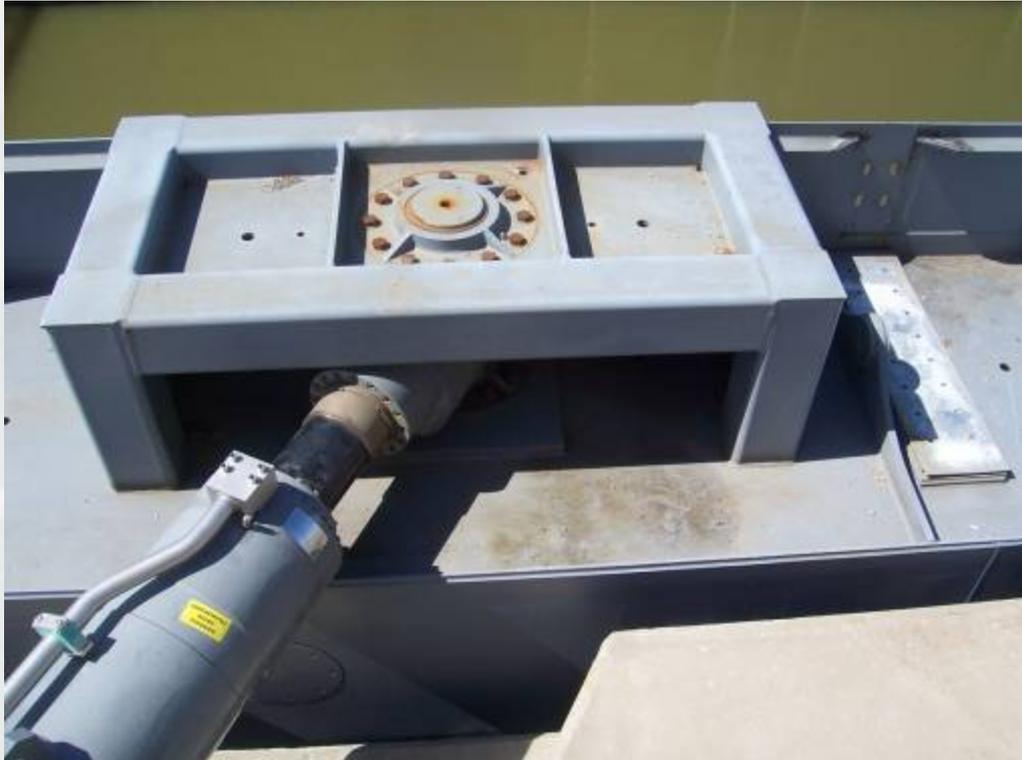
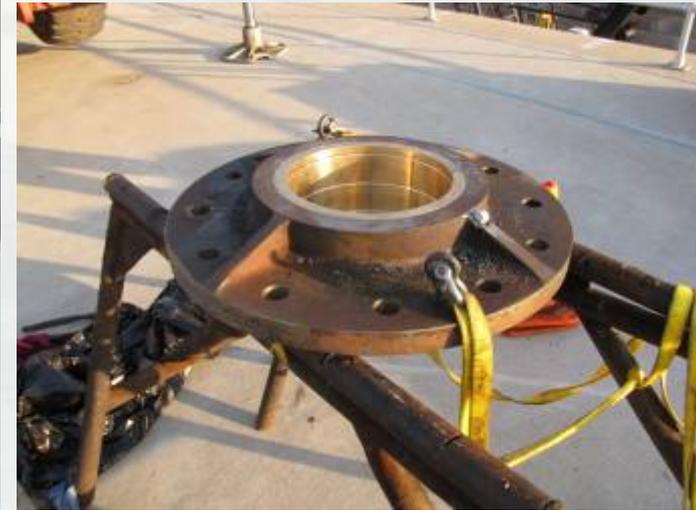
- Material: Tenmat T814
- Original bushings looked good when removed, but replace because of other failures

New greaseable bushing

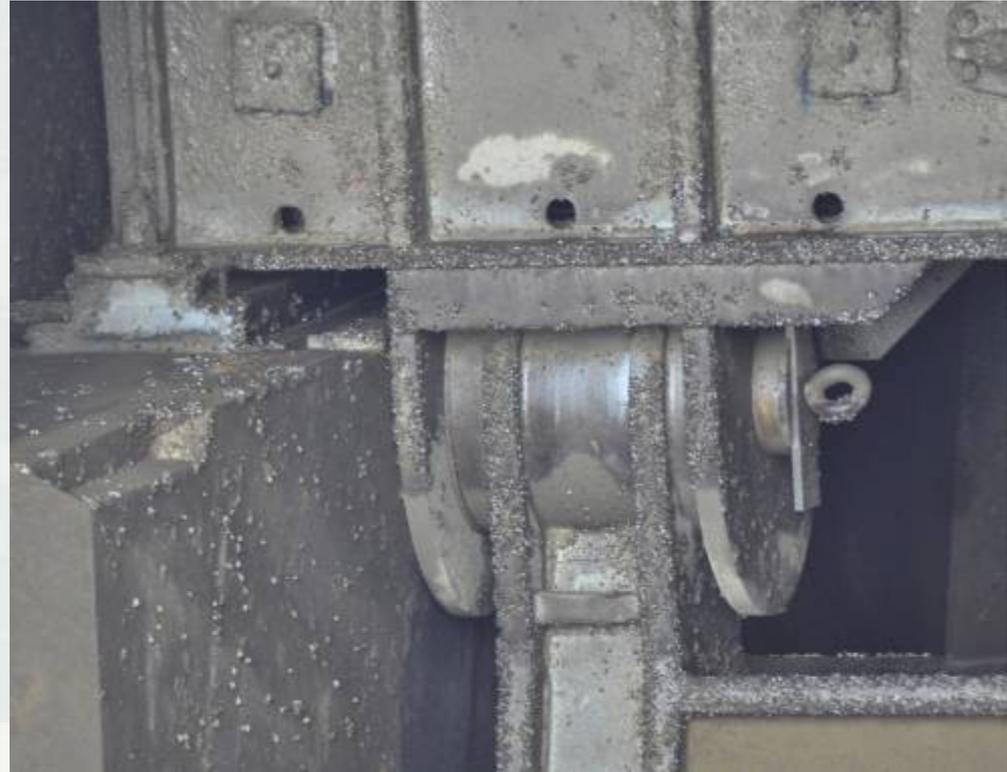
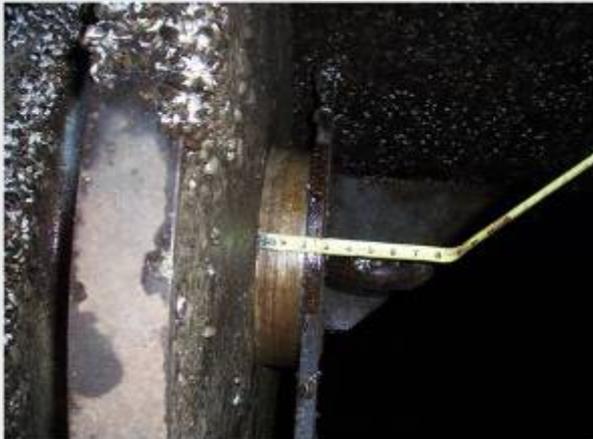
- Material: CIP 121
- Pin keeper broke bolts
- Pin worked out 2-1/4"

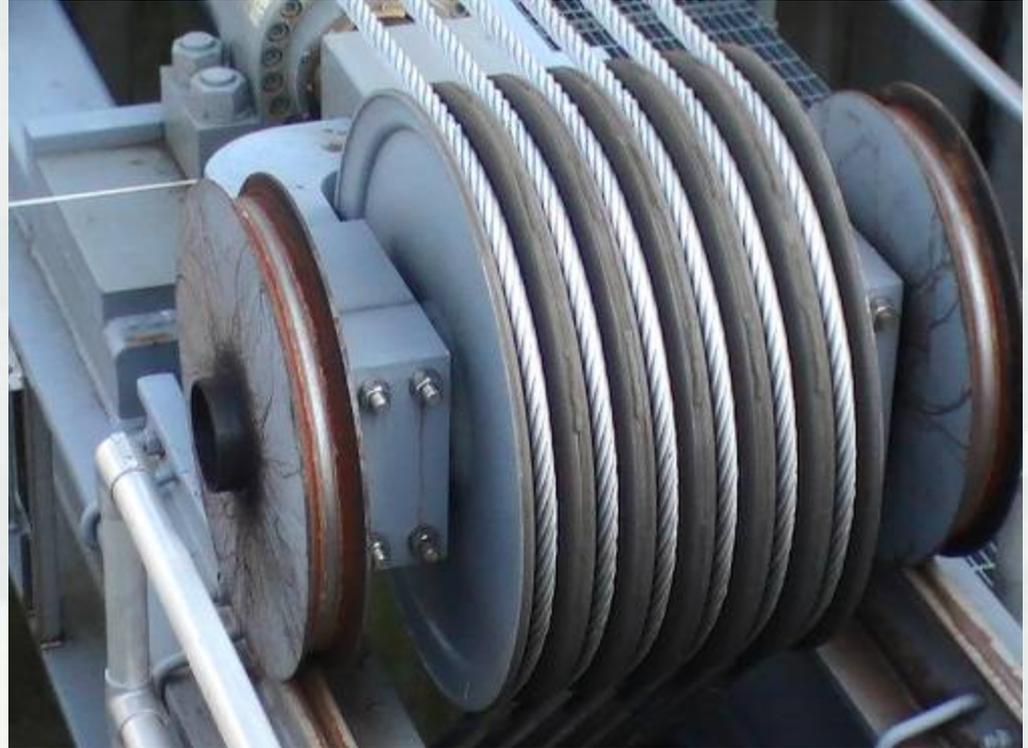
- Material: CIP 121
- Problems at Cold Temperatures
- Thermal contraction very different from steel

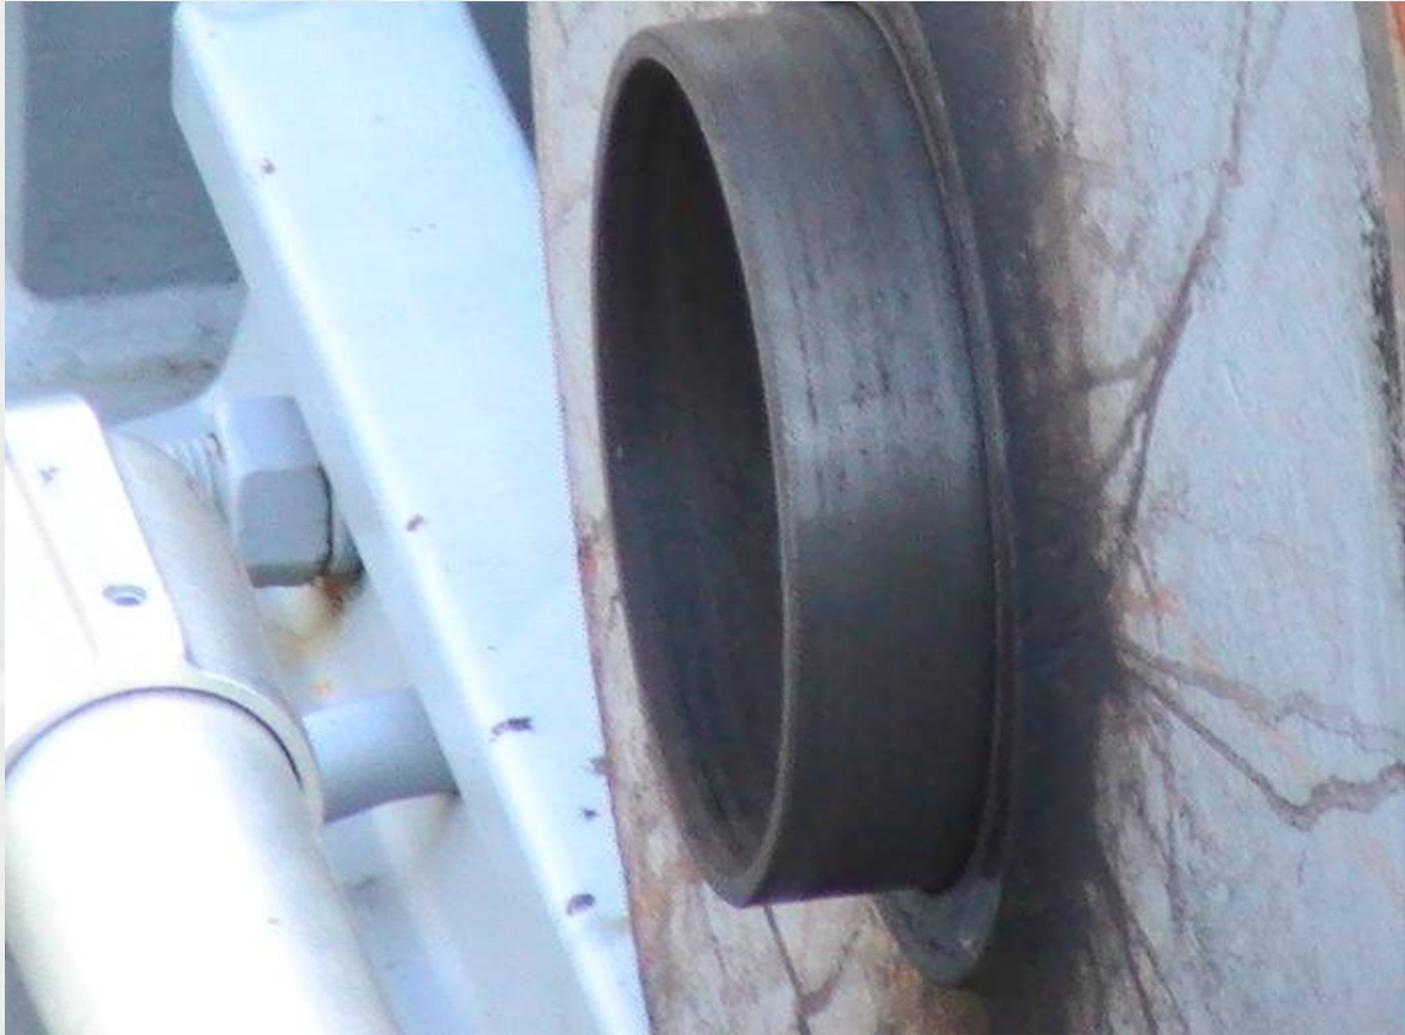
Valve bushing working its way out
