McAlpine South Chamber Dewatering

Louisville District

Lock Maintenance Workshop

15 February 2011

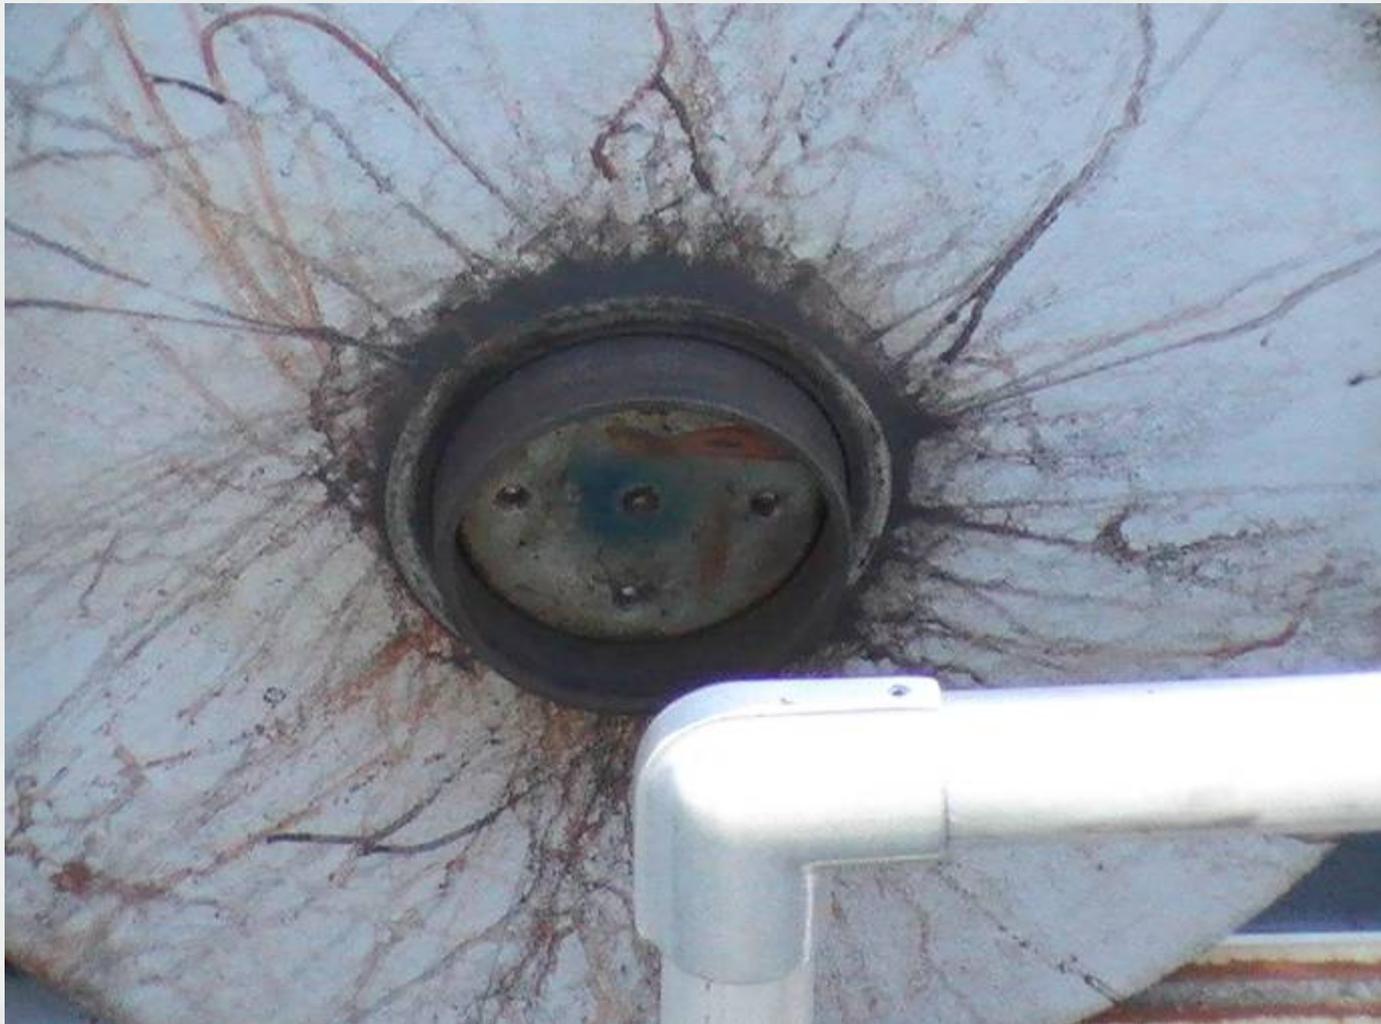
The bushing broke the keeper bolts and shot the keeper off

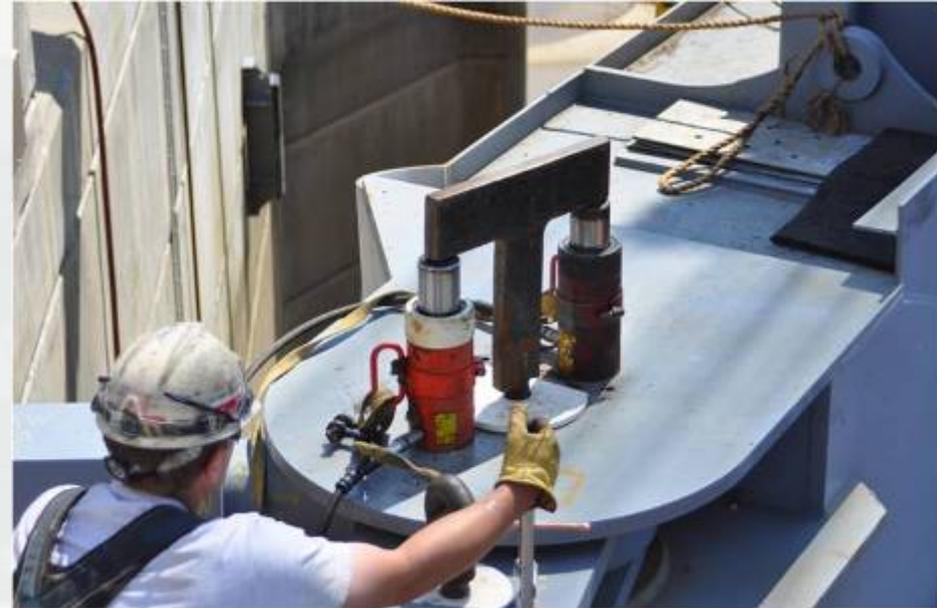
Attempting to pull gudgeon pin

- Not successful removing pins
- Shreve slated to go to MVS

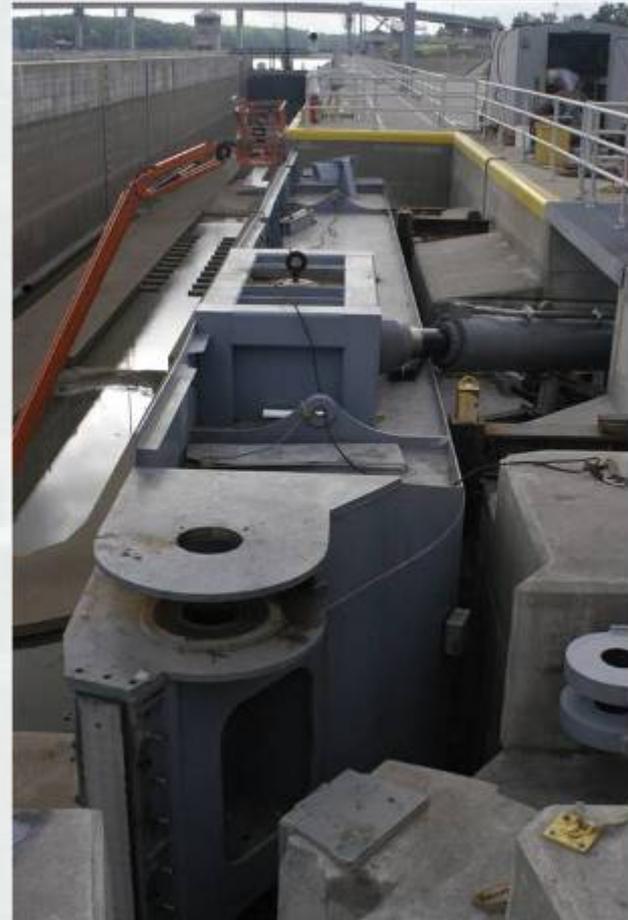
- New top guide design required because of walkway cutout in concrete
- Fabricated and installed by repair crew

Walkway cutout in concrete

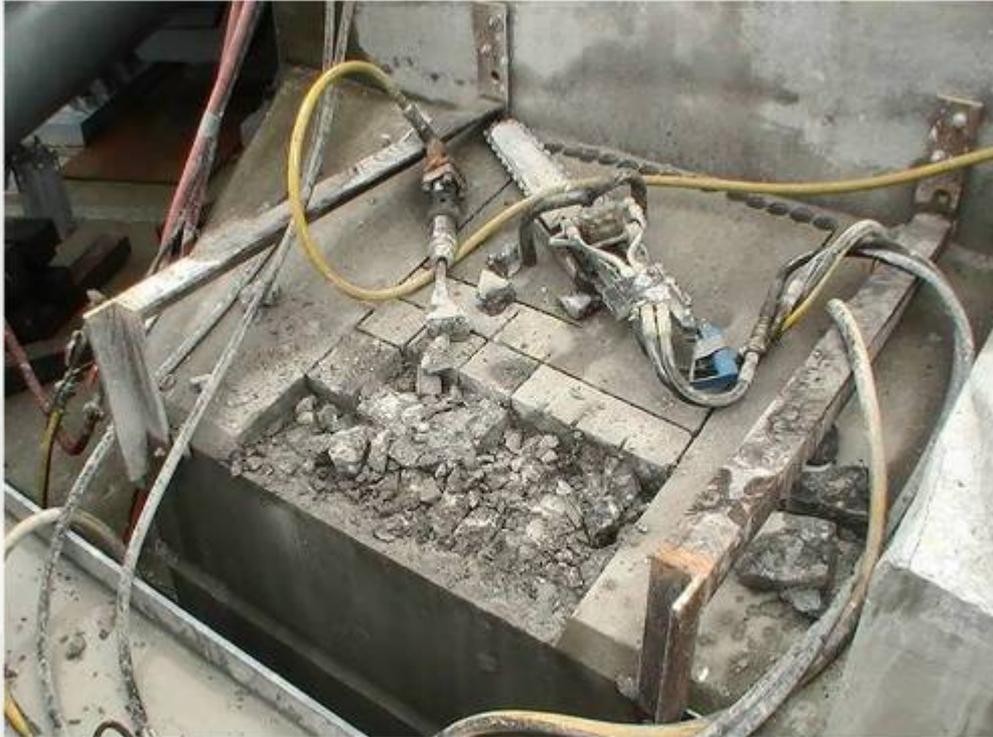
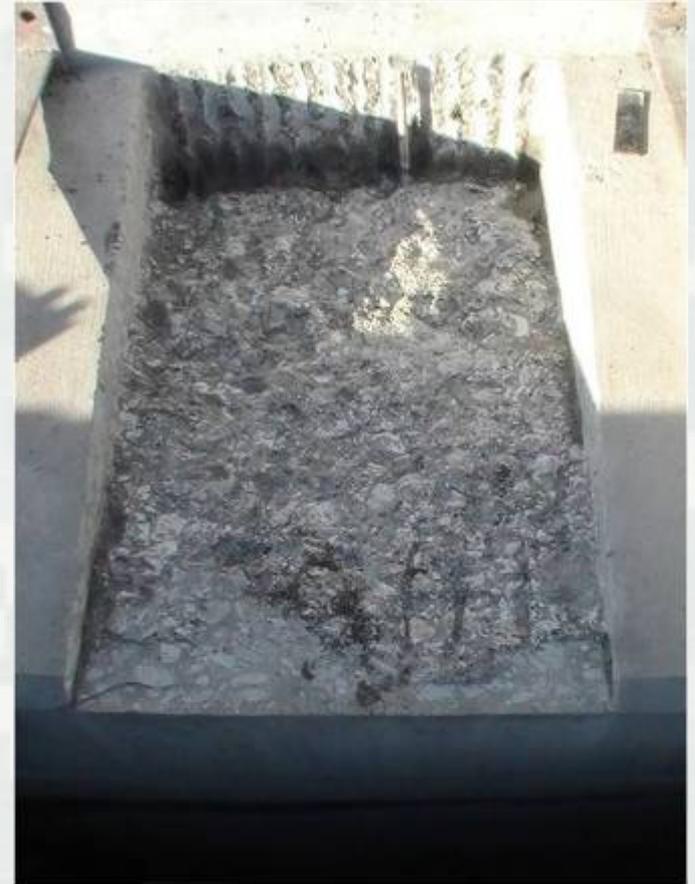
Concrete needed removed to mount new guide system
