2011 Lock Maintenance Workshop

Review of 2010 Lock Closures

Anthony Perkins

Mobile District

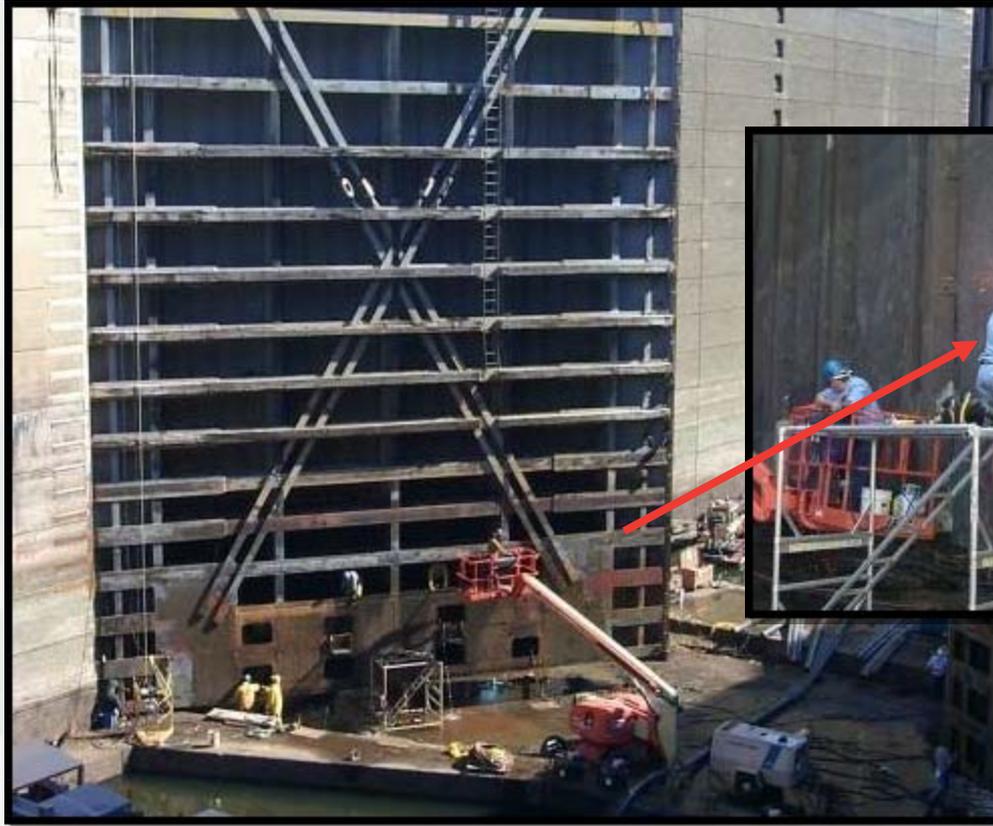
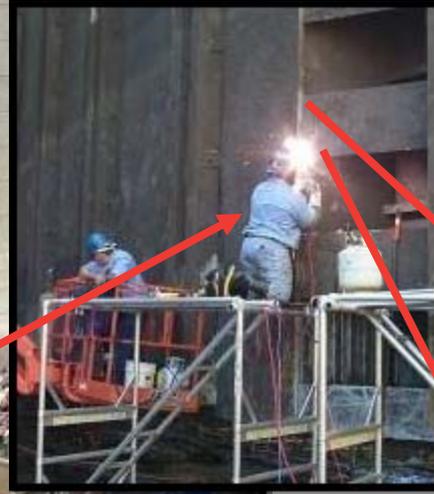
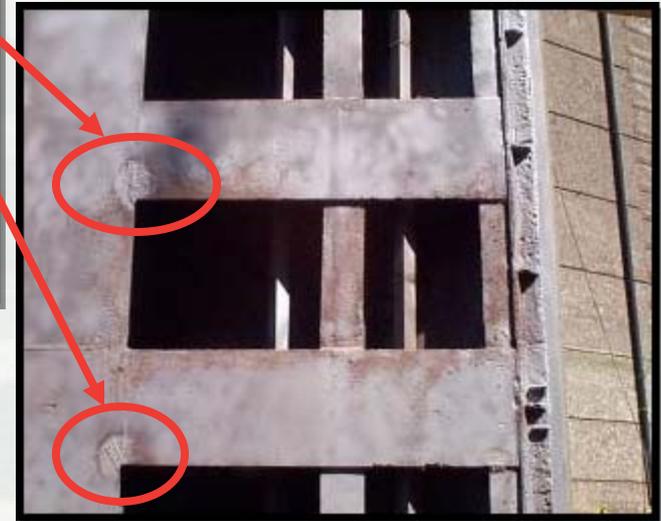
Holt Lock – Lower Miter Gates

Anticipated numerous crack repairs based on previous closures and inspections

- **Lock Closure 2000: Several hundred cracks repaired.**
- **Lock Closure 2010: Over 400 cracks repaired, some in critical high stress areas.**

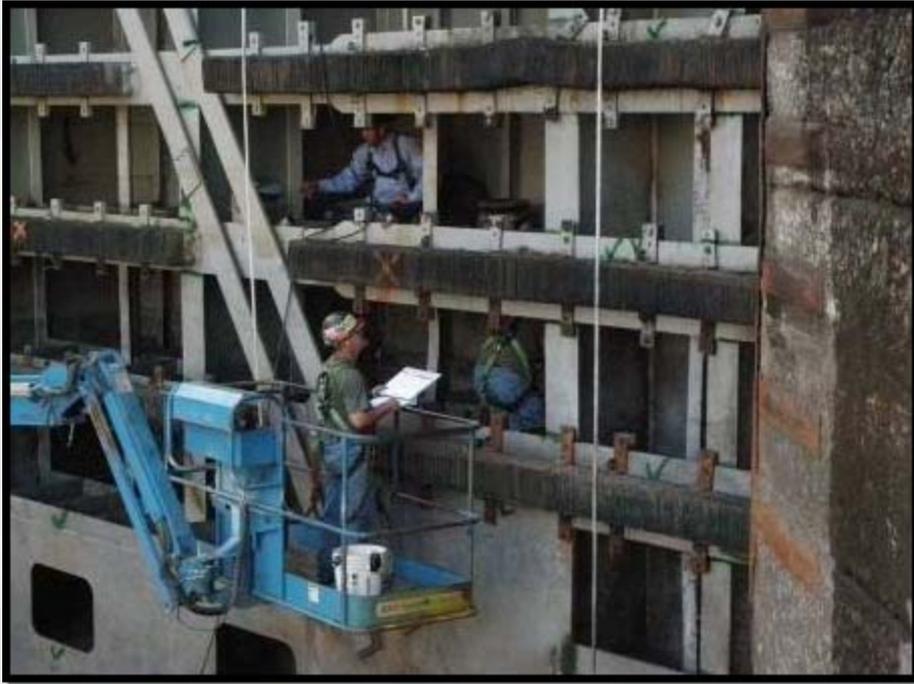
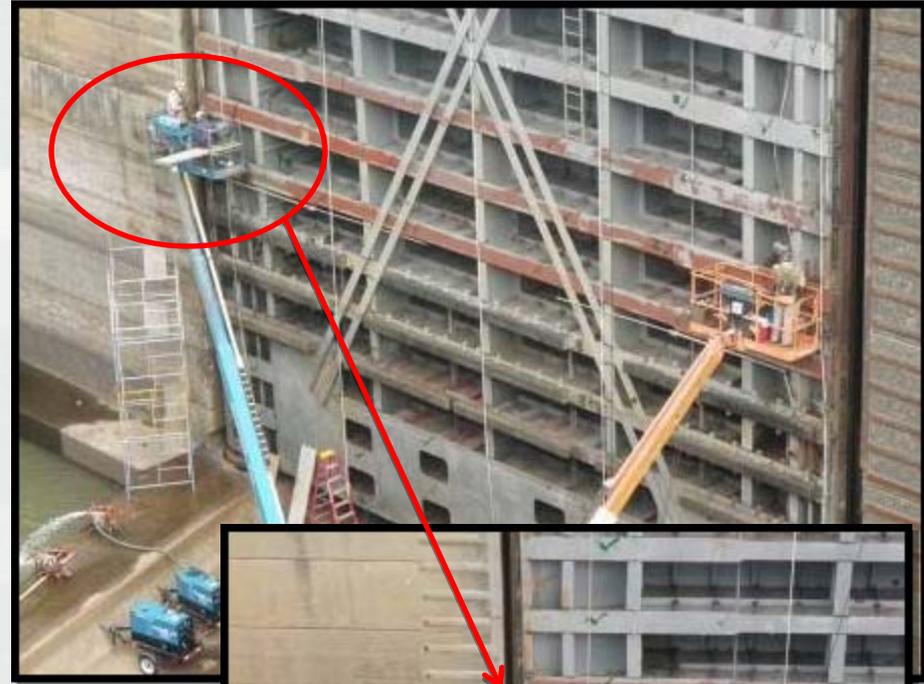
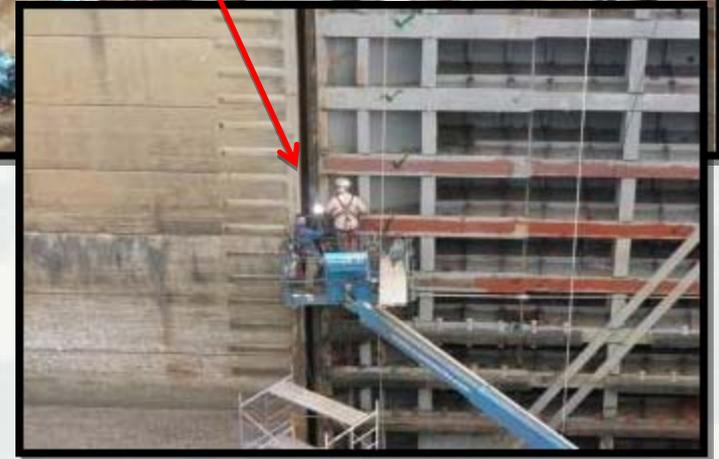
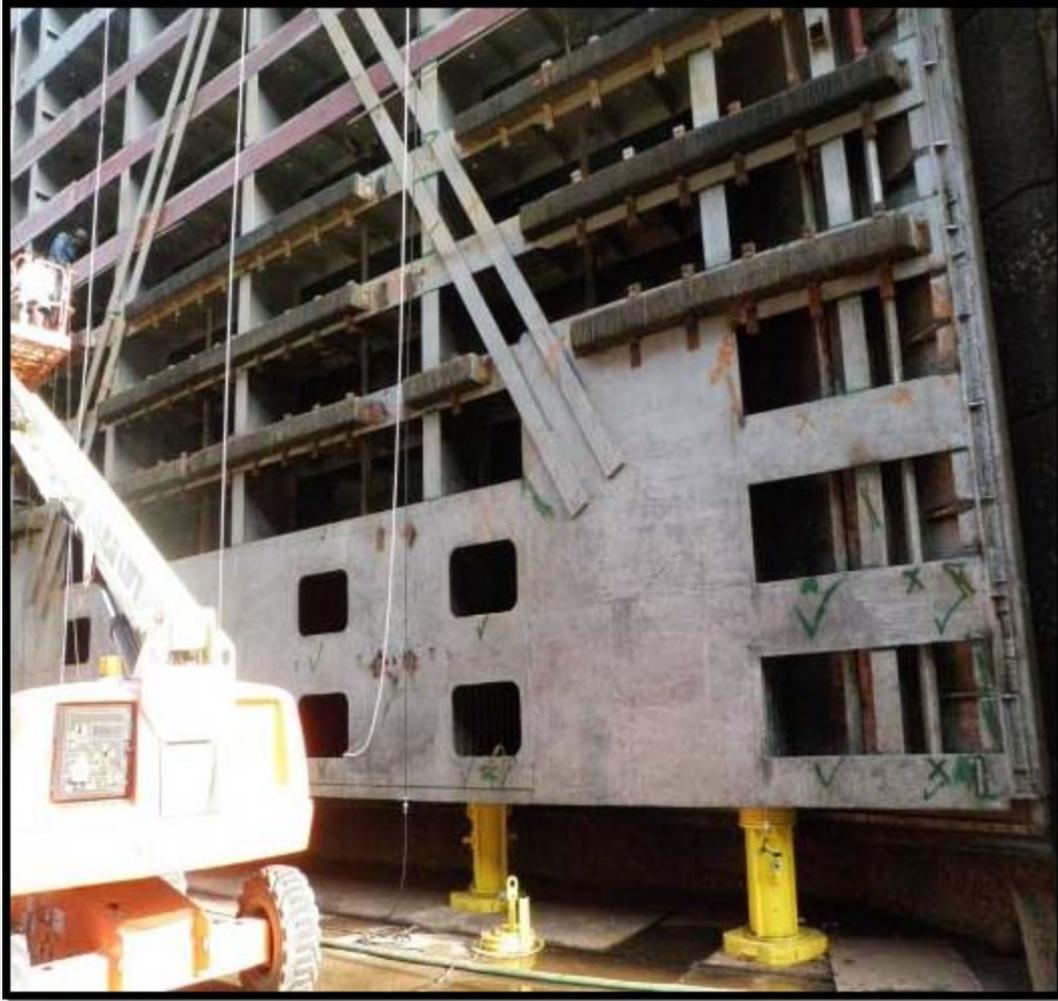
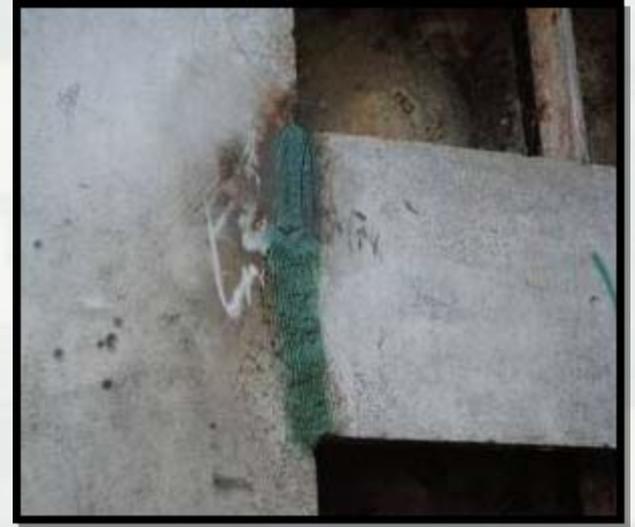
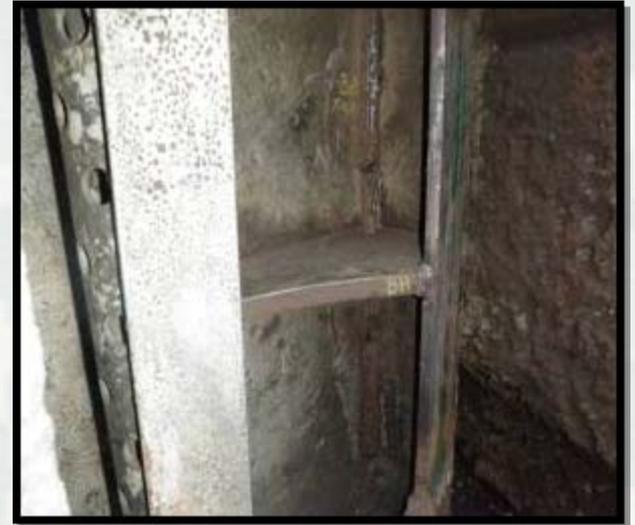
Holt Lock – Lower Miter Gates

All cracks repaired and documented; however, due to continued fatigue cracking, which increases gate failure risk, new miter gates are being designed for replacement.

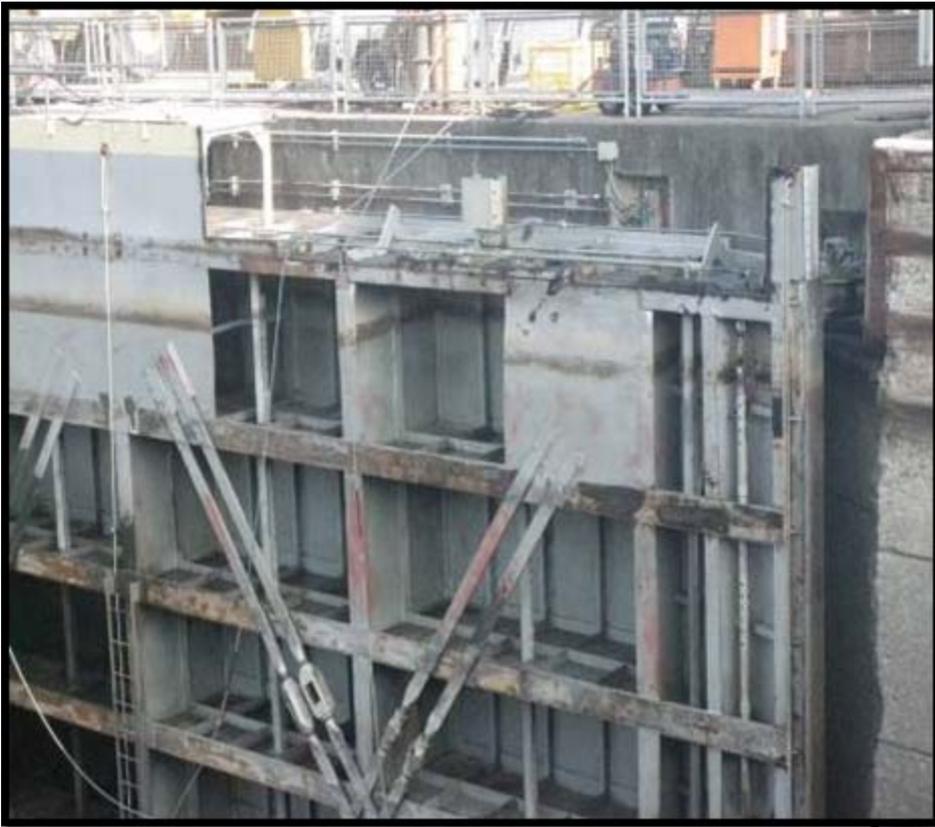
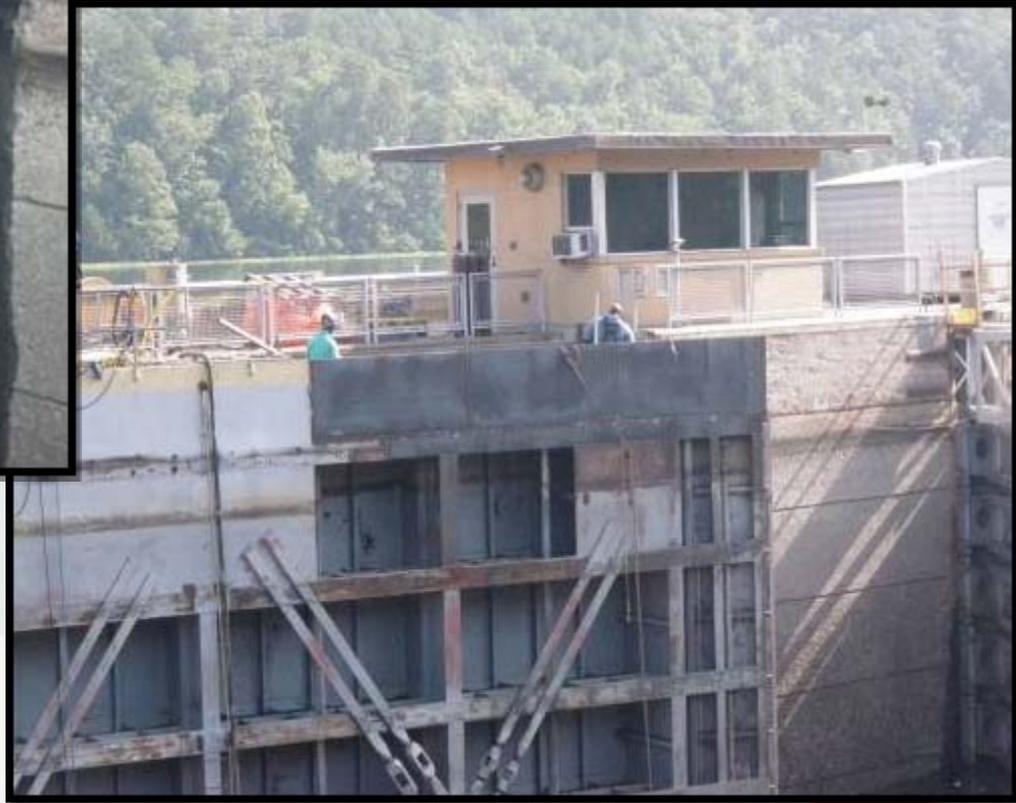
Upper Miter Gate Repair – Damage from Barge.

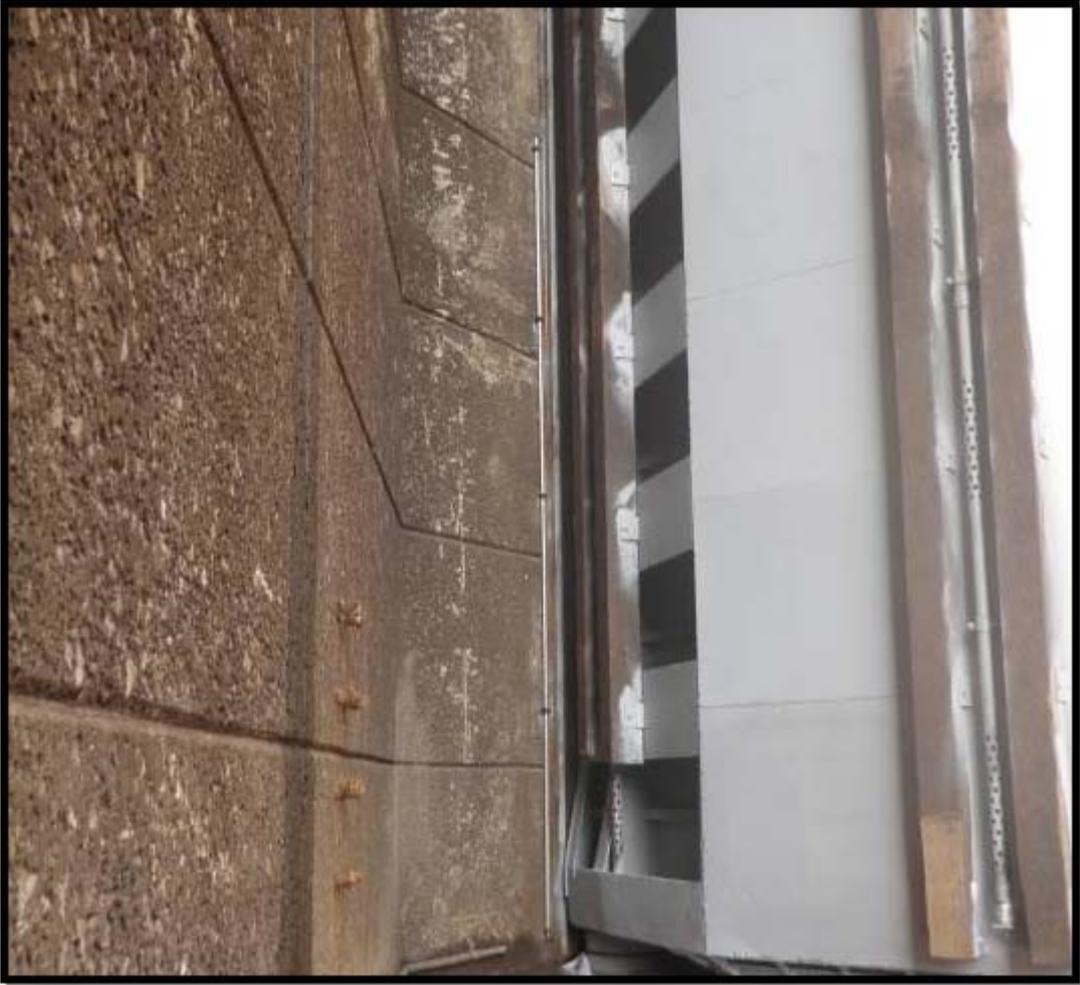
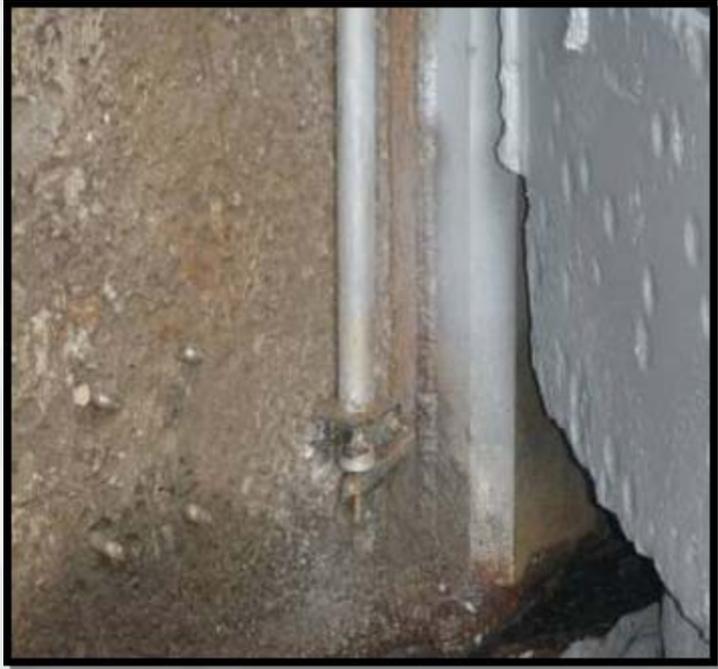
New corrosion protection rods

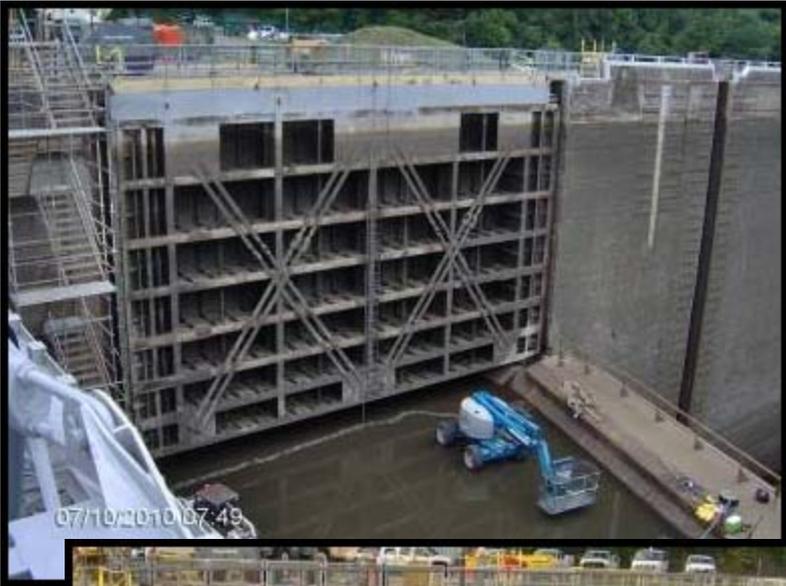
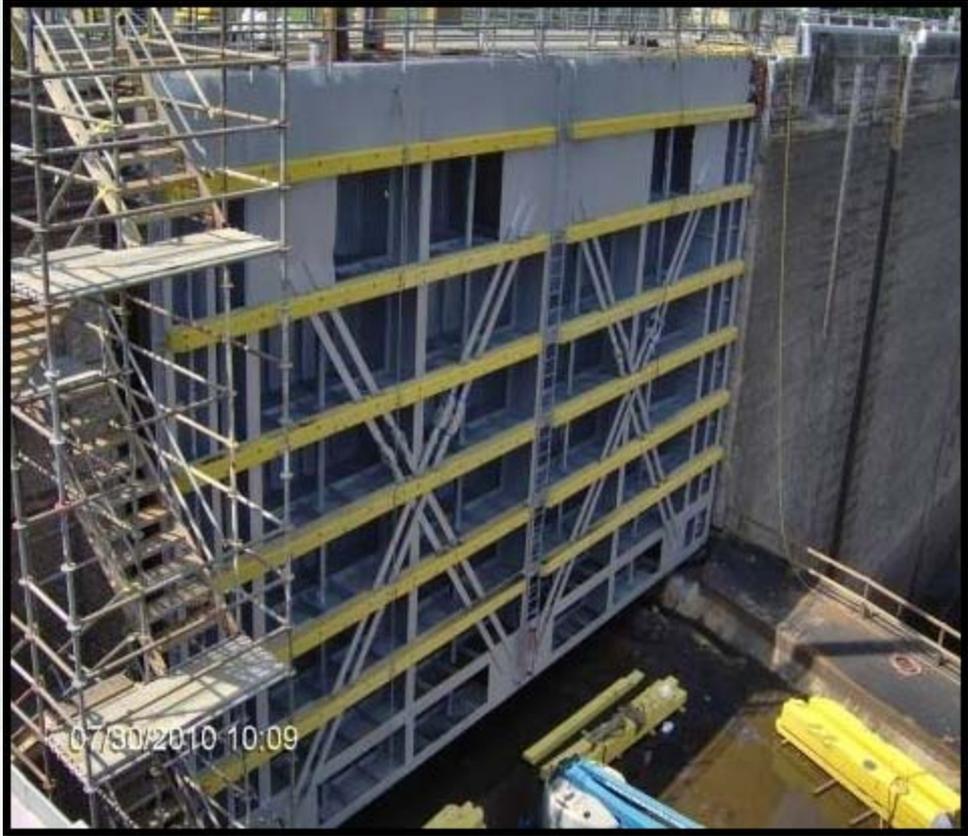
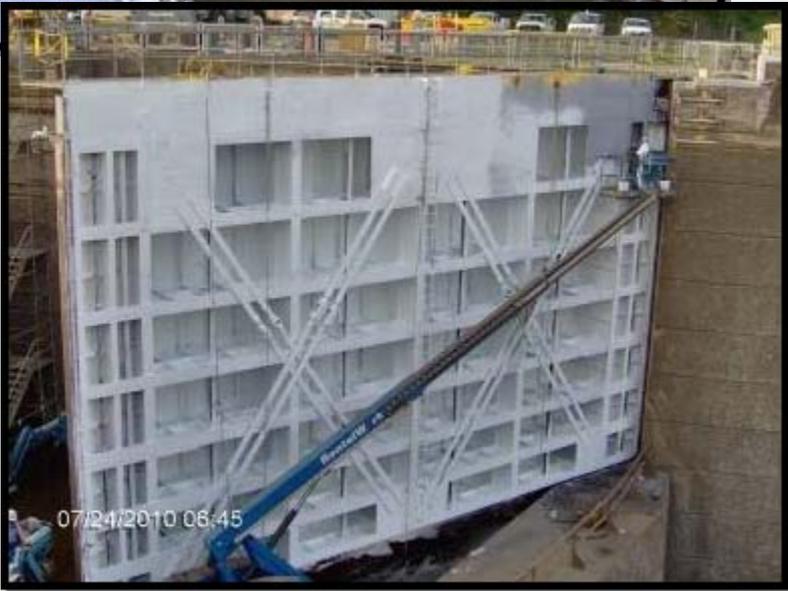
Painting & Timber Replacement

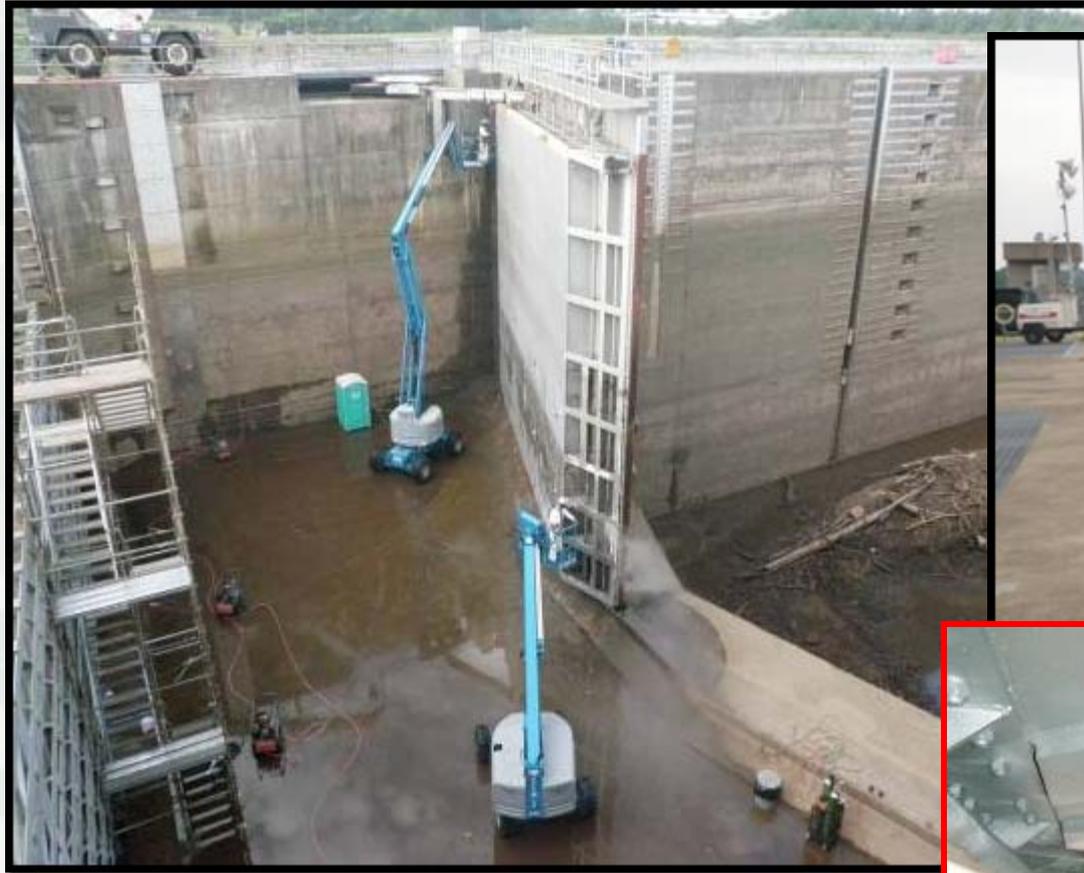
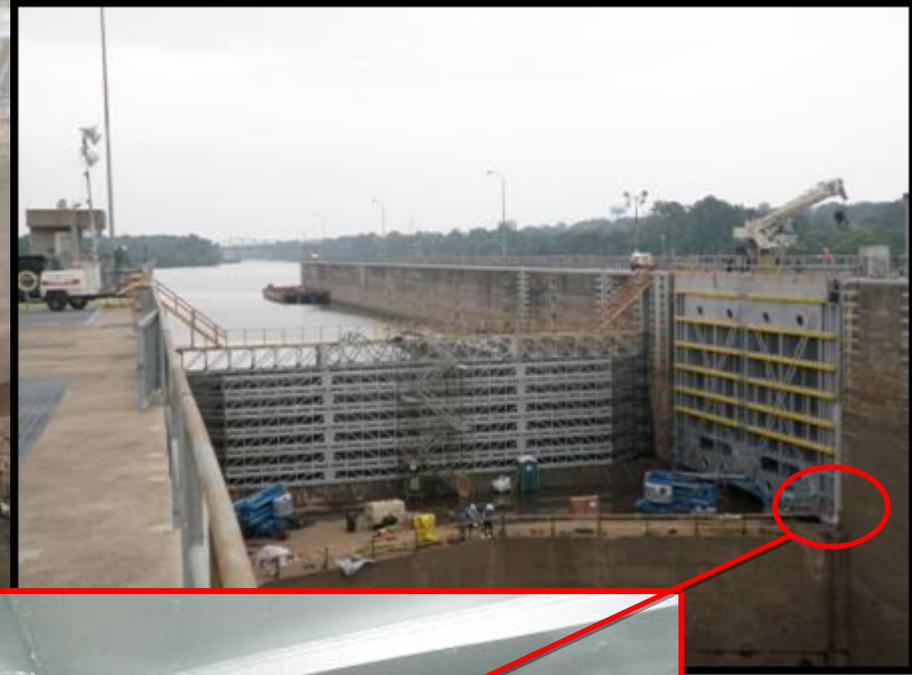
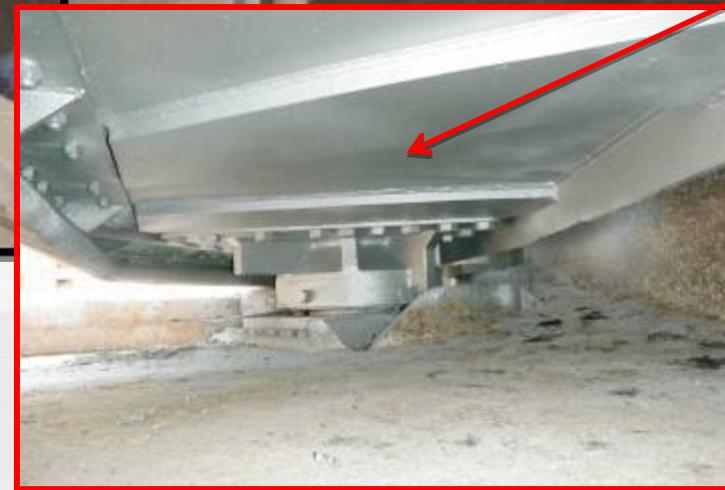
Oliver Lock Closure

Overall, miter gate structural steel and components, pintle assy., in very good condition.

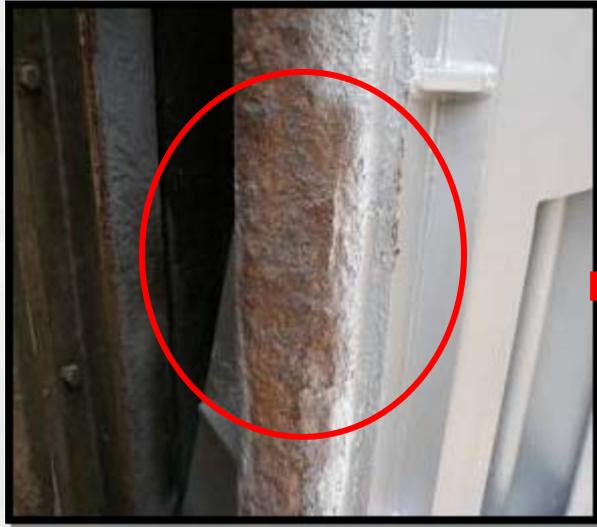
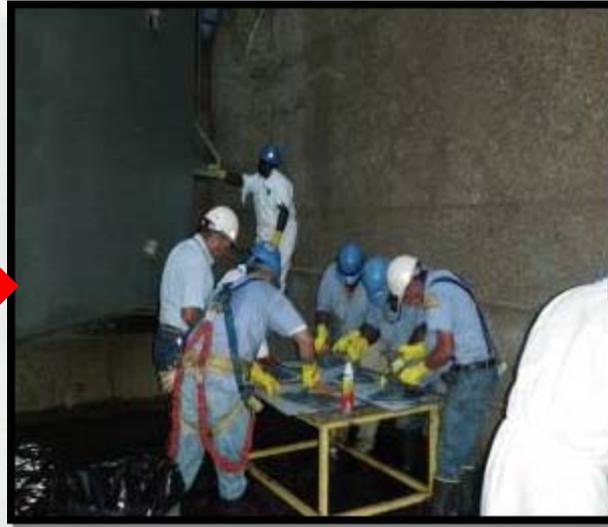
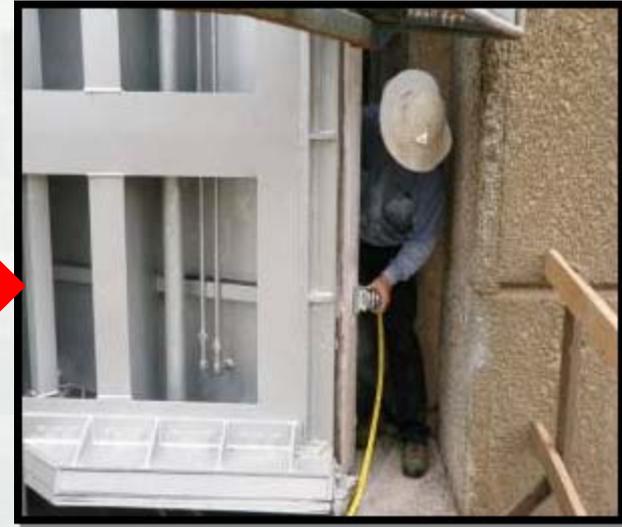
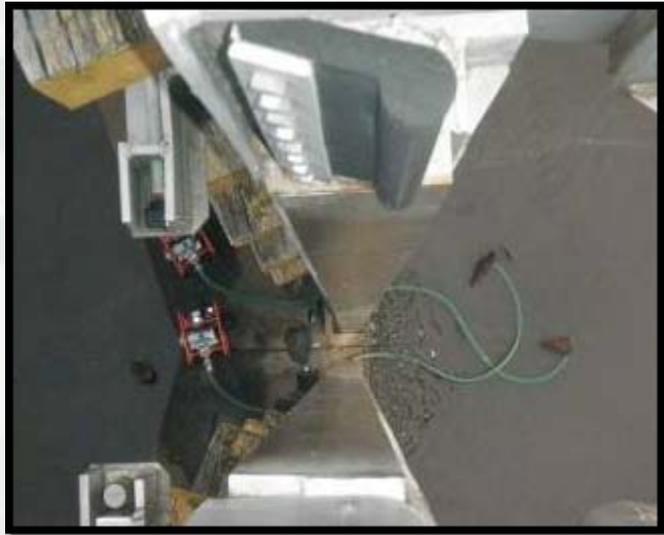
Oliver Lock Closure

Found severe corrosion on miter gate contact blocks. Maintenance crews mixed and applied Belzona (metal compound) to re-surface contact blocks. Belzona re-surfaced blocks is a proven, long lasting repair.

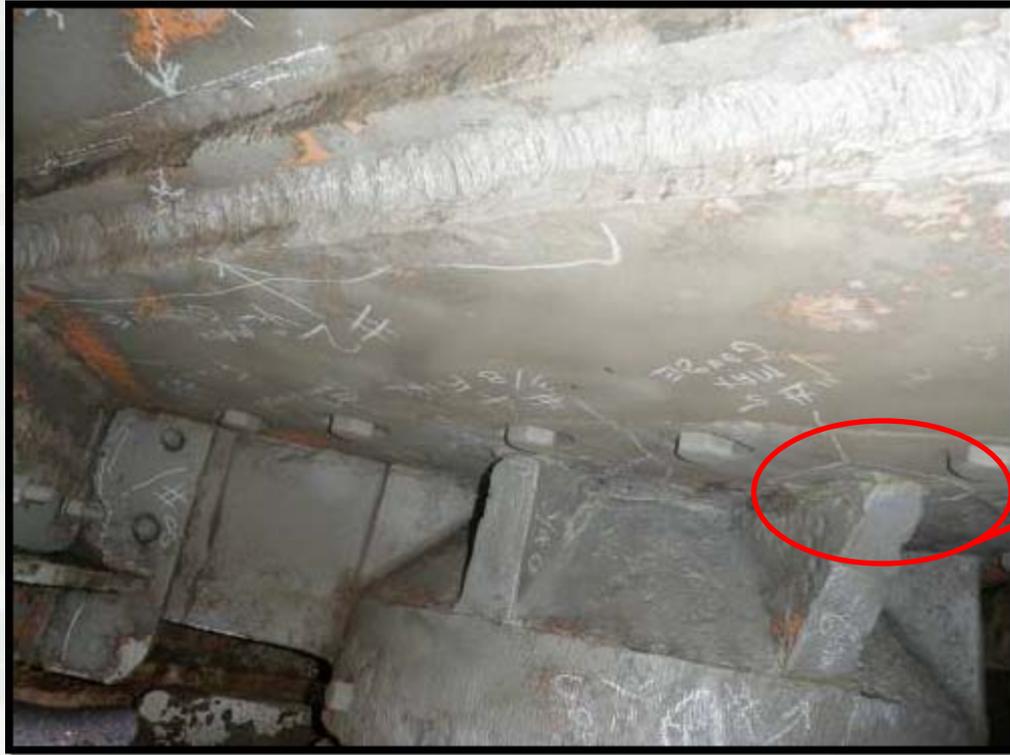
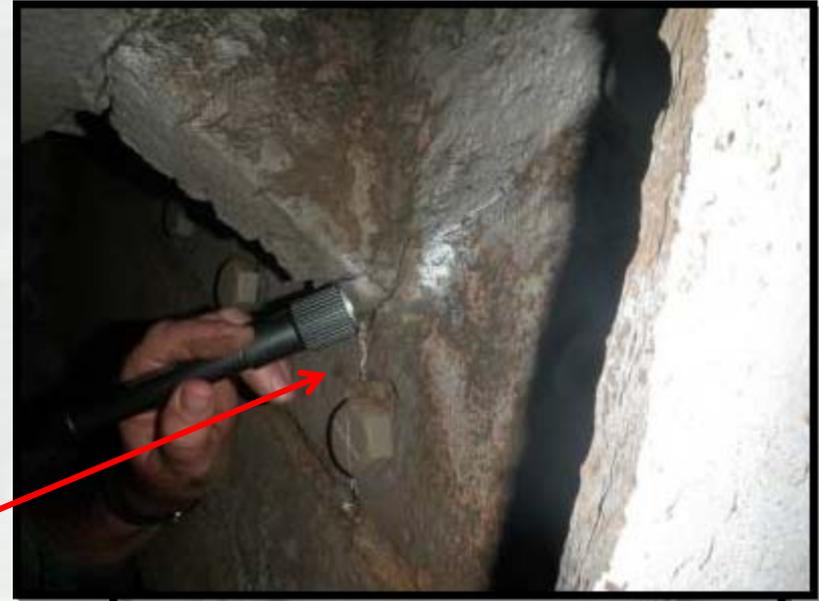
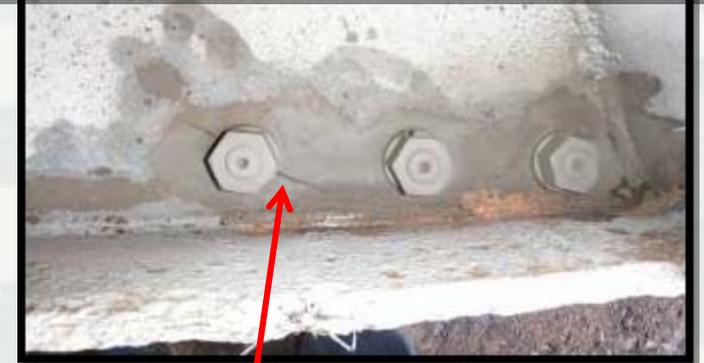
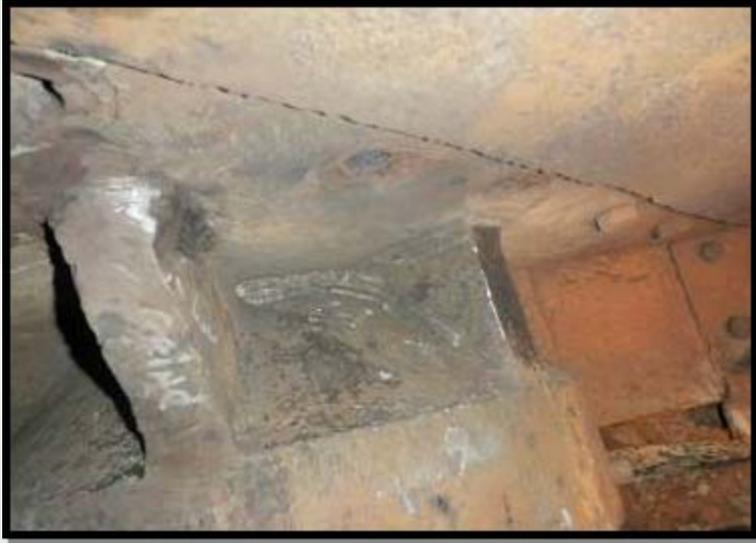
Coffeeville Lock Closure

Crack

Cracking and loose bolts on Lower Miter Gate Pintle Sockets. Pintle assemblies were repaired and bolts replaced; however, due to severity of cracks, pintle sockets are planned for replacement at next Lock Closure (2014).

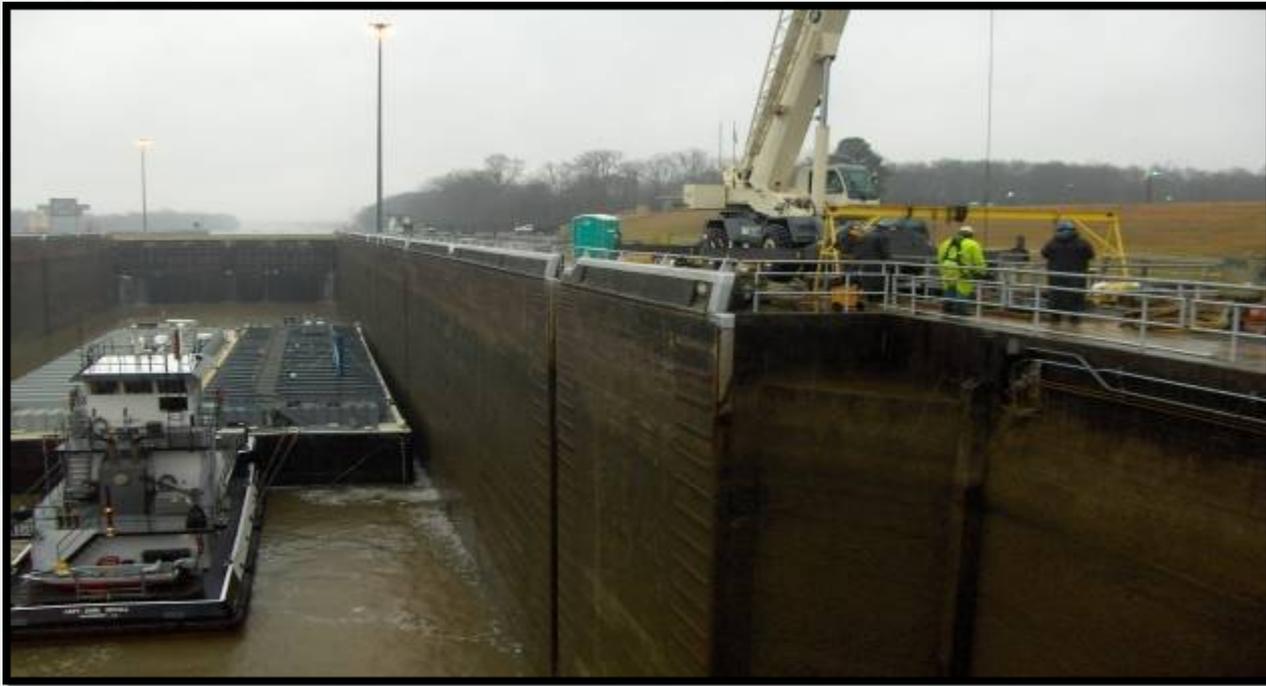
Demopolis Emptying Valve Repair

- Currently repairing lower land valve; therefore operating on only river side emptying valve.
- Work includes repair of operating machinery (links & pins), support beams, seals and complete painting.
- Once repairs are complete on land valve, repair crew will move to river valve for same overhaul work.

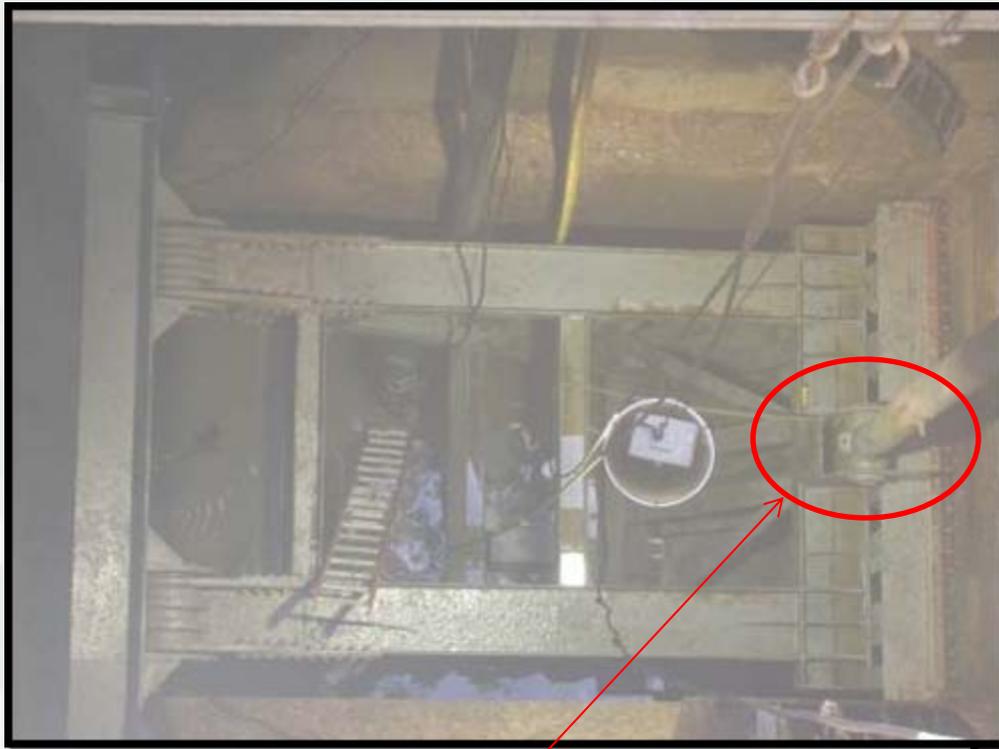
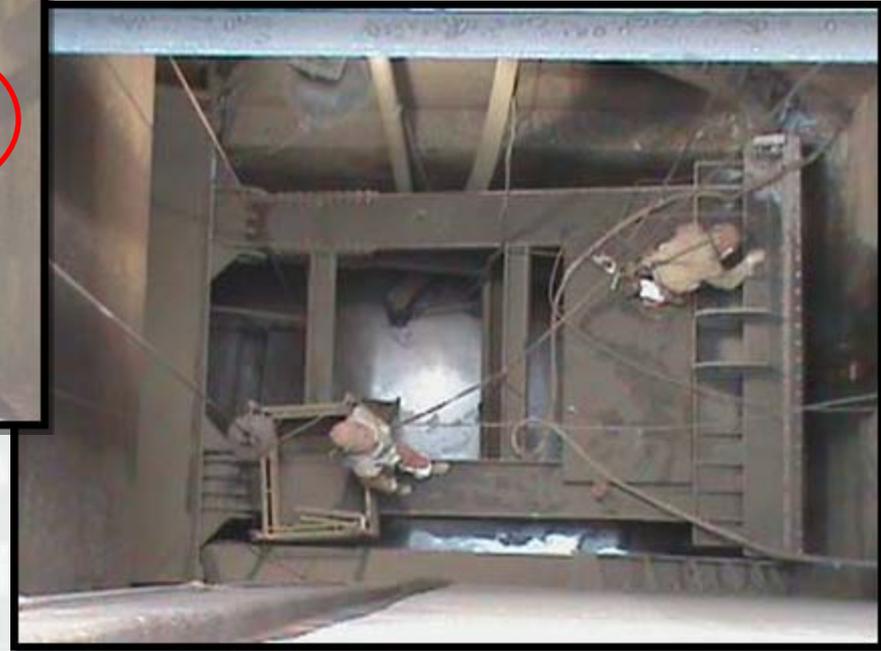
Demopolis Valve Repair – cont.

Operating (strut) arm & pin for lifting valve to open – heavily worn

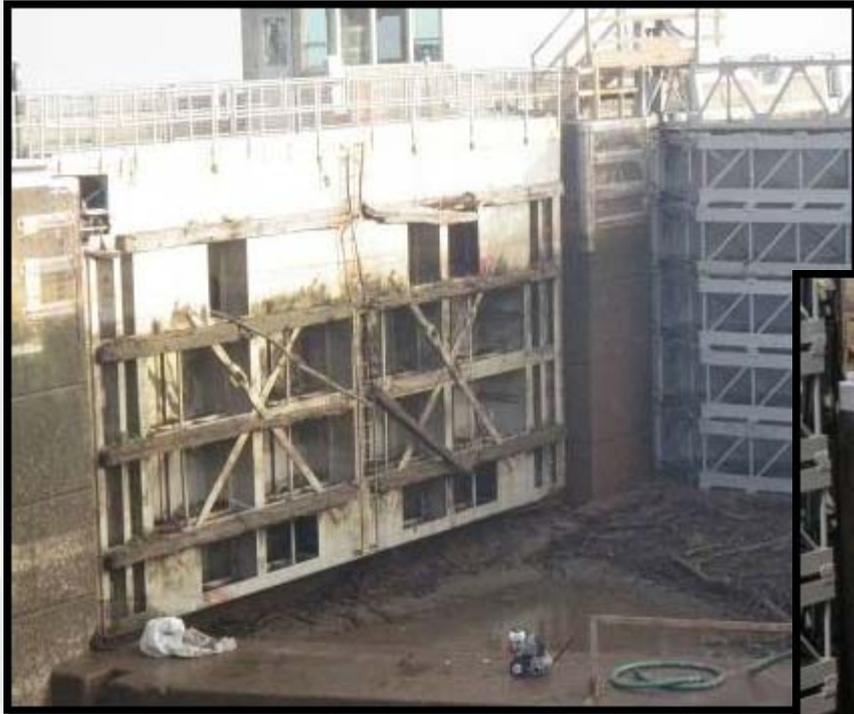
Damaged / Rotten timbers

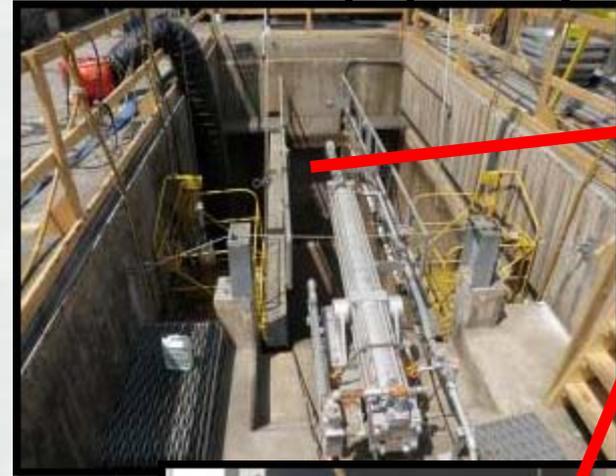
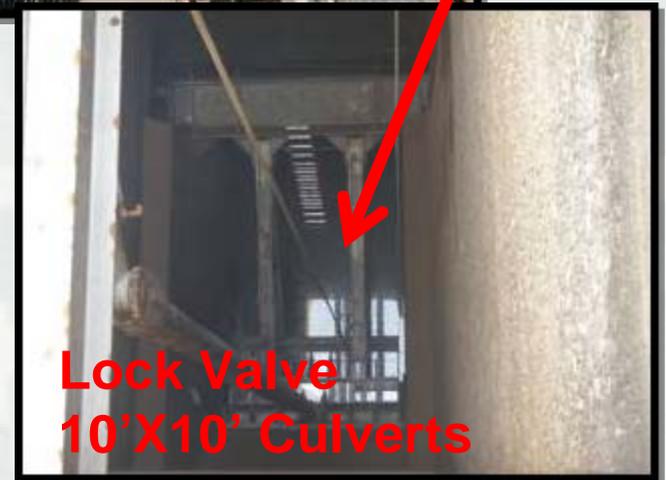
Lock Valve Equip. & Cylinder

While Locks were de-watered, maintenance/repair was performed on all four lock valves. **Not normally done during routine lock closure.*

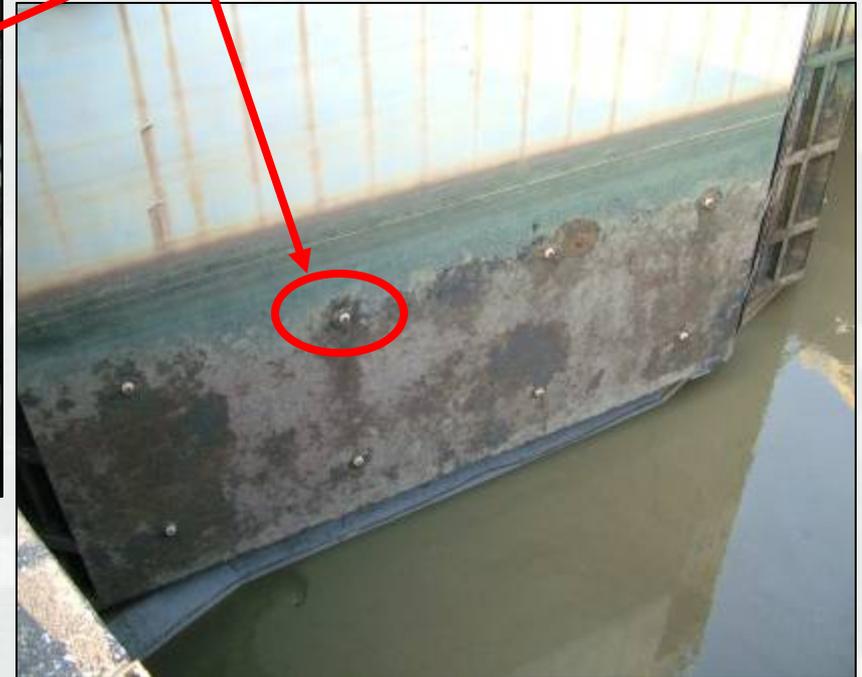
Cathodic Protection anodes
(upstream and downstream
sides of gates)

Inspected and repaired damaged cathodic protection anodes for corrosion protection (along with newly painted surfaces).

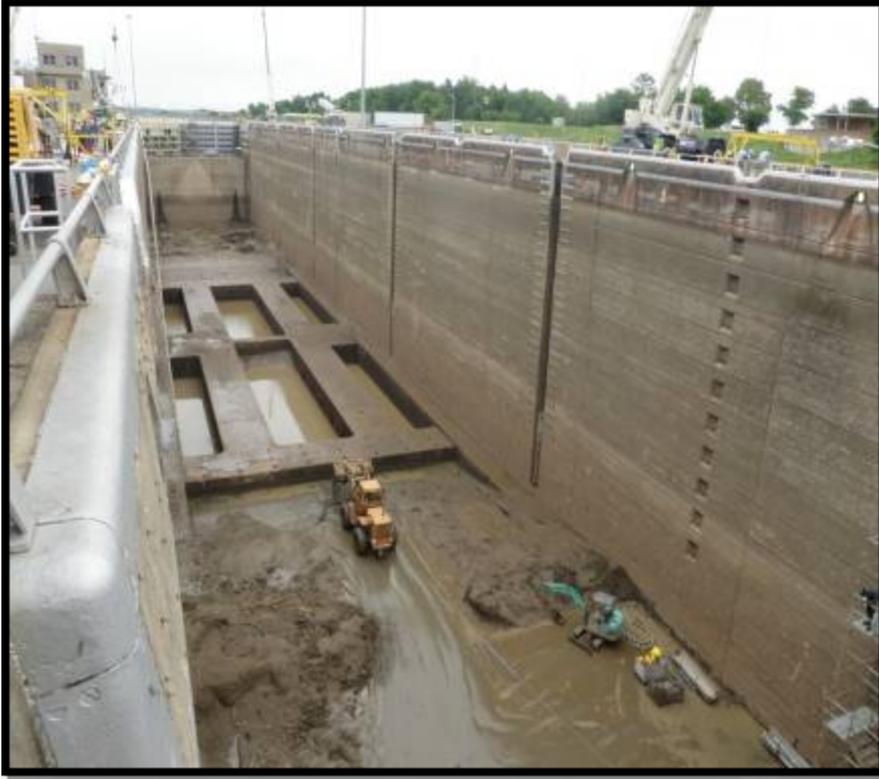
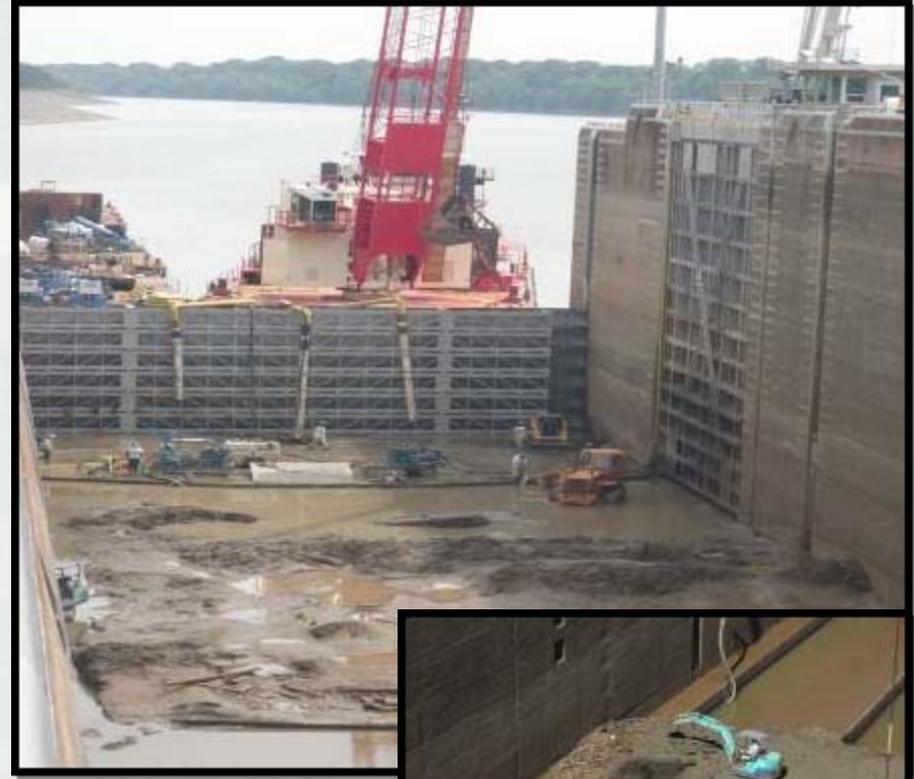
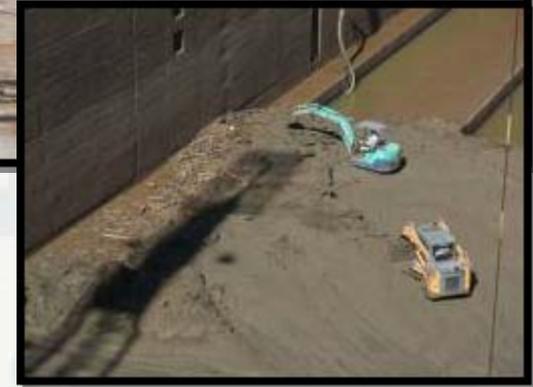
Millers Ferry Lock

- Repaired lock emptying/filling valves
- Minor repairs and painting of miter gates
- Re-surfaced miter gate contact blocks
- * Large amounts of mud and silt had to be removed prior to inspection and repair.

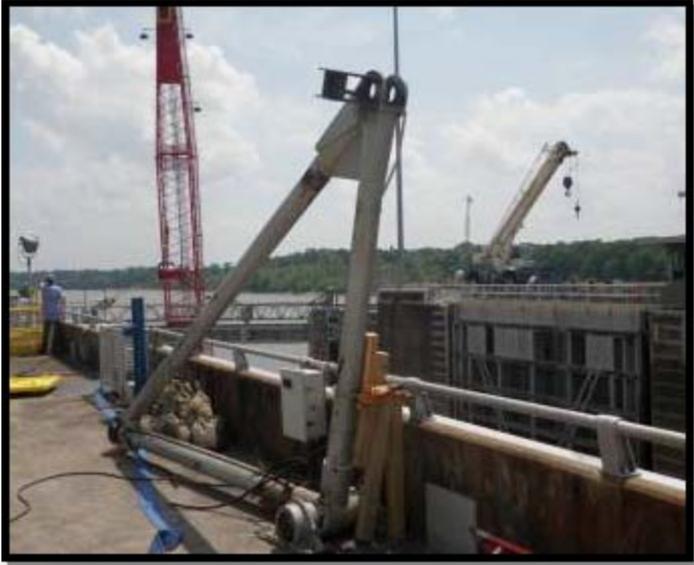
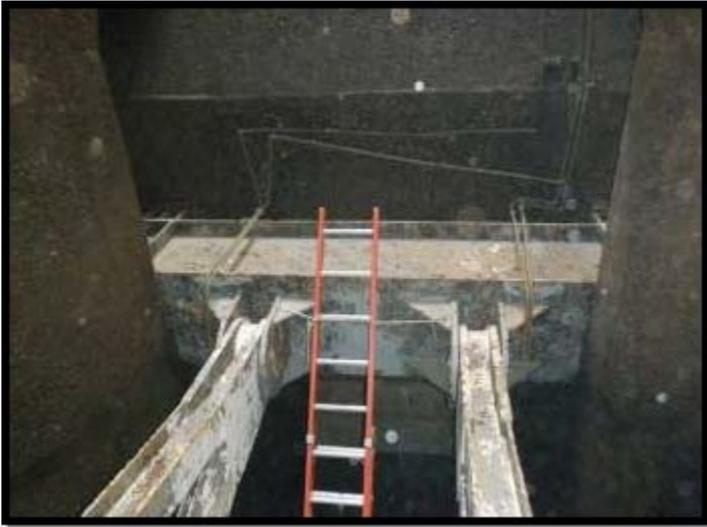
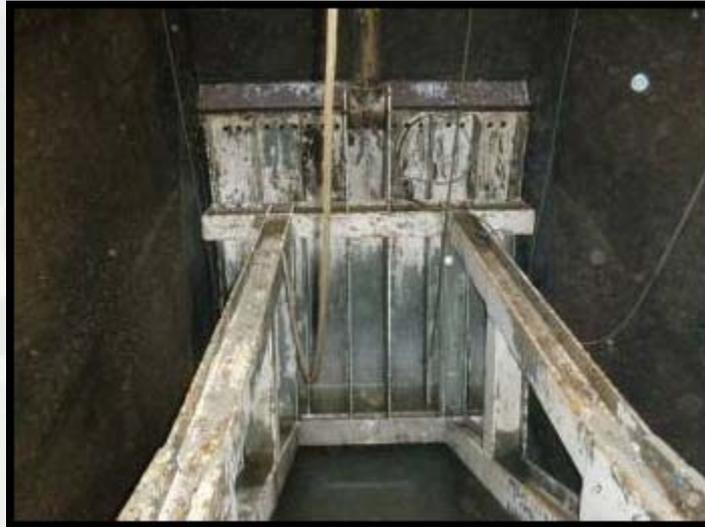
Millers Ferry Lock

- All four lock valves required replacement of connection pins and support beams along with repairs to machinery and full painting.
- Operating components were disassembled and repaired.
- Broken grease lines were replaced
