2011 Lock Maintenance Workshop

Review of 2010 Lock Closures

Anthony Perkins

Mobile District

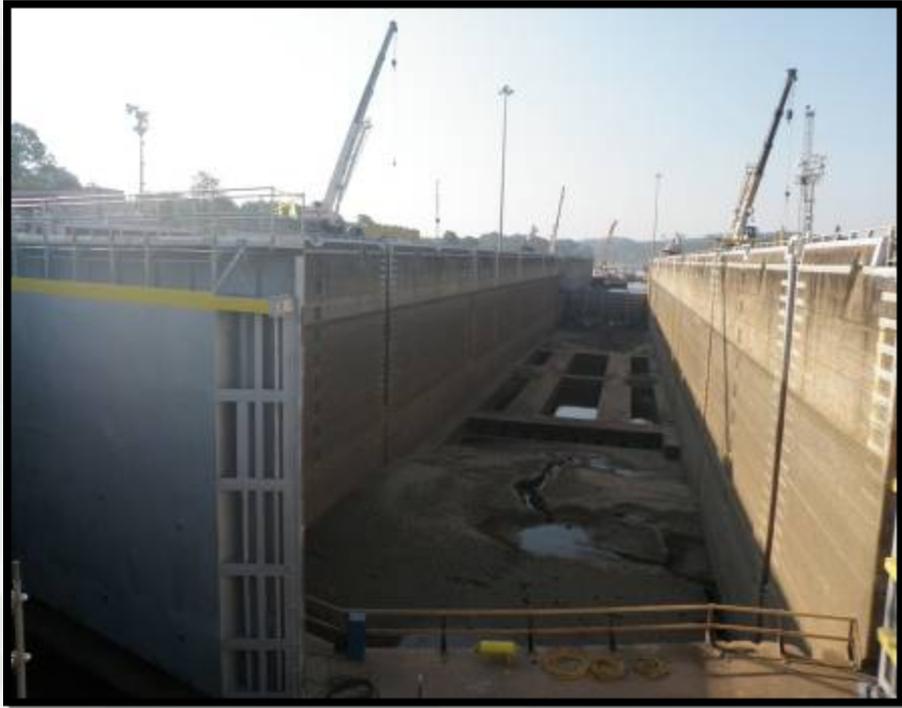
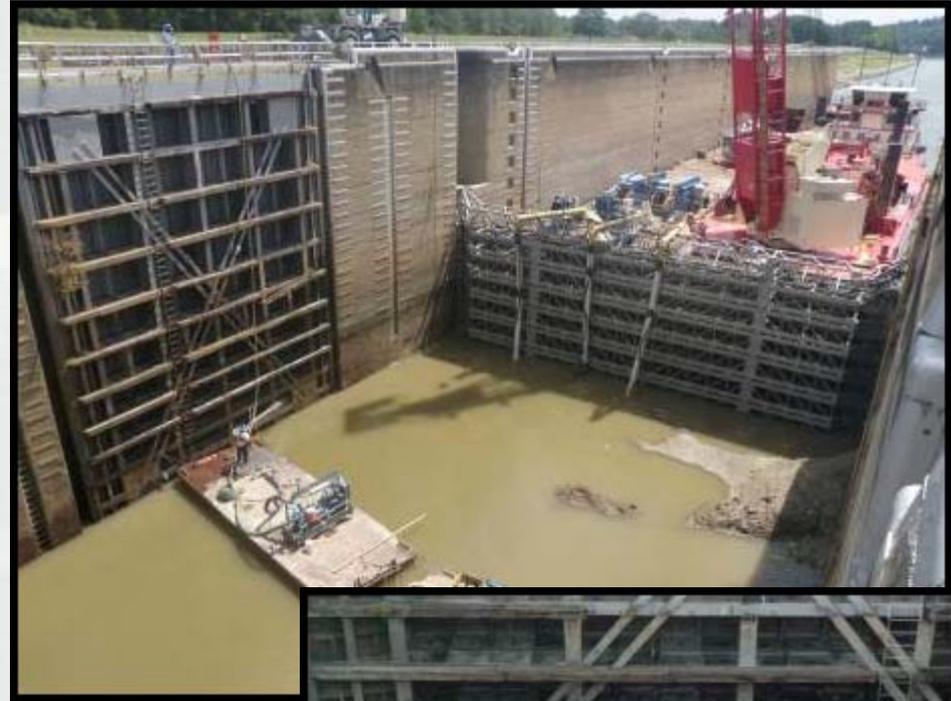
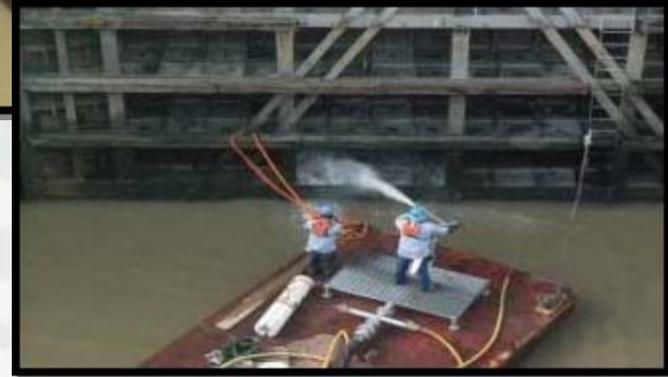
Claiborne Lock

- Repaired lock emptying/filling valves
- Minor repairs and painting of miter gates
- * Large amounts of mud and silt had to be removed prior to inspection and repair.

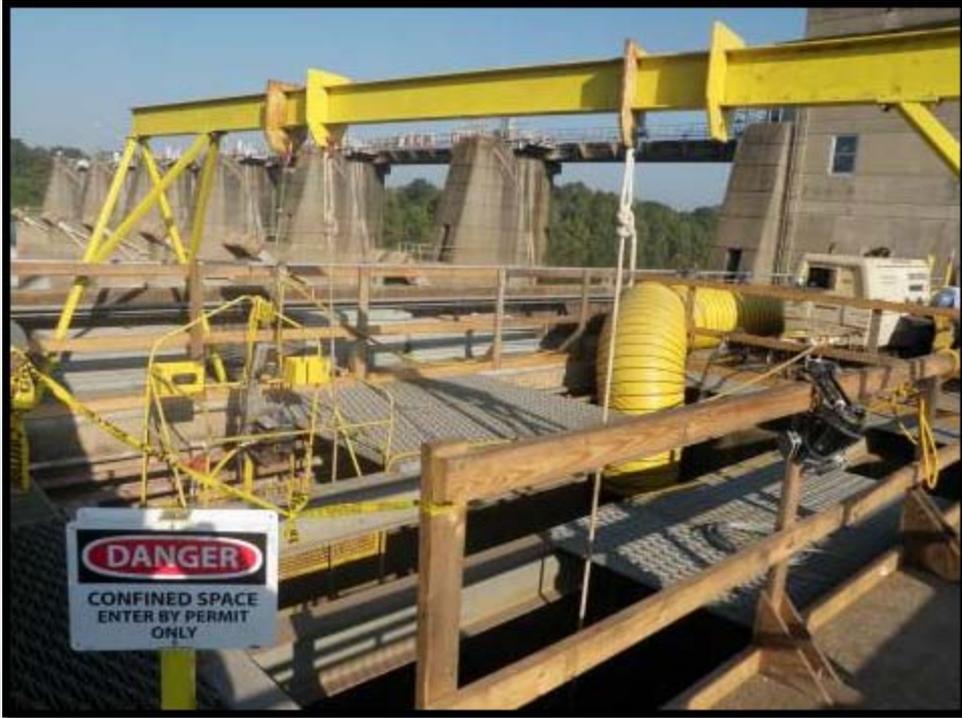
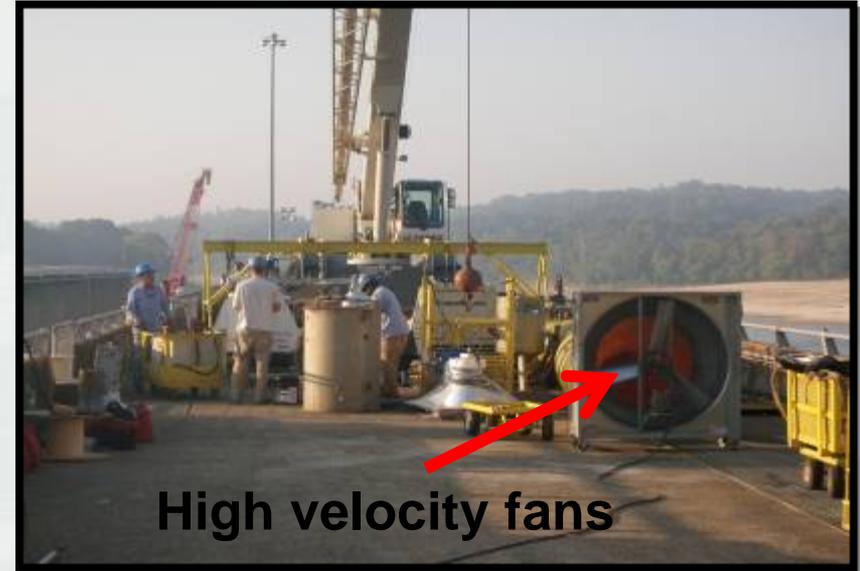
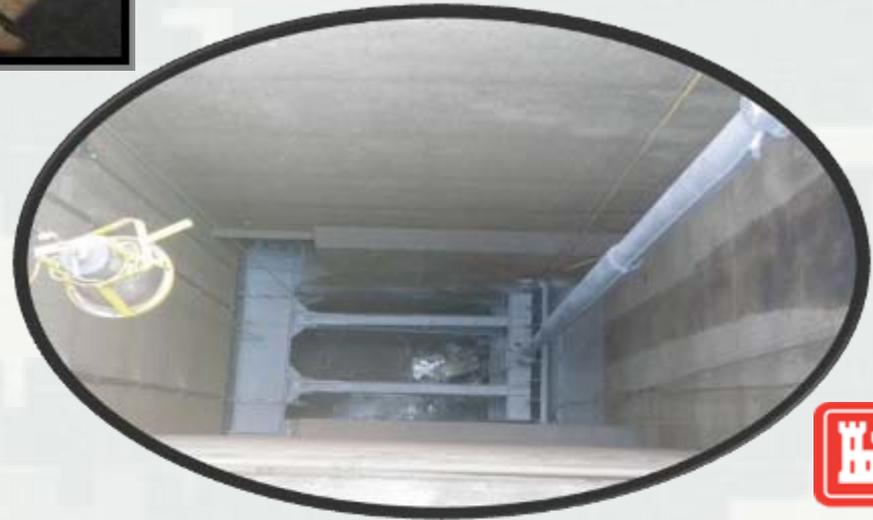
Claiborne Lock

Lock valve repairs and painting required special ventilation and lighting due to location deep inside lock walls

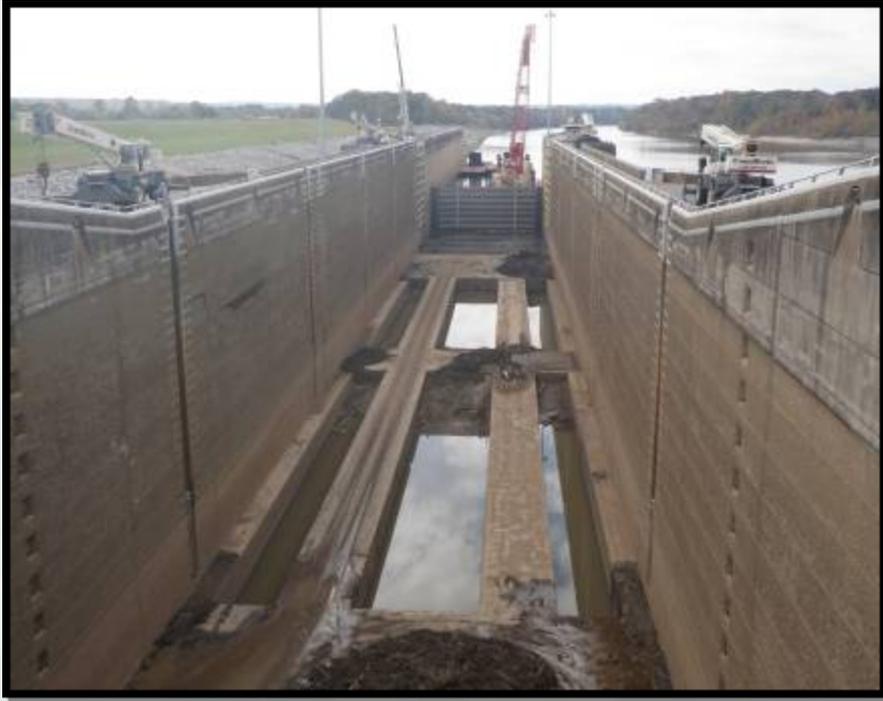
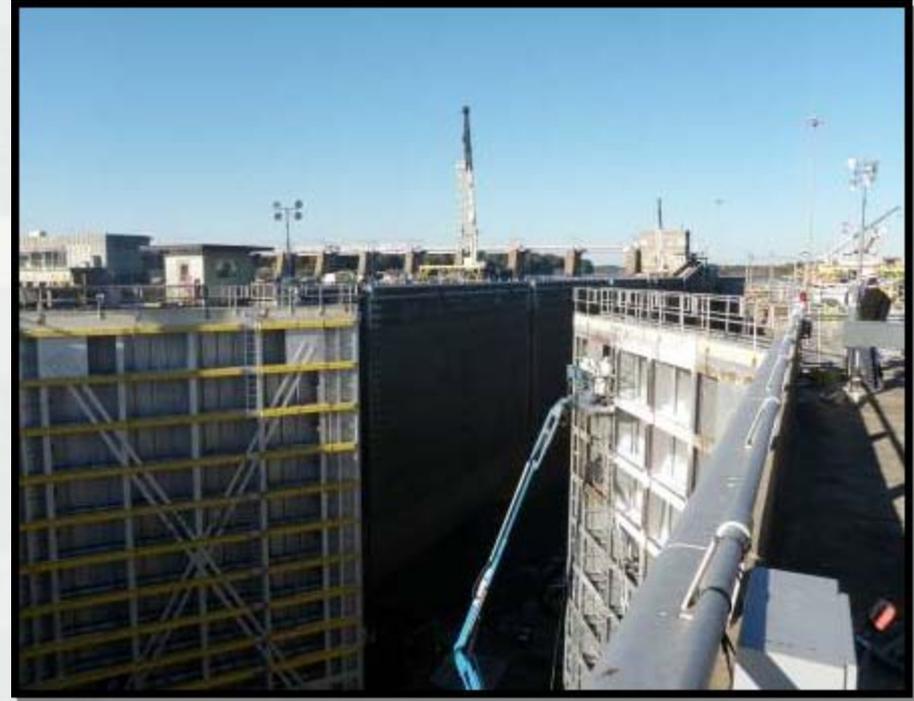
Robert F. Henry Lock

- Repaired lock emptying/filling valves
- Minor repairs and painting of miter gates
- Re-surfaced miter gate contact blocks
- Repaired corroded embedded piping (in bottom of lock chamber)
- Repaired lower miter gate top connection pin (gudgeon pin)
- * Large amounts of mud and silt had to be removed prior to inspection and repair.

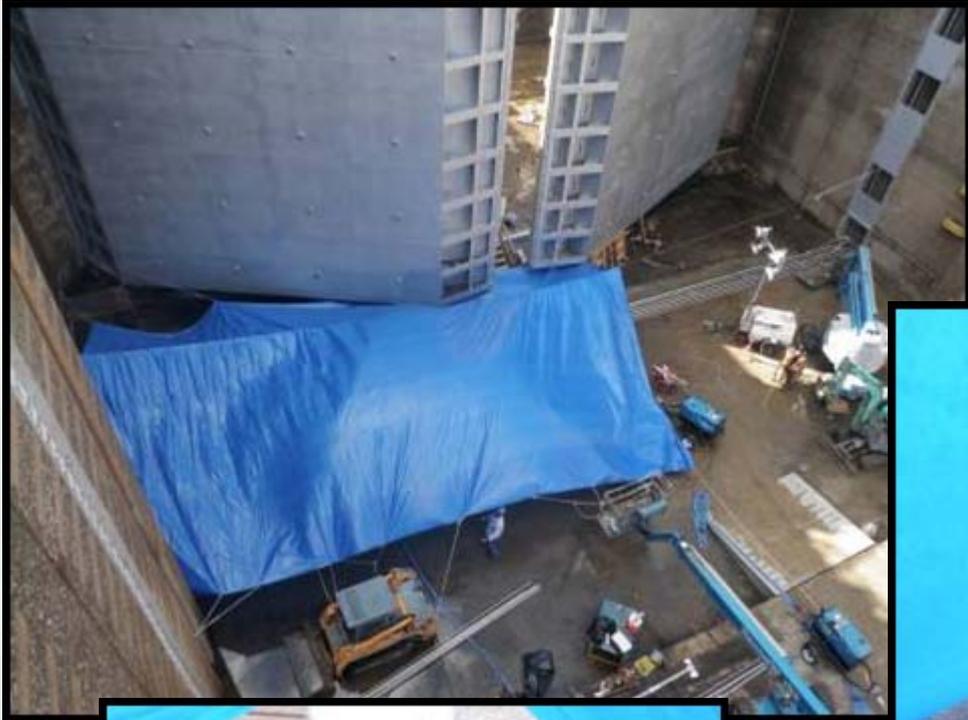
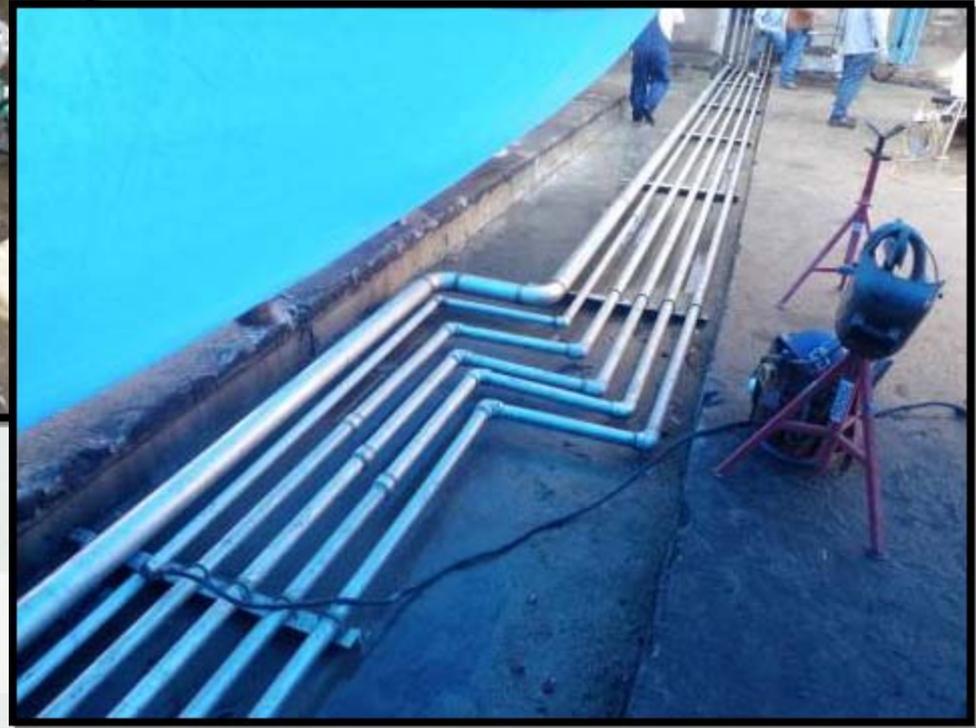
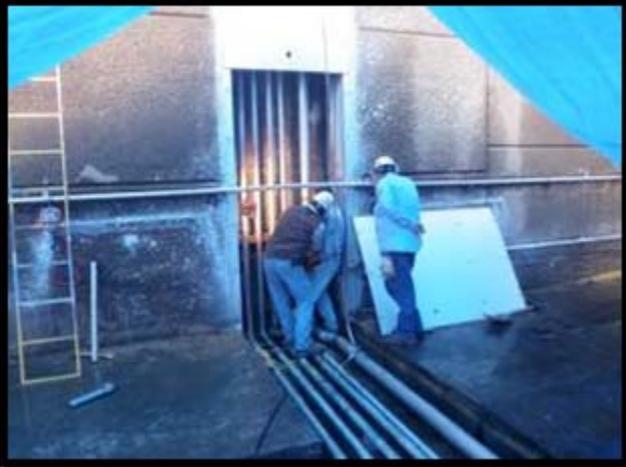
Repair piping –
hydraulic, water & air

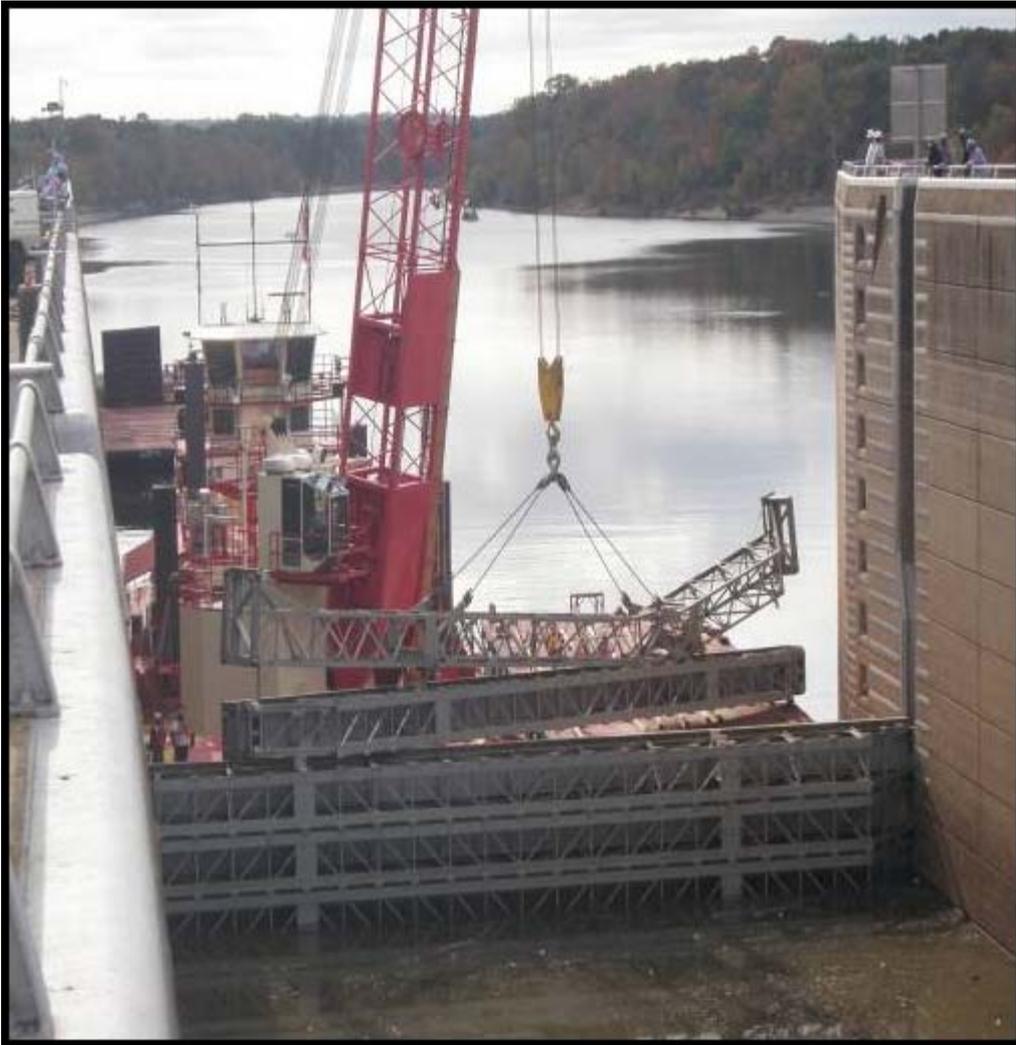
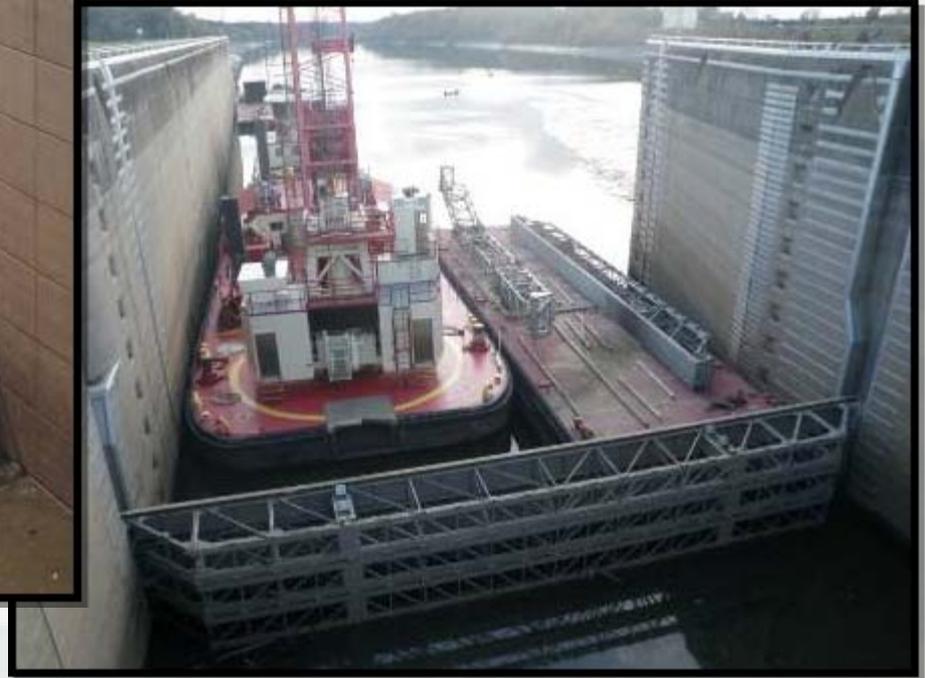
Stoplog Incident – Damaged Lifting Beam & logs.

- **Do not attempt lifting of stoplog until proper connection of lifting beam hooks to stoplog are verified by experienced and properly trained employee.**

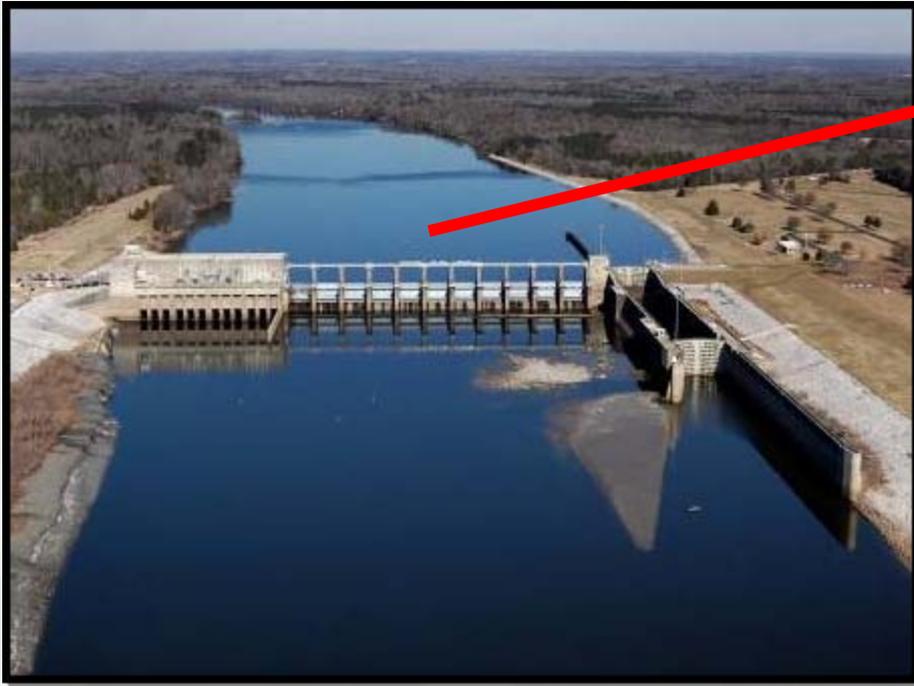
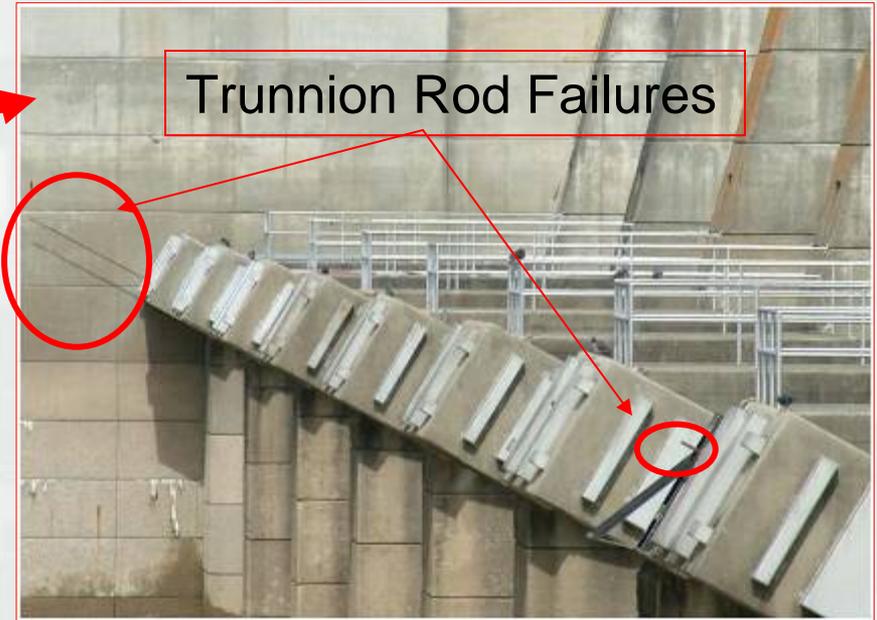
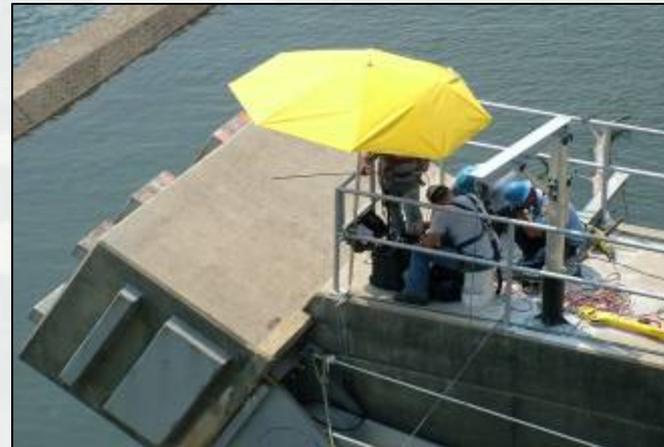
RF Henry Lock & Dam

Trunnion Rod Inspections / Testing
National Team formed to study
spillway trunnion rod failures
