Lock 25 Roller Gate Repairs

Lock and Dam Maintenance
Workshop 2011

Lock and Dam #25

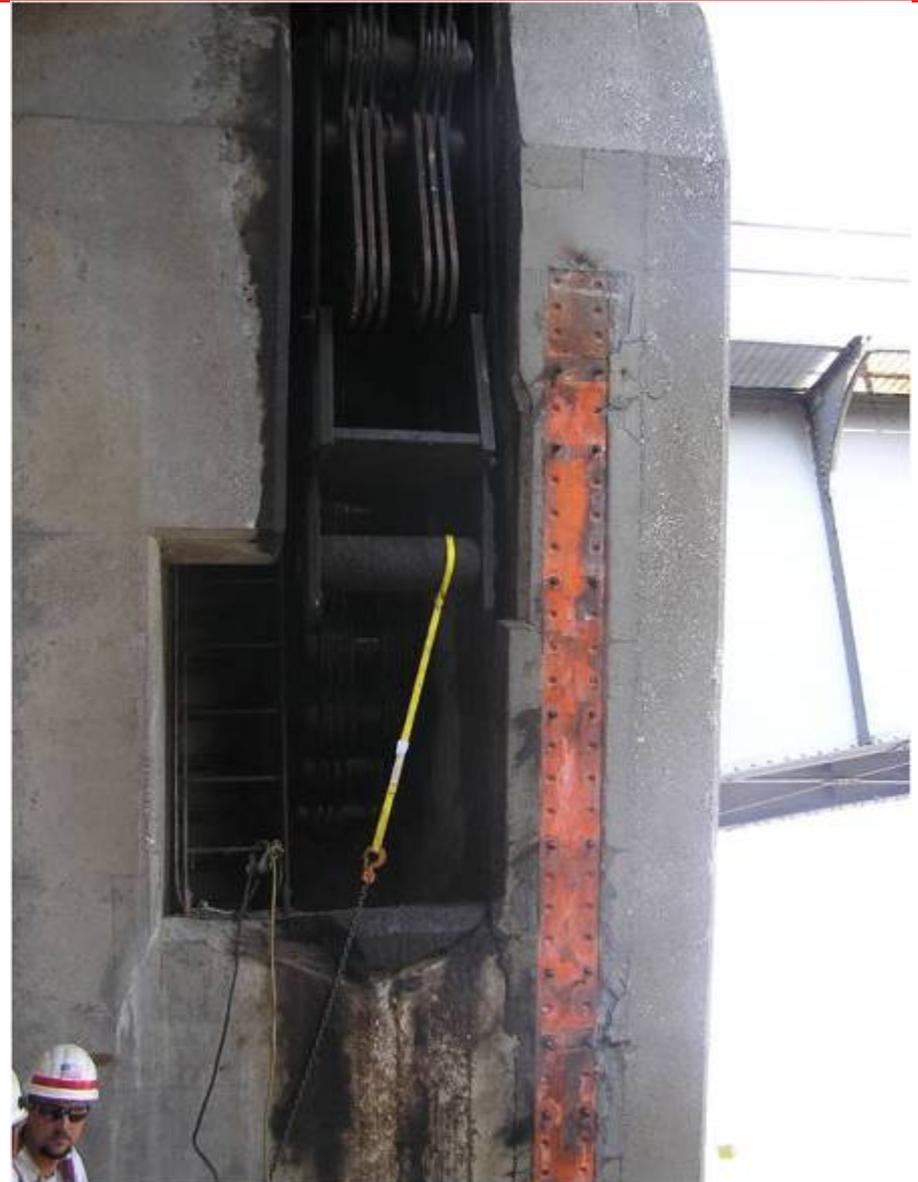
Initial Response

- Chain connection ripped out of the gate. 5 Plates.

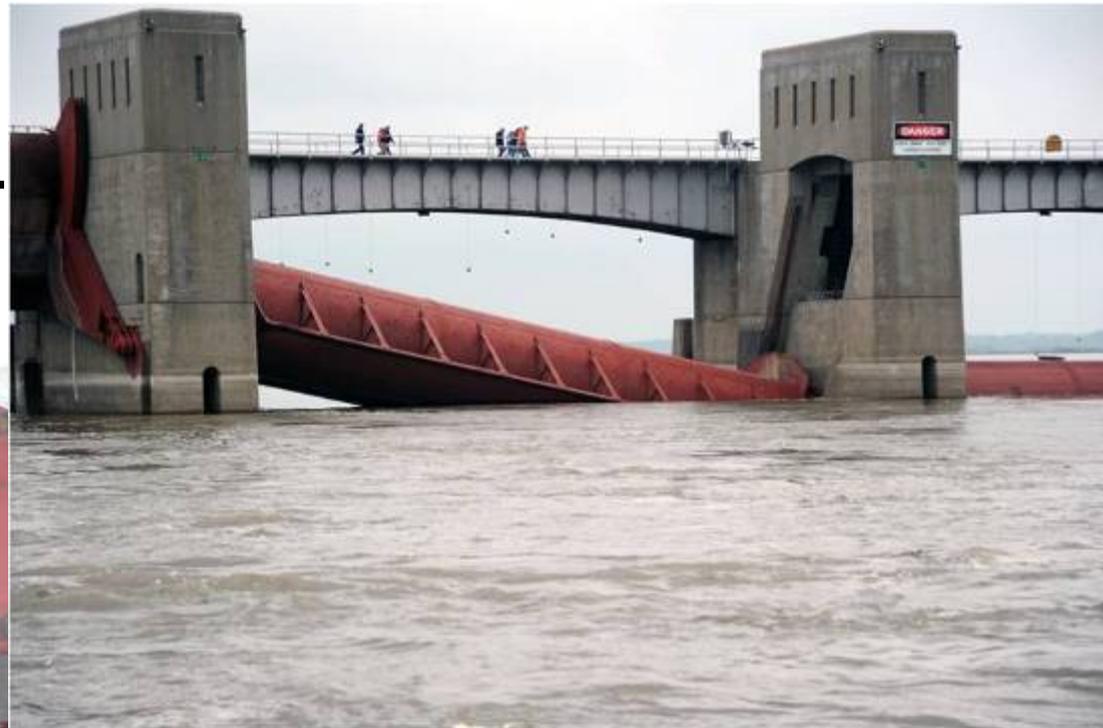
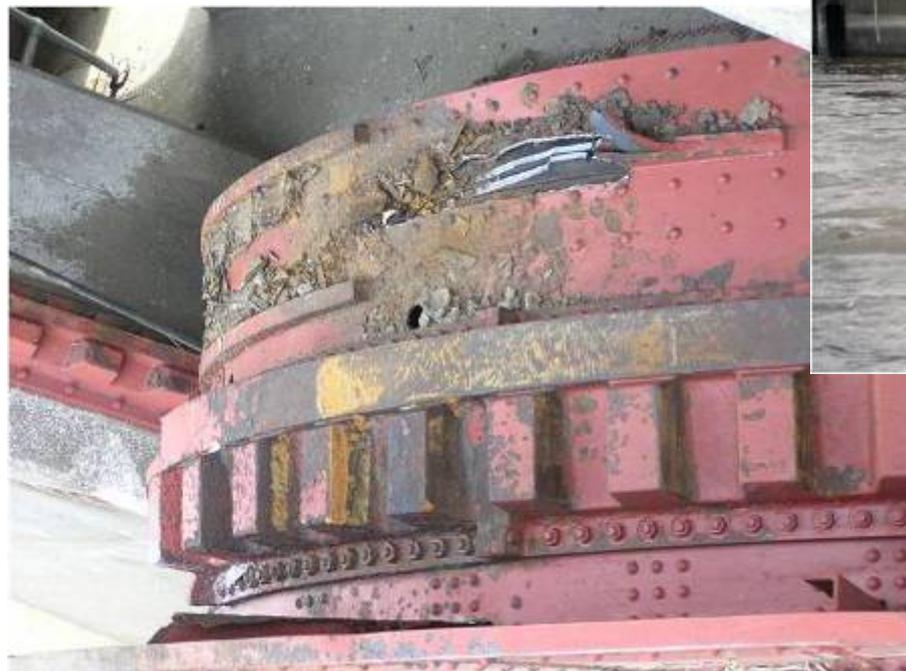
- Downstream view of gate. NOT horizontal.

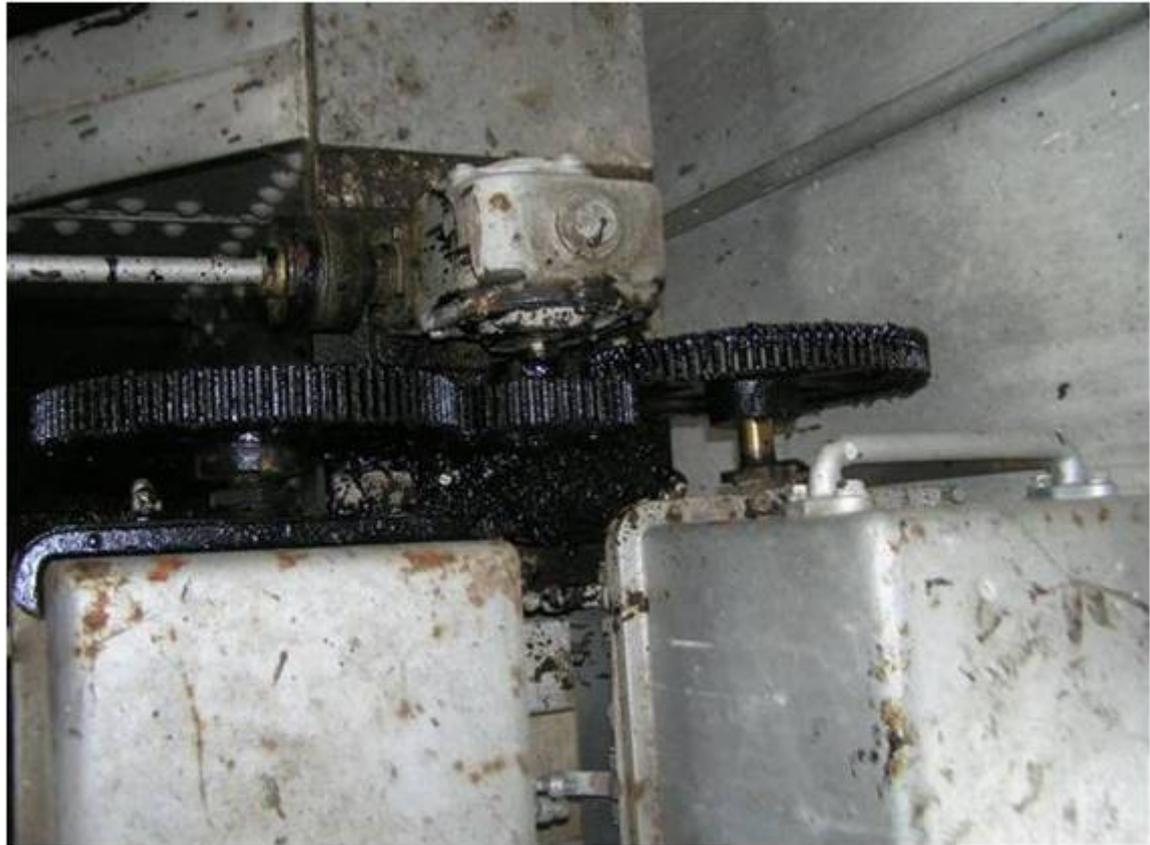
What Happened

- Limit Switch failure.
- Upper limit switch gear had moved out its shaft which prevented it from turning.

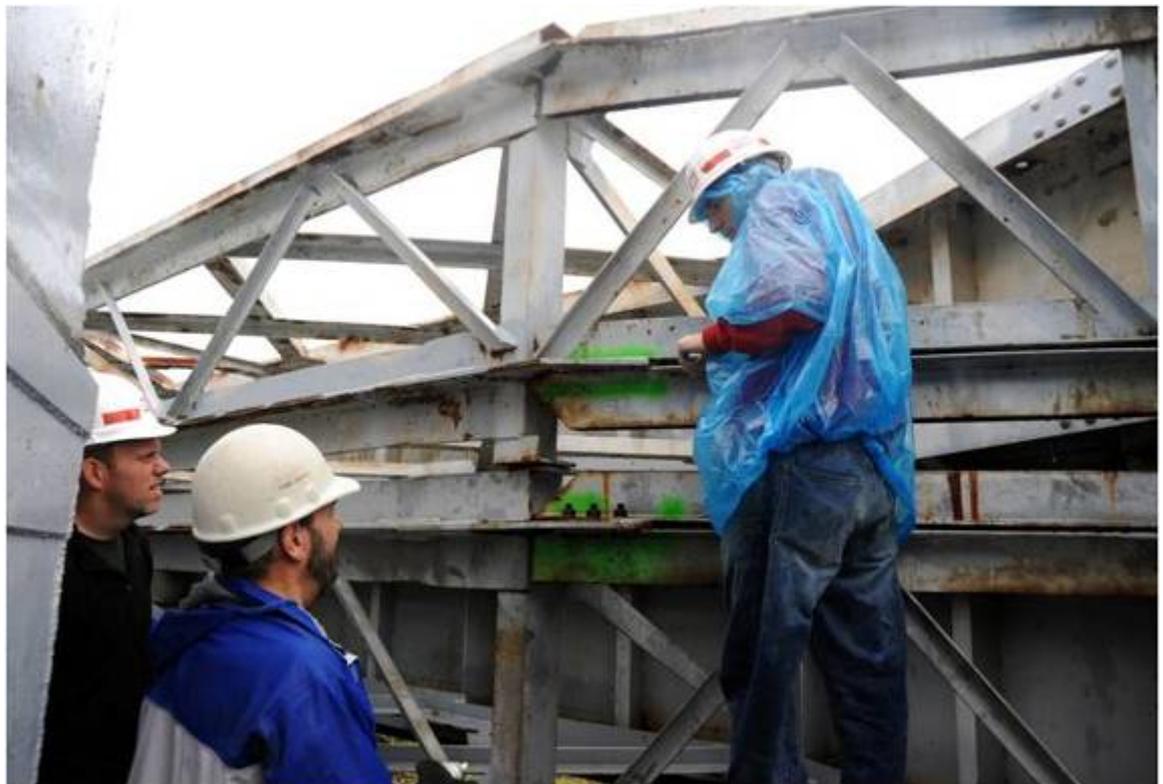
- Lock 25
Stoplogs are condemned due to fracture critical welds.
- Borrowed Lock
17 stoplogs

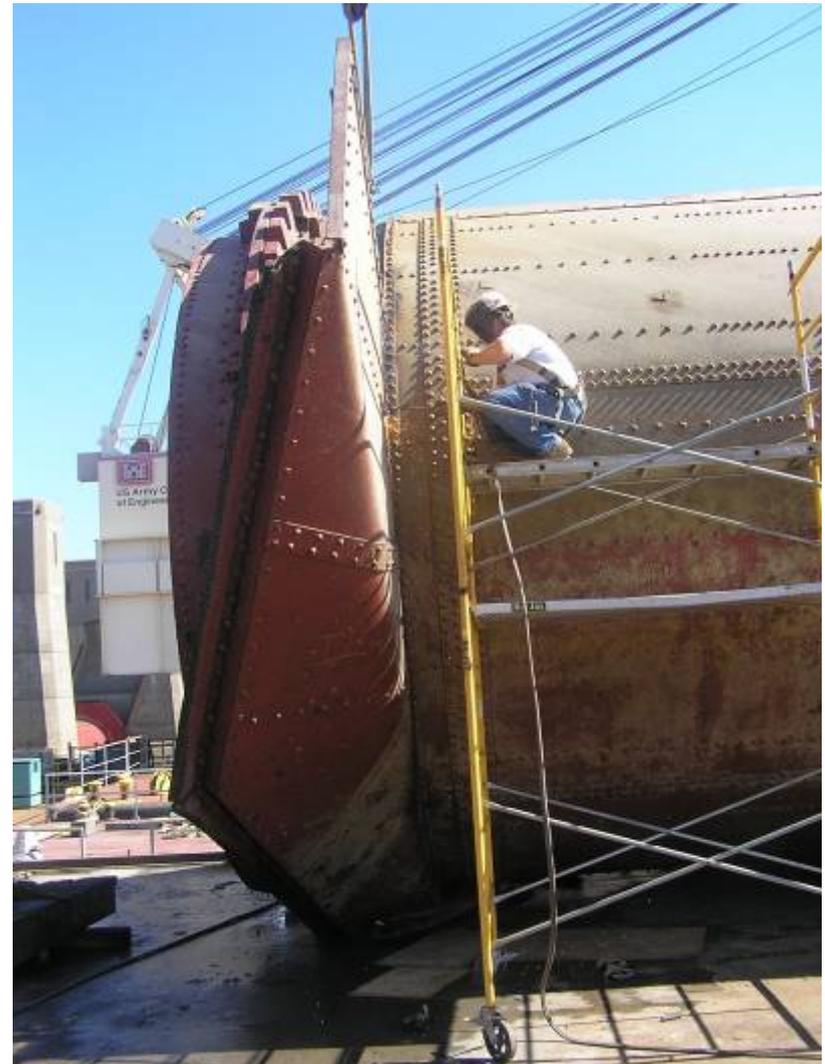
- Both side shields had to be removed.
- Both were damaged during the failure.
- Sealing Surface against both piers.

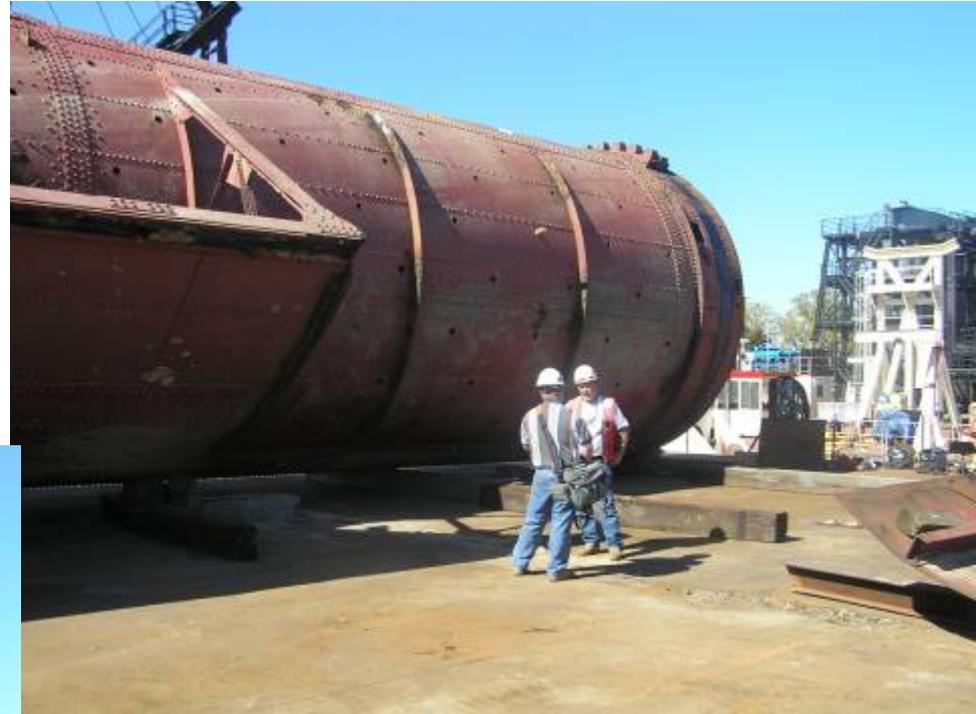
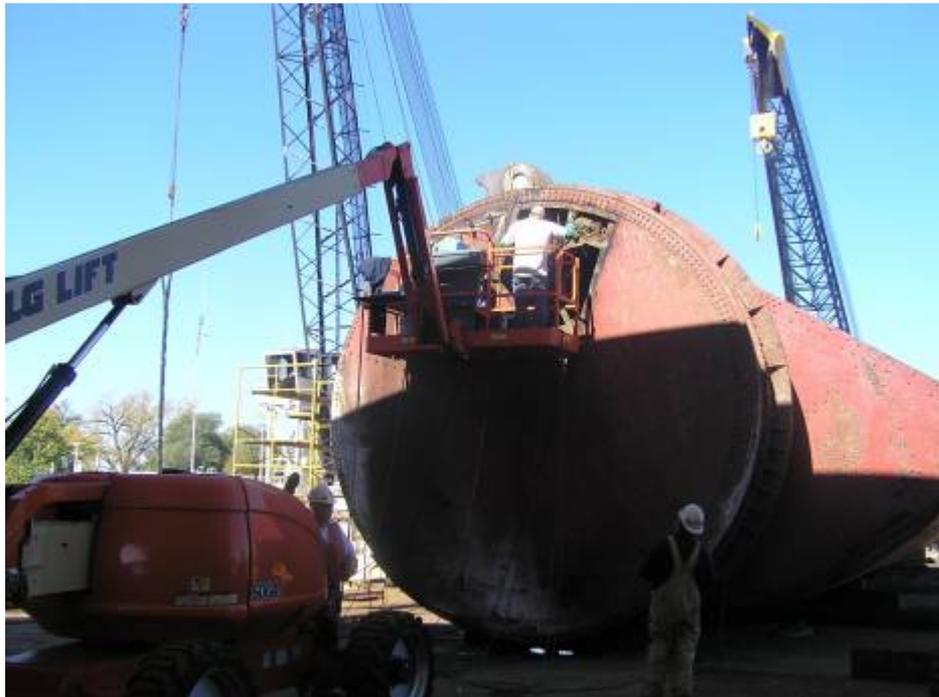
- Chain lug plate replacement. This was the main failure point.
- Critical path for reinstallation.
- 5 Plates hucked together.

- Approximately 30ft of apron had to be removed.
- This was a key point for the installation of the gate.

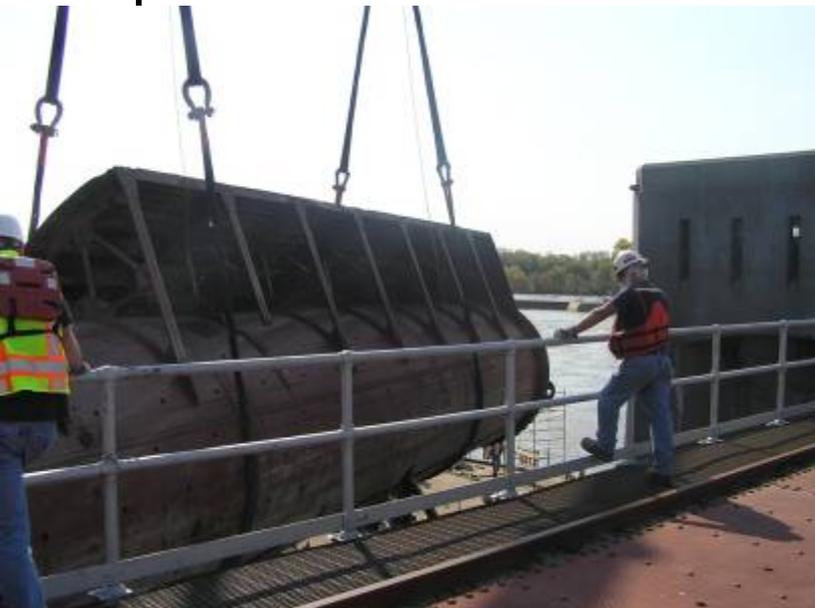
- Wire rope slings had to be replaced due to damage during removal.
