Miter Gate Pintle Ball Replacement

Chouteau Lock and Dam 17

12 February 2013

21 Day Scheduled Closure

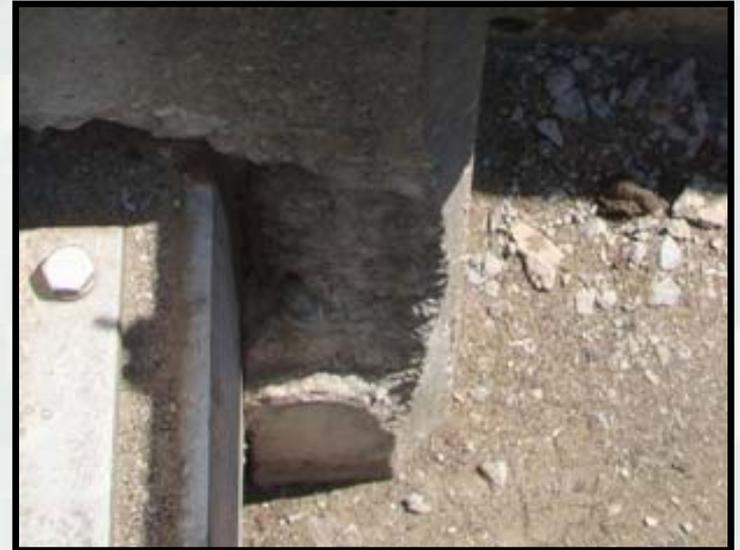
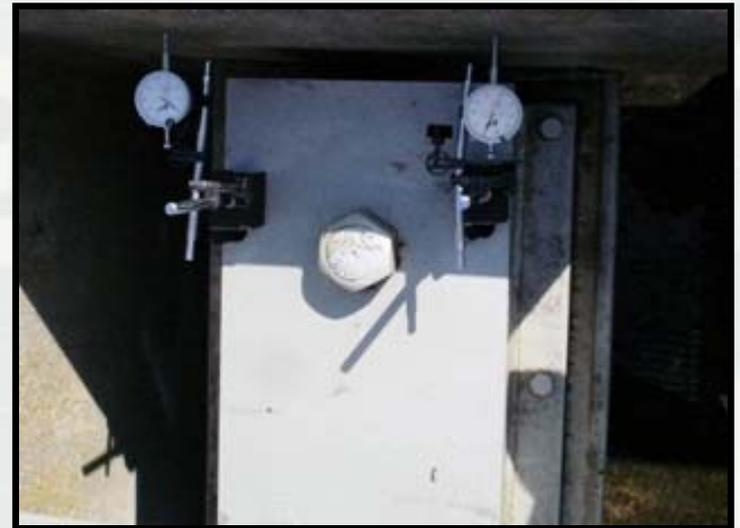
- 2009 Dewater Findings
 - ▶ Ruptured Pintle Grease line
 - ▶ Wear gap over 3/16" (normal under 1/20")
 - ▶ Lubrication attempts unsuccessful
 - ▶ Conclusion grease grooves worn smooth

- 2011 Top Anchorage
 - ▶ Concrete breaking around embedded metal
 - ▶ Measured 1/32" movement during operation
 - ▶ Minimal movement on other Gates

- ▶ Repair worn Miter Gate pintle to prevent future damage to embedded castings, eventual failure and unscheduled outage to navigation
