To Engineer is Human

Mills Dam #2 - Tainter Gate Leakage

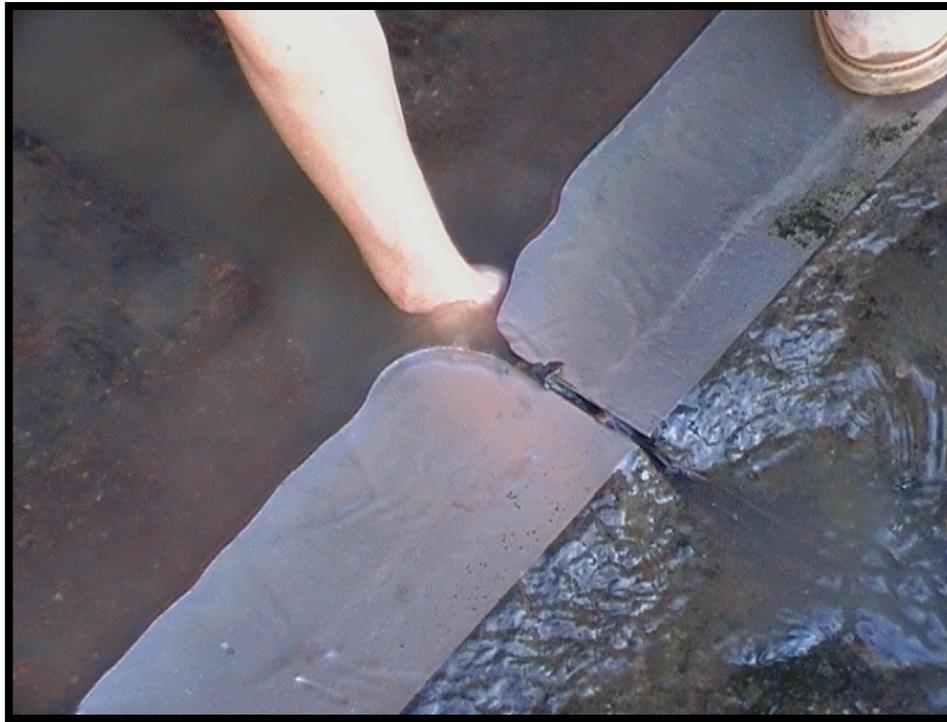
Mills Tainter Gate Embedded Bottom Sill

The concrete around the embedded bottom sill plate has eroded away to the extent that water is going through the monolith joint.

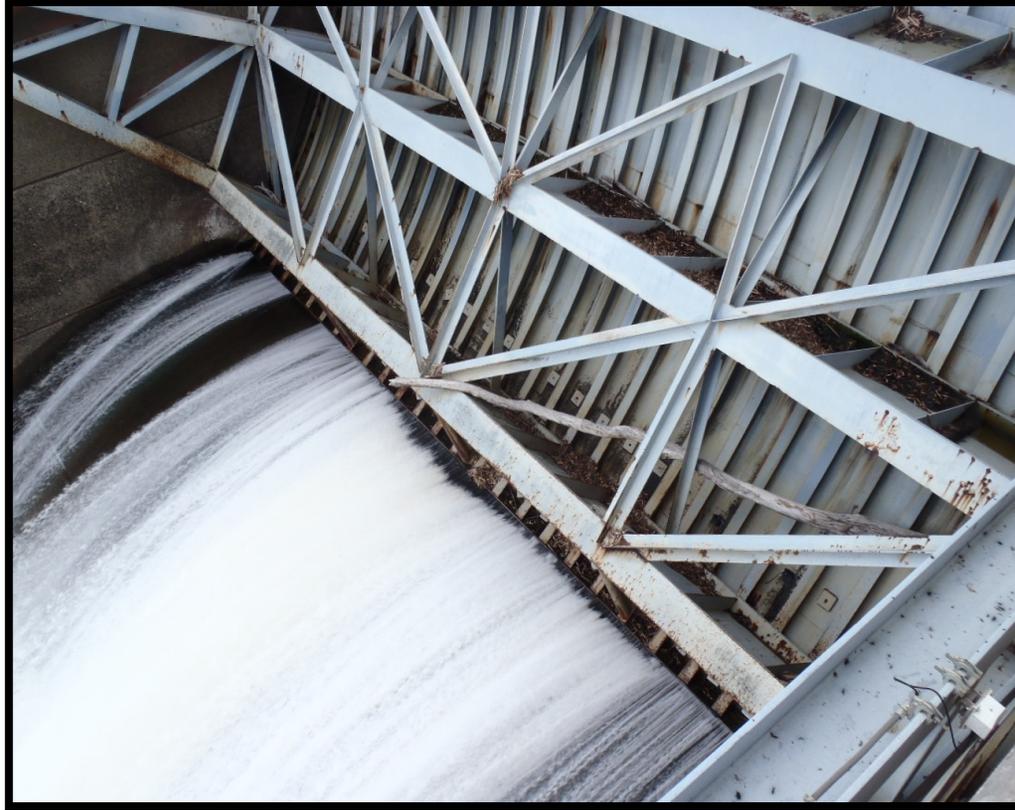
Mills Tainter Gate Leakage

Mills Tainter gates leak, have vibration issues and have ogee concrete erosion.

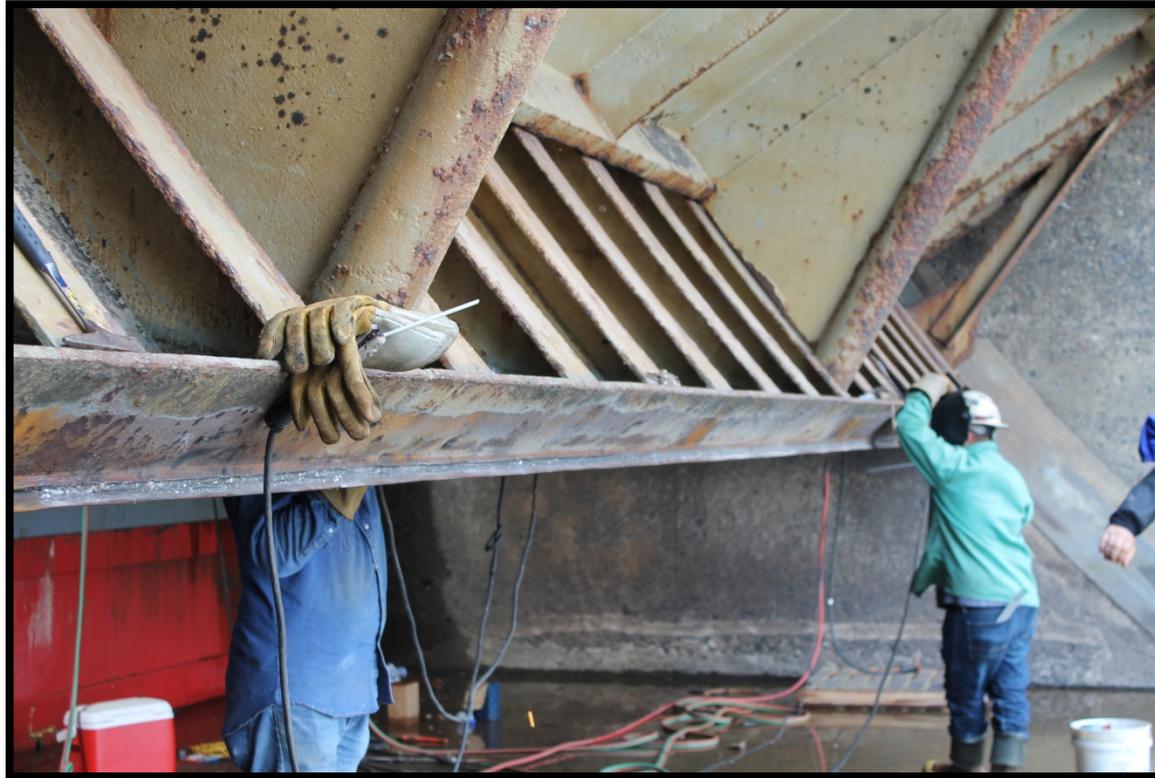
Mills Knife Edge Repair

It was assumed that the knife edge and the embedded metal was causing the leaks.

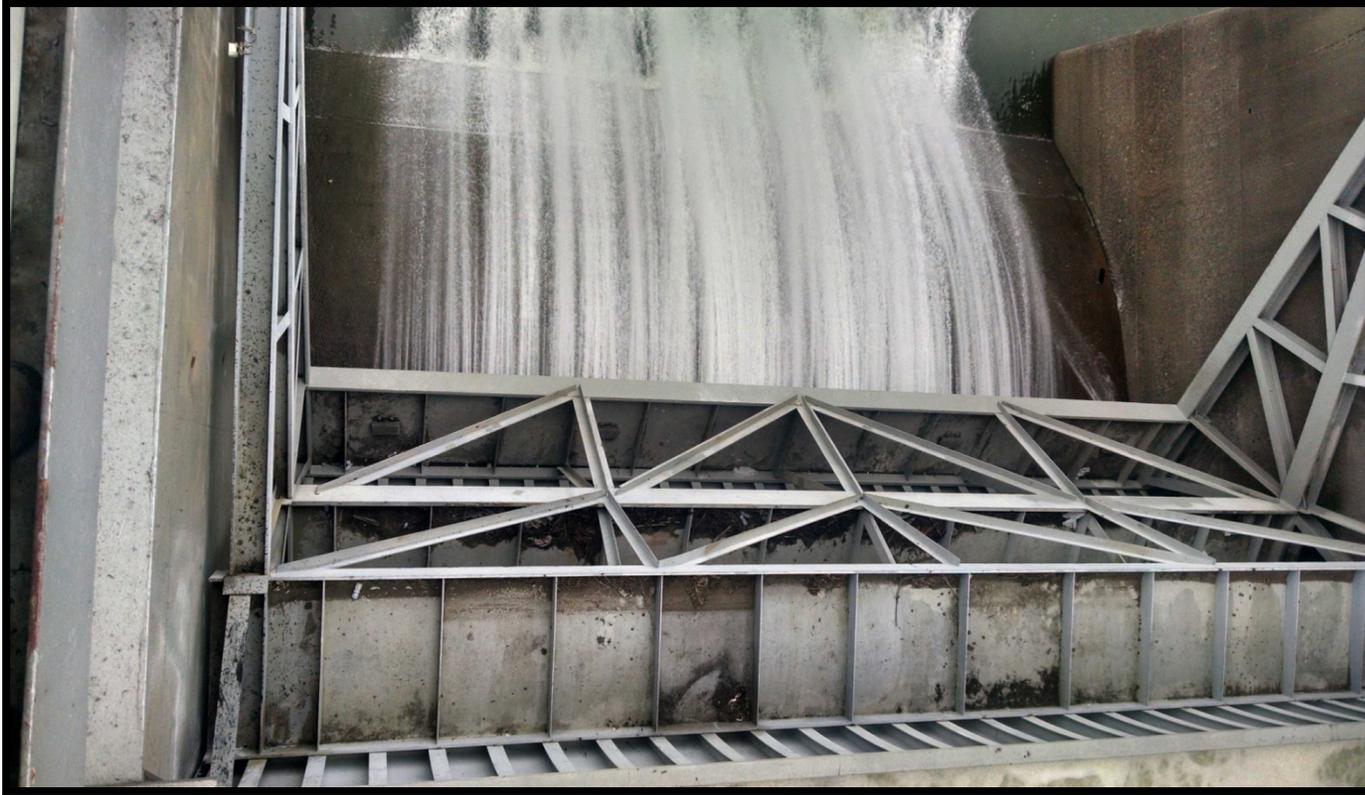
After the Repairs

The gate still leaked

- After the field worked very hard to machine the knife edge to within 0.020" by grinding and feeler gauges. We checked the bottom girder beam deflection calculations.
- The beam deflection calculations indicated that the beam was deflecting approximately $5/8$ " to $3/4$ ".

- Our Survey Crew was asked to measure the bottom girder and bottom seal deflection with reflectors.
- The results showed that the bottom girder measured $5/8$ " horizontally and $3/8$ " vertically.
- The results also showed that the seal deflected $7/8$ " horizontally and $3/16$ " vertically.

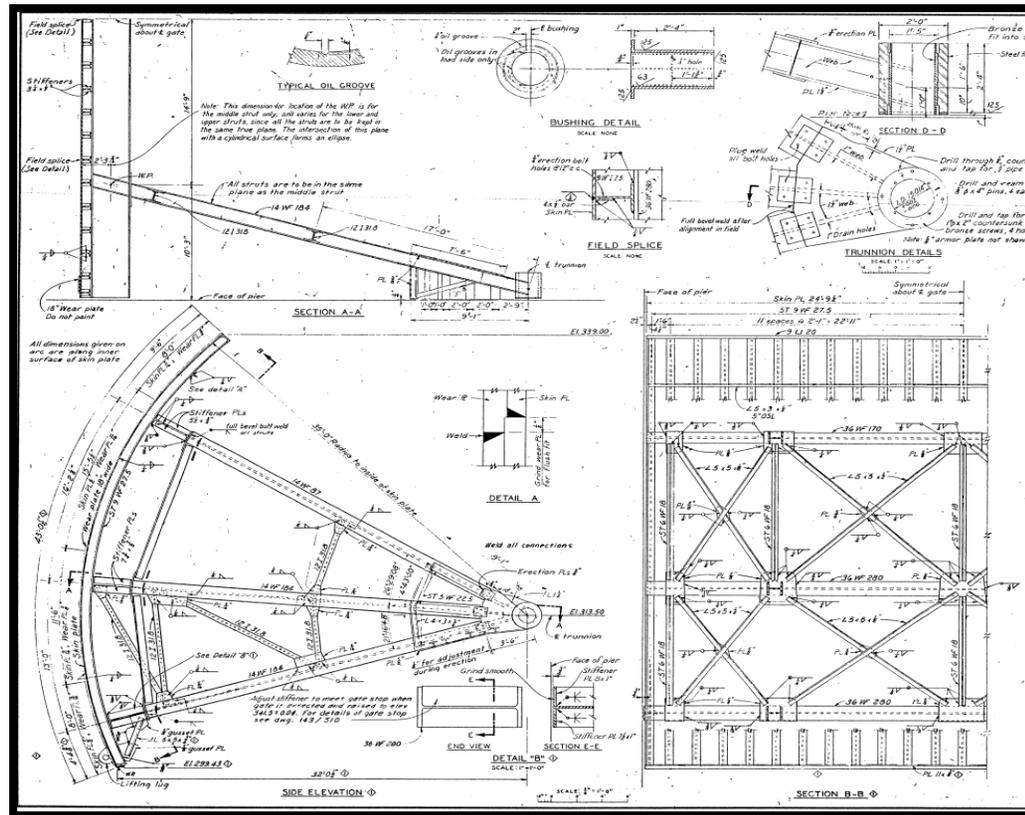
Dardanelle Tainter Gates

The trunnions are at the 1/3 height and the strut arms are angled in 10' to reduce the span.

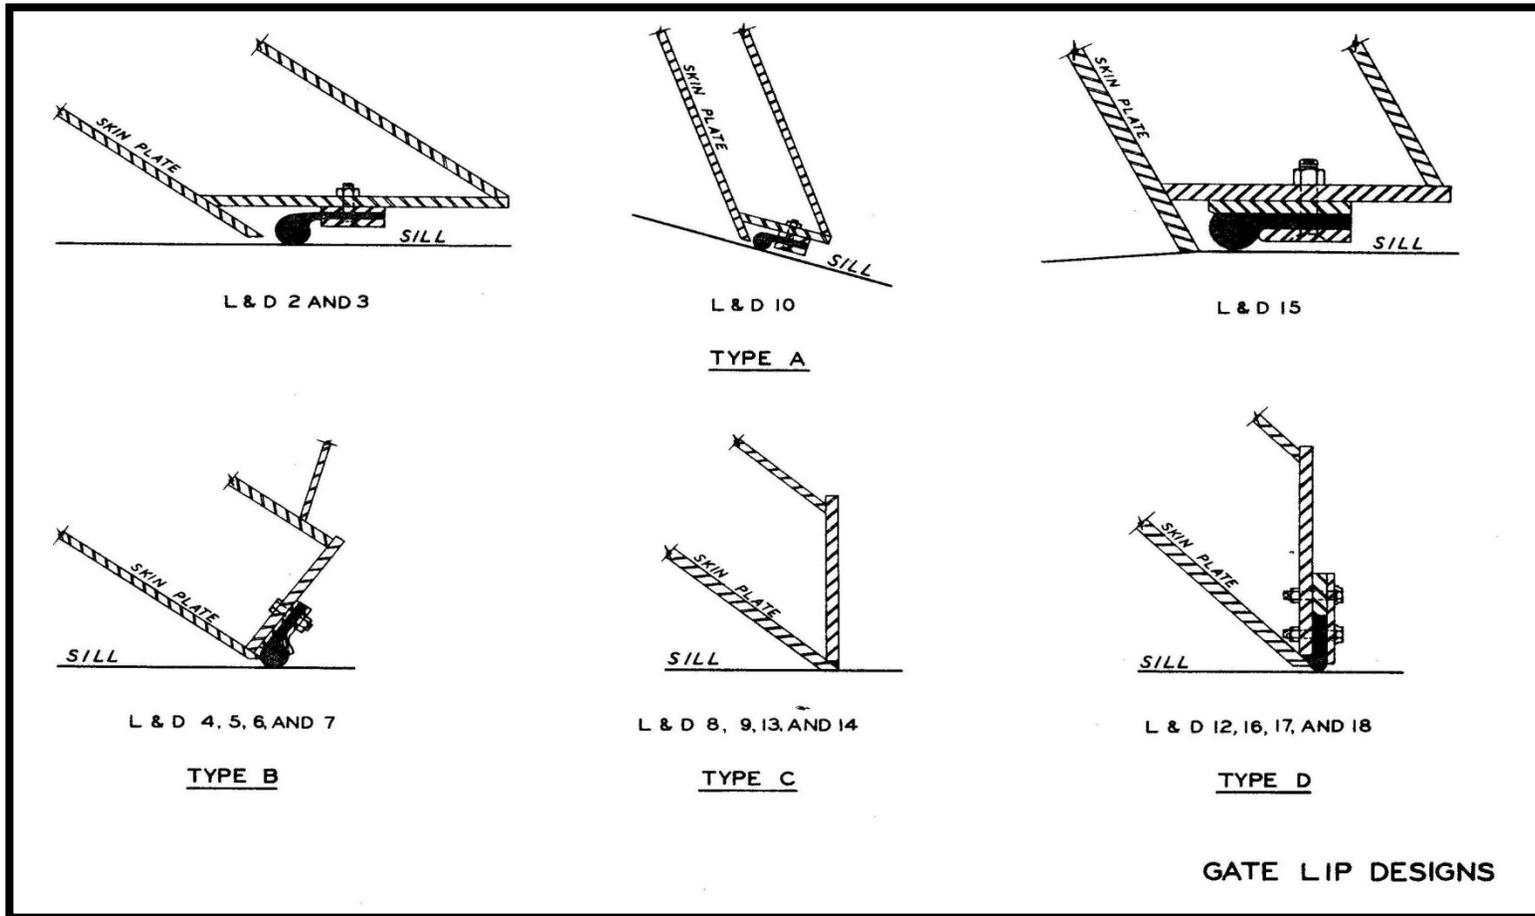
Contingency Plan

- In 1971 the US Waterways Experiment Station conducted a vibration study to try to stop the tainter gate vibration along the Arkansas River.
- ASCE – American Society of Civil Engineers provided another publication.
- They concluded that the vibration was caused by the bottom rubber seal and the lip configuration.

Tainter Gate Lip Designs
