THE ST.LAWRENCE SEAWAY (QUÉBEC, Canada)

REHABILITATION PROGRAM OF NAVIGATION LOCKS AFFECTED BY ALKALI-AGGREGATE REACTION

By : Marie Gaudreault ing, M. Eng

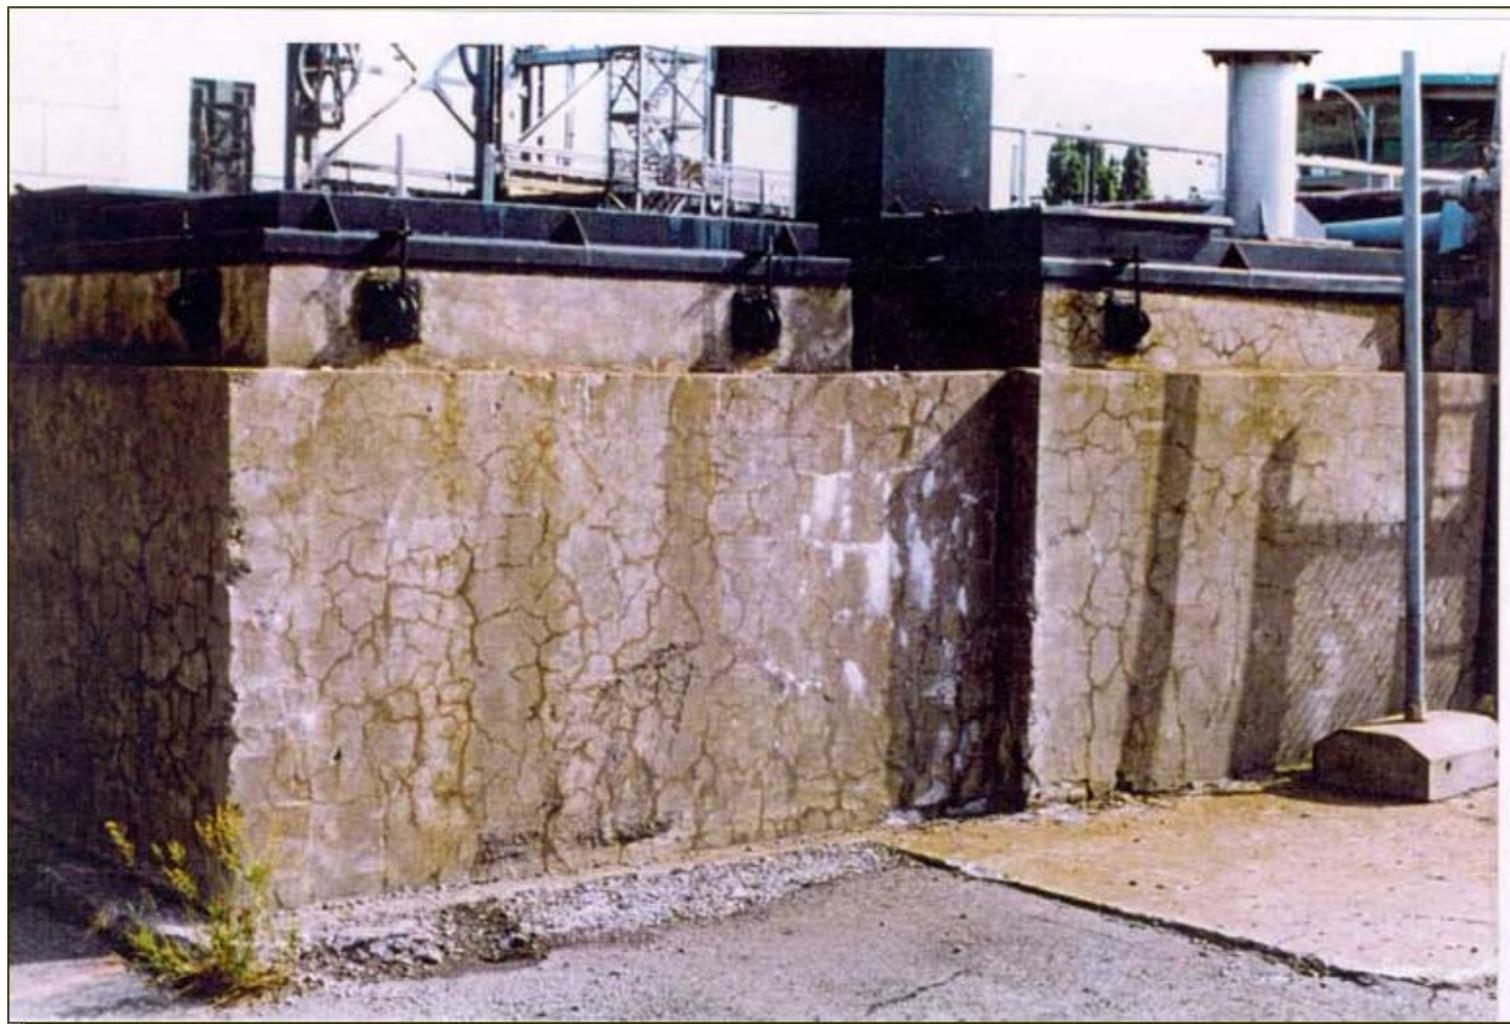
Visual Symptoms

- ◆ Identified in the early 80's
- ◆ Persisting occurrence of operational problems due to mechanical equipment “jamming” tight
- ◆ Surveying records
- ◆ Visual symptoms associated with concrete swelling due to AAR
- ◆ Laboratory testing for reactivity potential of concrete aggregates

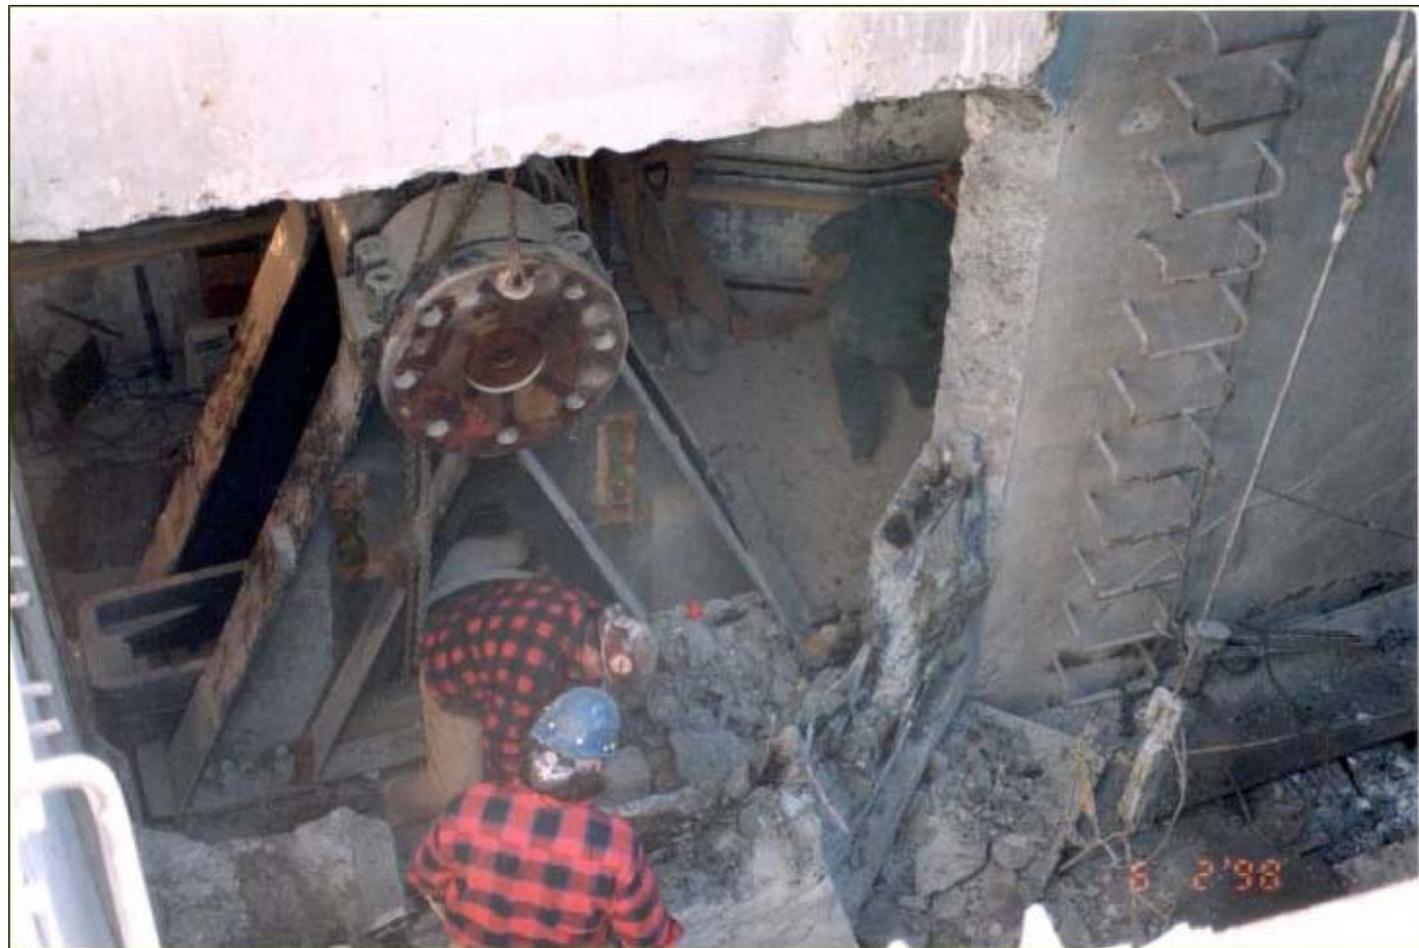
Taintor Valve lever arm realignment

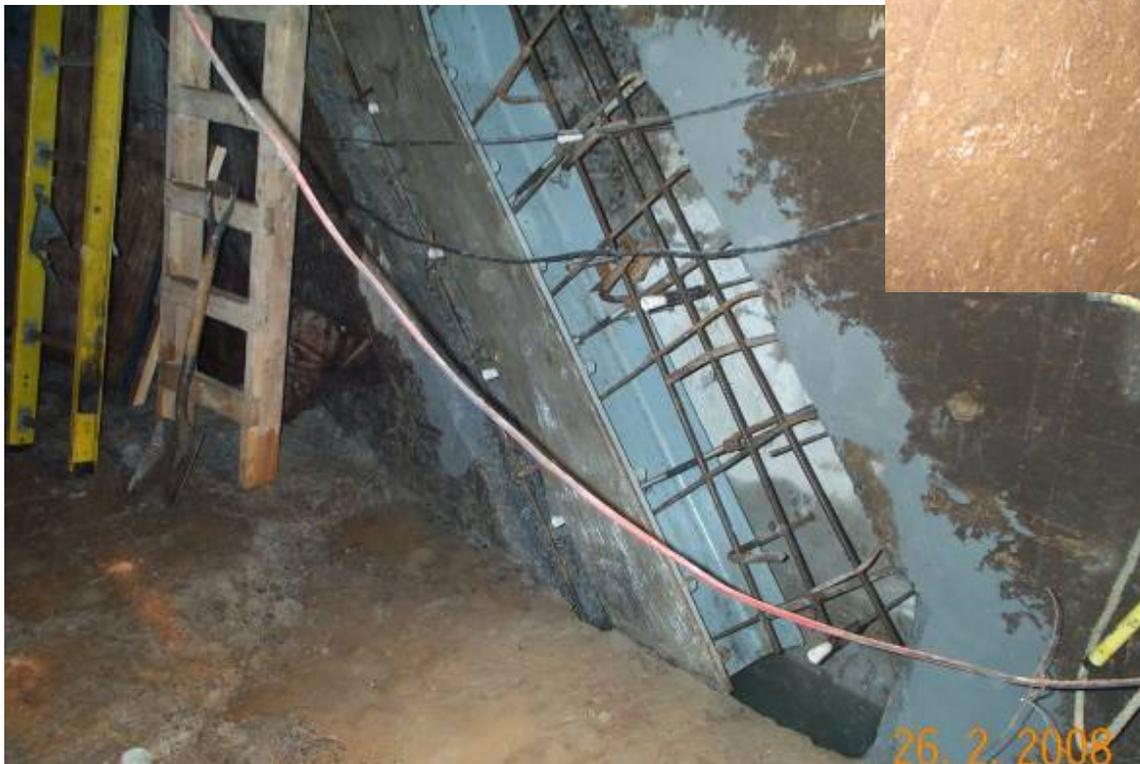
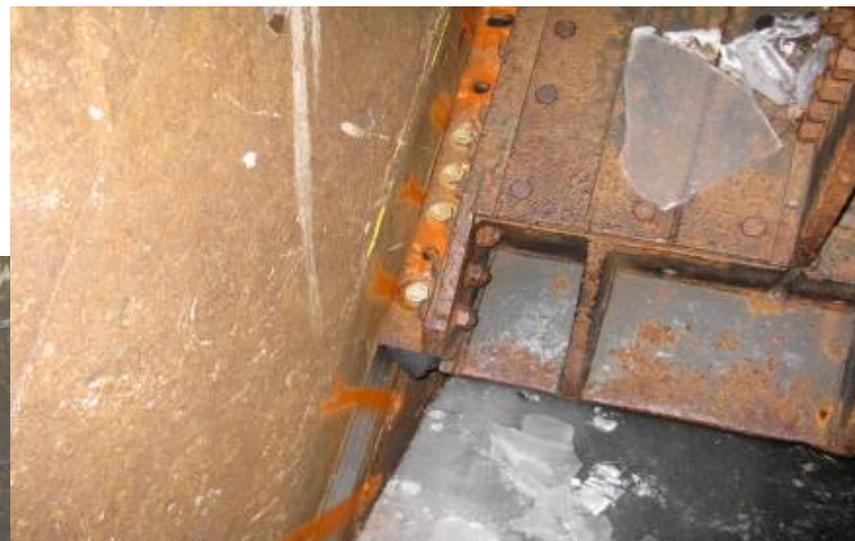
F/E Taintor Valve side seal realignment

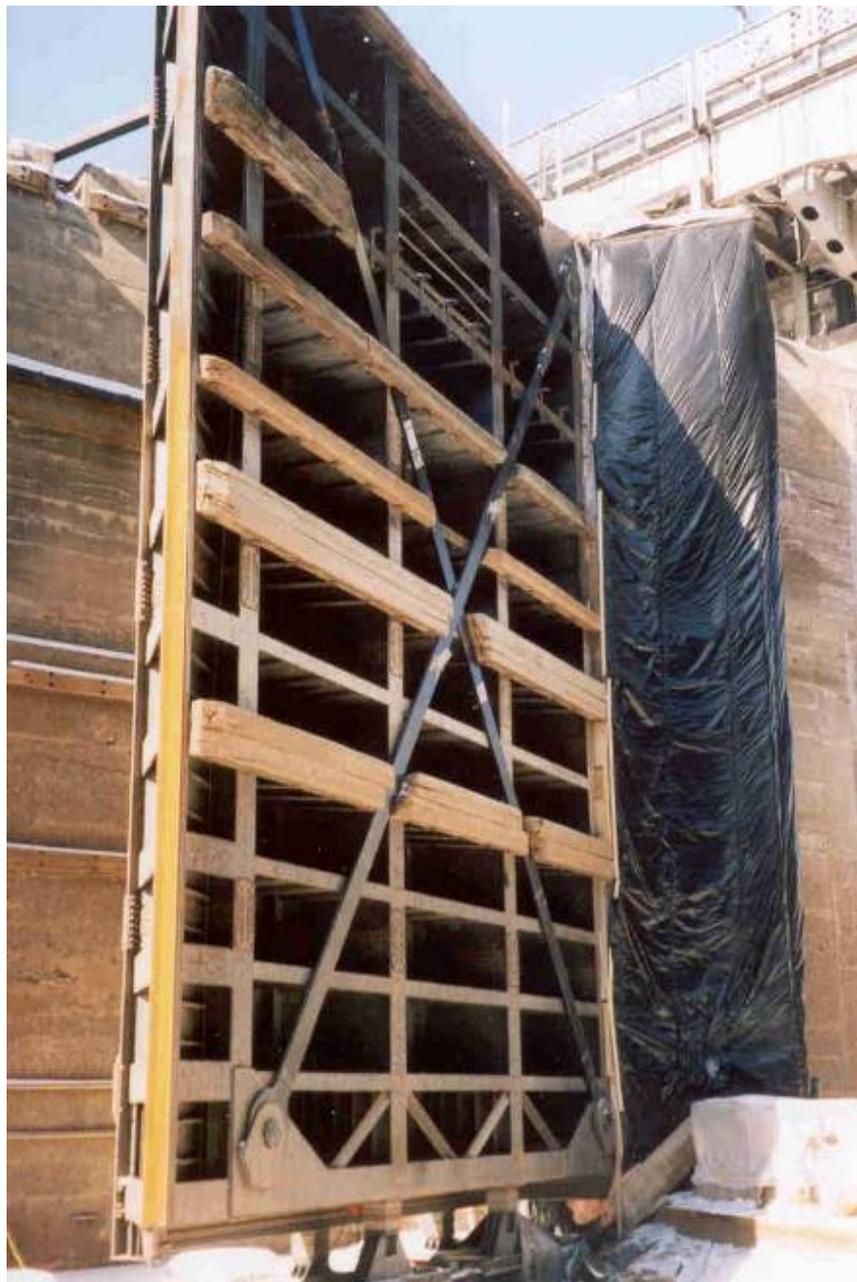
Gate Realignment

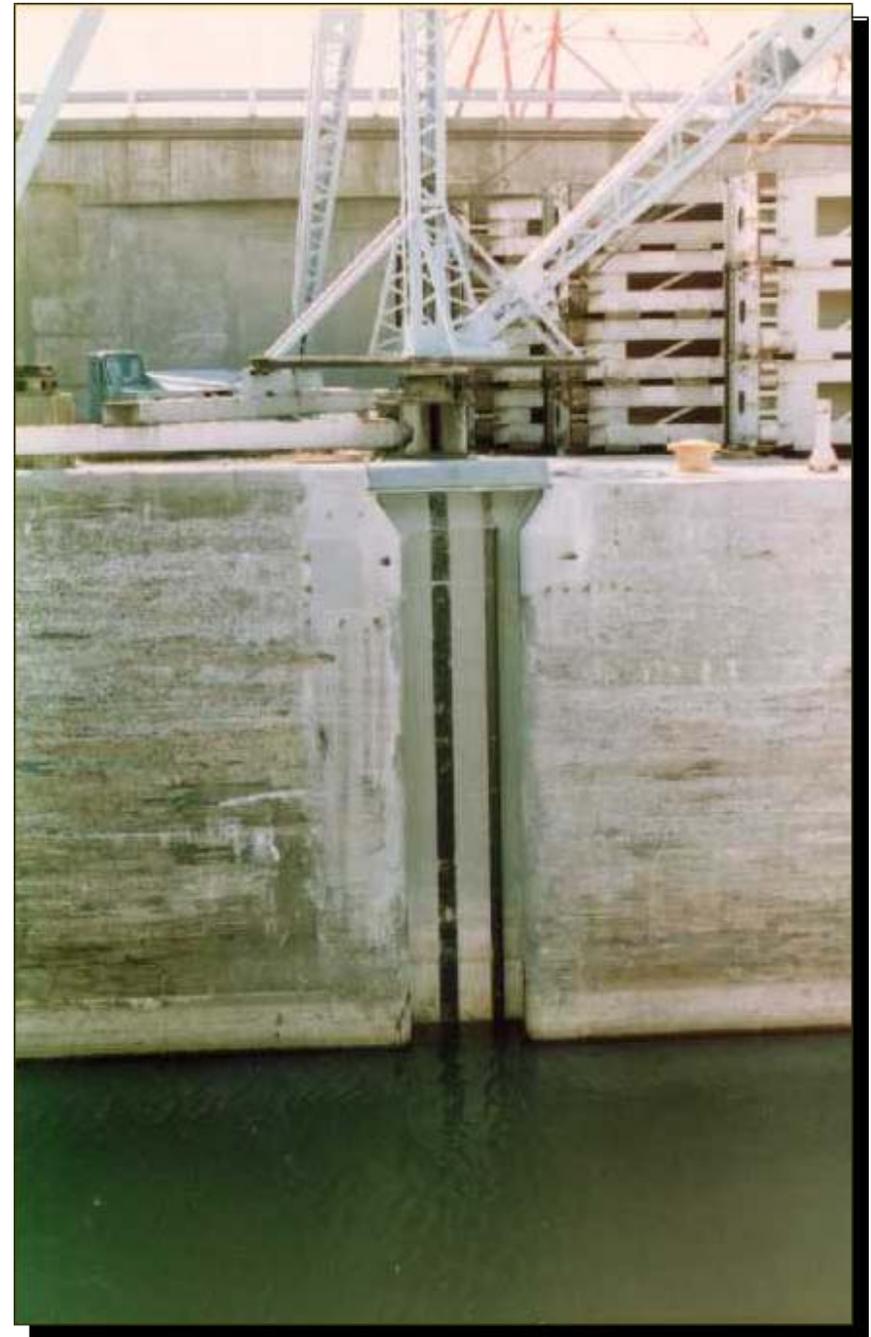
Structural Modifications

- ◆ **Mechanical adjustments**
 - Valve and gate re-alignments
 - Roller tracks re-positioning
- ◆ **Structural modifications**
 - Reconstruction of concrete recesses
 - Reconstruction of access covers
- ◆ **Crack injections**
- ◆ **Confinement and strenghtening techniques**

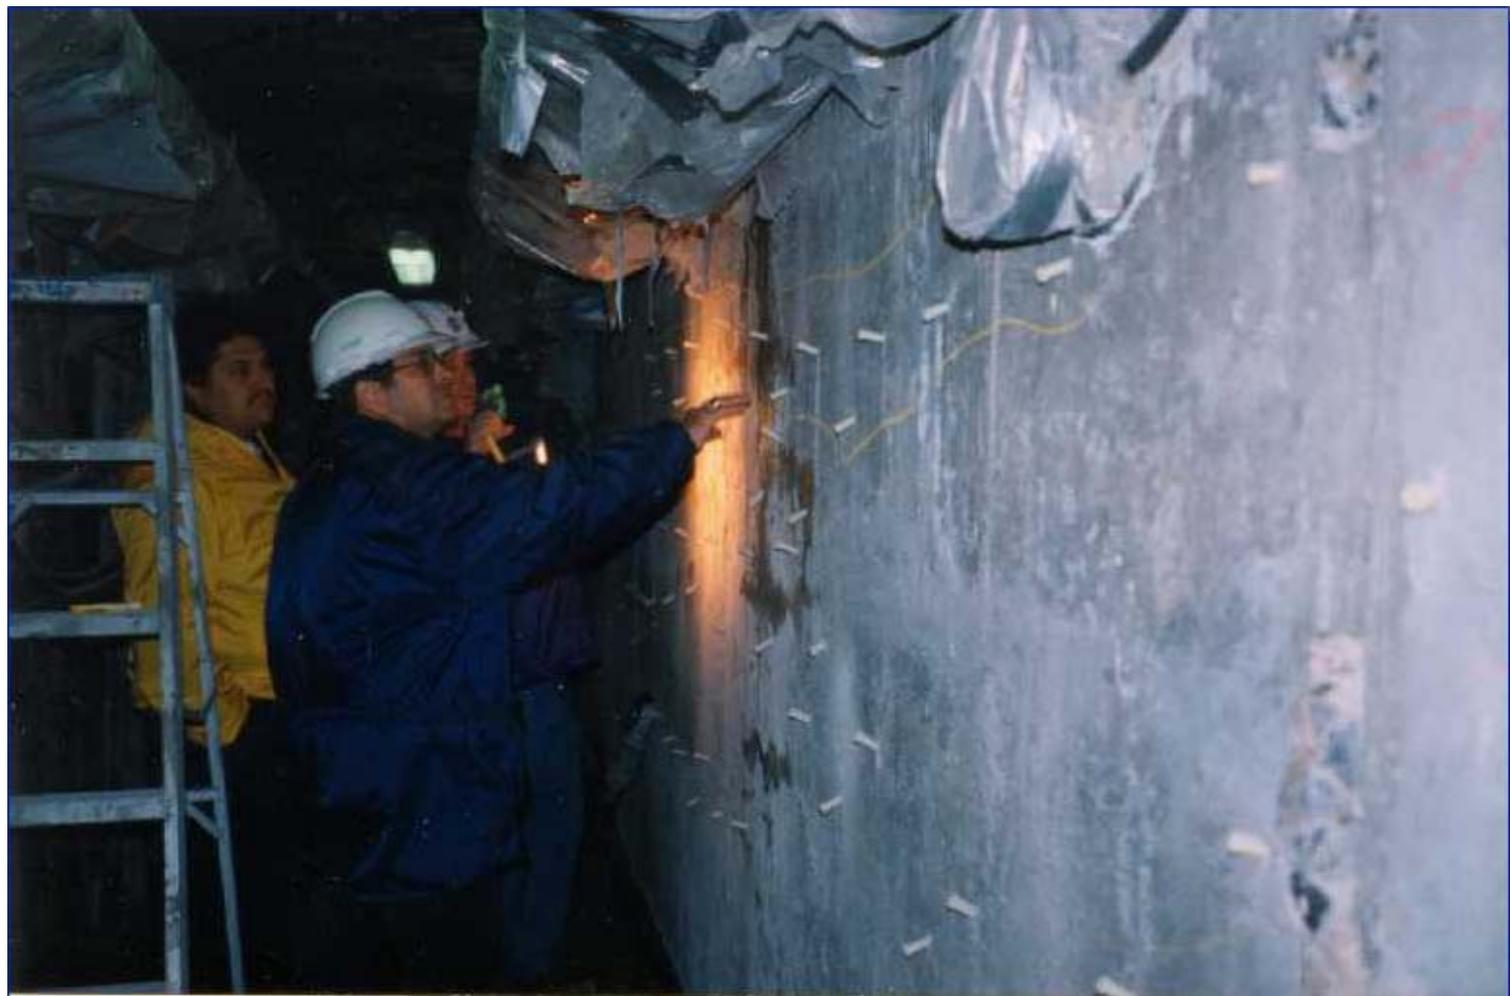
Crack Injections

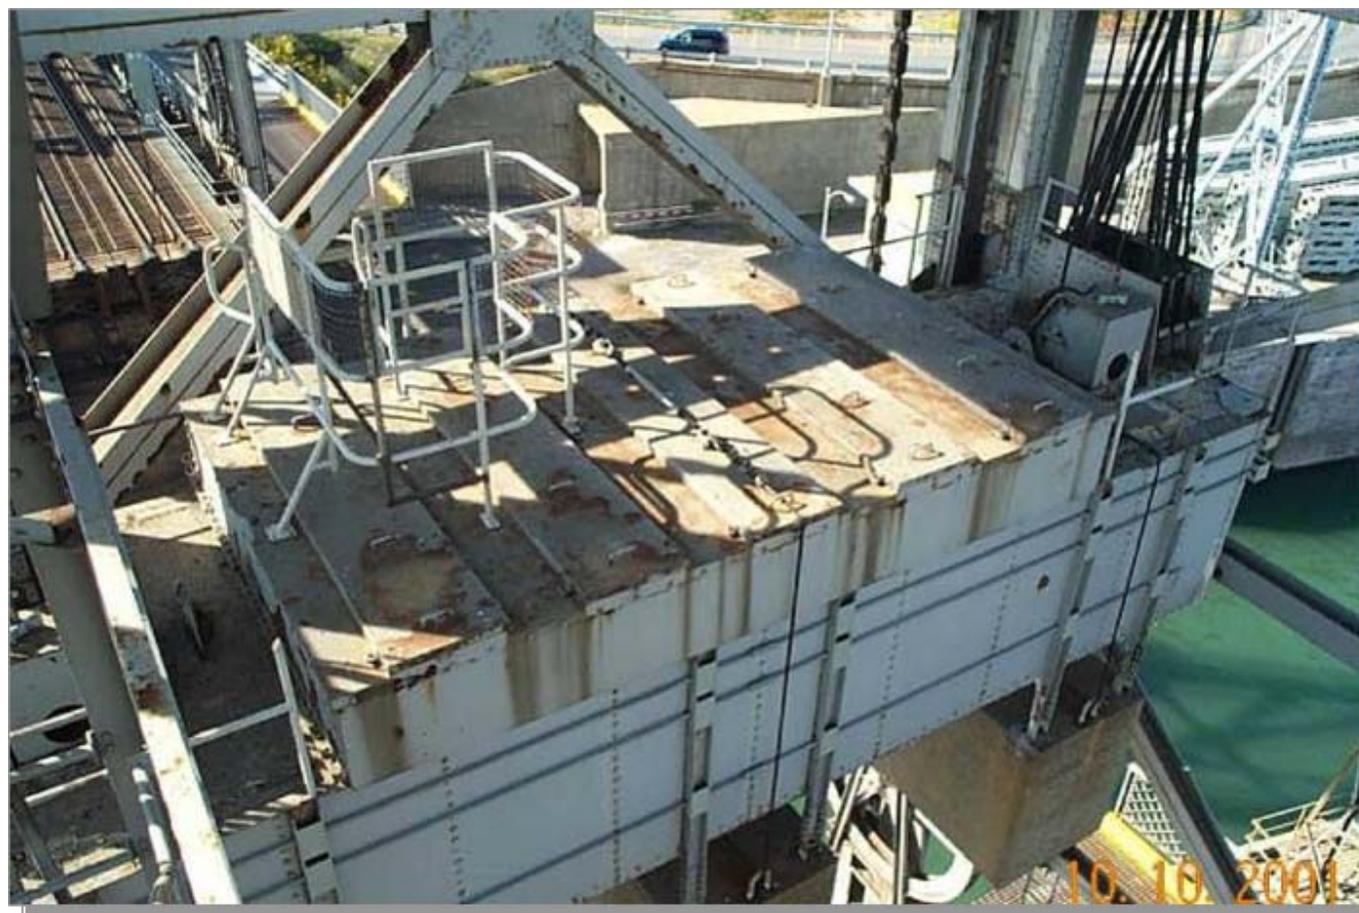
Confinement and strengthening

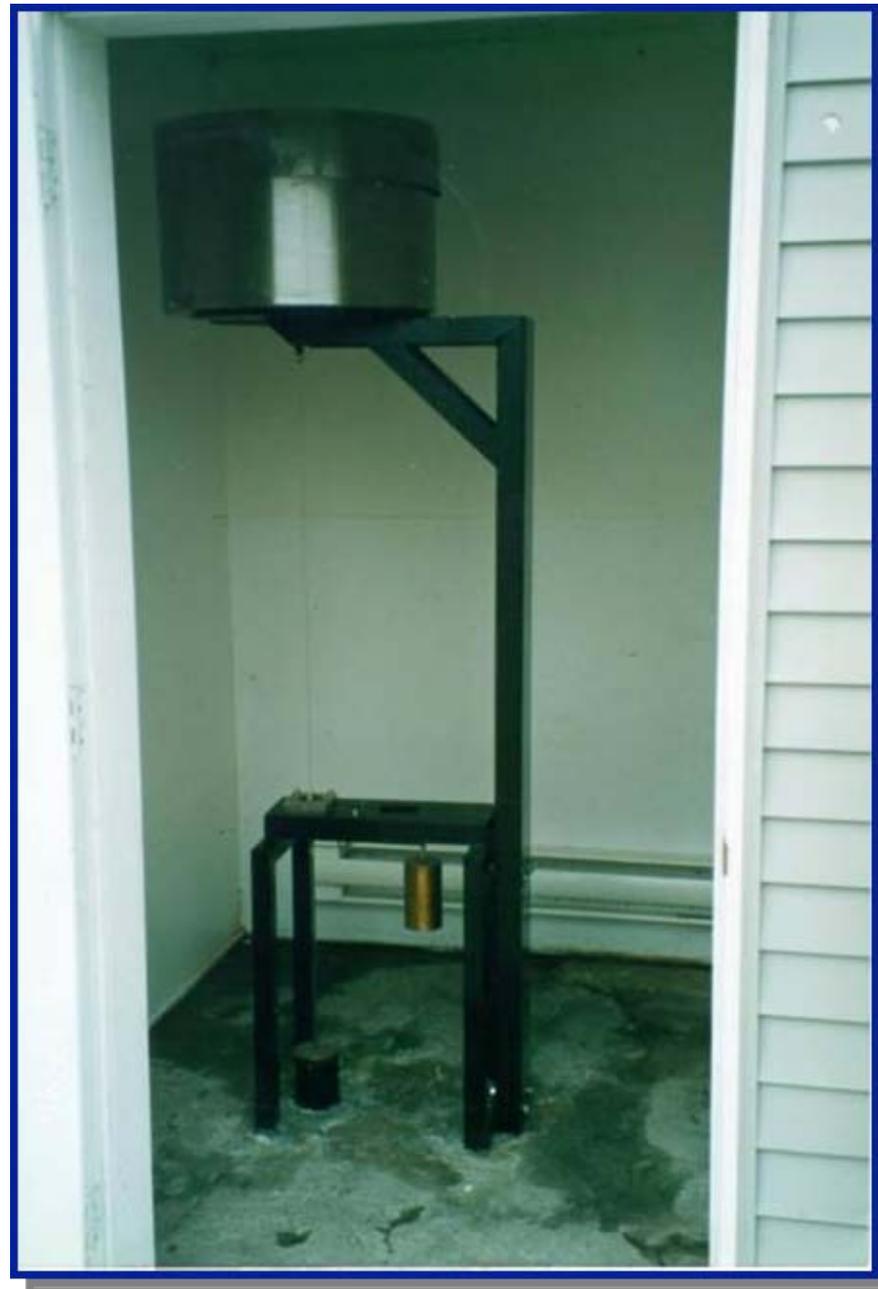
Inverted Pendulum

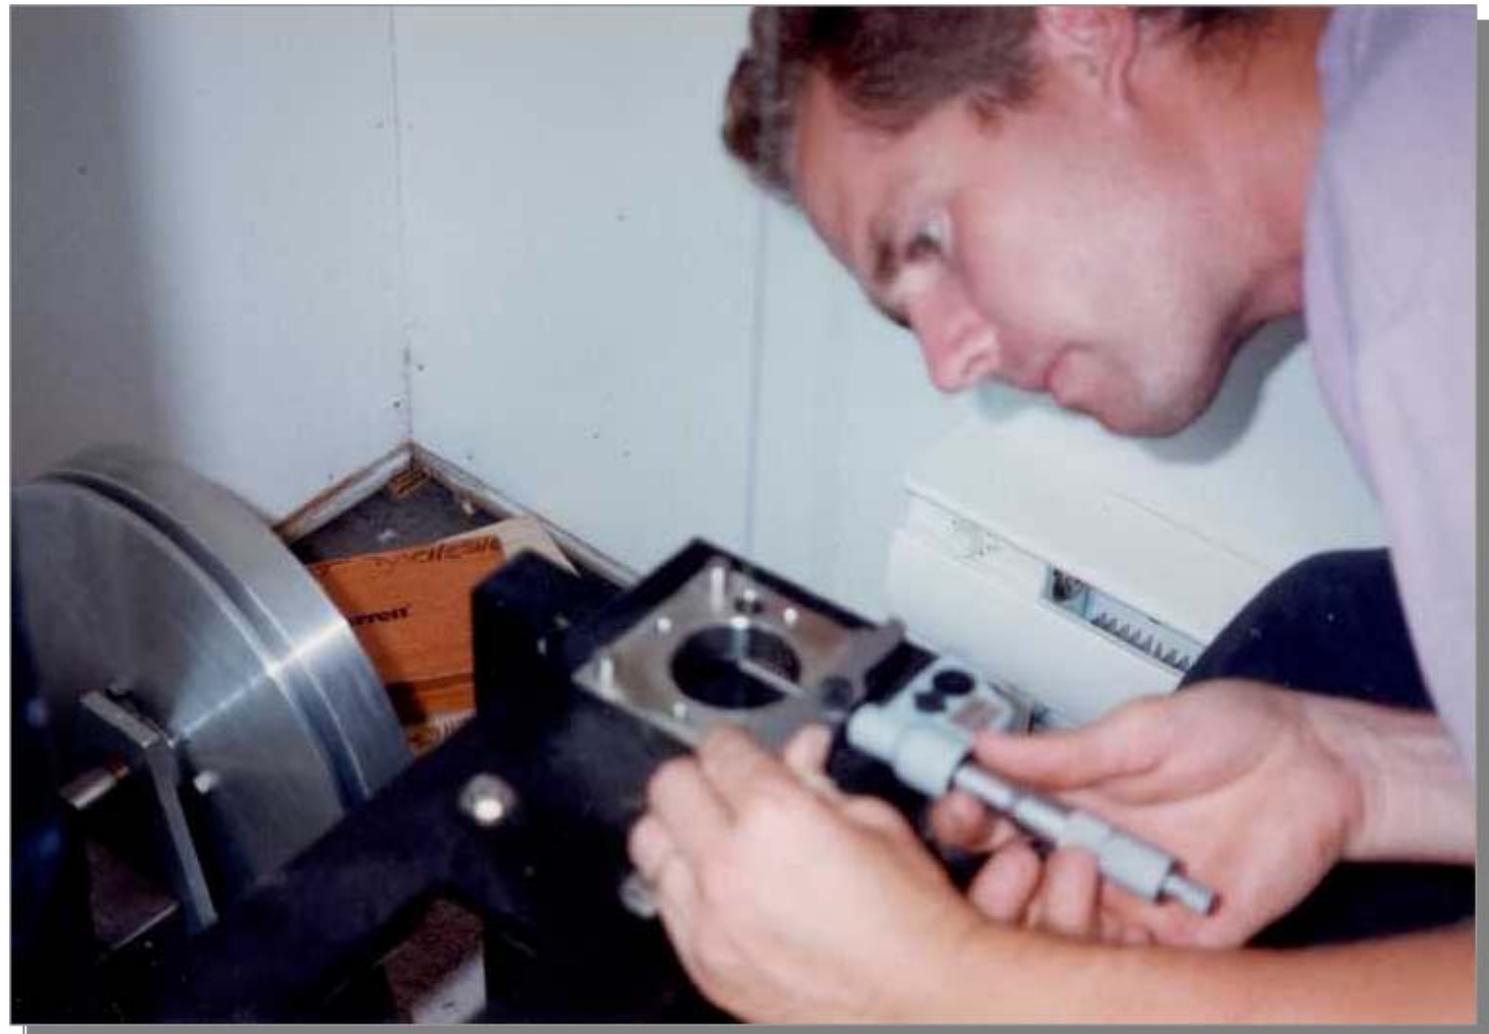
Inverted Pendulum

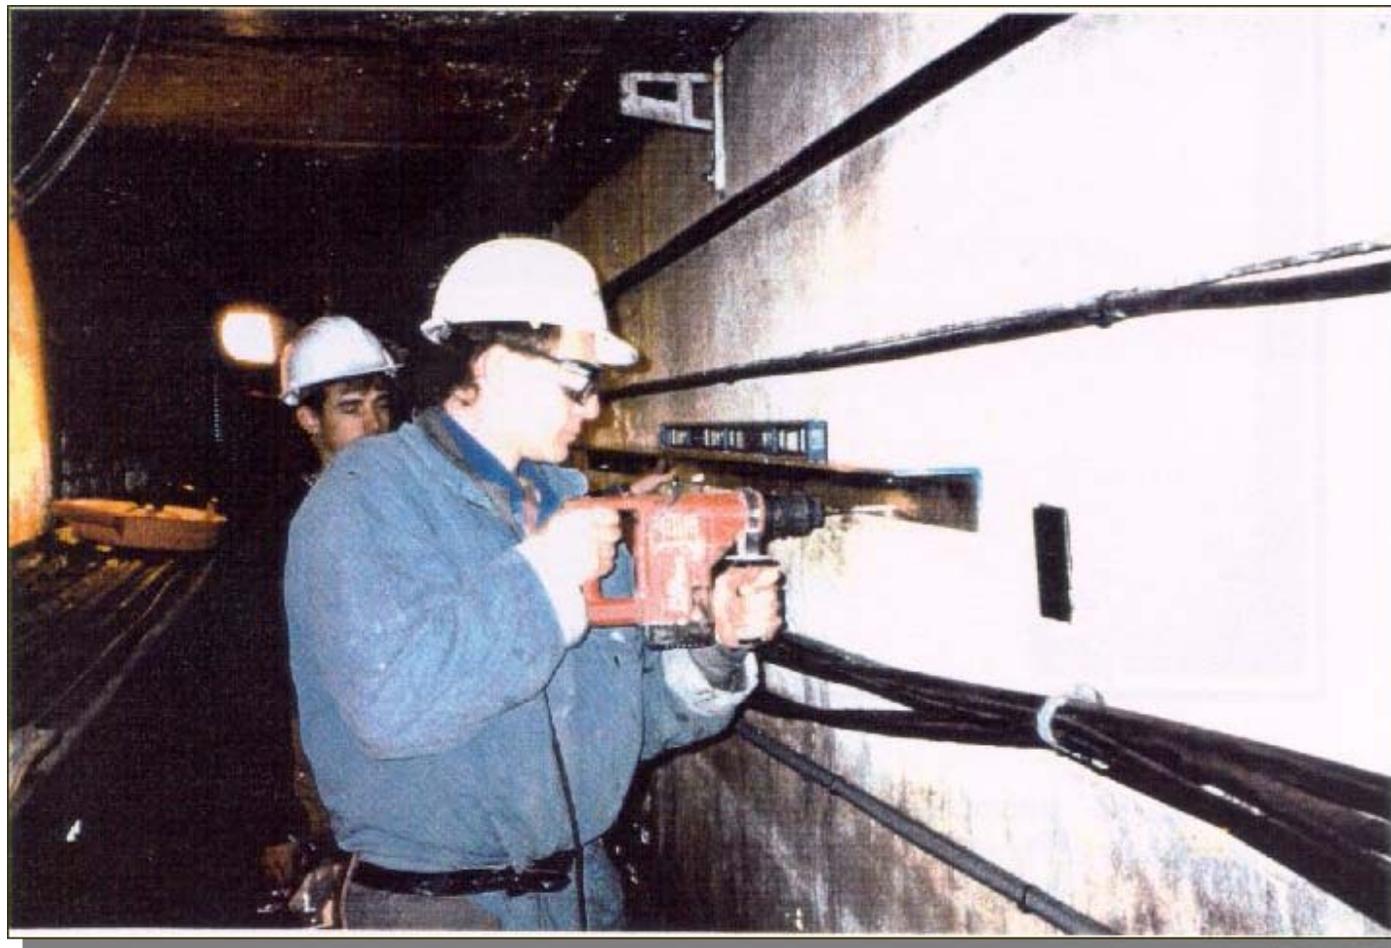
Surface Extensometer

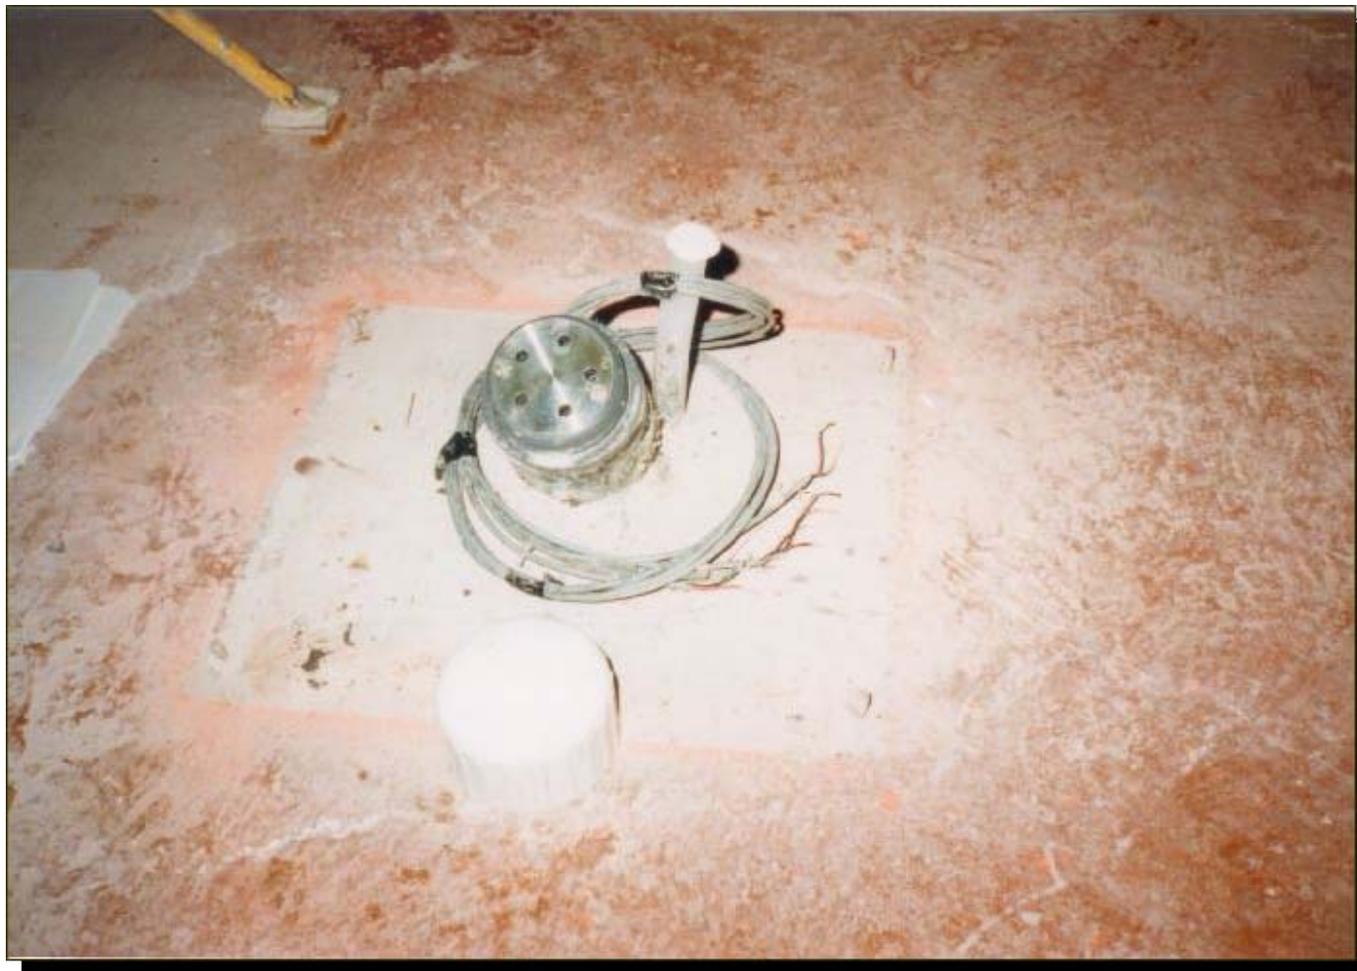
Multiple Point Extensometer

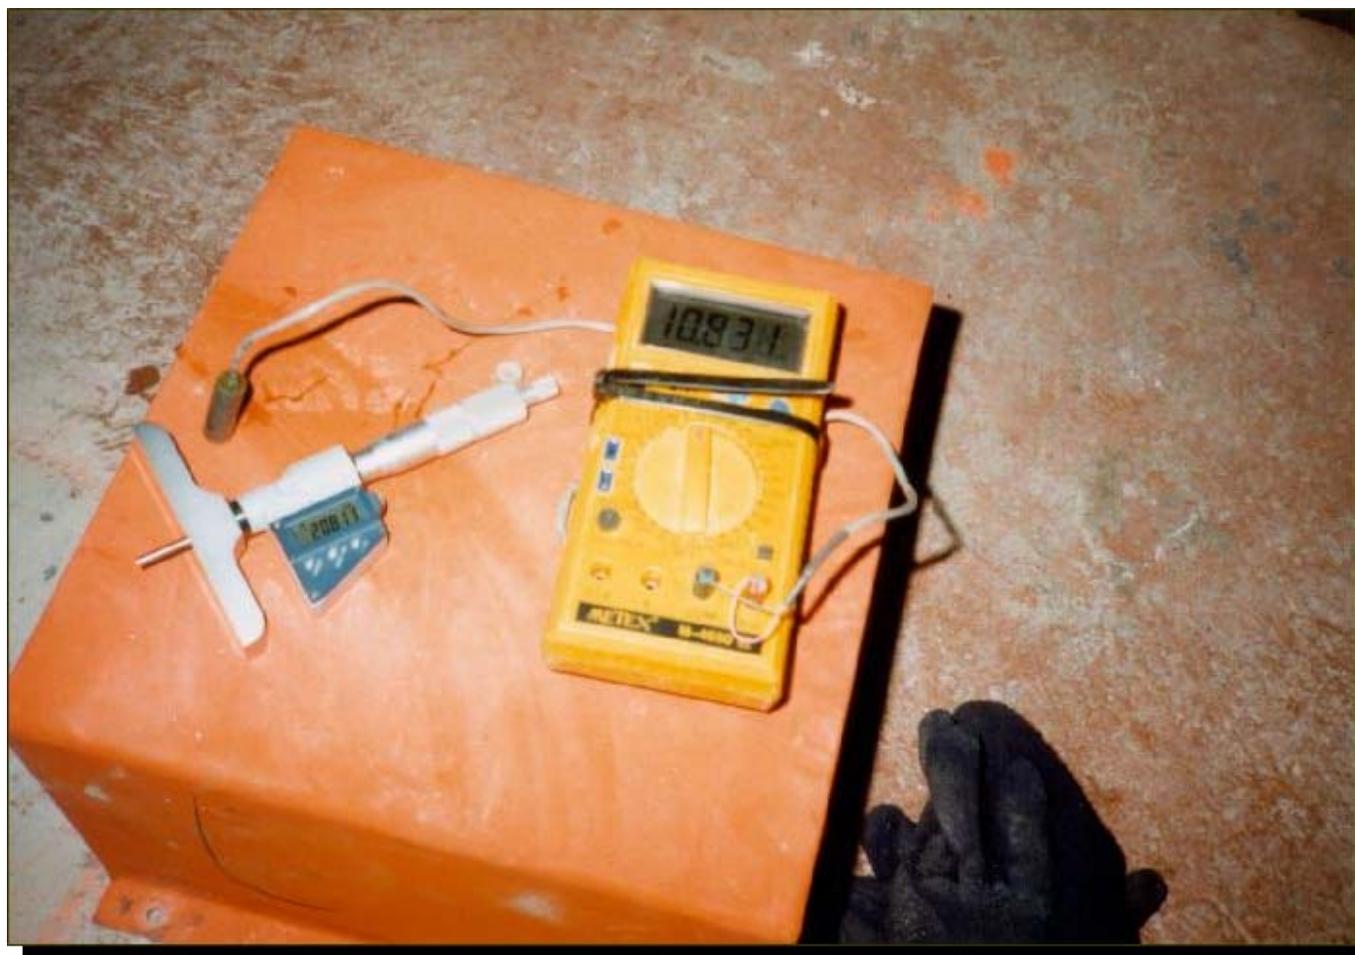
Multiple Point Extensometer

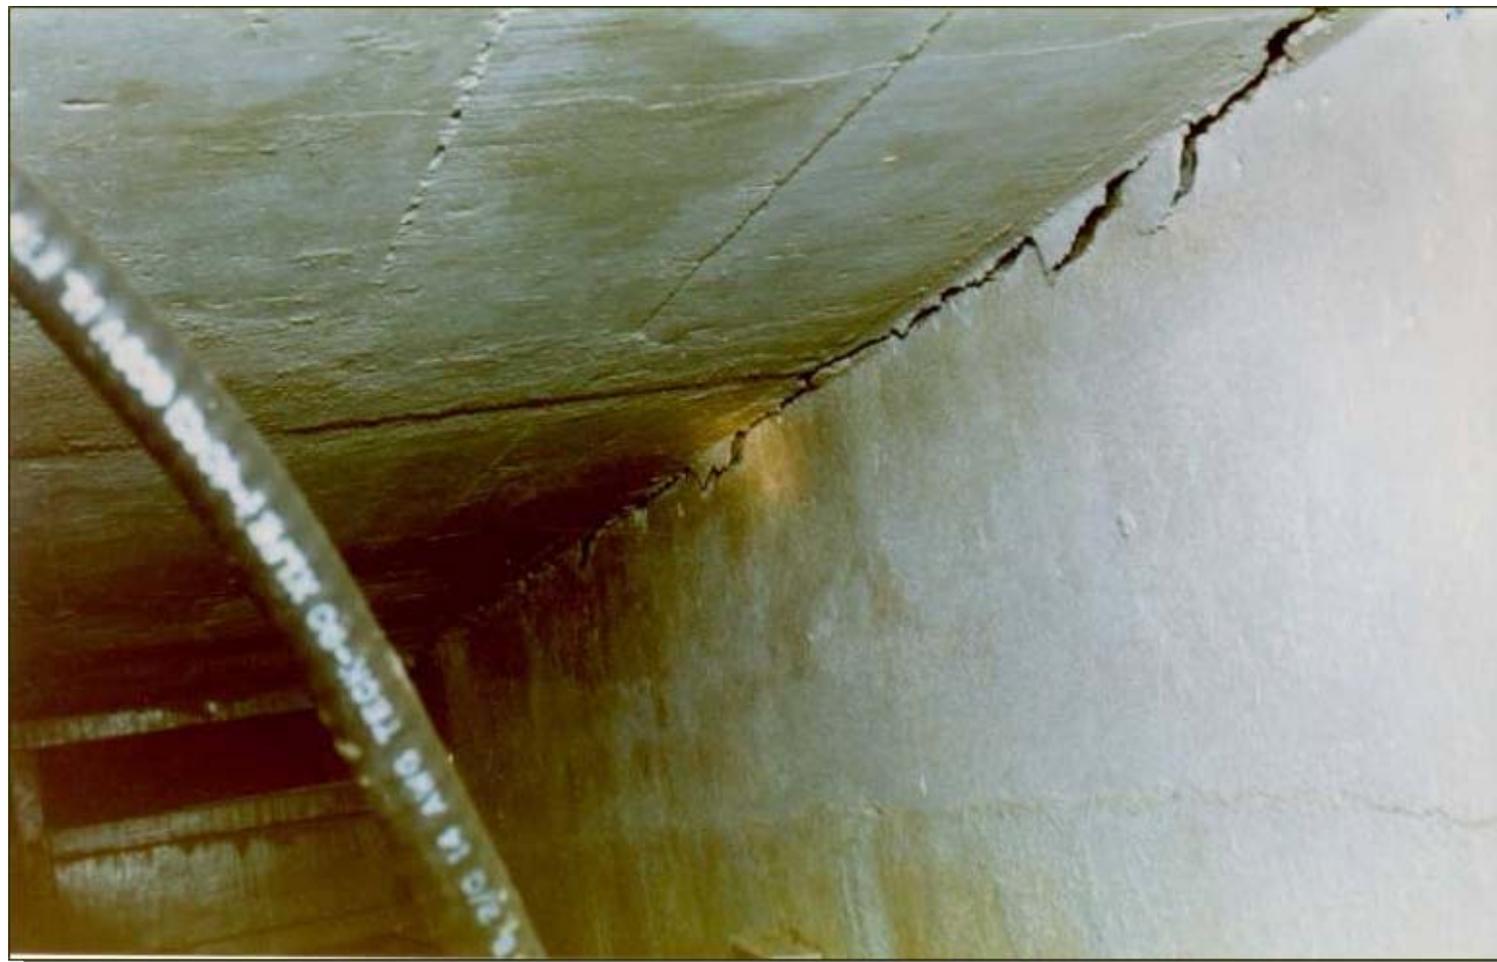
Observed cracking

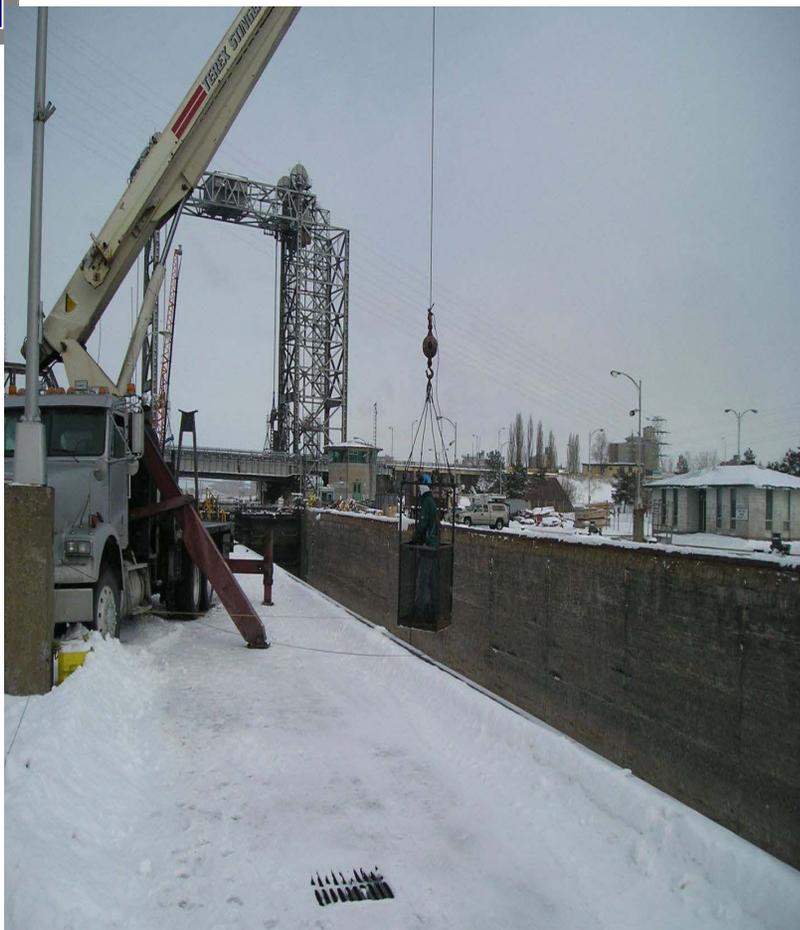
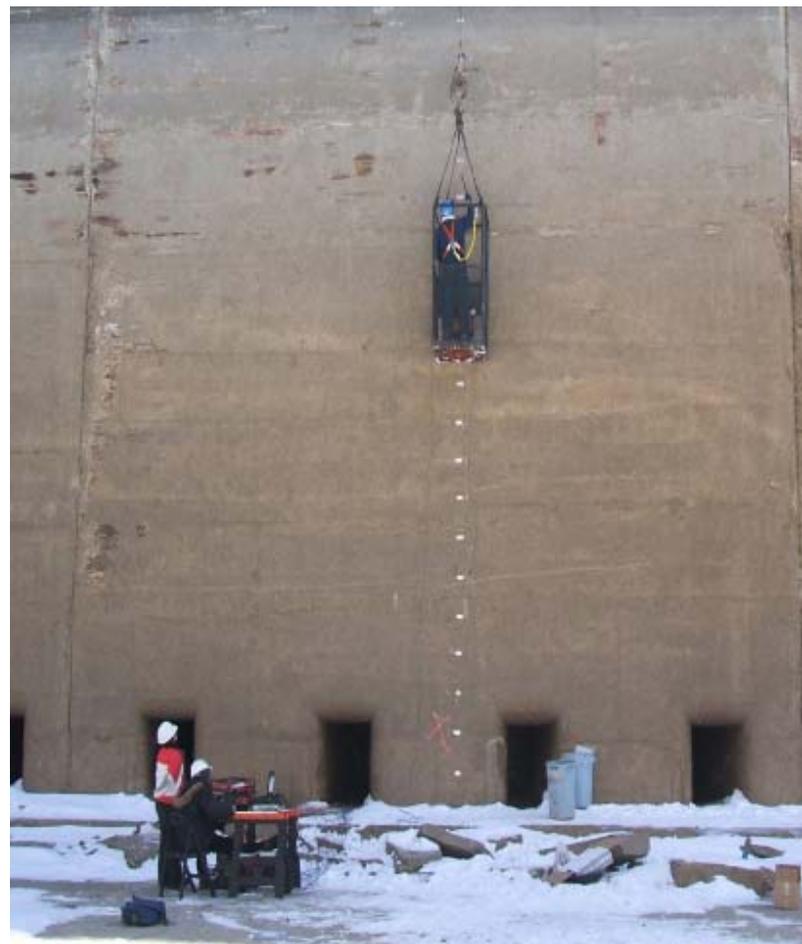
Sonic Tomography - St-lambert Lock

Installation of sources

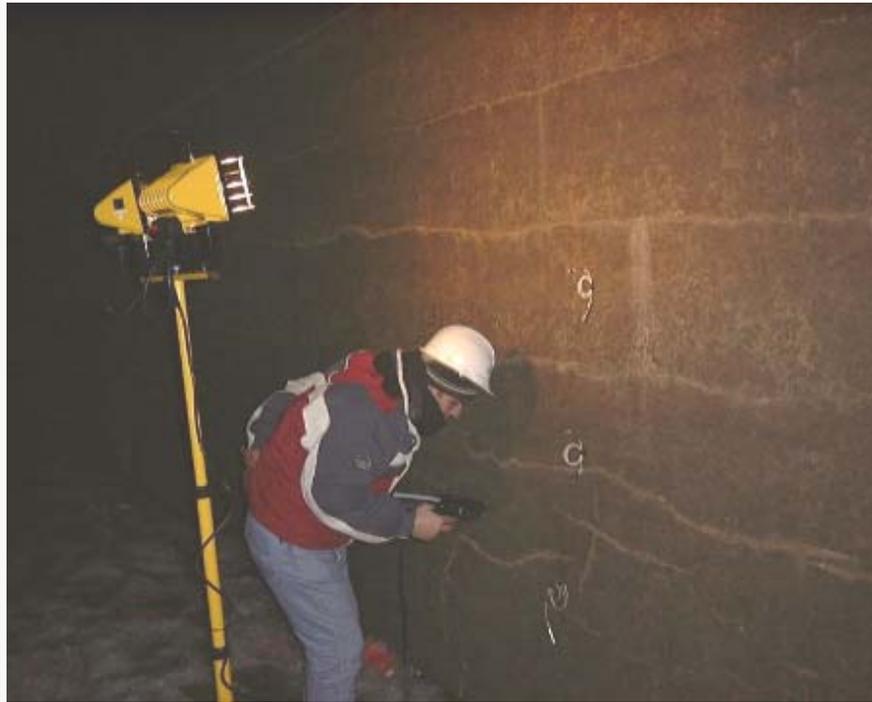
Installation of captors

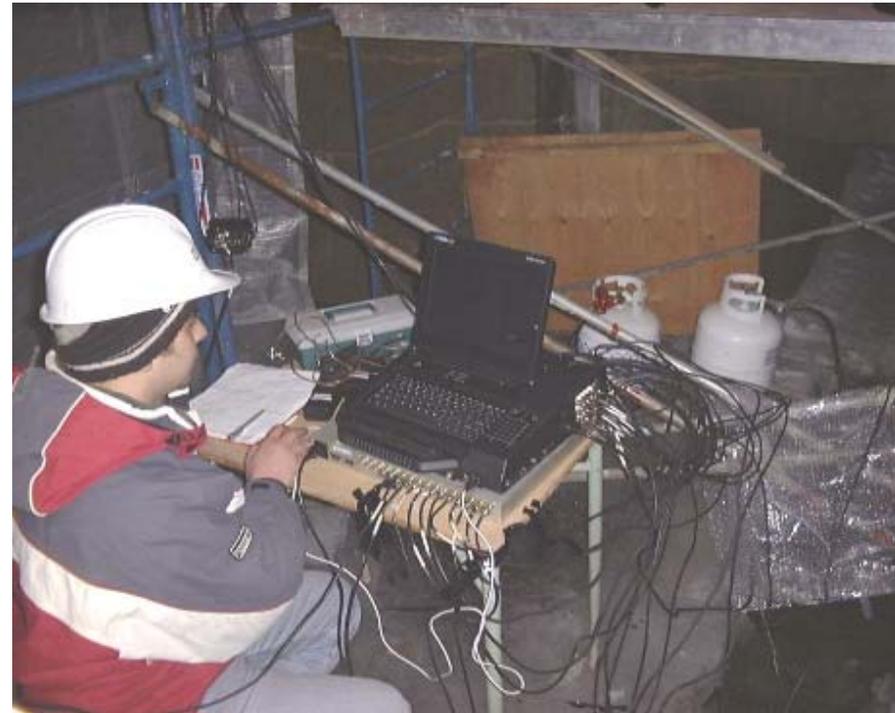
Data acquisition system

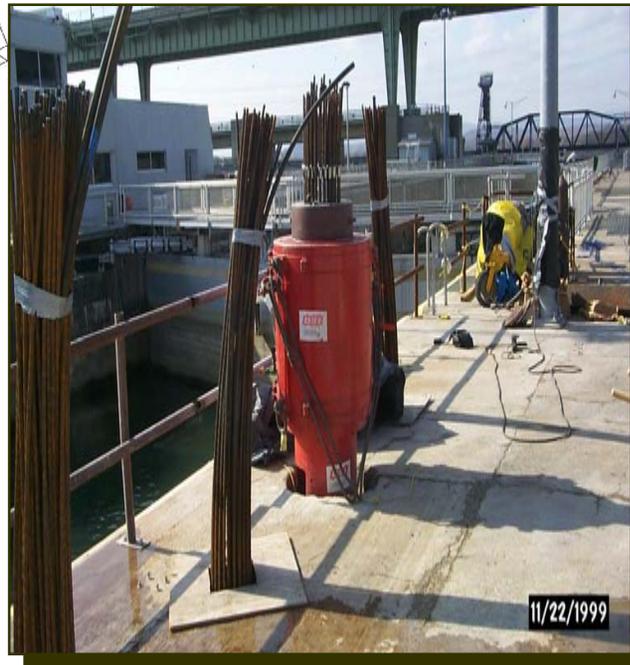
Post tensioning

Post-tension verticale (canal)
74 éléments barres
Post-tension verticale (route)
75 éléments barres
Post-tension horizontale
100 éléments barres
Post-tension diagonale
44 éléments barres

- ◆ Modelling of post-tension anchors resulted in low efficiency in the long term. Rate of growth reduced by only small margin.
- ◆ Solution abandoned
