# Markland 1200' Gate Replacement and Wall Quoin Refurbishment

July 11 – November 17 2011

Craig Moulton and Kevin Vessels  
Louisville District

# Markland Locks and Dam

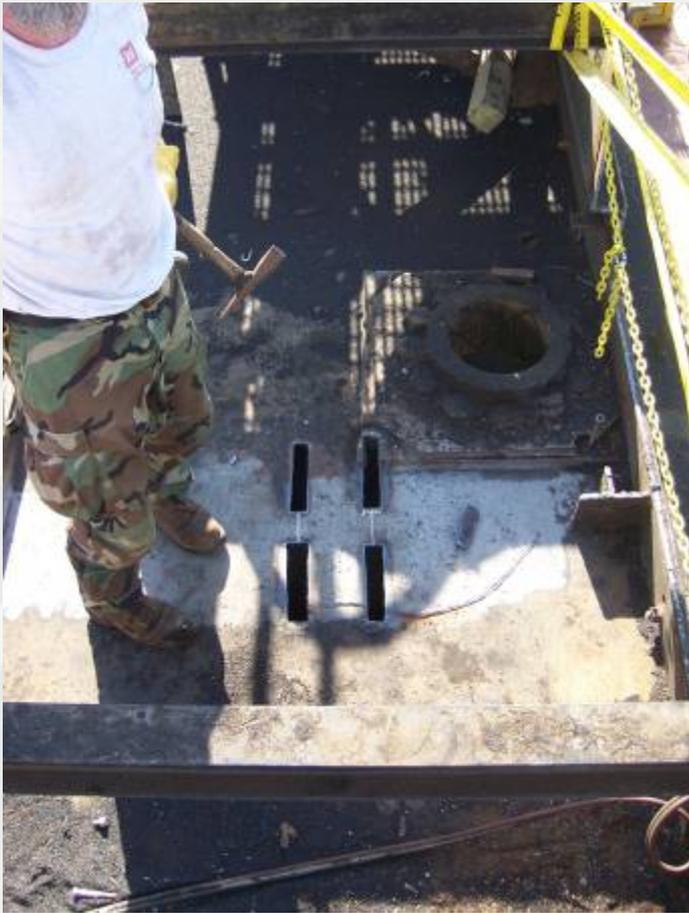
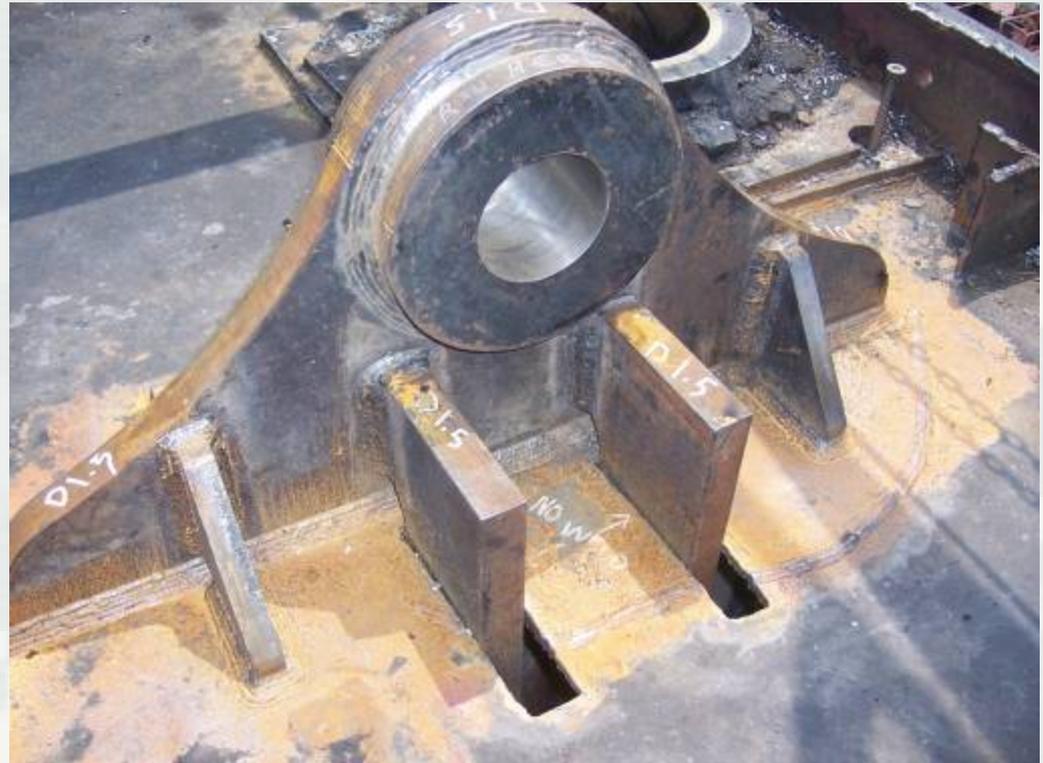
# Lifting Lugs for Existing Leaves

New lifting lugs for gate tie into the second girder

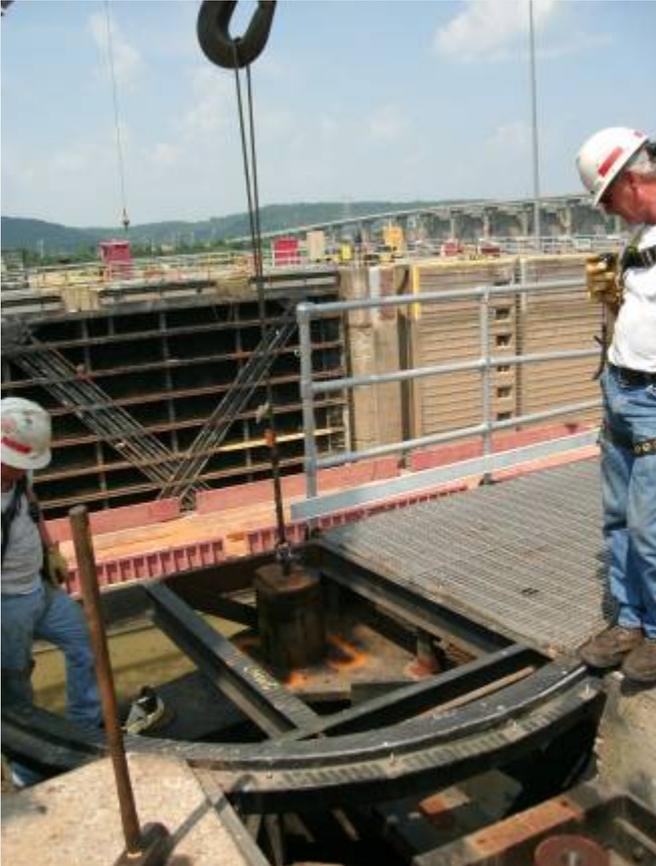
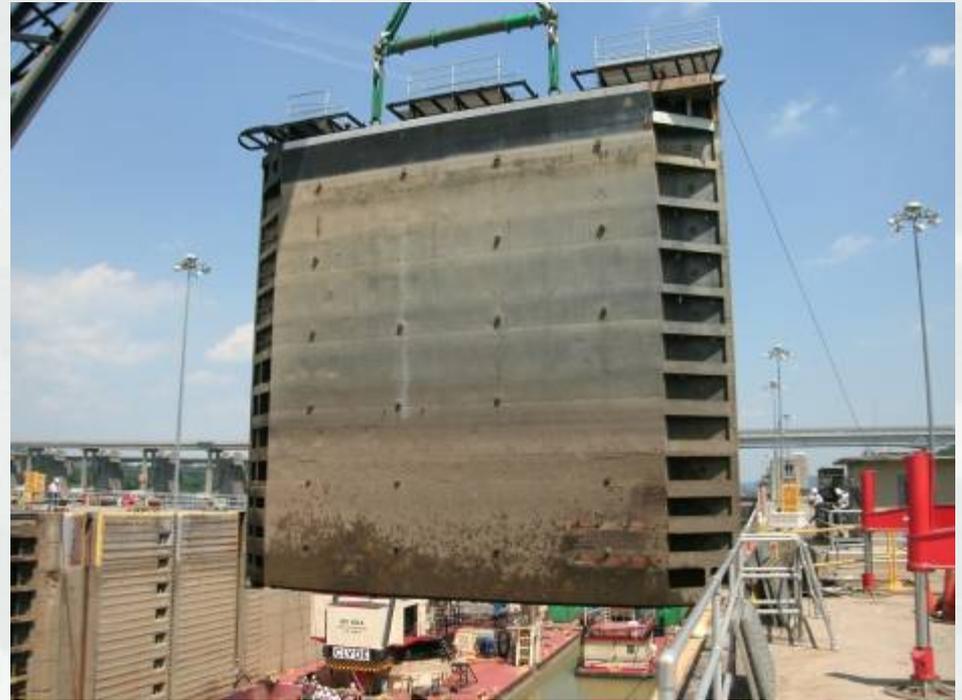
# Removal of Existing Gate Leaves

Lifting the existing gate leaves in the wet

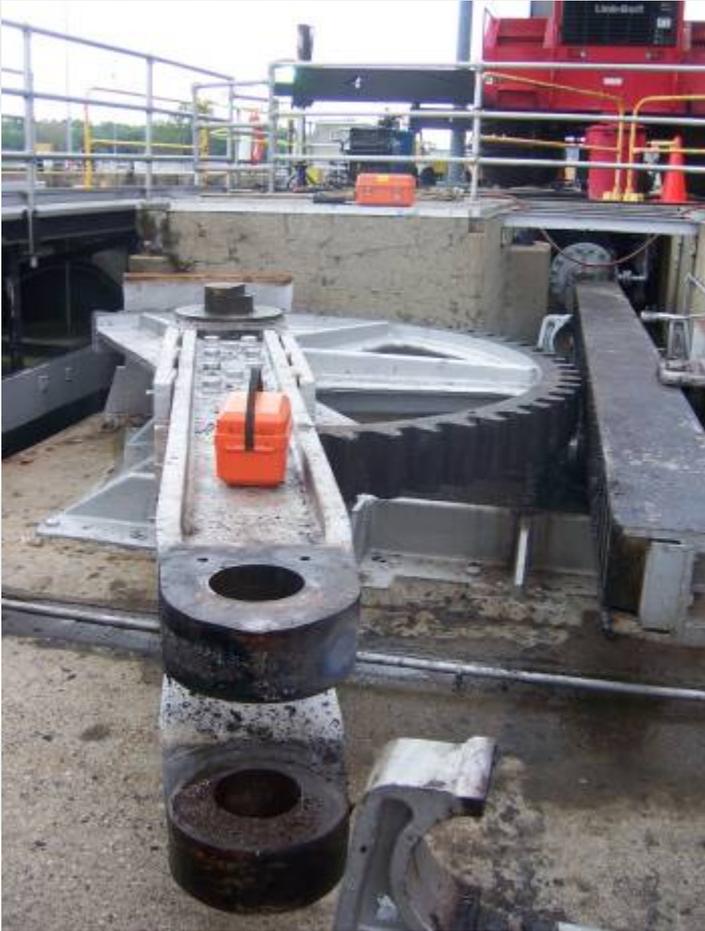
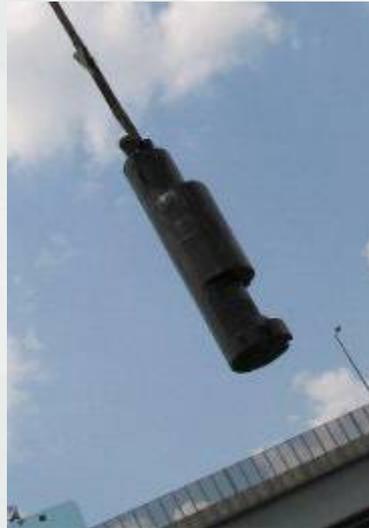
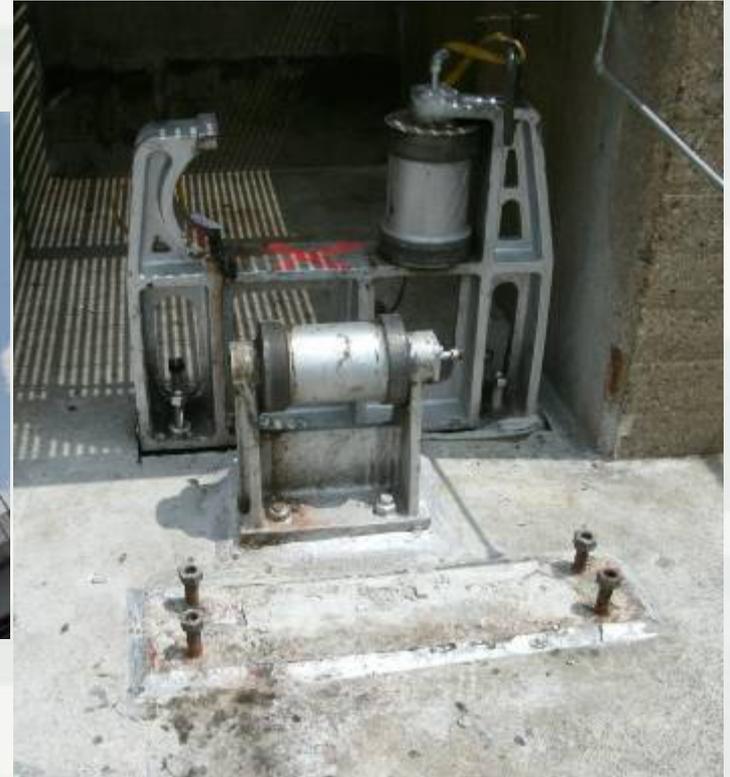
# Miter Gate Machinery

Miter gate machinery operating radius was changed to improve operating conditions

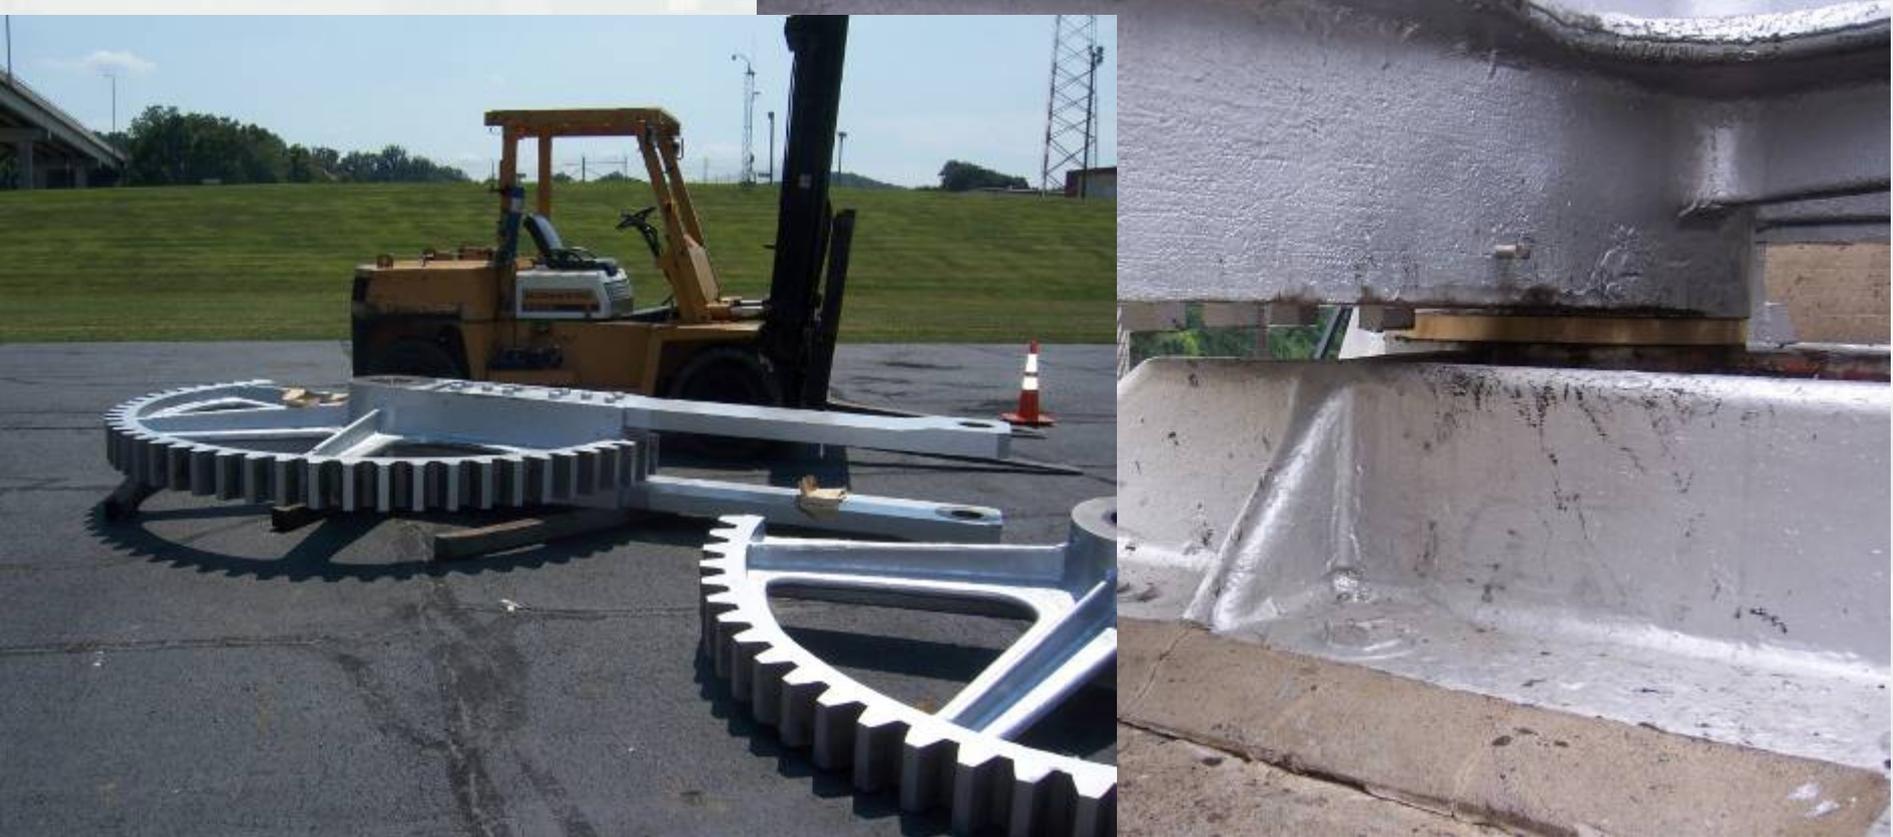
# Miter Gate Machinery

Supplied sector arms had to be machined to fit with existing sector gear

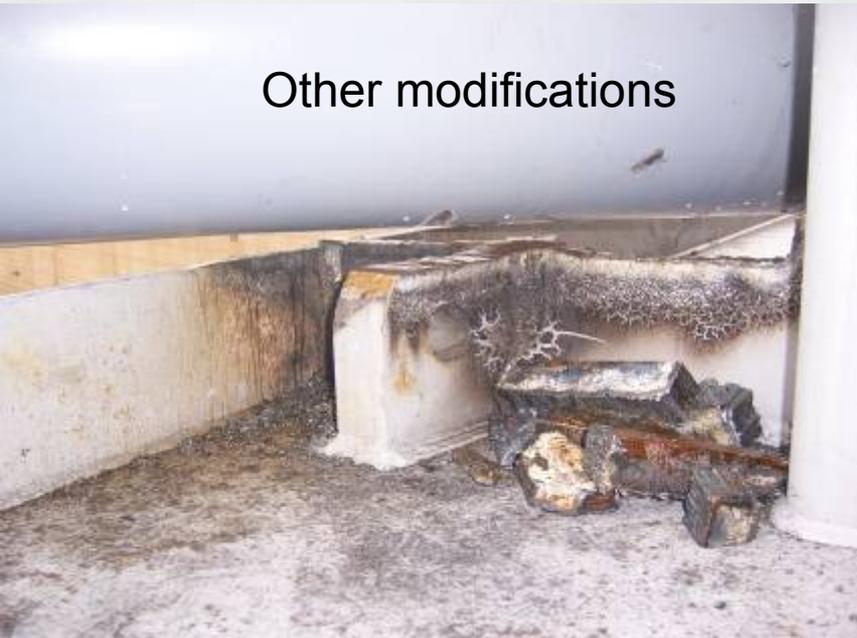
# Miter Gate Machinery

Other modifications

Final Machinery Angle

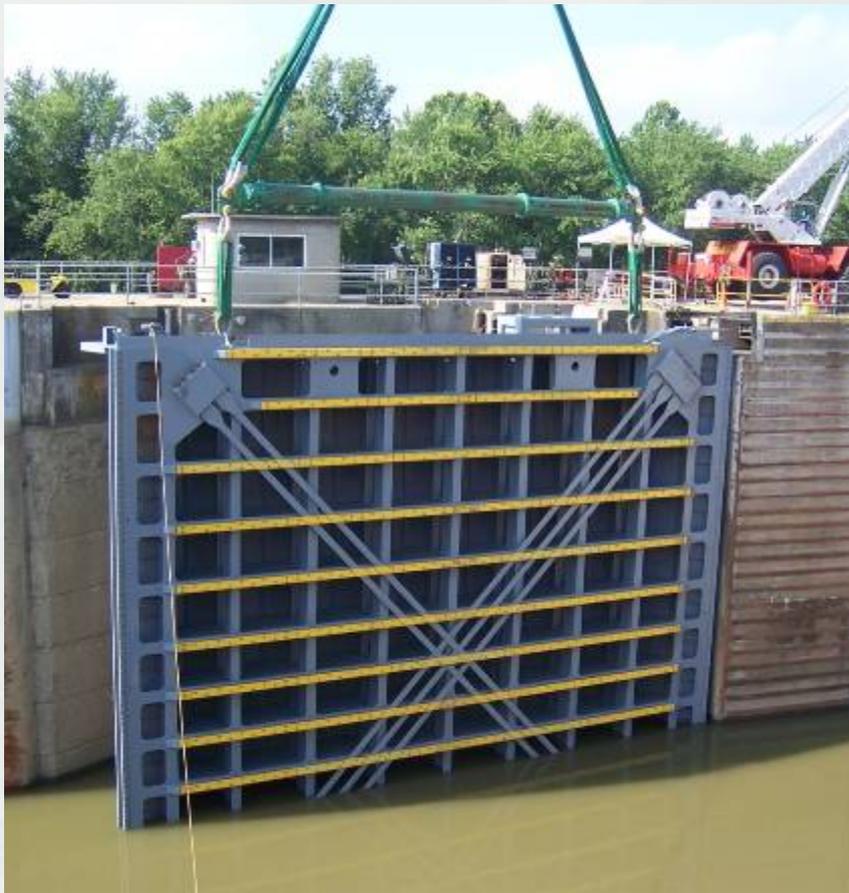
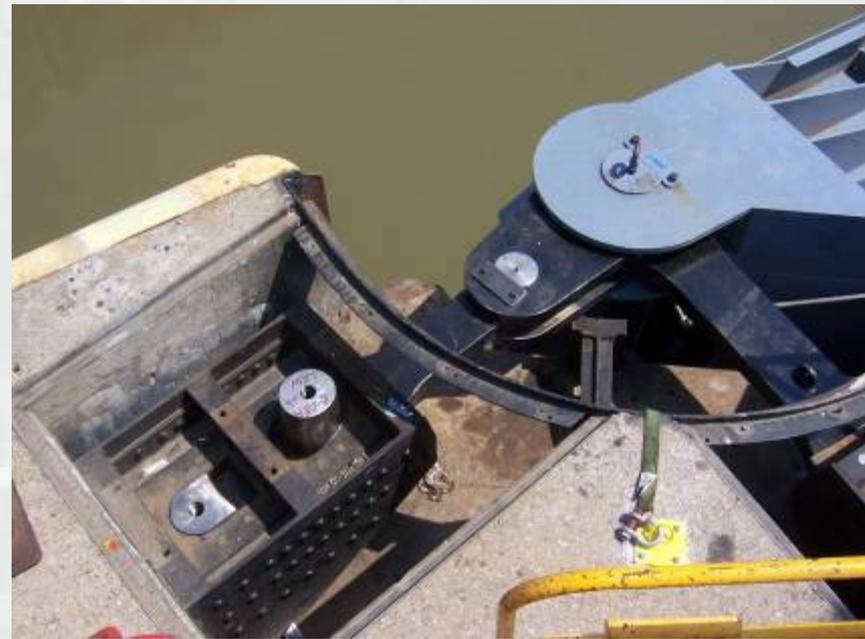
# Checking Fit on the New Gate

New ASTM A709 anchor arms.  
Designed using original style  
wedges and anchorages

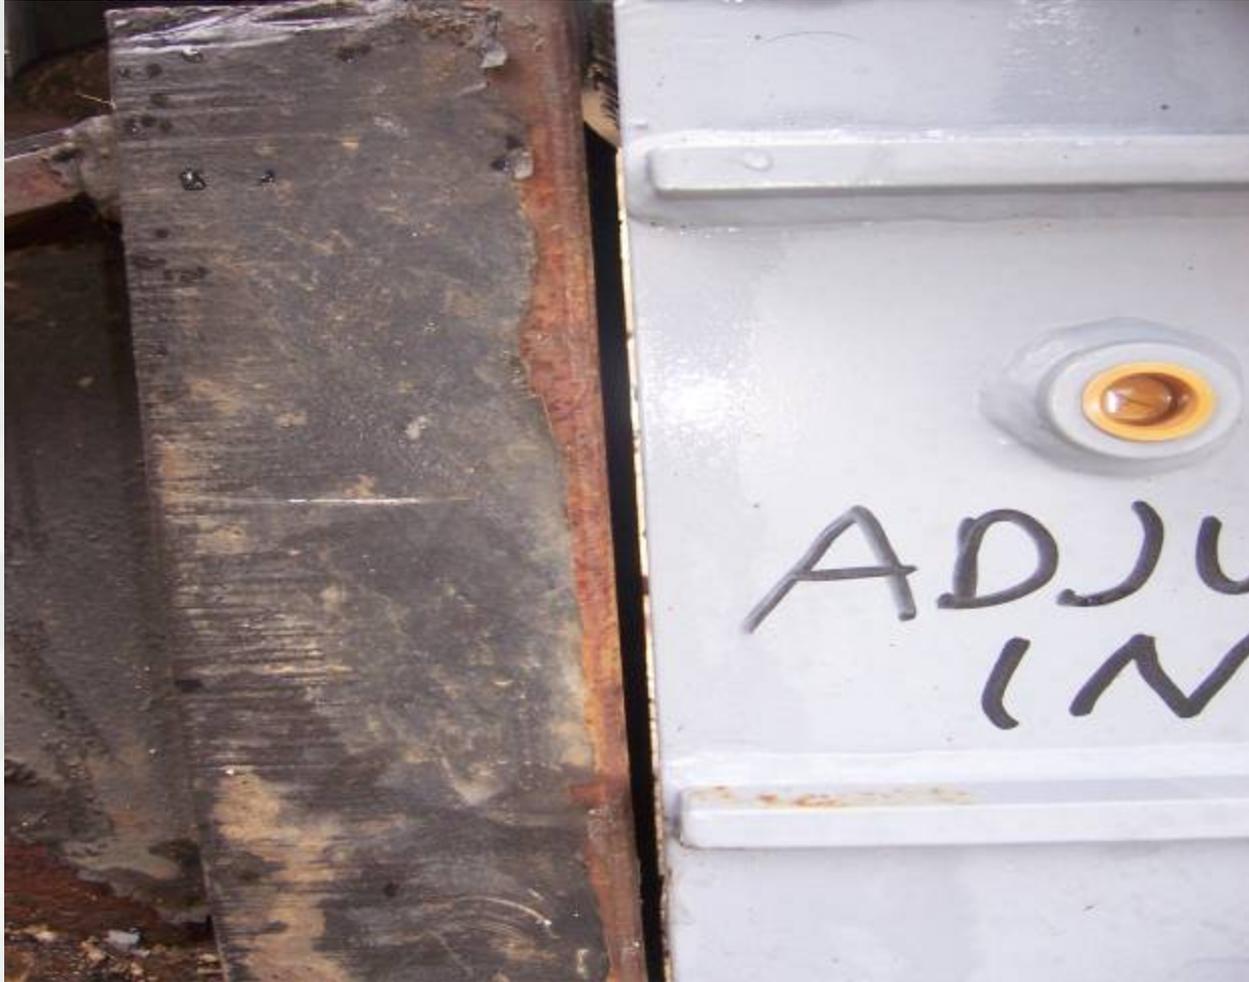
# Fit Problems

New miter gate was very tight to the wall quoin, similar to the existing miter gate. However, with the new adjustment wedges on the gate, this would not work

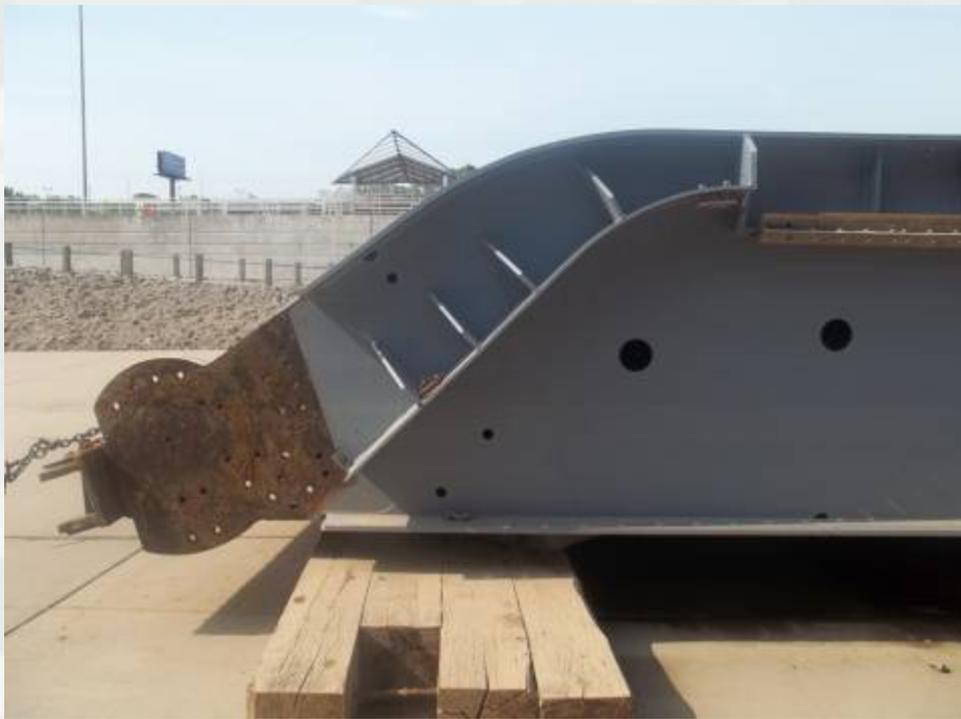
# Seal Modifications

Transition from vertical to horizontal seal was in the wrong location. The sill was modified from the original drawings by Operations.

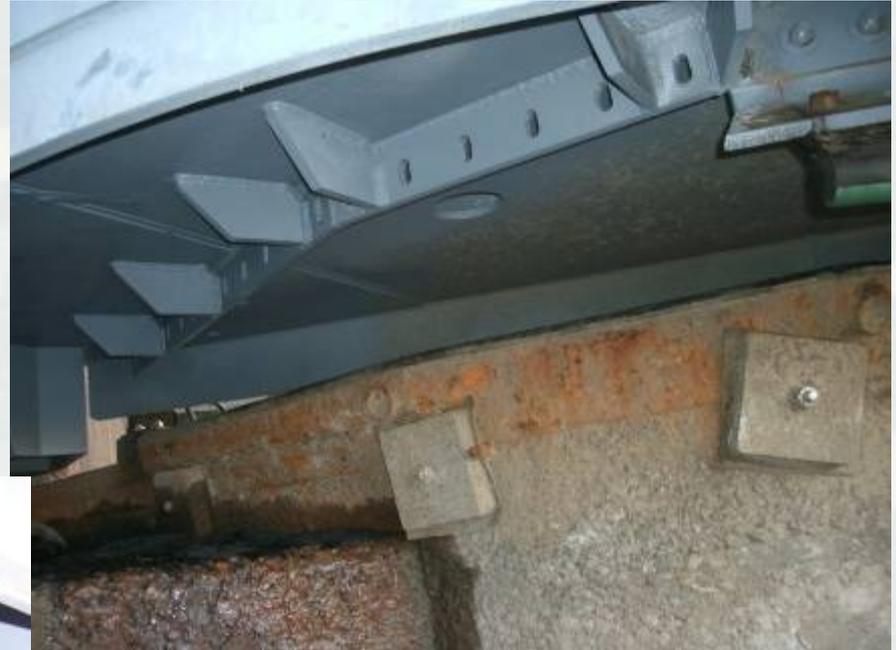
# Seal Modifications Heel

Constructed new seal supports  
from the existing sill.

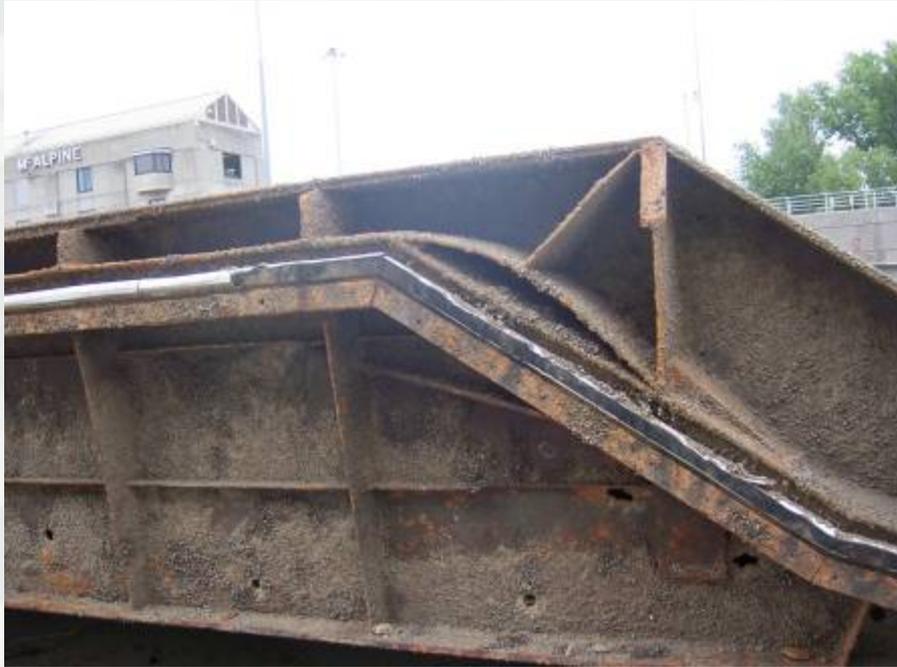
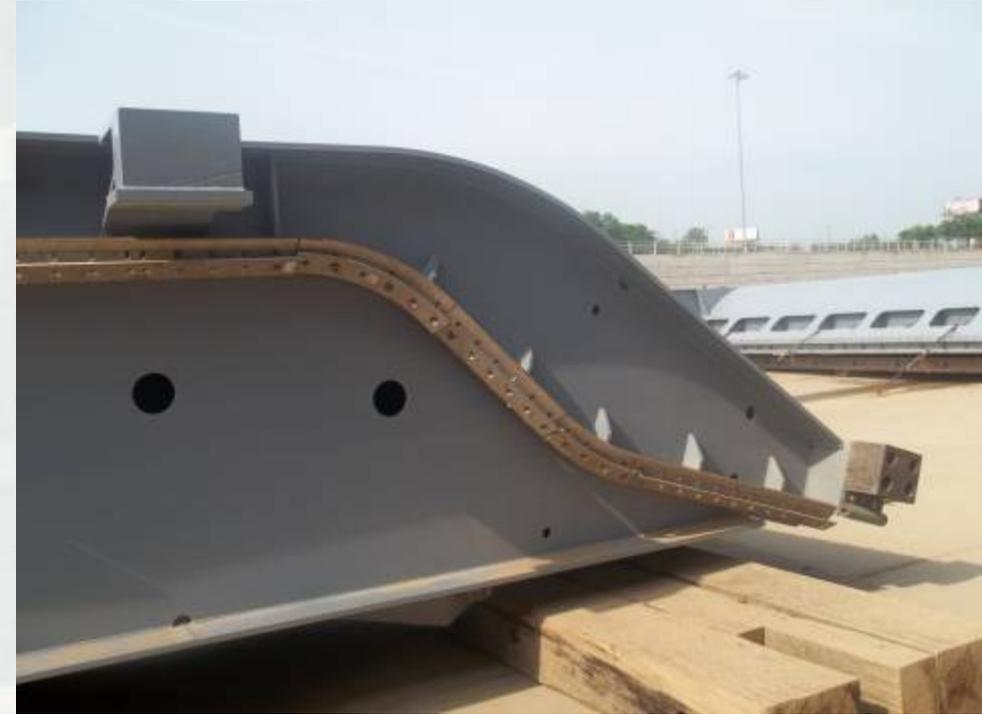
# Seal Modifications Toe

When the sill was modified by Operations, the curved section at the toe was replaced by a straight section to avoid complications with fabricating the curved horizontal sill piece.

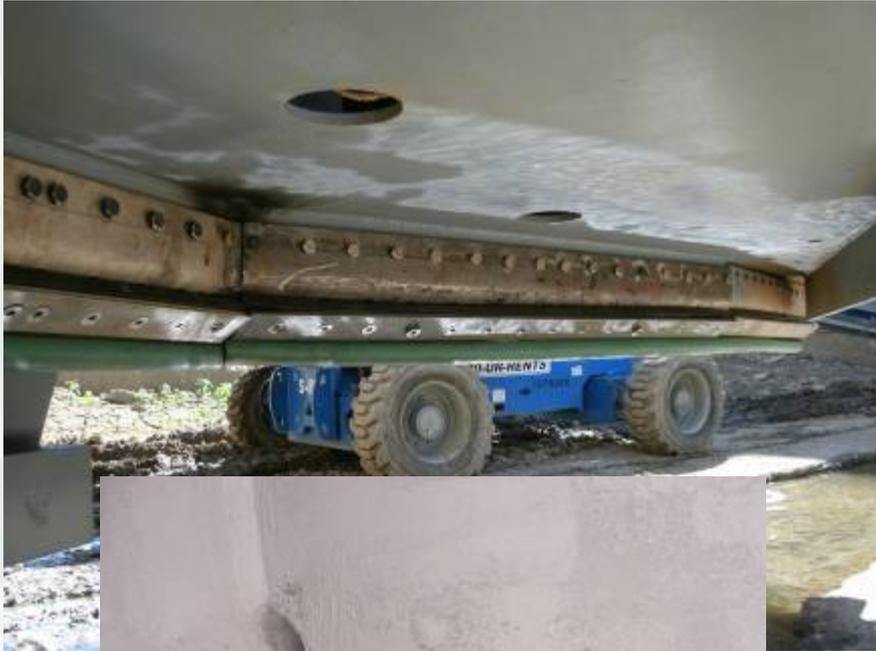
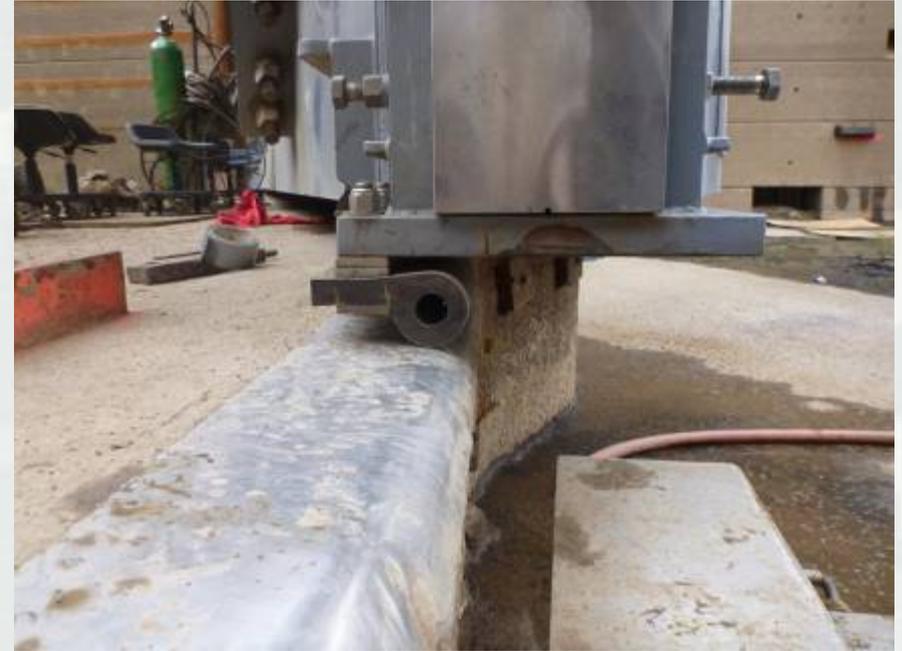
# Seal Modifications Toe

Toe section was fabricated similar to the heel. Had to modify other, minor parts of the seal also.

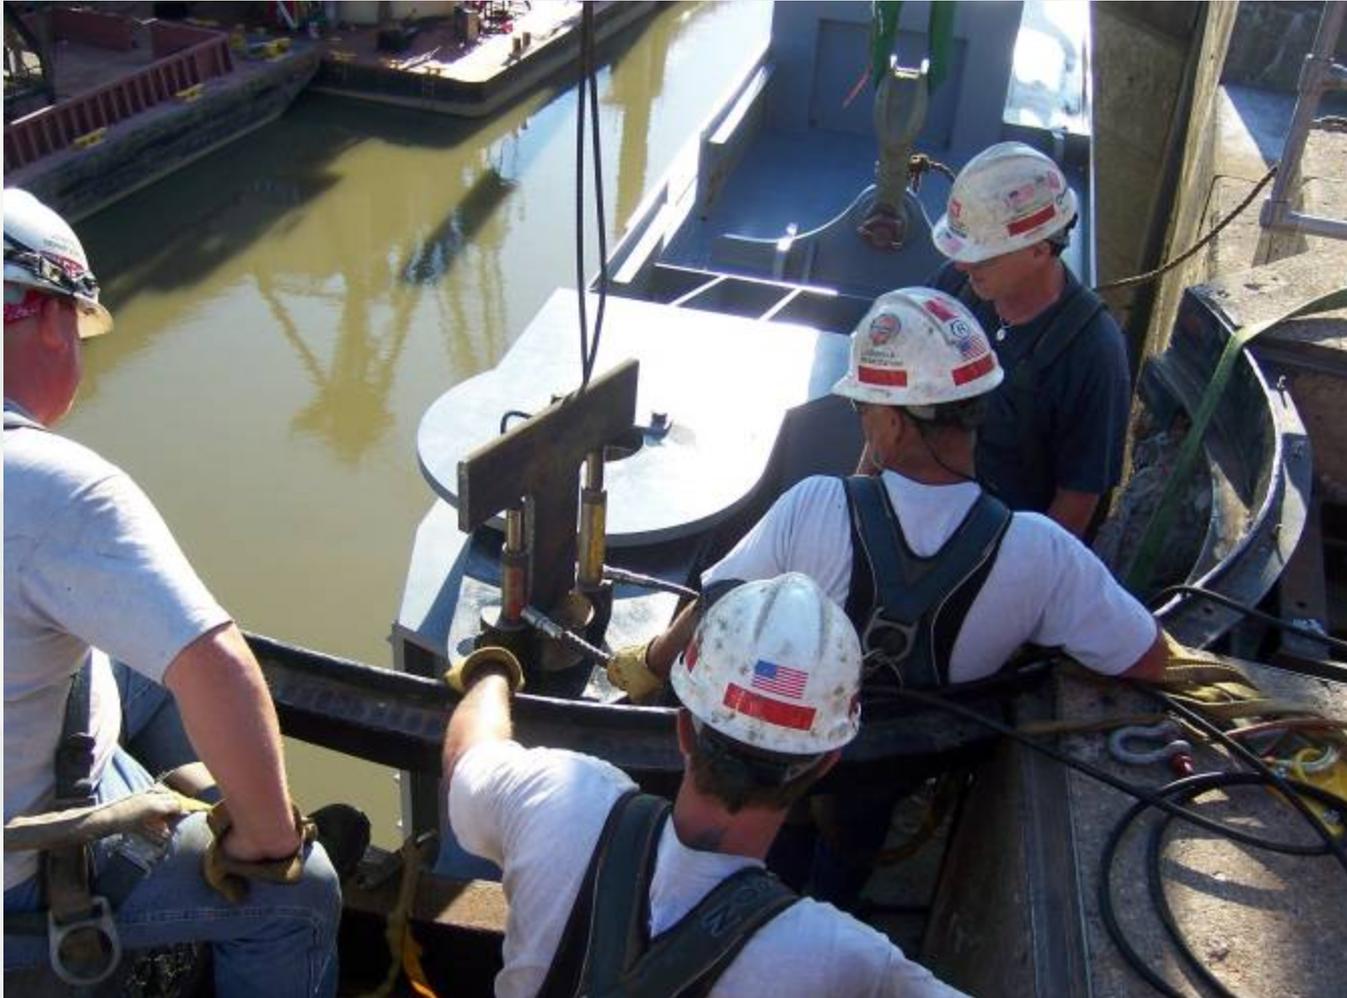
# Remove the New Gate

Had to rewater chamber. Had to save all pins to reuse them

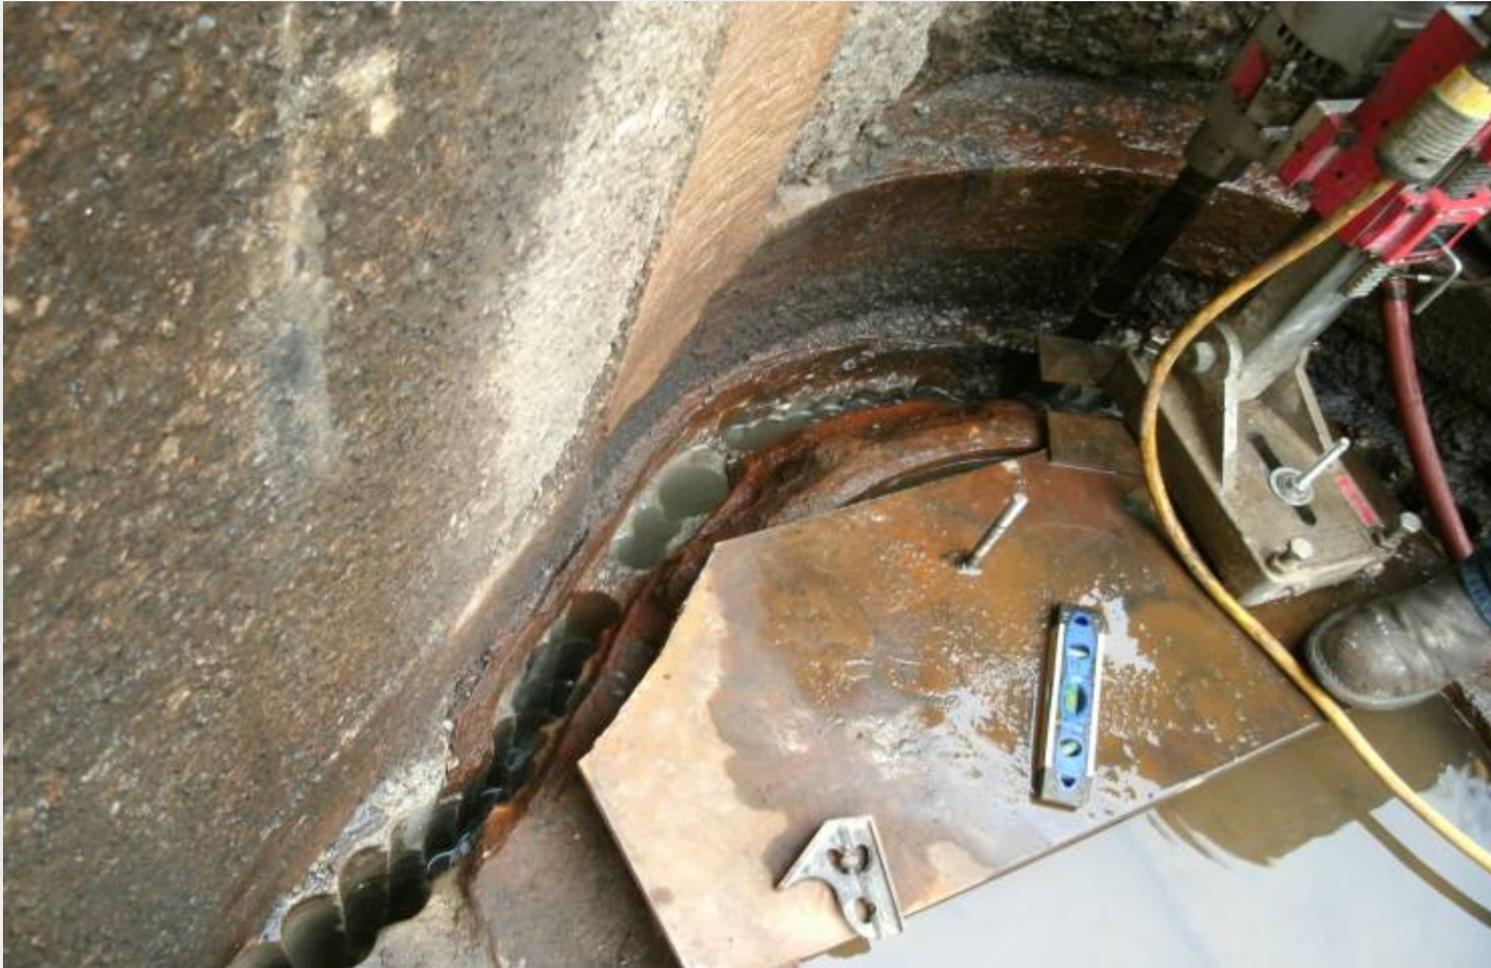
The chamber was dewatered again and we started cutting out the lower old pintle bases. It took a combination of air arcing, core drilling and diamond wire sawing to remove them.

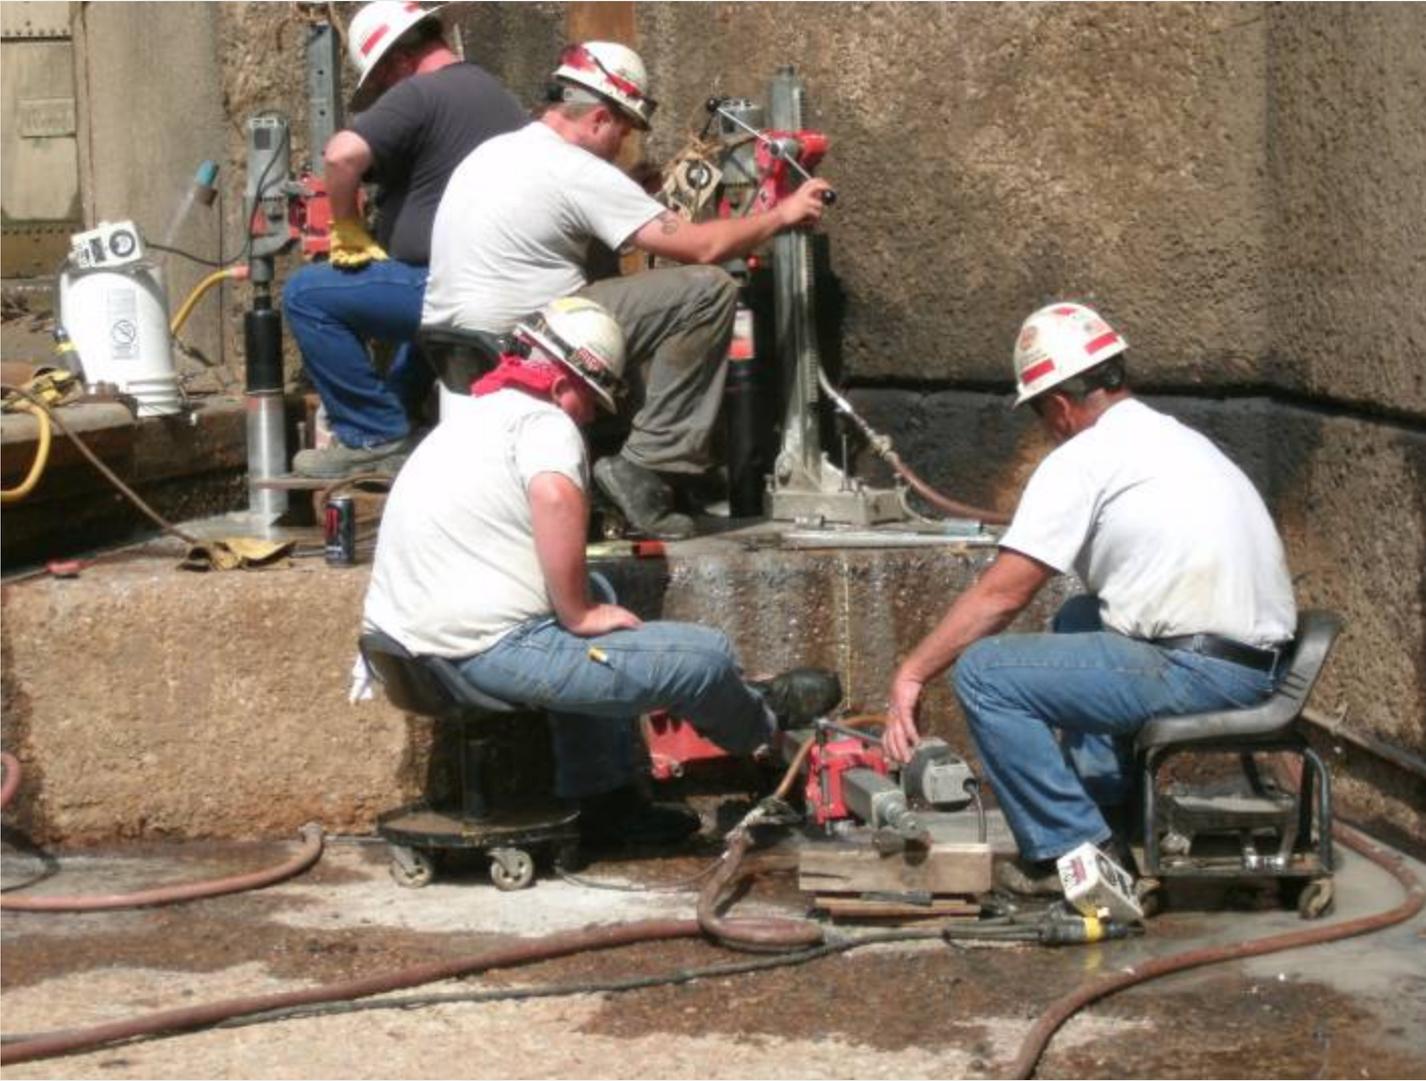
## Horizontal and vertical core drilling

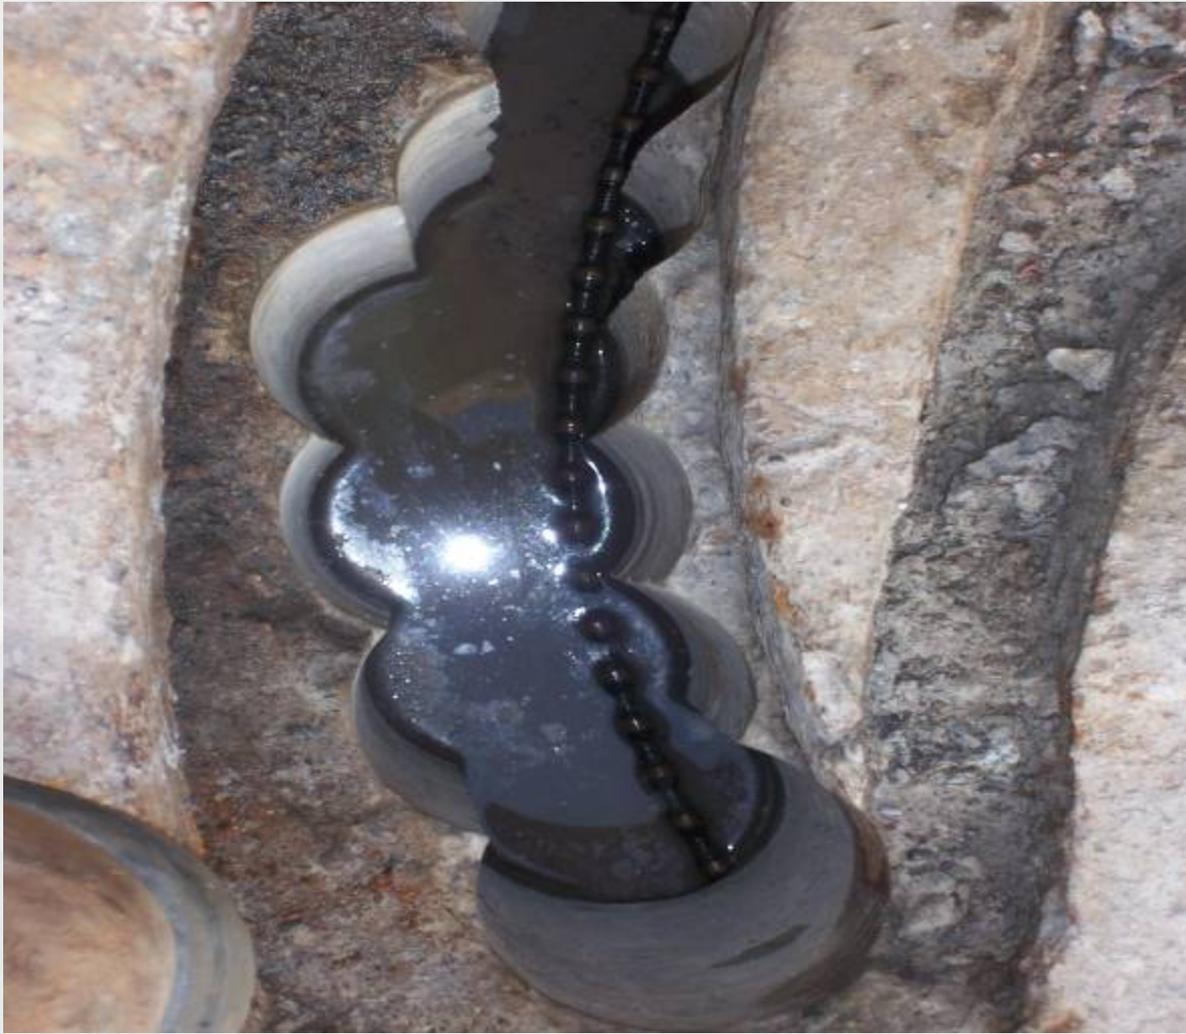
Diamond wire fed in behind the pintle base after air arcing and core drilling

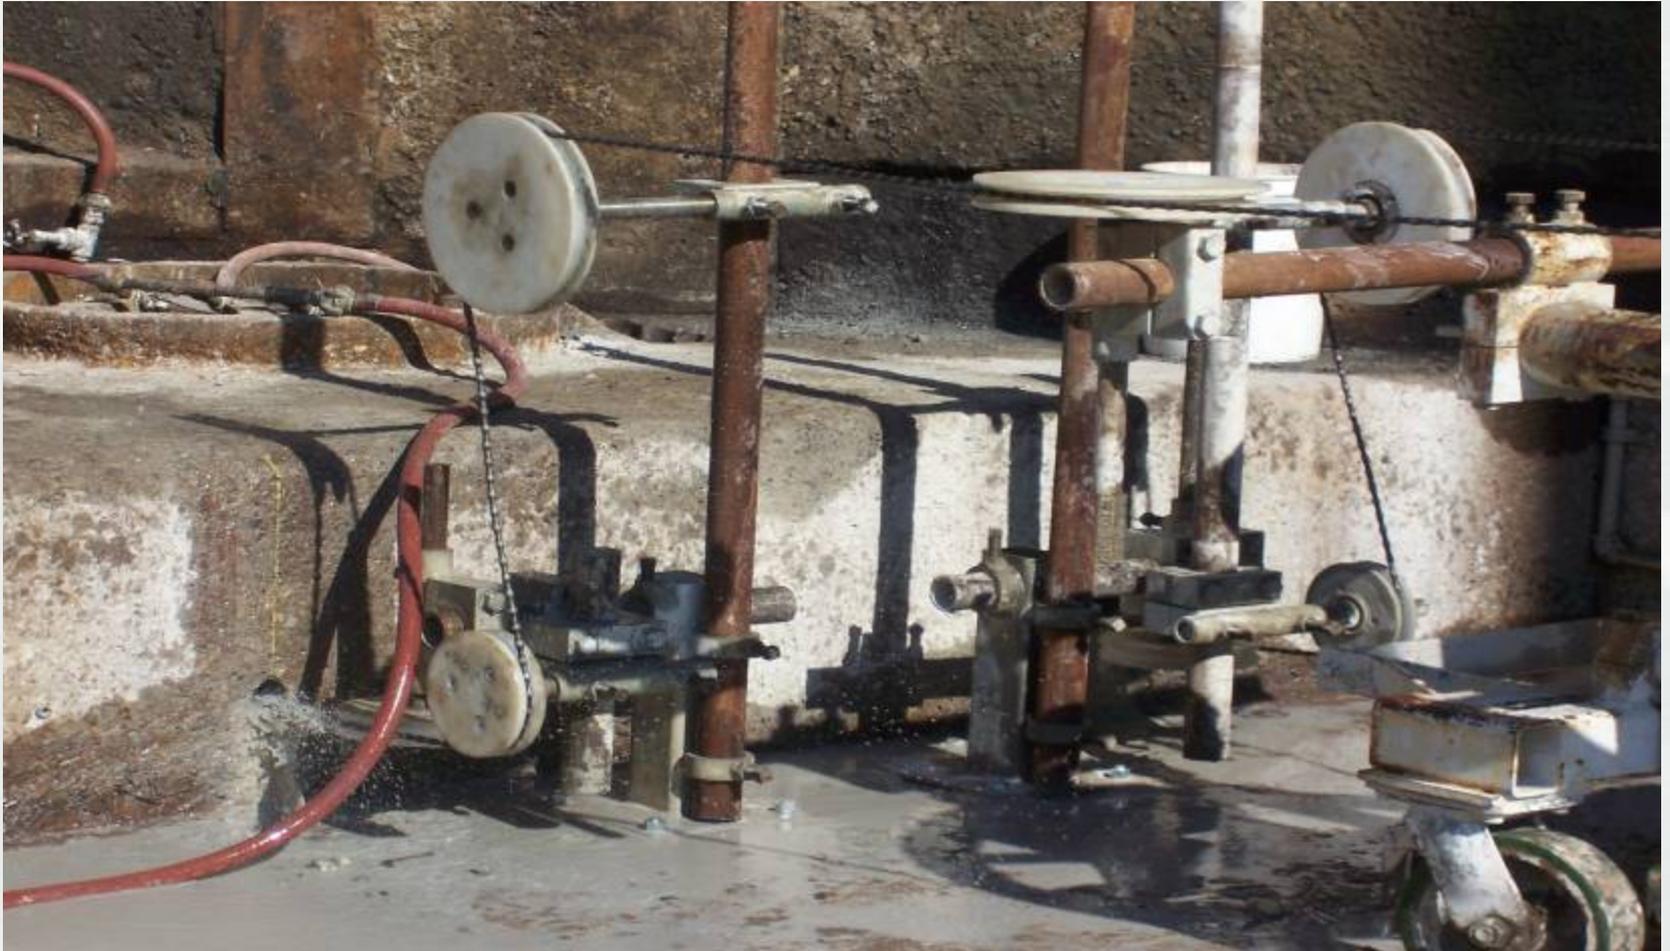
# Diamond wire saw

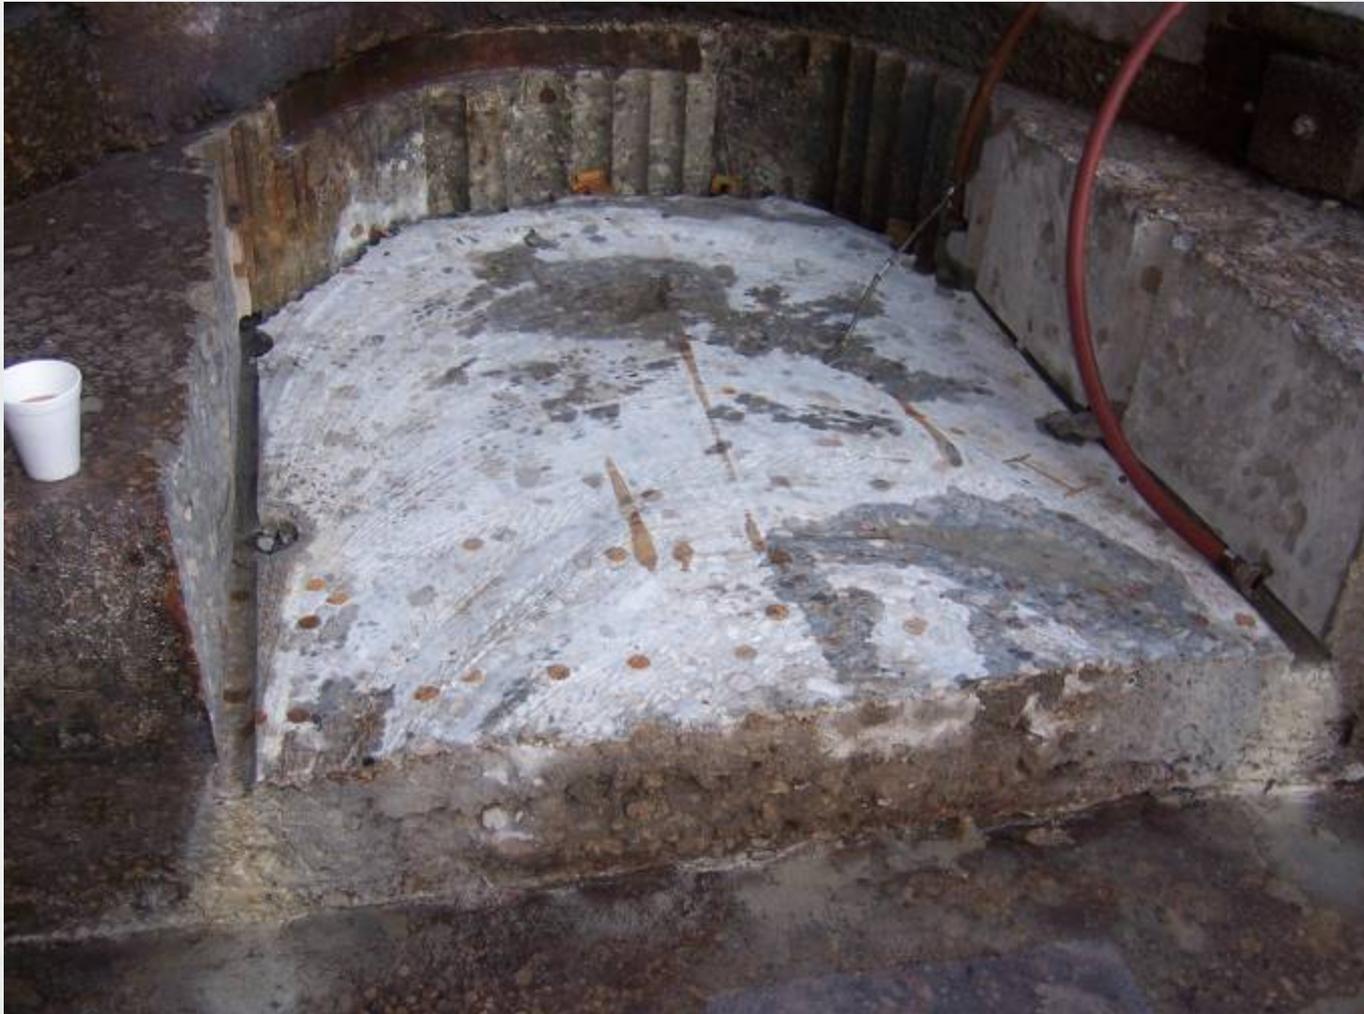
First time we tried to save as much rebar as we could. Decided on the upper end to remove and reinstall it all.

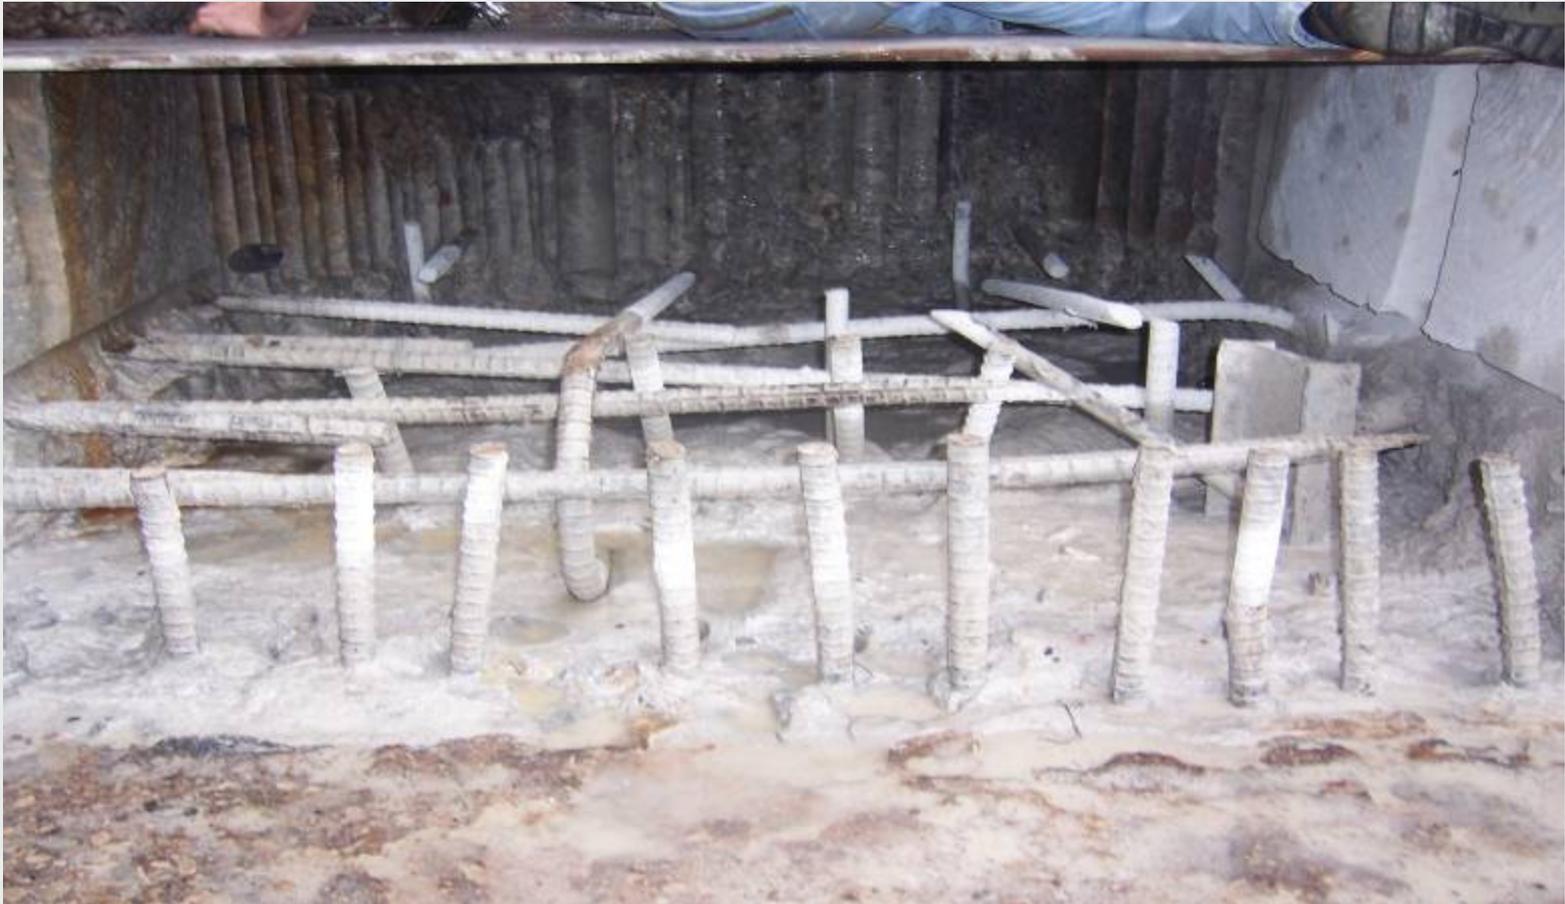
Ended up with this after chipping the rest of the concrete away.
