# Markland 1200' Gate Replacement and Wall Quoin Refurbishment

July 11 – November 17 2011

Craig Moulton and Kevin Vessels  
Louisville District

# Markland Locks and Dam

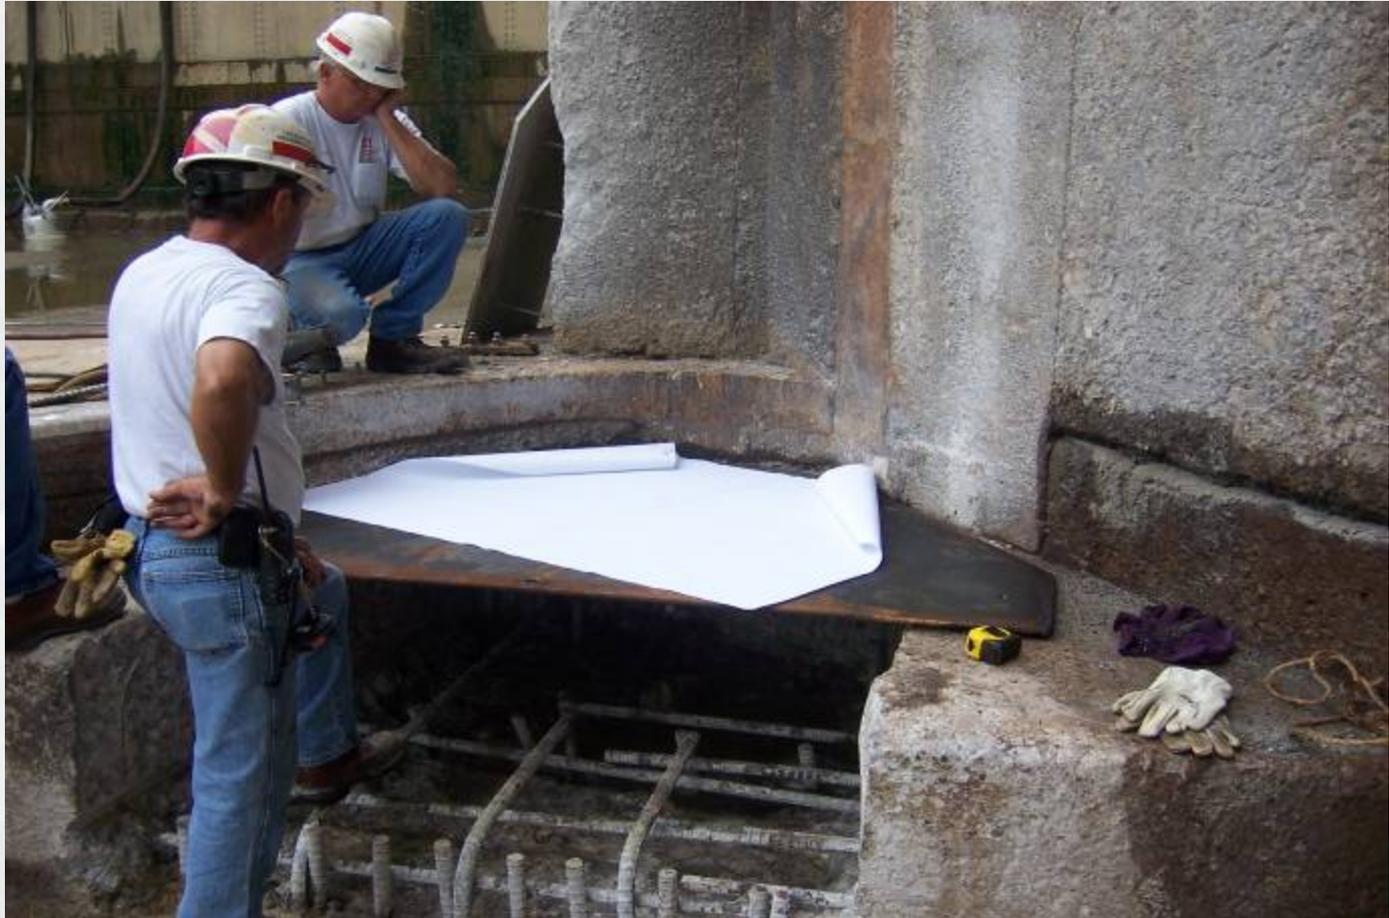
Prior to removing the pintle bases we surveyed in base lines so we would always know where the centerline of the pintles were originally. We used the baselines to move the pintles 5/16”.

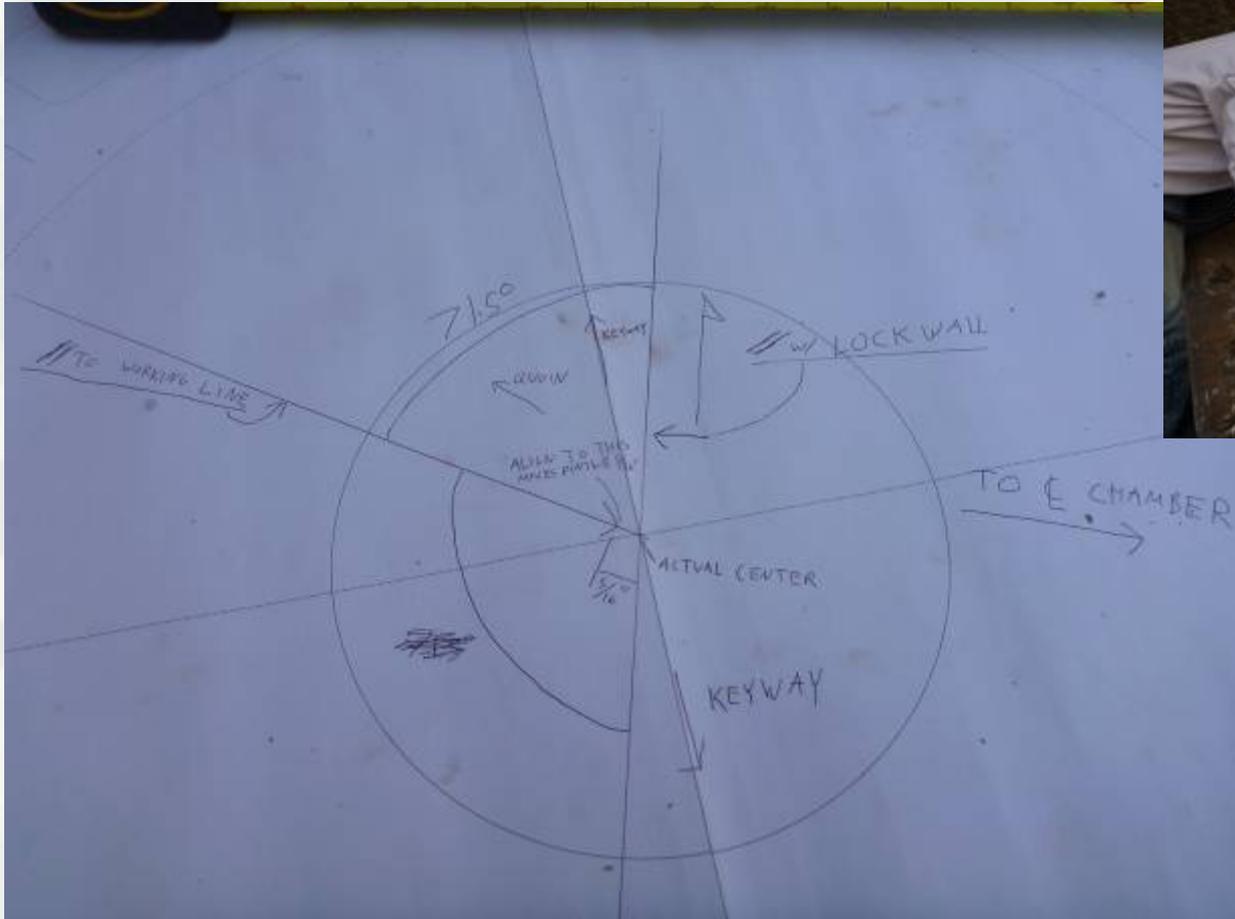
# Pintle Base Template

Used transit and life-size print of pintle base to move it  $\frac{5}{16}$ " along working line

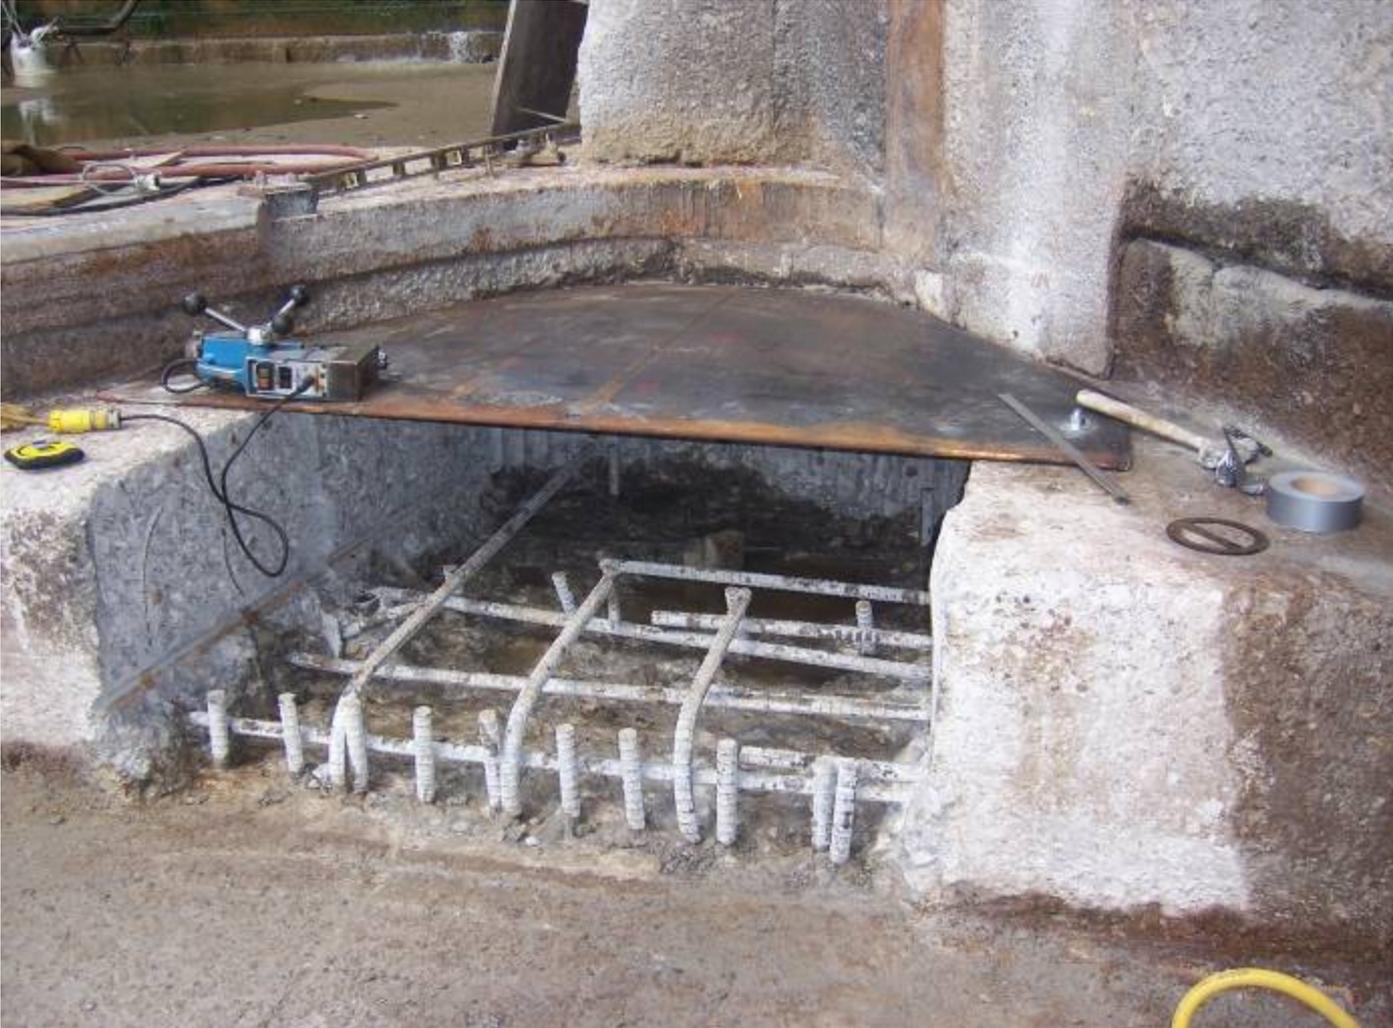
# Drilling template for pintle base bolts

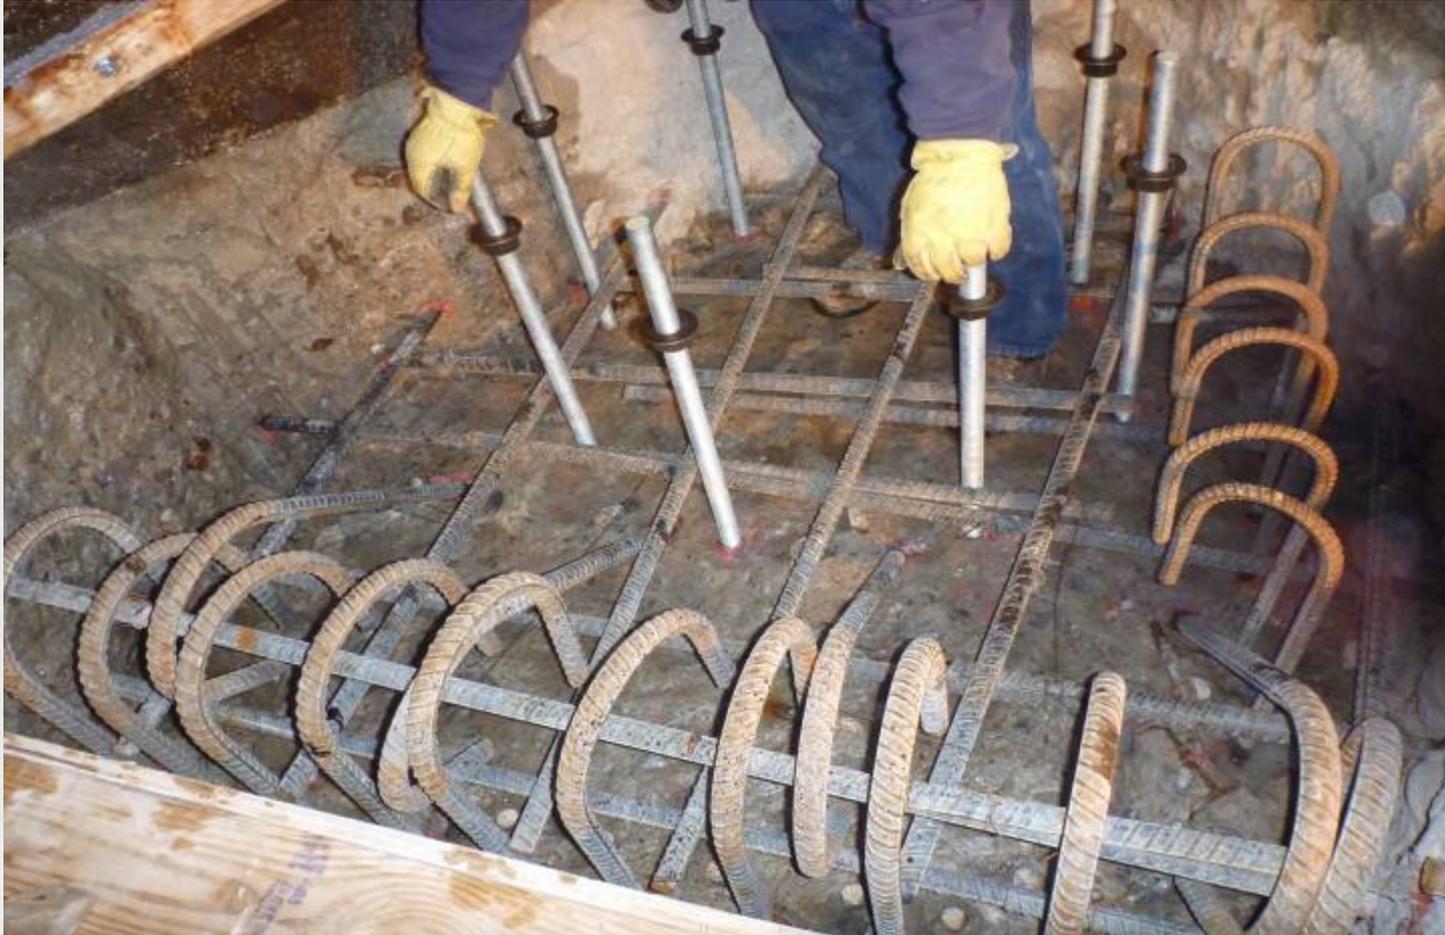
# Pintle base bolts with pintle base leveling nuts and washers

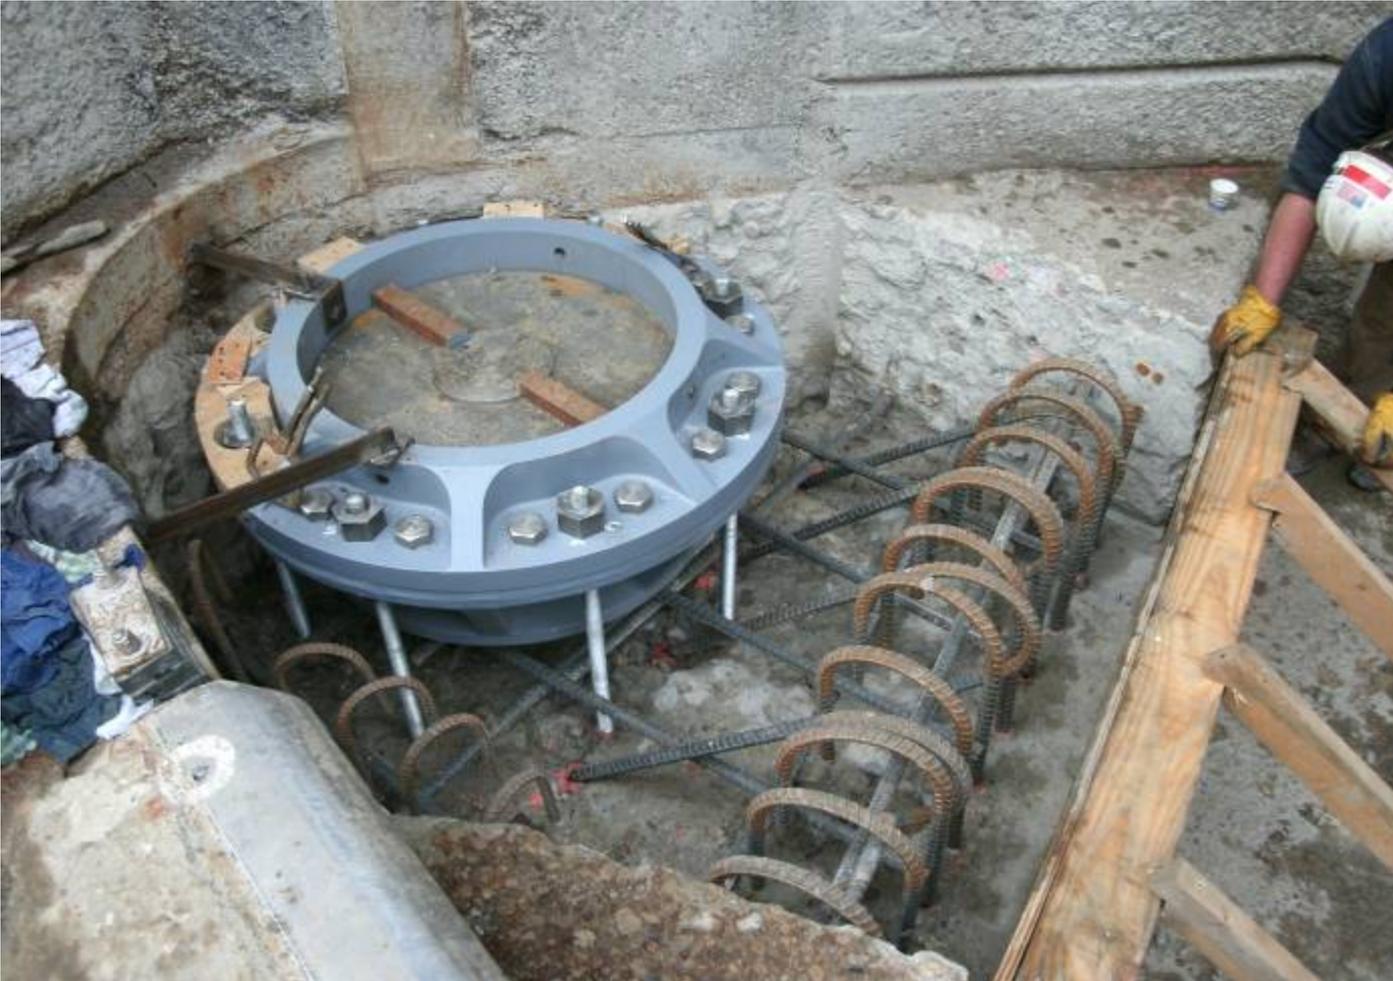
Pintle base set, anchored and ready for concrete.

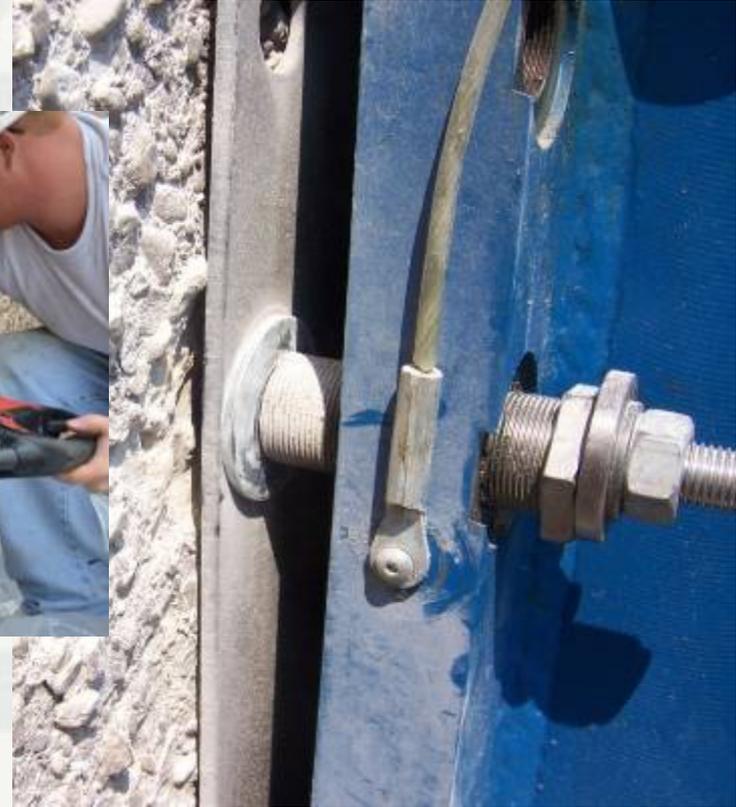
# Climax Milling Machine Setup

Drilling templates were supplied to drill the mounting holes for the Climax beds

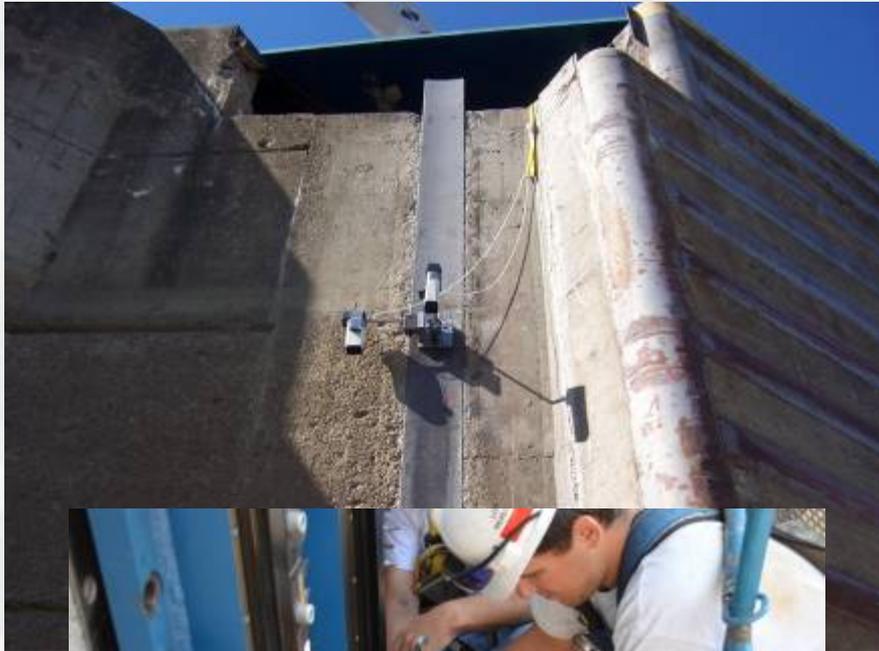
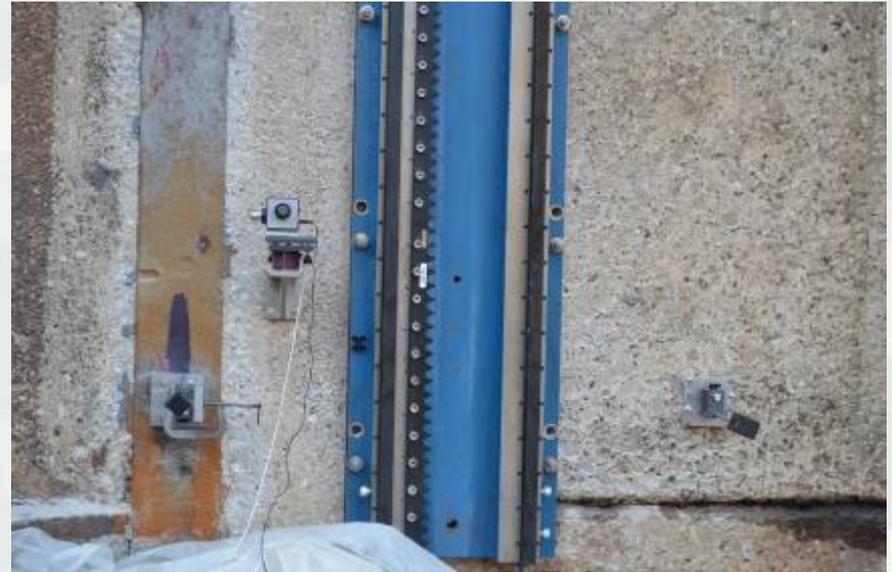
# Setup

Hamar laser system was supplied for aligning the beds. LRS had to create plates and method for aligning laser to wall quoin. Hamar system had issues with daylight.

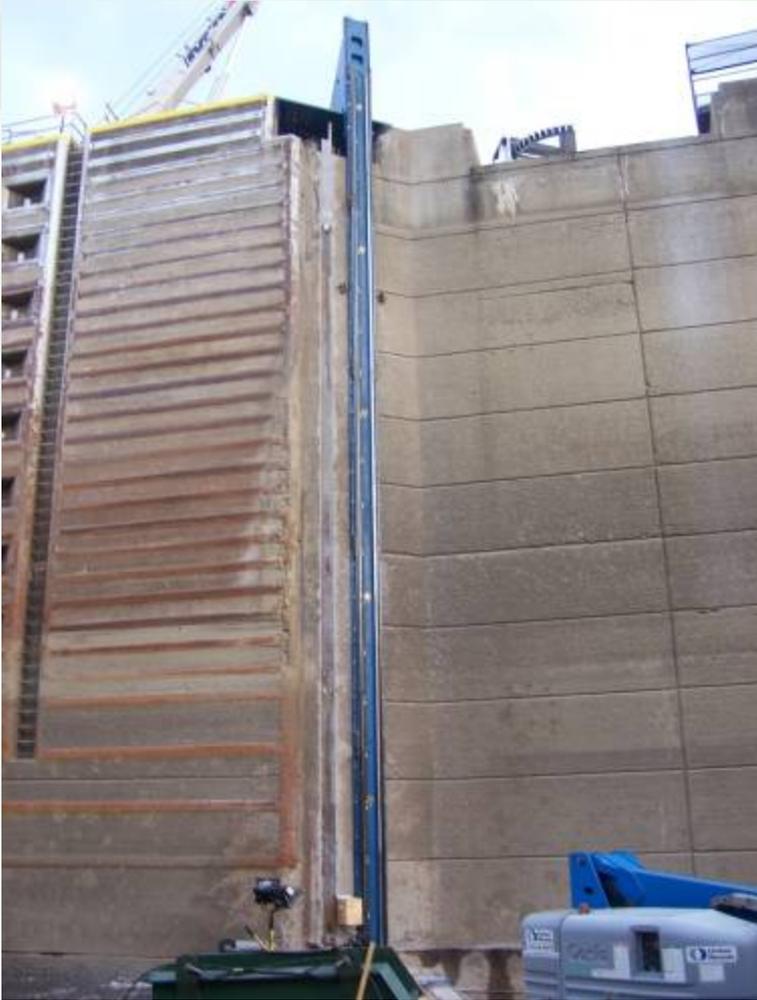
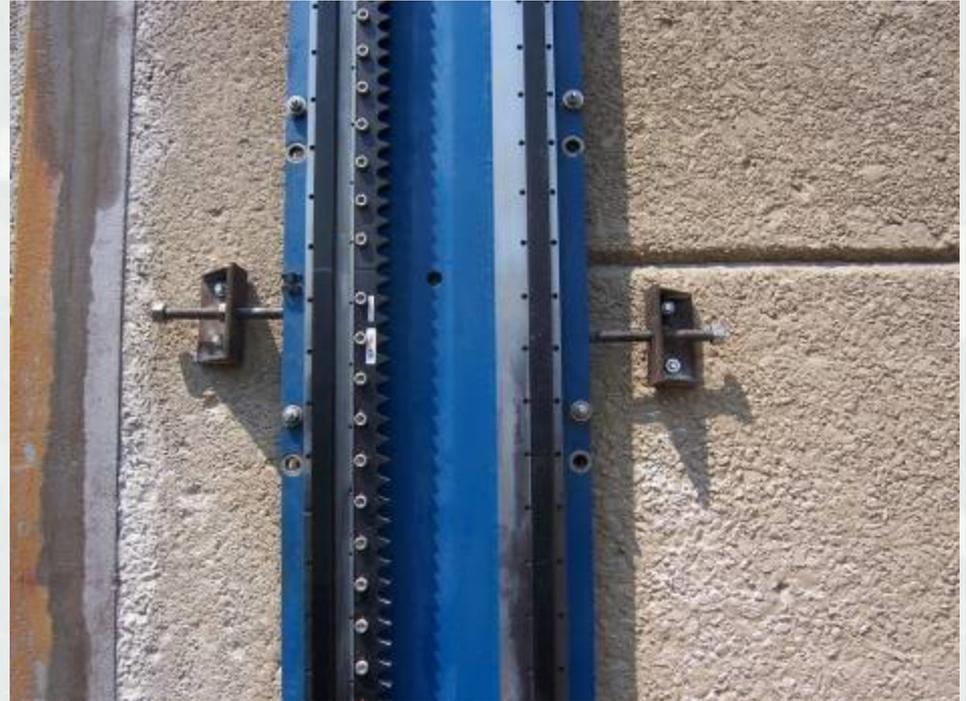
# Setup

Alignment process was repeated for every bed section.

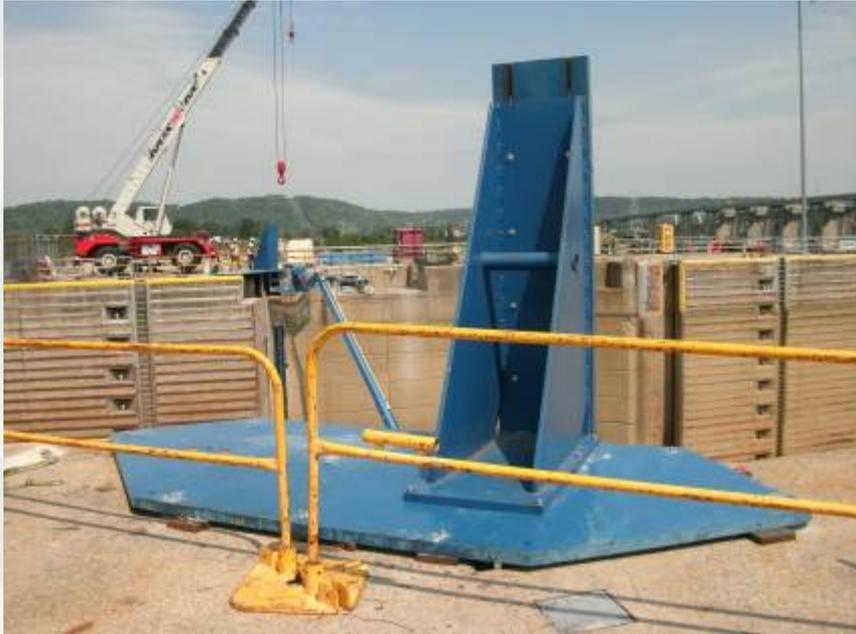
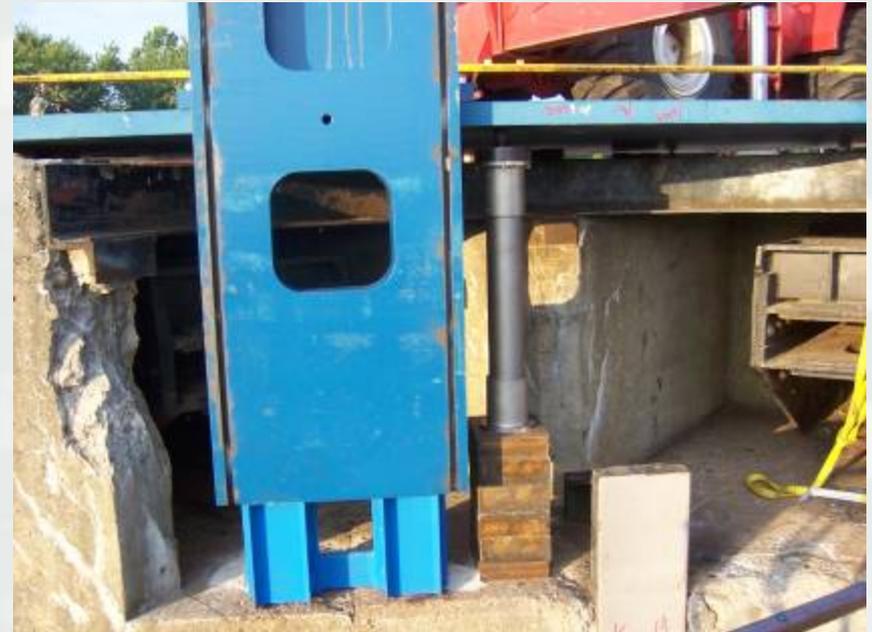
# Setup

Climax supplied bracket and plate for extension above the wall quoin. LRS had to supply the lower extension bracket. The mounting plate needed to be aligned to the beds already mounted to the wall.

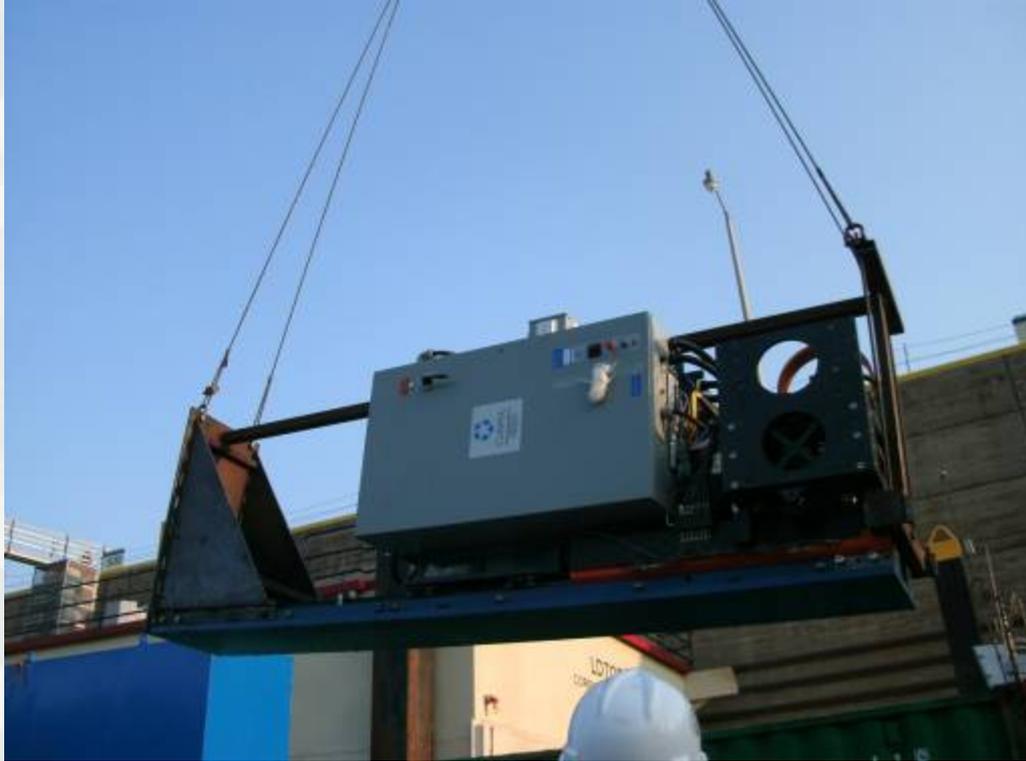
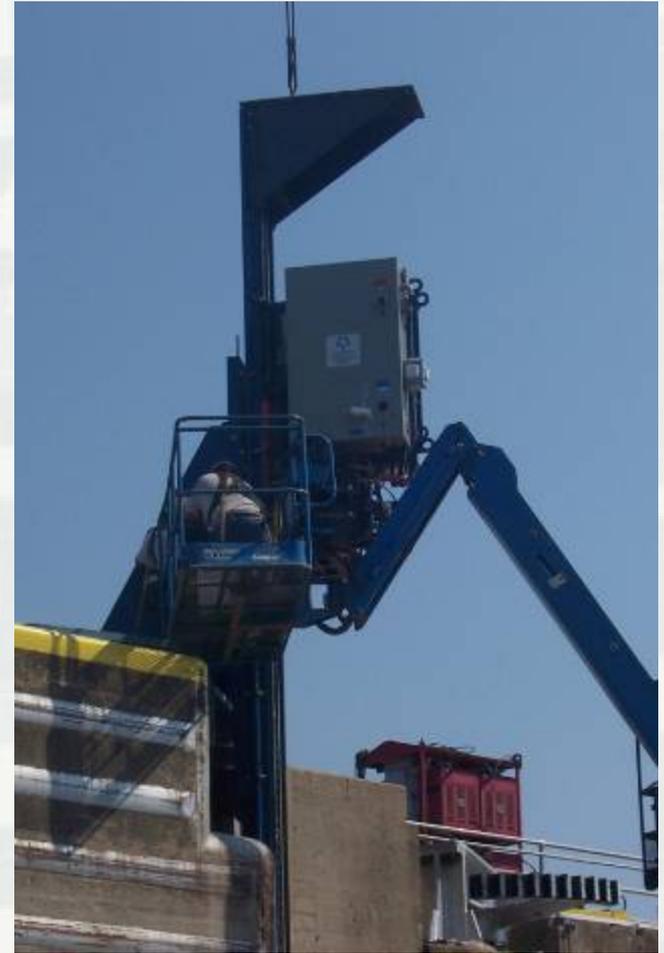
# Setup

LRS designed lifting bracket to remove the Climax Machine from the box, stand it up, and mount it on the top of the wall.

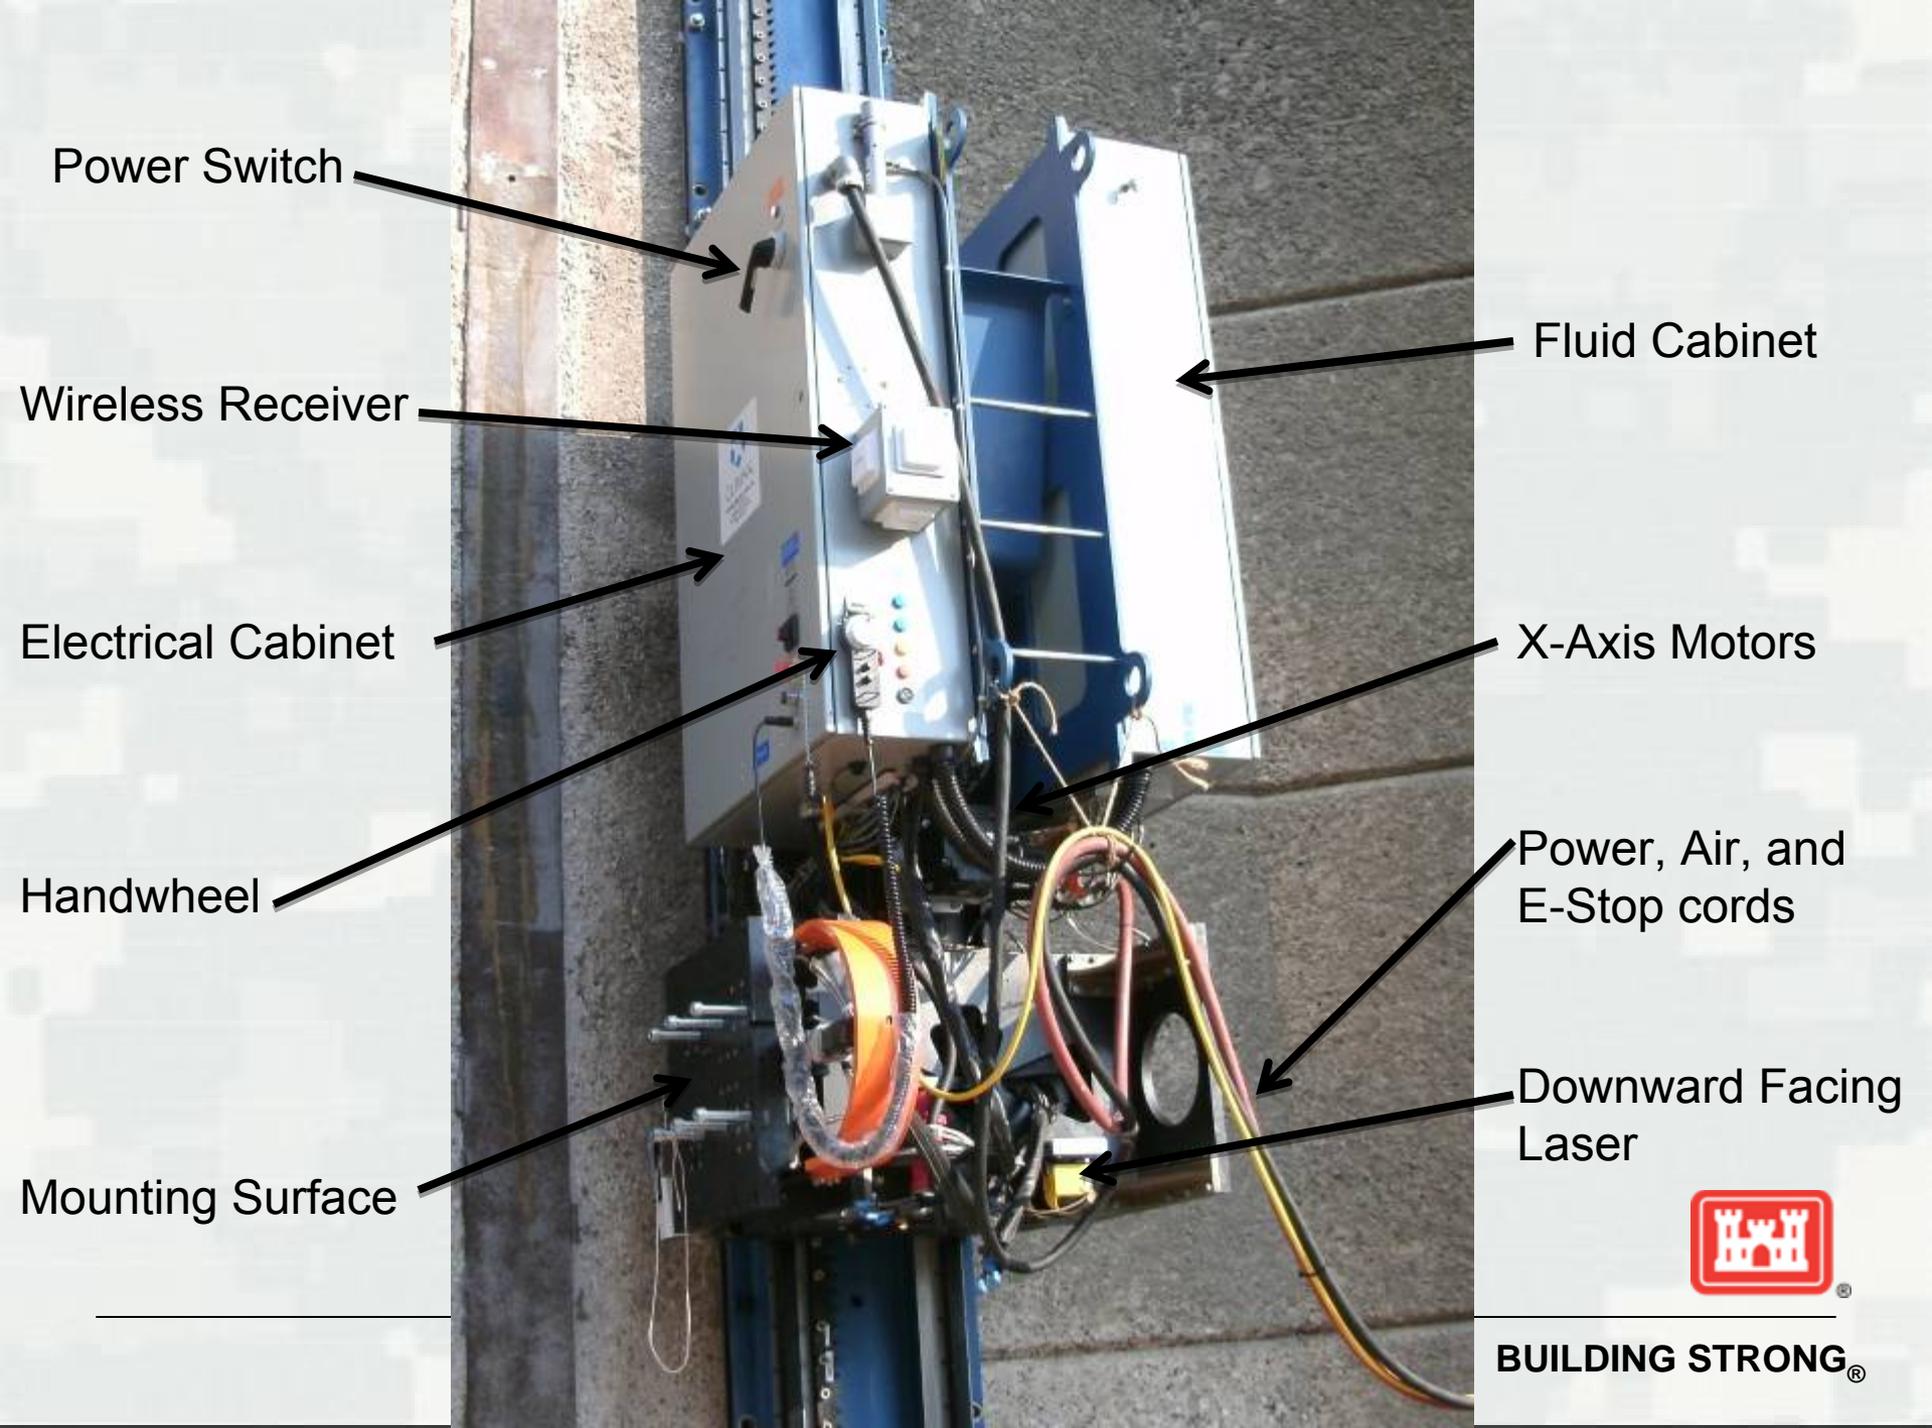
Power Switch

Fluid Cabinet

Wireless Receiver

X-Axis Motors

Electrical Cabinet

Power, Air, and E-Stop cords

Handwheel

Downward Facing Laser

Mounting Surface

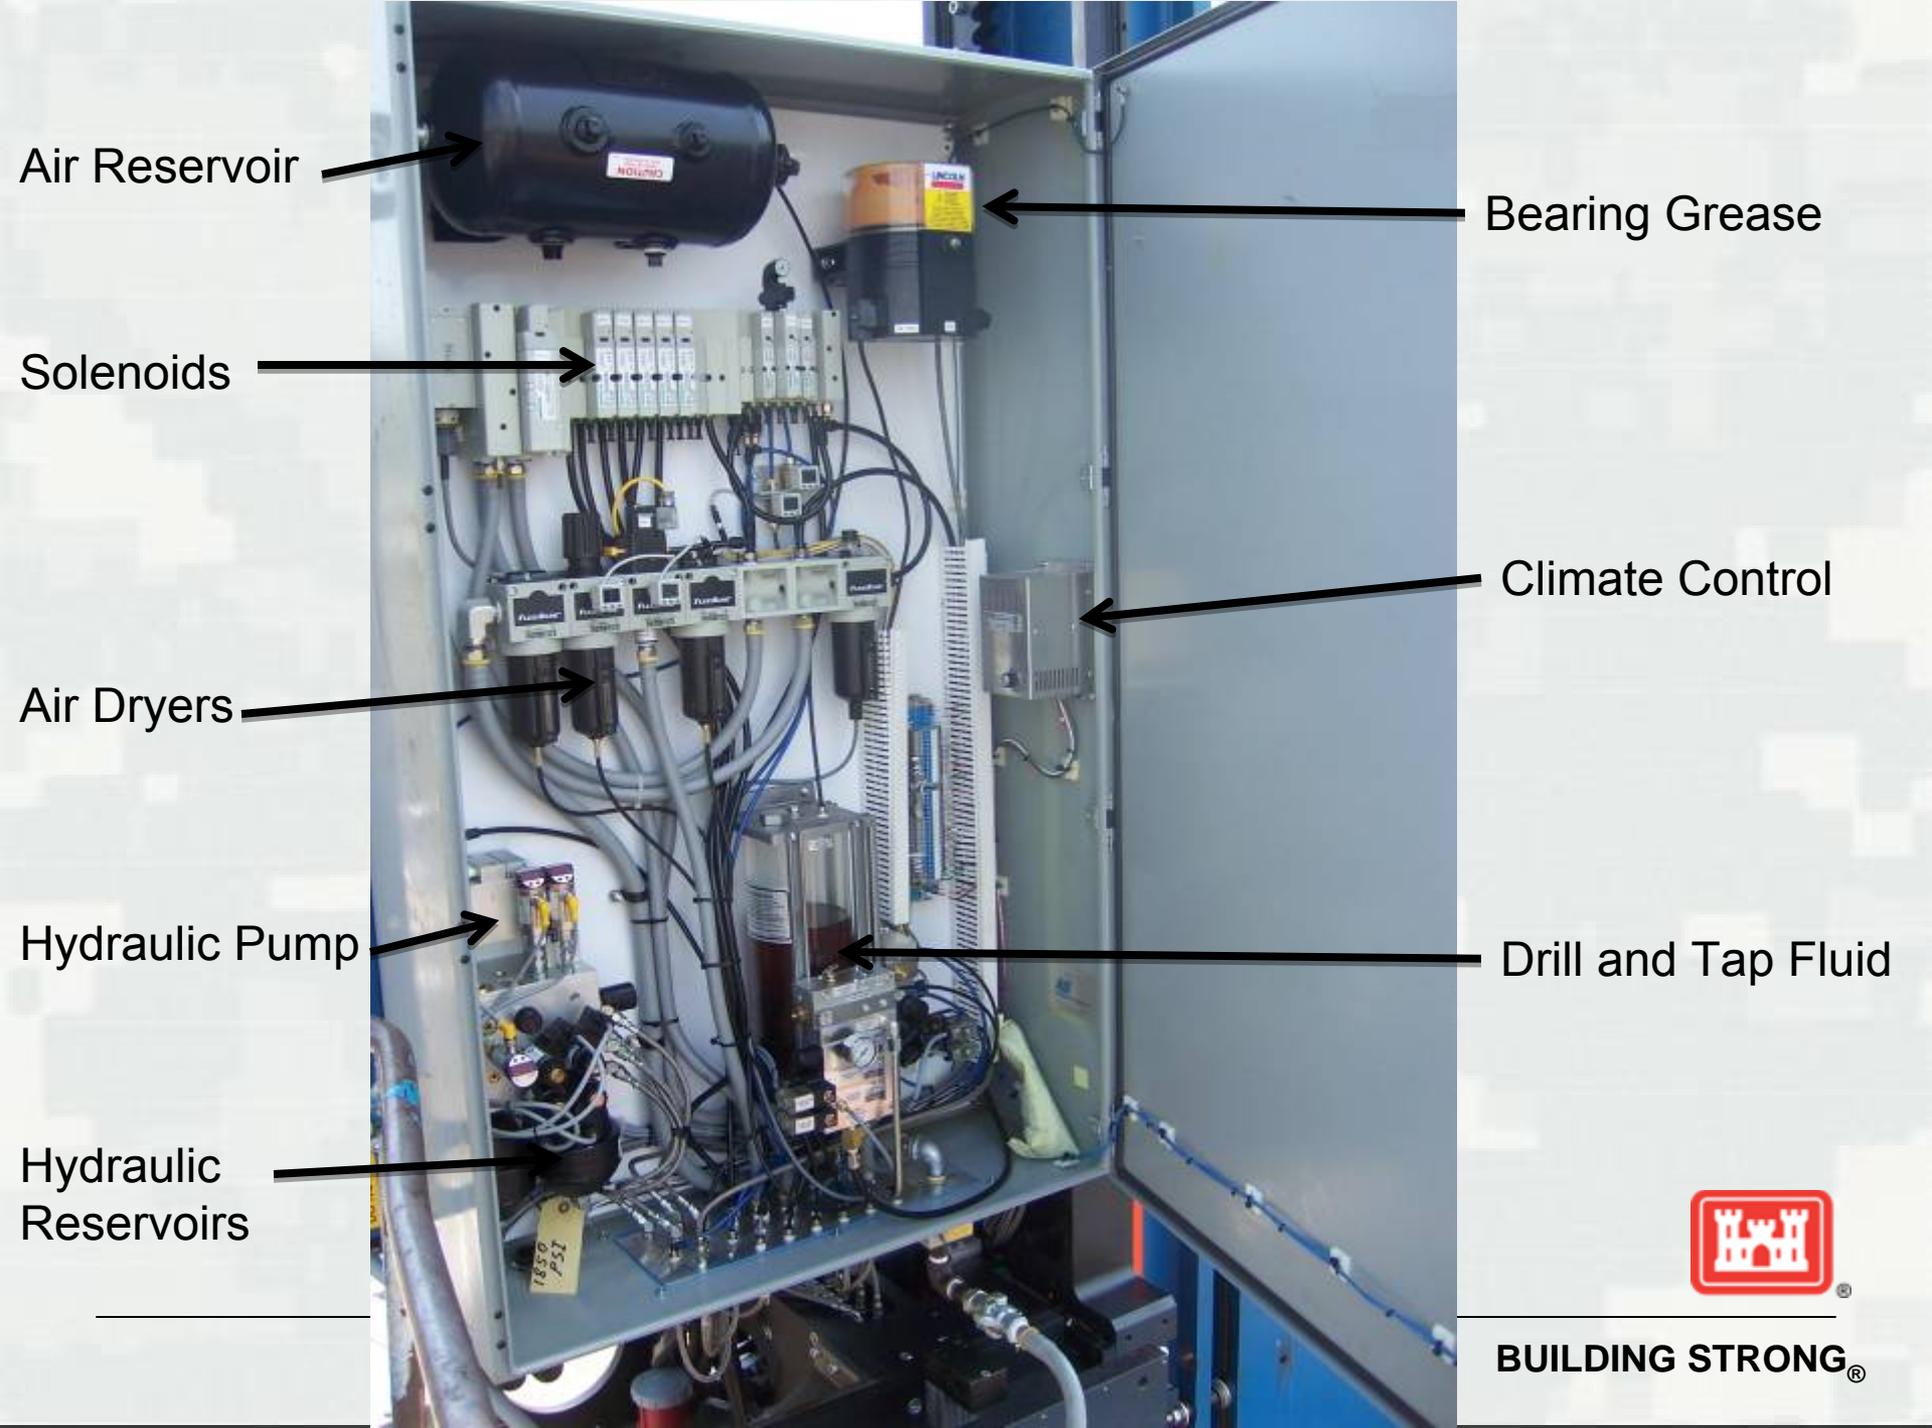
Air Reservoir

Bearing Grease

Solenoids

Climate Control

Air Dryers

Drill and Tap Fluid

Hydraulic Pump

Hydraulic Reservoirs

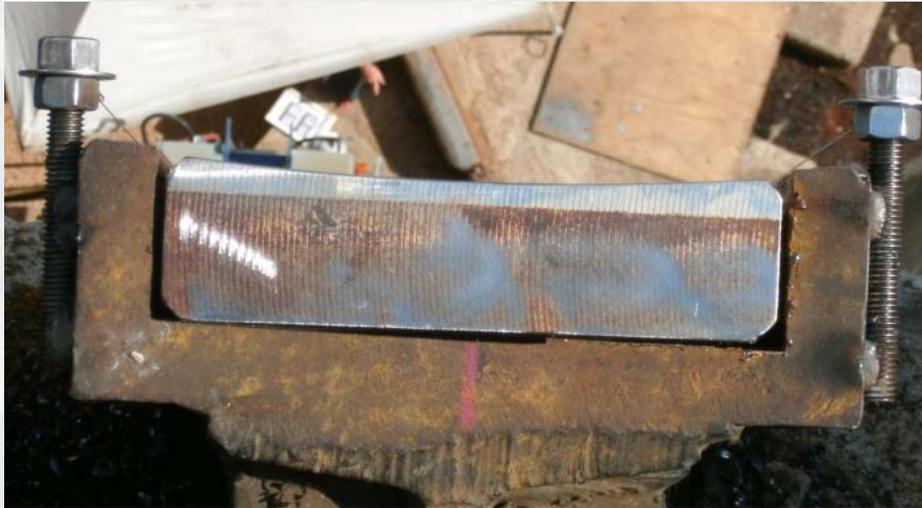
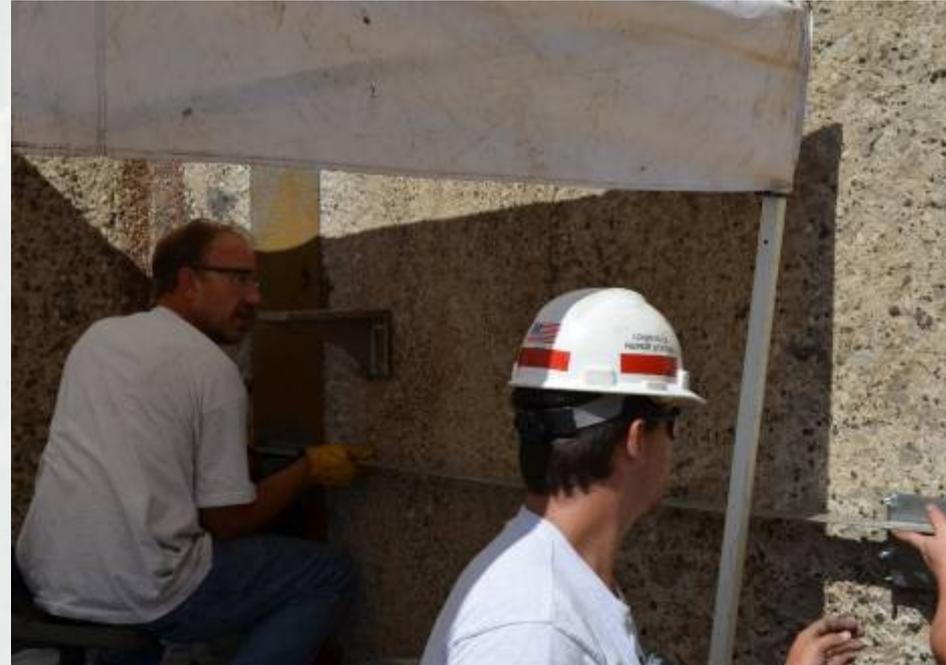
# Milling Problems

Quoin was worn on the downstream edge at the bottom. This caused a misalignment of the laser plate that set the “twist” of the milling machine. Therefore, the milling machine ended up cutting the quoin on a slant. In the future, “twist” should be set from the top of the quoin.

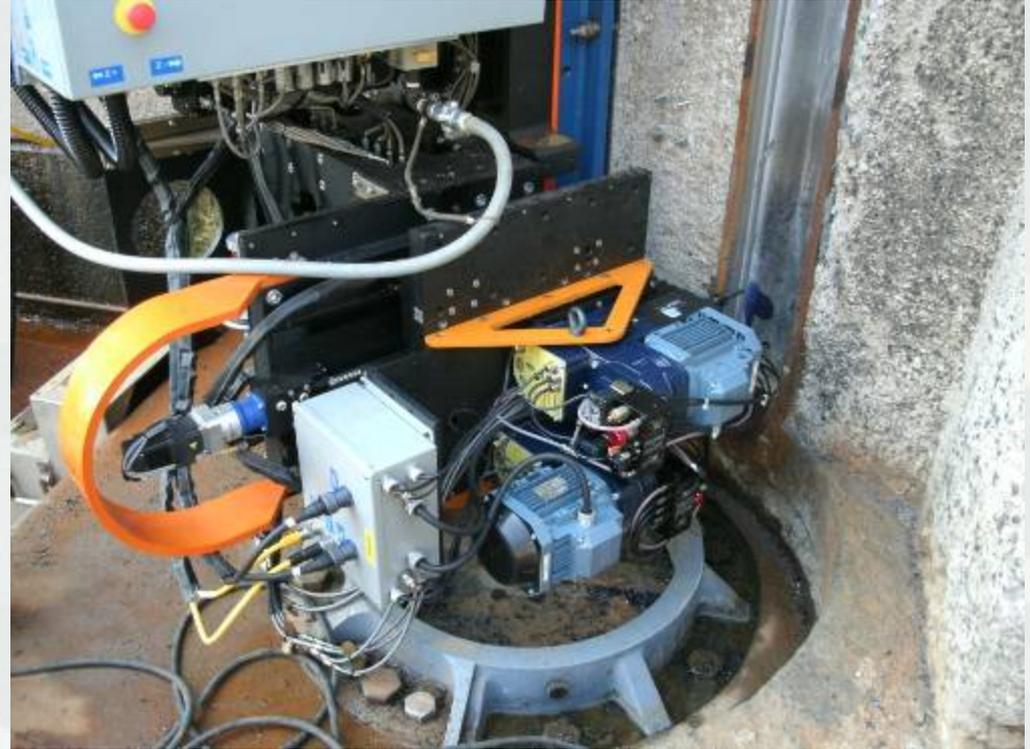
# Drilling and Tapping

Went very smoothly. Could drill and tap all but one hole.

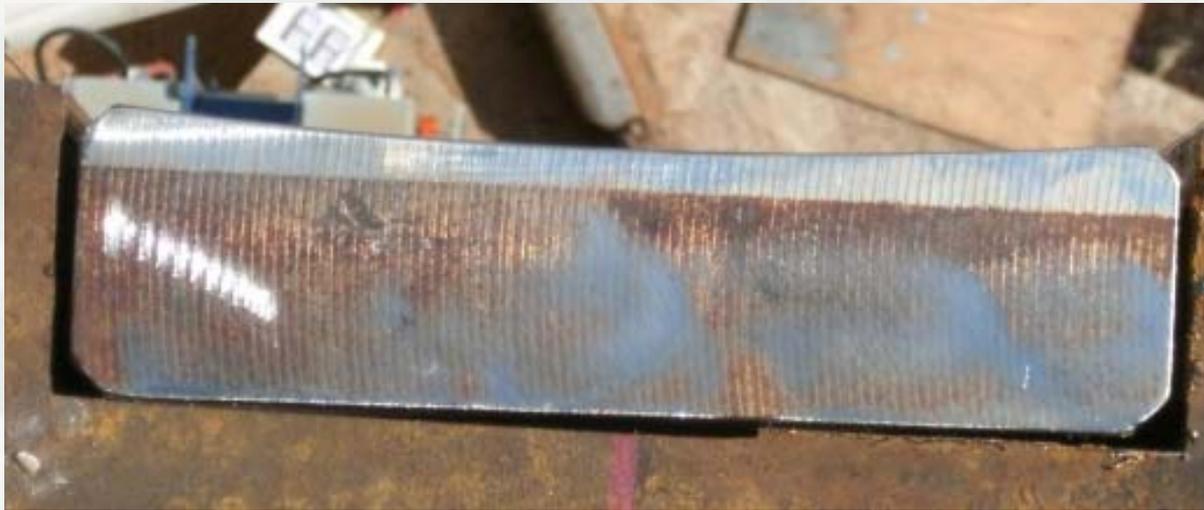
# New Wall Quoin Blocks

A36 steel blocks with 304 stainless, explosion clad onto it. Designed to simultaneously minimize corrosion of embedded steel and wear surface.

- Need to tolerance total length of blocks
- Need to add spec on total bow of block

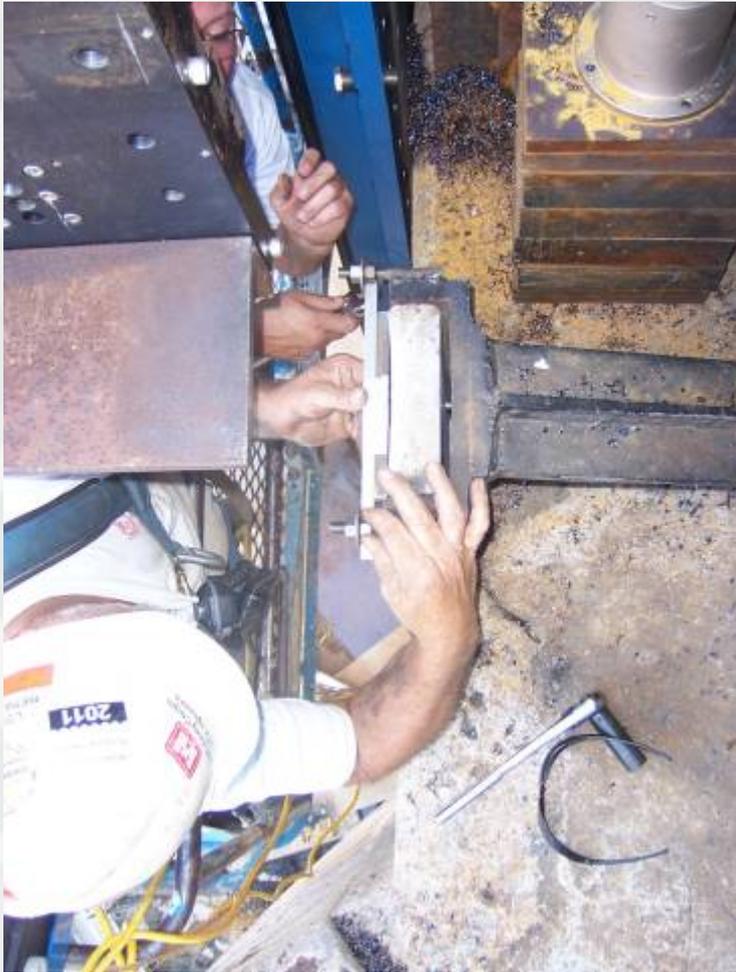
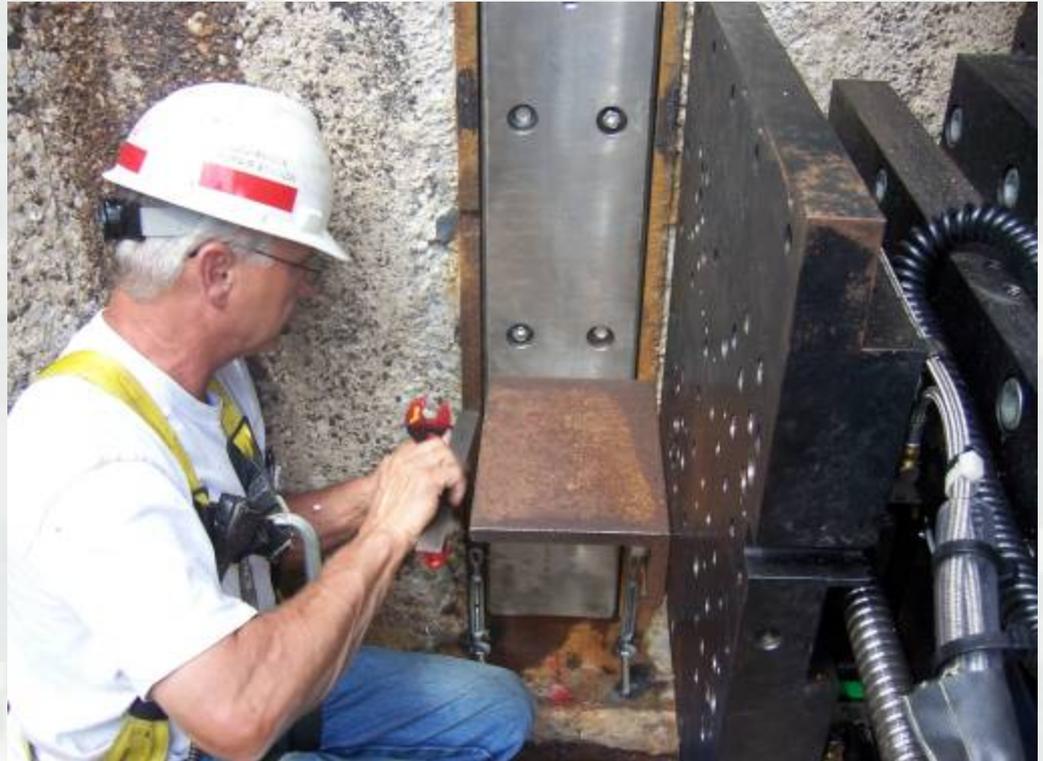
# Quoin Block Adjustment

Used string-line to adjust wall quoins to original position.

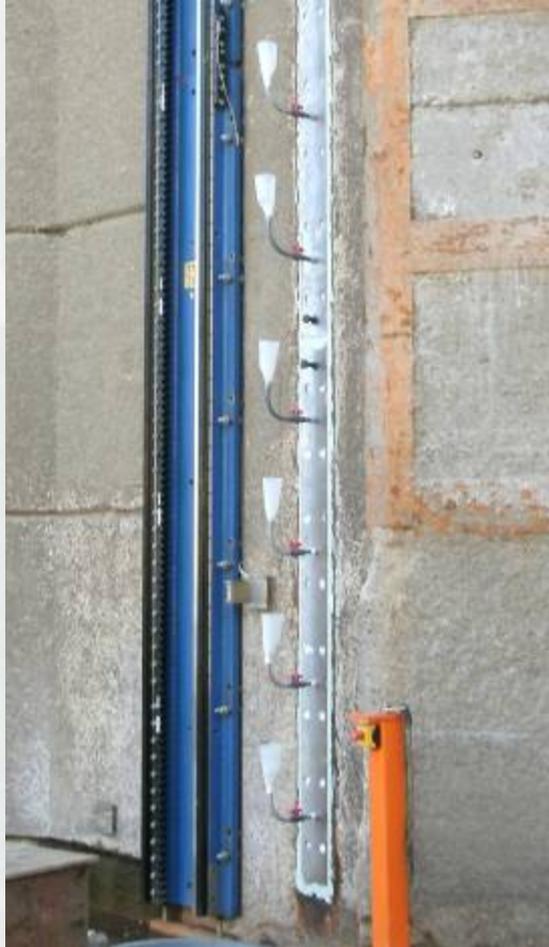
# Quoin Block Backing Material

1/2" pipe had too much friction for Copps

Funnels worked well, just had to wait for lower section to dry
