# Markland 1200' Gate Replacement and Wall Quoin Refurbishment

July 11 – November 17 2011

Craig Moulton and Kevin Vessels  
Louisville District

# Markland Locks and Dam

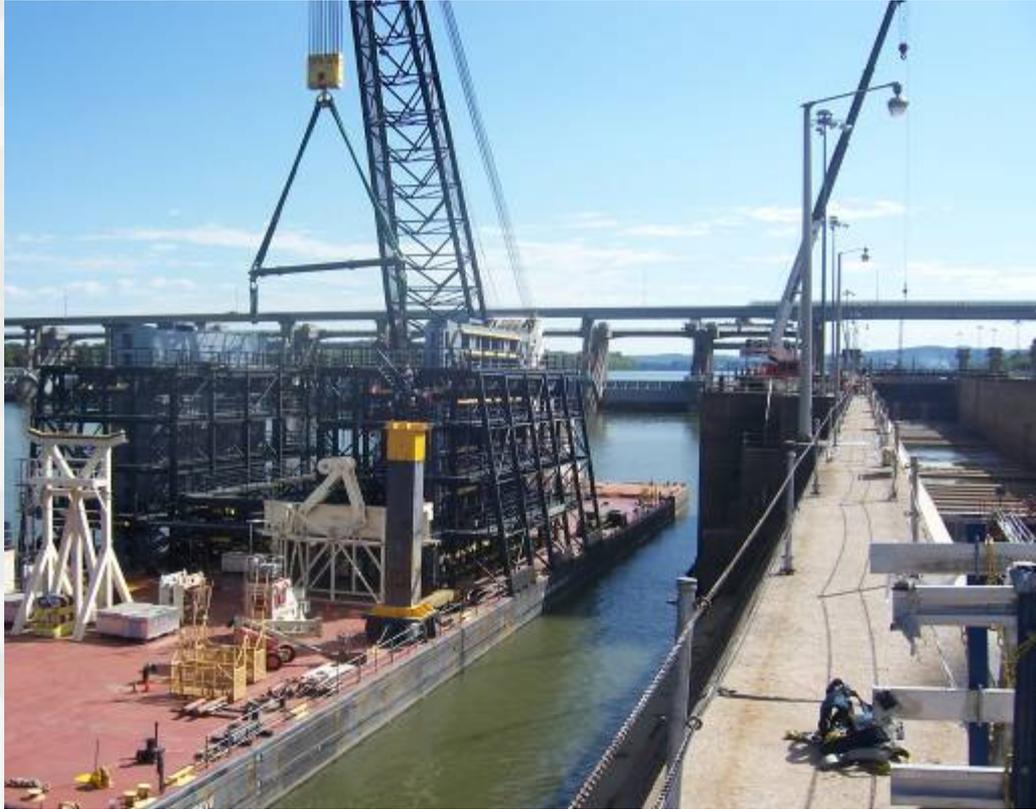
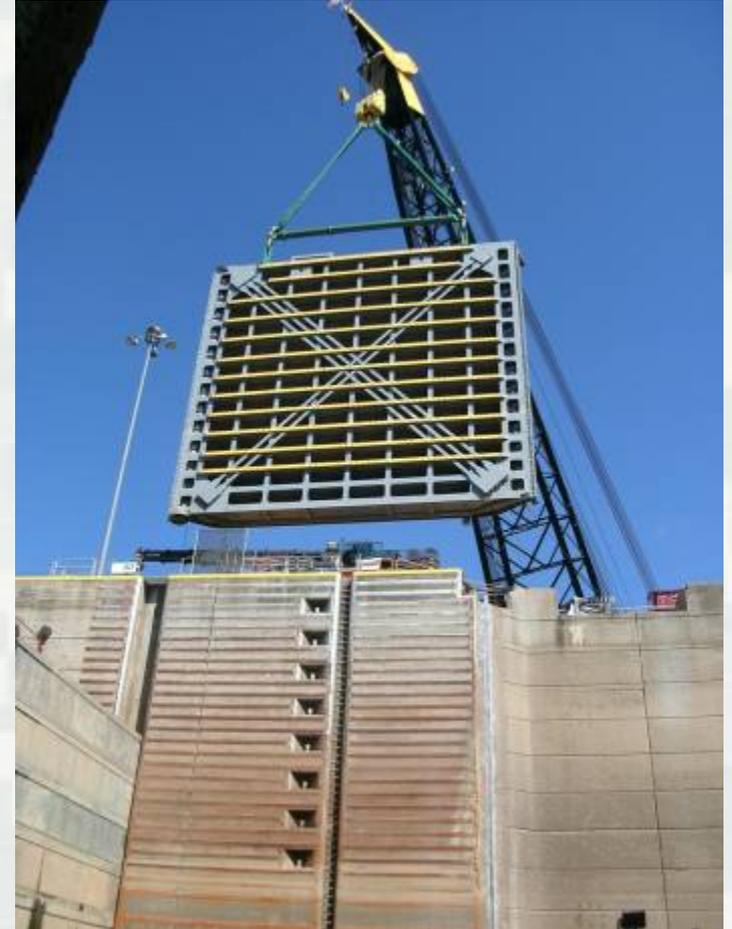
# Setting the Gates Over the Wall

Developed new method for setting gate in the dry.  
Will save 1 week per gate movement.

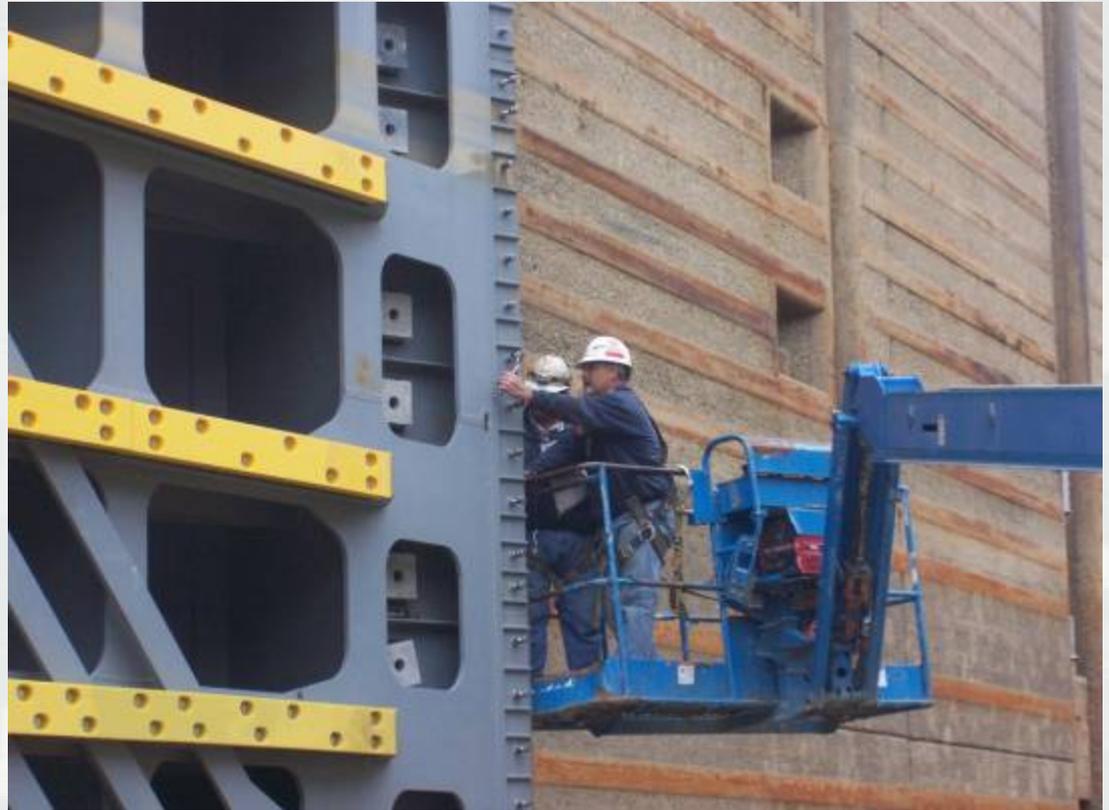
# Gate Adjustments

Wedge adjustment system allowed only  $\frac{1}{2}$ " total adjustment. Developed new adjustment method to prevent removing the blocks to add shims.

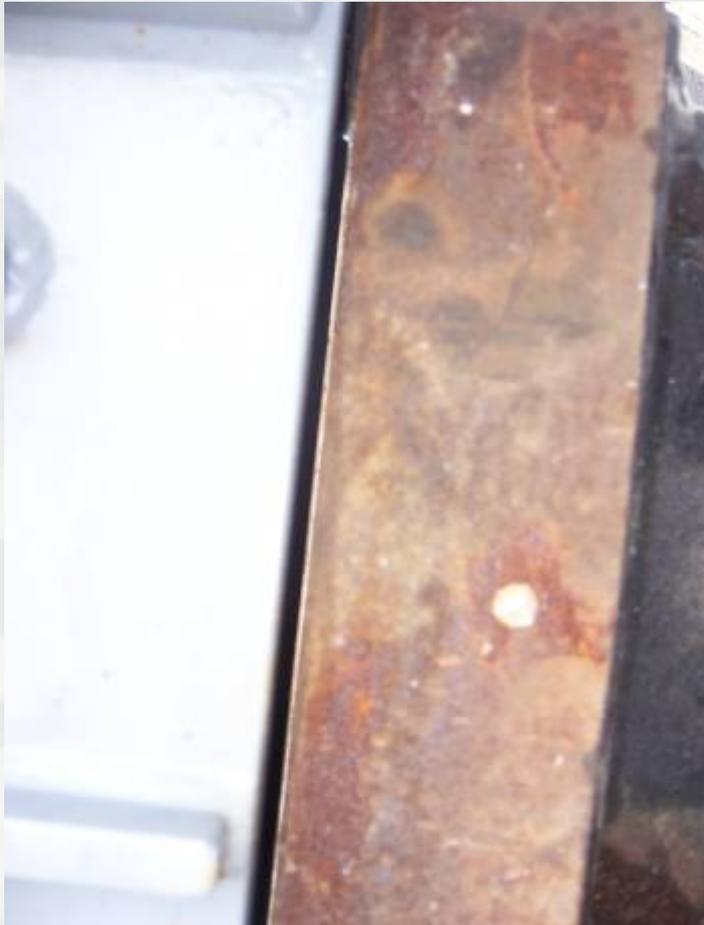
# Gate Adjustments

There was a pre-existing problem with the gate leaves that caused the quoin blocks to be adjusted all the way in and 1" larger miter blocks to be installed. The wedge adjustment system did not have a large enough adjustment range to accommodate this even after we moved the pintles. The quoin blocks had to be sent to a contractor to be milled. To install shims behind the miter blocks, the blocks had to be completely removed.

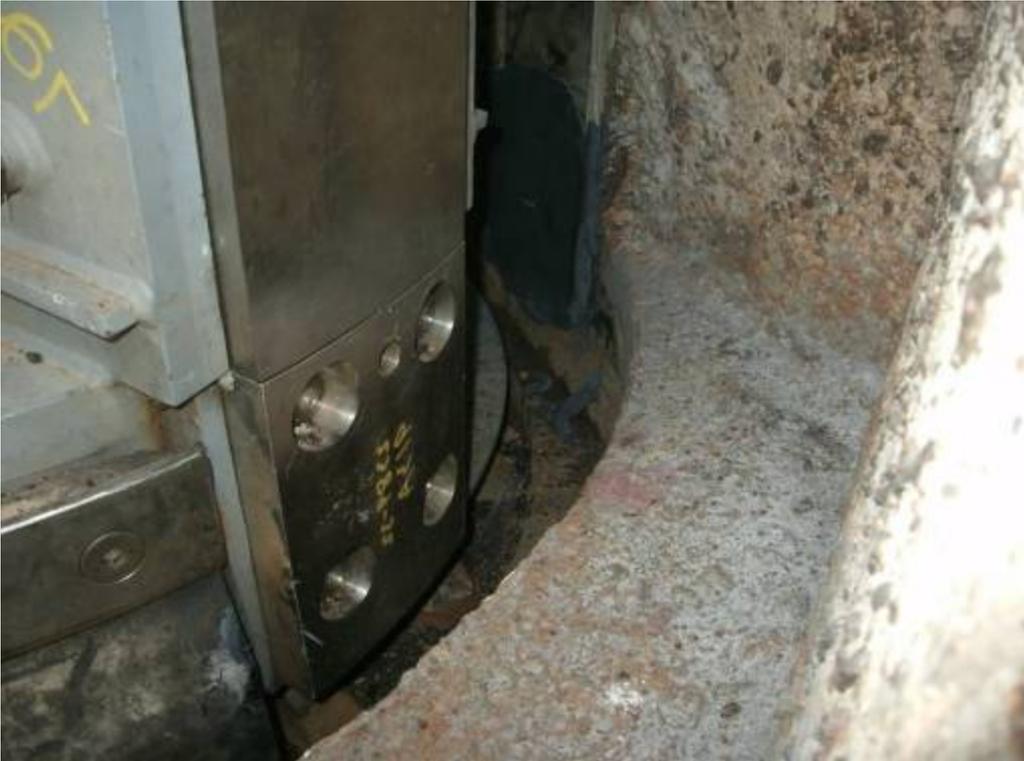
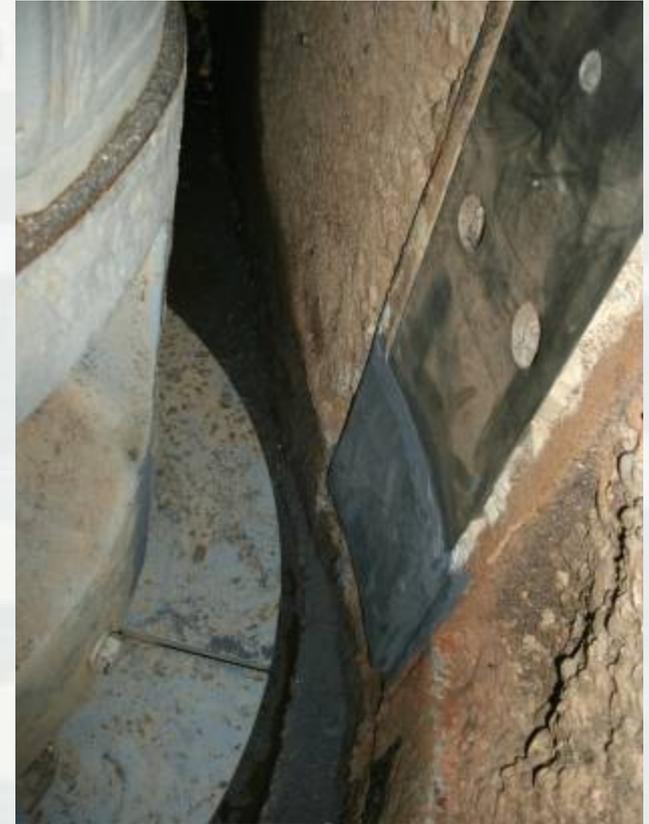
# Gate Adjustments

Could not adjust bottom quoin block out to wall quoin. Used polymer steel to fill the gap.

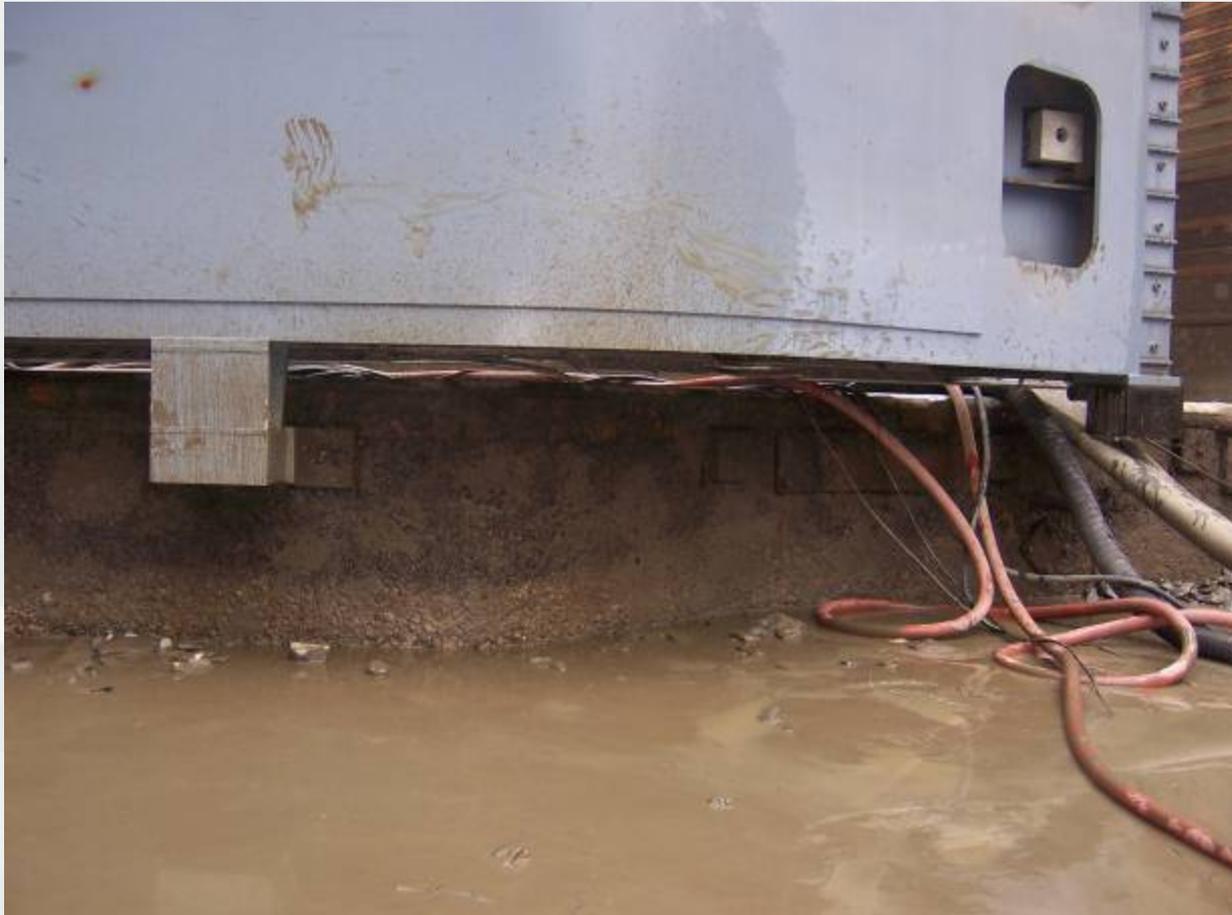
# Gate Stop Modifications

Designed gate stop was in the wrong position

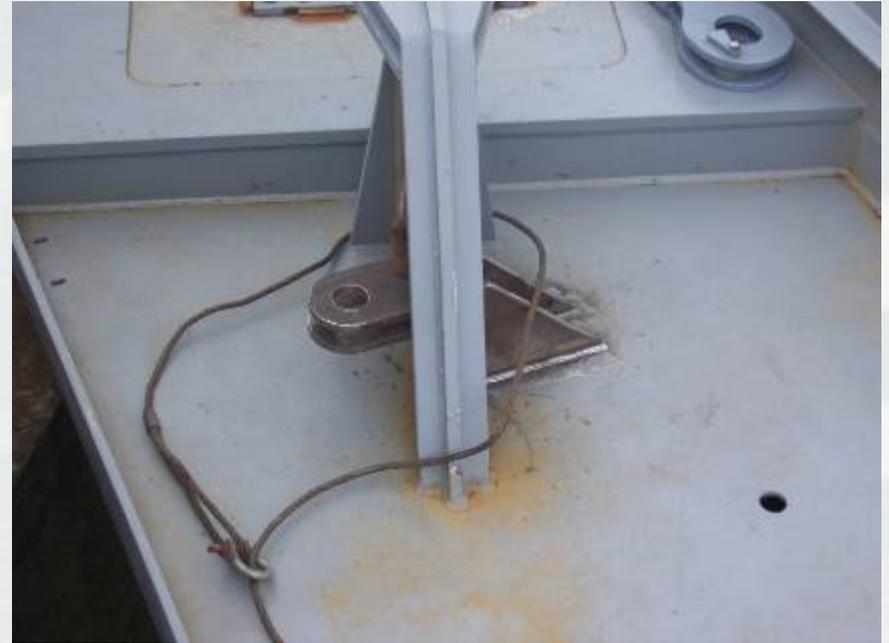
# Upper Recess Latches

No upper recess latch  
designed with gate

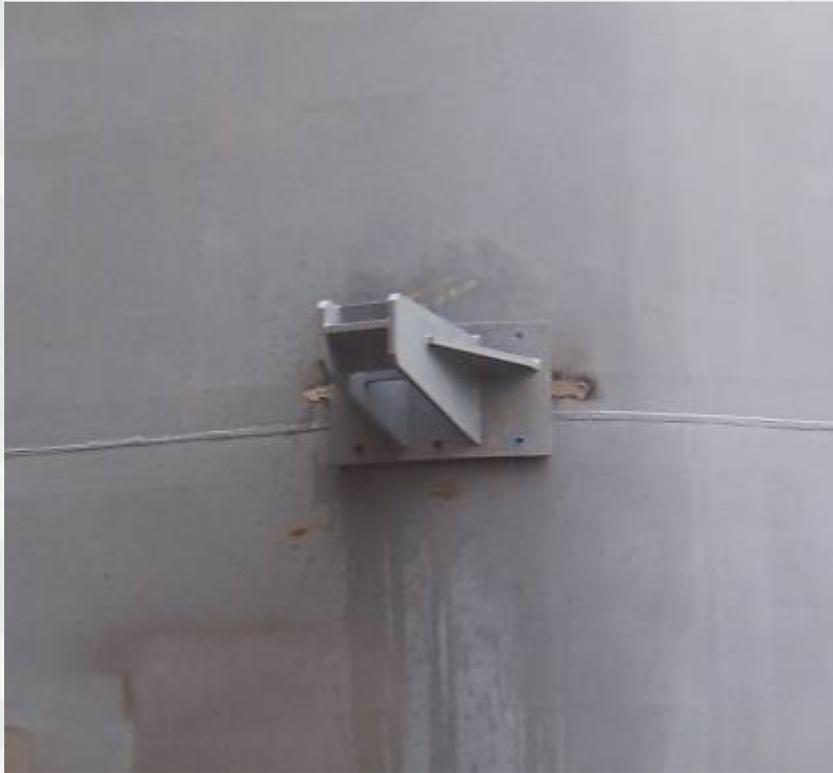
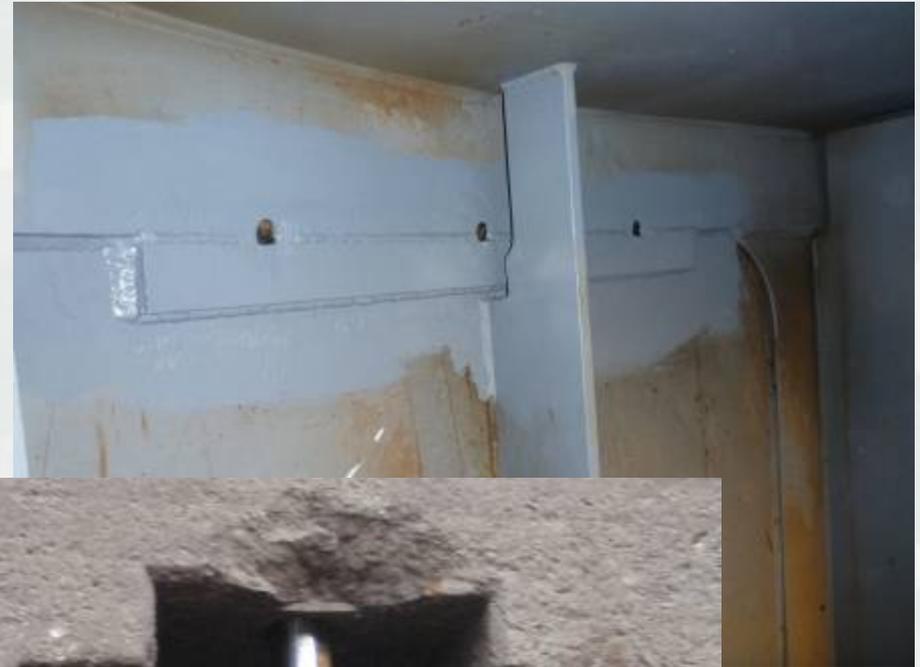
# Lower Recess Latch

Original gate latch was welded to fit. The upper end had modifications done that were not transferred to the new gate.

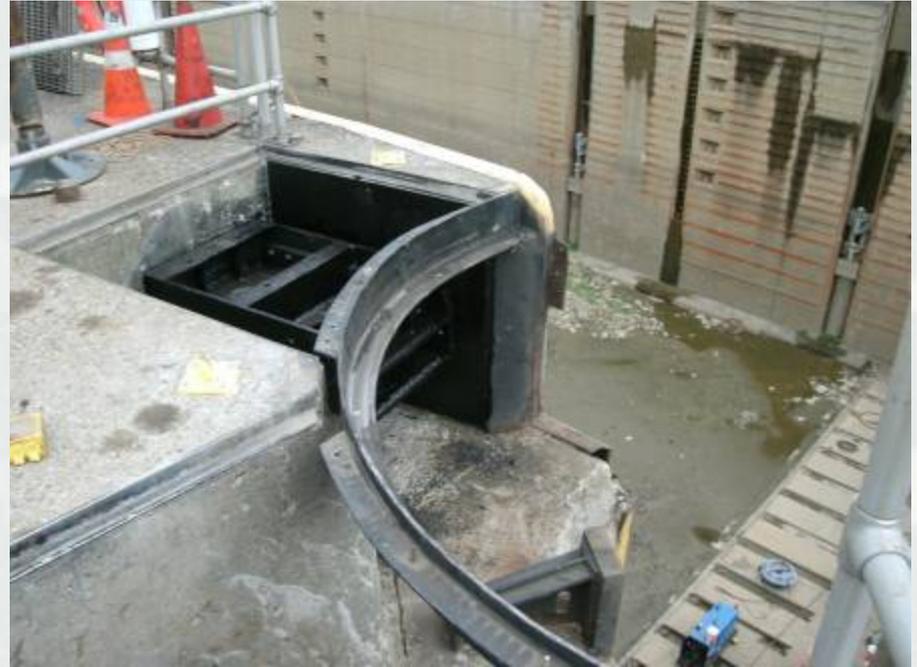
# Walkway Modifications

Walkway was too big to fit with the existing supports and concrete.

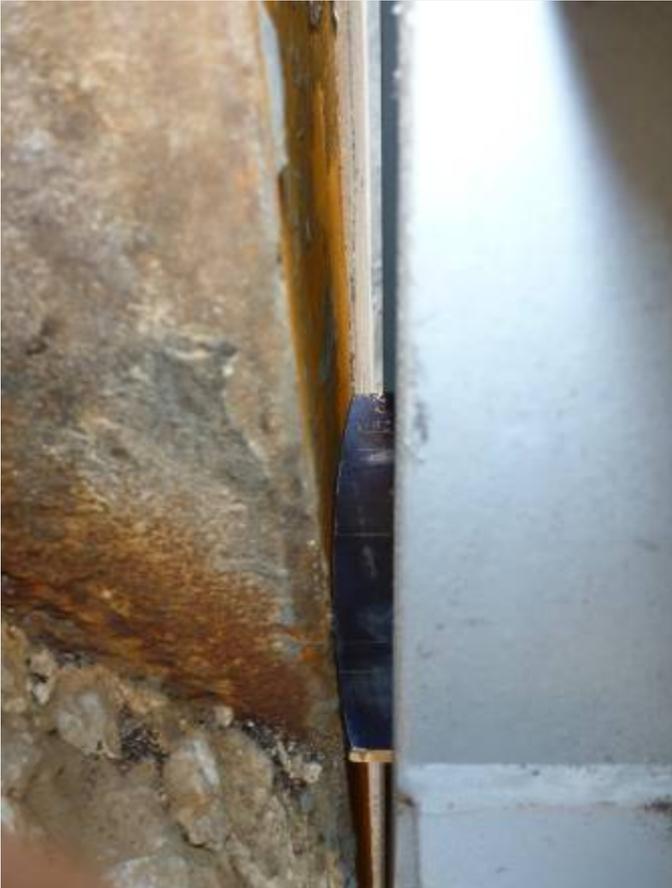
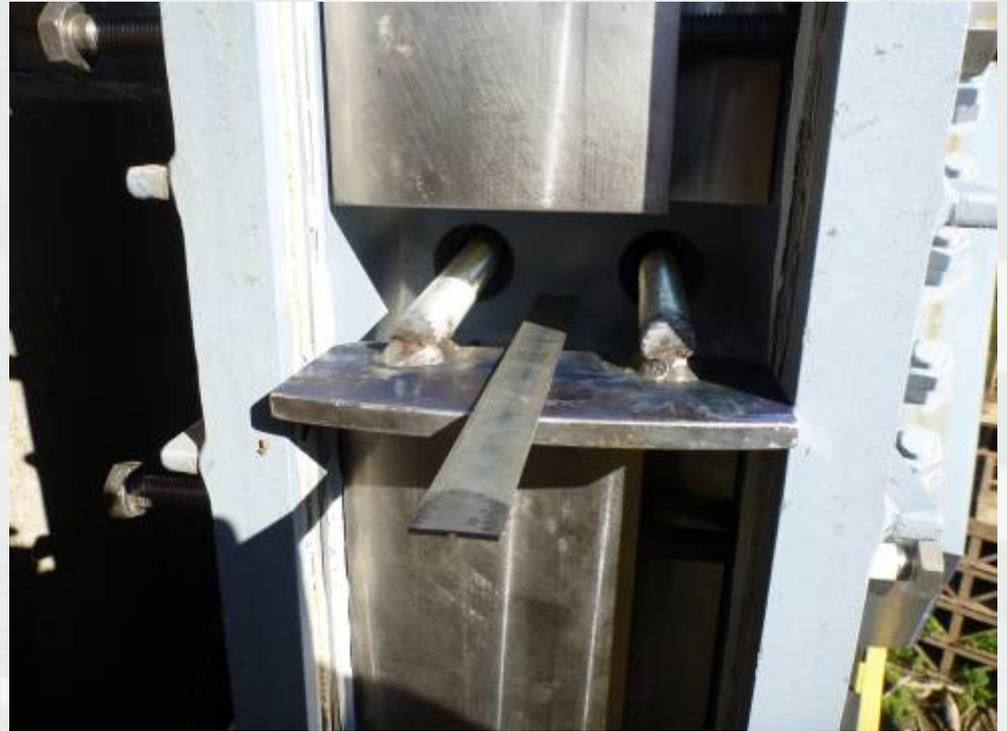
# Quoin Block Measurement

After the lower end measurements did not work well, needed an accurate system for the upper end.
