# Evaluation of Embedded Wall Quoin Rehabilitation Methods

**Ross W. Woodbury, P.E.**

Louisville District

1 March 2012

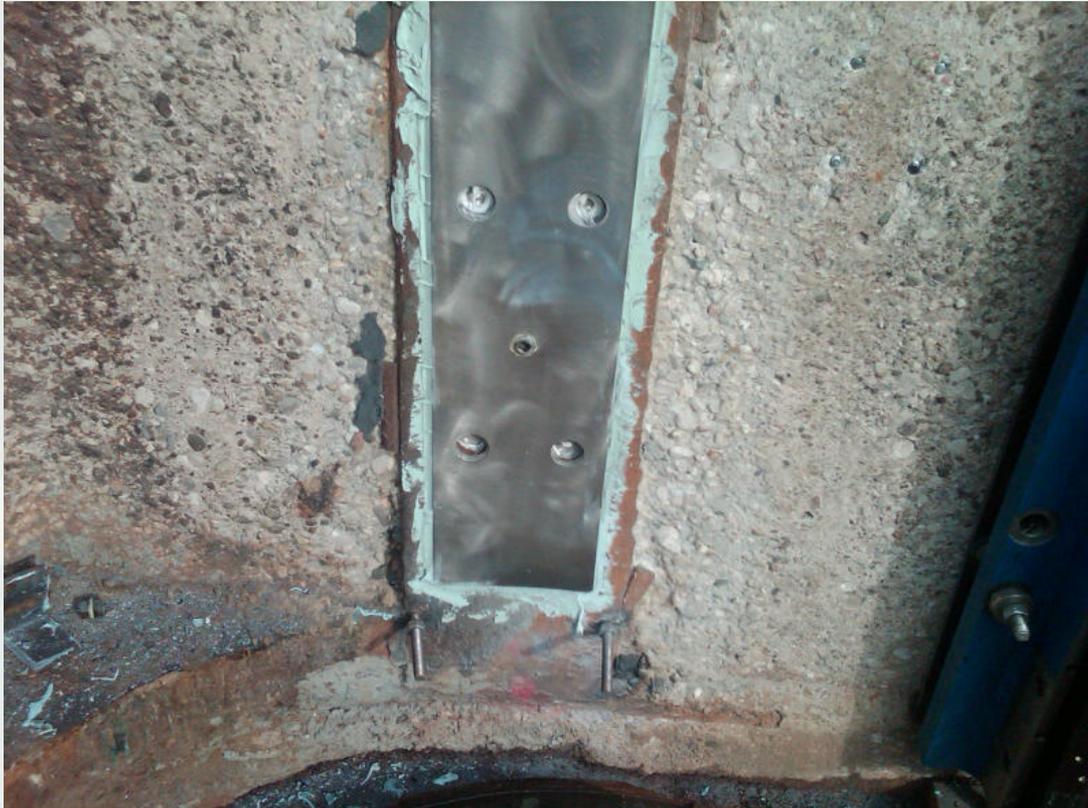
# Finished Wall Quoin

- Both projects will have wall quoin blocks that are adjustable and replaceable in the future
- Markland's are stainless steel clad on the bearing surface and backed with epoxy
- Meldahl's are carbon steel and backed with zinc
- Both projects will have new miter gates
- Both projects will have new or refurbished anchorages
- Meldahl will now have horizontal seals

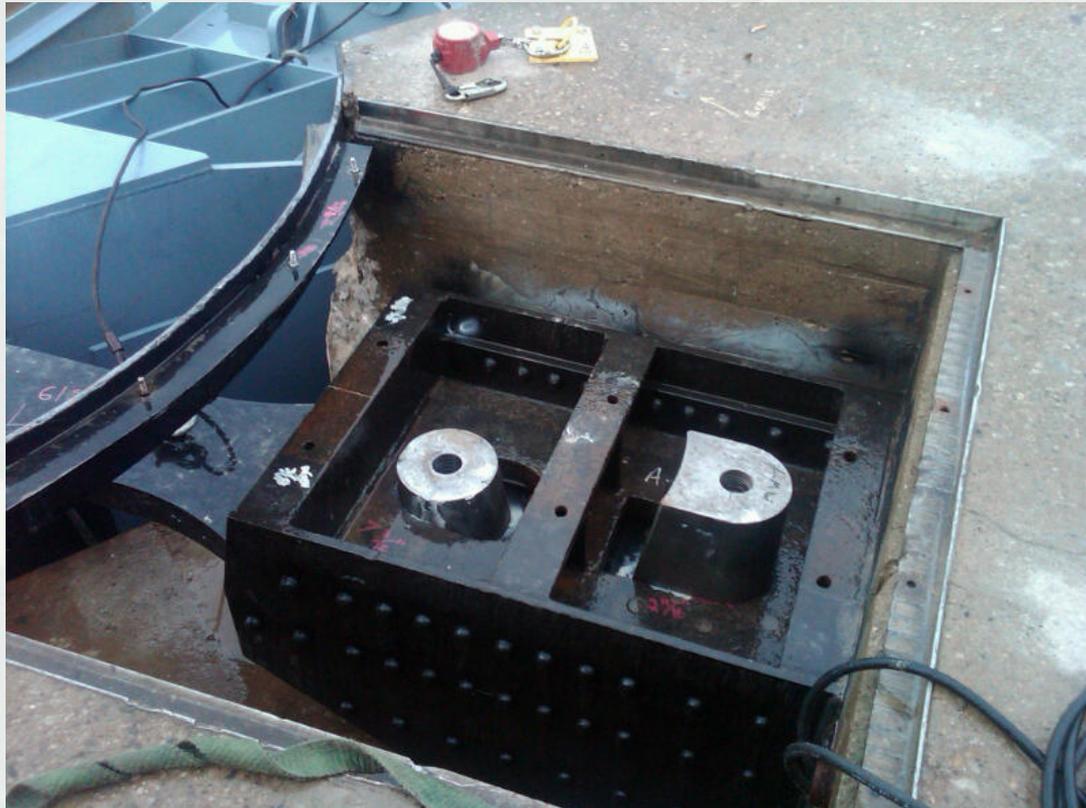
# Refurbished Markland Anchorage

- Existing embedded anchorage reused
- Heavy riveted structure analyzed for fatigue by Louisville Engineering Division. No concerns or problems found.
- Anchorages were sandblasted, inspected for cracks and defects by NDT methods. Anchorages were painted and assembled using original style components but with improved material properties and inspection during fabrication.

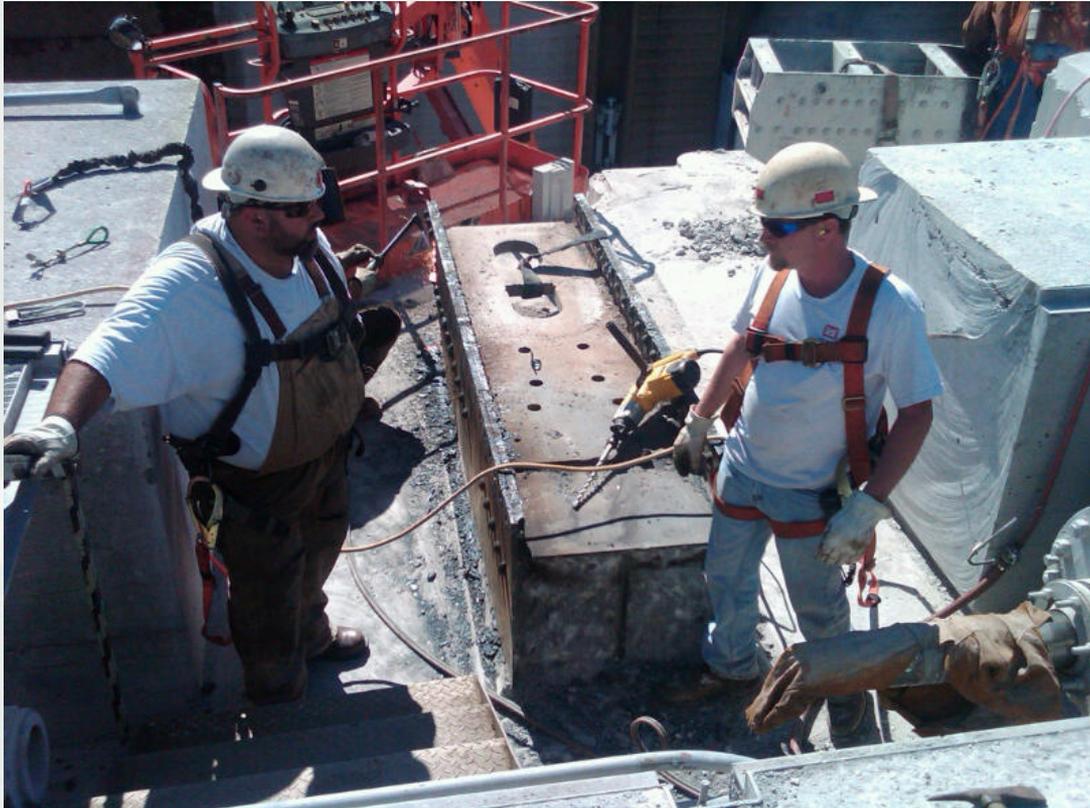
# Meldahl Anchorage

- The existing concrete around the anchorage was removed and the existing structure was modified to accept a new style anchorage per Huntington District Engineering Division. This was in response to the anchor arm failure at Greenup lock.

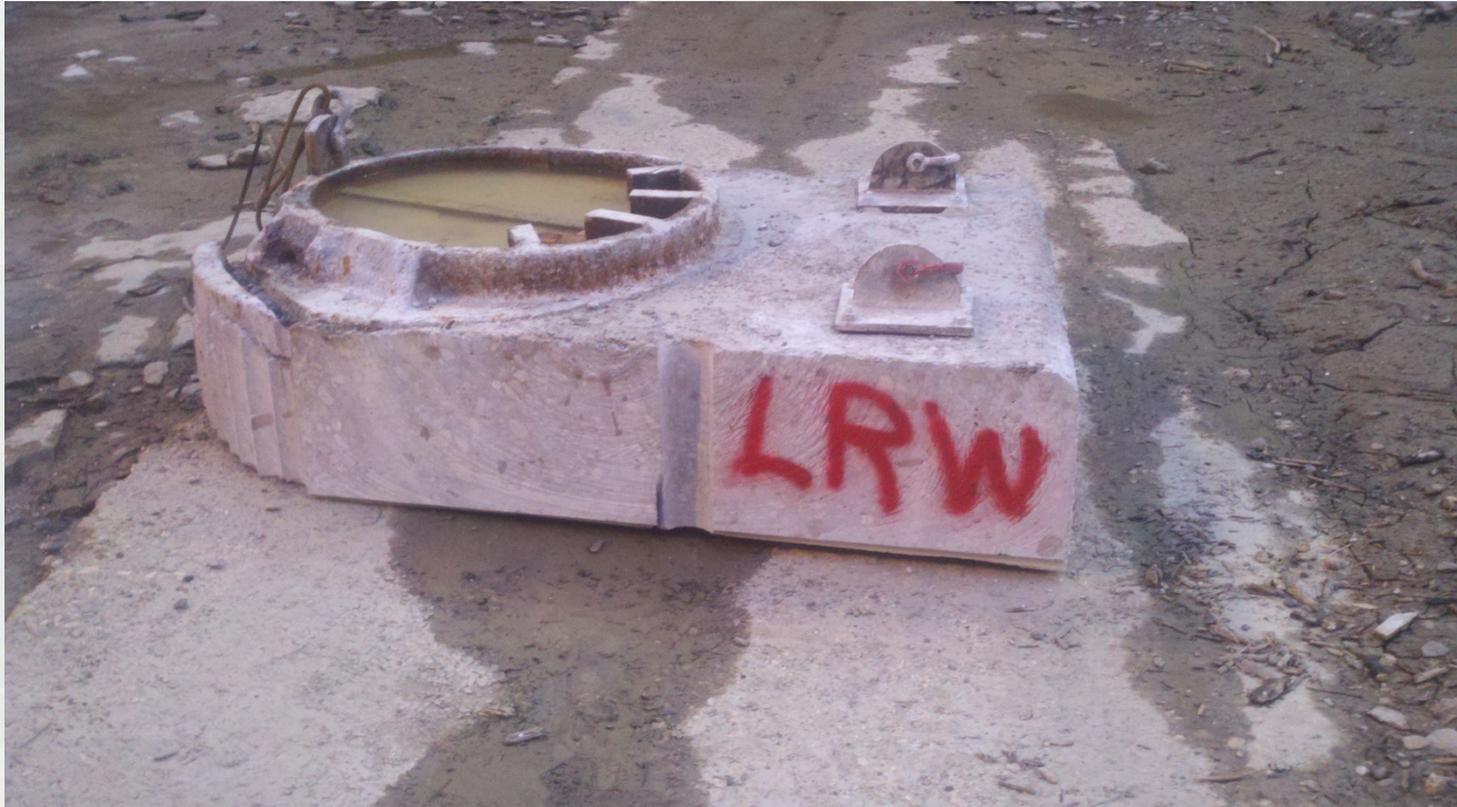
# Markland Pintle Base

- Markland pintle bases were replaced to change to a fixed pintle and the existing bases were damaged when the gates fell.
- Meldahl bases were modified to make the pintles fixed.
