Lock & Dam 52

Embedded Anchorage Replacement

Louisville District

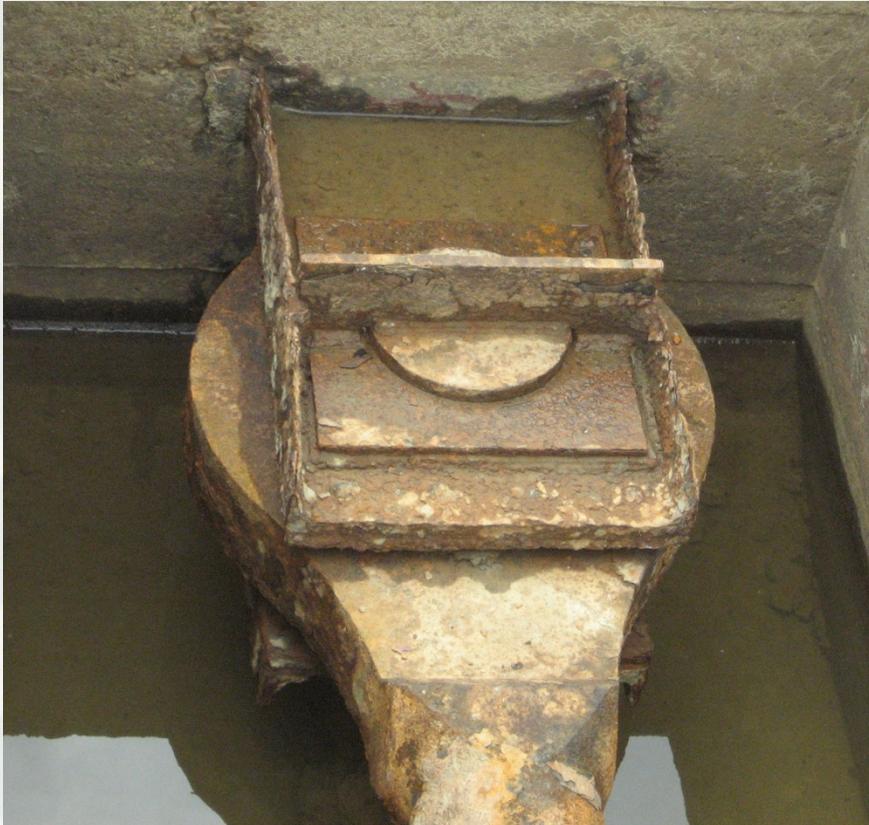
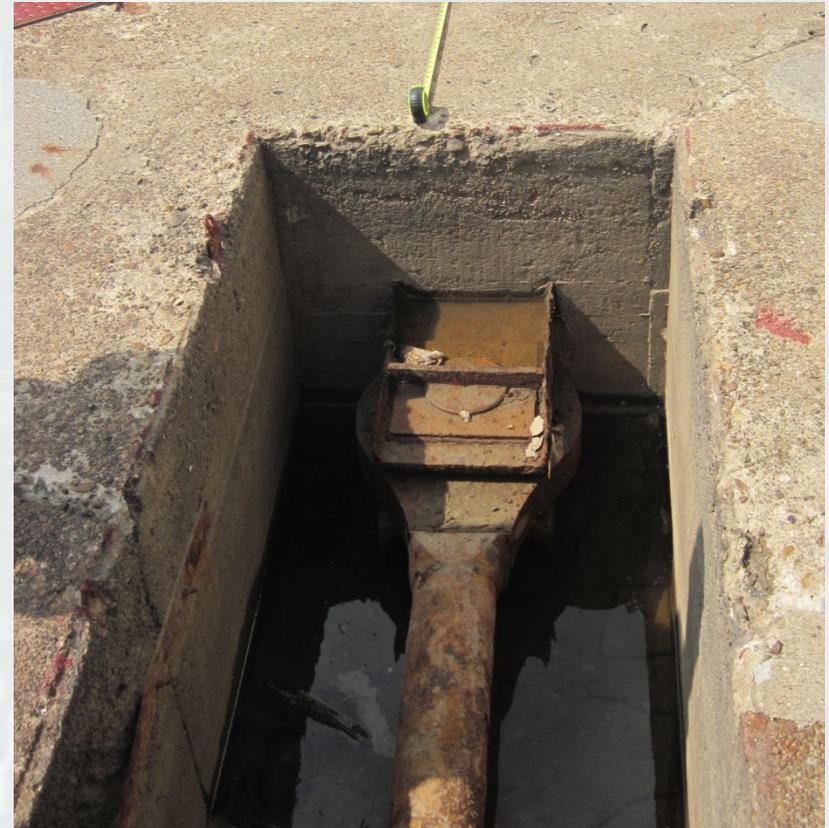
Purpose

- Replace severely deteriorated embedded anchorage members.

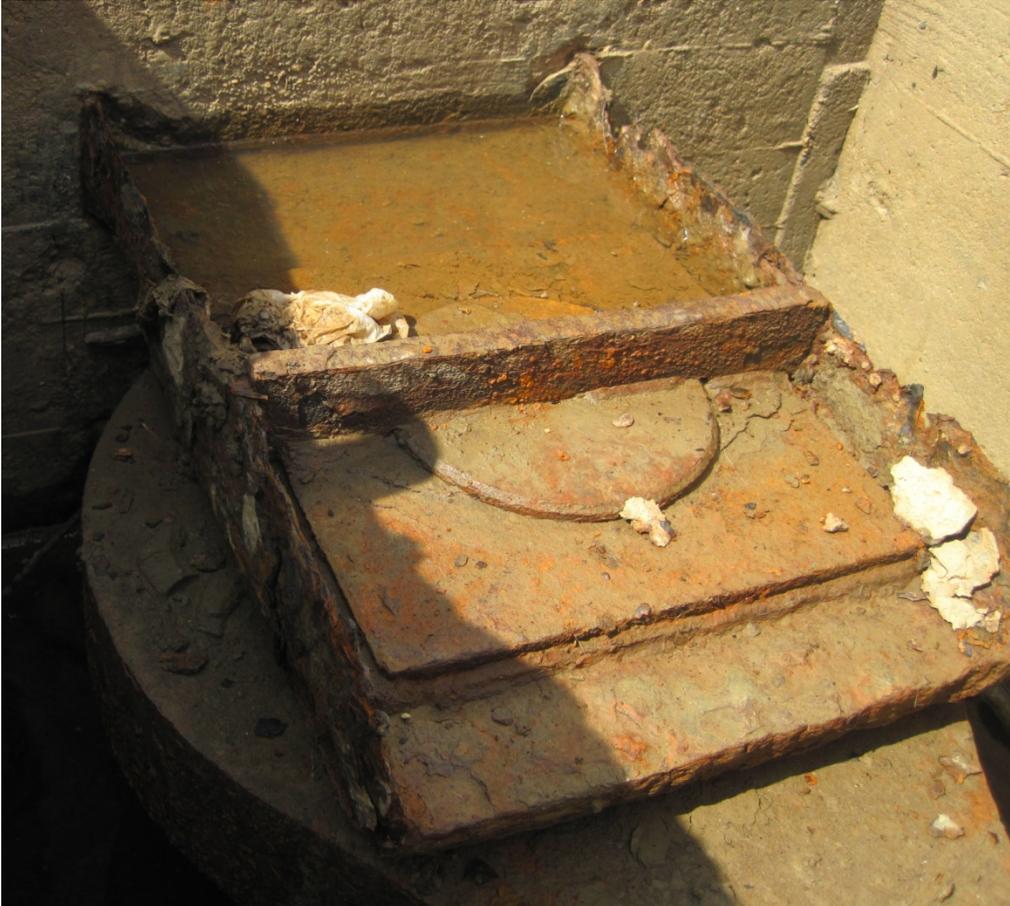
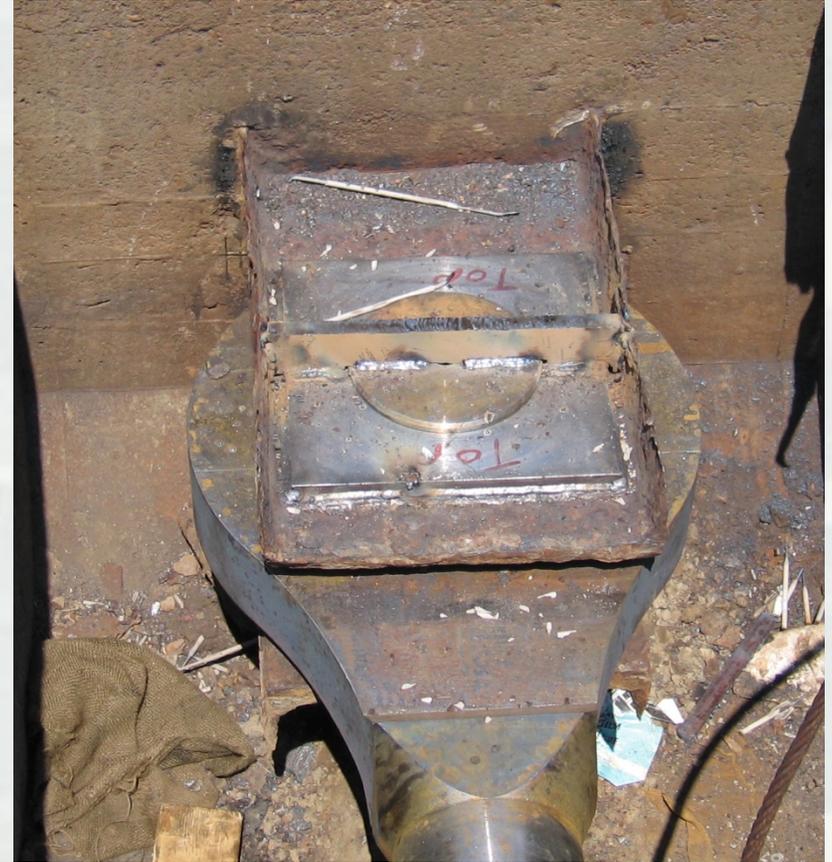
Purpose cont.

- Additional plates had been welded on during past maintenance projects in attempts to delay a major failure.

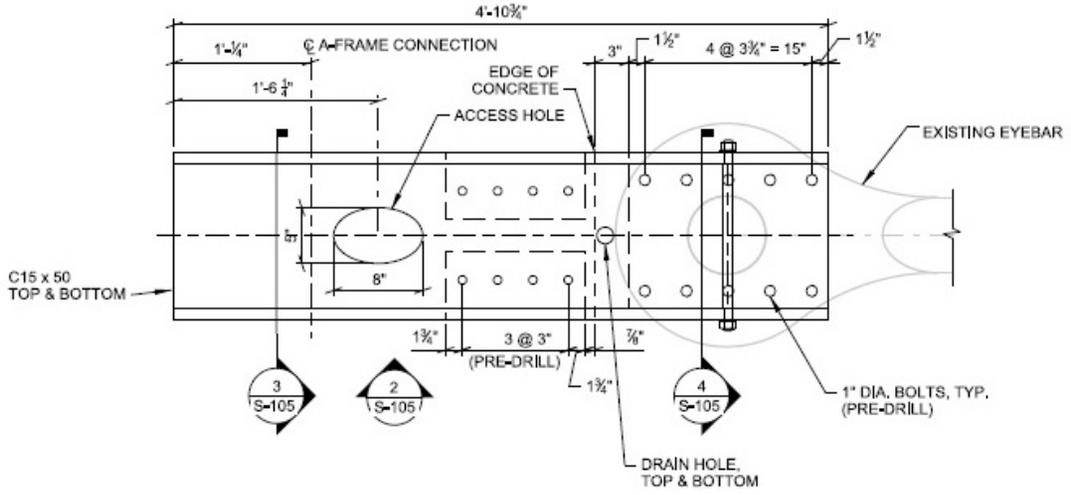
1 PLAN - 4'-10 3/4" ANCHOR BEAM

Replacement Anchorage Bolted Design
