Lock and Dam 52, 2015 Work

Kevin Vessels

Louisville District

February 2016

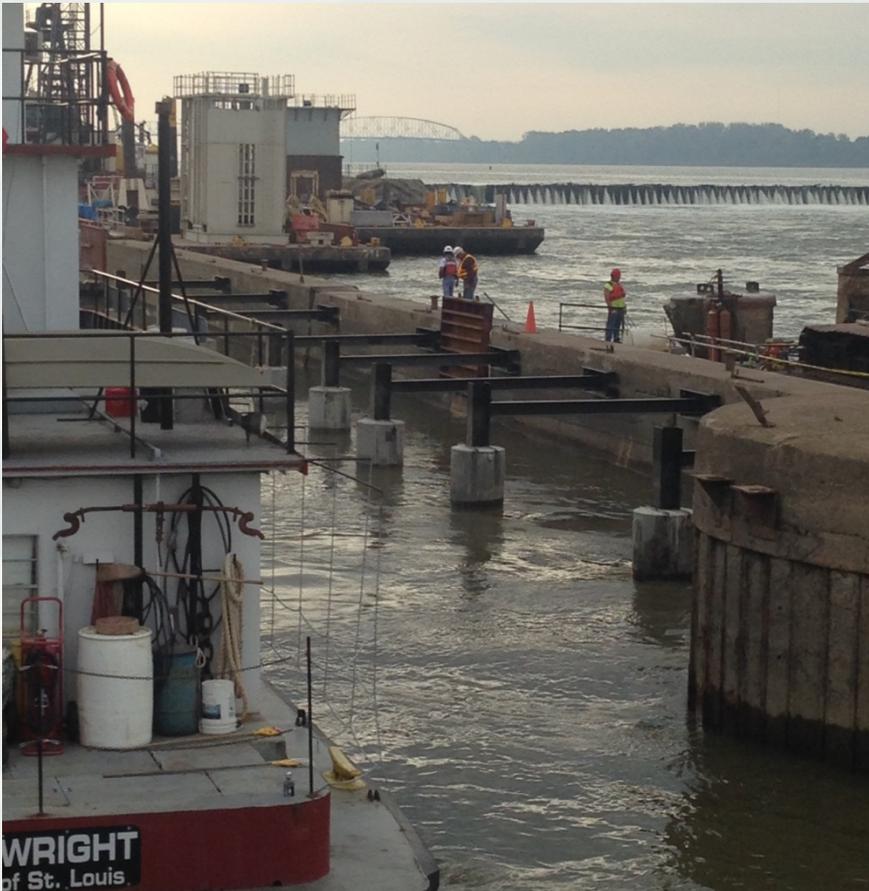
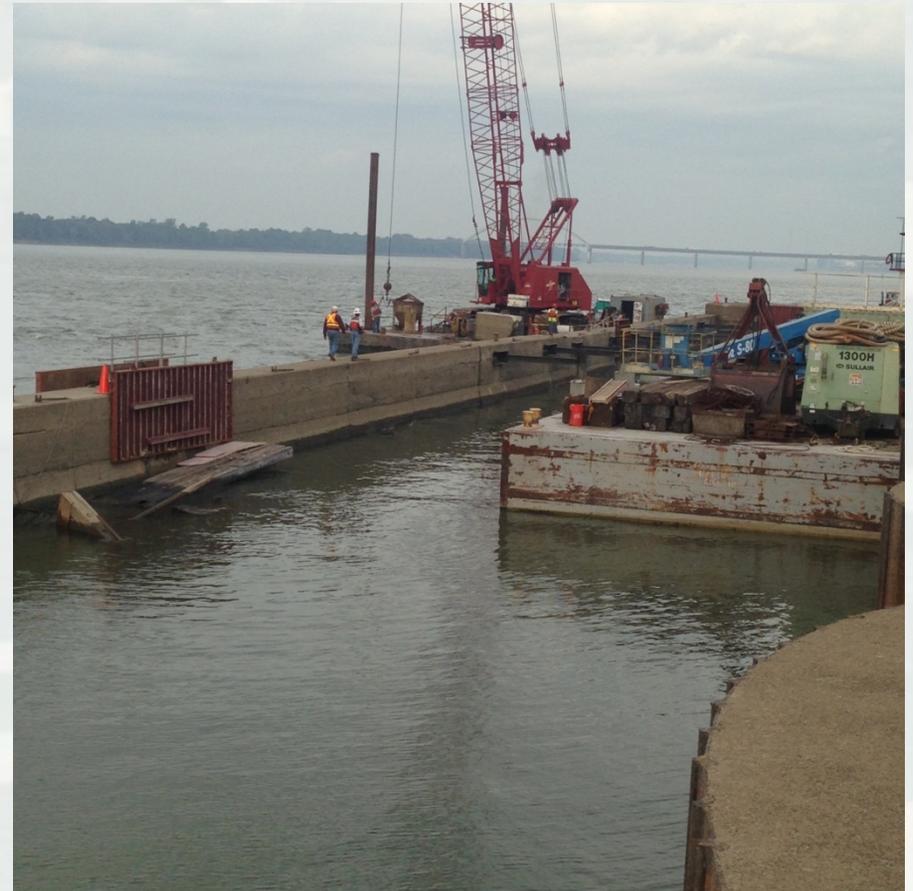
Lower 600 ft Guide Wall Stabilization and part of monolith 6 pulled and replaced (Contractor, Massman)

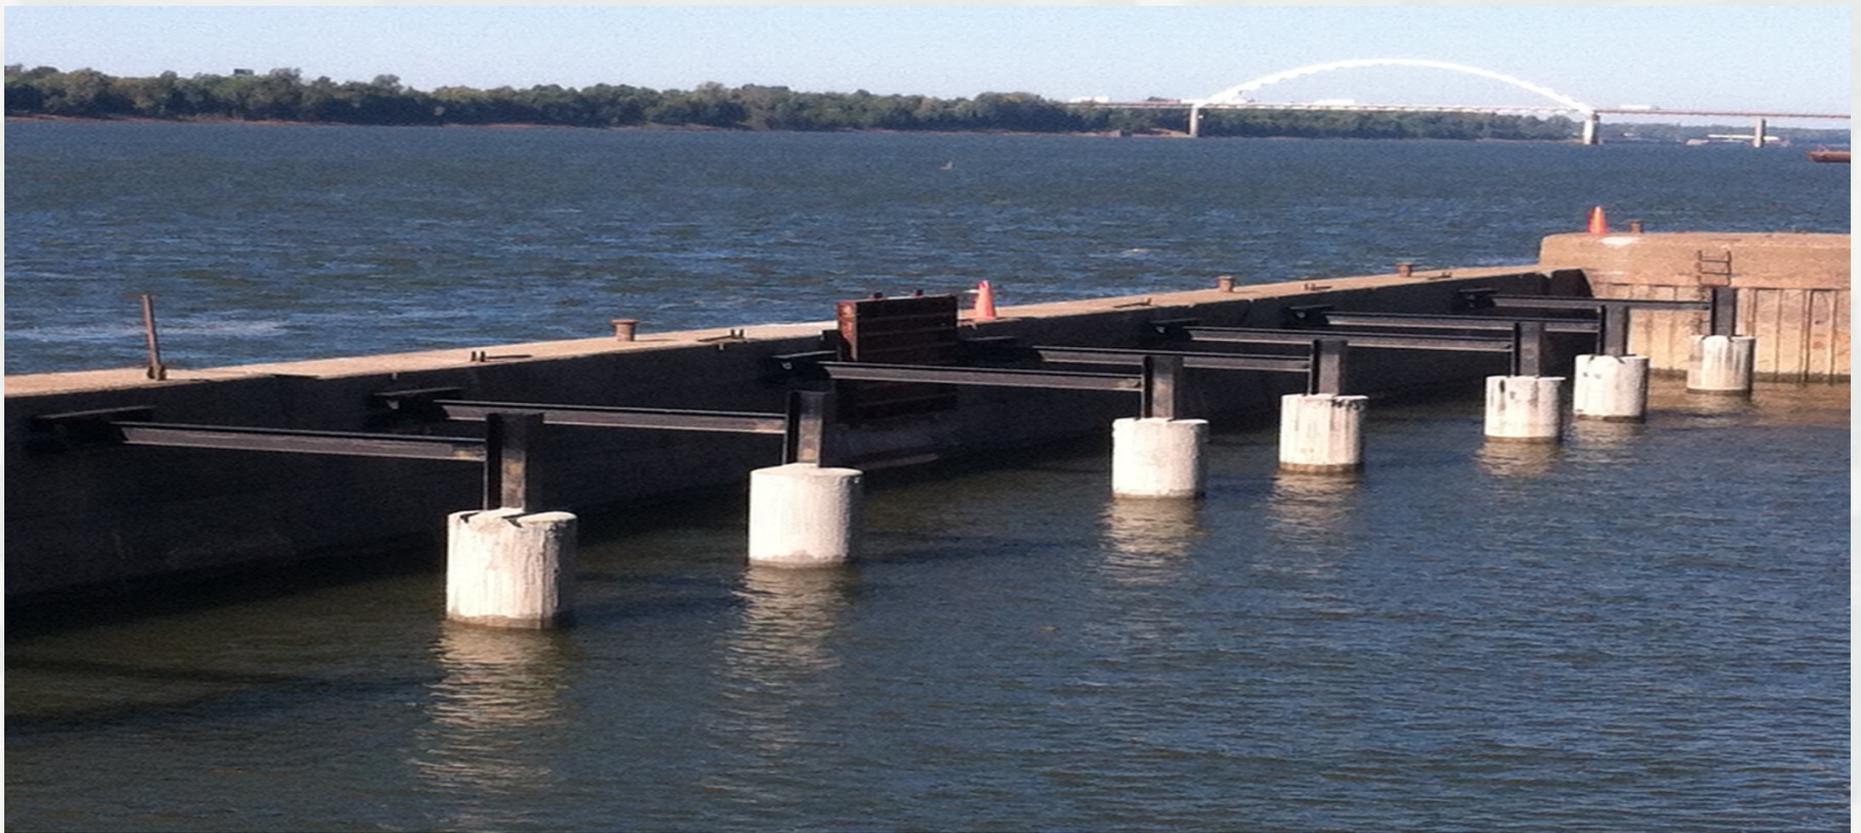
Downstream View

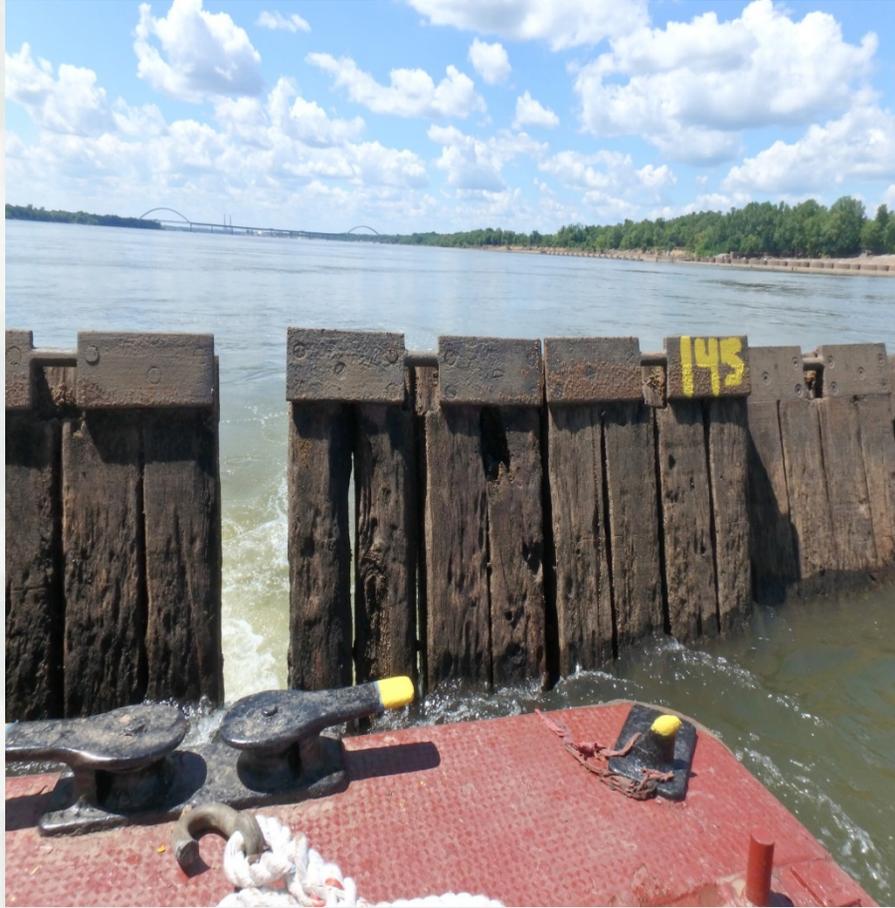
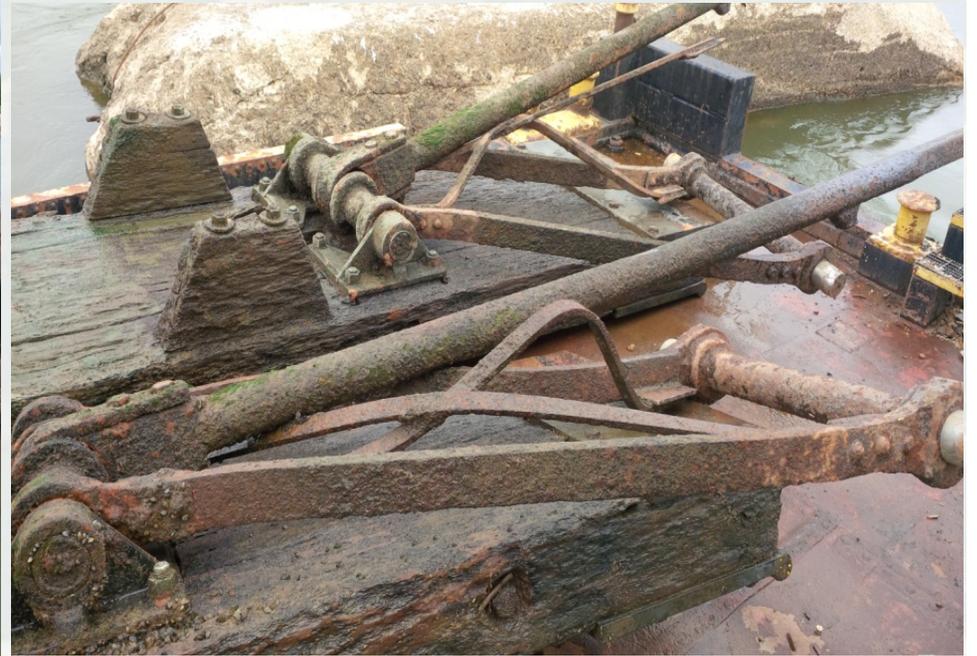
Replacing Wickets

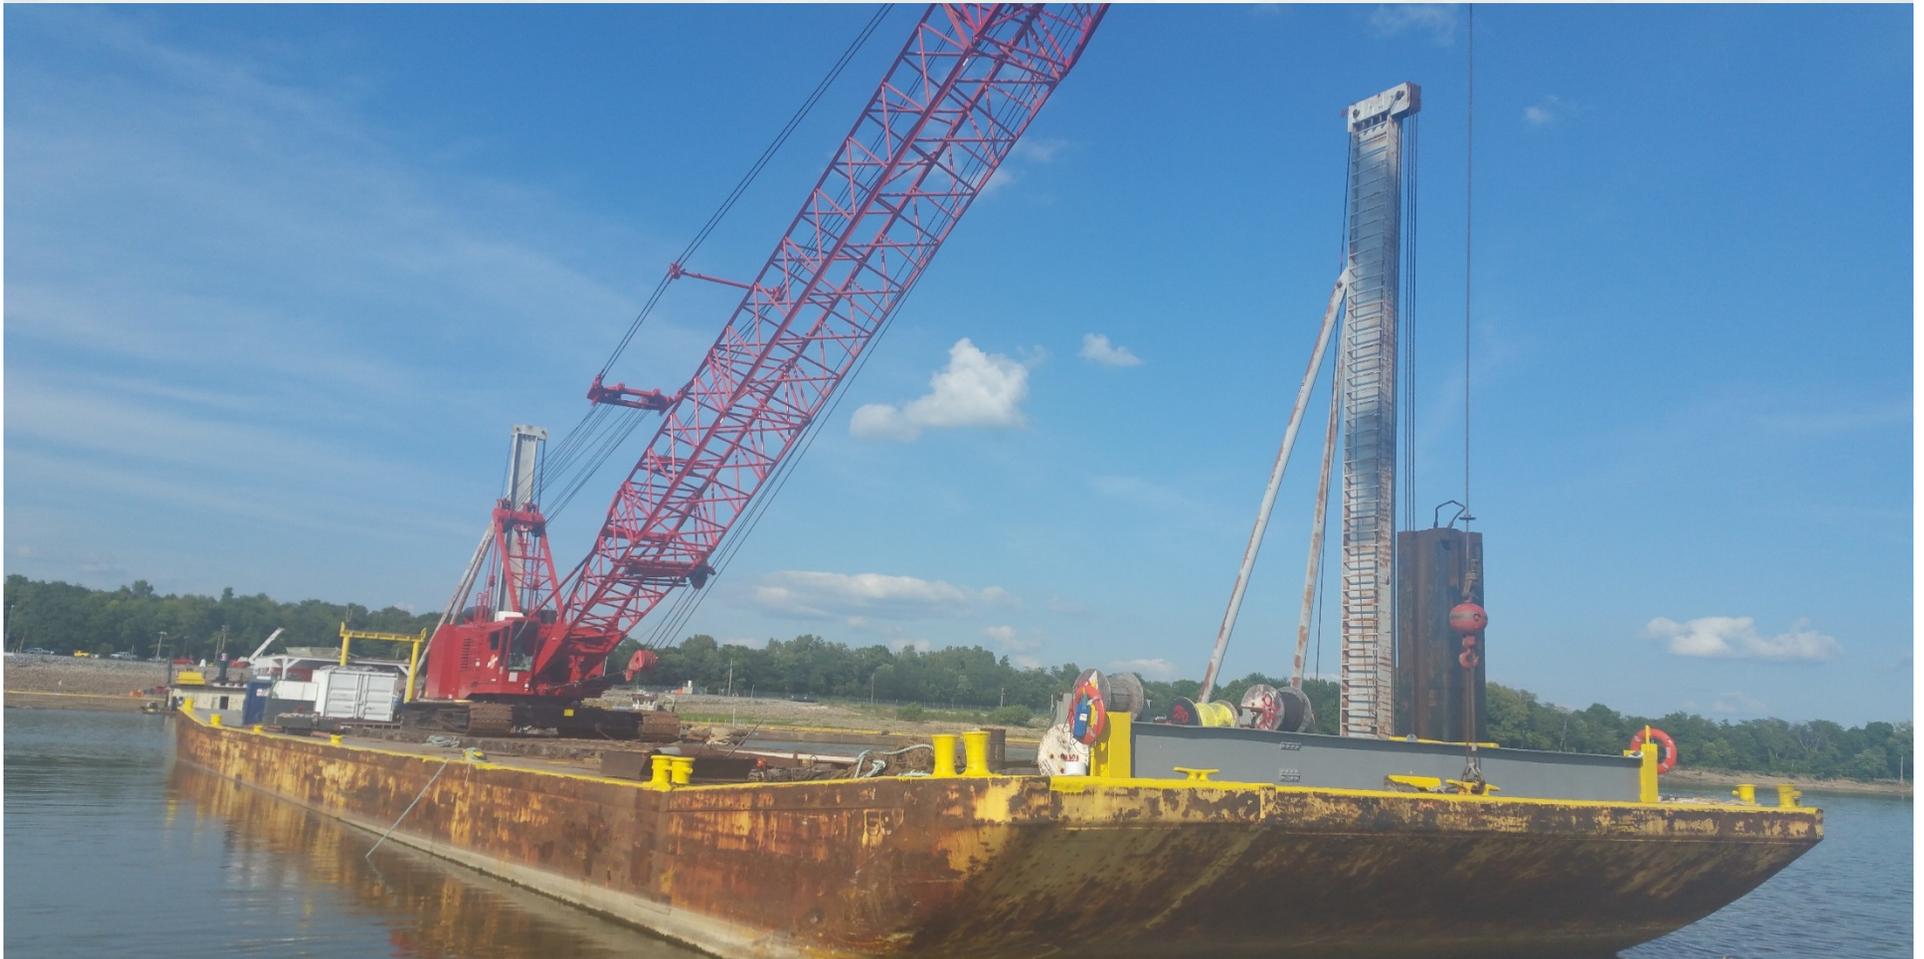
Contractor barge and crane to handle the dive box and wickets for L&D 52

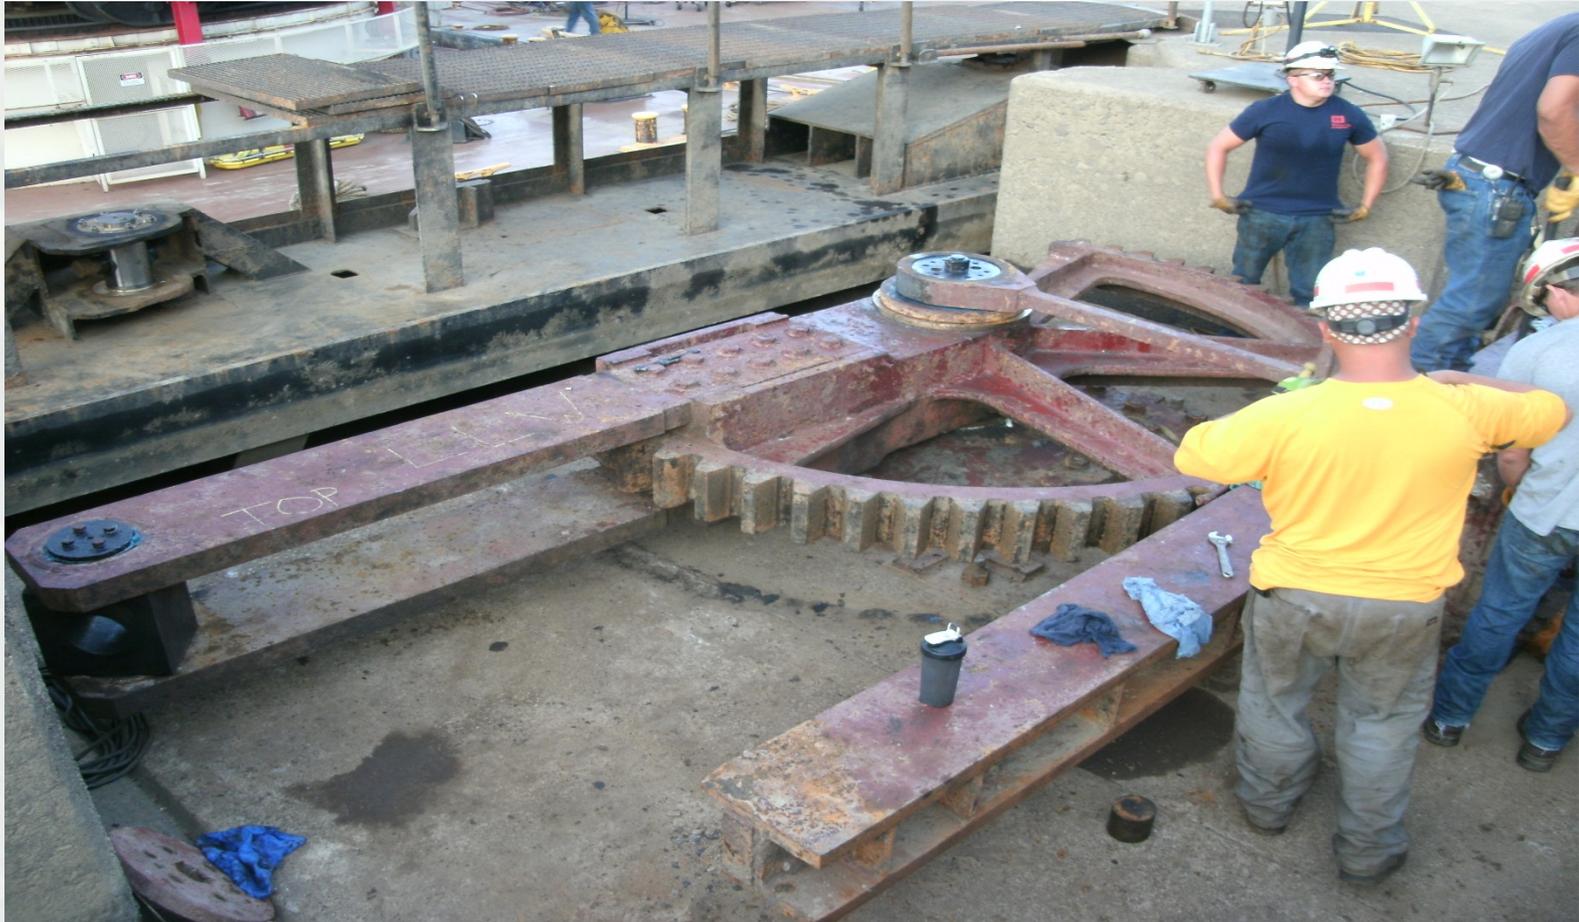
1,200' Upper and Lower Miter Gate Machinery Repair

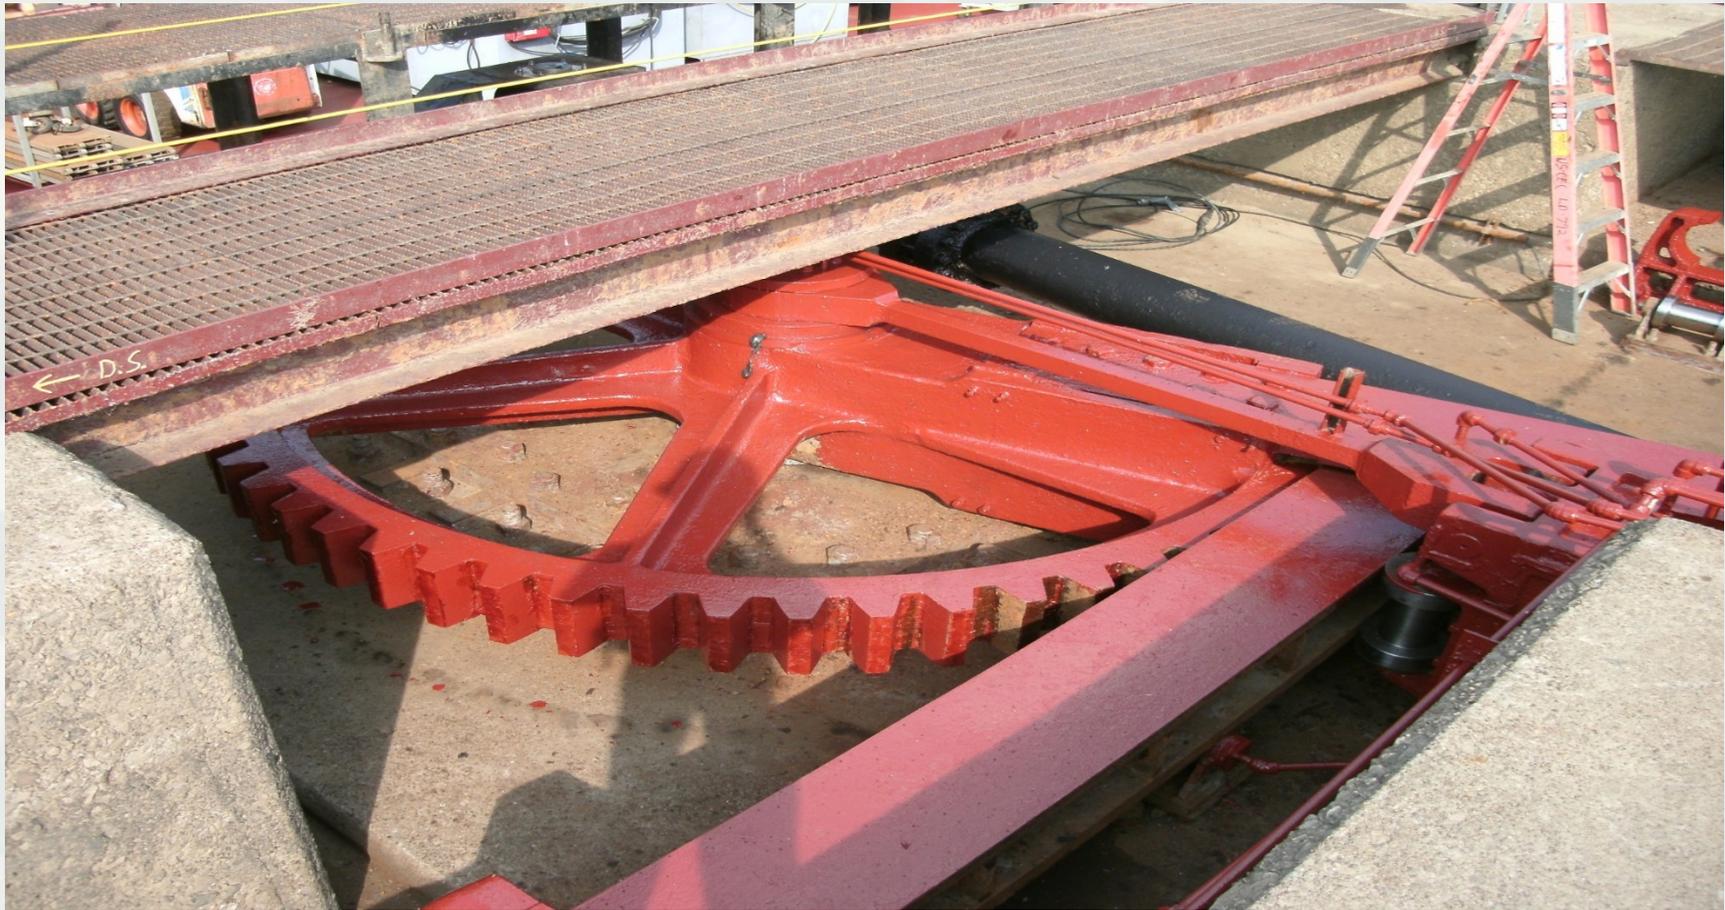
Pay no attention to the painted gear teeth, the paint was removed prior to greasing

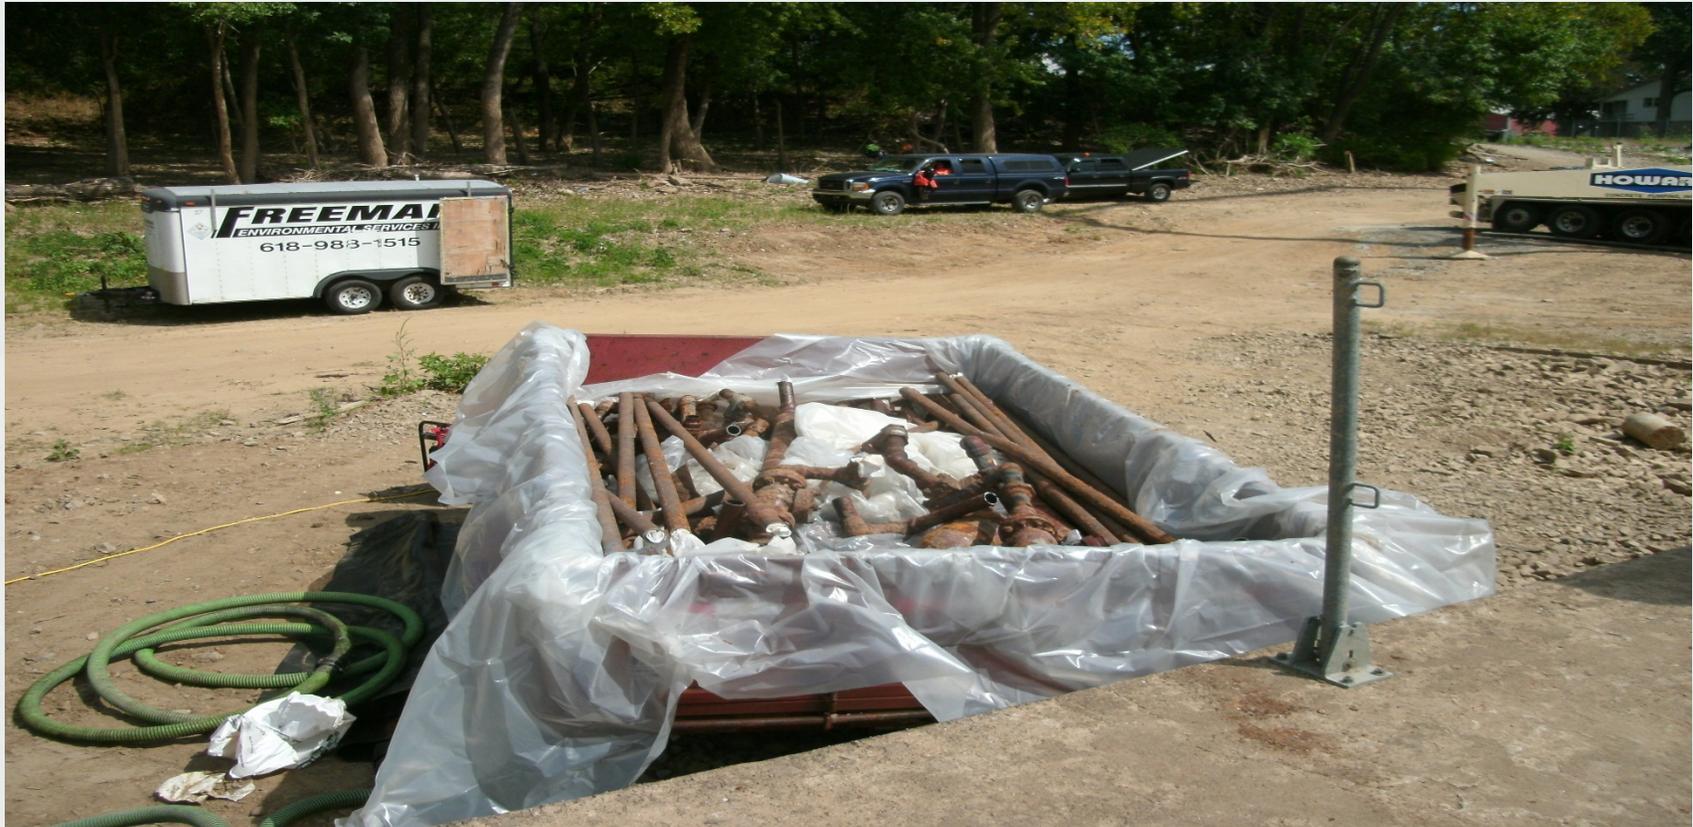
Lower 1,200' Hydraulic Miter Gate Controls and Piping Replacement

(MATOC Contractor, T&T Construction, they subbed the work to Rend Lake Plumbing and Heating). The sub did a great job. A lot of the piping was pre-fabricated and trucked in.

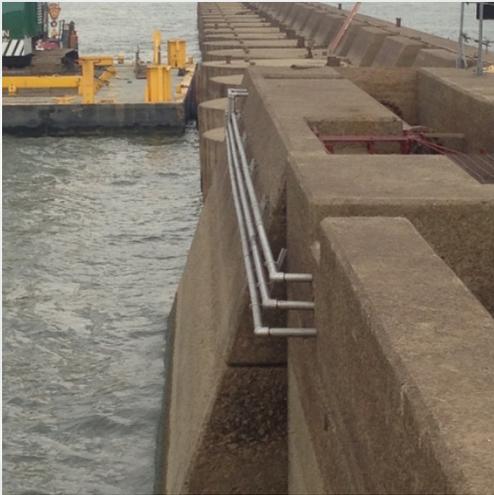
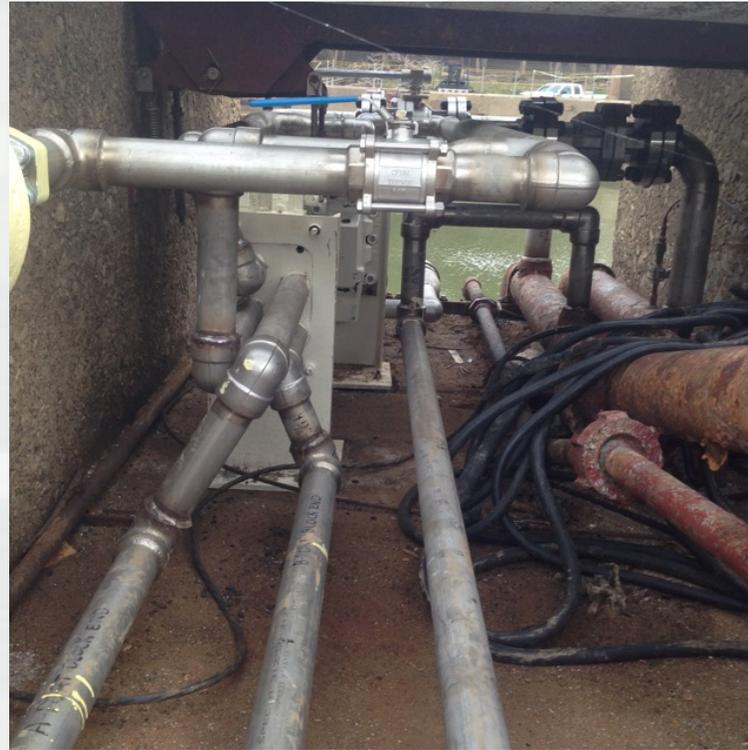
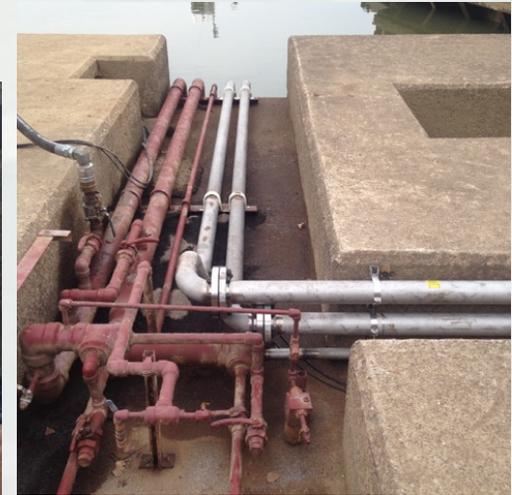
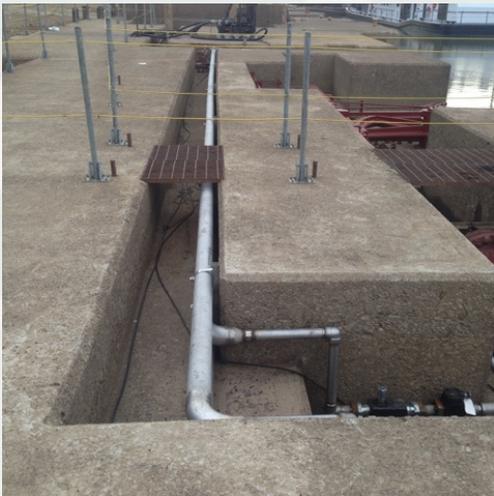
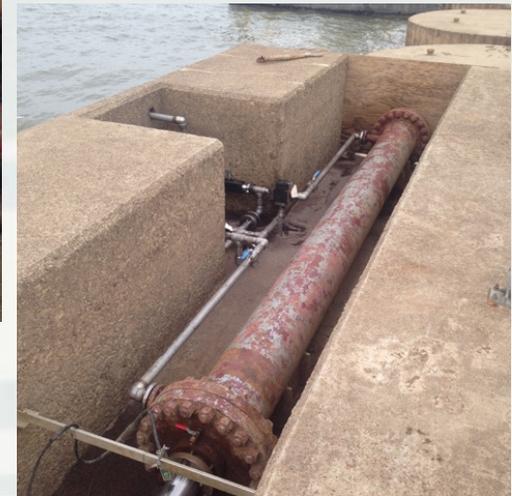
Contractor removed 600 Gallons of fluid and replaced everything with SS piping

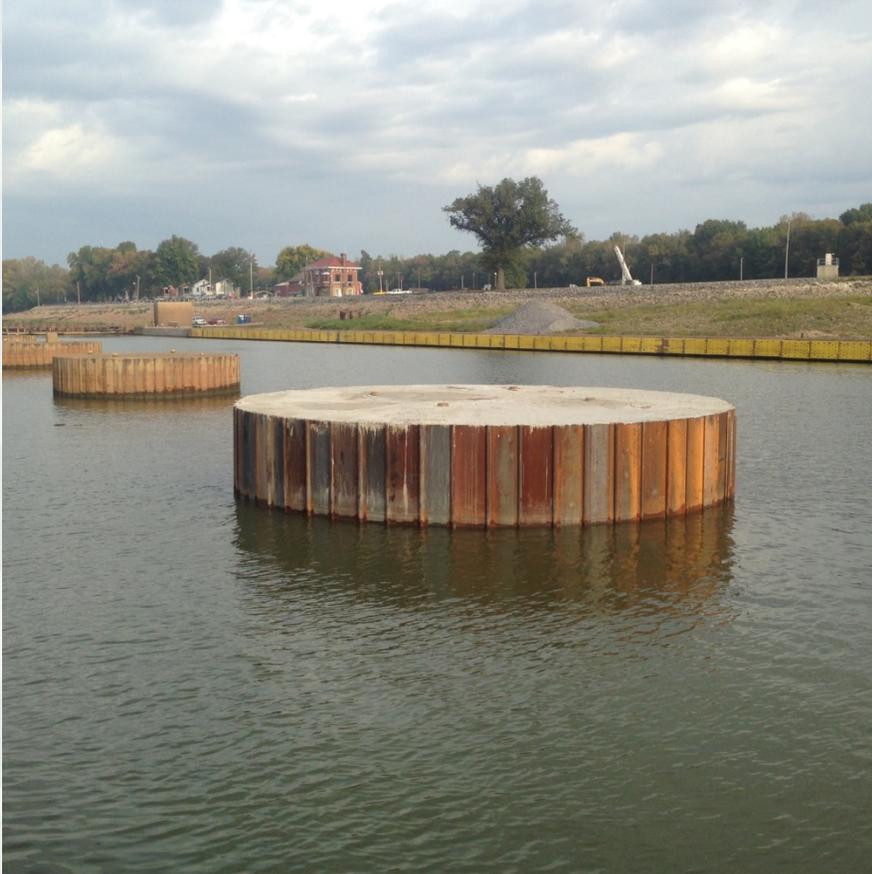
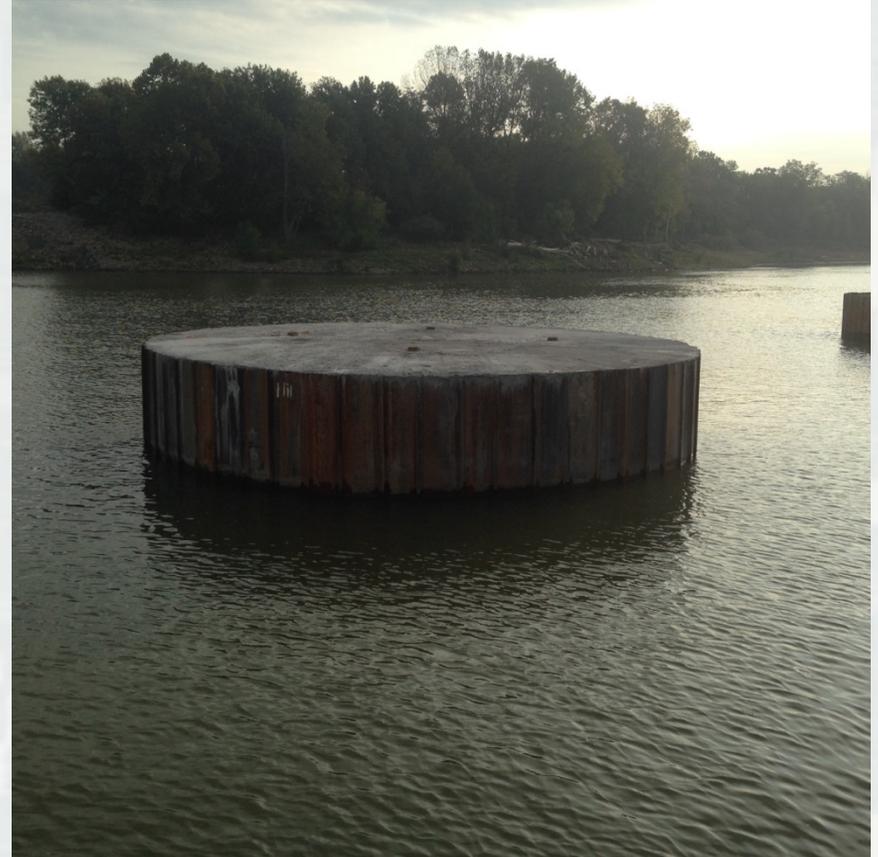
Upper 1200' 3rd cell build by Nashville Fleet

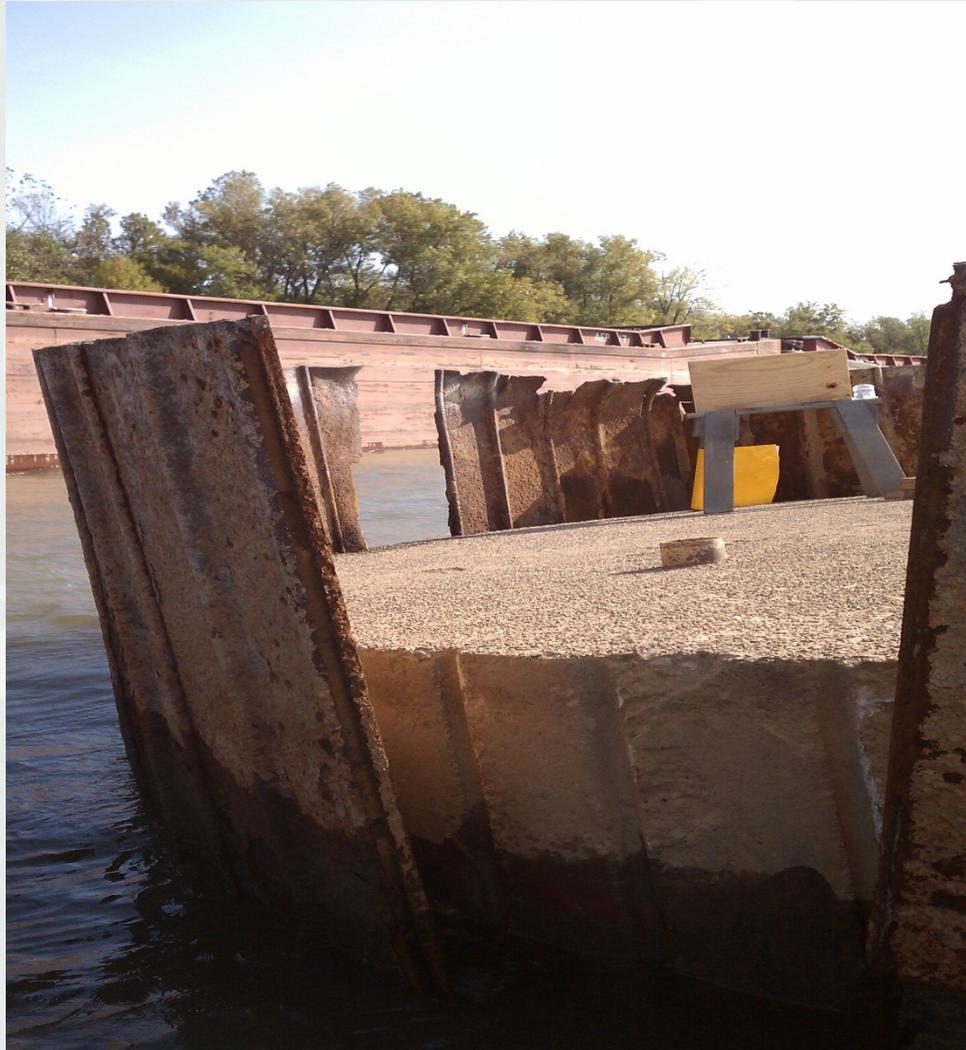
This is why it was removed by contract and replaced by Nashville District

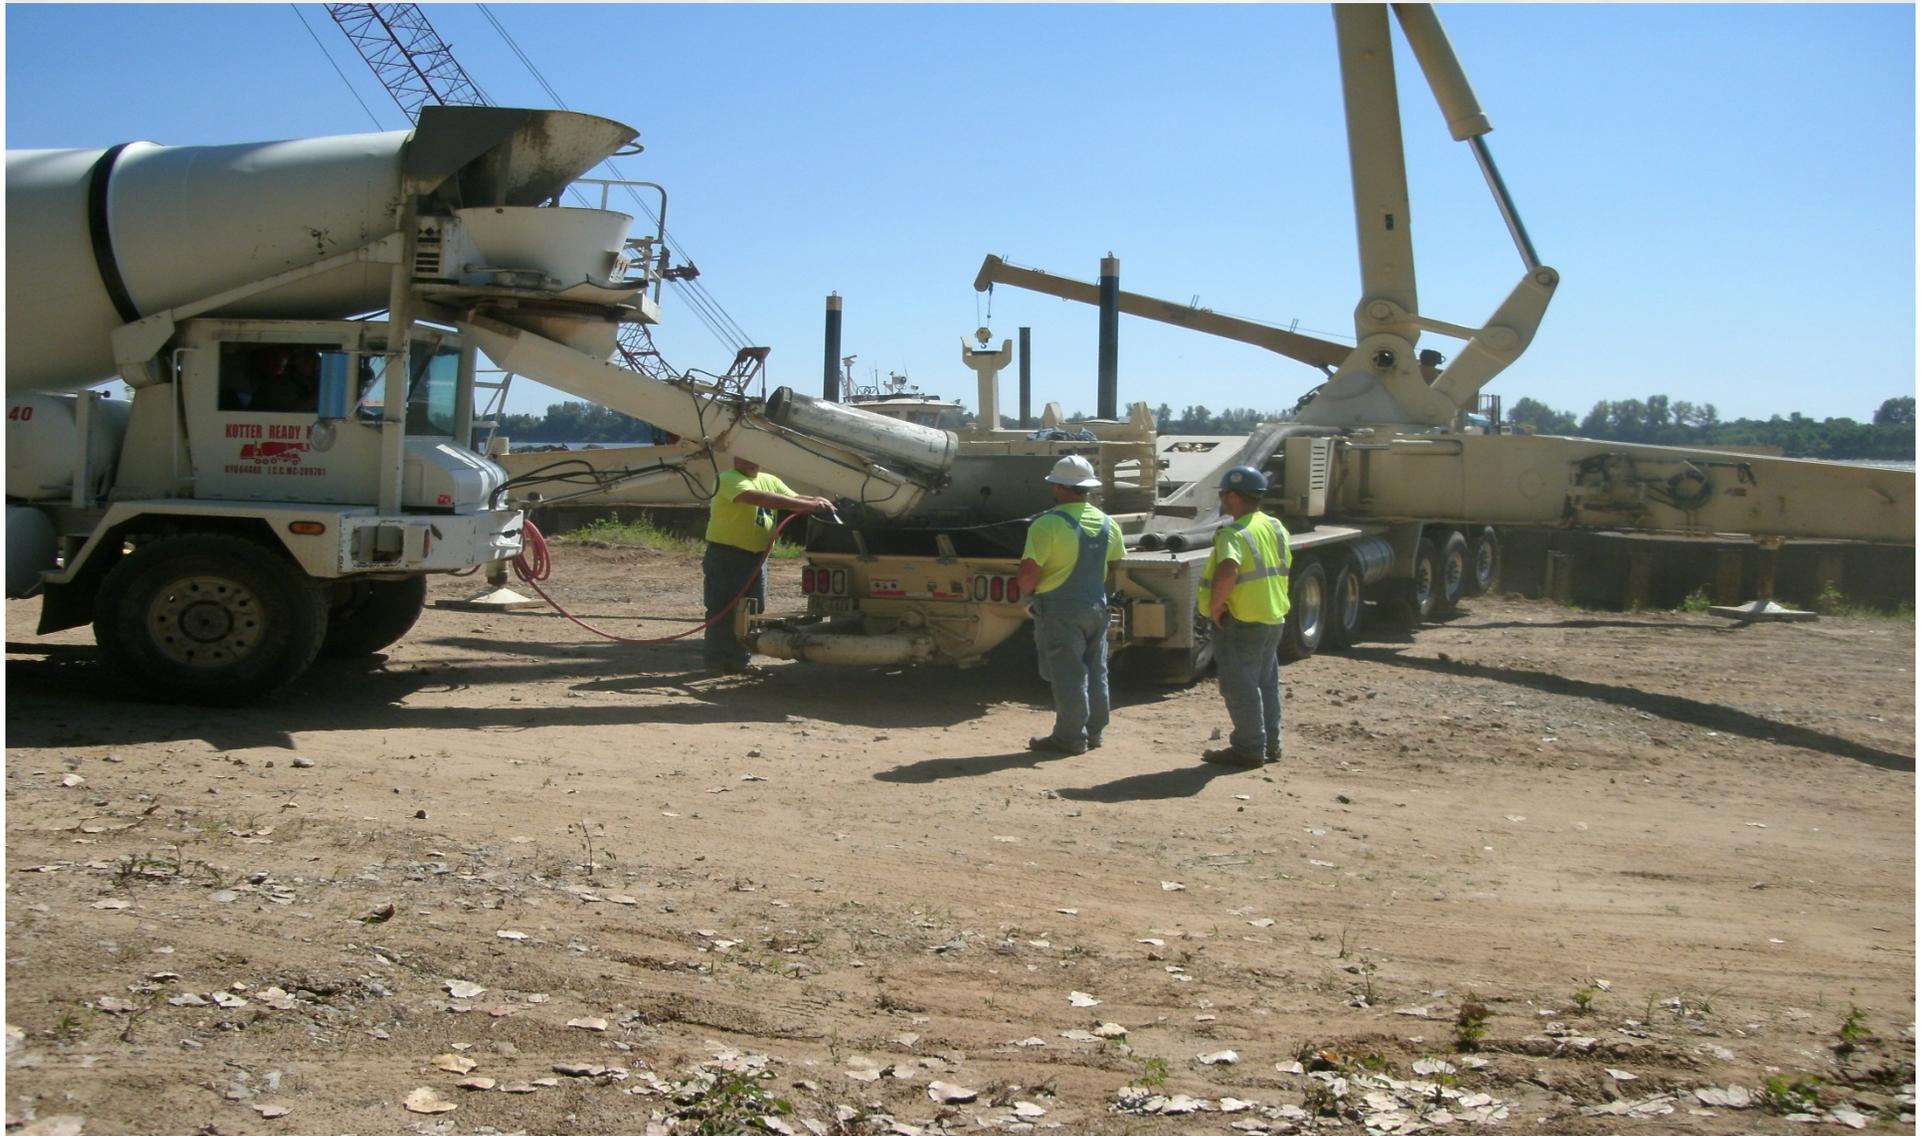
1,200' Cell Fill With Concrete

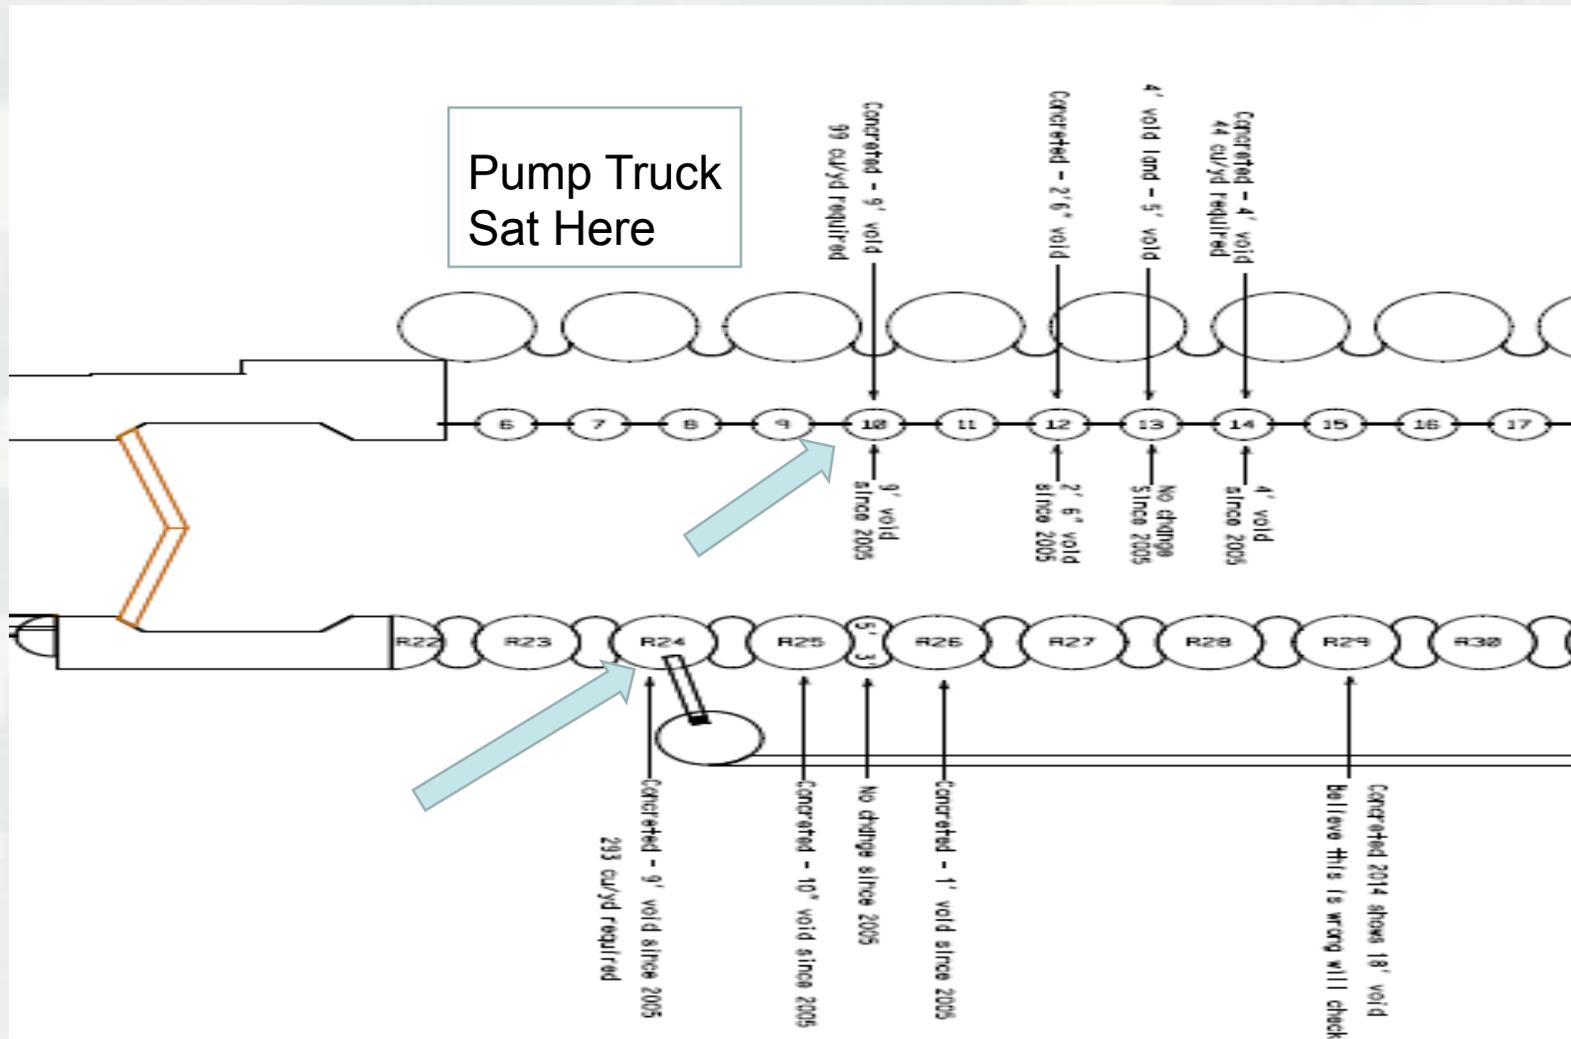
Filled Flume Cell F 10 and River Wall Cell R 24

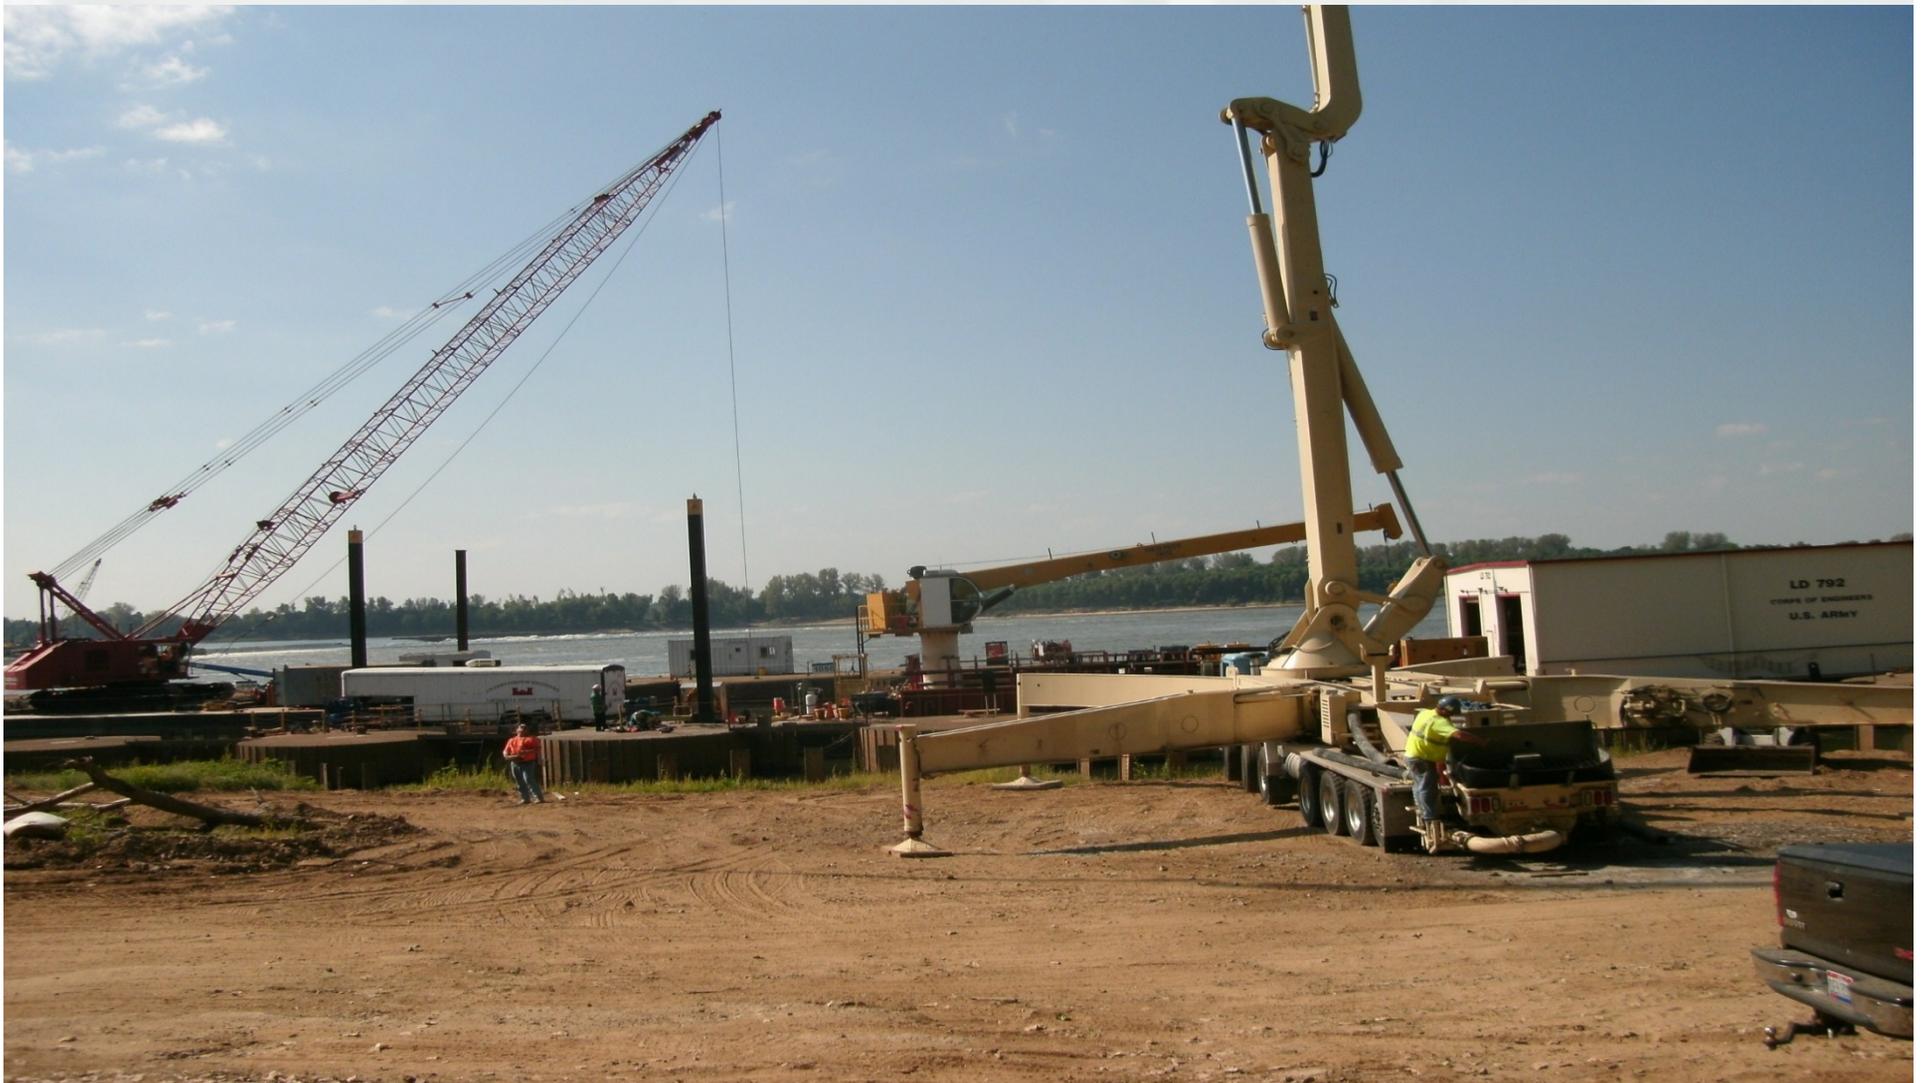
You have the concrete pump contractor, Massman with the 600' guide wall, LRS and the Hydraulic Piping, which you can't see, all at the same time on the lower end.

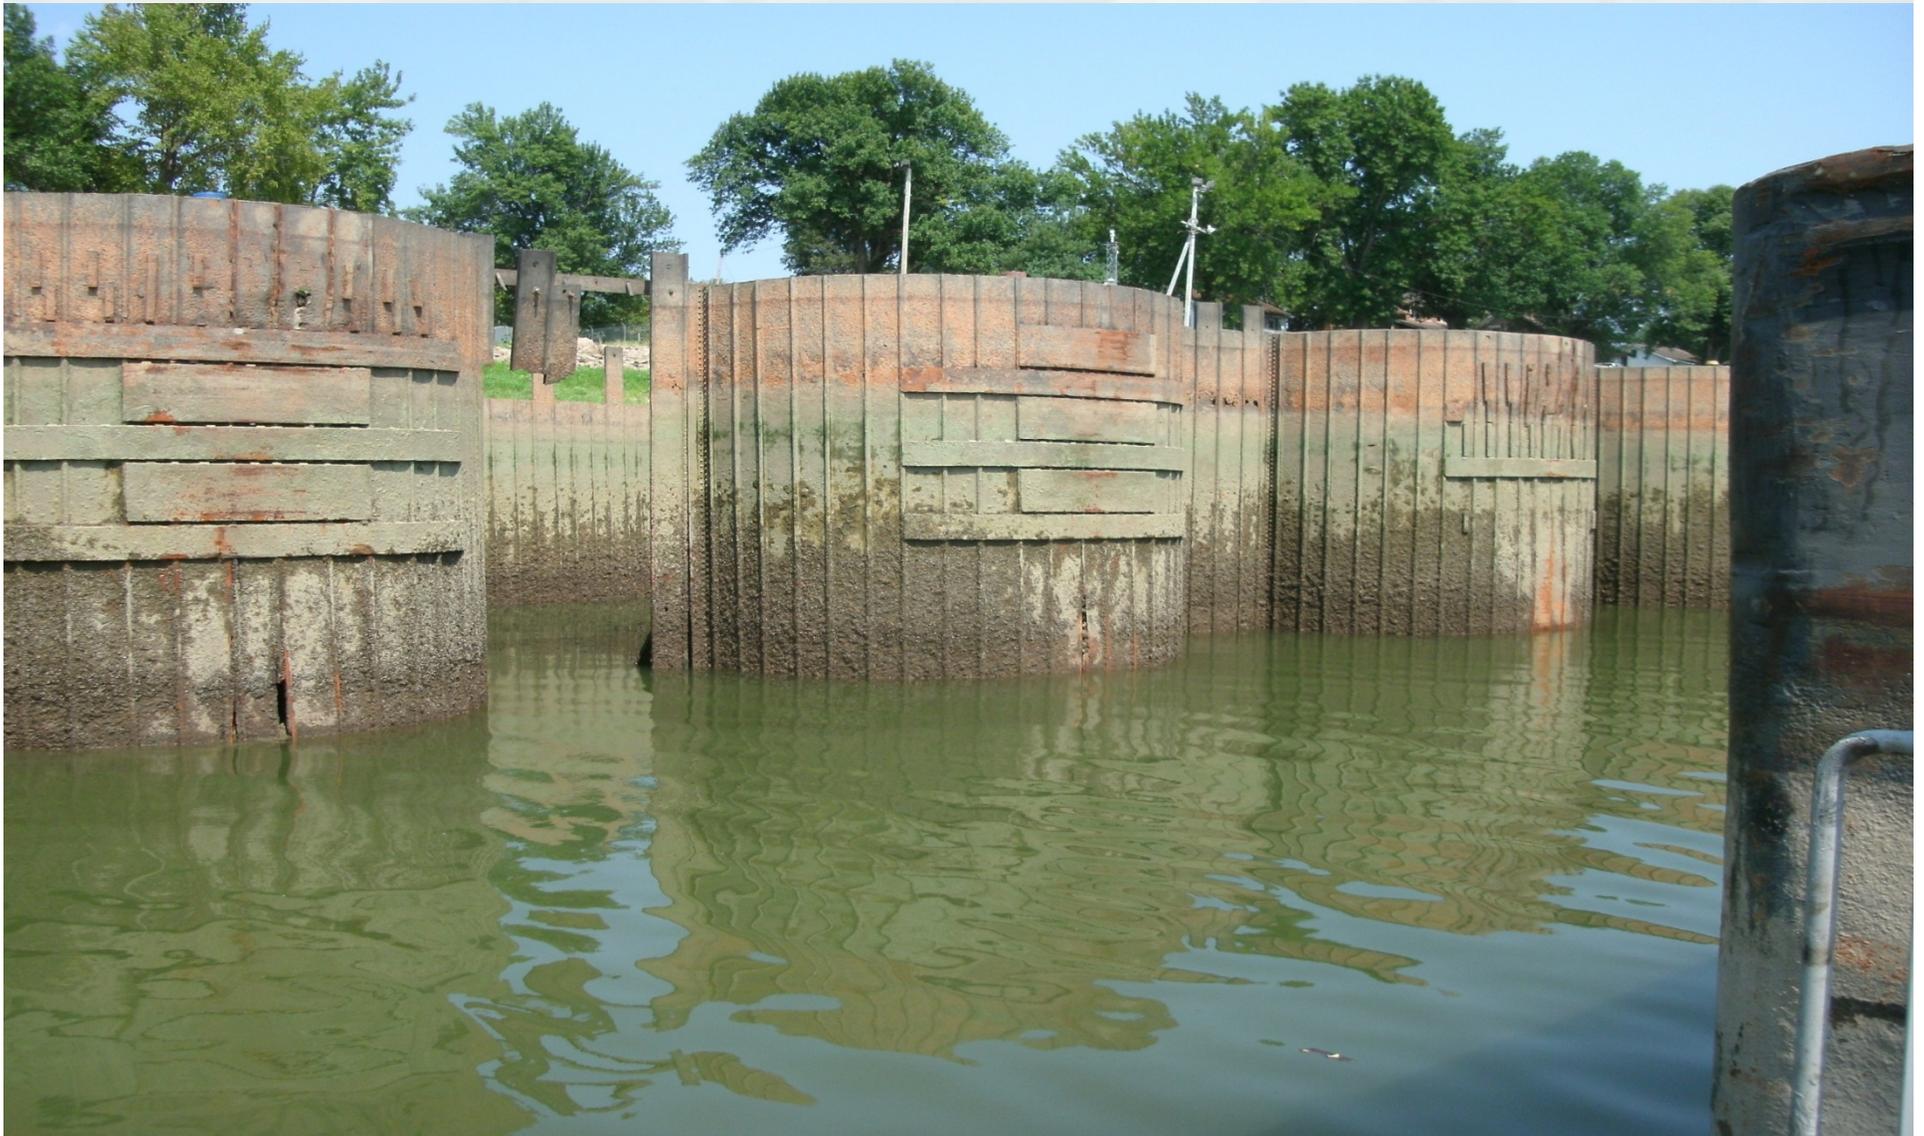
Flume Cell F 10, you can see where fill is leaking out
