Lock and Dam 52, 2015 Work

Kevin Vessels

Louisville District

February 2016

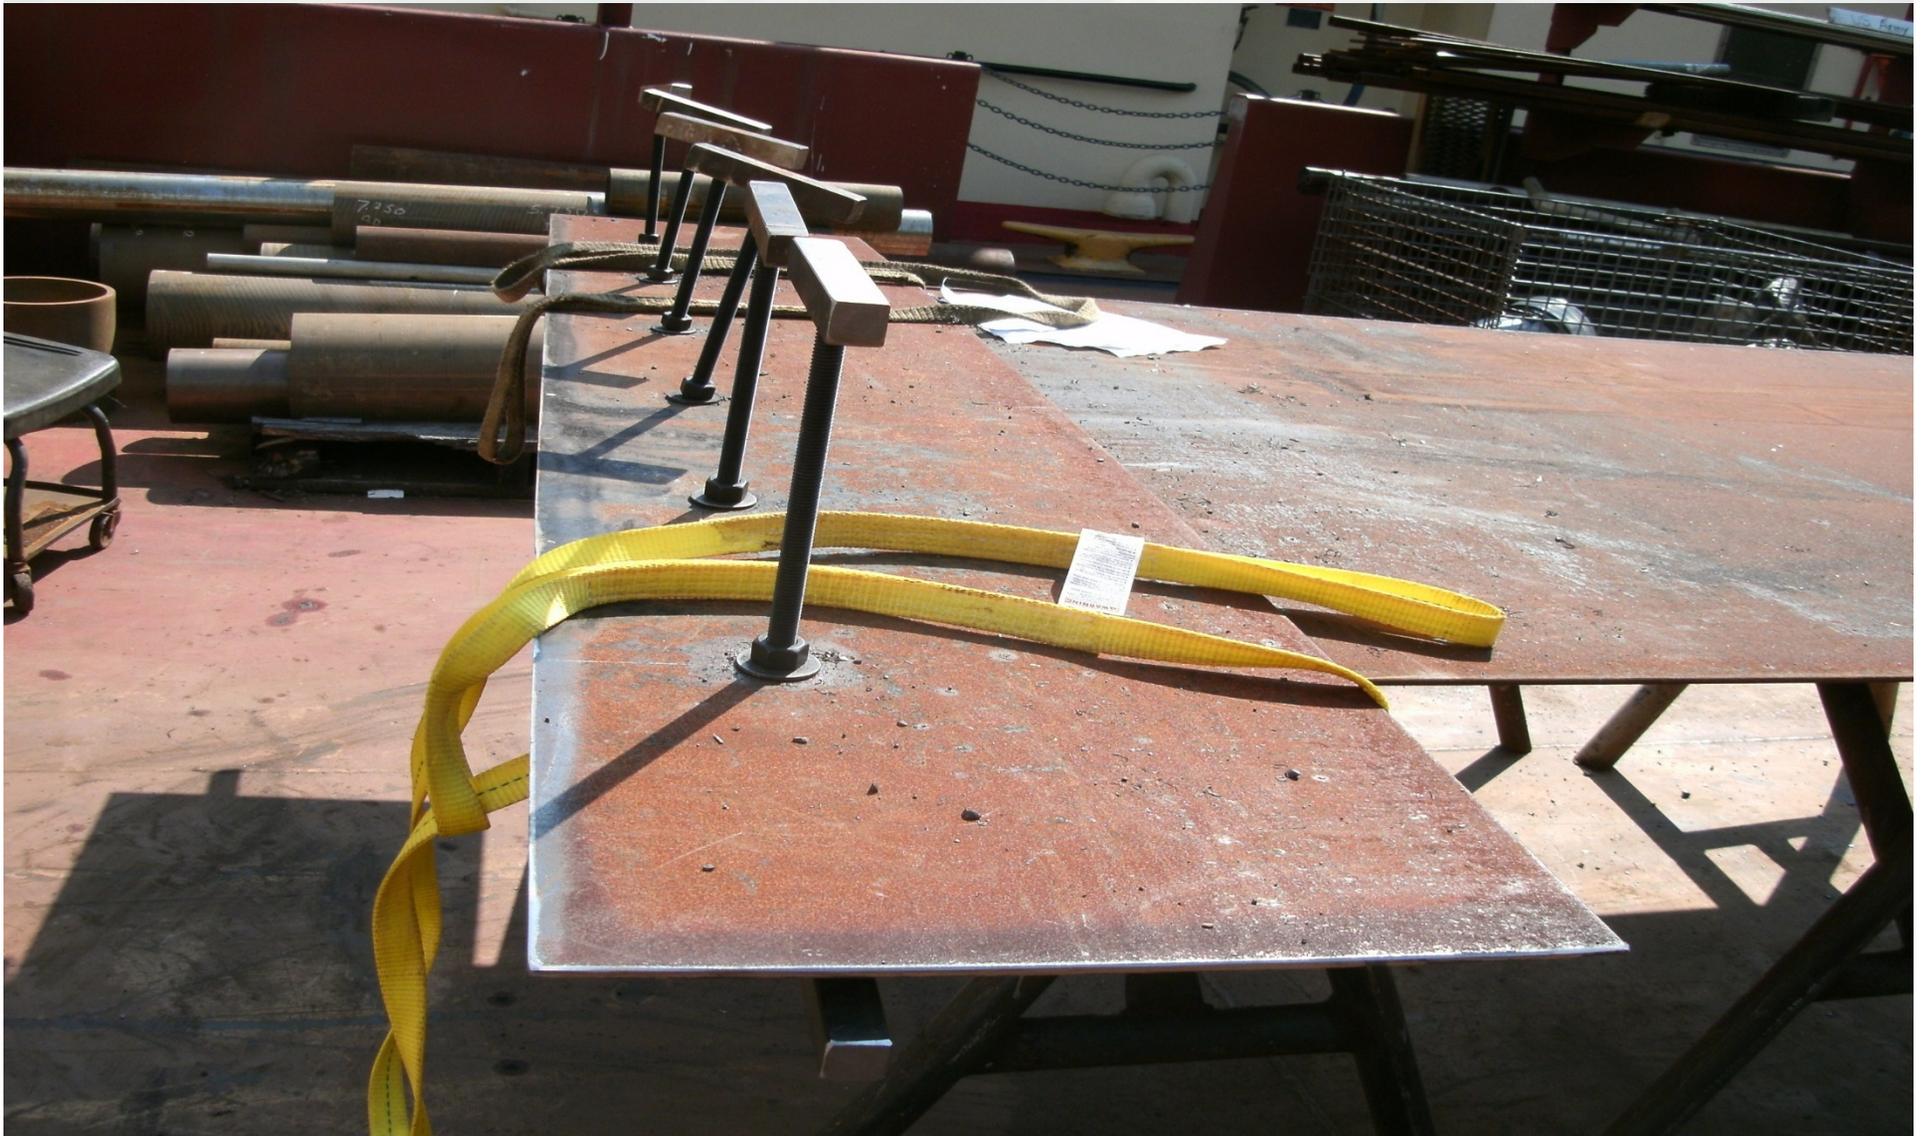
Divers had to install three of these concrete forms on the cell to keep the tremmie concrete from leaking out

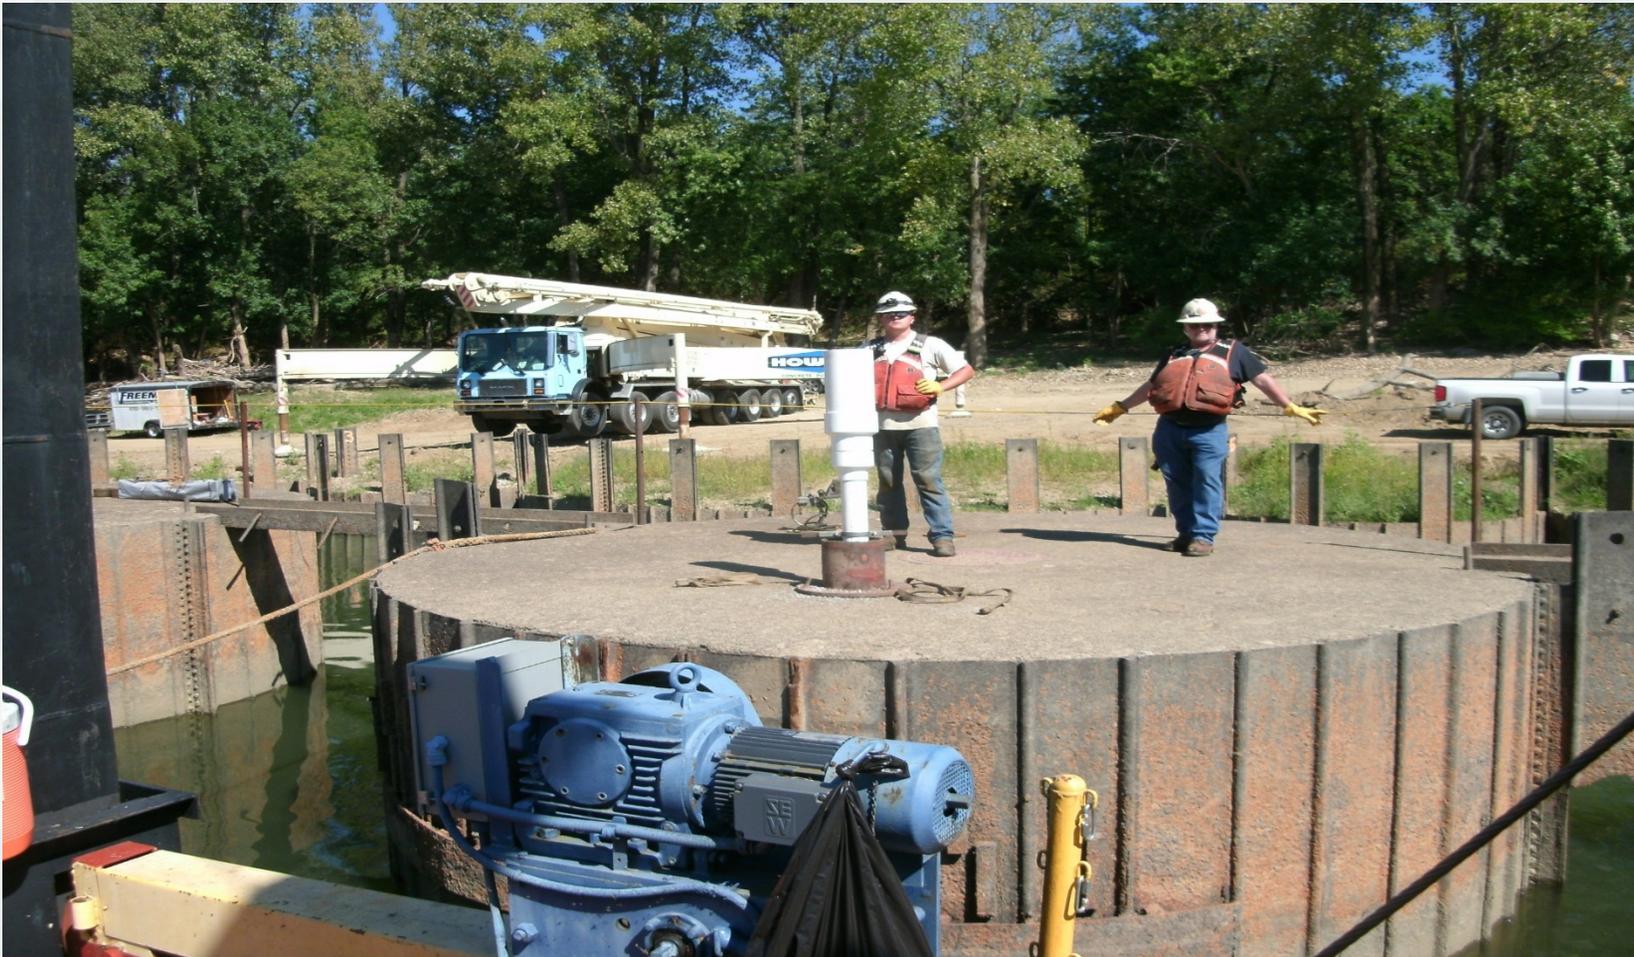
PVC Tremmie Pipe, funnel, 8" to 6" to 4". It wasn't a good idea, it caused the rock to crush together and clog at the 4" pipe. Just a 6" reducer to insert the 4" pump pipe into would have worked.

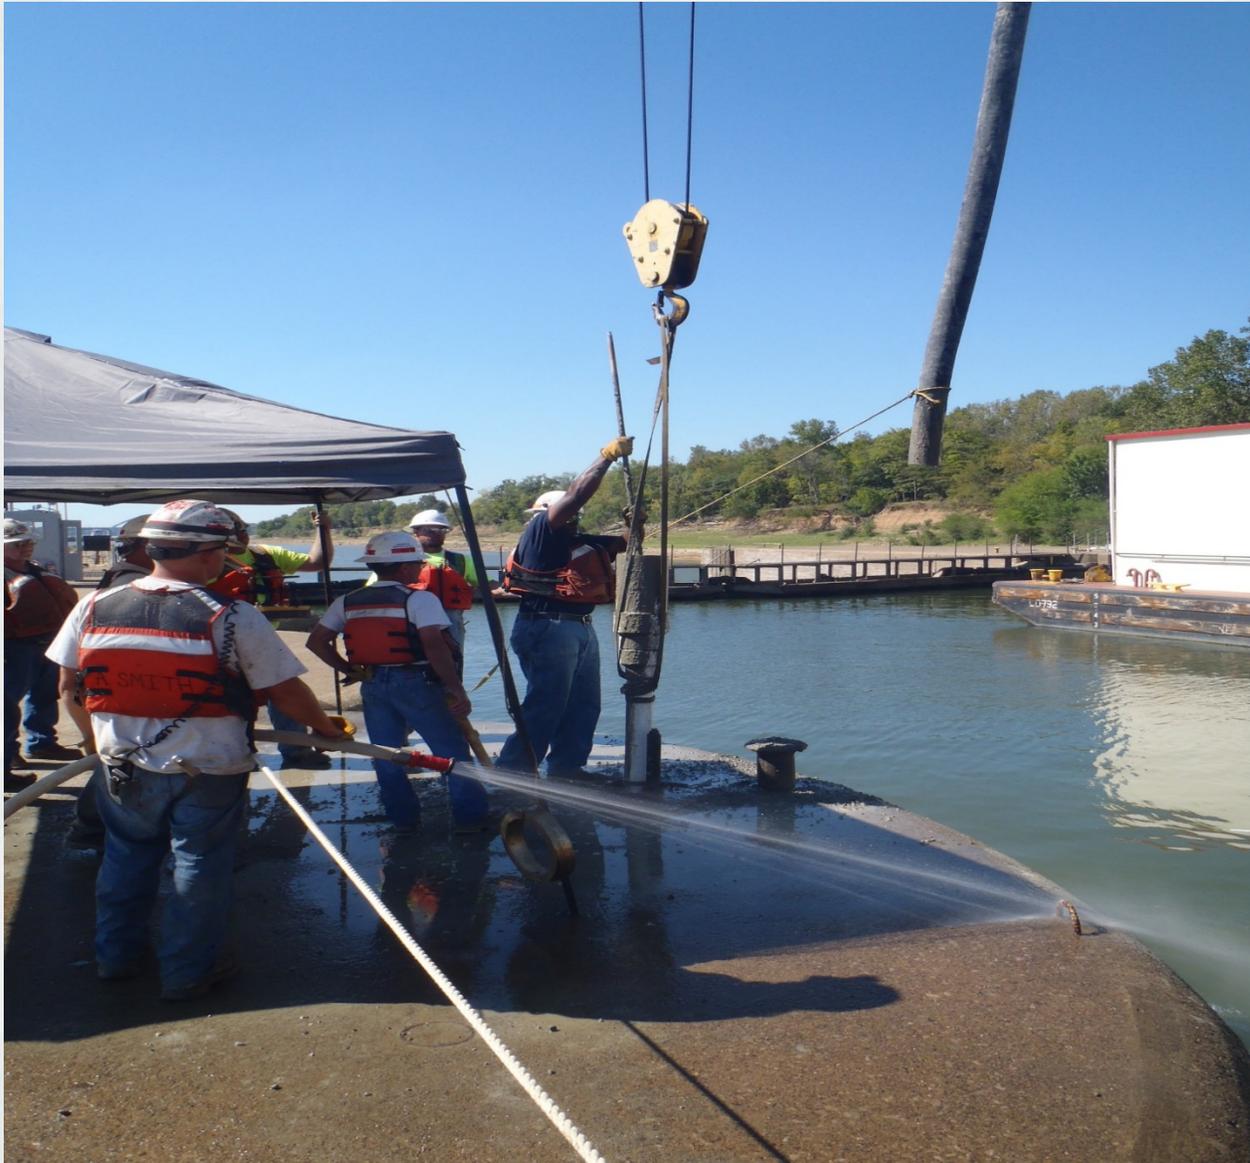
Clogged

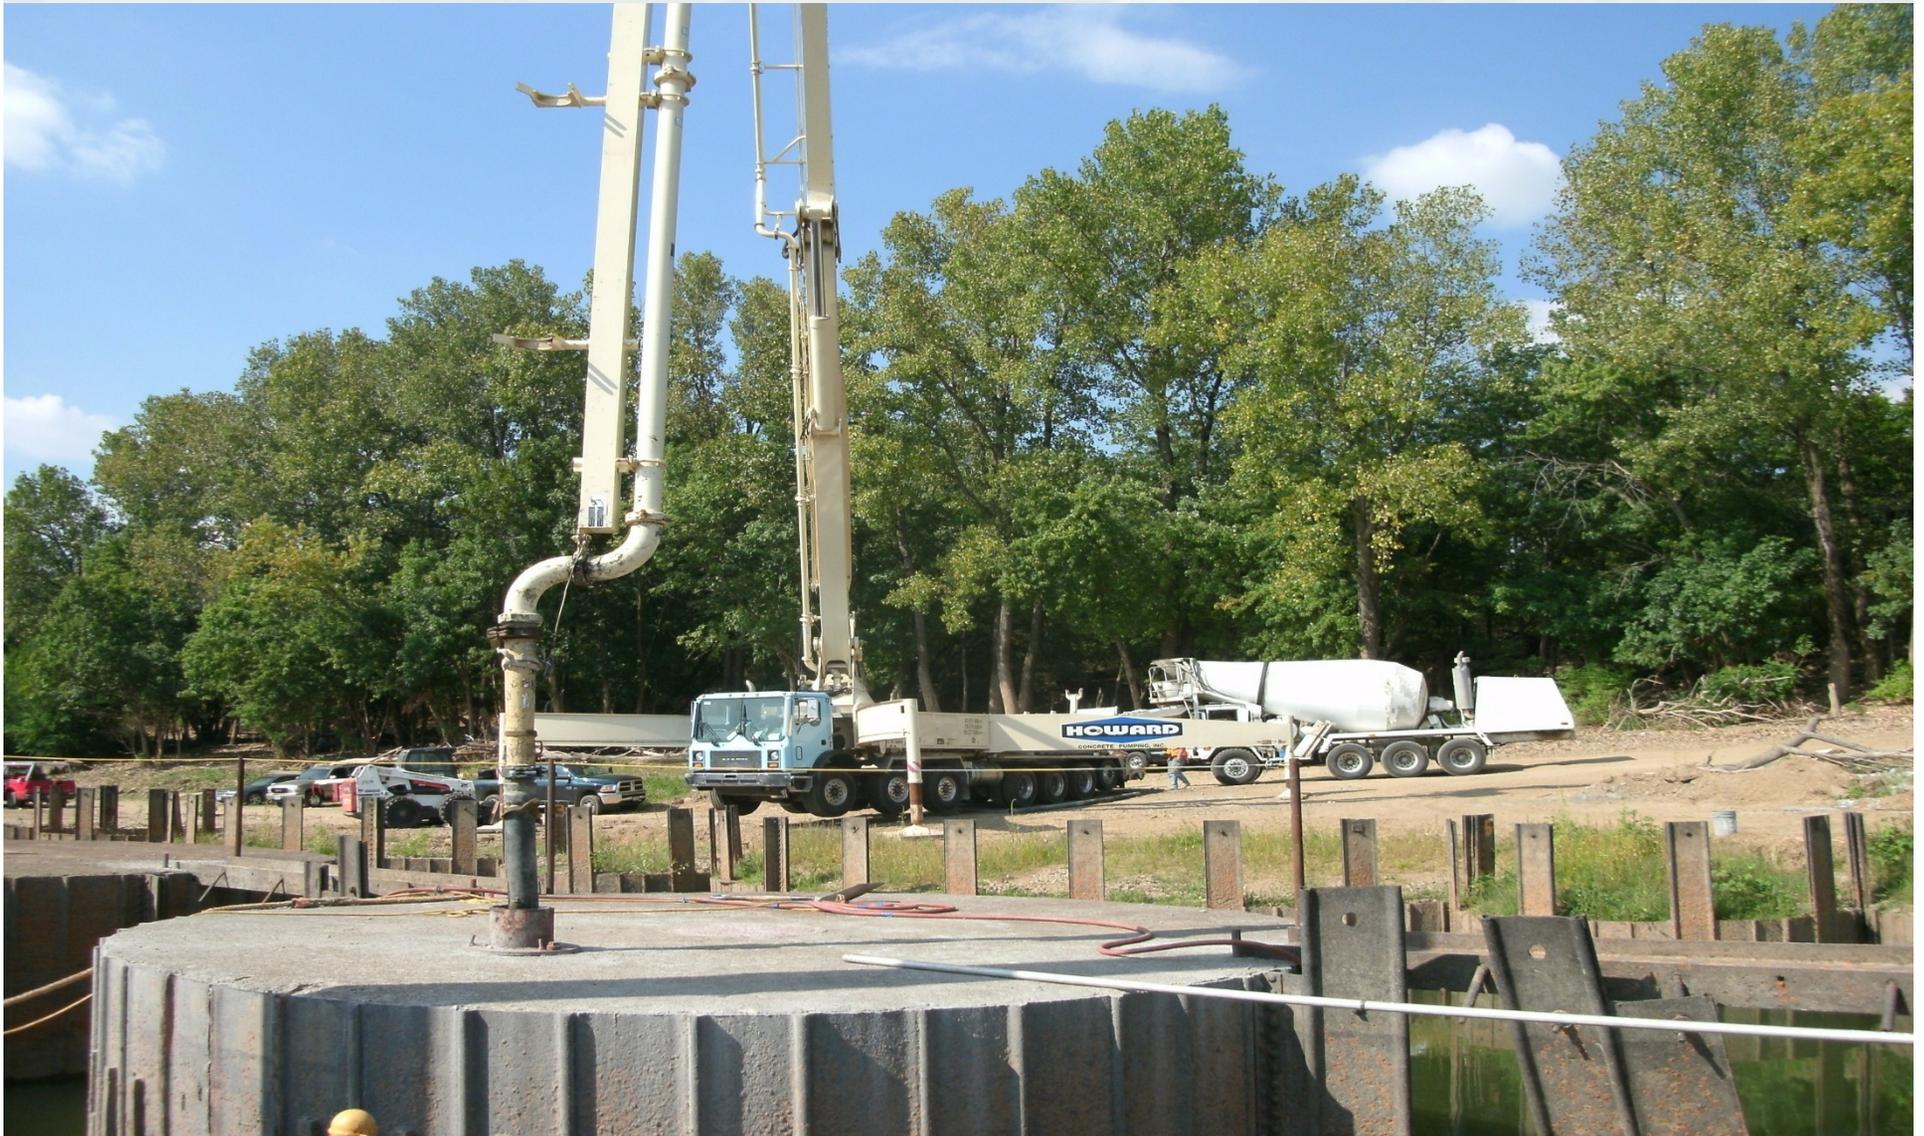
We ended up using 2 – 10' sections of rubber pump pipe as the Tremmie Pipe

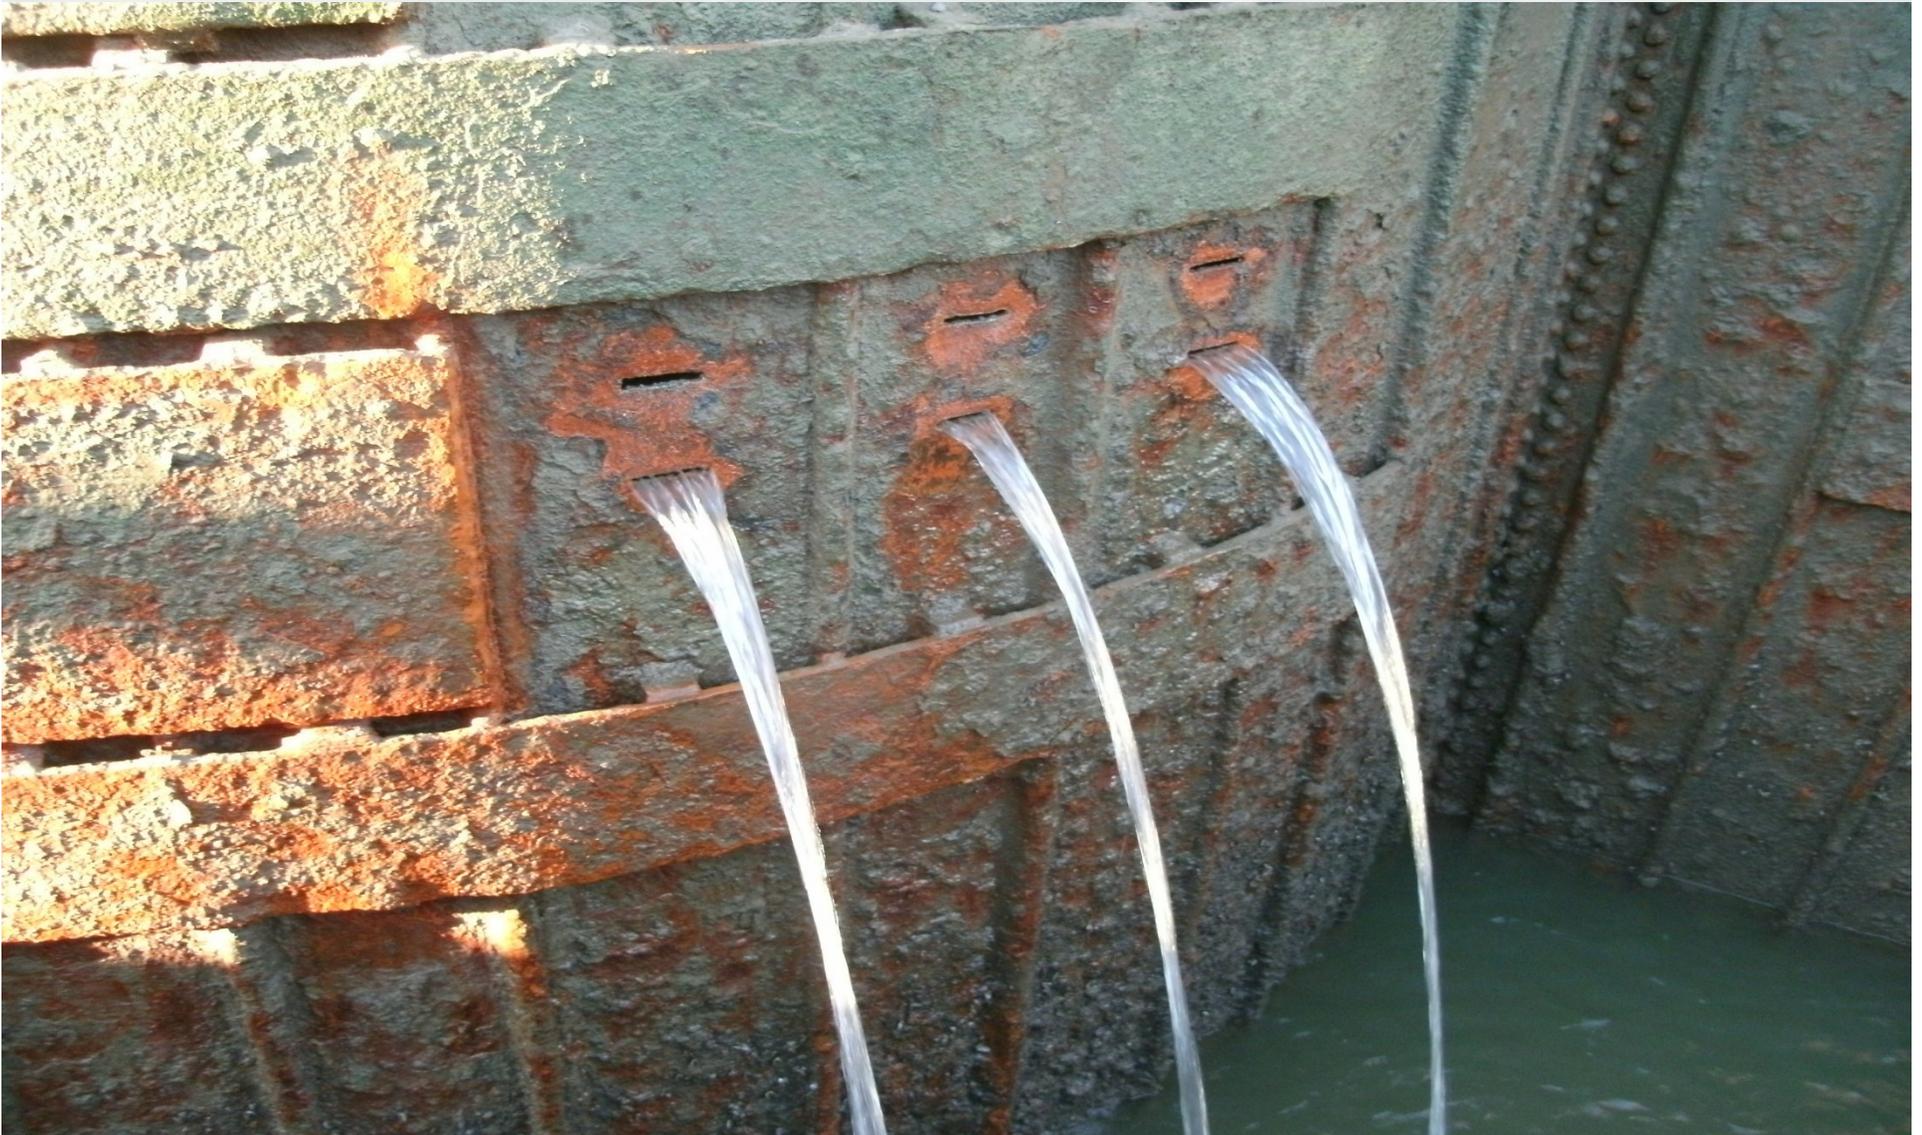
Cut slots just below the old concrete fill to let the water out while filling with concrete

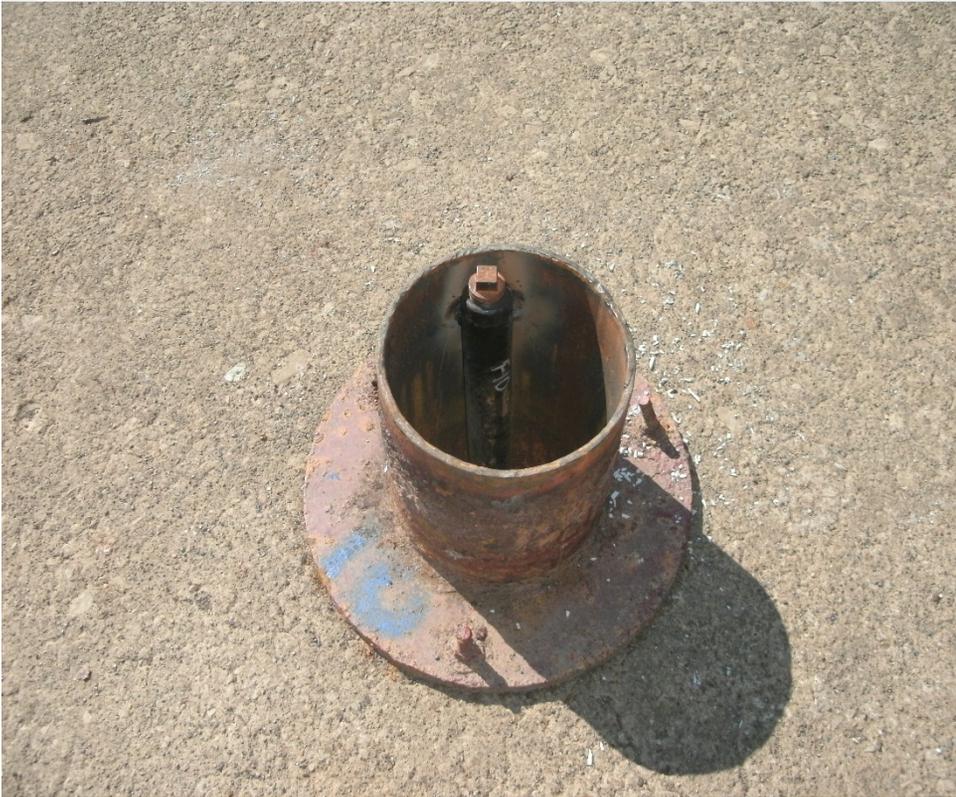
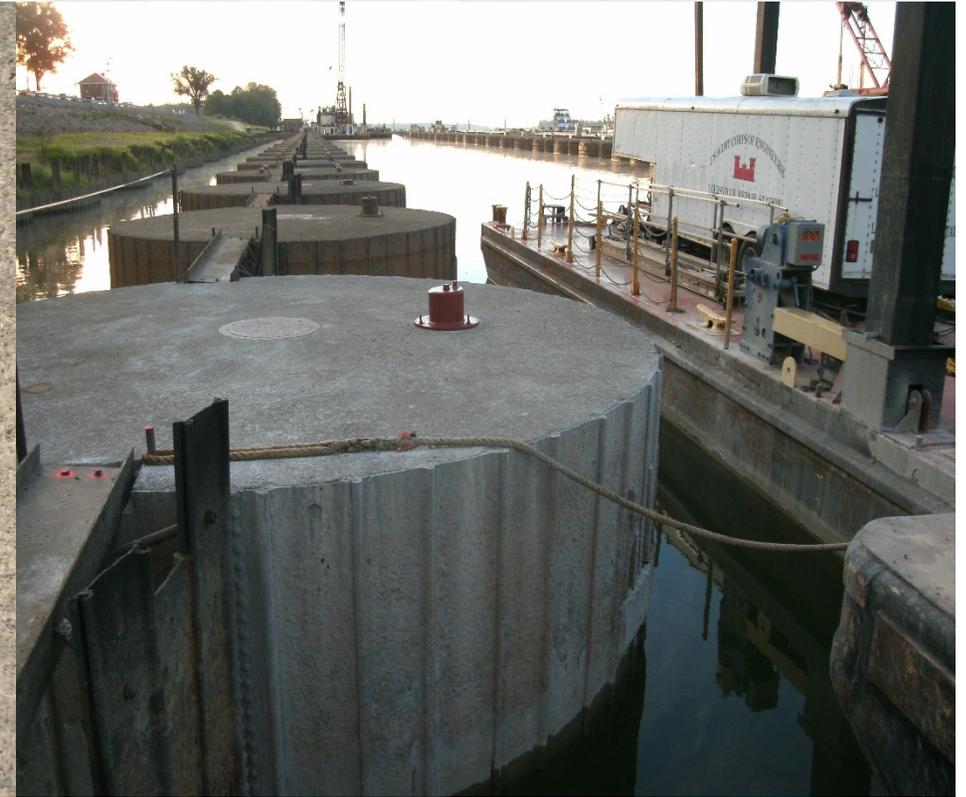
The 10" pipe was left from a previous concrete fill in 2007. This was to monitor the cell fill depth and fill with more concrete if required. We left a new sounding pipe. Will have to core drill to fill any more

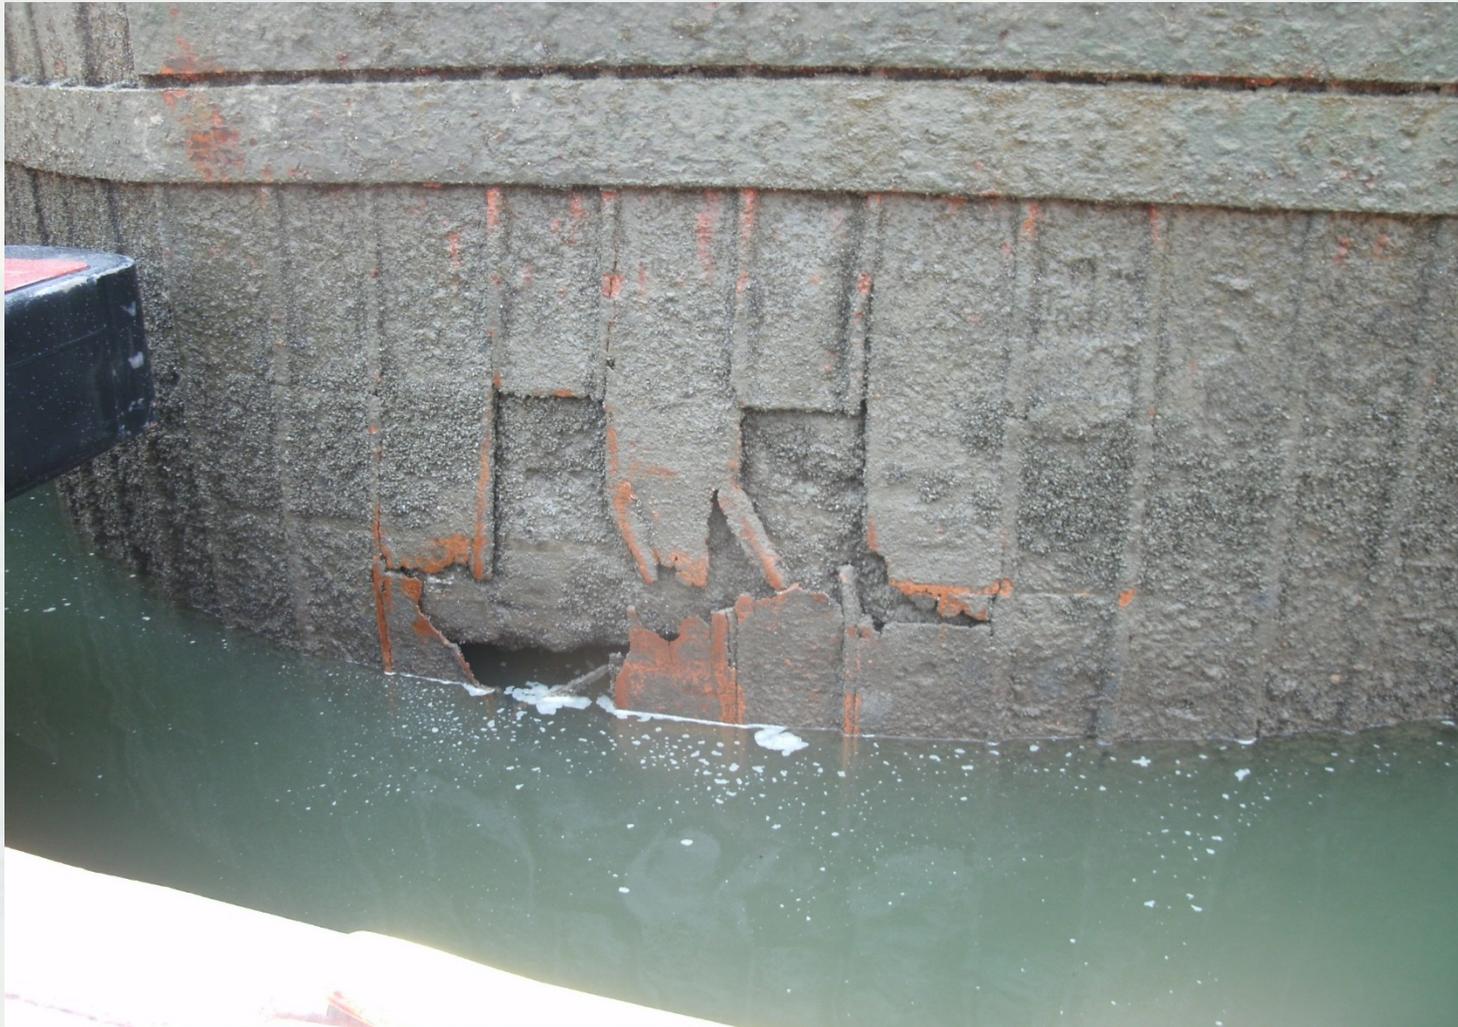
We still have serious issues with the cells at L&D 52

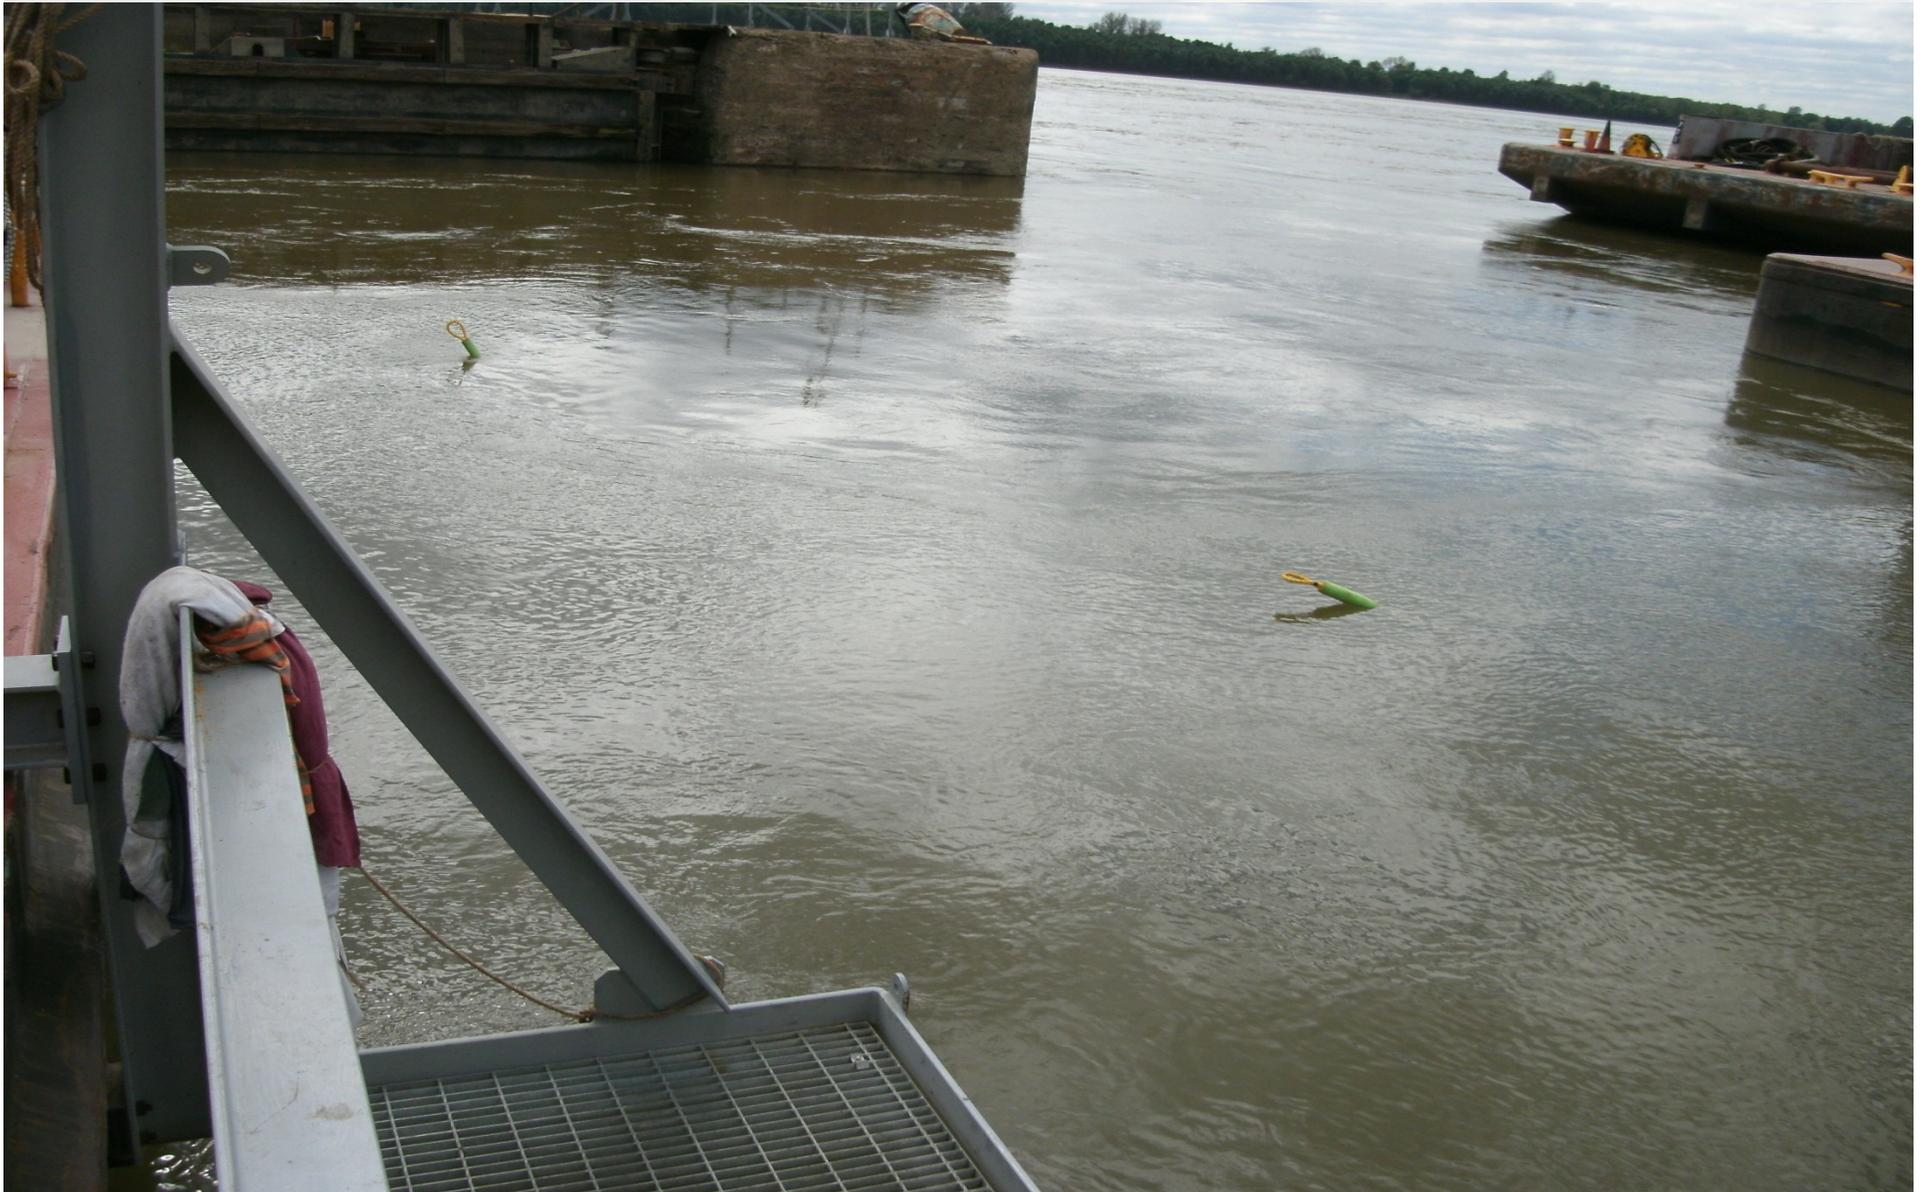
600' Chamber Lower Sill Repair, buoys set by divers marking the box setting location

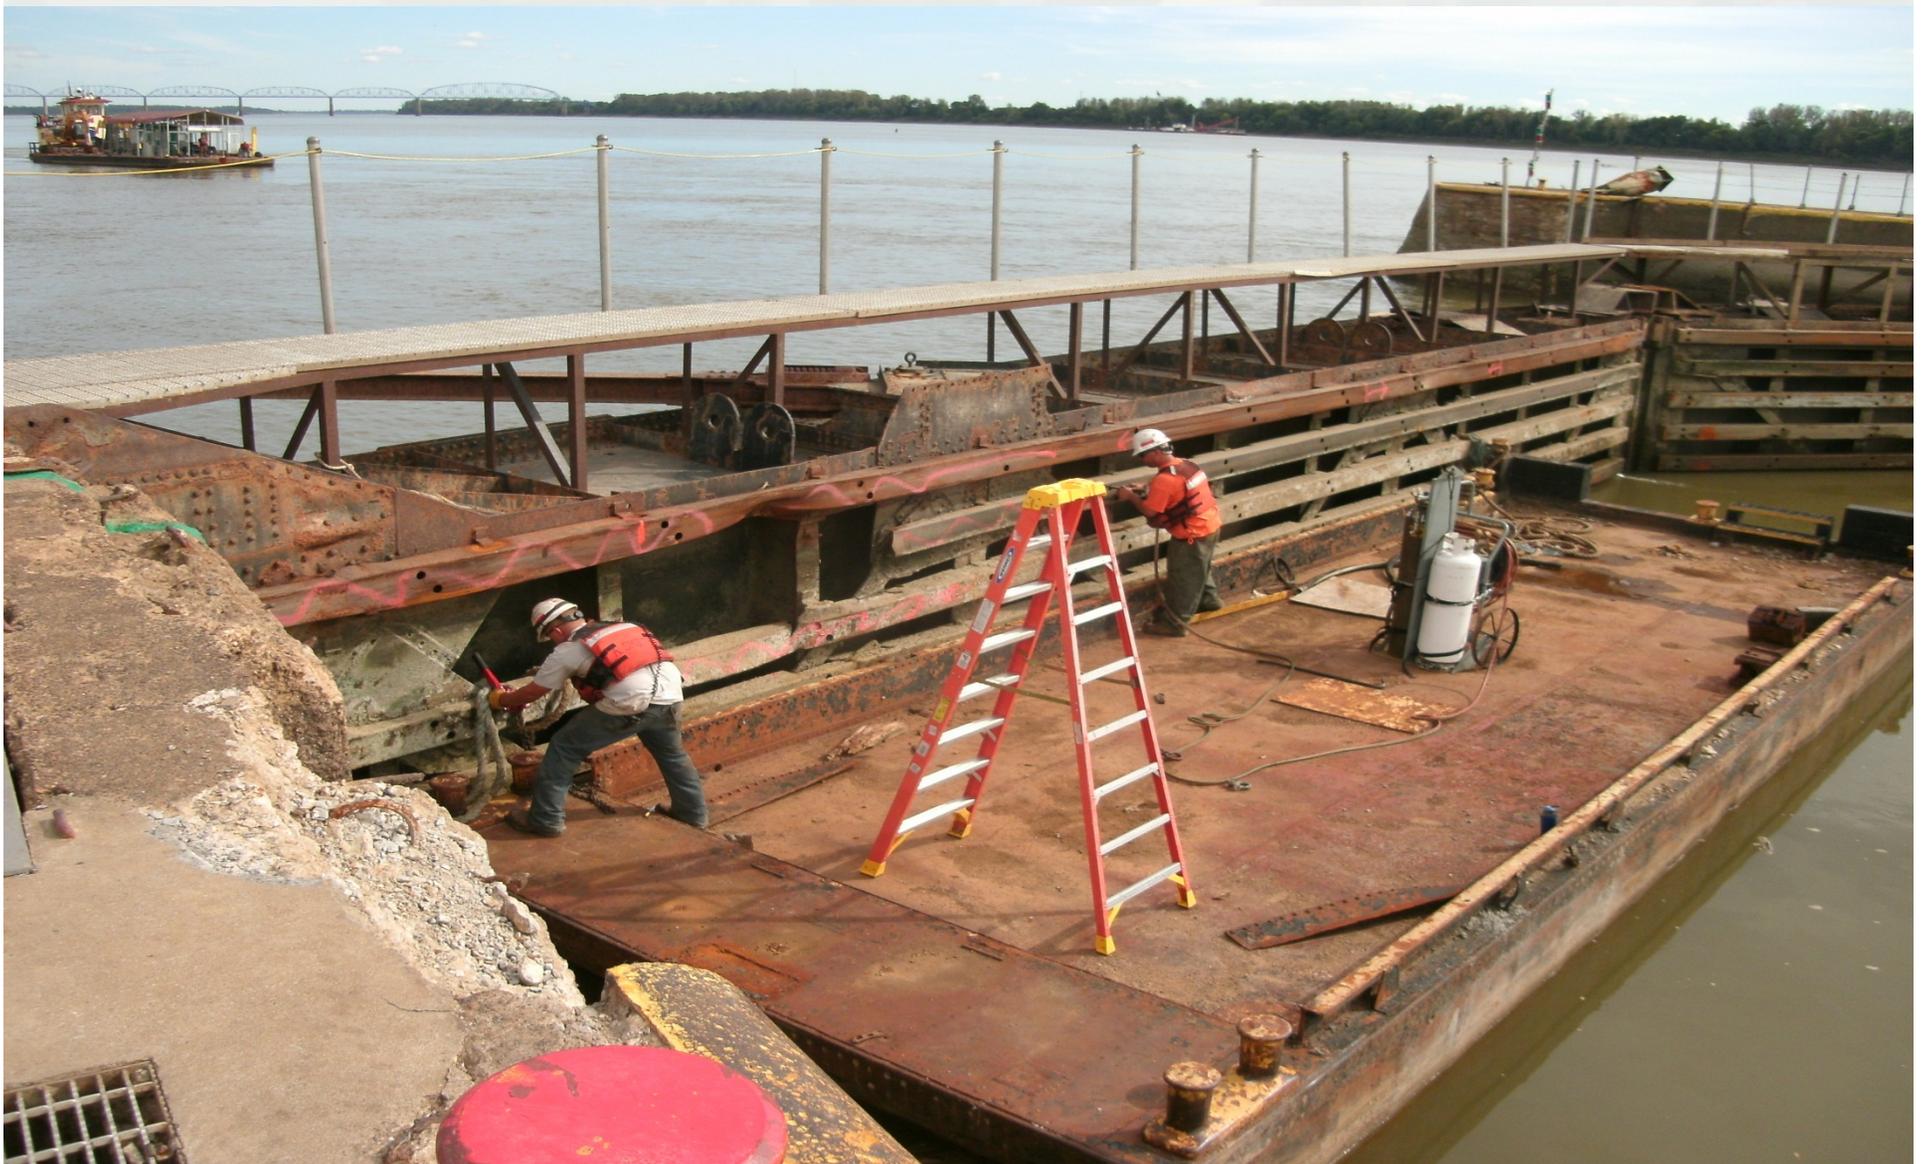
We even threw in some 600' rub fender and concrete repair

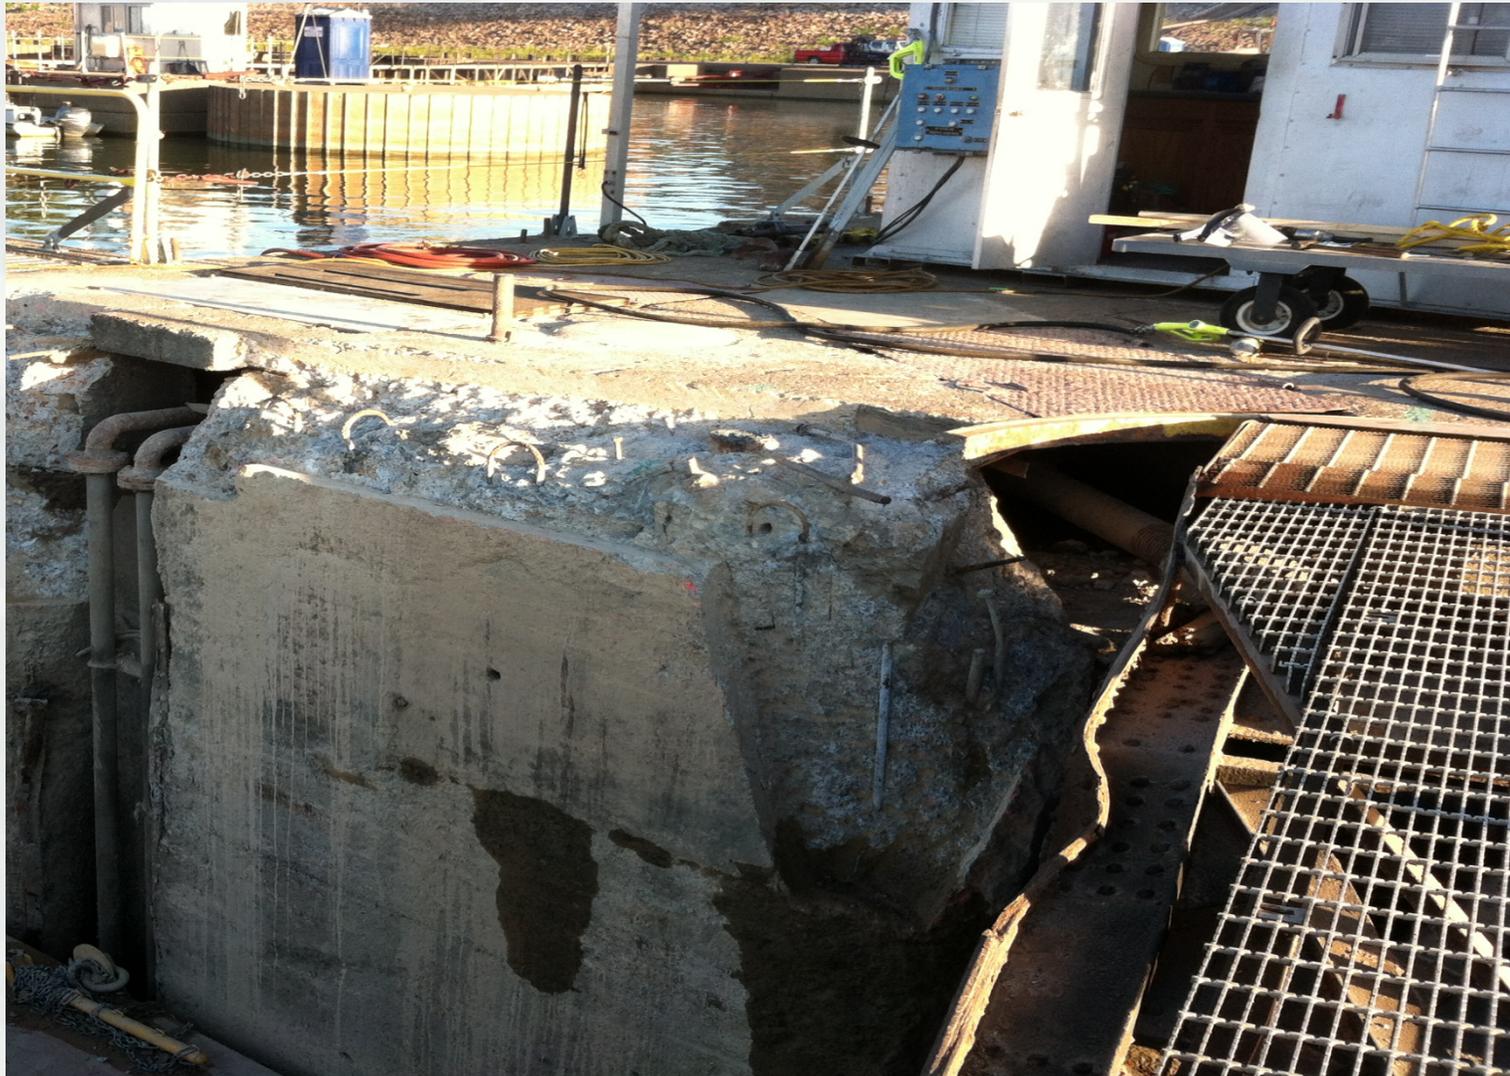
600' Upper Middle Wall Gate Area
