Monitoring and Assessment of Polymer Materials in Civil Works Infrastructure Applications

Monitoring Completed Navigation Projects
(MCNP)

Lock Maintenance Workshop

10 Feb 2016

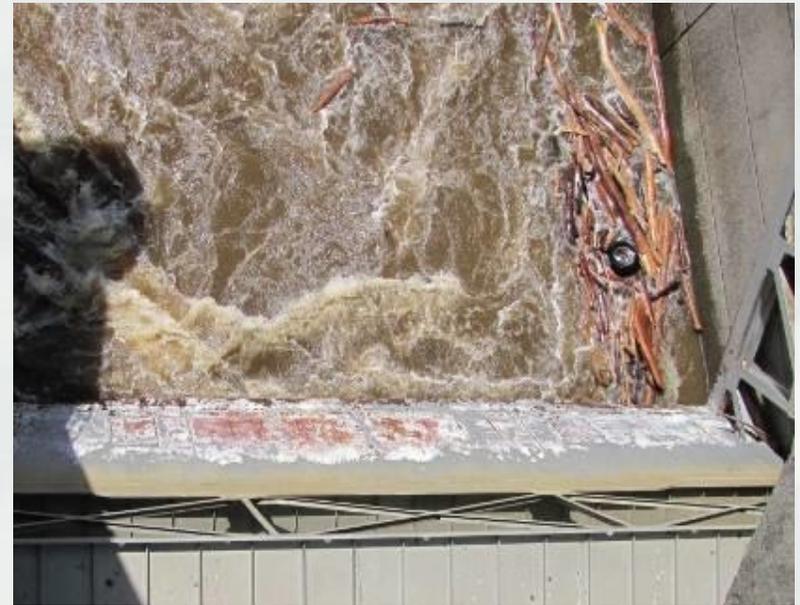
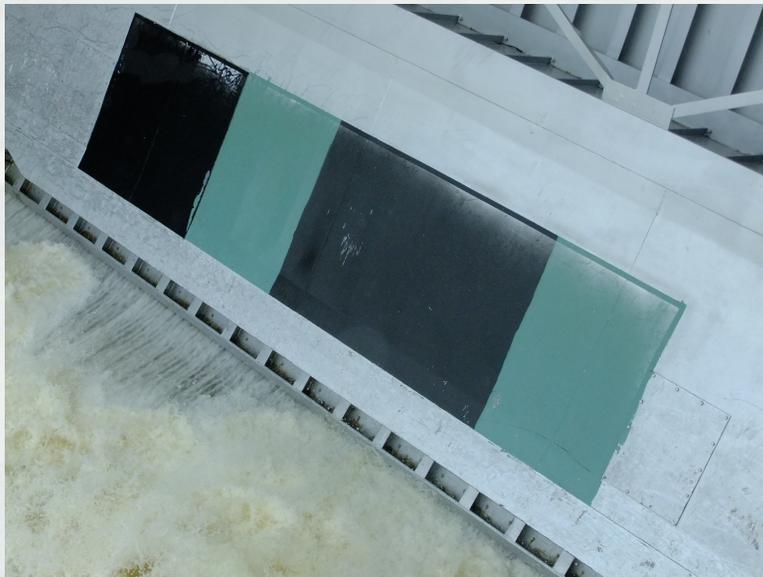
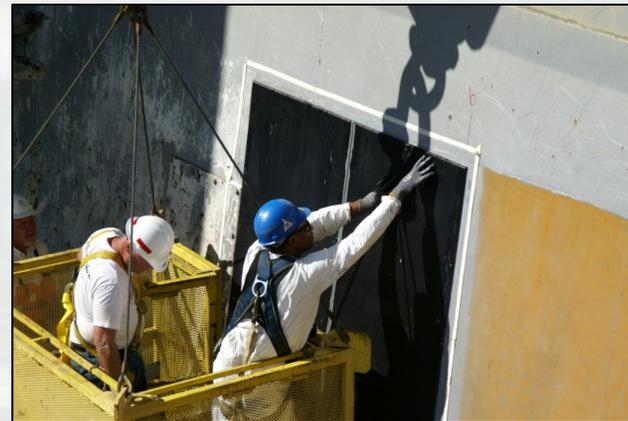
Impact / Abrasion Resistant Coatings

- Howell Heflin Dam, AL
- Adhesively applied UHMWPE
- 2 different ceramic epoxy coatings
- Vinyl 3-A-Z system

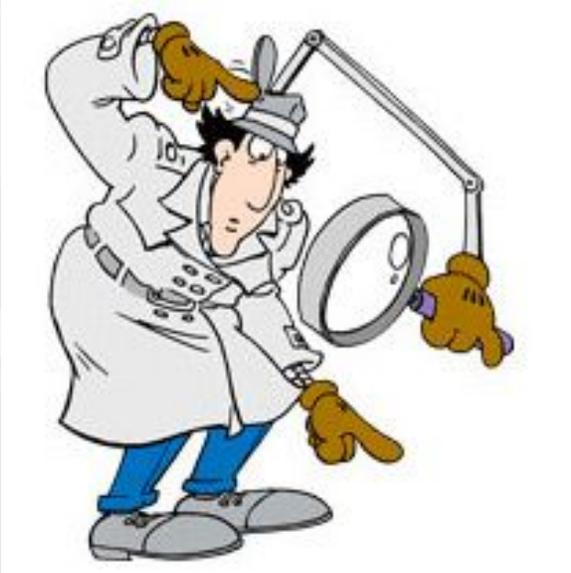
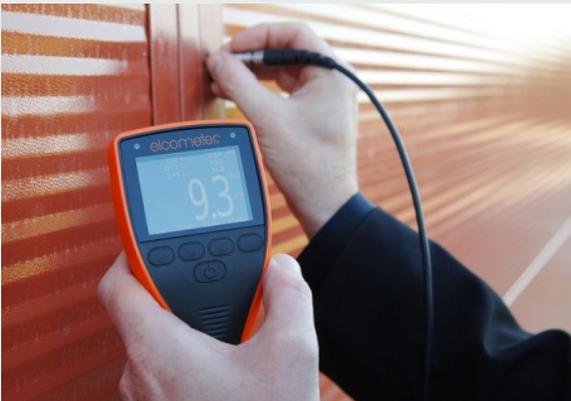
12 Month Field Evaluation

- **Inspection Techniques**
- Visual Observation
 - ▶ Rust
 - ▶ Blister
 - ▶ Undercutting
 - ▶ Impact Damage
 - ▶ Delamination
 - ▶ Cracking
- Dry Film Thickness

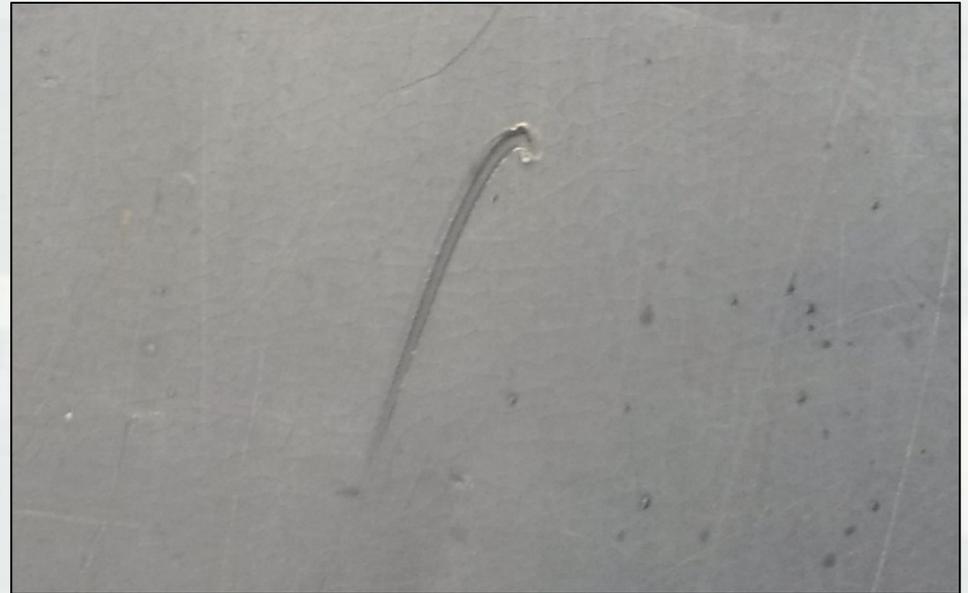
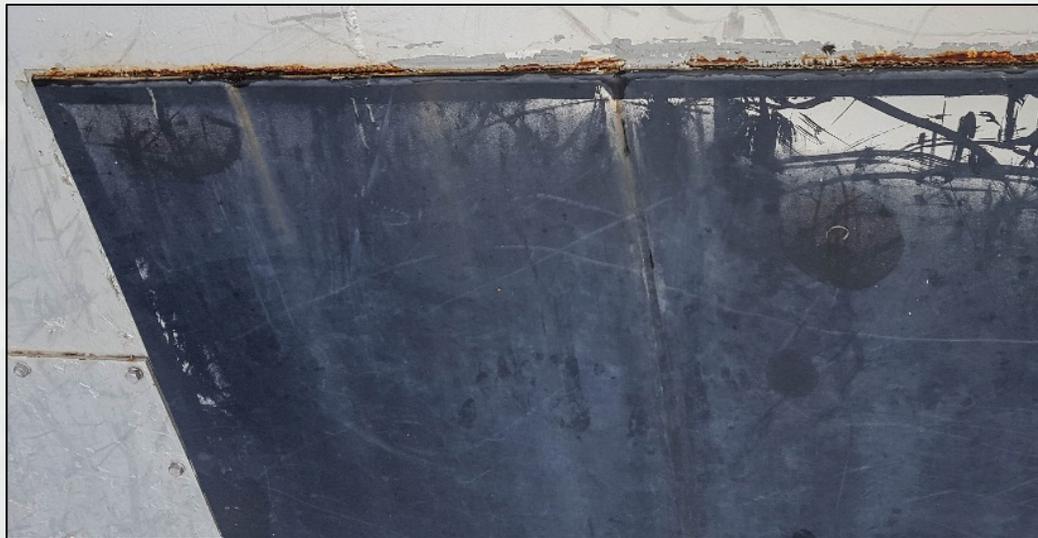
12 Month Field Evaluation

- UHMWPE
- Good Adhesion
- Few areas with 1-2 cm deep gouging
- Some corrosion on edges
 - ▶ Due to poor painting

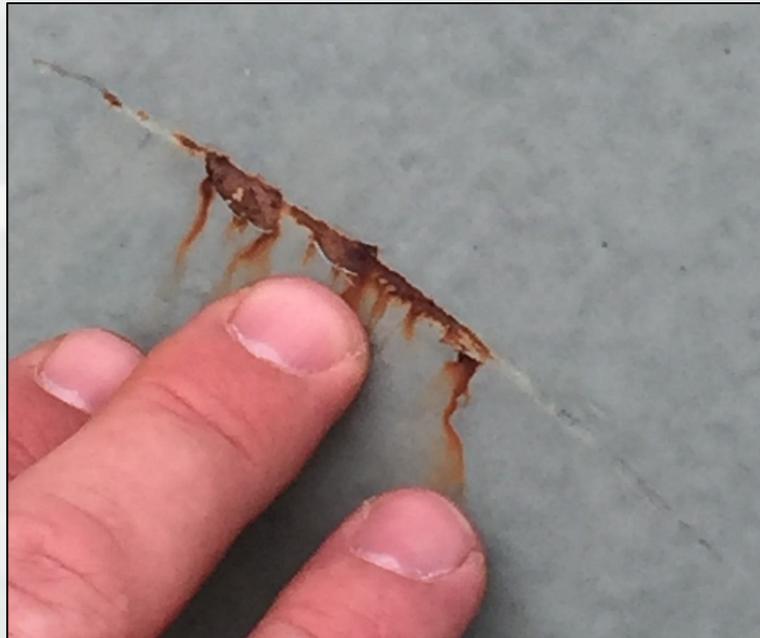
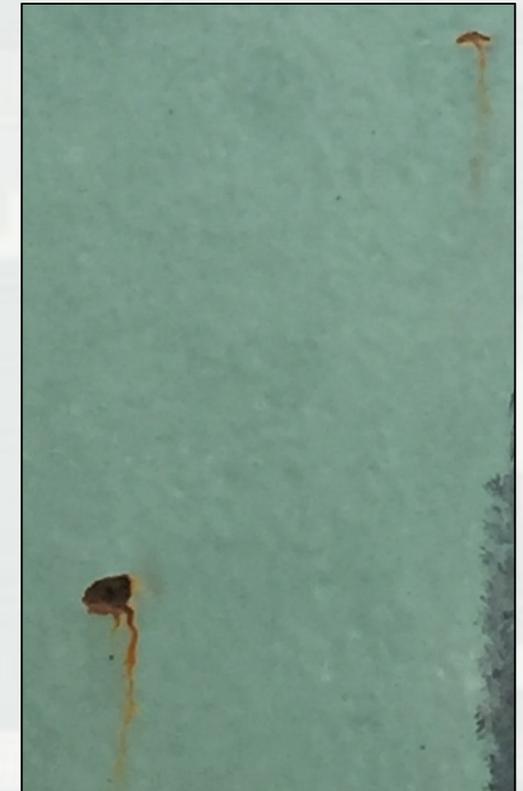
12 Month Field Evaluation

- **Ceramic Epoxy Coatings**
- **Impact/abrasion down to substrate**
- **No blistering or rust undercutting**
- **No chalking**

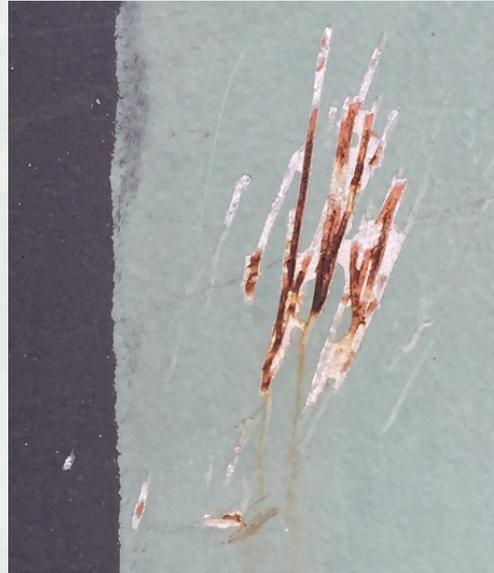
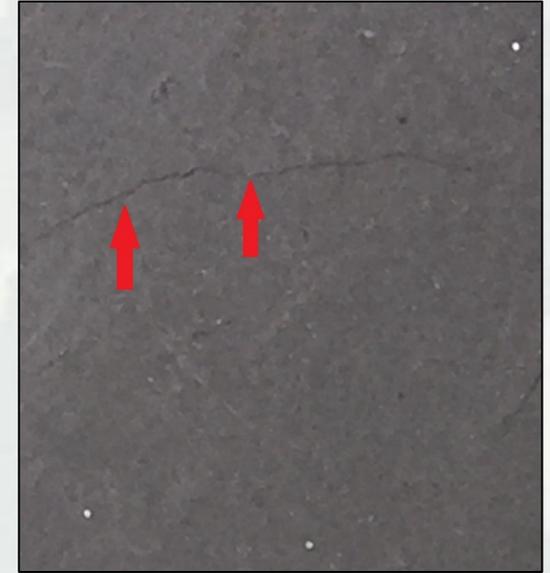
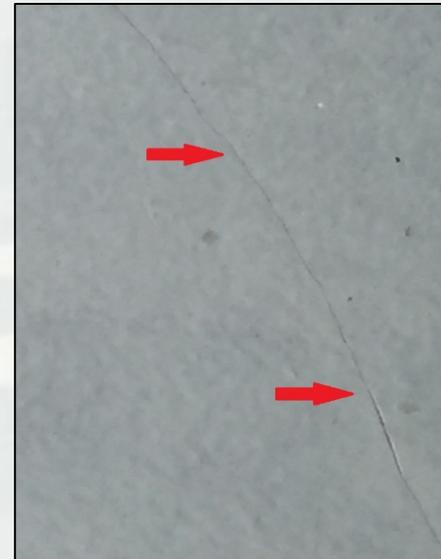
12 Month Field Evaluation

- Ceramic Coatings on Vinyl 3-A-Z
- Impact/abrasion damage
- Vinyl 3-A-Z showing
- Cracking due to differences in thermal expansion coefficients

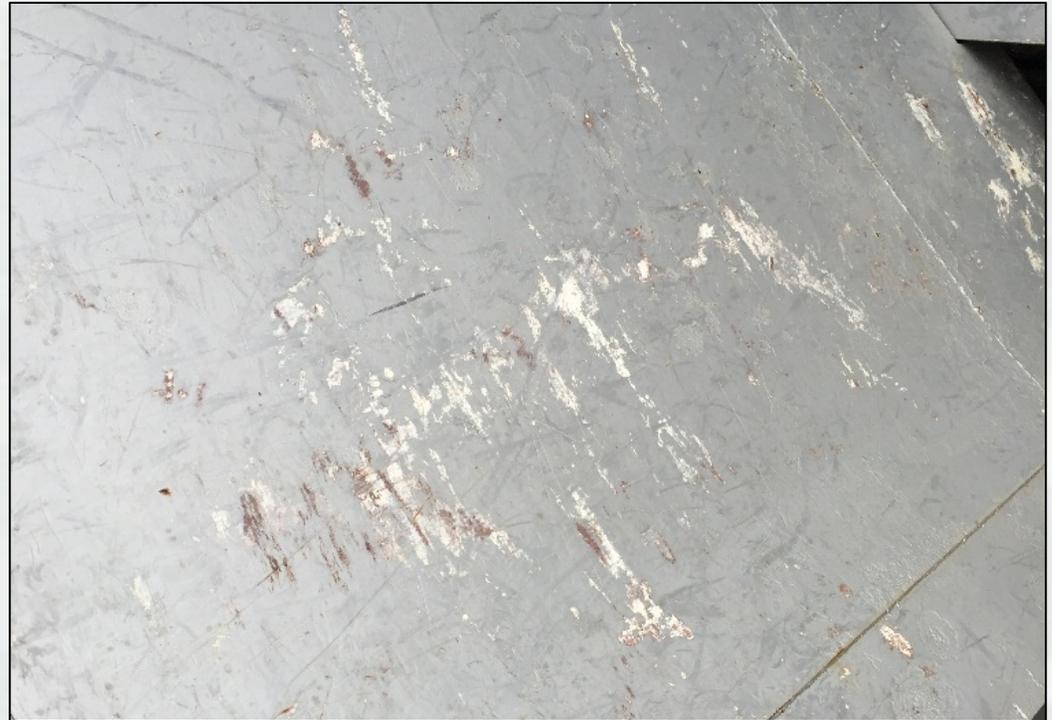
12 Month Field Evaluation

- Vinyl 3-A-Z System
- Extensive impact/abrasion damage
- White intermediate and zinc primer showing
- Substrate corroding

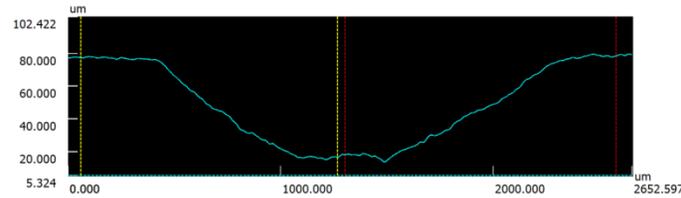
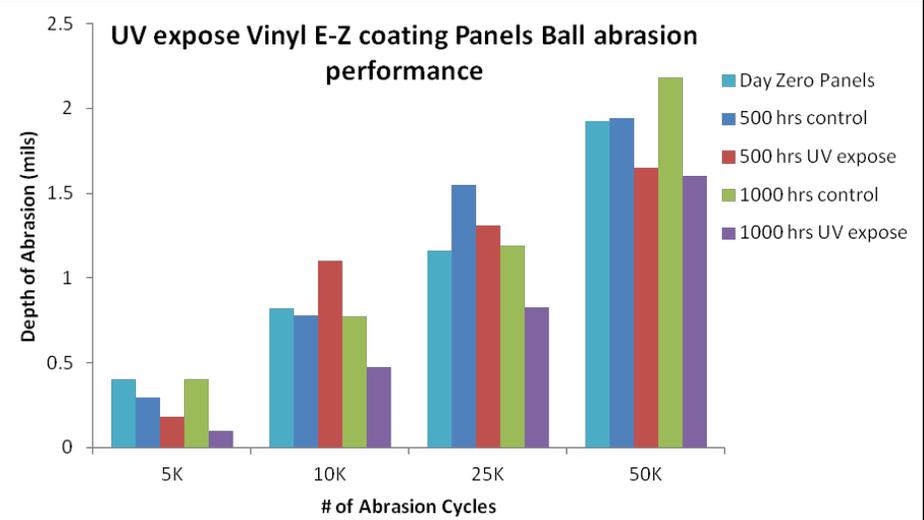
Laboratory Testing

Laser-optical image

3D profile

Scan length vs surface profile

# Abrasion cycles	Average abraded depth(mils)				
	Control			UV exposed	
	Day Zero	500hrs	1000hrs	500hrs	1000hrs
5K	0.403771	0.293648	0.402392	0.177446	0.098796
10K	0.822081	0.777488	0.774316	1.100619	0.475666
25K	1.158557	1.548223	1.188726	1.307371	0.825105
50K	1.924887	1.942578	2.180357	1.648378	1.603866

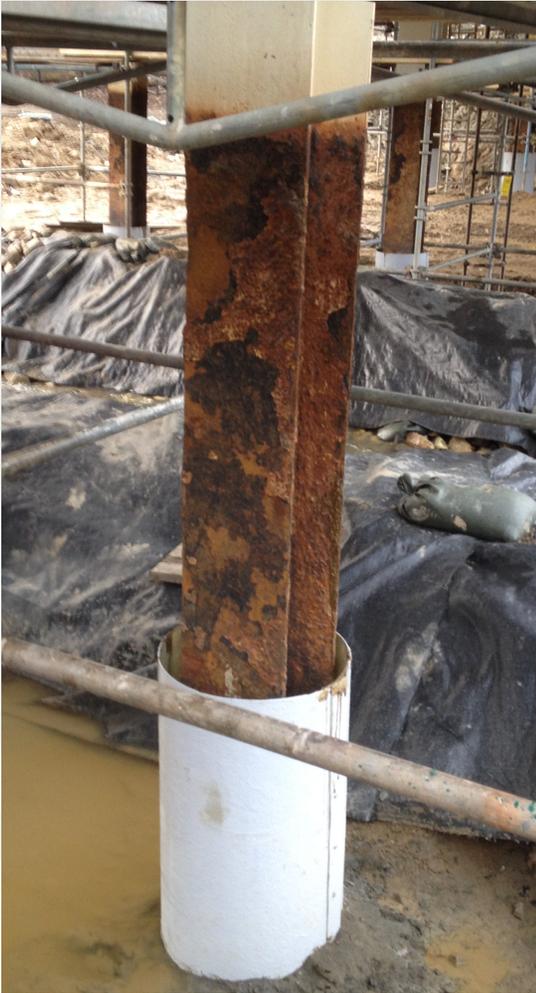
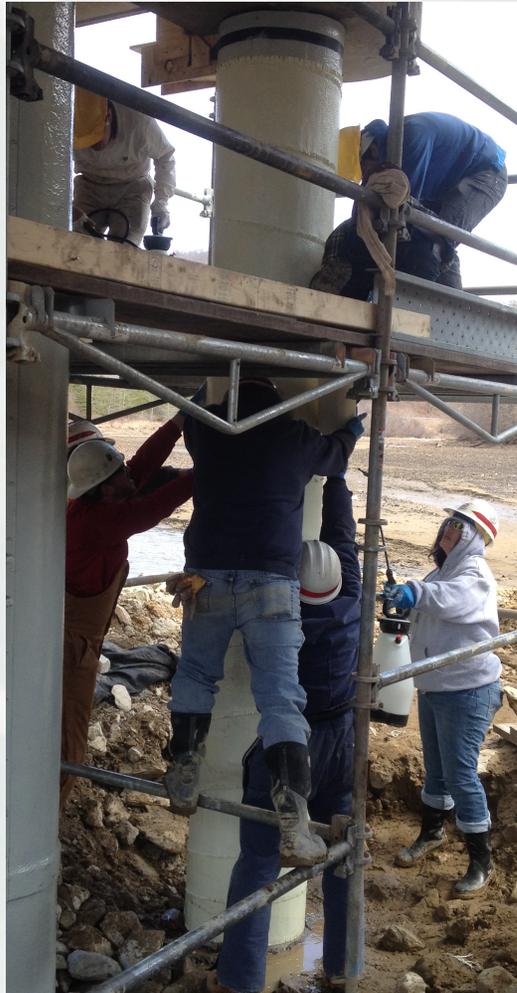
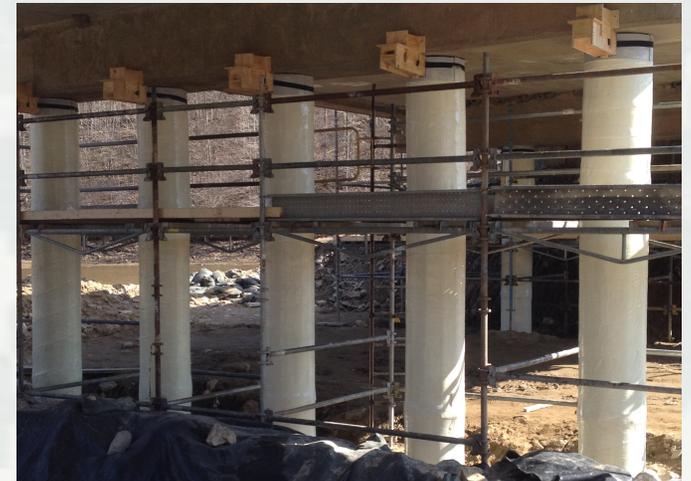
Composite Pile Repair

- East Lynn Lake, WV
- FRP Shell
- Epoxy Grout
- FRP Wrap
- Self Consolidating Concrete

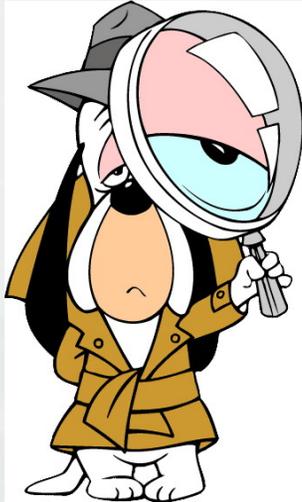
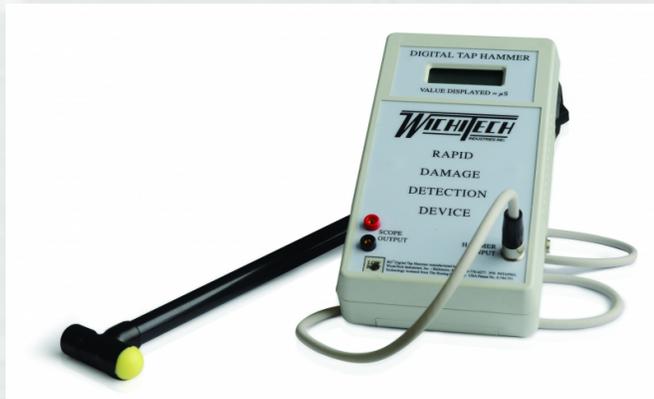
20 Month Field Evaluation

- **Inspection Techniques**
- Visual Observation
 - ▶ Cracking
 - ▶ Swelling
 - ▶ Brooming
 - ▶ Impact Damage
- Digital Tap Hammer
 - ▶ Quantitative
 - ▶ Probes Delaminations

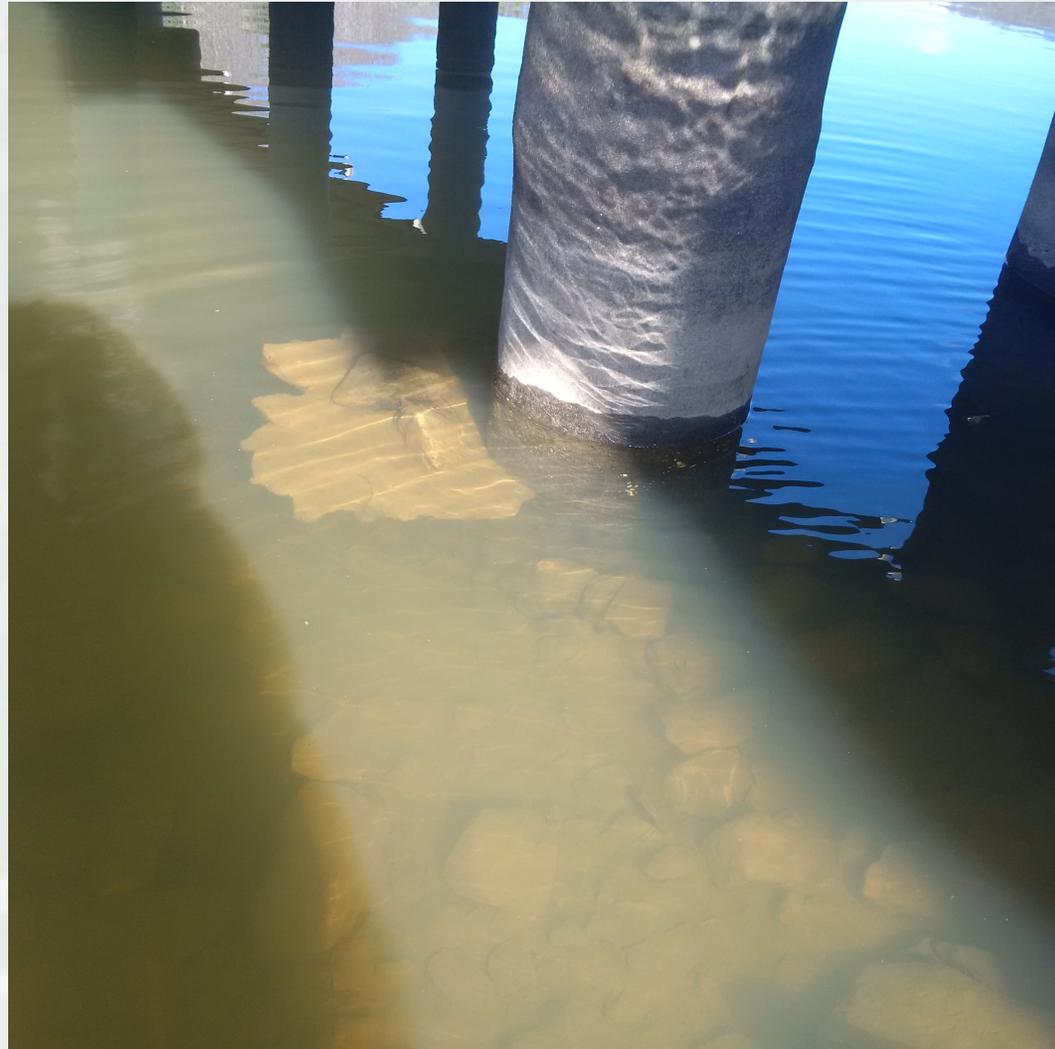
20 Month Field Evaluation

- Scour / Erosion
- Bare Steel Exposed
- Repair
 - ▶ Restore Mudline
 - ▶ New, Larger Riprap

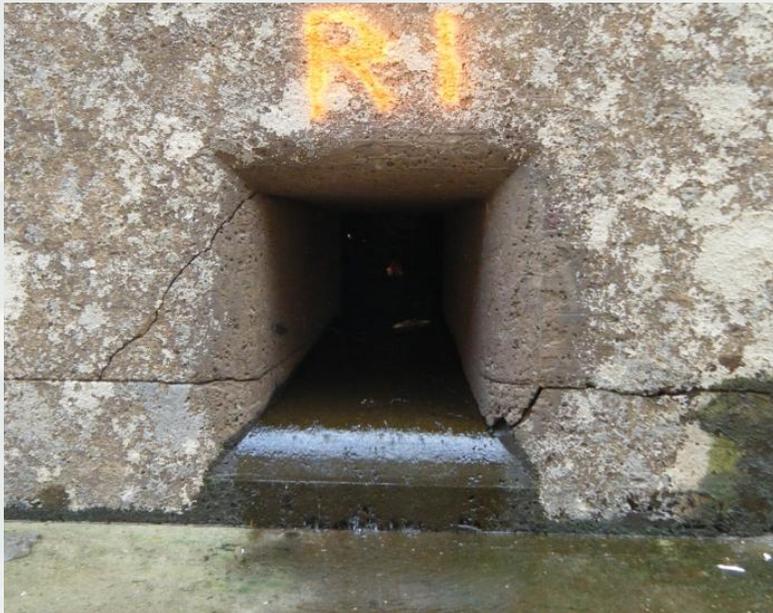
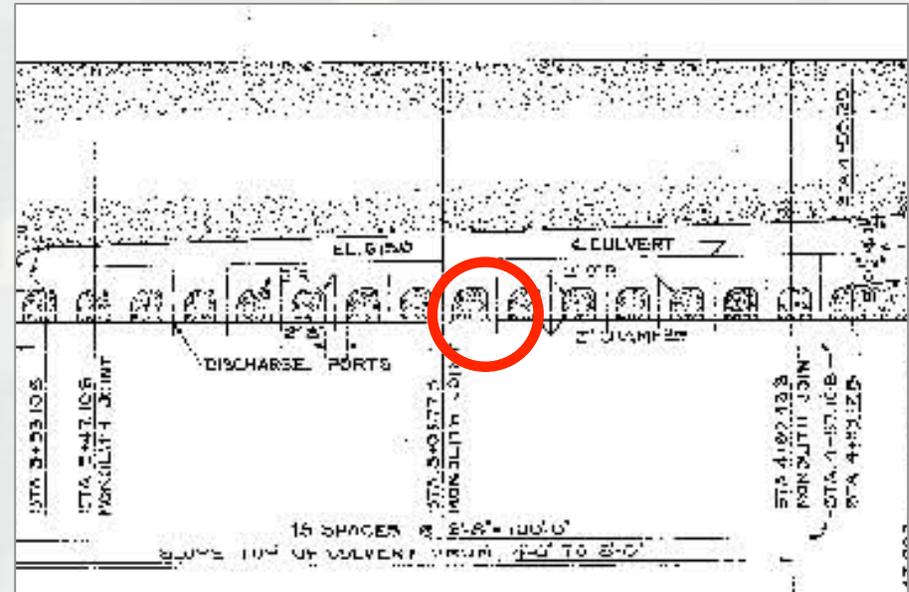
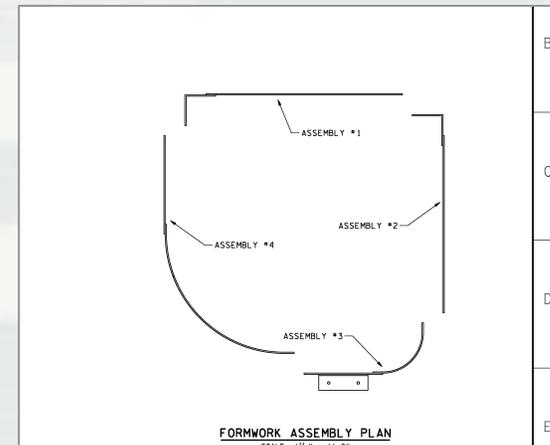
FRP Wrap Concrete Repair

- Chickamauga Lock – Chattanooga, TN
- FRP Wrap
- Primer
 - ▶ Promotes Adhesion

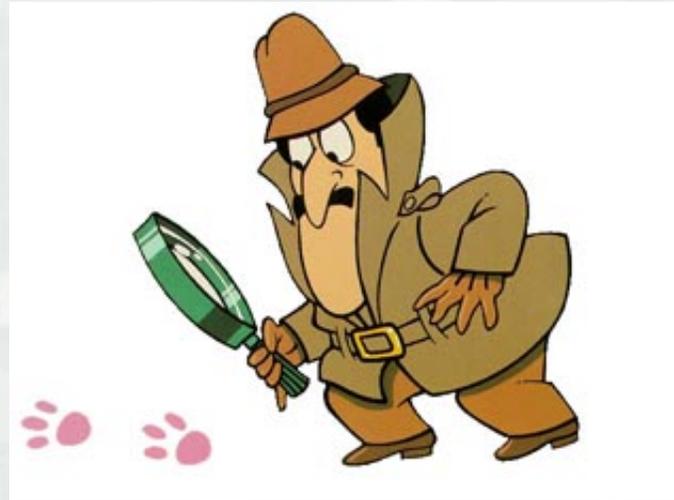
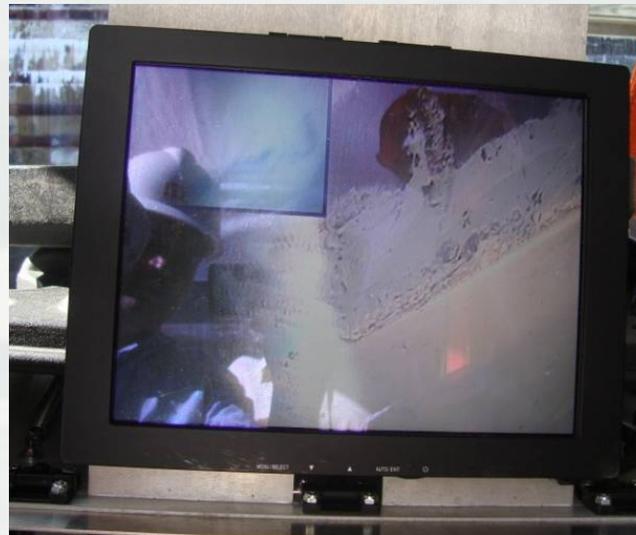
12 Month Field Evaluation

- **Inspection Techniques**

- Visual Observation - Divers

- ▶ Cracking
- ▶ Disbonding
- ▶ Swelling

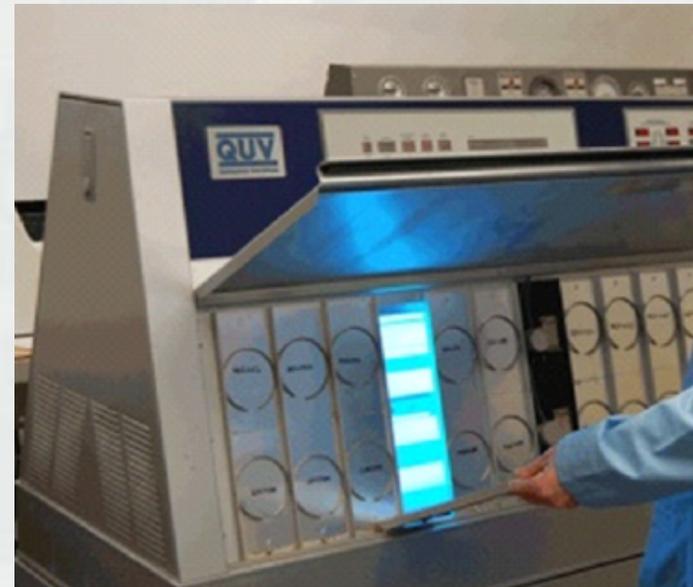
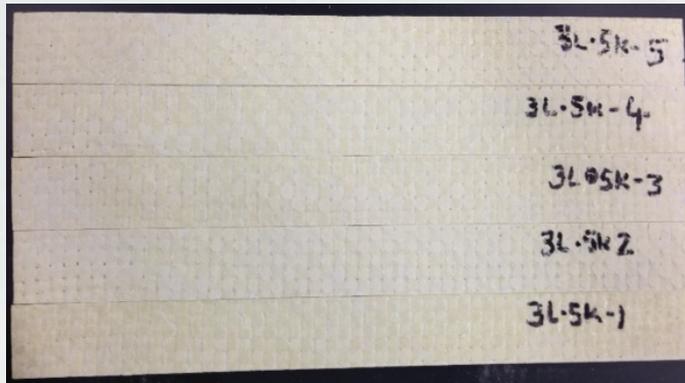
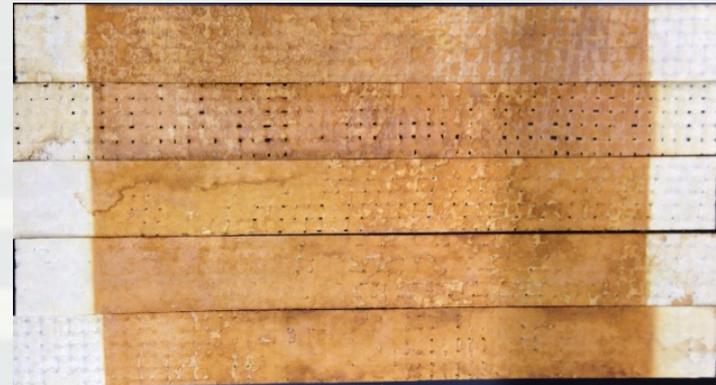
Laboratory Testing

- Accelerated Weathering
 - ▶ Immersion
 - ▶ UV
 - ▶ Atmospheric
- Compression Testing
 - ▶ Wrapped Concrete Cylinders
- Tensile Testing

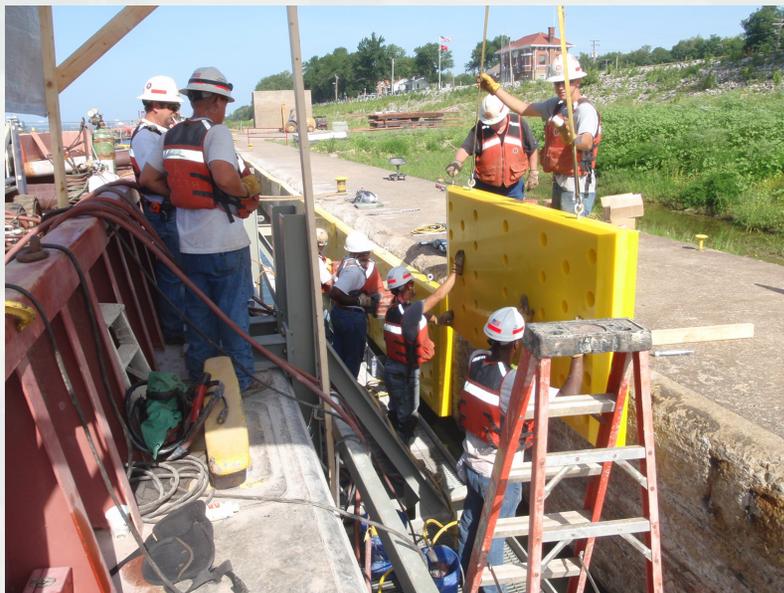
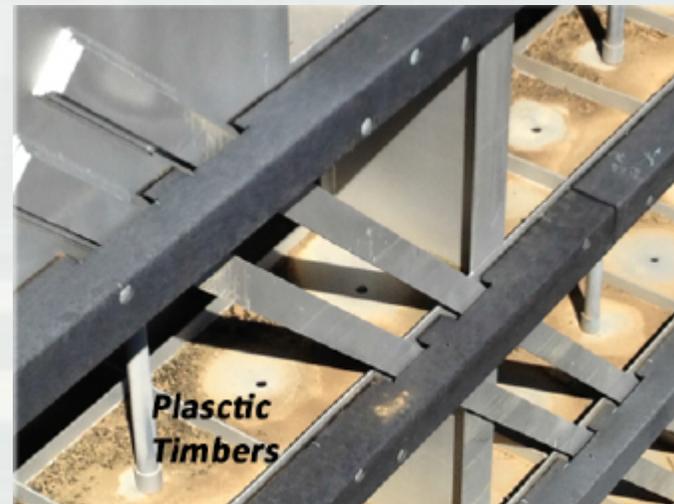
Composite Timbers

- Bumpers
 - ▶ Many locks across USACE
- Wall Armor
 - ▶ Lock and Dam 52

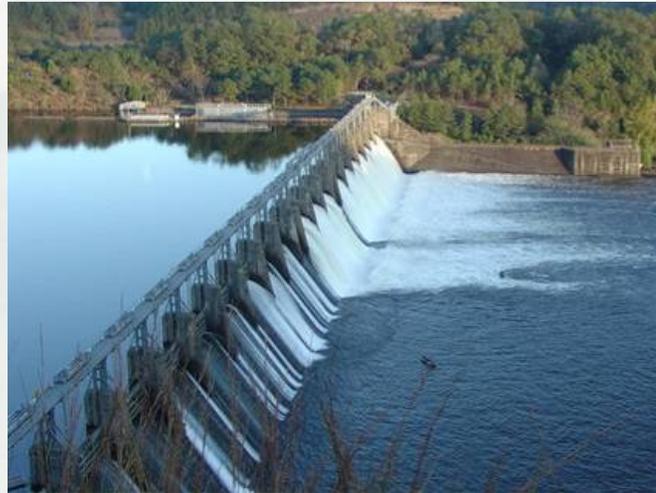
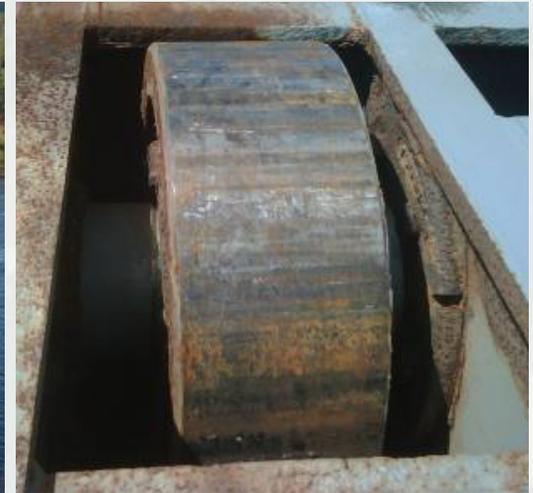
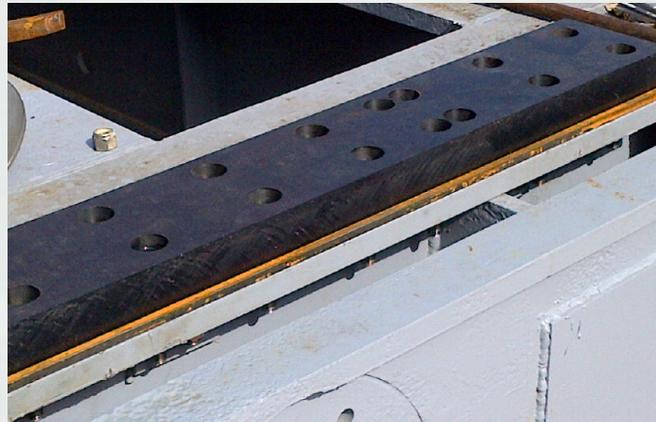
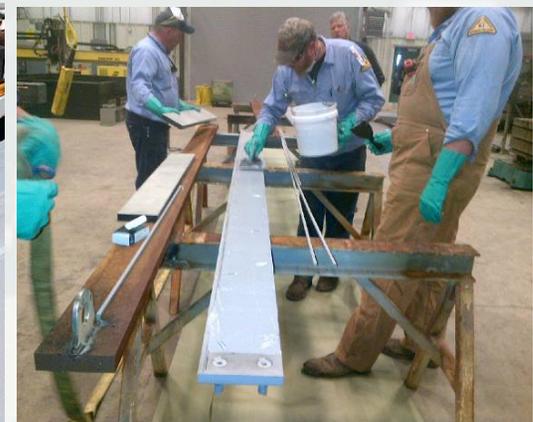
Polymer Slides

- Bankhead Dam, AL
- Iteration #1
 - UHMW-PE
 - ▶ Mechanically Fastened
- Iteration #2
 - PTFE
 - ▶ Mechanically Fastened
 - UHMW-PE
 - ▶ Adhesively Applied

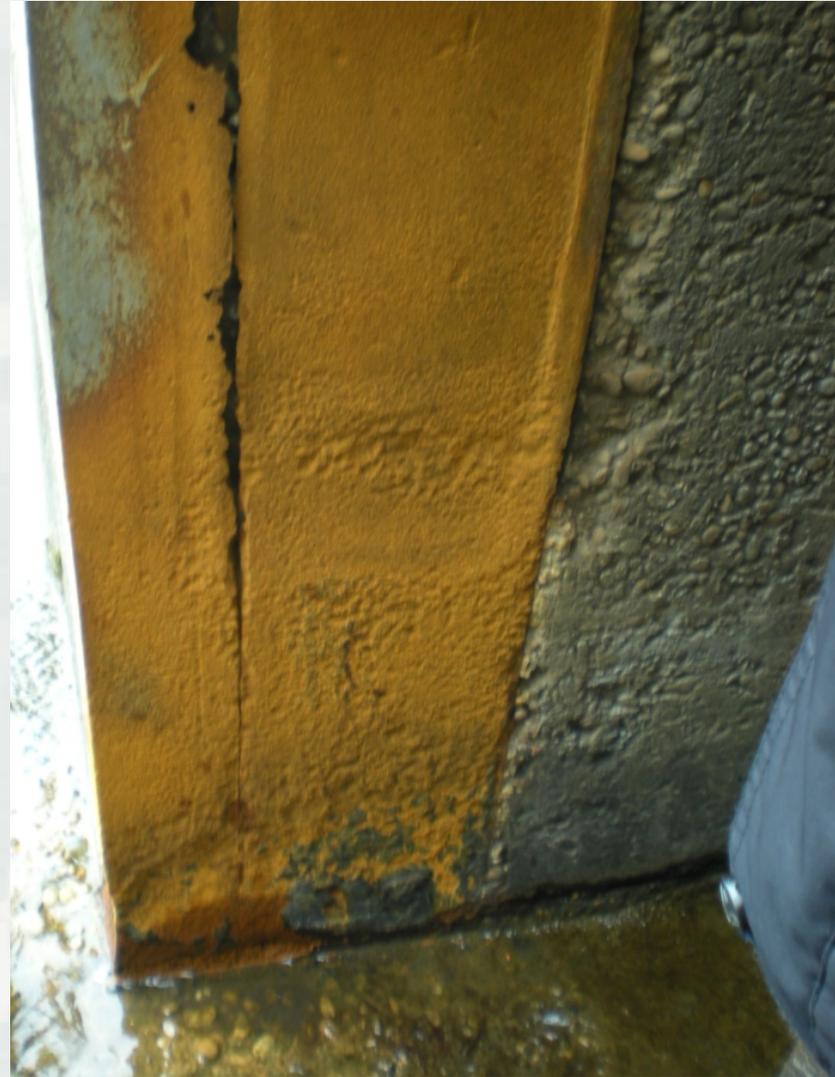
Polymer Slides

- Iteration #3
 - Imbedded Steel Plate
Badly Corroded
 - Belzona R-Metal Repair
 - Superglide Topcoat
- Iteration #4
 - Stainless Steel Plate
 - ▶ Imbedded in Composite
Sheet

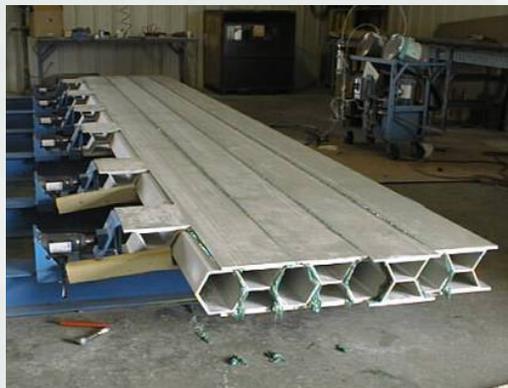
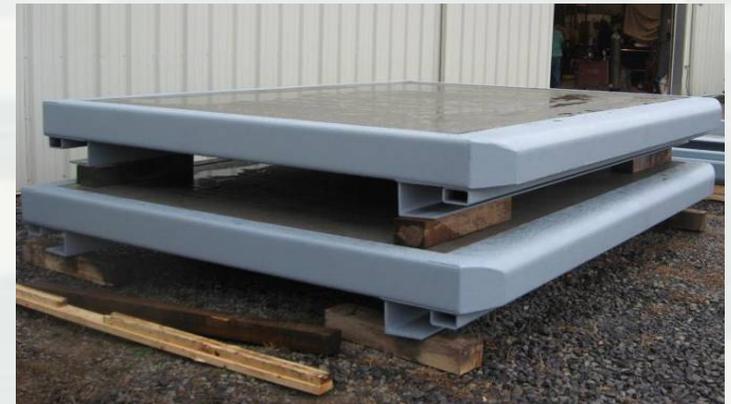
Composite Recess Panels

- Willow Island Lock, OH
- **Inspection Techniques**
- Visual Observation
 - ▶ Cracking
 - ▶ Swelling
 - ▶ Brooming
 - ▶ Abrasion
 - ▶ Impact Damage
- Digital Tap Hammer
 - ▶ Quantitative
 - ▶ Probes Delaminations

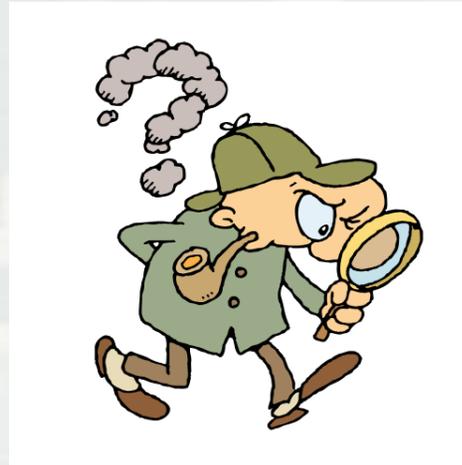
Composite Miter Blocks

- Hiram Chittenden Locks, WA
- **Inspection Techniques**
- Visual Observation
 - ▶ Cracking
 - ▶ Swelling
 - ▶ Brooming
 - ▶ Abrasion
 - ▶ Impact Damage
- Digital Tap Hammer
 - ▶ Quantitative
 - ▶ Probes Delaminations

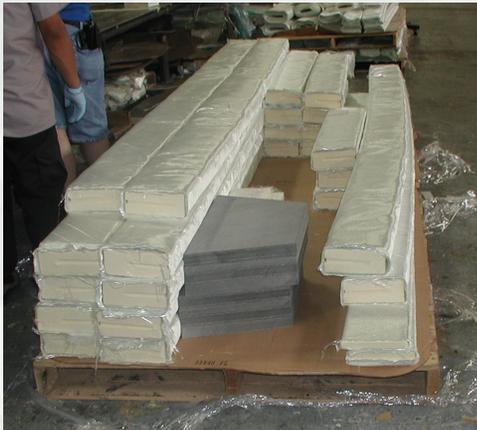
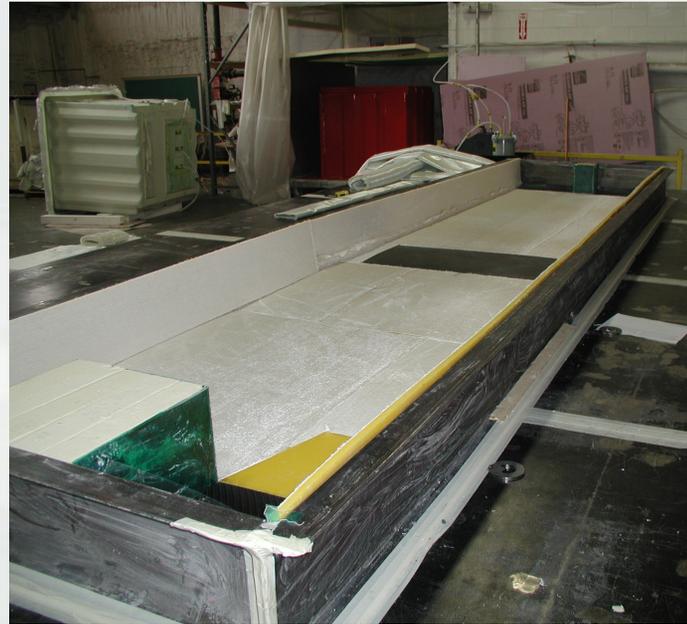
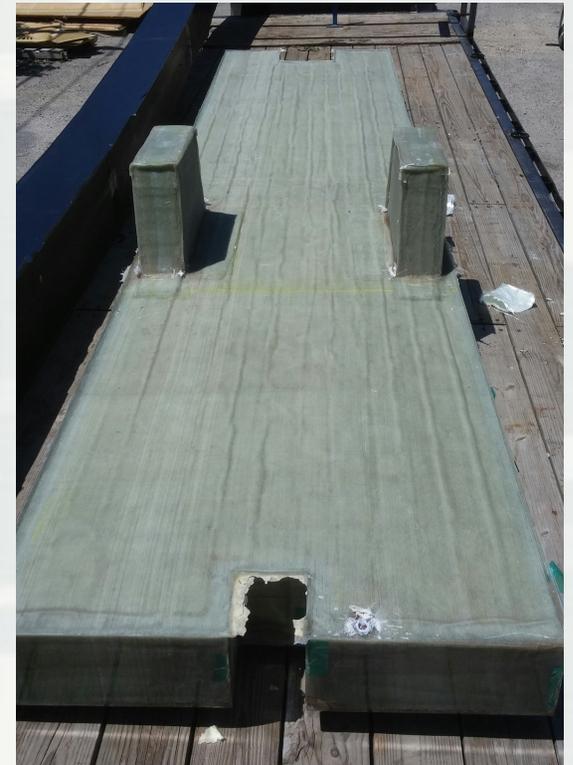
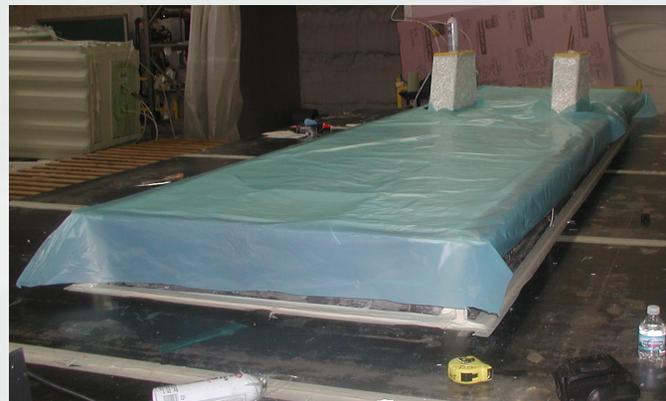
Composite Wicket Gate

- Peoria Dam, IL
