L&D 07: Murray Lock Center Post Anchorage

9 Feb 2016

Background

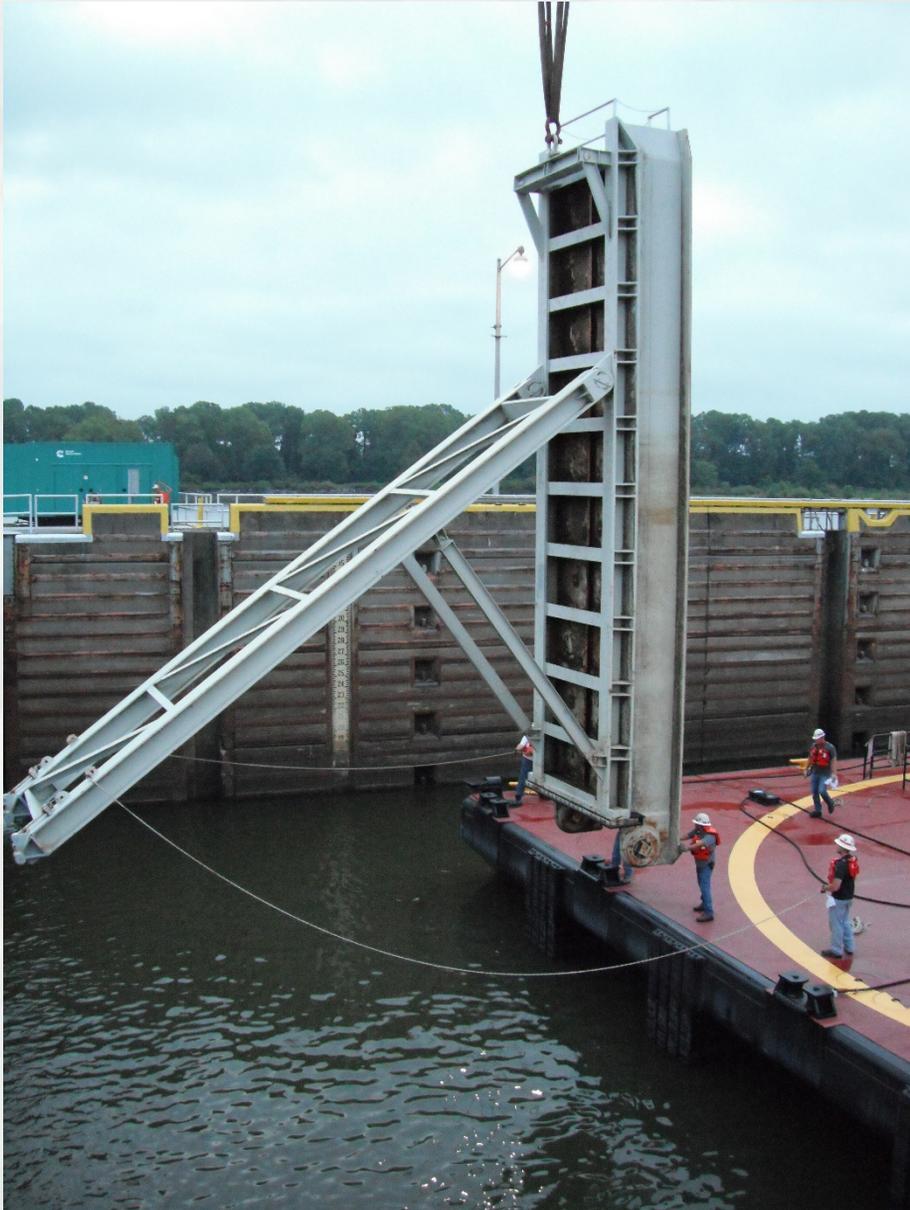
Dewater System

- Receiver in the concrete that anchors the centerpost in place.
- The centerpost marks the mid-point between the lock chamber width.

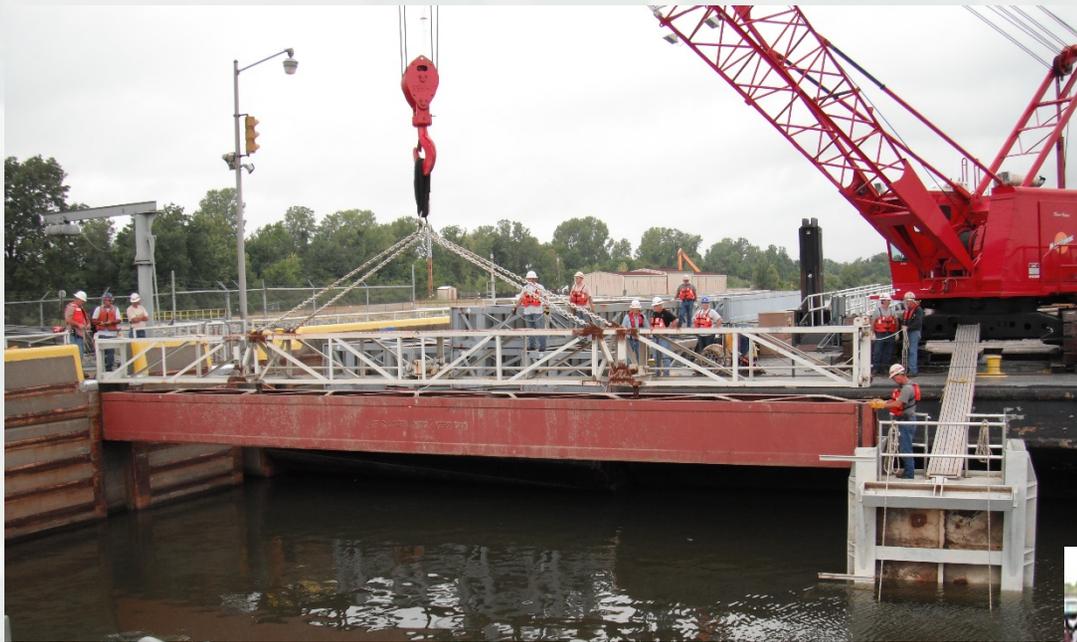
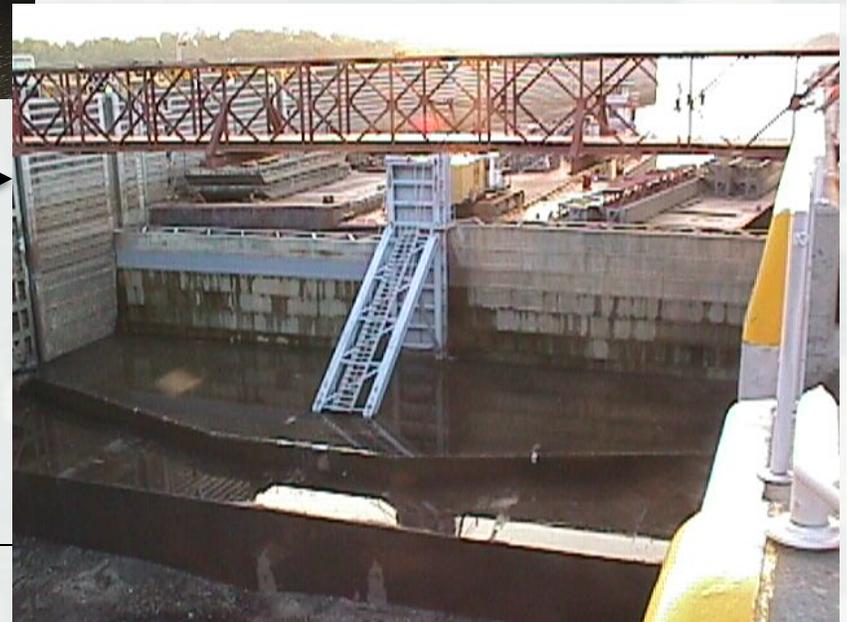
Dewater System

← Stoplogs are slid into place—stop log slots in the lock walls and centerpost.

Creates a closure system → that allows the chamber to be pumped dry to perform the required maintenance on below water assets.

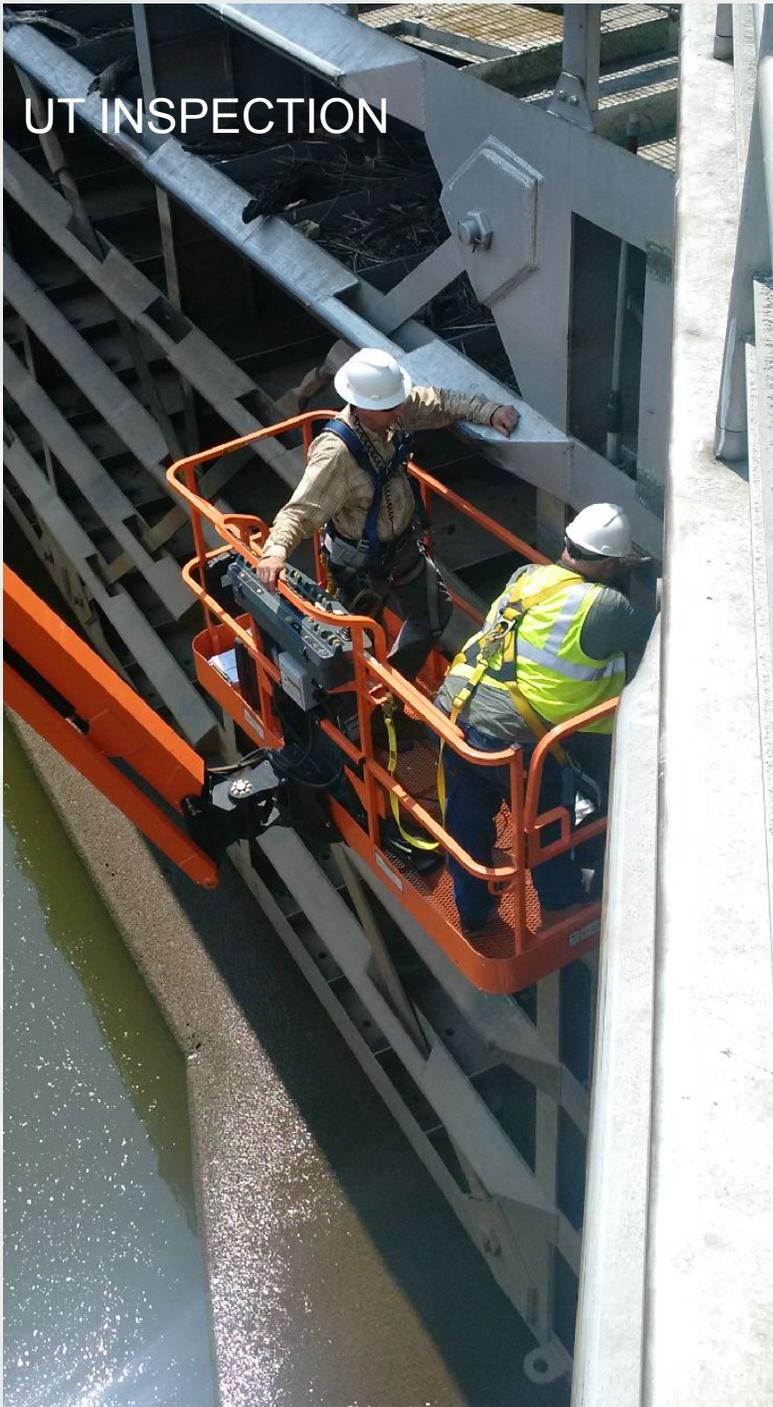
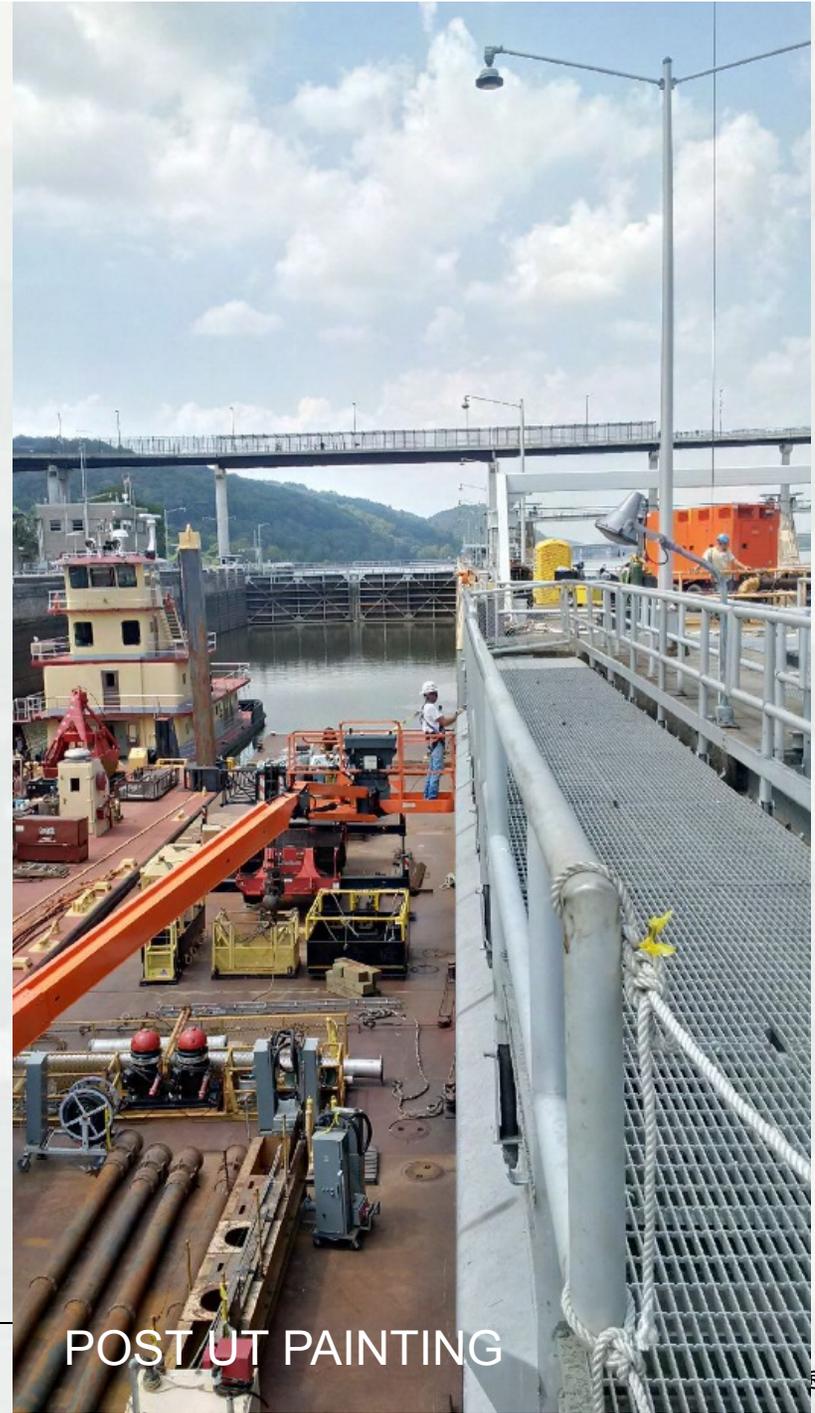
PREP MITER GATES FOR UT INSPECTION

POST UT PAINTING

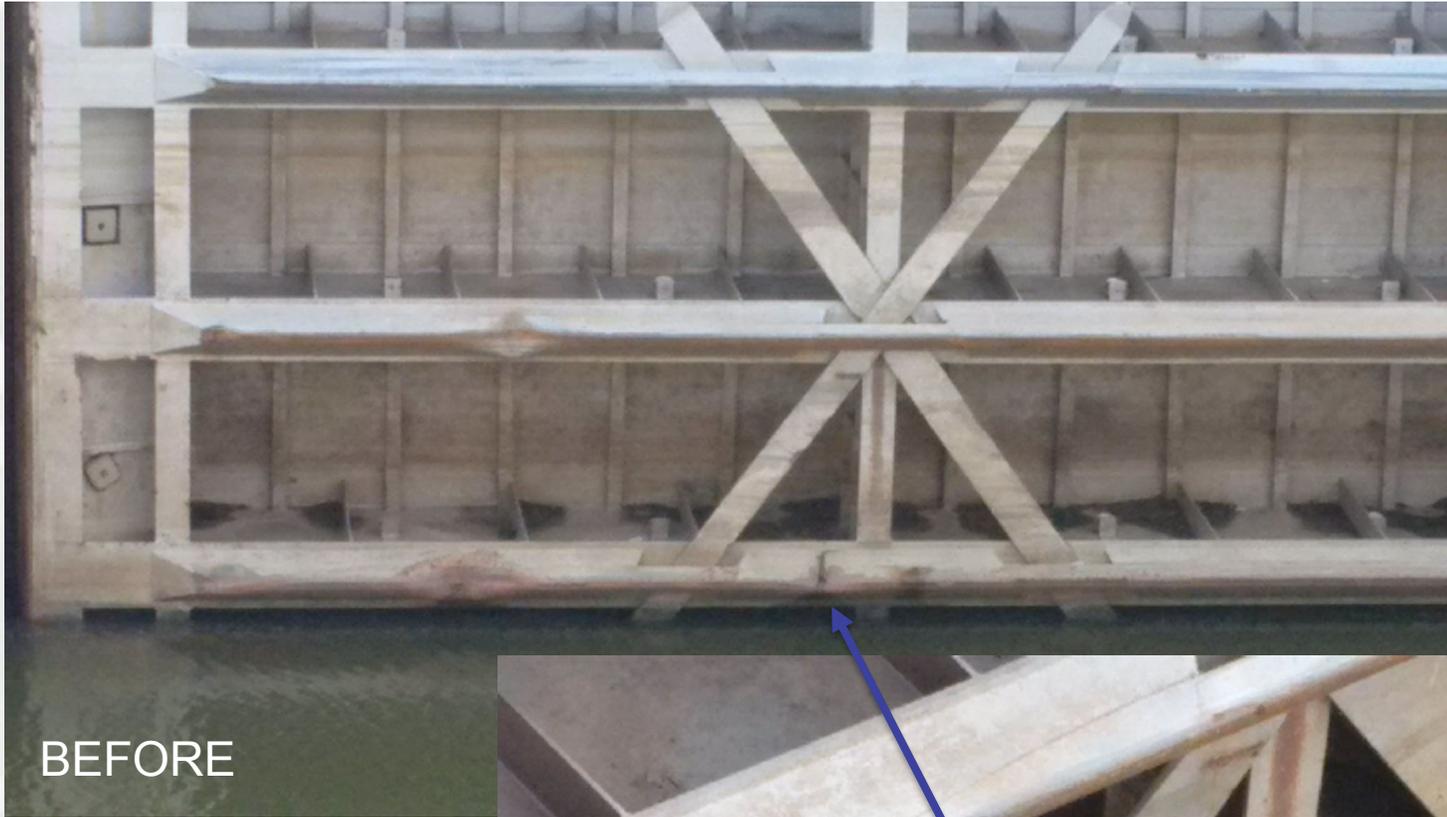
BEFORE

MITER GATE FENDER REPAIR

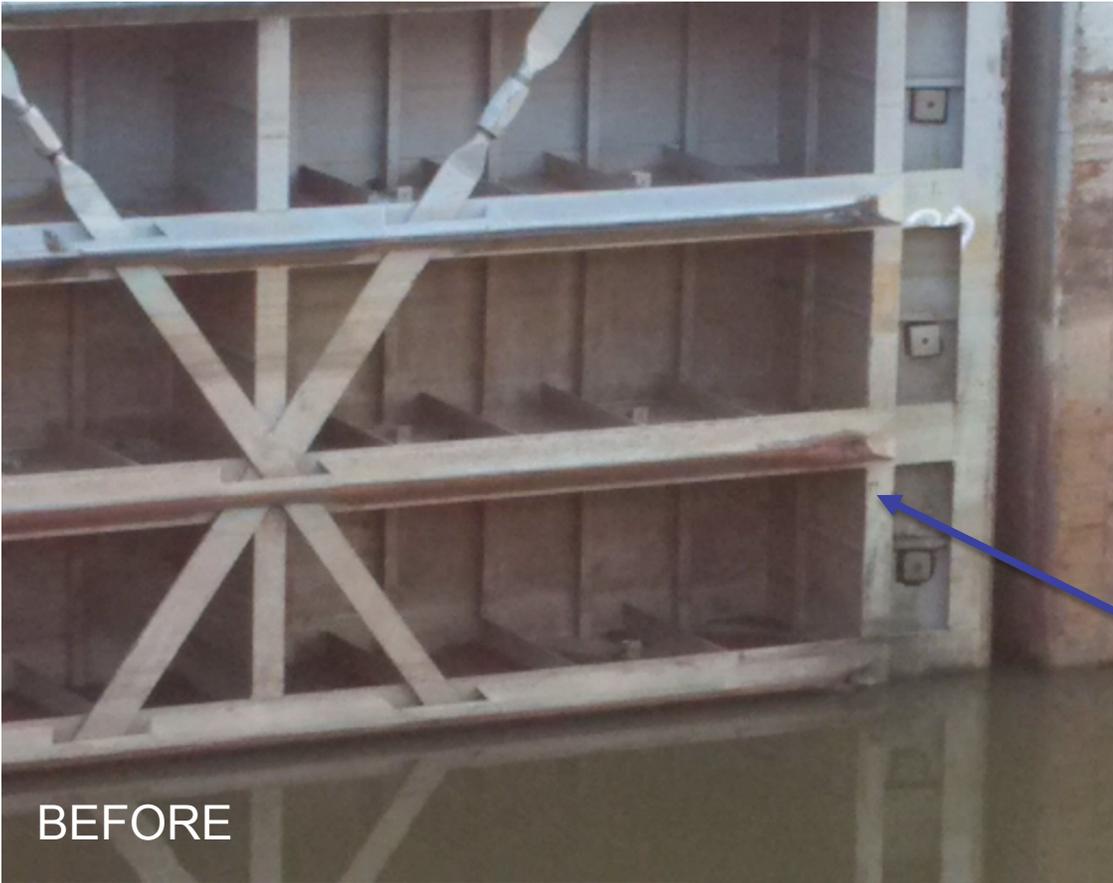
BEFORE

MITER GATE FENDER REPAIR

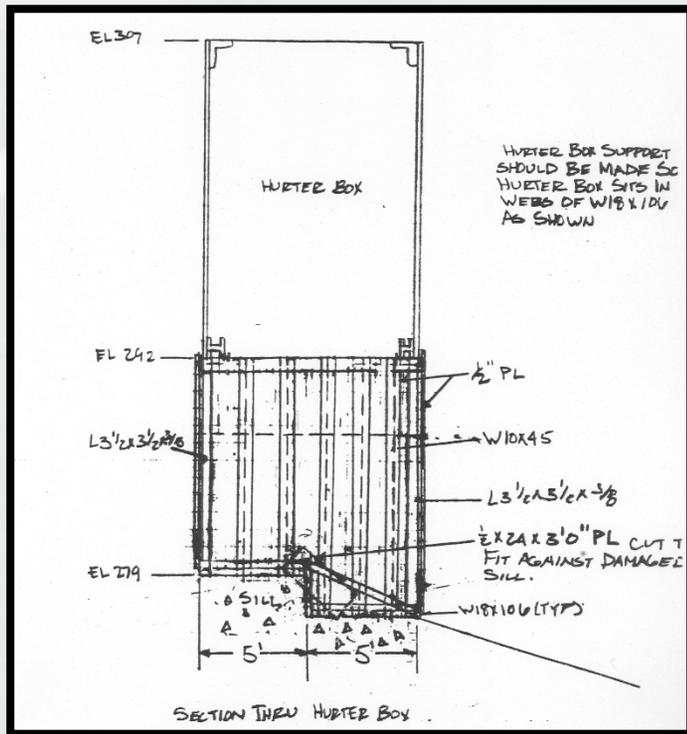
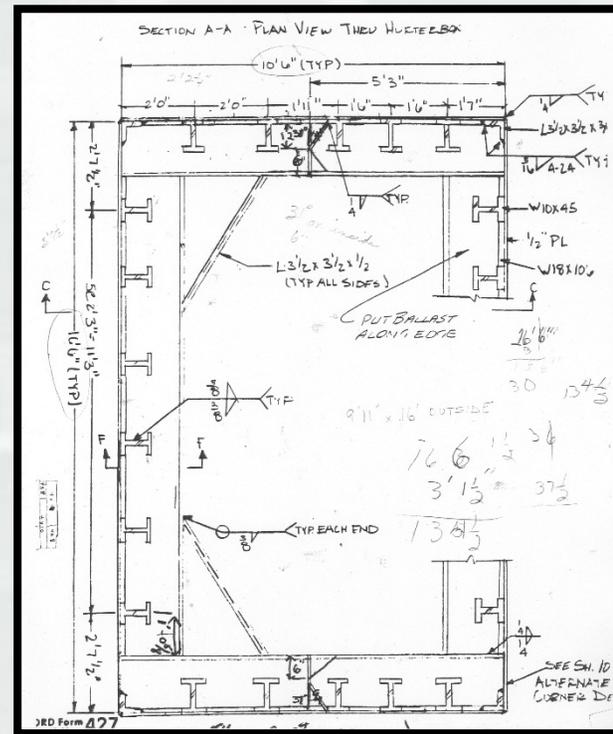
OPTION A: Dewatering Box

- Installation of a dewatering box
 - ▶ Estimated to weigh 90,000 lbs each
 - ▶ Anchored to the lock floor with concrete anchors
 - ▶ Dewater the box
- Remove and repair existing receiver/anchors
 - ▶ center post anchor has to be removed
 - ▶ corroded anchors will have to be core drilled to a depth of 36 inches
 - ▶ anchors will have to be cut off
 - ▶ sixteen new stainless steel anchors installed – grouted in place
- Total estimated ROM is \$1.5 million.
 - ▶ This solution still has a problem in that the anchorage is fracture critical and can only be inspected underwater where visibility is next to zero.

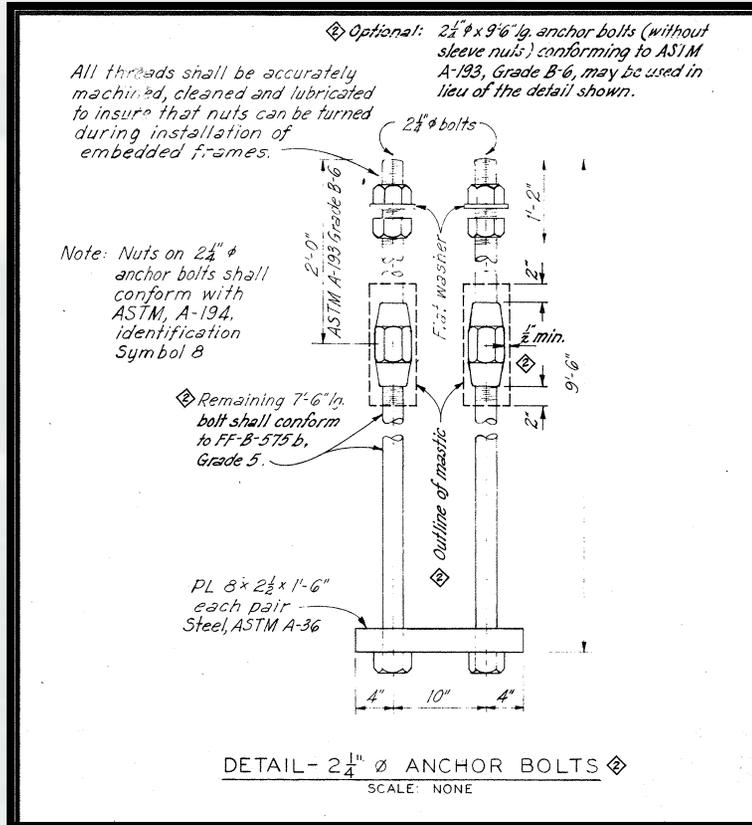
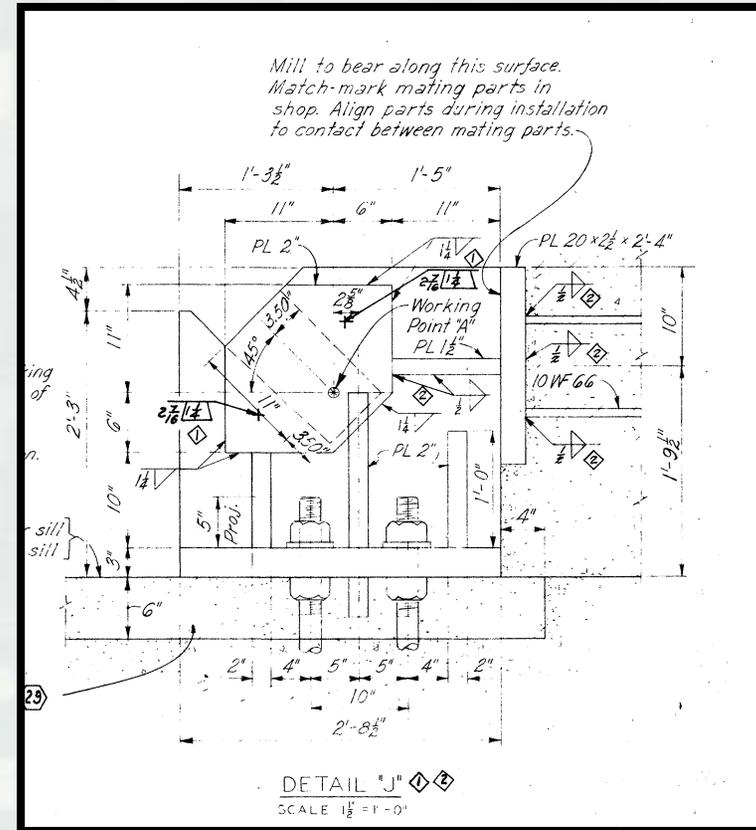
Embedded Anchorage

- On 29 August 2015, Craig Evans asked the dive team to do an underwater tactile inspection of the center post receiver.
- Our dive team inspected the embedded anchorage that holds the center post receiver.
 - ▶ Design: 8 – 9'6" long 2-1/4" diameter anchors resisting overturning.
 - Top 2' of anchor: Stainless Steel (ASTM A-193)
 - Option for the bolt to be Stainless Steel
 - ▶ Inspection: 6 of the 8 were corroded due to dissimilar metals (bolts are most likely carbon steel)
- These anchor bolts are considered **fracture critical** and are a life safety item during dewater operation.

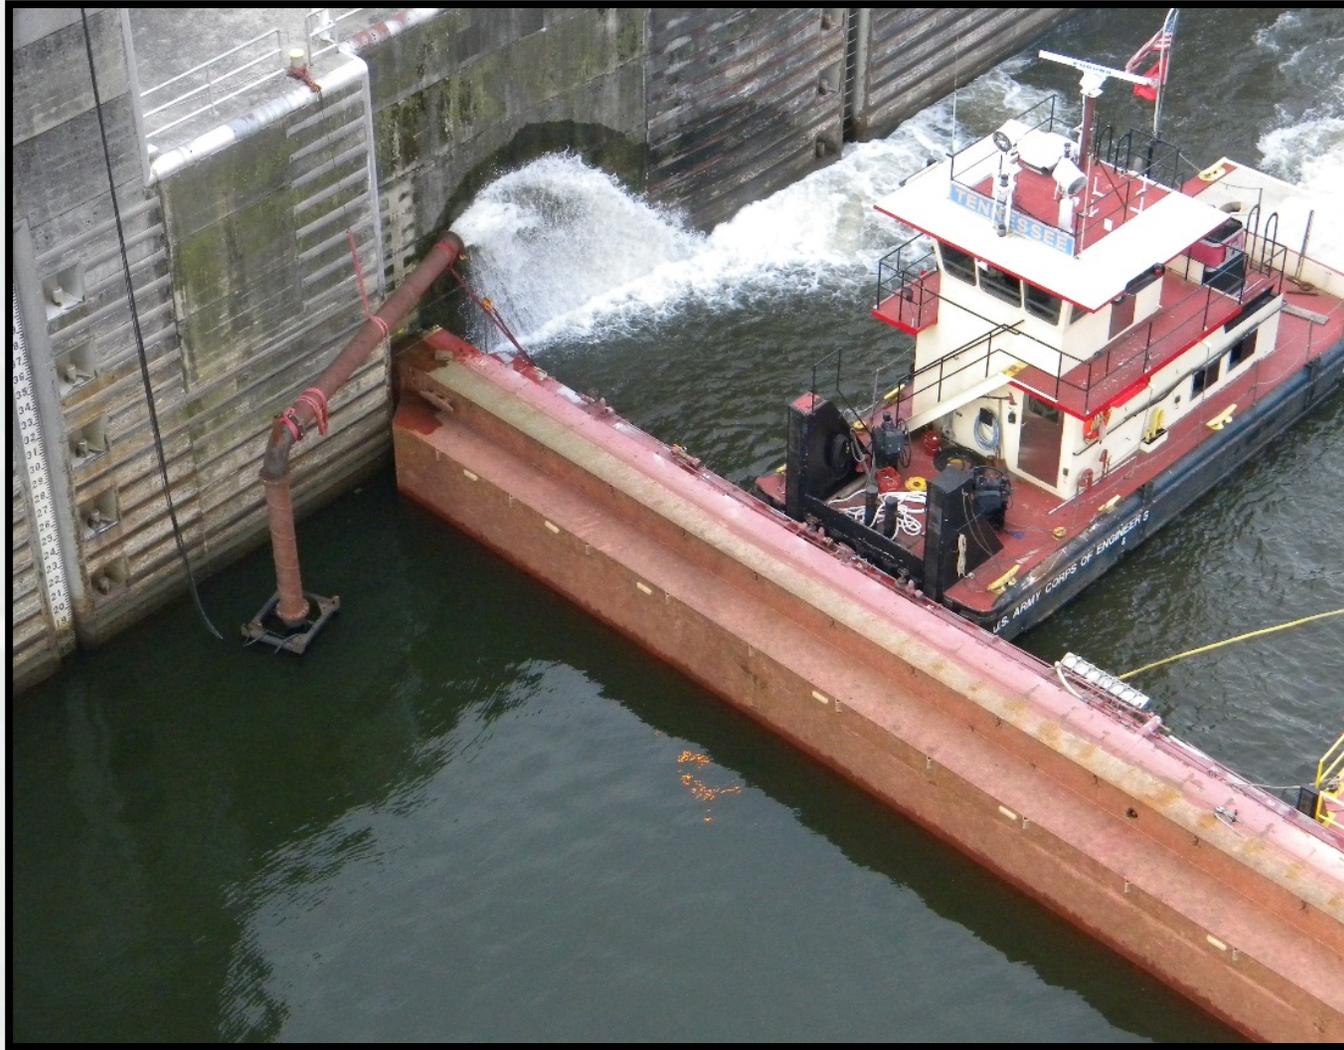
OPTION C: Towable Bulkhead/Floating Caisson

- Nashville has a floating caisson
 - ▶ Weight: 417,000 lbs
 - ▶ Dimension: 113'-5" wide by 27' 8" tall
 - ▶ Working Limits:
 - Drawings: 13'-26'
 - Actual: 17' to 25'
 - (Murray is 15.5' to 25' feet)
- The newly designed floating bulkhead has had several issues with the actual operations of the new floating caisson. The floating bulkhead in theory will work. Slots will have to be cut to allow the caisson to fit into position.
- The total estimated ROM of \$3 million.
 - Nashville District prefers the 110' stoplog option.
