MITER GATE EMBEDDED ANCHORAGE SOO LOCKS Sault Ste. Marie, MI

POE Lock General Information

Miter Gate Embedded Anchorage

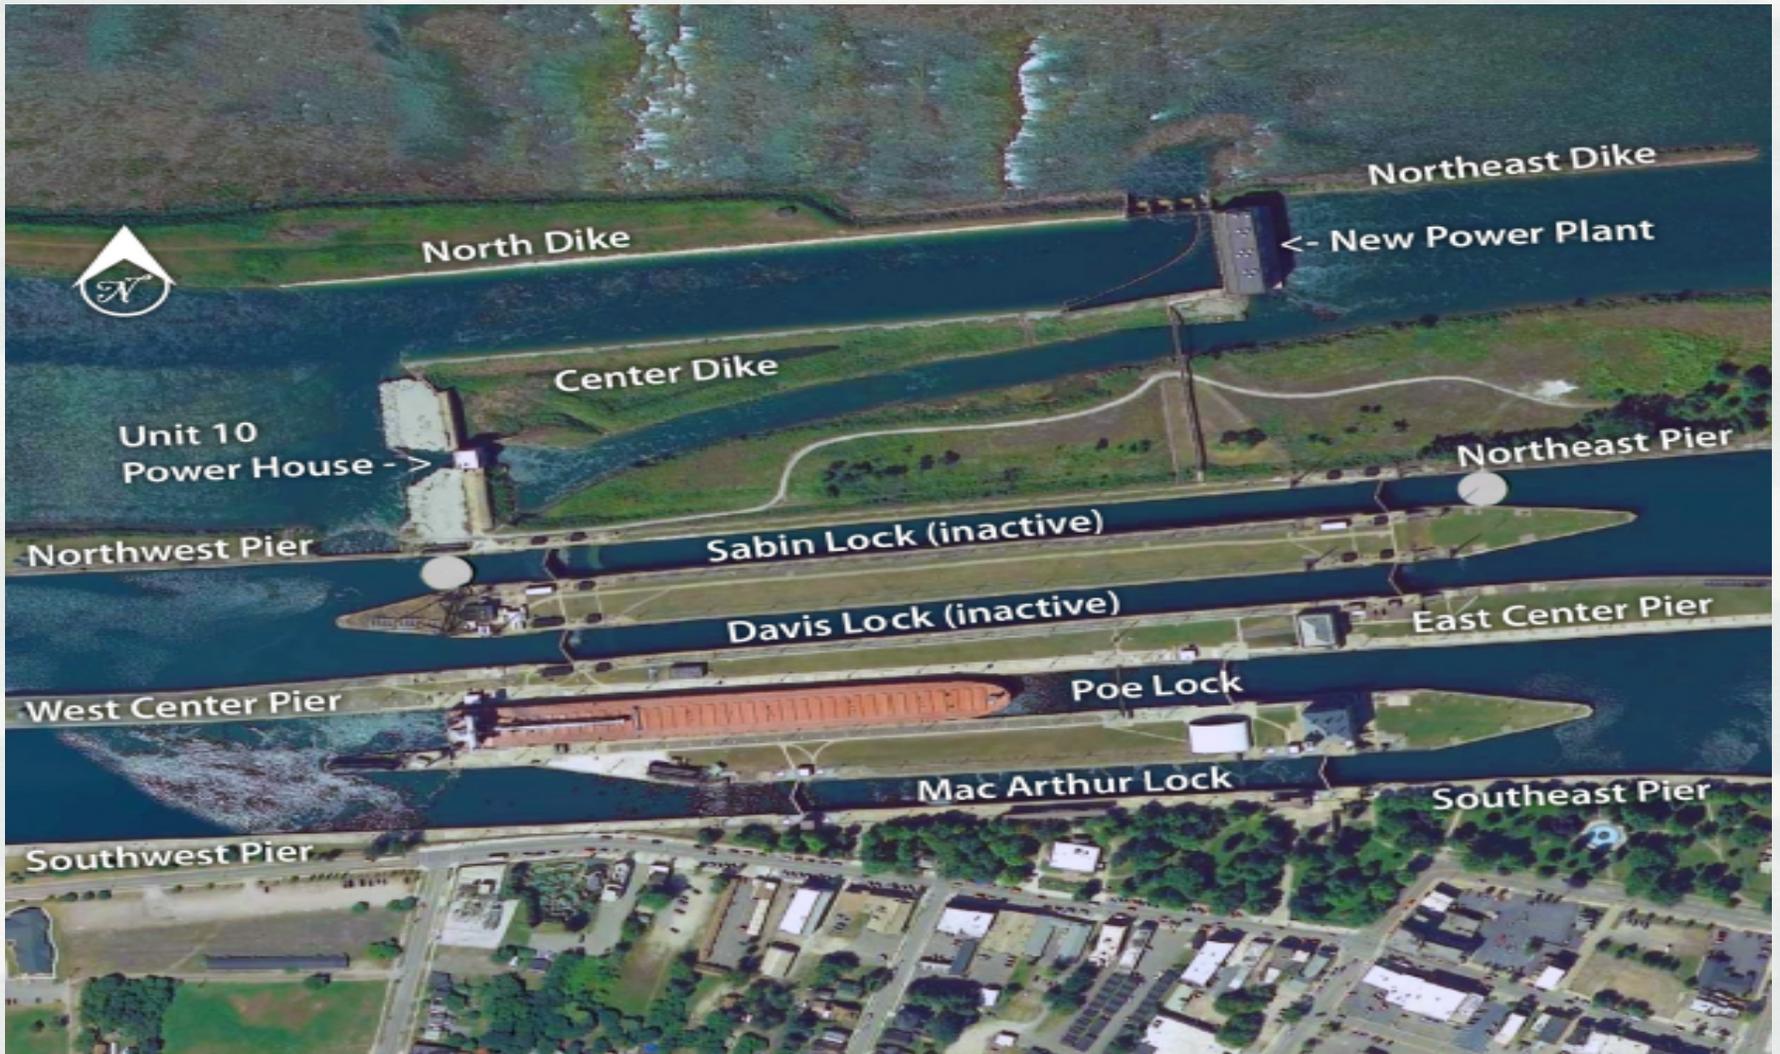
Plan View No. 1,2,3,4

- The POE lock was formally dedicated and placed into service on 26 June 1969 (47 years old).
- POE Lock chamber 110 ft x 1200 ft
- 32 ft depth of water over the sills at normal lower pool.
- Head of 21.5 feet
- Approx. 63 ft wide gate leaf between contact blocks
- Approx. 37 ft tall between CL gudgeon and sill
- Miter angle 1:3, or 18.4 degrees
- 1-Upstream Operating Gate, 2 Downstream Operating Gates, and 1 Downstream maintenance Gate
- ASTM A36 Steel

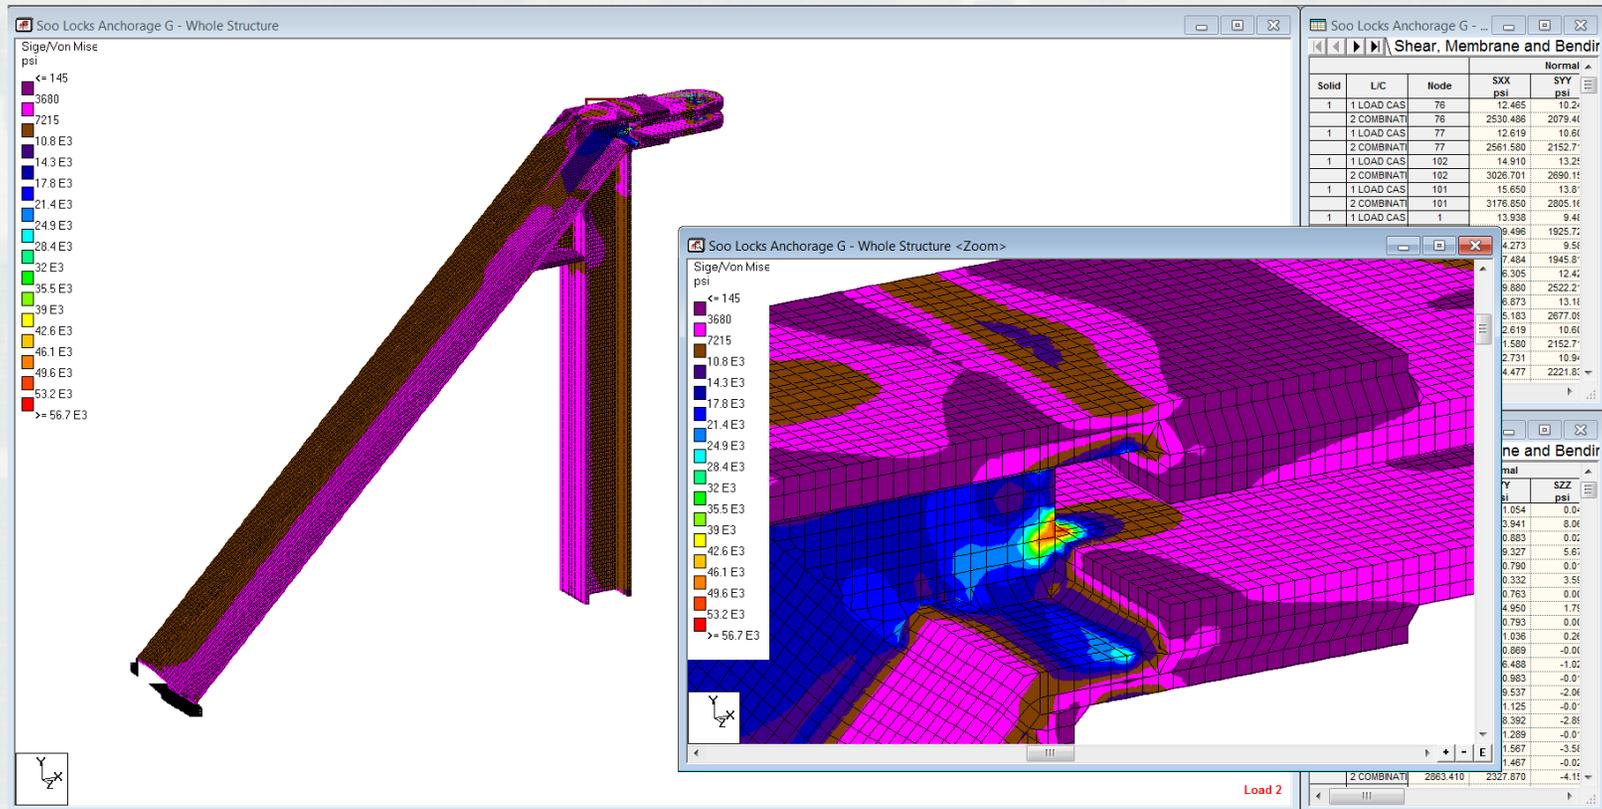
Step-2 Linear FEA Secondary Anchorage Sige / Von Mise Stress (psi)

Stress results of the secondary anchorage for gate #1 are shown to be 40 ksi to 49 ksi

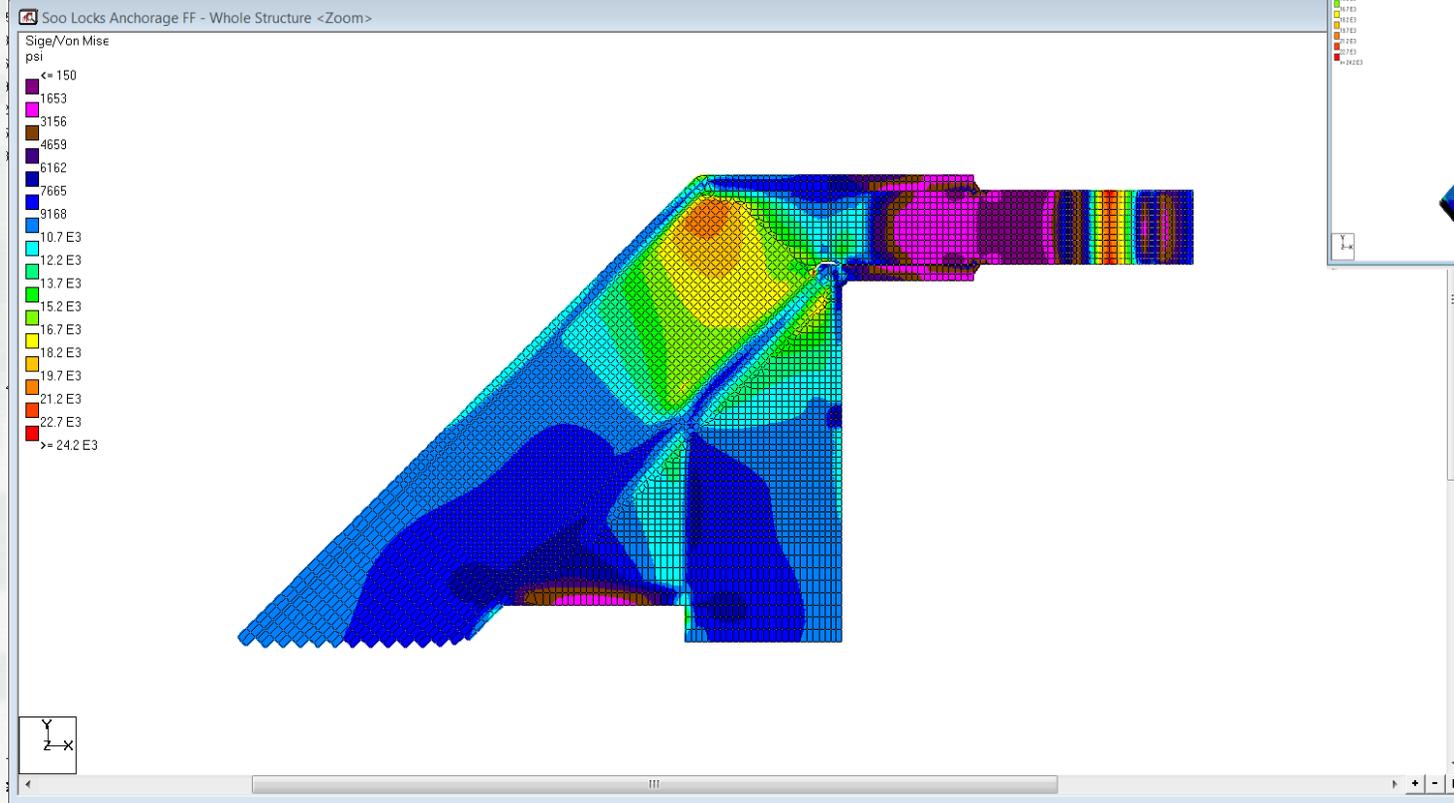
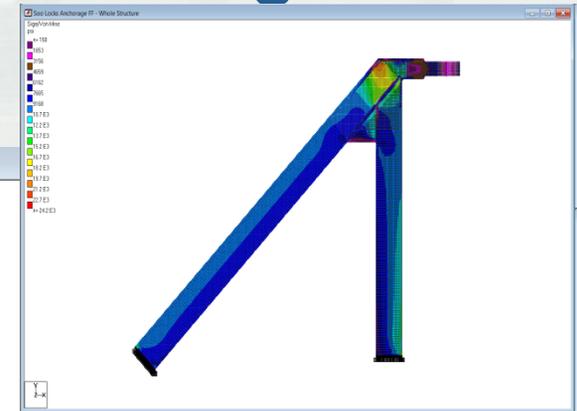
Step-2 (continued) Linear FEA Primary Anchorage Sige / Von Mise Stress (psi)

Stress results of the Primary anchorage for gate #1 are shown to be 20 ksi to 25 ksi

- Secondary Embedded Anchorage measured load values were slightly higher than calculated values
- Primary Embedded Anchorage measured load values were significantly higher than calculated values
 - Values revealed an **88 kip** spike at point of gate mitering

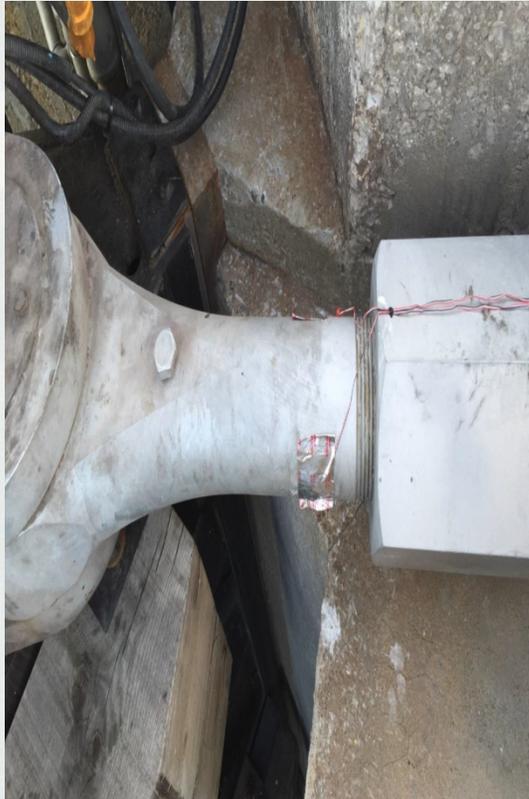
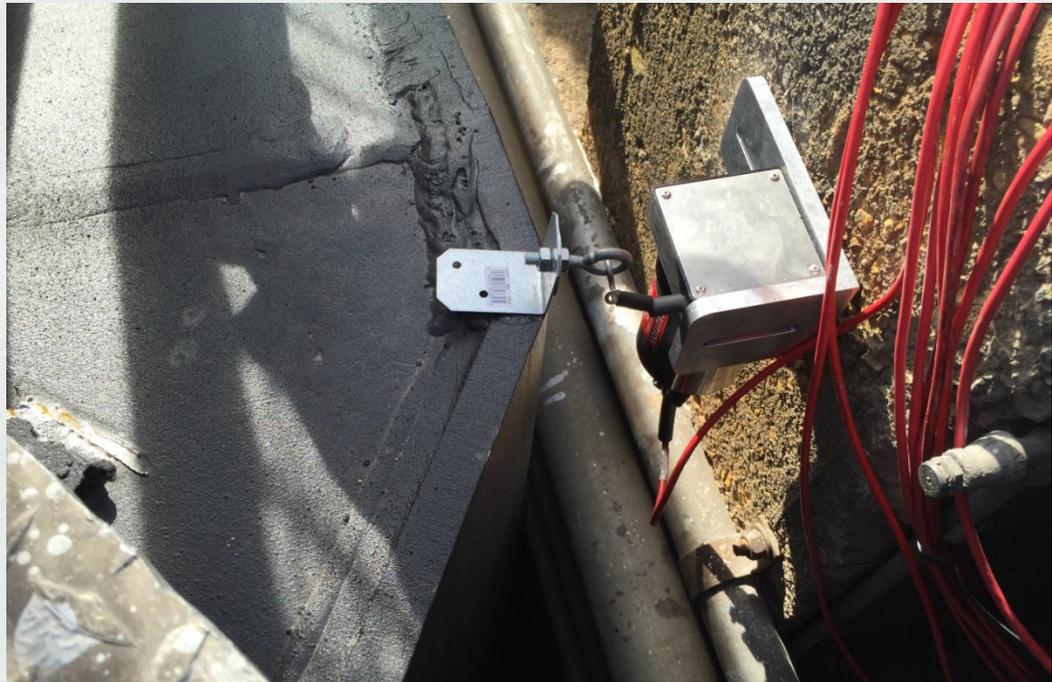
Step 4 Instrumentation to determine actual cyclic loads Strain Gage (BDI)

Foil strain sensors and string pot
attachments

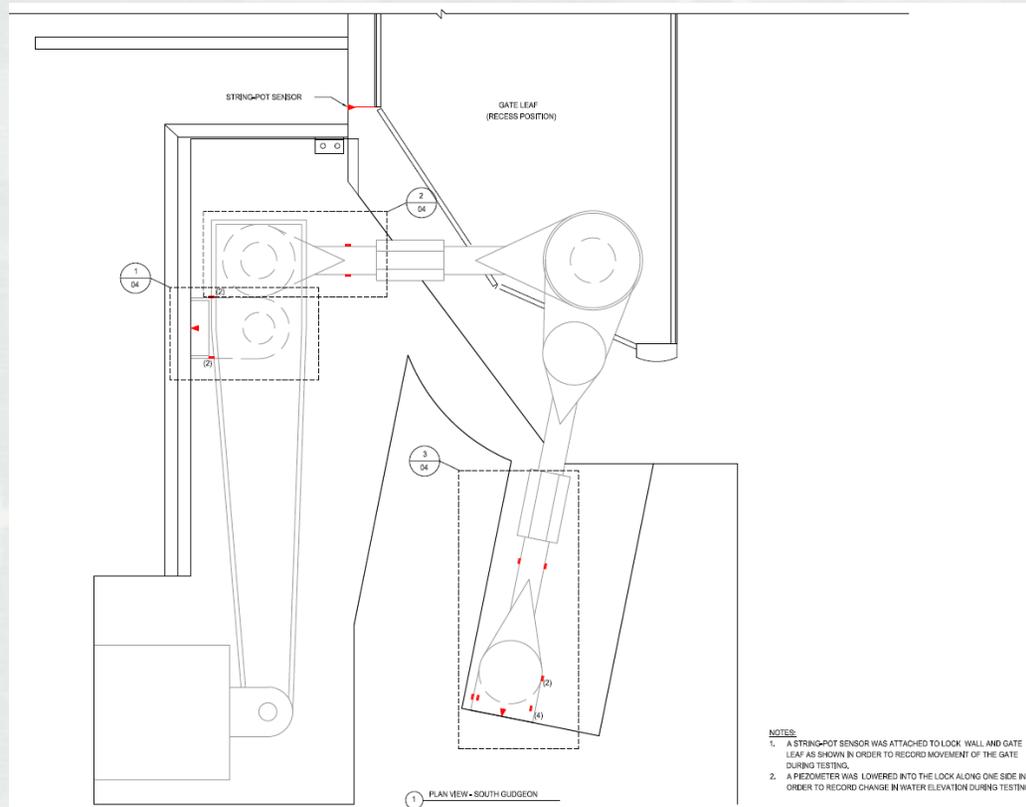
Step 4 (continued) **Strain Gage Layout**

**Overall Instrumentation Locations –
Plan View of South Gate Anchorage**

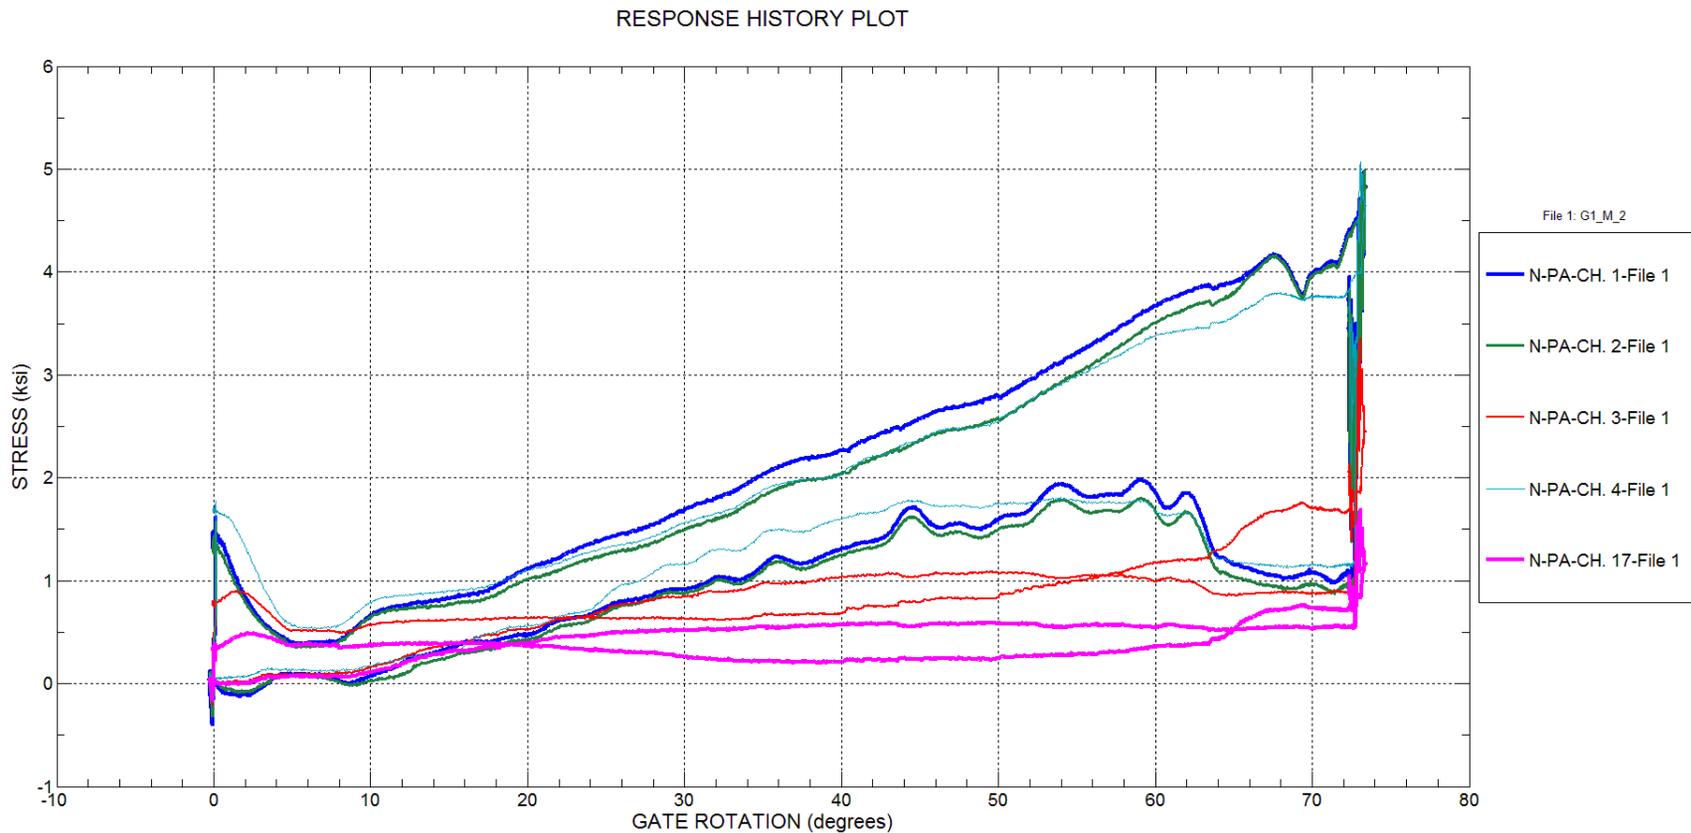
Step 4 (continued) ANCHOR BAR STRESS PLOTS (GATE 1 – NORTH ANCHORAGE)

Figure 3.9 – Stress Plot – Gate 1 – North Primary Anchor – Miter Tests.
(Blue = Ch. 1, Green = Ch. 2, Red = Ch. 3, Light Blue = Ch. 4, Pink = Ch. 17).

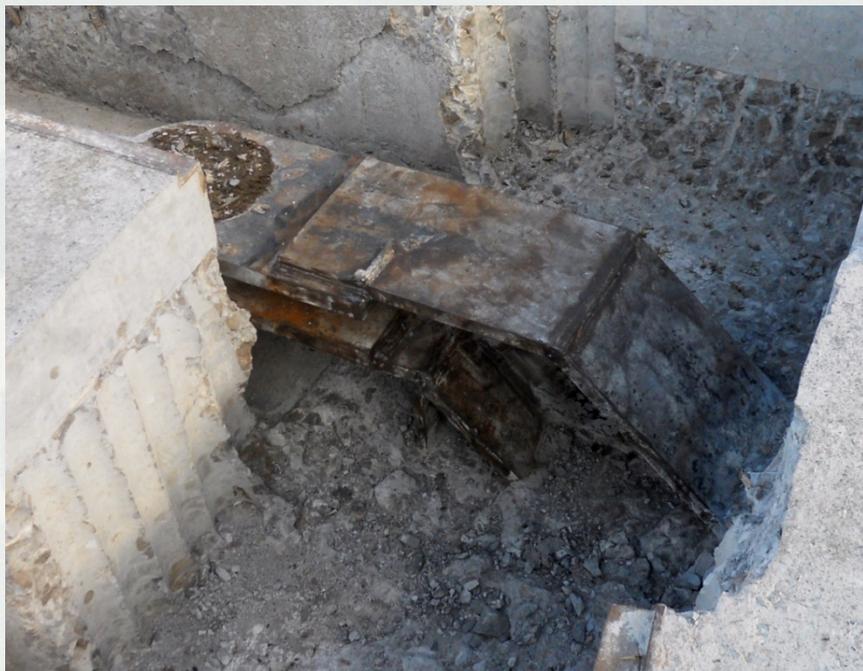
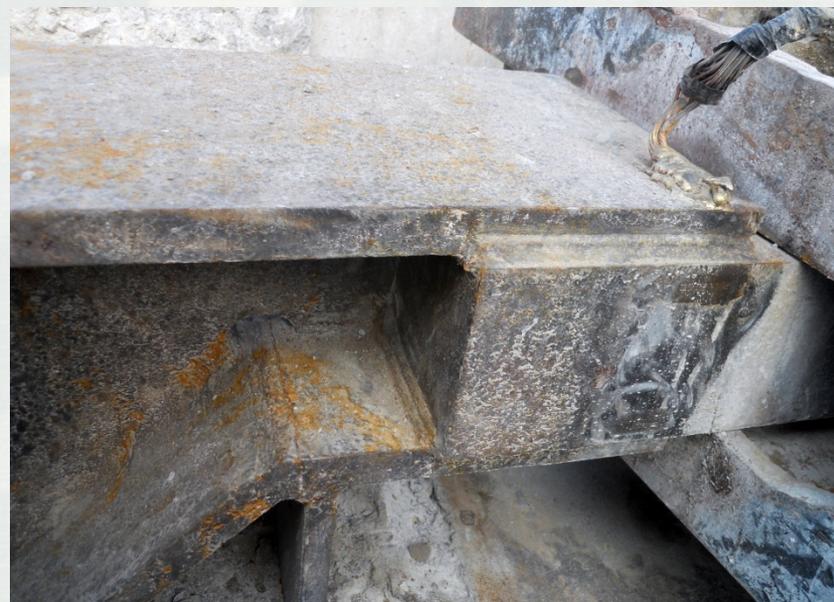
Step 5,8 (continued)

Step 5,8 - **Concrete Removal** to expose the upper embedded anchorage region of one leaf of gate 3S, for inspection

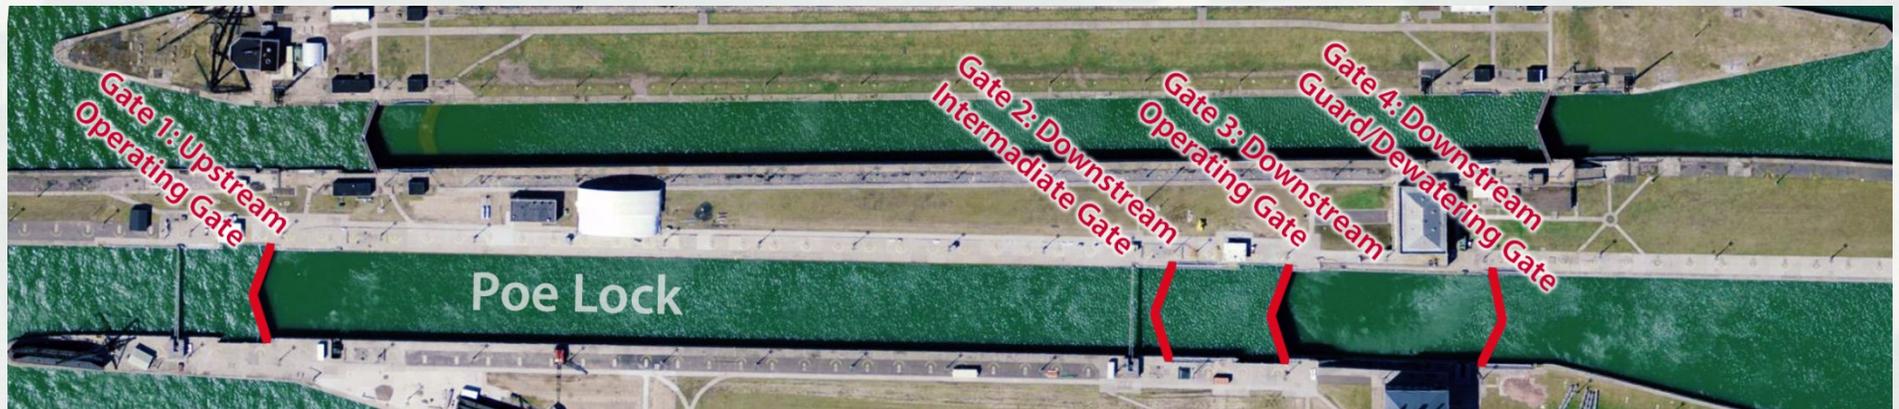
Embedded Anchorages Exposure, NDT, and IRRM Repairs Update

- Gates exposed to date:
 - Gate 3 South- Exposed 5 August
 - Gate 1 South- Exposed 27 August
 - Gate 1 North- Exposed 18 September
 - Gate 3 North- Exposed 13 October
- Gates to be exposed:
 - Gate 2 North- Exposure expected by 30 Oct
 - Gate 2 South- Exposure expected by 18 Nov

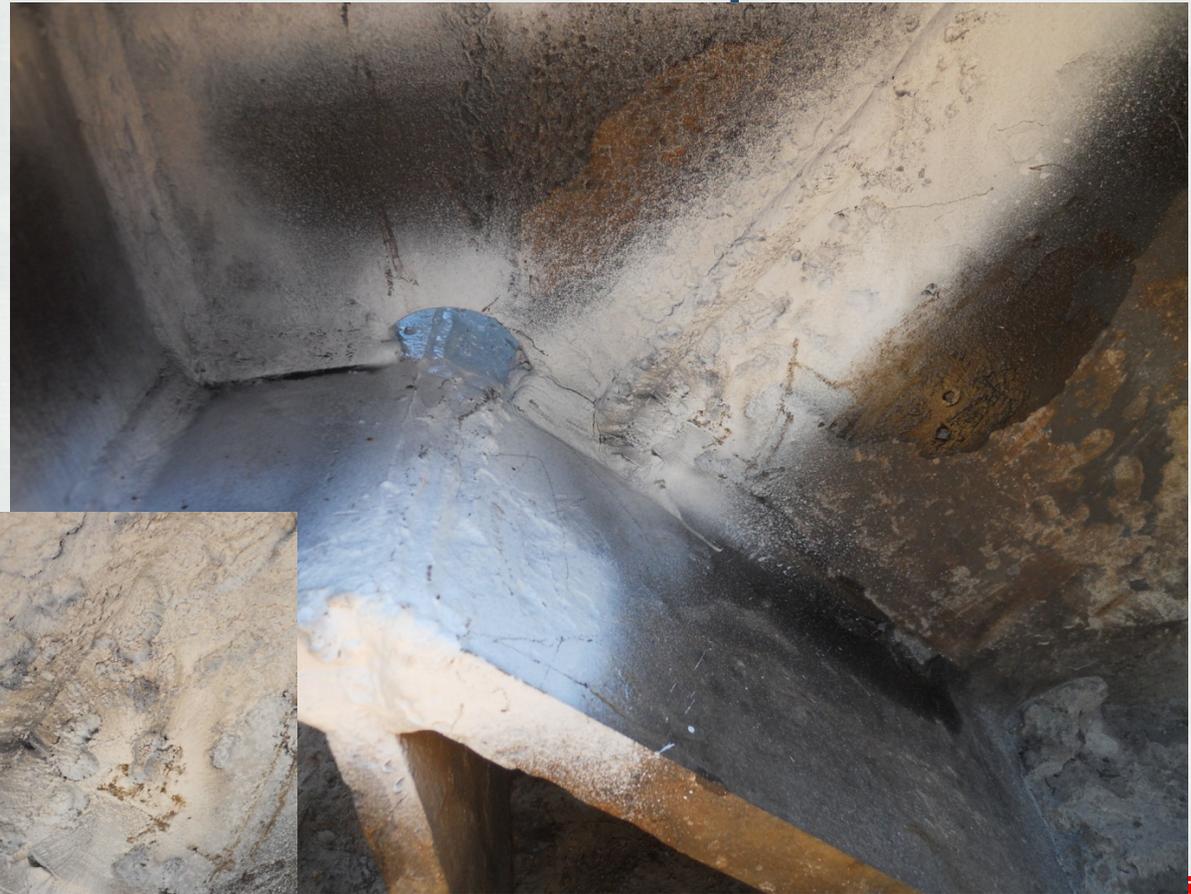
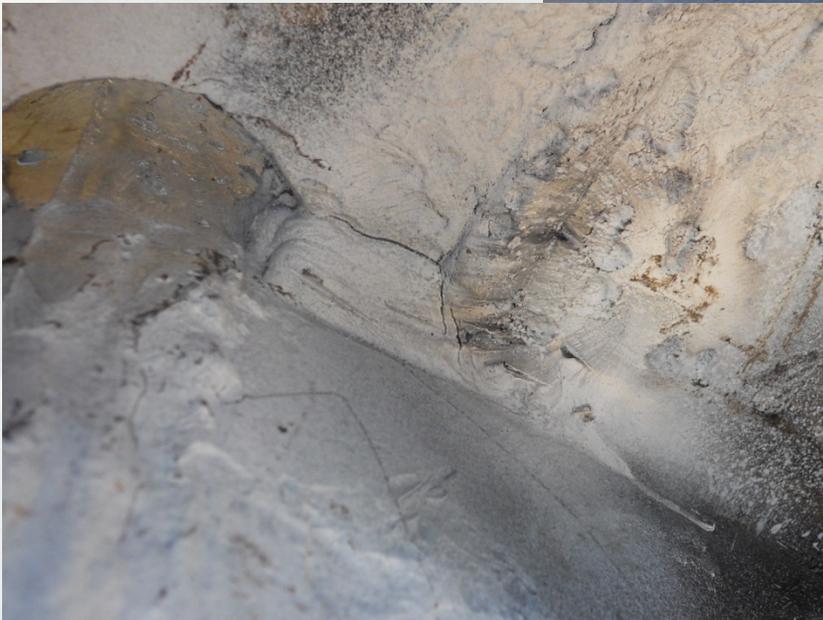
Primary
Embedment

Step 6 - Inspection (visual then NDT) followed with crack repair

- NDT has confirmed independent FEA model results
 - Majority of cracks and inclusions have been found in areas where model shows highest stress
- Poor Weld Fabrication- NDT shows porosity and non-fusion in welds
- Questionable Steel Quality- NDT shows de-lamination, pitting and corrosion

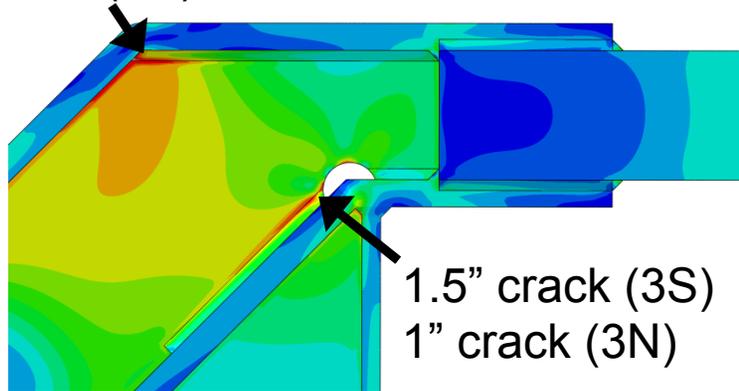
Primary Anchorage

1" crack (3S) &
1" inclusion (1N)

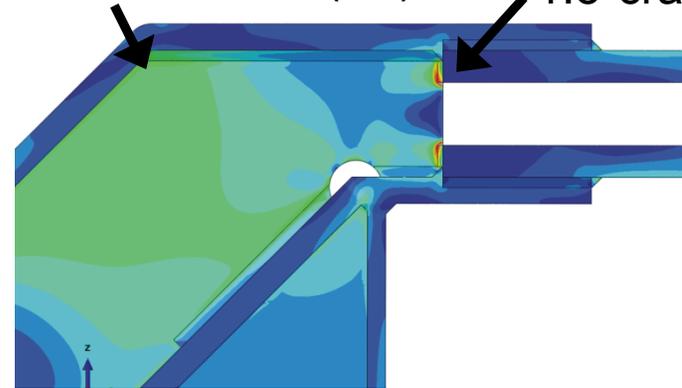
Secondary Anchorage

1" inclusion x 3 (1S)
1" inclusion (3S) 1.5" crack x 3 (1S)

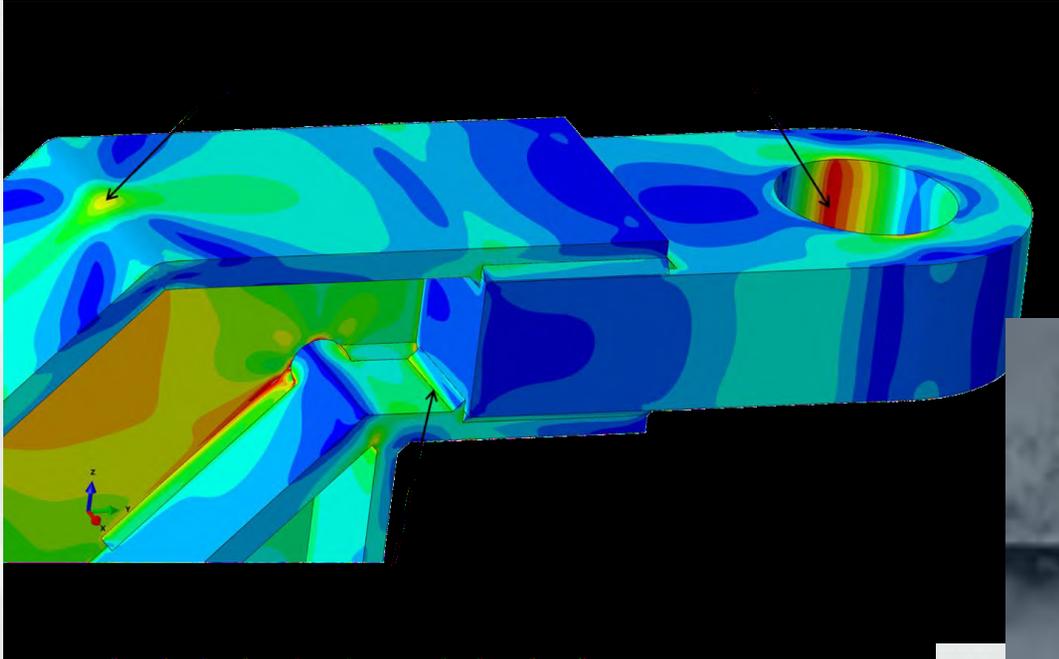
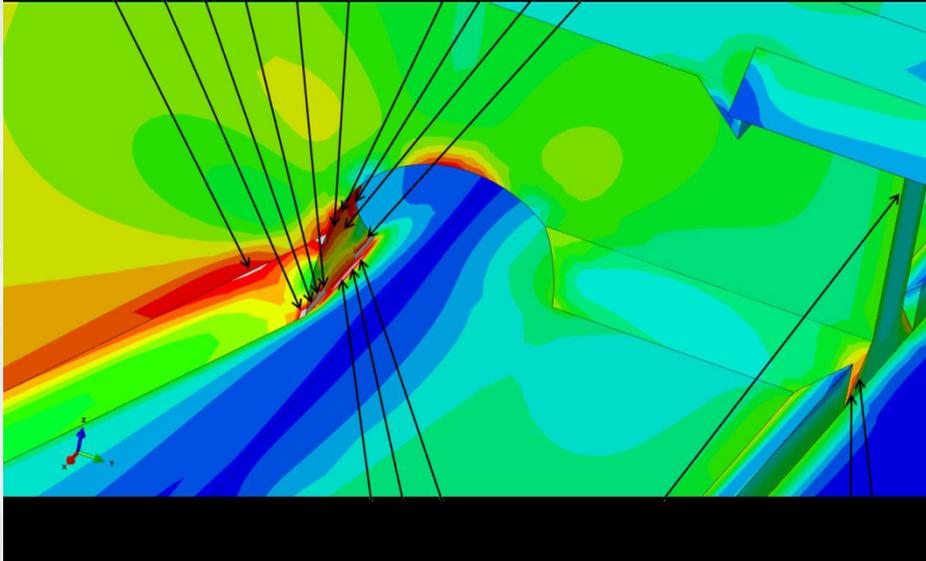
Step 7 (continued) **Primary Embedded Anchorage**

Traction Load Design Life (years)	Explicit Pin Design Life (years)
Primary Embedded Anchorage		
Upper Flange Joint	16	27
Lower Cope	8	3
Lower Flange to Vertical Flange	14	4
Horizontal Flange to Connection Plate - Lower	93	34
Horizontal Flange to Connection Plate - Upper	61852	infinite
Pin Hole	76	43
Bushing	n/a	31
Connecting Pin	n/a	> 1000
Secondary Embedded Anchorage		
Upper Flange Joint	371	366
Lower Cope	267	263
Vertical Web to Connection Plate - Lower	2	2
Vertical Web to Connection Plate - Upper	1	< 1
Pin Hole	41	762
Bushing	n/a	26
Connecting Pin	n/a	> 1000

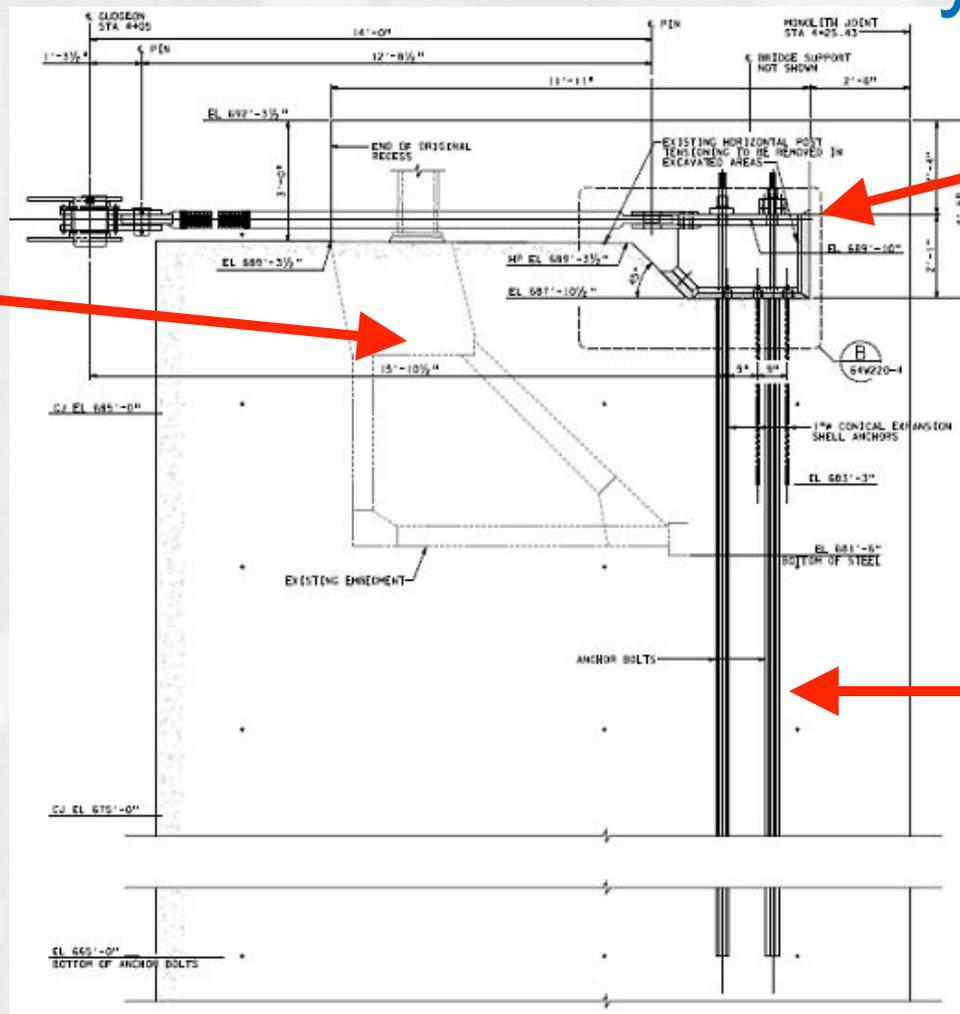
Step 11 (continued) COA 5 – Post Tension Anchor Rod System

Existing A-frame

Anchorage frame set further away from lock wall than existing frame

30' long anchor rods transferring load to monolith

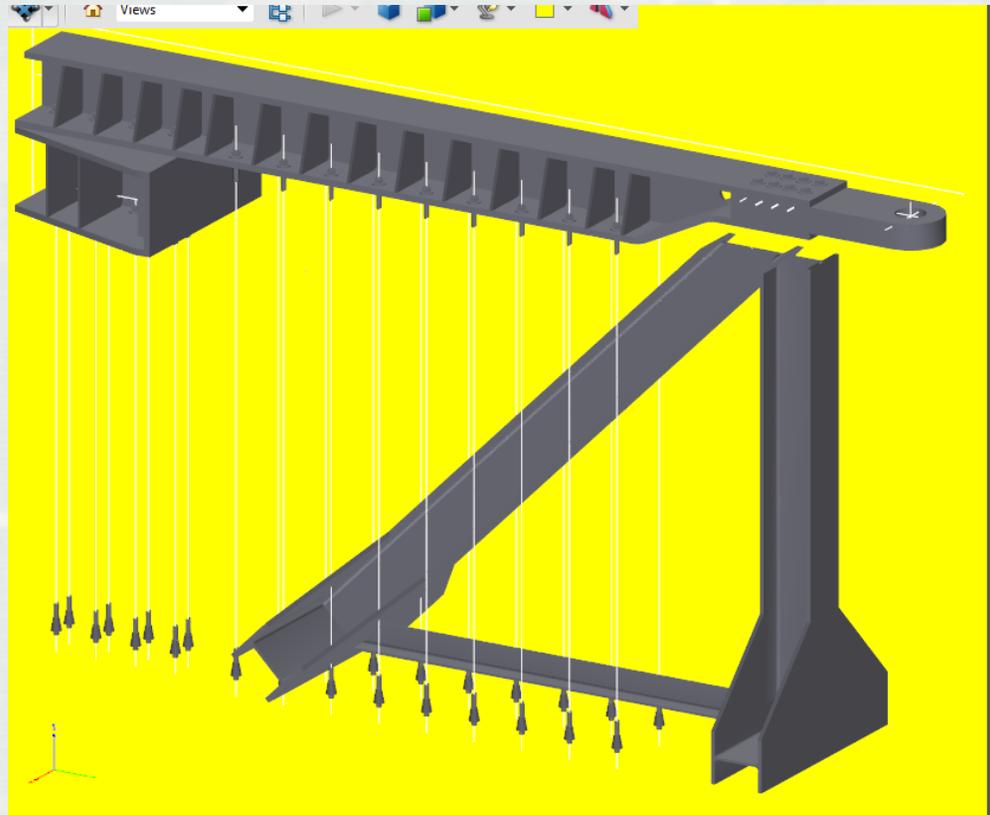
Permanent Design Solution

- Embedded frame can be installed prior to winter shutdown
- Pin Plates are a bolt up feature
- Demolition of existing anchor frame top and installation of pin plates can be completed in winter shutdown
