2011 LOCK MAINTENANCE WORKSHOP

Mark Sawka, P.E., Chief, Structural & Architectural Design Section

Extended System Outage Overview

Applications of Self Lubricating and Materials
The Dalles Miter Gate - Composites Material Use Quoin
and Miter Blocks

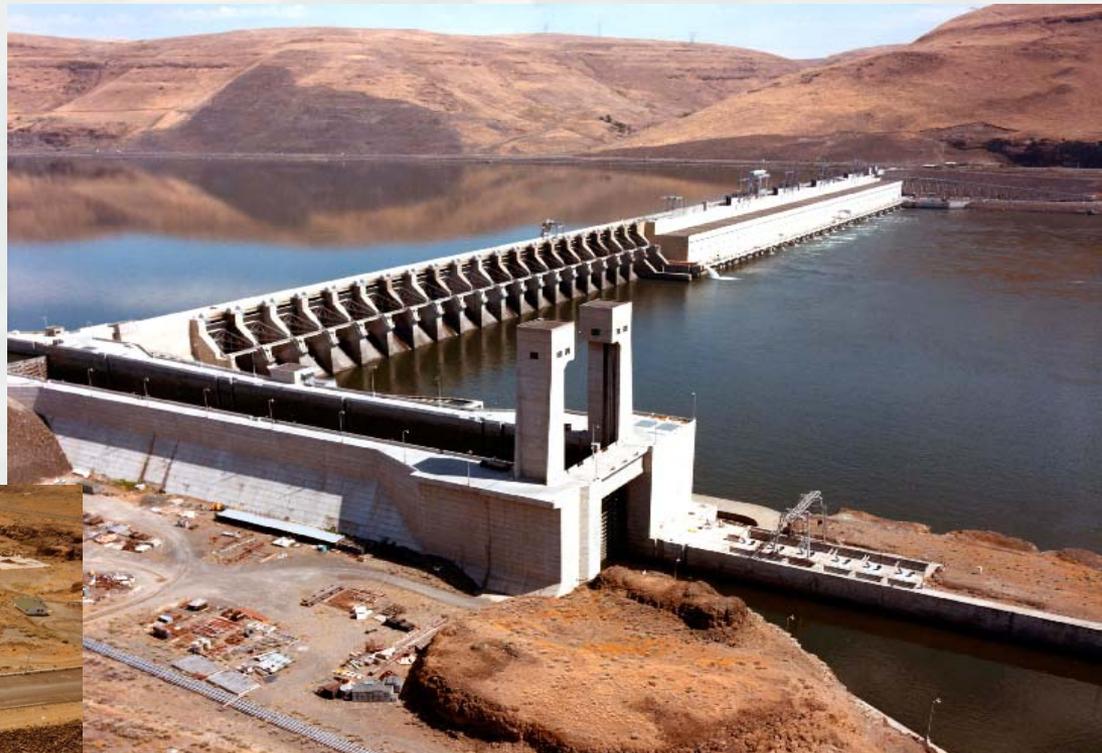
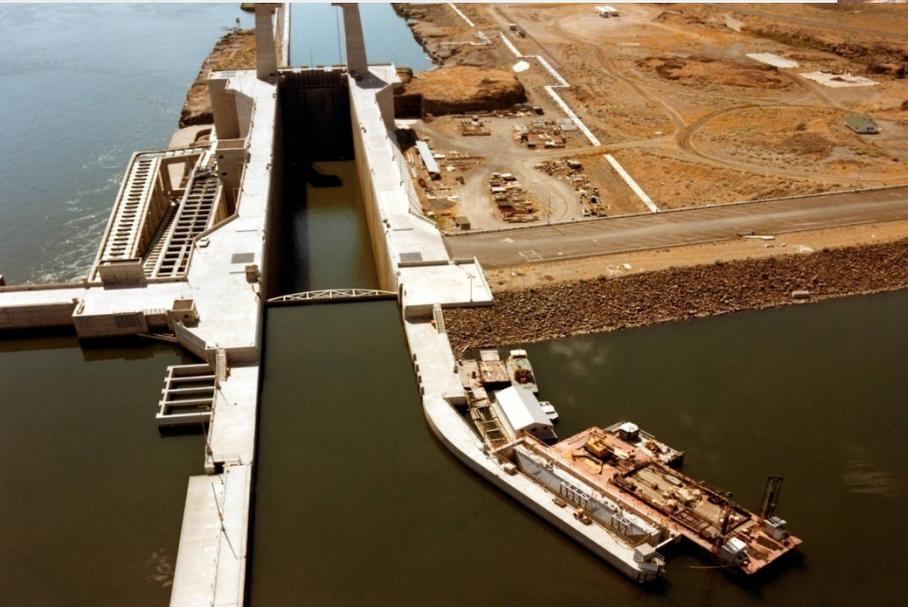
JOHN DAY LOCK

REPLACING: ONE DOWNSTREAM GATE; TWO FRICTION SHEAVES, FOUR TANTIER VALVES

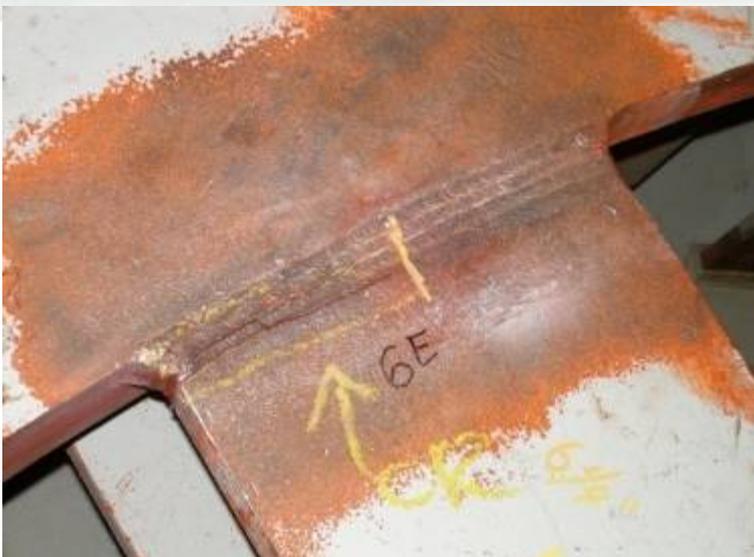
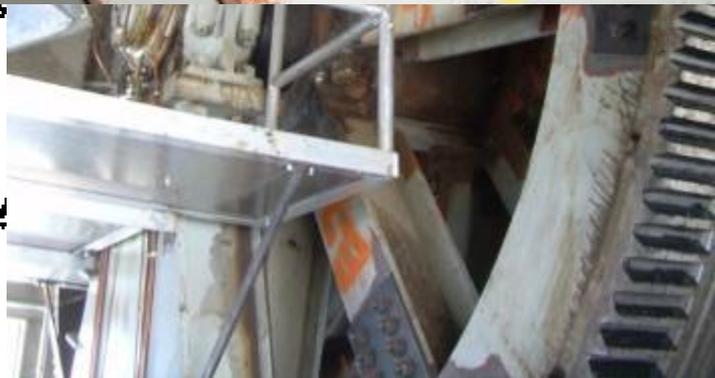
JOHN DAY LOCK – ORIGINAL D/S LIFT GATE, FRICTION SHEAVE

Nav Lock opened 1968

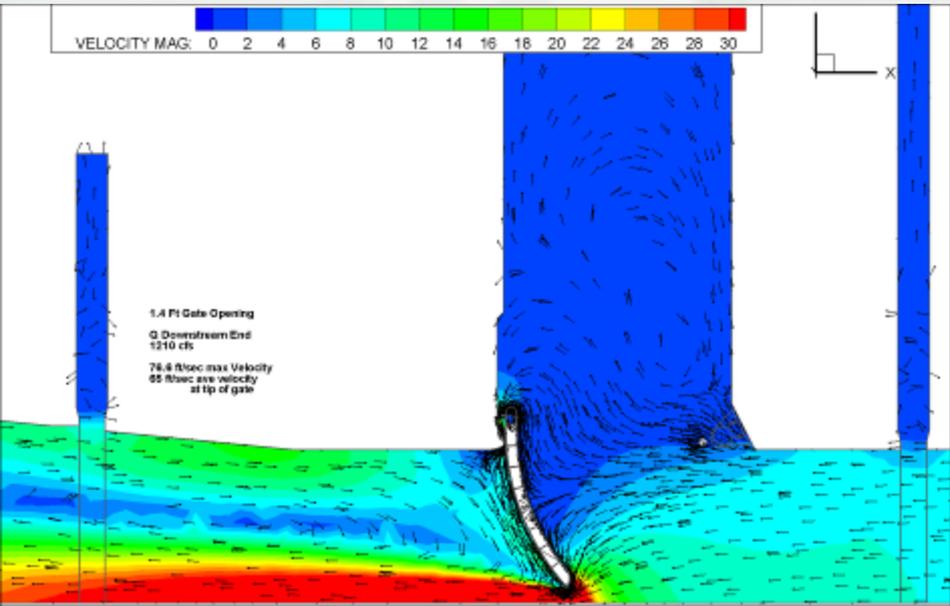
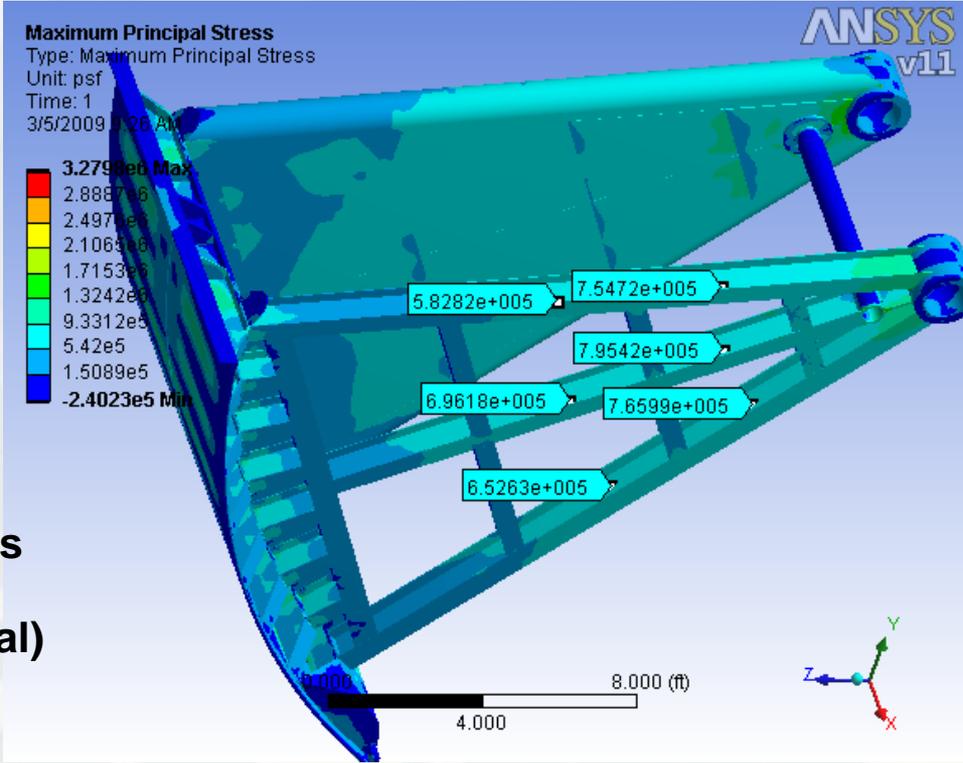
JOHN DAY/THE DALLES TAINTER VALVES

- Corps Design Guidance is 27 Years Old
- Does Not Address Fatigue
 - Does Not Address High Head Situations

ERDC Recommend Modeling (CFD and Physical)

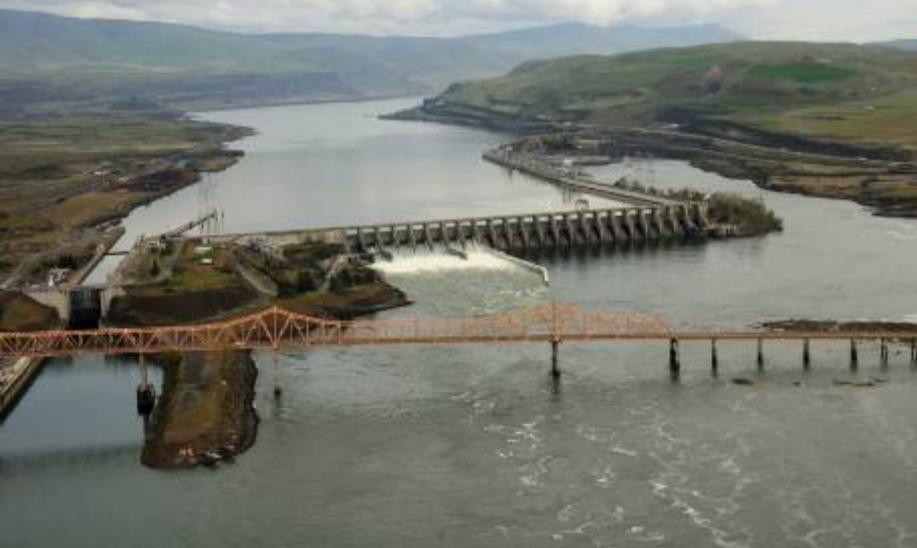
THE DALLES LOCK

REPLACING: ONE DOWNSTREAM GATE; FOUR Tainter VALVES

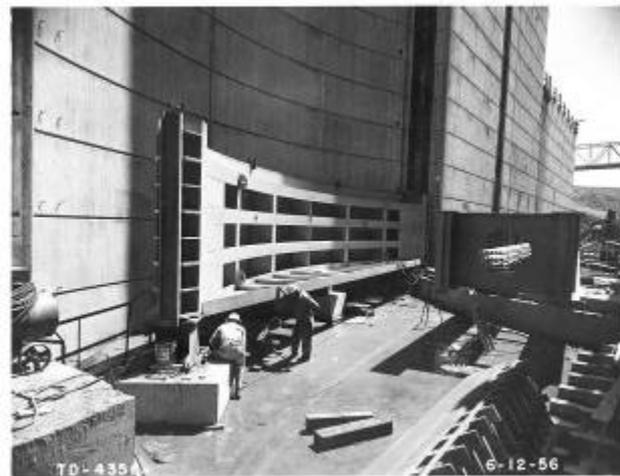
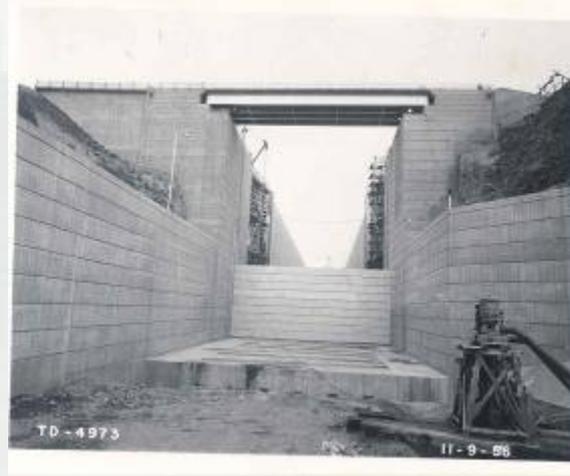
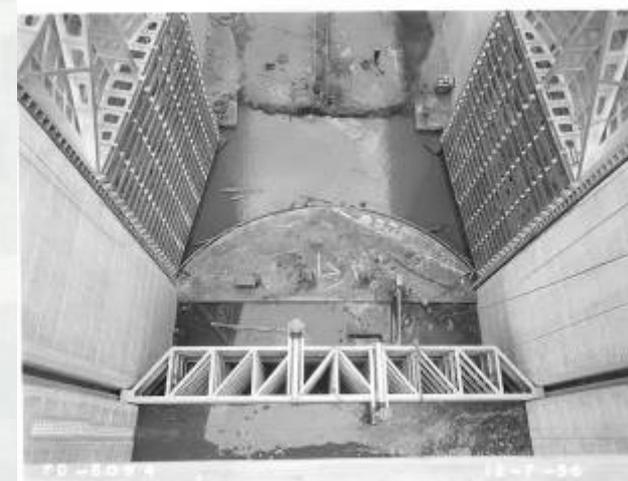
THE DALLES MITER GATE – ORIGINAL GATE

Constructed from 1954 to 1956

Delivered in nine pieces and field spliced

Fixed/Rigid Diagonals – no adjustability

Leaf Weight: 678 kips

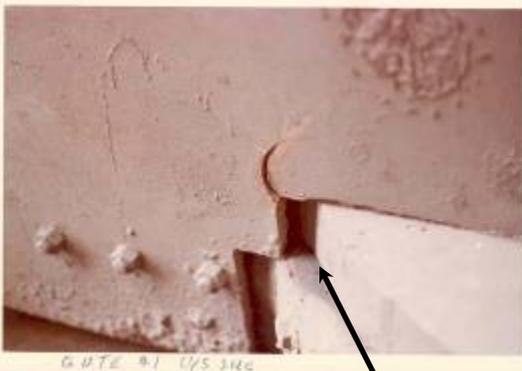
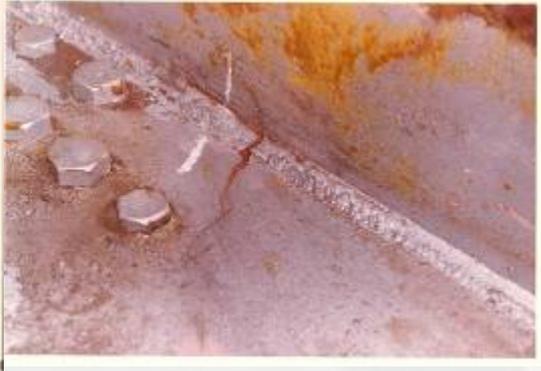
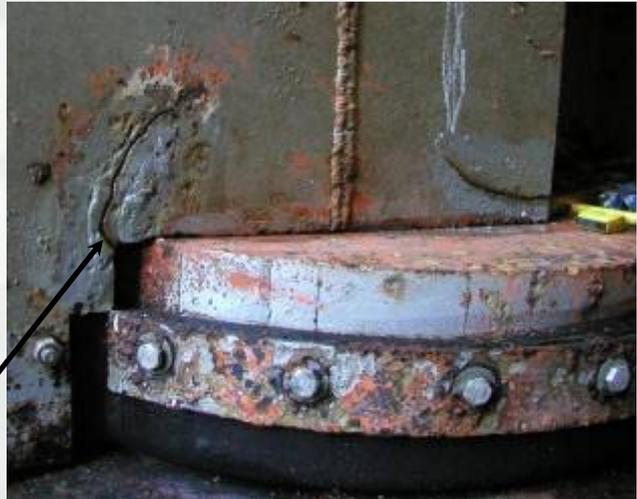
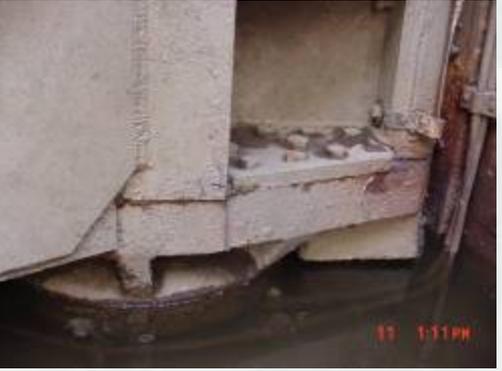
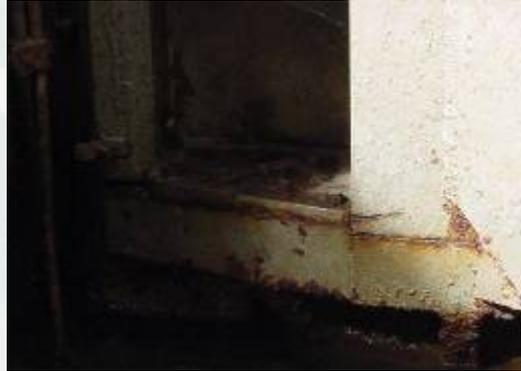
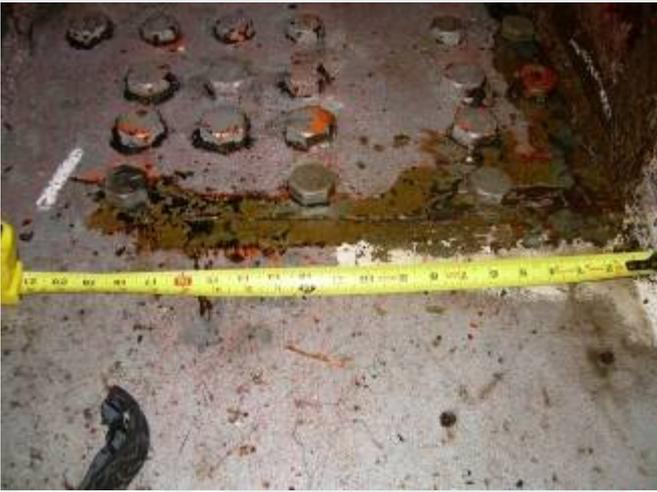
THE DALLES MITER GATE – 1979 TO 2007 REPAIR HISTORY

1979

Same Crack – Re-cracked
Through Repair

2005

2007

NOTE – All Cracks Shown All Years Were Repaired

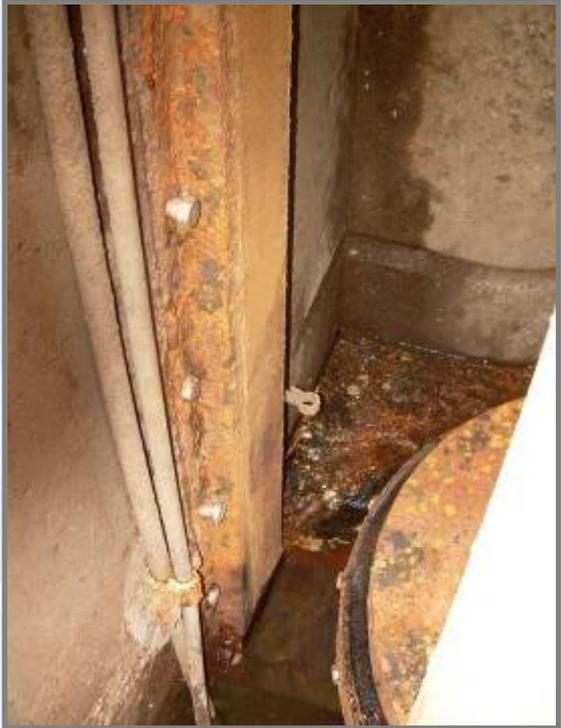
- Miter gate does not make miter or quoin contact. Load is being transferred elsewhere through the pintle area and into areas where the quoin/miter do make contact
- The gate was not designed for this loading condition

Quoin Block Showing No Contact

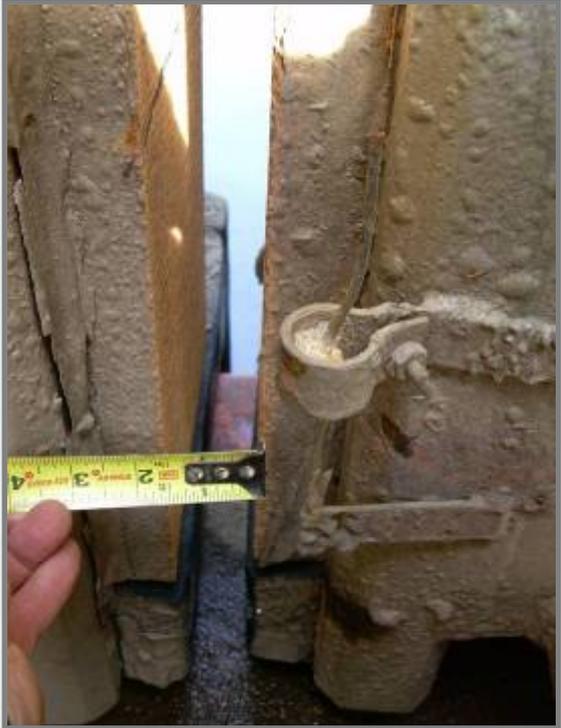
Gate in Closed Position – No Miter Contact

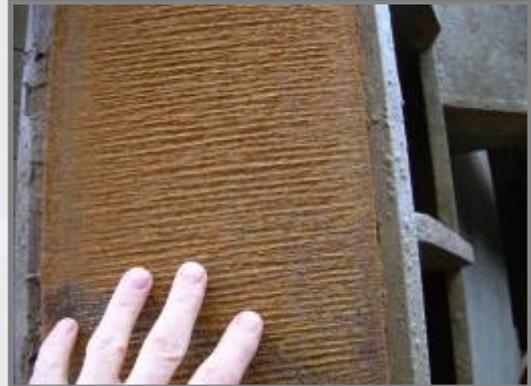
Miter Block Eroded

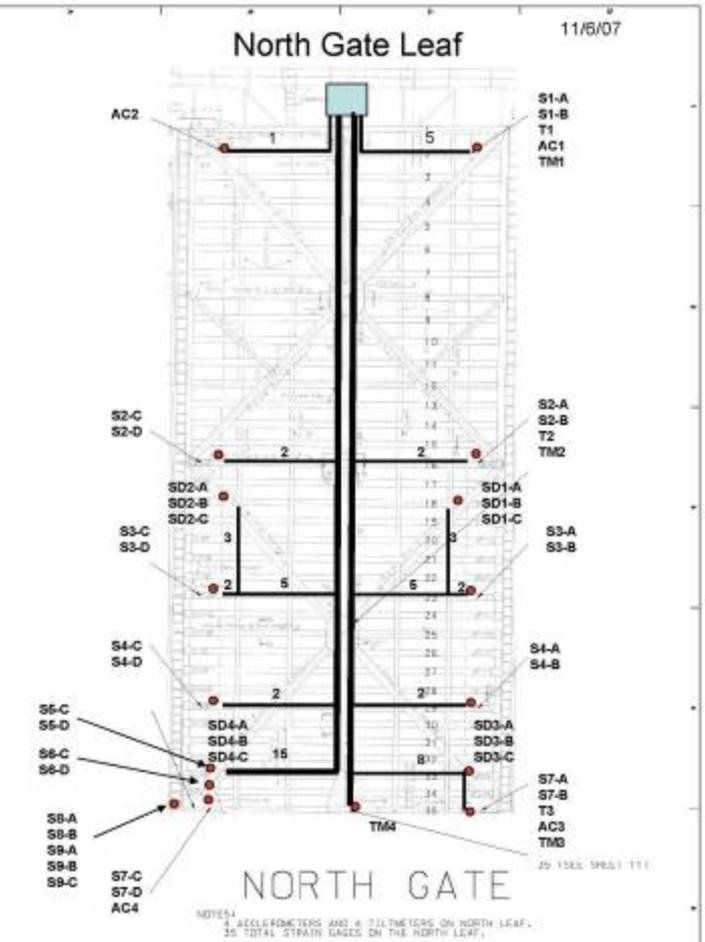
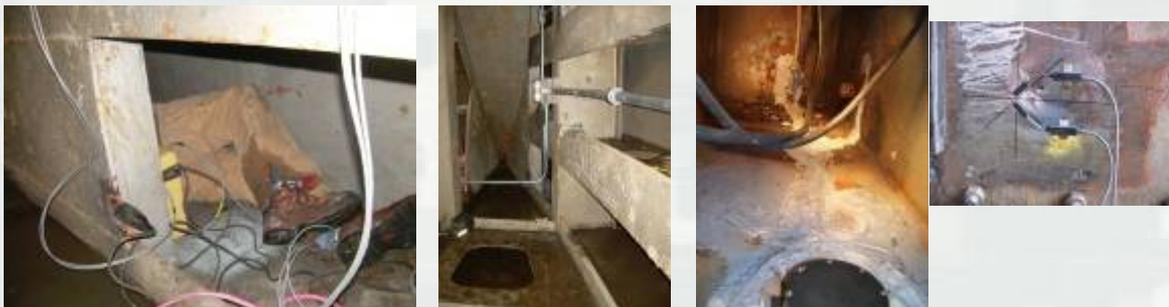
THE DALLES MITER GATE – 2007 INSTRUMENTATION

ERDC installs 60 strain gages, 4 tiltmeters, 4 accelerometers, and a data acquisition system which provides near real time remote access to instrumentation via web interface

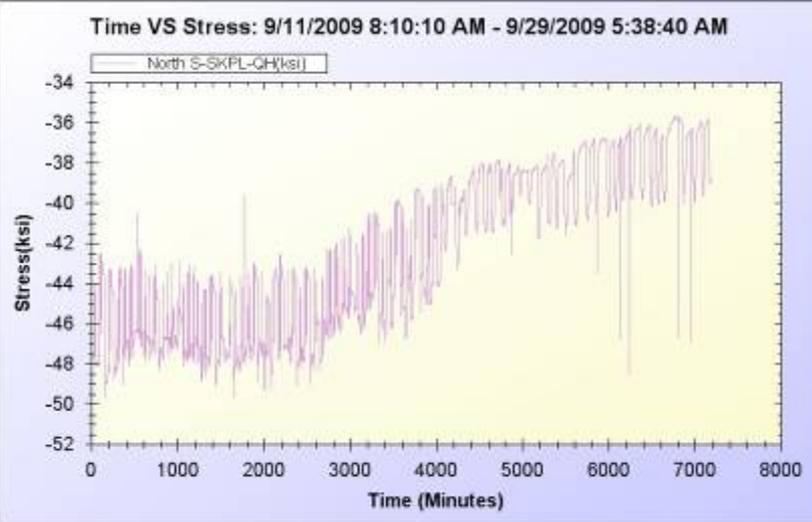
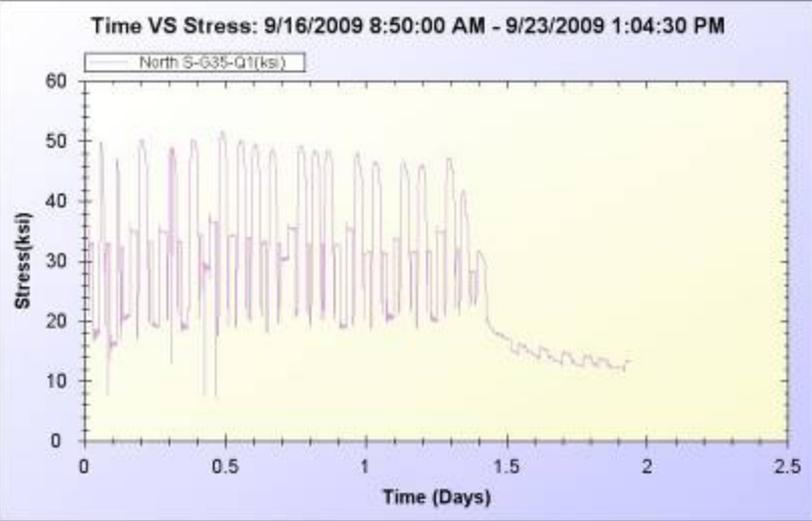
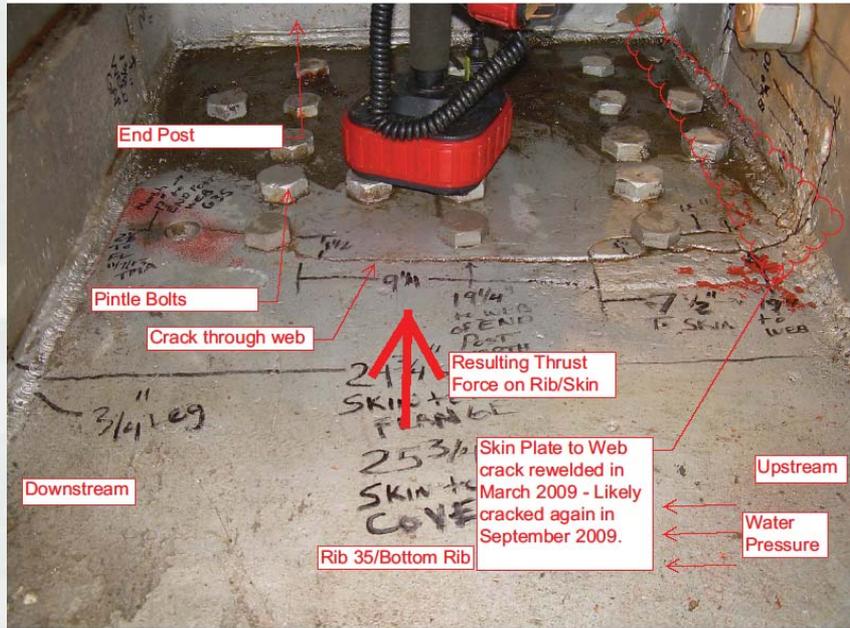
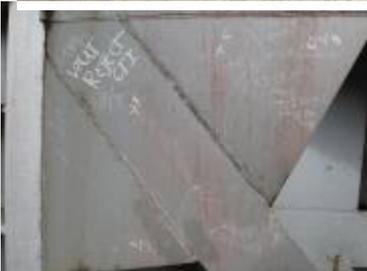
THE DALLES MITER GATE – 2009 EMERGENCY OUTAGE

Noise reported by Project
 Instrumentation indicates sharp change in stress; likely cracking
 Emergency Outage and Emergency Contract
 Repairs

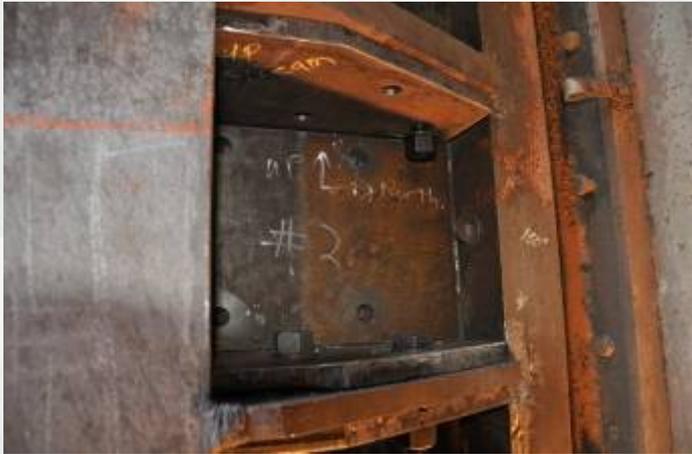
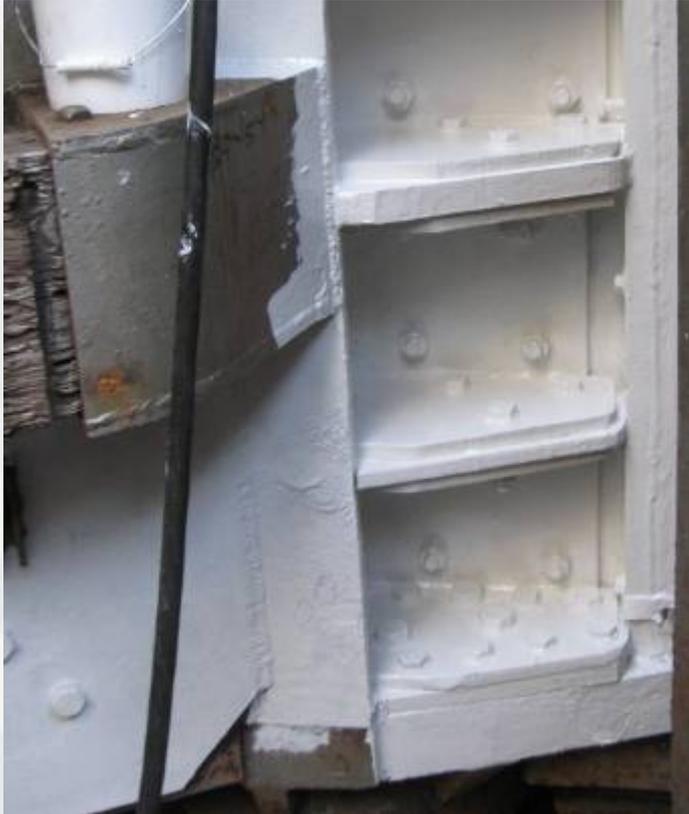
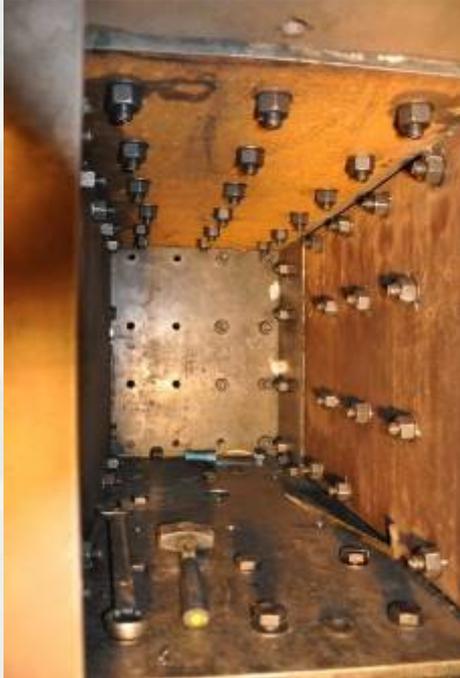
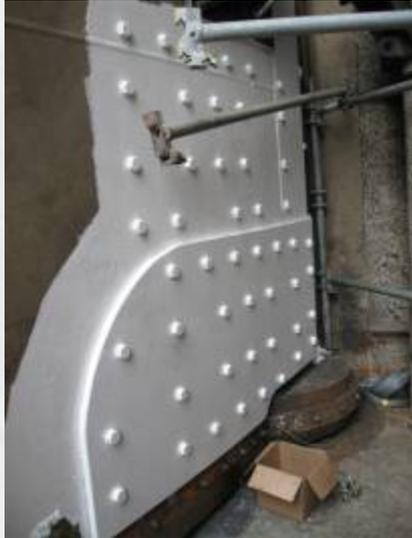
THE DALLES MITER GATE – 2009 EMERGENCY REPAIRS

Bolted Repairs to Bridge Failed Welds

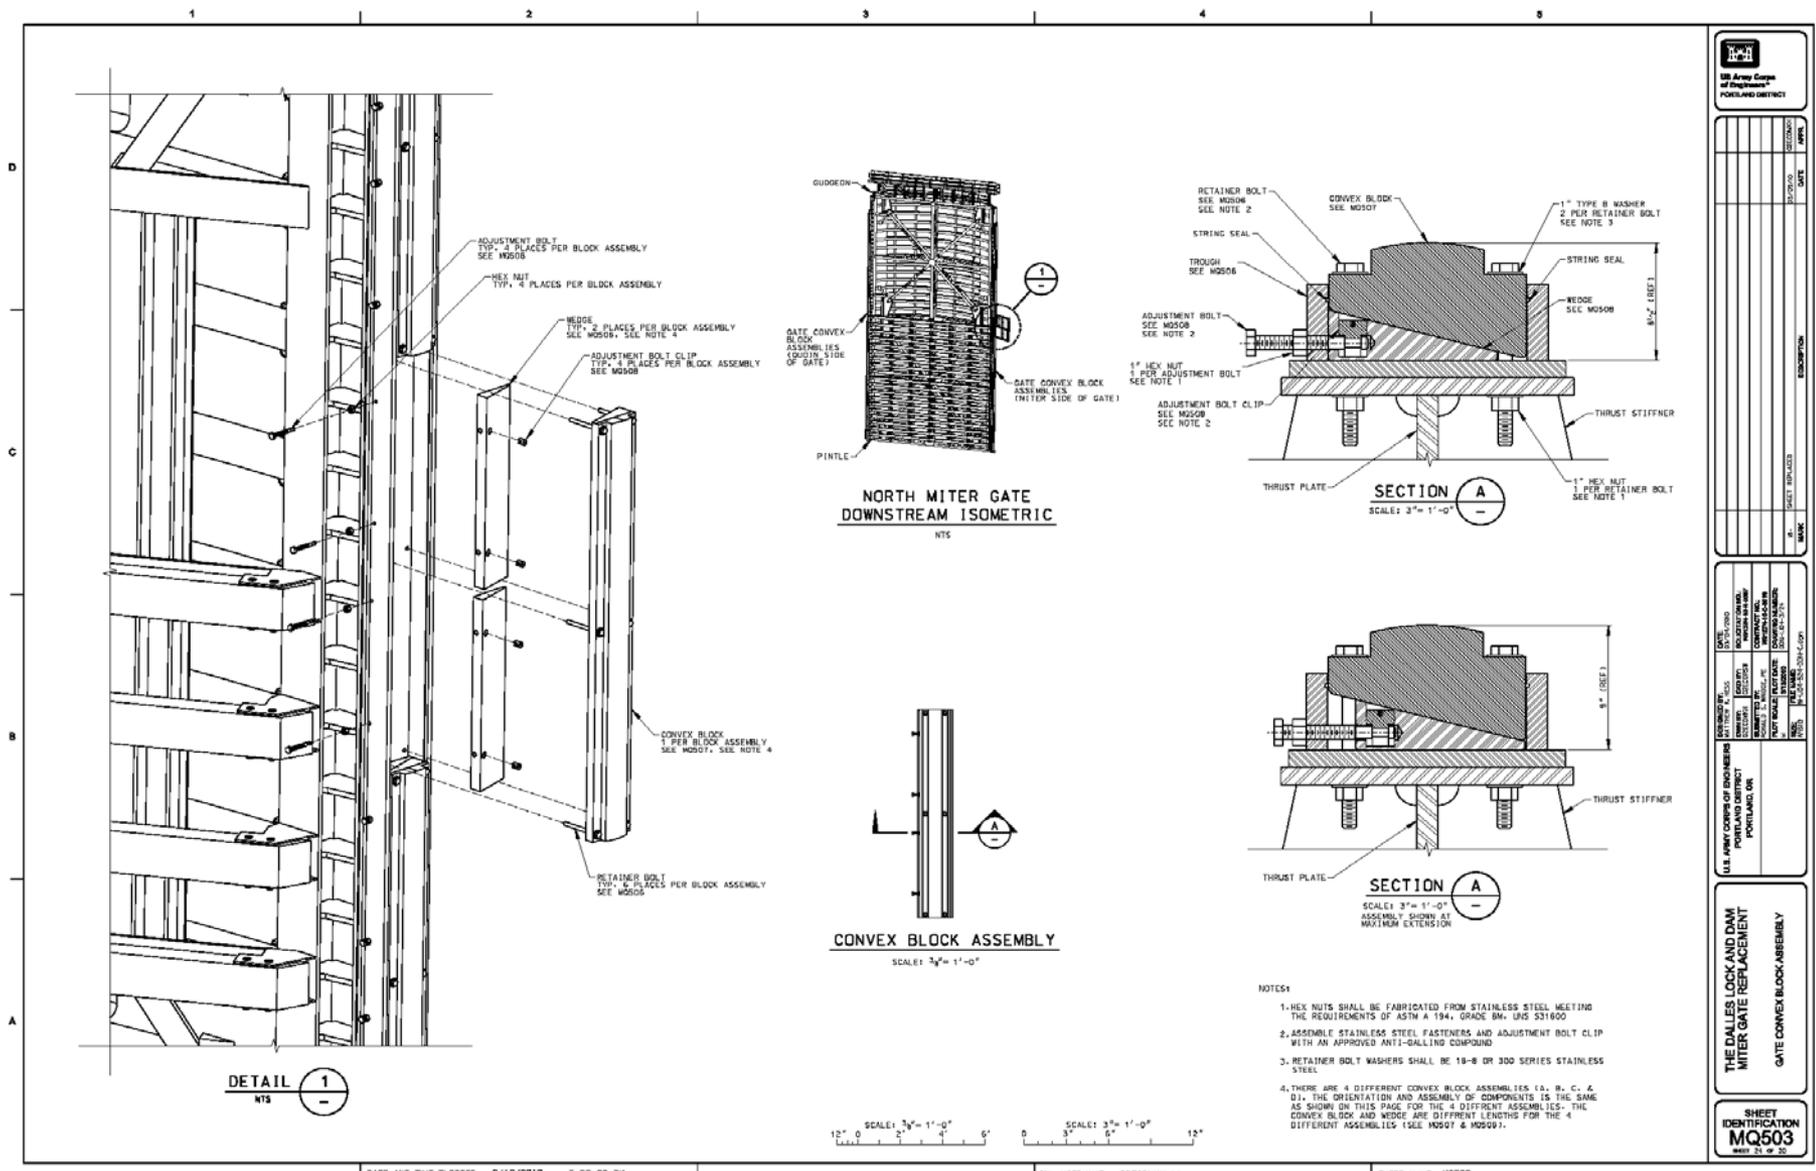
The Dalles Replacement Miter Gate

THE DALLES LOCK AND DAM
 MITER GATE REPLACEMENT
 GATE CONVEX BLOCK ASSEMBLY

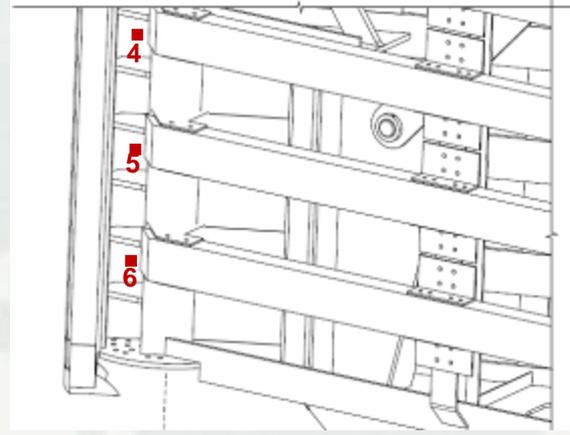
The Dalles Replacement Miter Gate – SMART Gate Technology

Instrumentation Summary:

- 6 Strain Gages on thrust web quoin side
- 6 Strain gages on thrust web miter side
- 8 Strain gages on flange and skin plate of G33
- 8 Strain gages on flange and skin plate of G34
- 4 Strain gages on flange and skin plate of G35
- 6 Strain gages on diagonals (one on each)
- 3 Tilt meters located on G1 and G34 as shown
- 2 RTD's on G16 (co-located with strain gages)
- 2 RTD's on G34 (co-located with strain gages)

■ Strain Gage Location

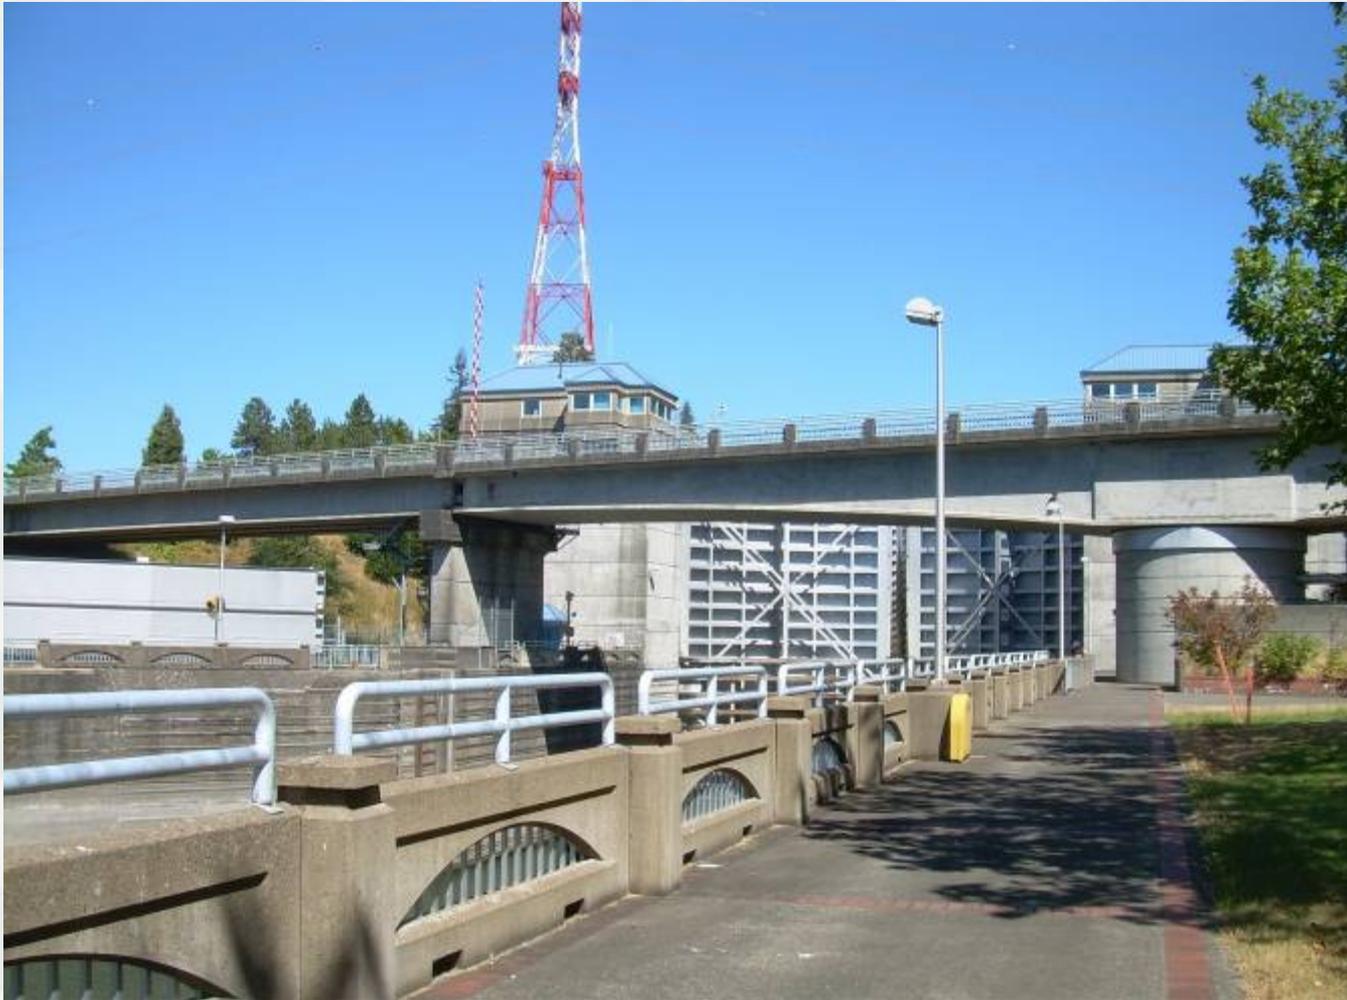
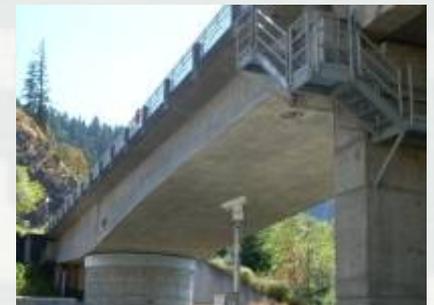
Applications in NWP:

Bonneville Swing Bridge: Center Pivot Bearing, Centering/Lifting Wedges, Balance Wheels

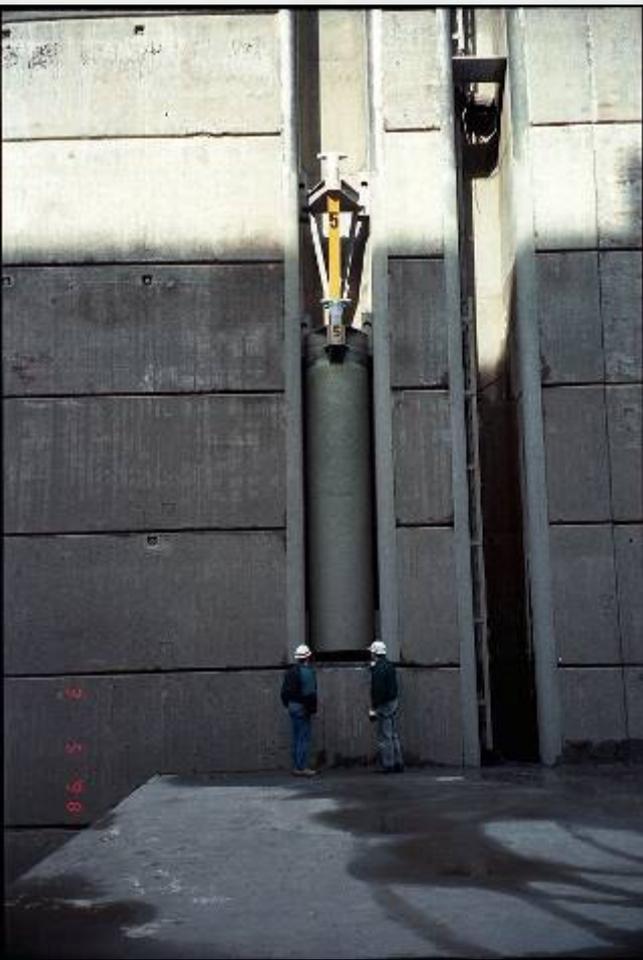
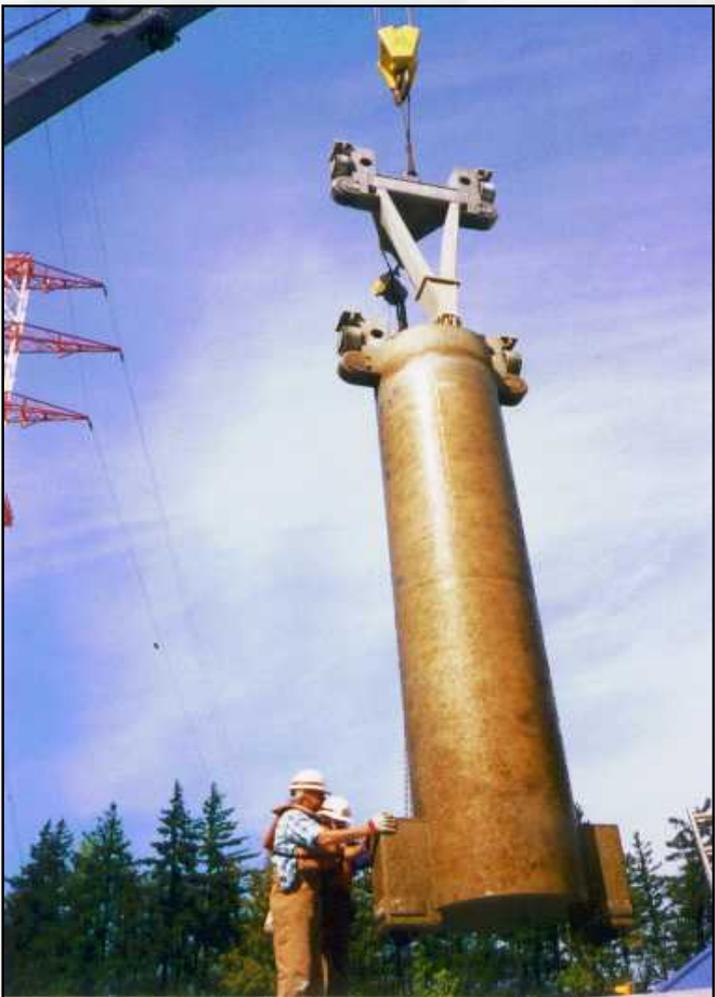
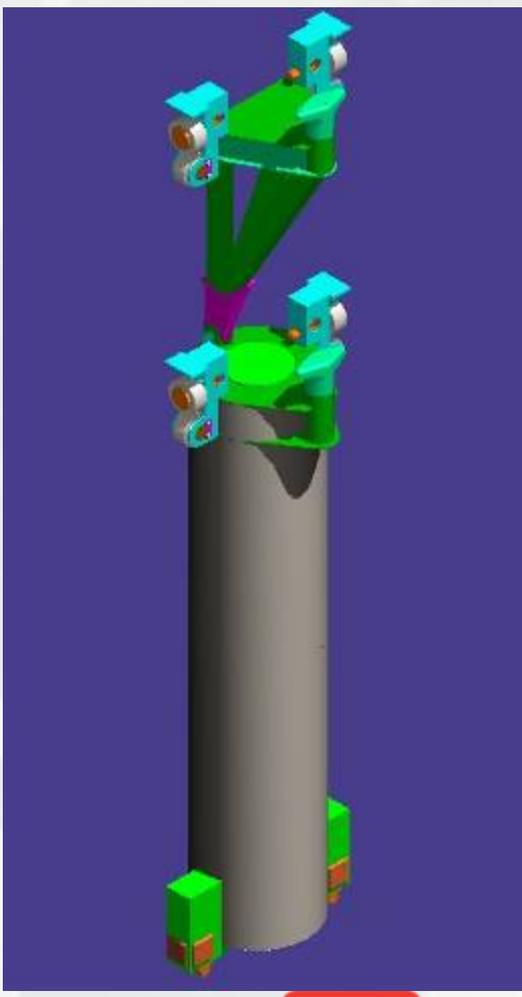
Applications in NWP: NAVIGATION

Bonneville: Floating Mooring Bit, Guide and Reaction Rollers, Floating Mooring Bit, Lower Guide Plates

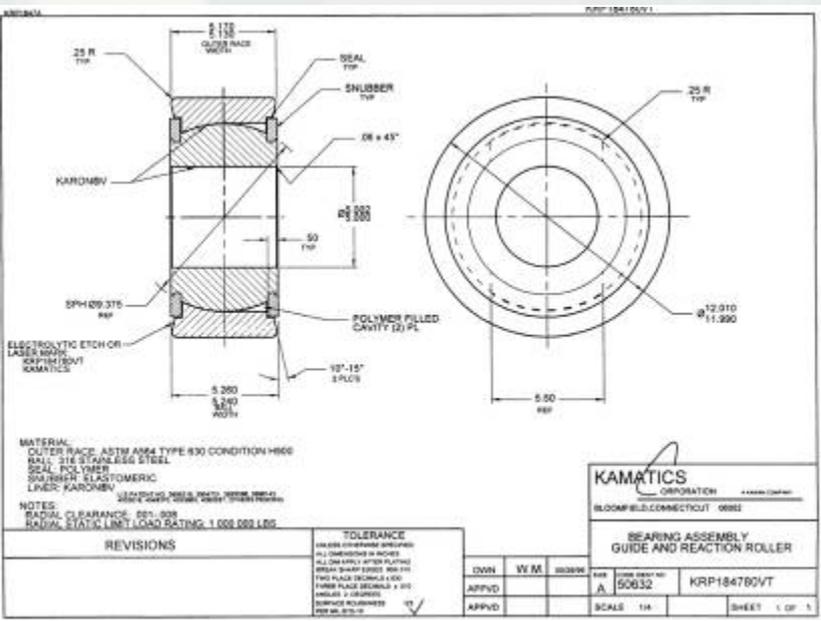
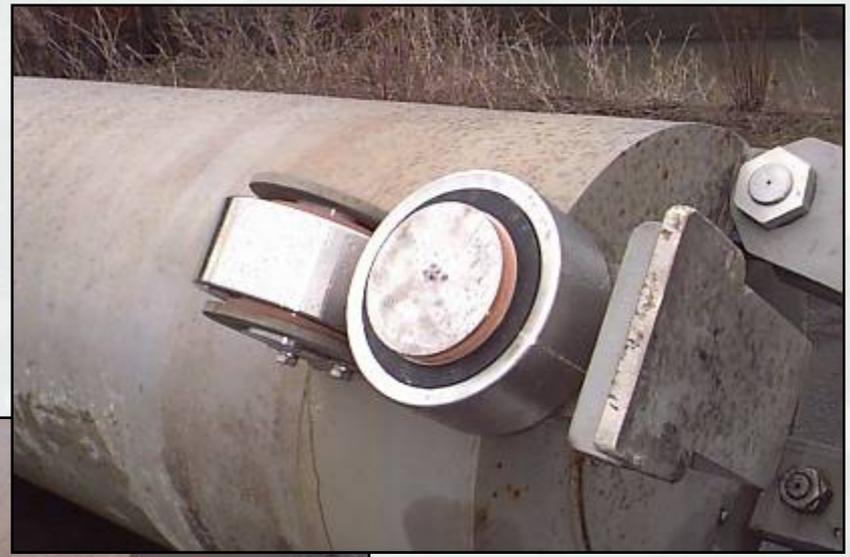
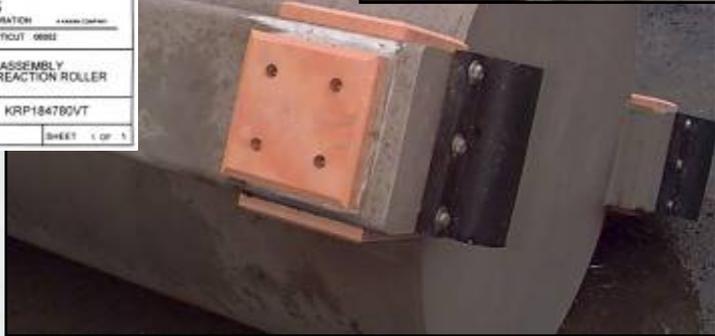
Applications in NWP: NAVIGATION

Bonneville: Floating Mooring Bit, Guide and Reaction Rollers, Floating Mooring Bit, Lower Guide Plates

- Stick-slip operation of the FMB's occurred immediately after the lock became operational in 1993
- Initial FMB modifications were completed in 1994
- Significant stick-slip operation of the FMB's reoccurred within one year after initial modifications
- Final FMB modifications were completed in March 1997

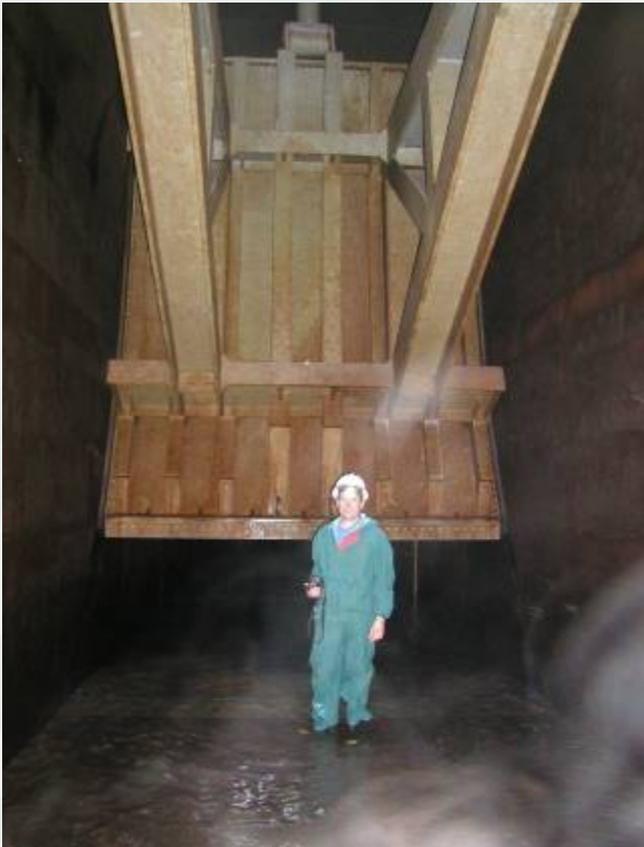
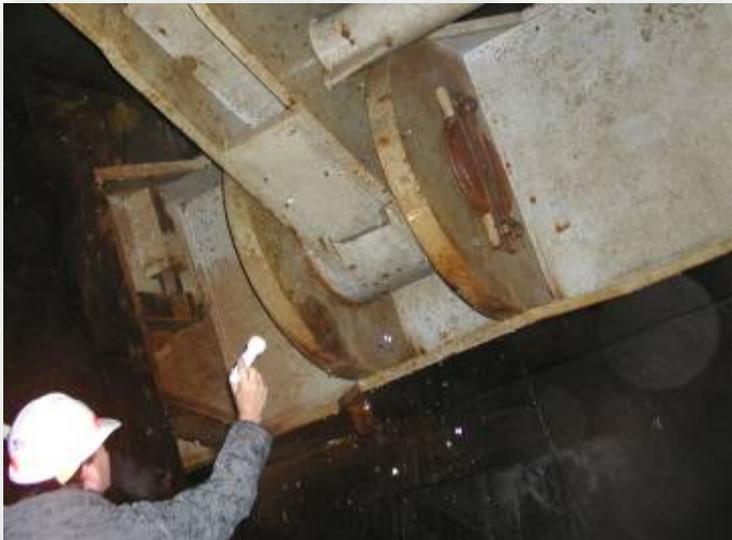
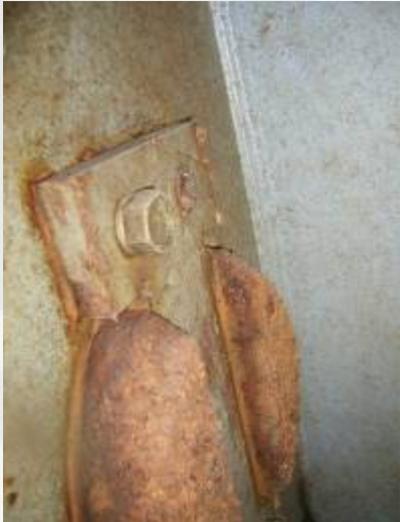
Applications in NWP: NAVIGATION

Bonneville: Filling and Emptying Valves

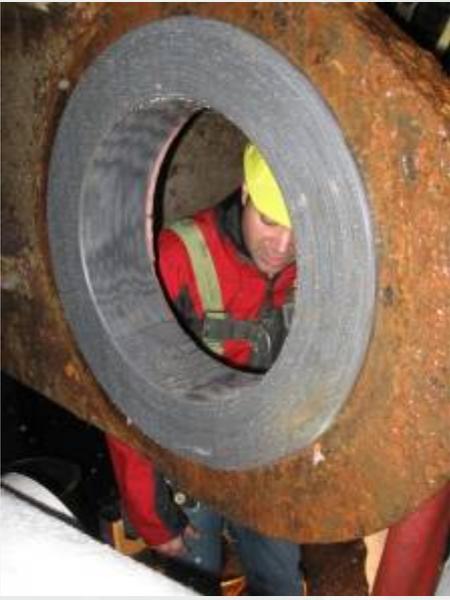
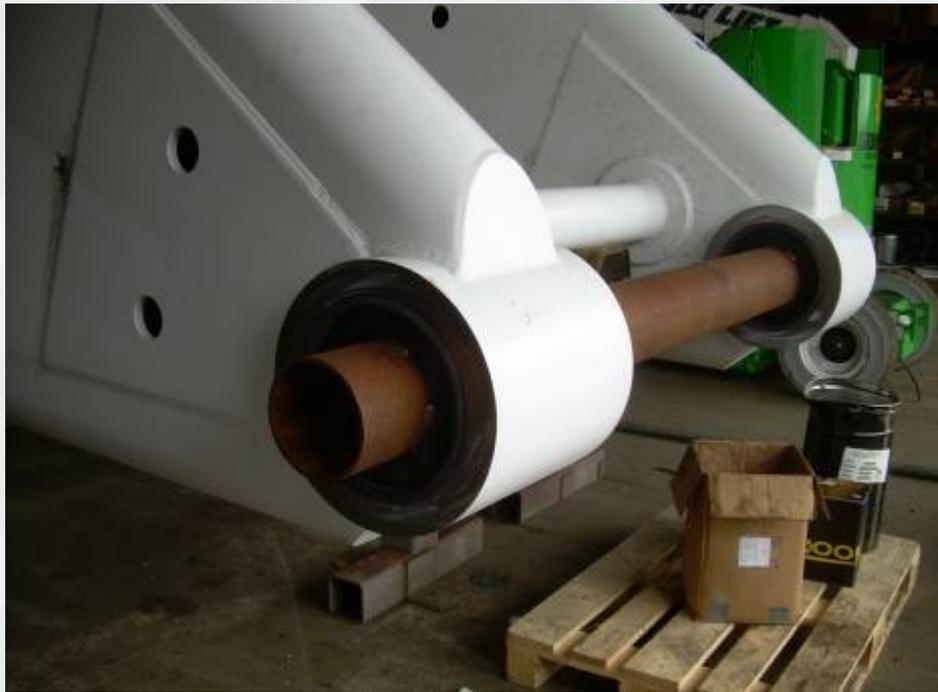
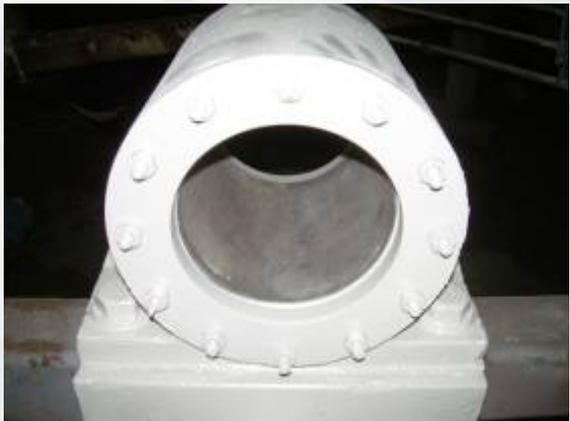
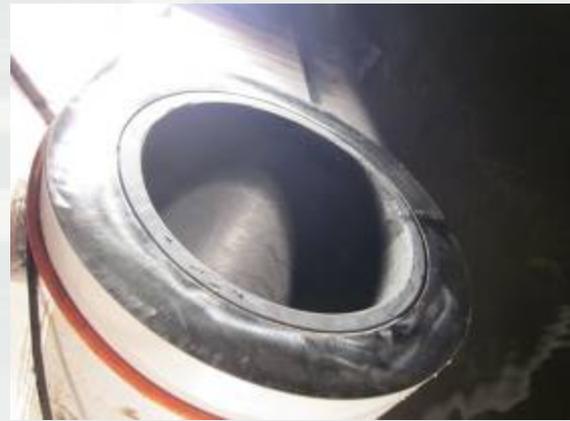
The Dalles: Filling and Emptying Valve Trunnion Bushings, Crosshead and Line Shaft Bushings, Sector Gear Pin Bushing, Sector Gear Support Roller Bushings, Miter Gate Pin Bushings, Miter Gate Pintle/Gudgeons

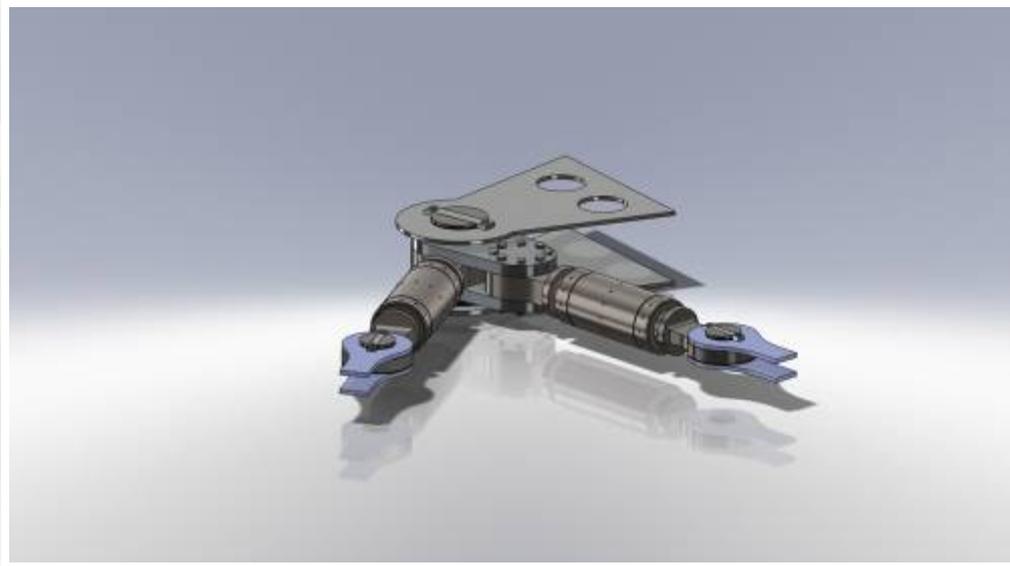
Applications in NWP: The Dalles: Miter Gate Gudgeons

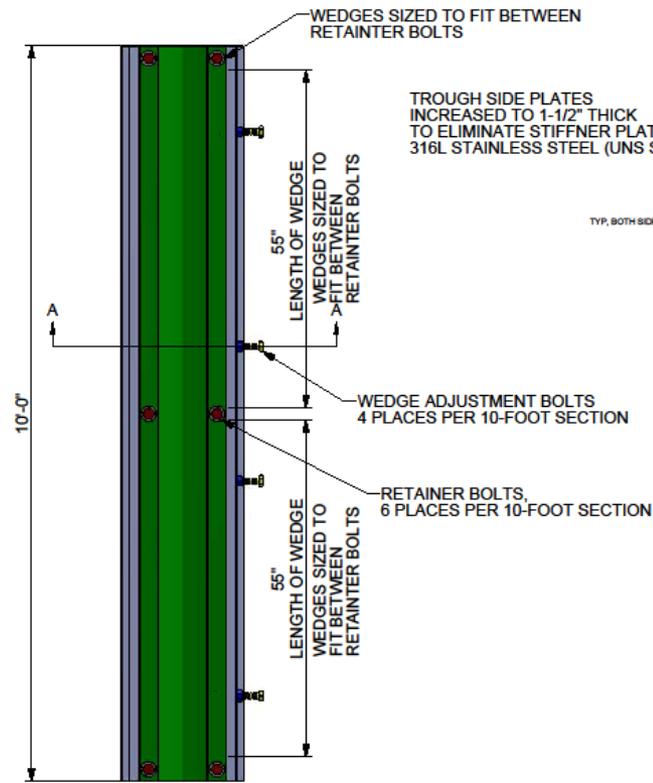
CONVEX BLOCK ASSEMBLY

The Dalles Miter Gate:

Composites Material Use in Adjustable Quoin & Miter Blocks:
