Methods and Materials to Improve the Durability of Concrete Repairs

USACE Lock Maintenance Workshop
12 February 2015

Robert D. Moser, Ph.D.

Concrete and Materials Branch
Engineering Systems and Materials Division
Geotechnical and Structures Laboratory
U.S. Army Engineer Research and Development Center

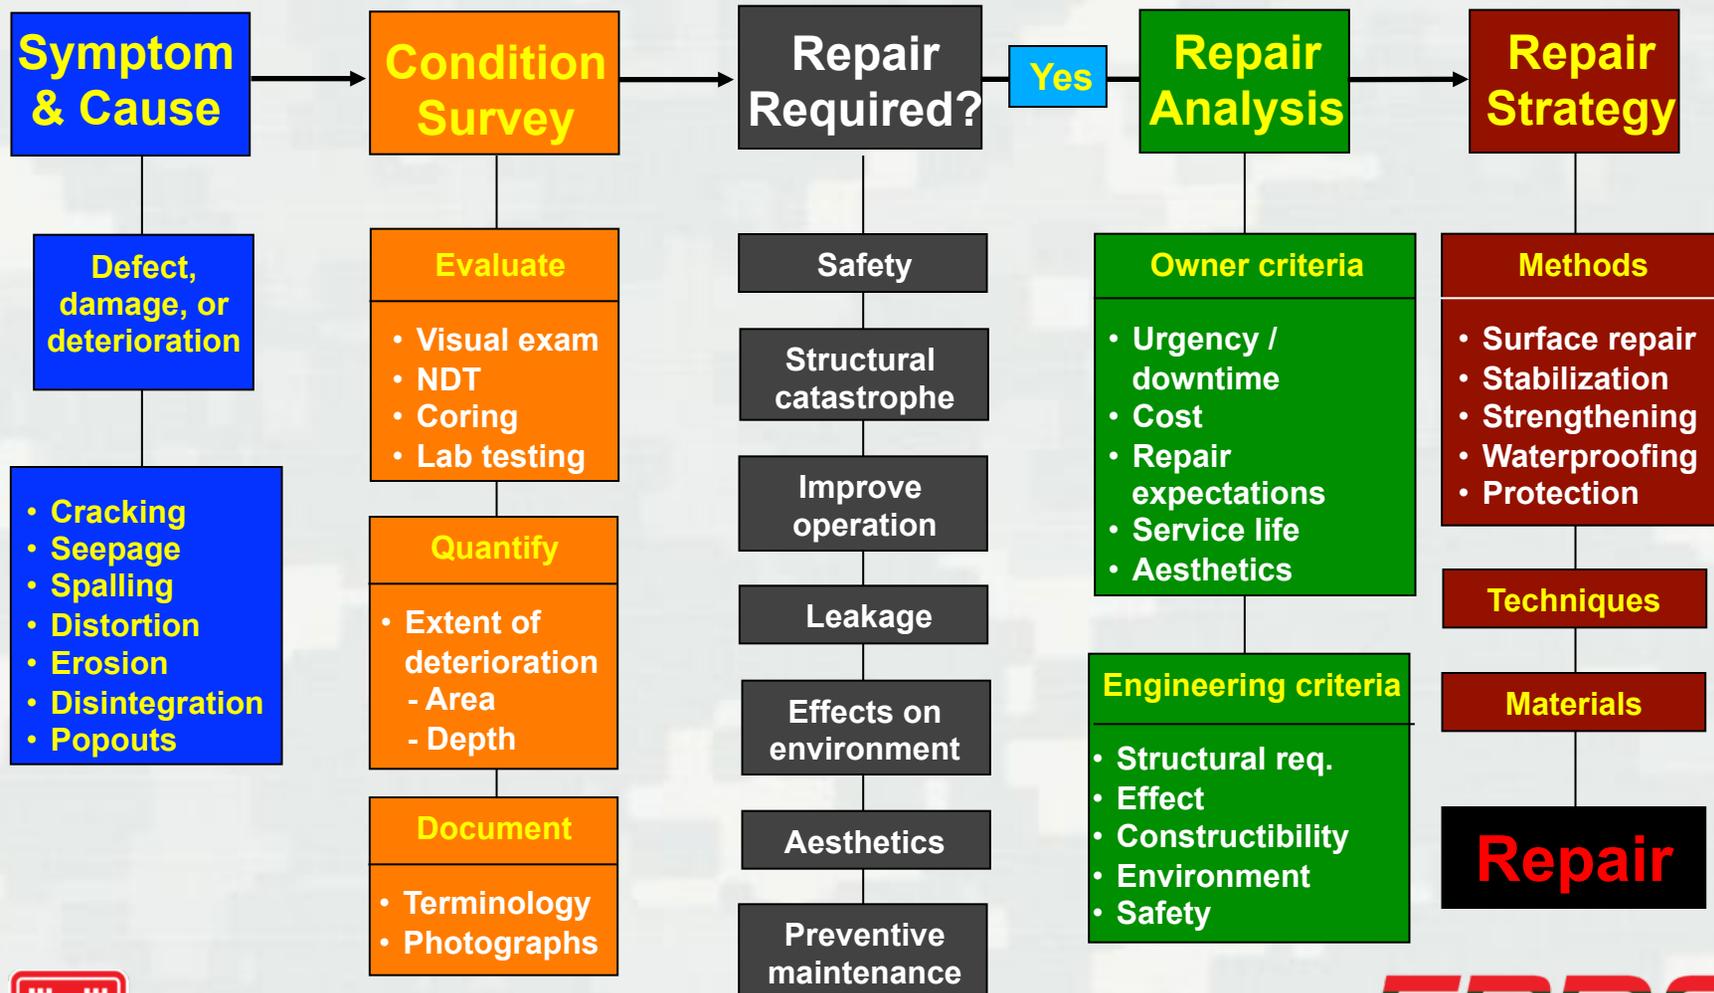
Concrete Repair Process

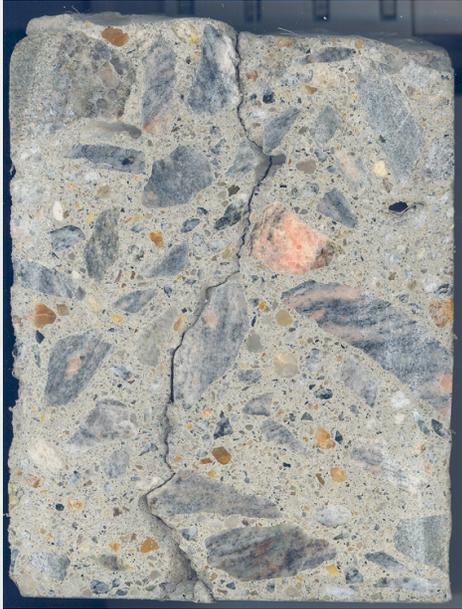
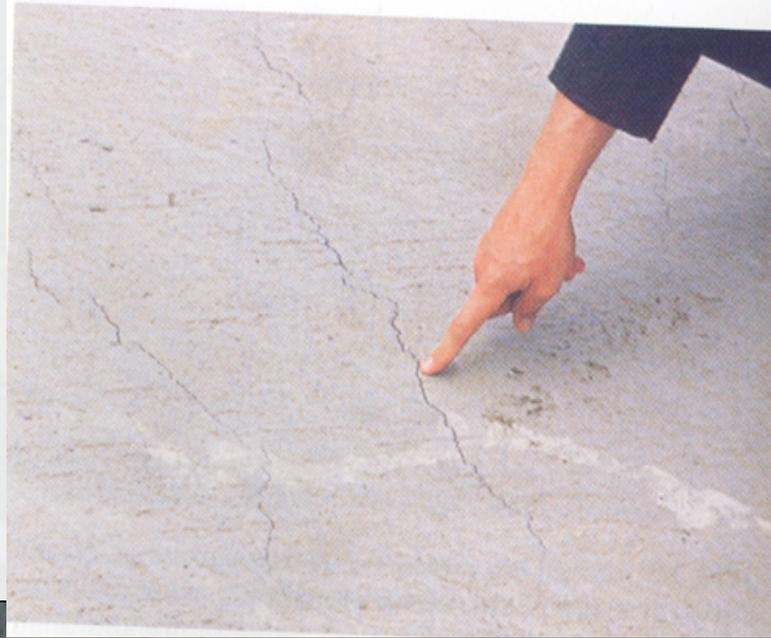
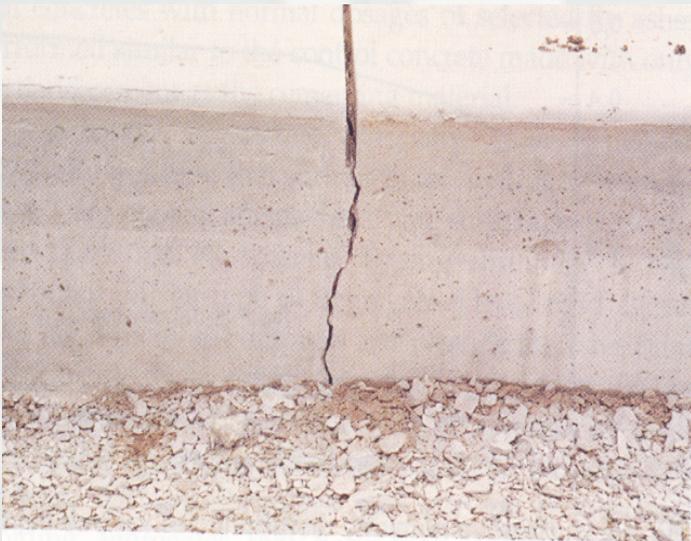
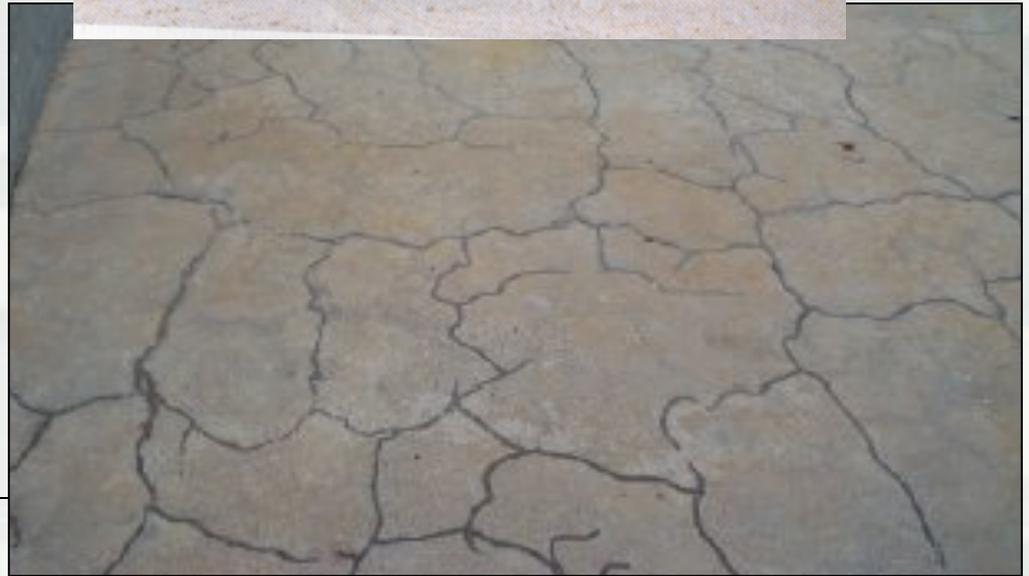
Shrinkage-Induced Cracking

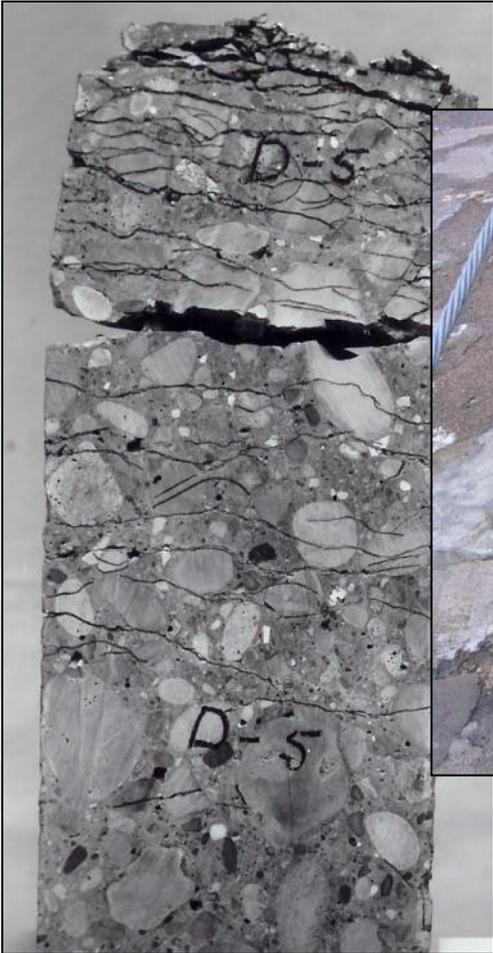
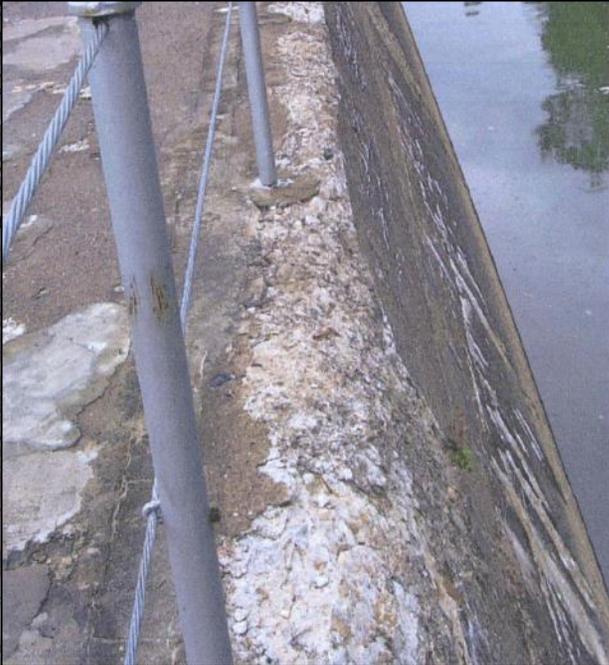
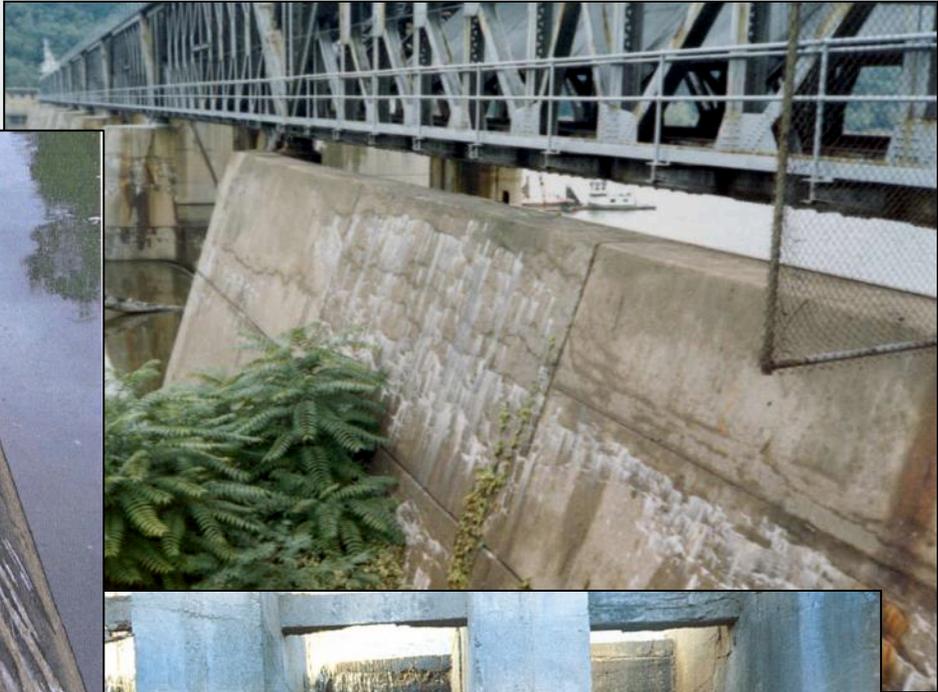
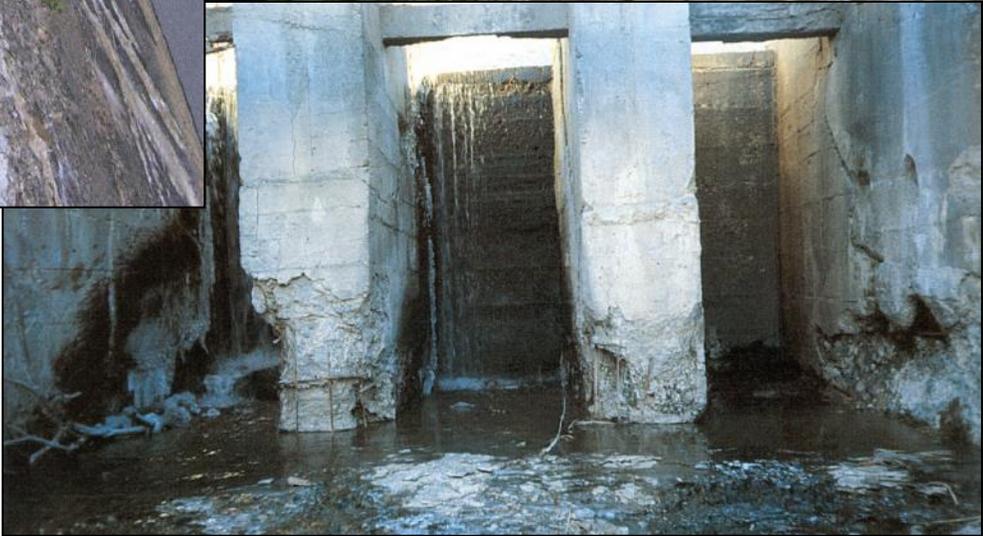
Freezing & Thawing

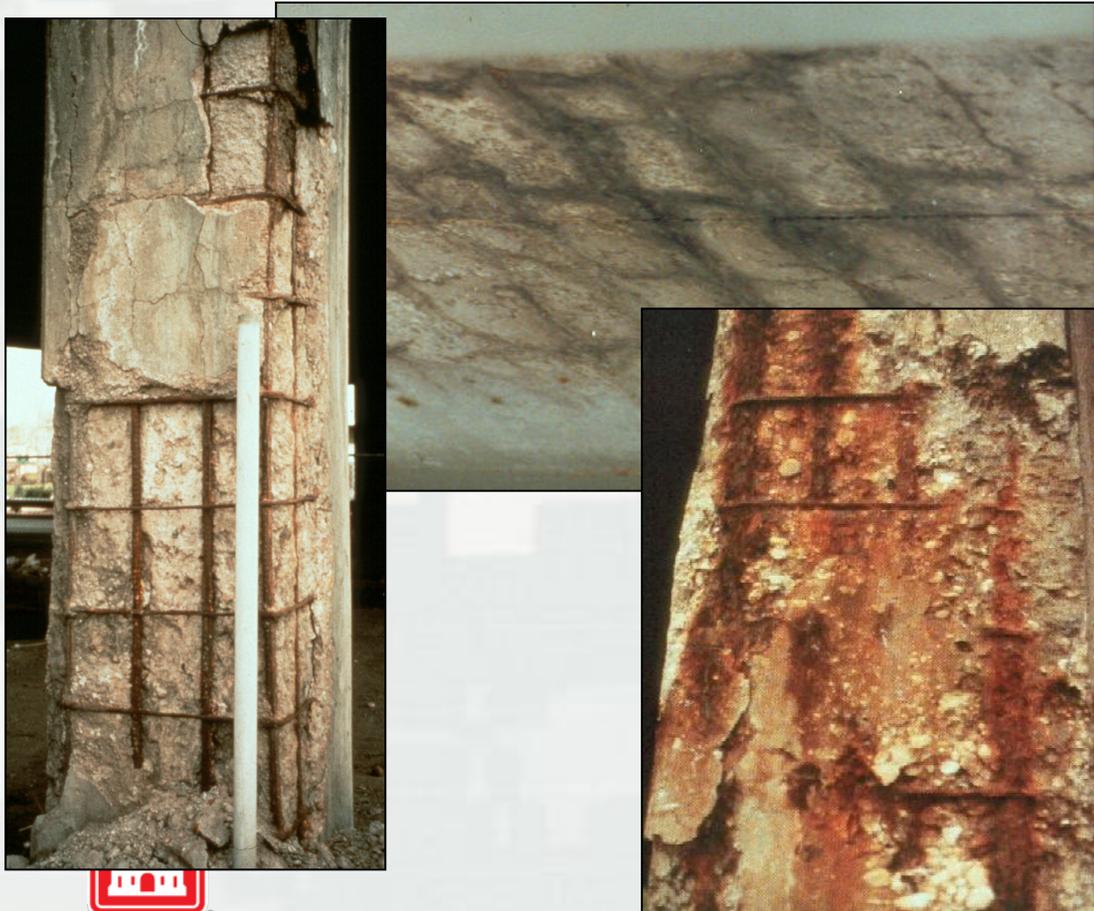
Corrosion

- Destruction of a metal by a chemical, electrochemical, or electrolytic reaction within its environment
- Resulting expansion causes cracking, spalling, and delamination of concrete cover

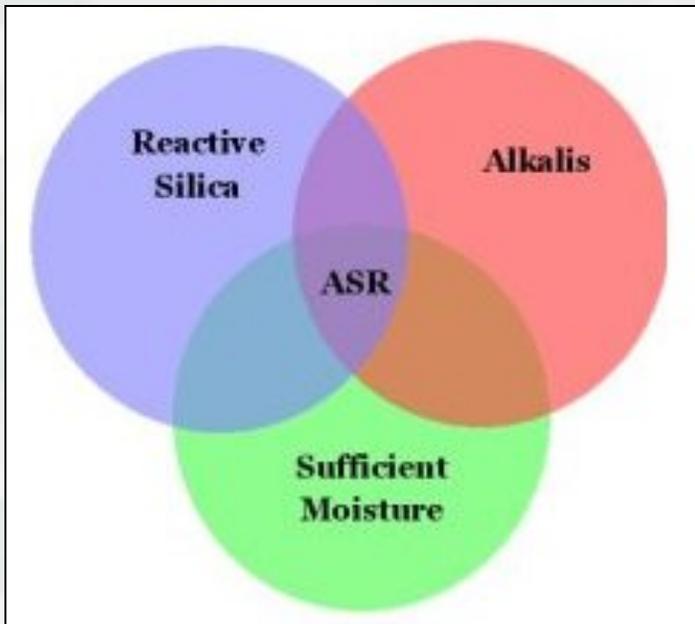
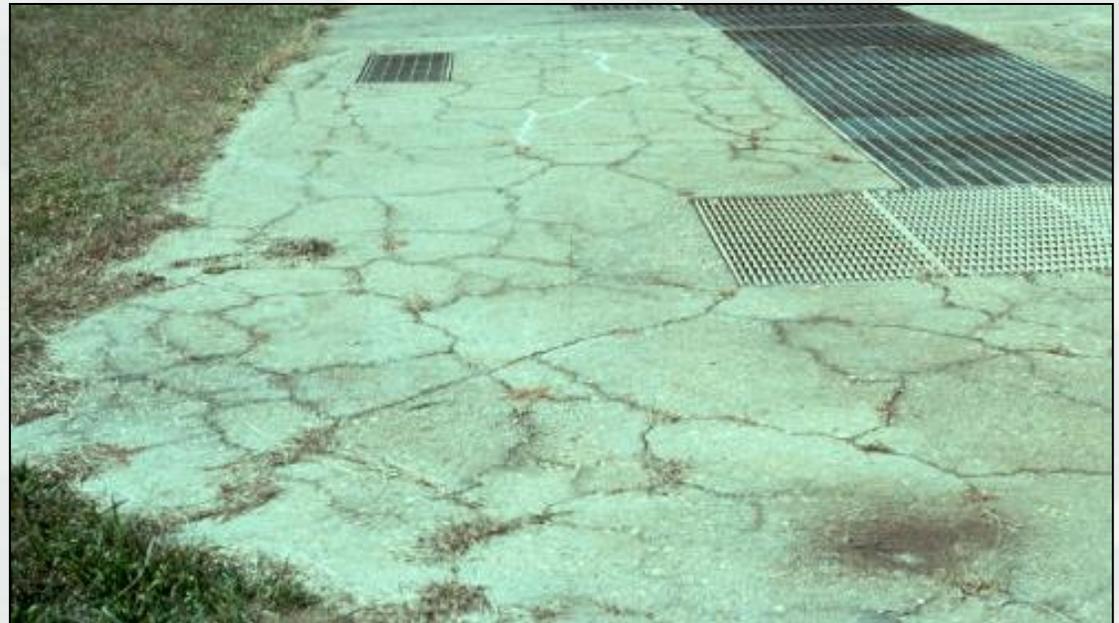
Reactive Aggregate Alkali-Silica Reaction (ASR)

- In its simplest form, ASR can be visualized as a two-step process
 - Alkali + Silica = Gel Reaction Product

Gel Reaction Product + Moisture = Expansion

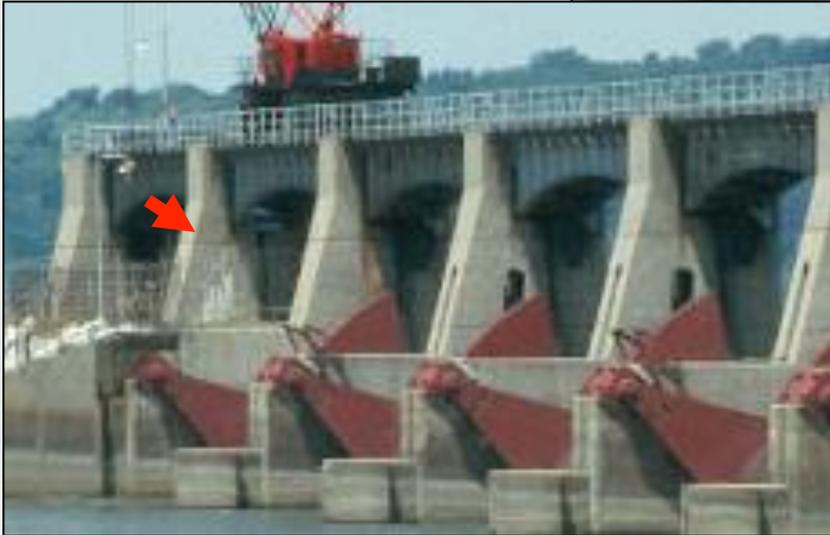
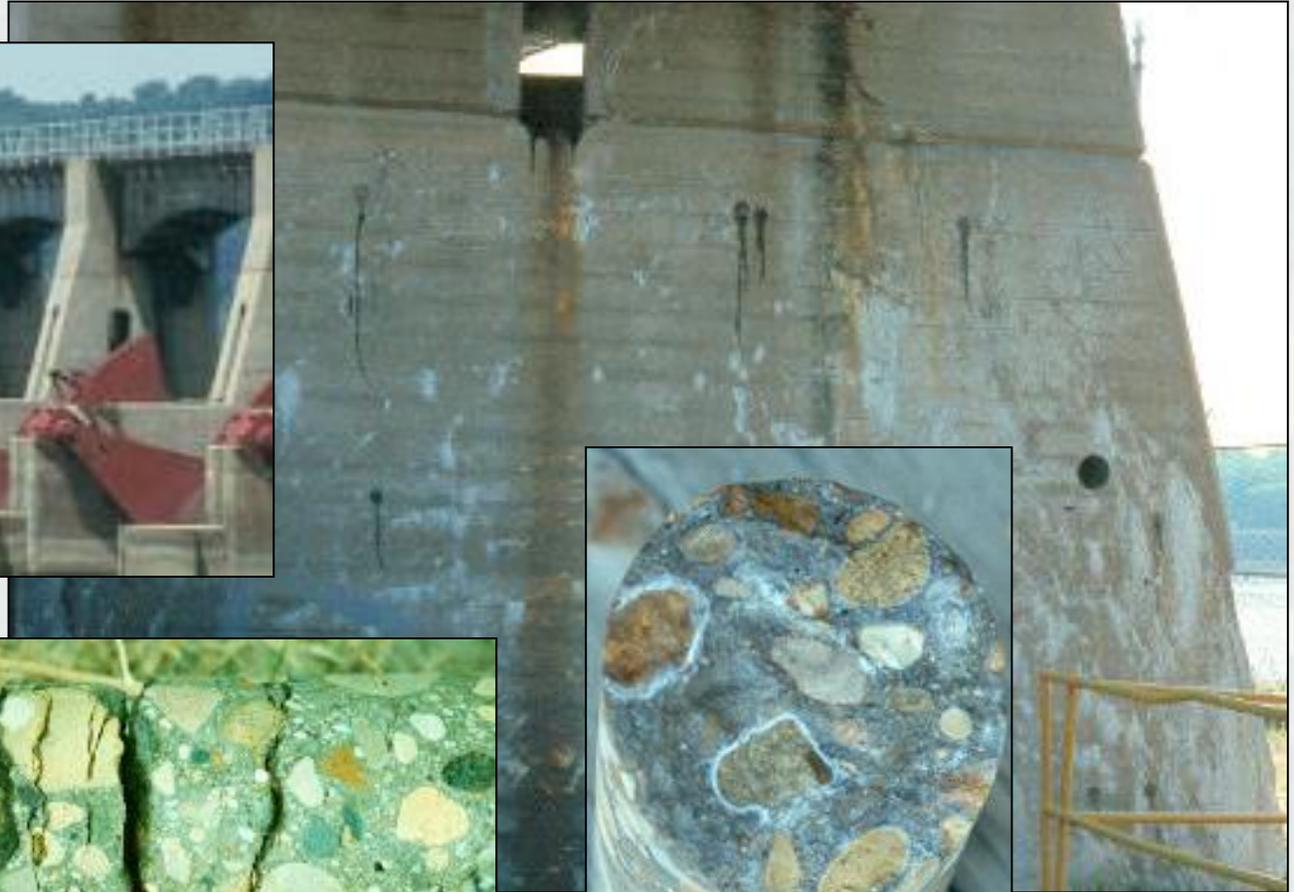
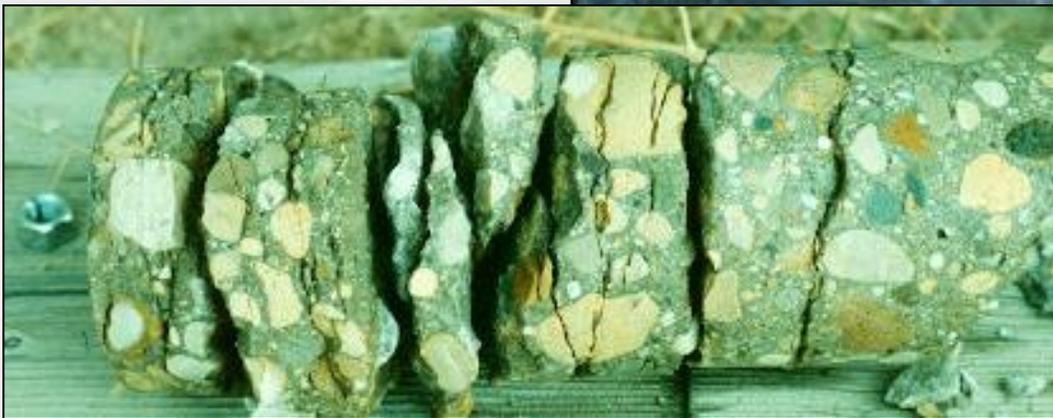
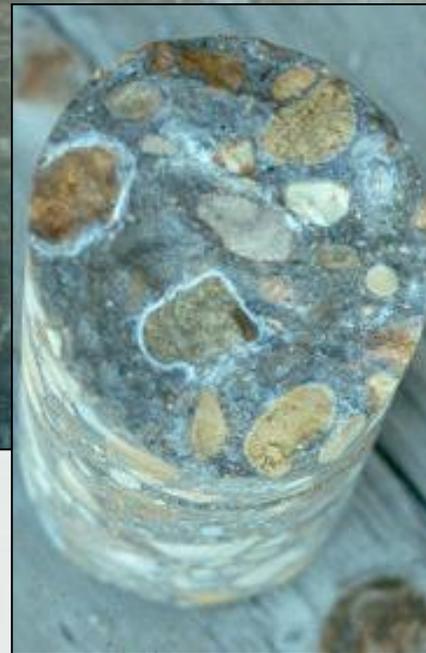
Cause of Deterioration? Combined?

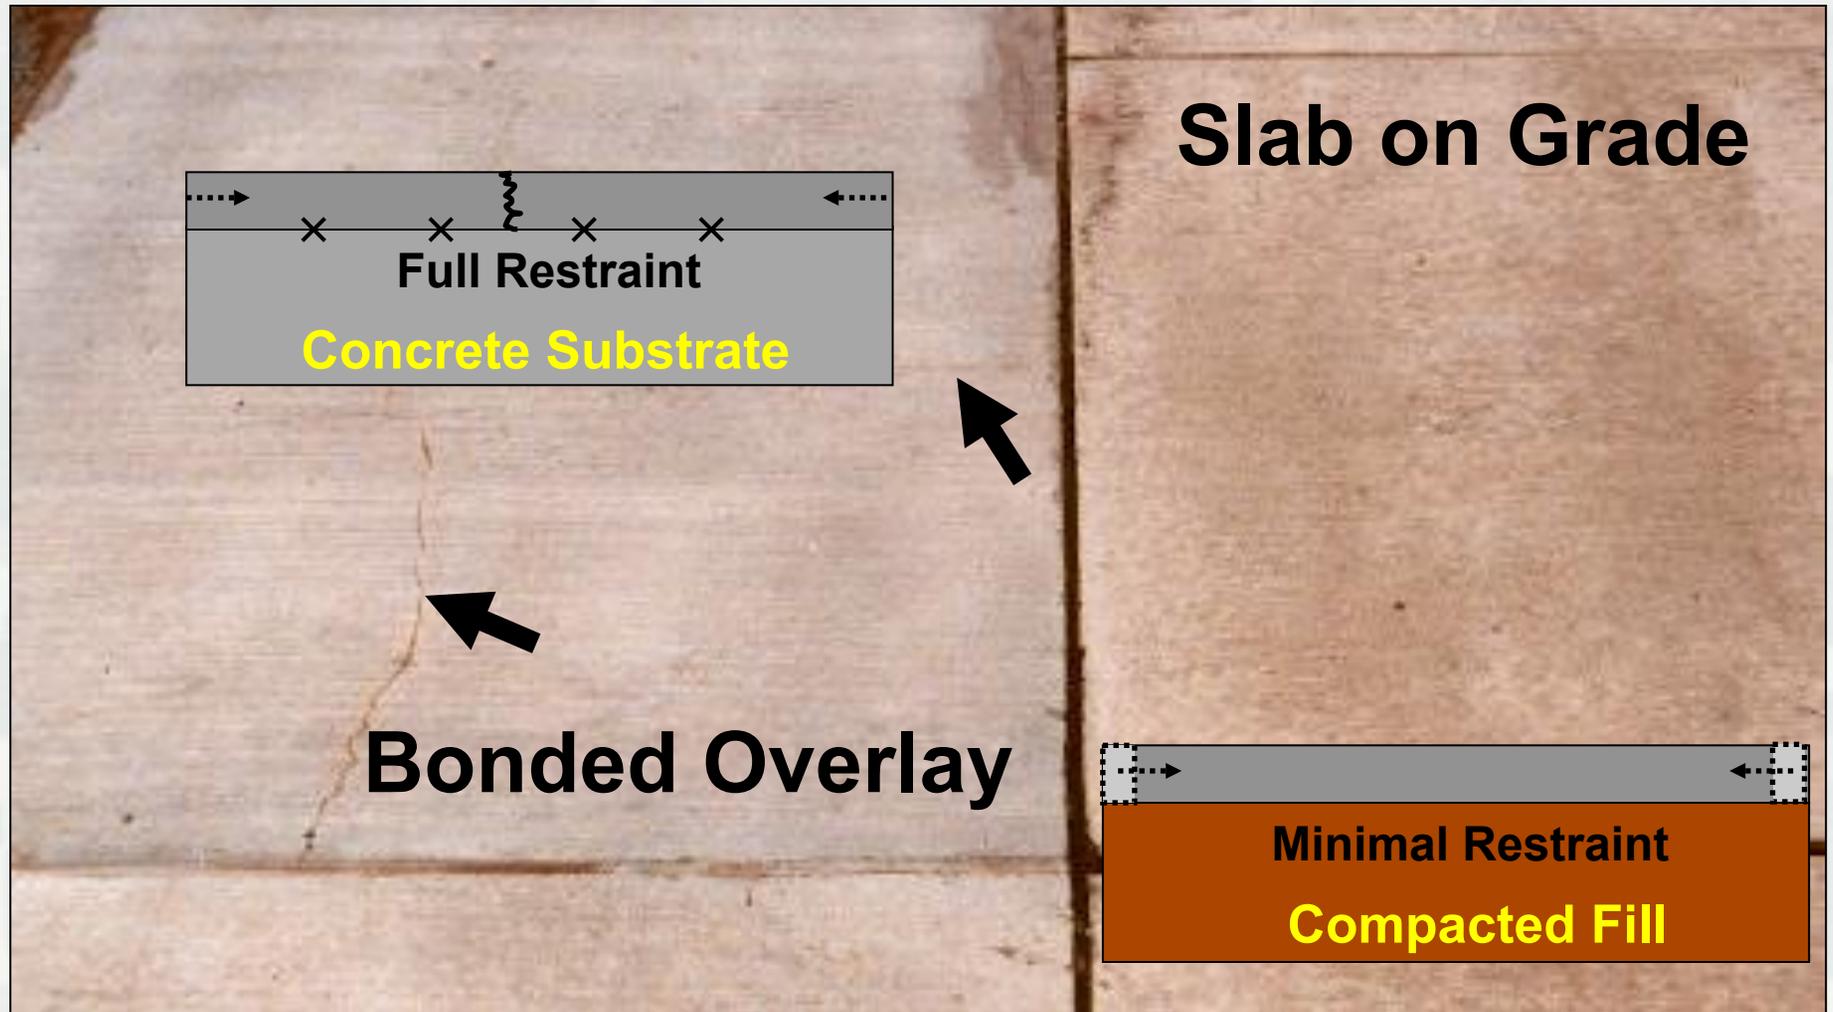
Cracking Resulting from Restraint

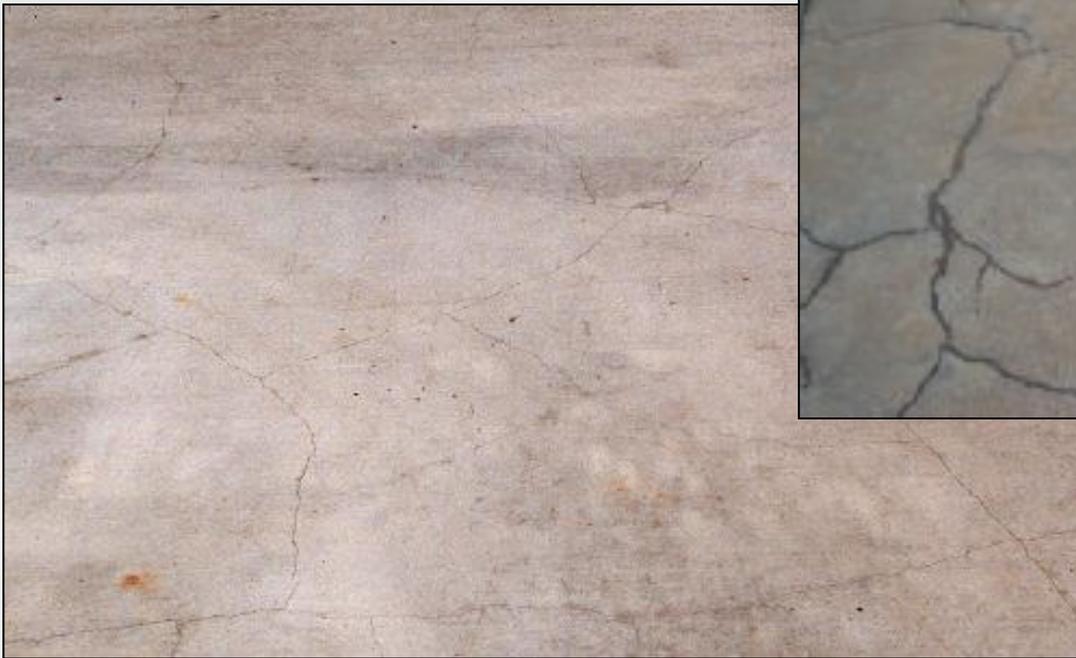
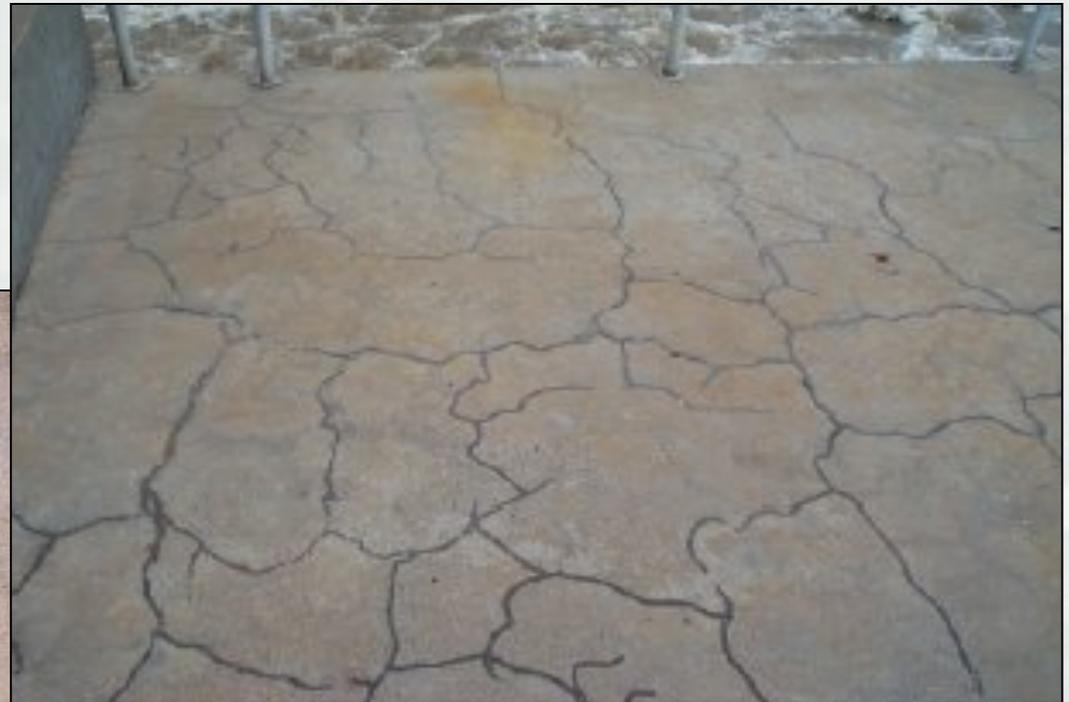
Map or Pattern Cracks

Restrained Shrinkage of Repair Materials

**4-in. Thick
Concrete
Overlays**

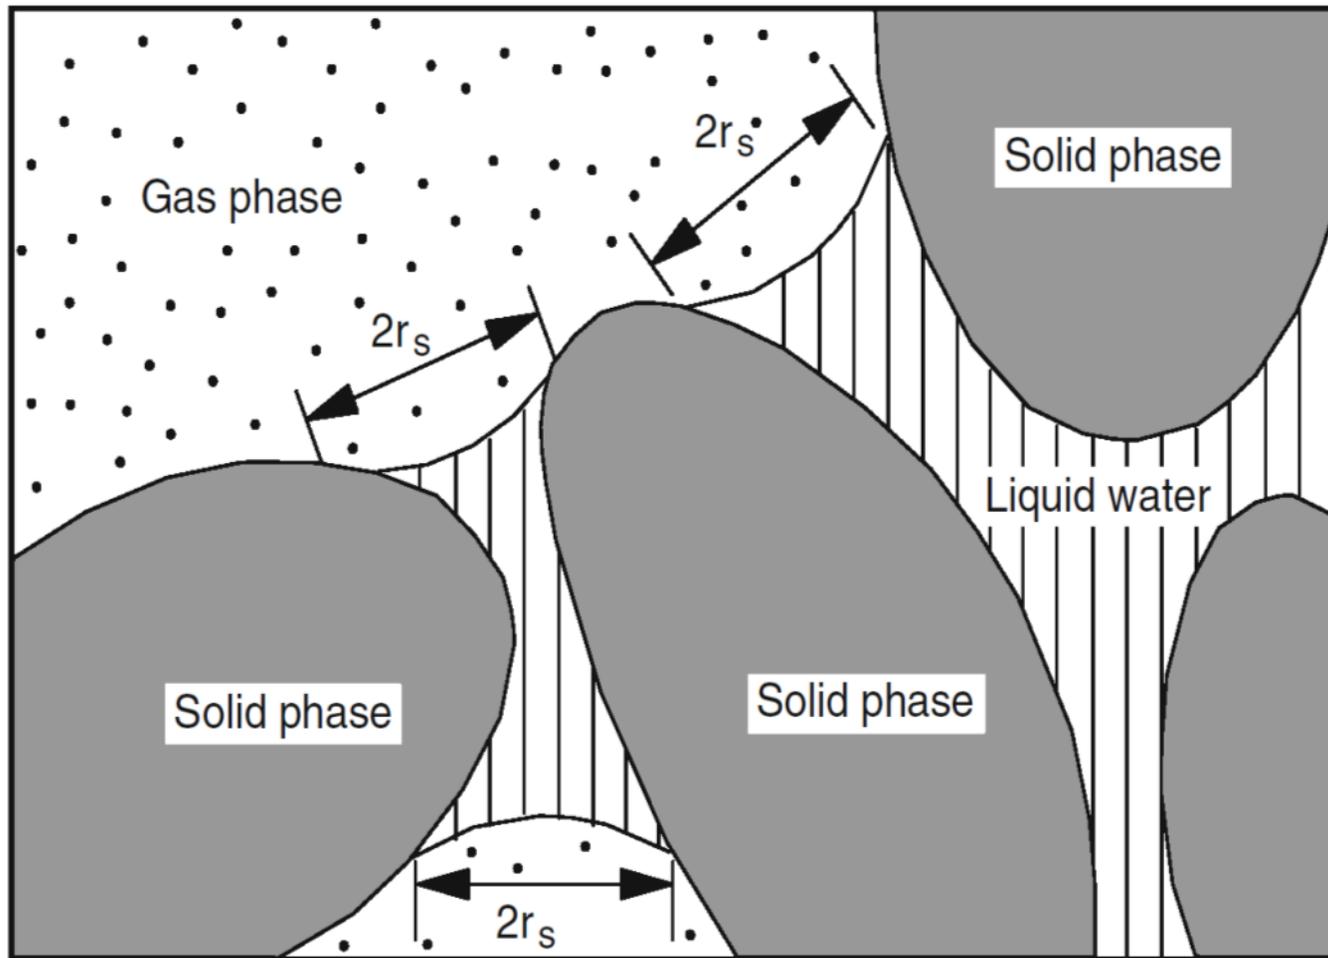
Drying Shrinkage in Concrete

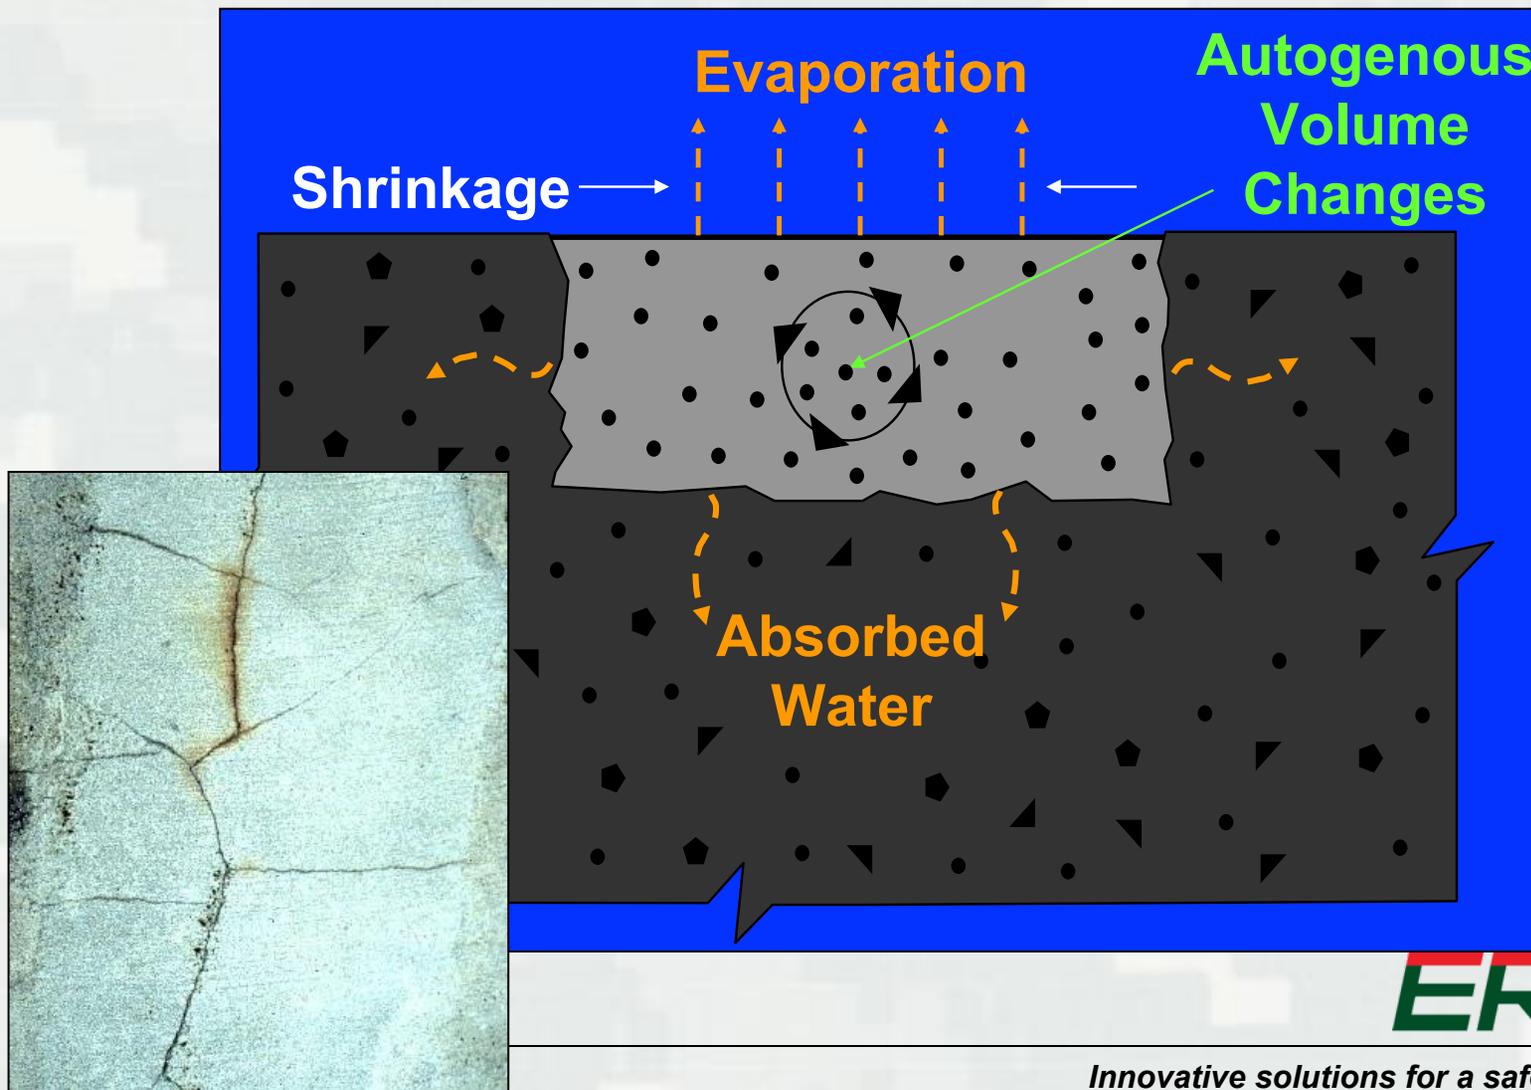
Drying Shrinkage

Moisture Loss

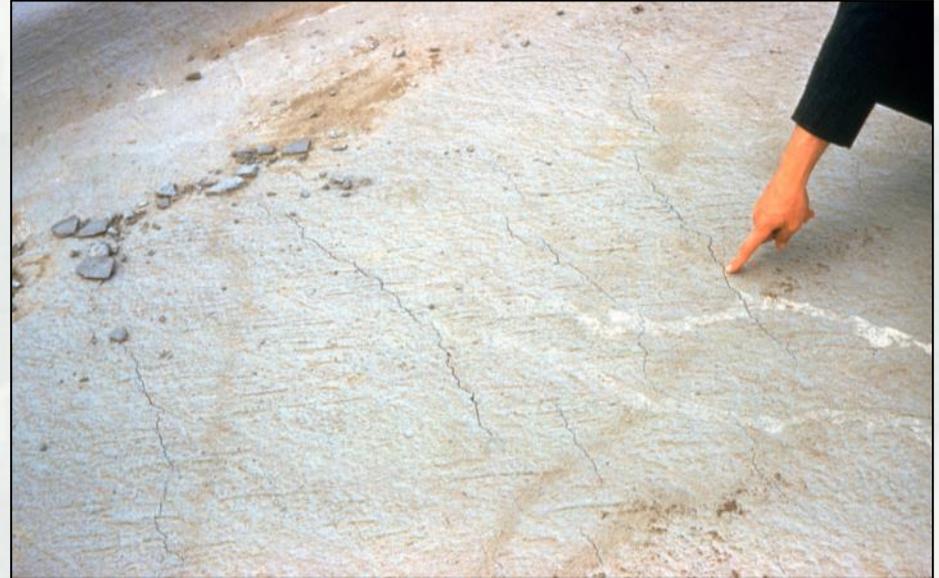
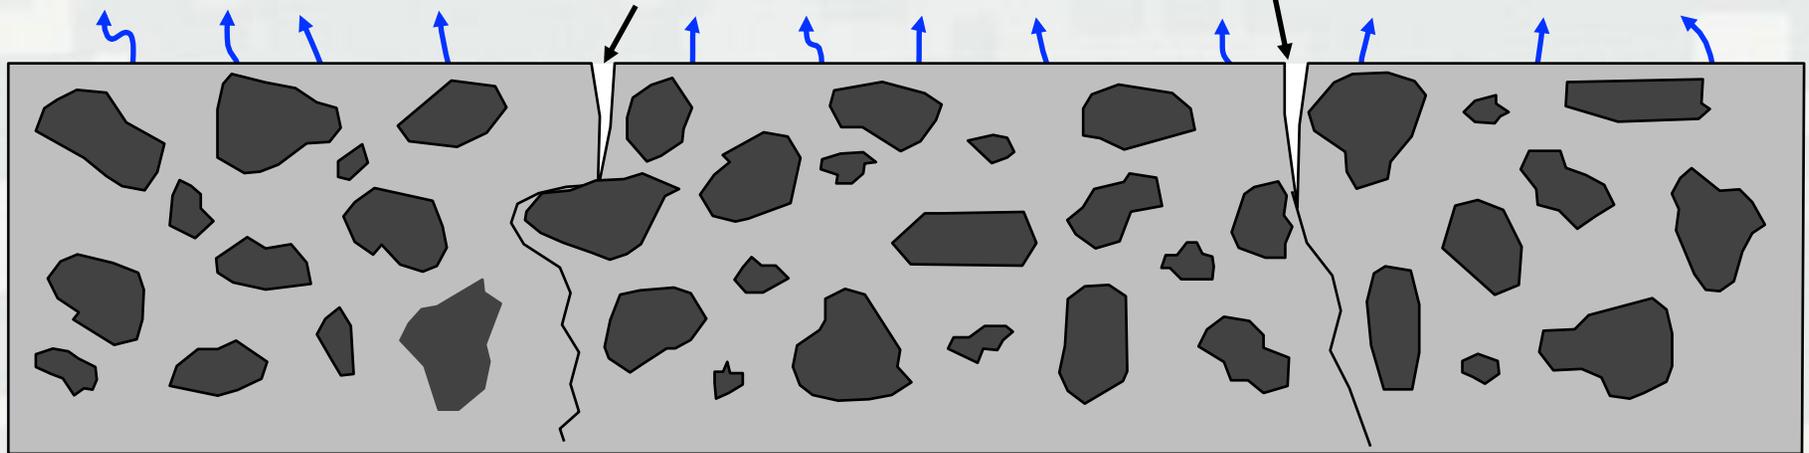
Shrinkage-Induced Cracking

Water Loss Through Evaporation

Shrinkage Cracks

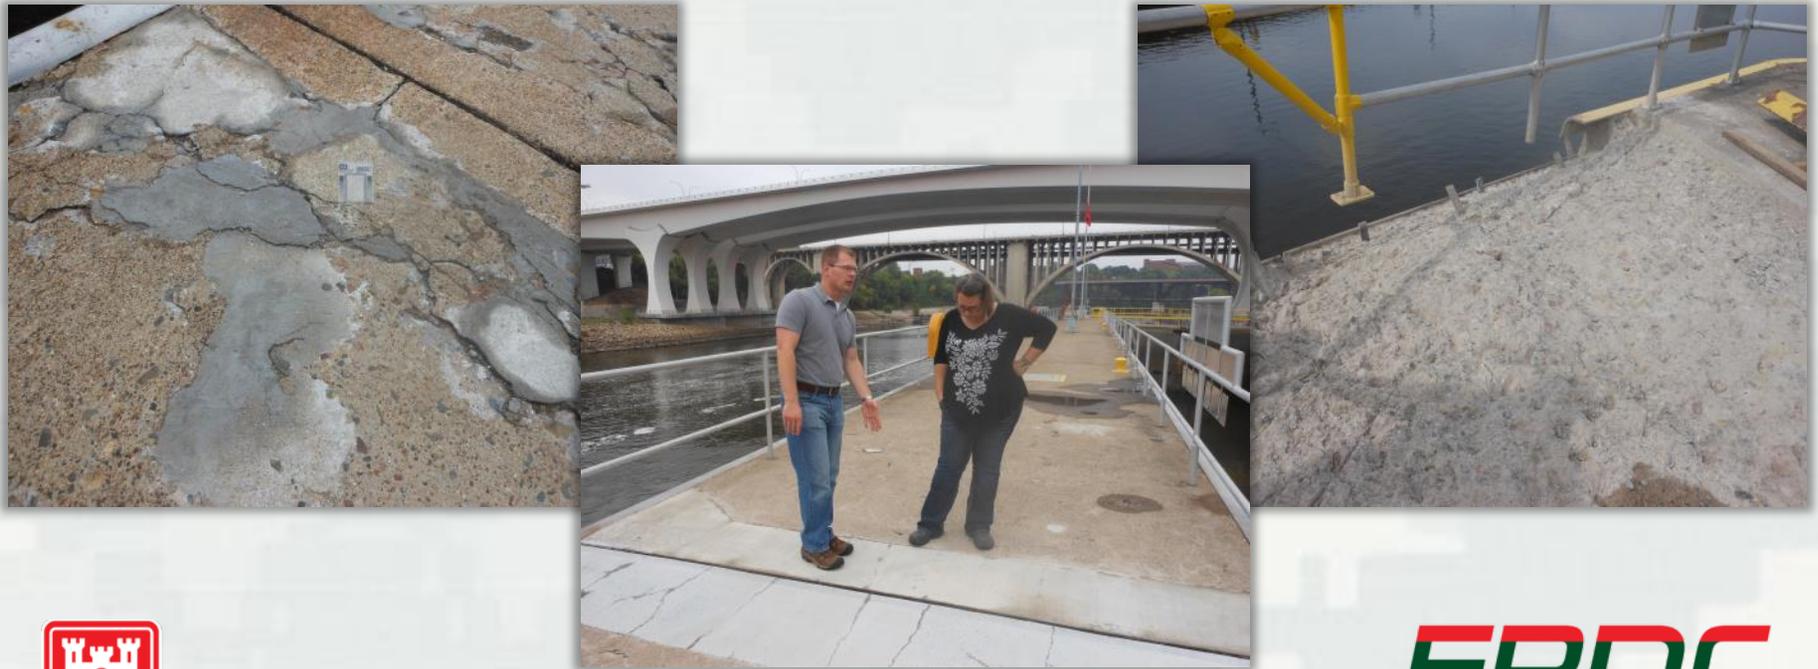
Site Visits to Inspect Deterioration

- Site visits to USACE Districts:
 - ▶ St. Paul District – Inspection of structures along the upper Mississippi River which have horizontal concrete distress or have been repaired.
 - ▶ Information gained on repair process (concrete removal techniques, surface preparation requirements and capabilities), current repair materials used, and material availability considerations.

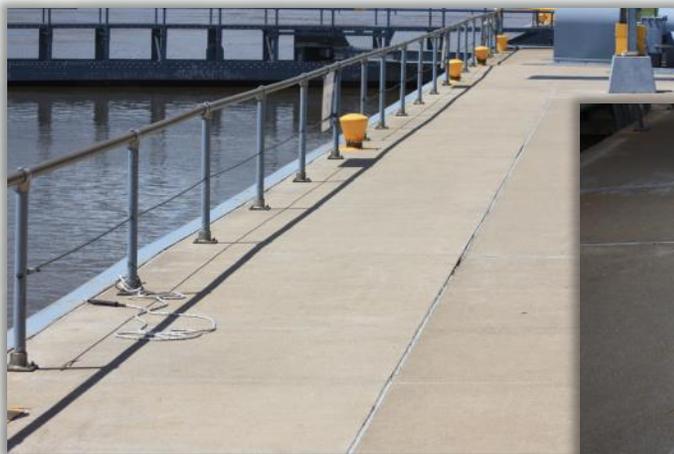
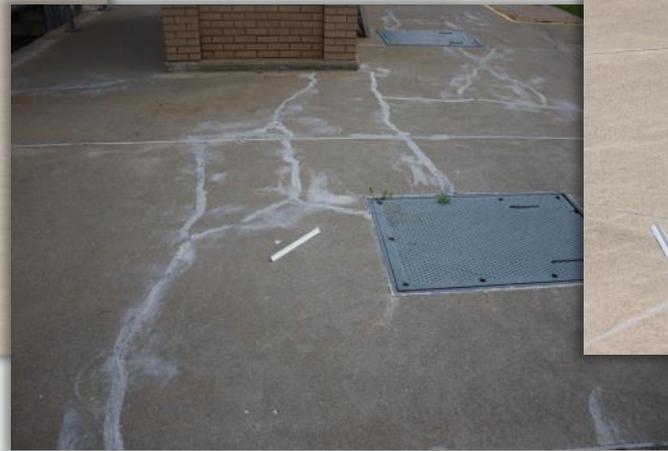
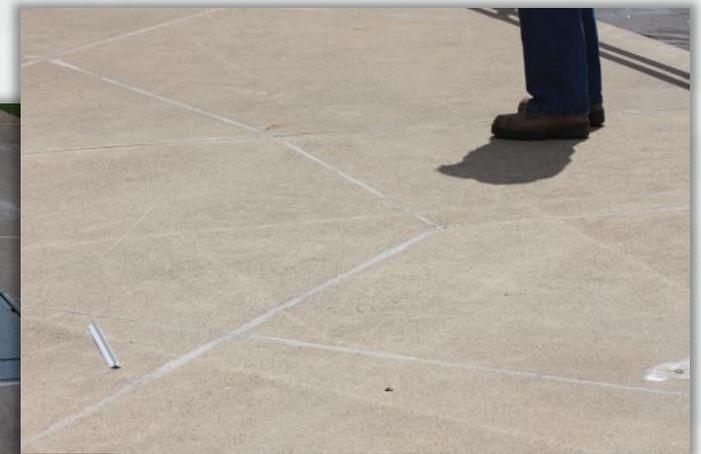
Site Visits to Inspect Deterioration

- Site visits to USACE Districts:
 - ▶ Rock Island District – Inspection of Lock and Dam 13, 14, and 15.
 - ▶ Sites of different types of horizontal concrete repairs.
 - ▶ Information gained on repair process (concrete removal techniques, surface preparation requirements) and recommended best practices. Main takeaway is that the unbonded repairs performed significantly better with little cracking.
 - ▶ Report completed summarizing periodic inspection of repairs.

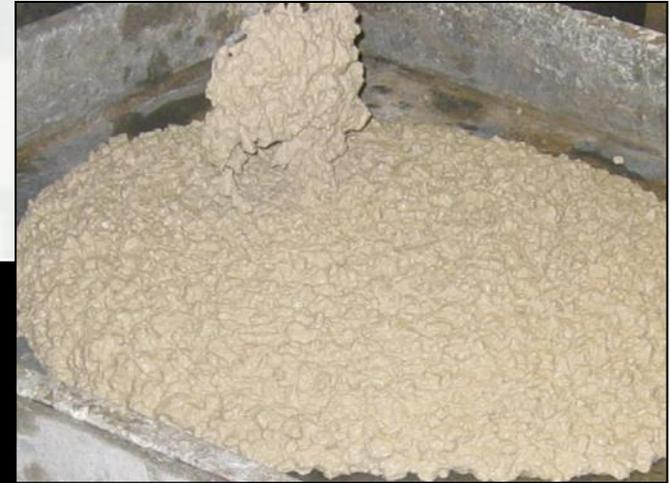
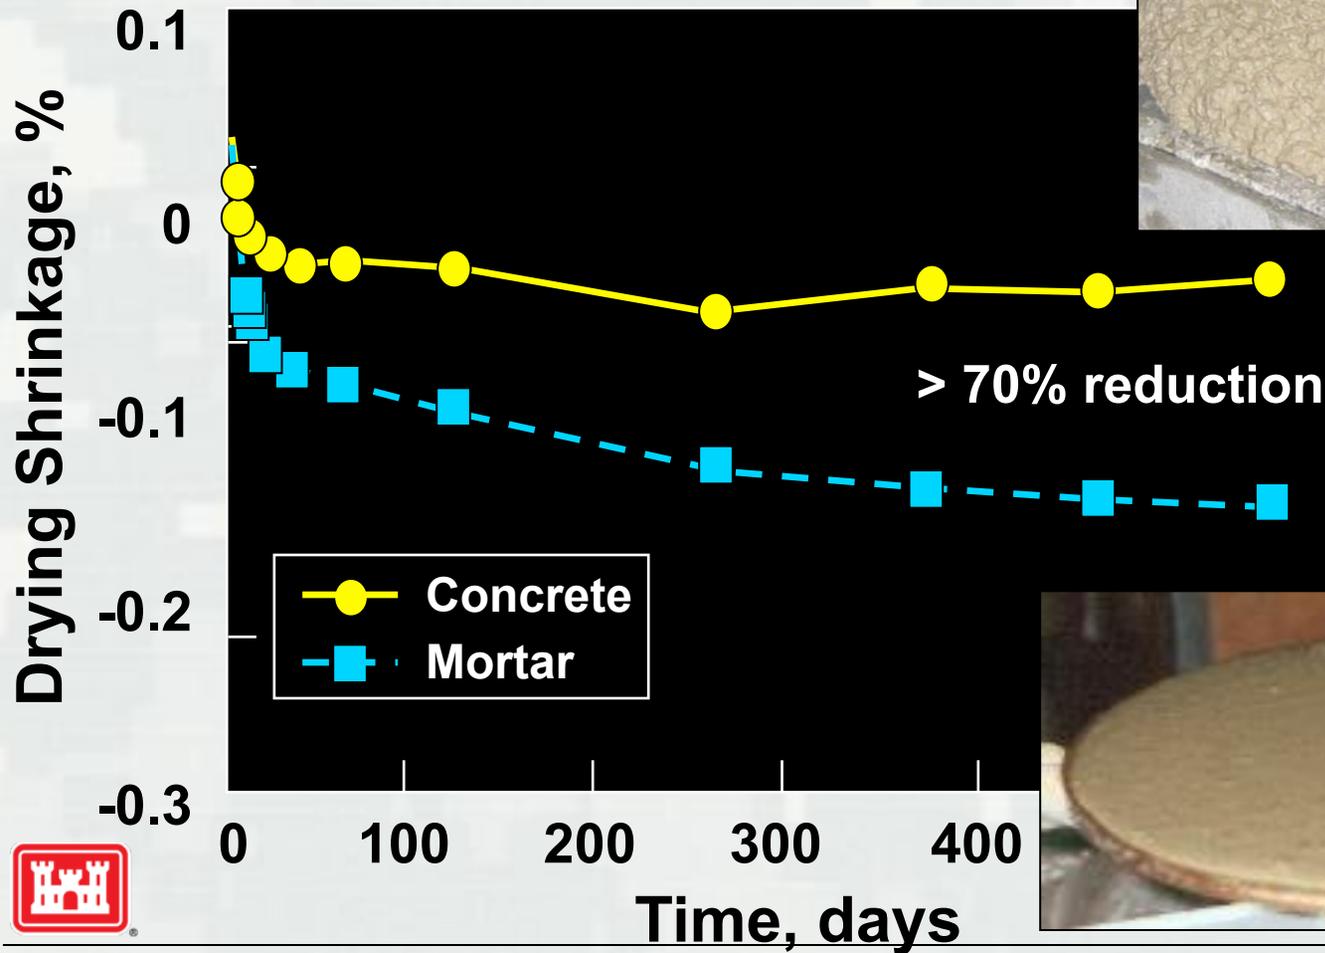
Drying Shrinkage

Effect of 3/4-in. Aggregate

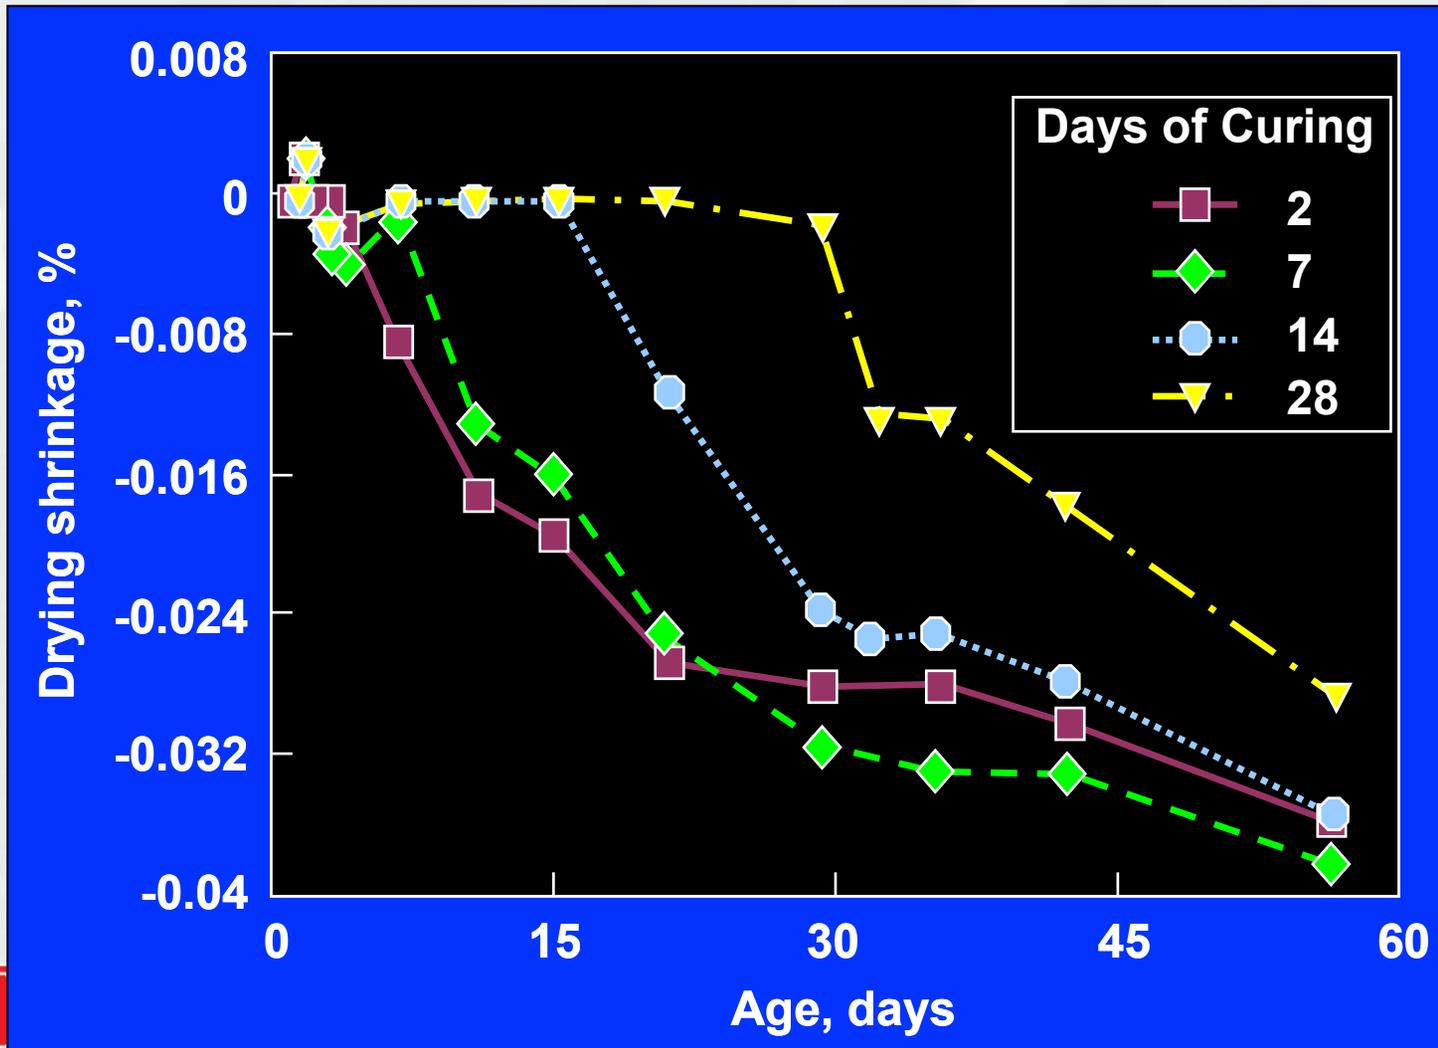
Effect of Curing on Shrinkage Early Age
