Methods and Materials to Improve the Durability of Concrete Repairs

USACE Lock Maintenance Workshop
12 February 2015

Robert D. Moser, Ph.D.

Concrete and Materials Branch
Engineering Systems and Materials Division
Geotechnical and Structures Laboratory
U.S. Army Engineer Research and Development Center

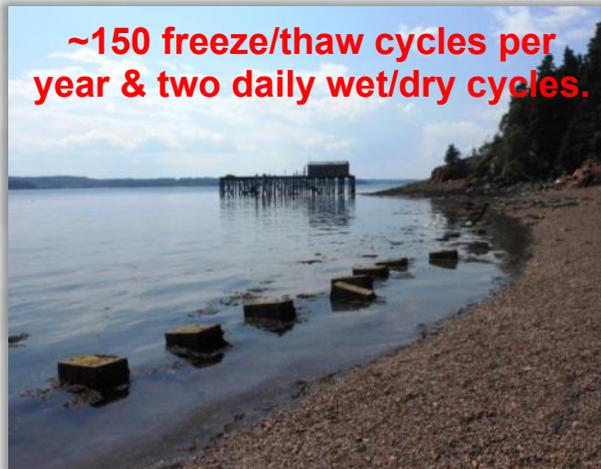
Treat Island REMR “Thin Repair” Slabs

- Ten repair slabs placed in 1995 as part of REMR “Thin Repair” project.
- Polymer modified, shrinkage reducing admixtures, rapid repair materials, alternative cements, etc...
- Not studied since completion of REMR.
- Samples retrieved for residual strength testing, petrographic, and chloride analysis.

~150 freeze/thaw cycles per year & two daily wet/dry cycles.

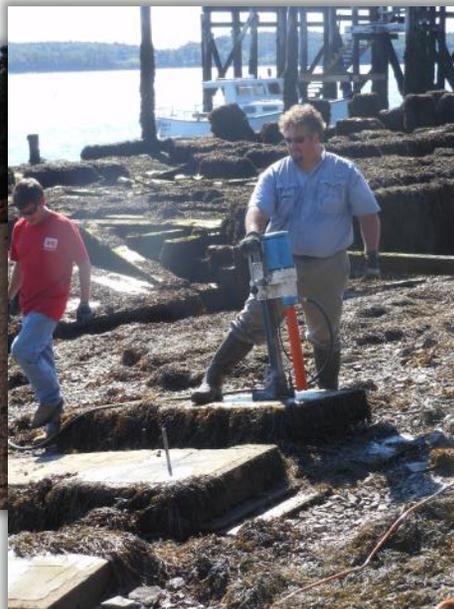
Treat Island Facility

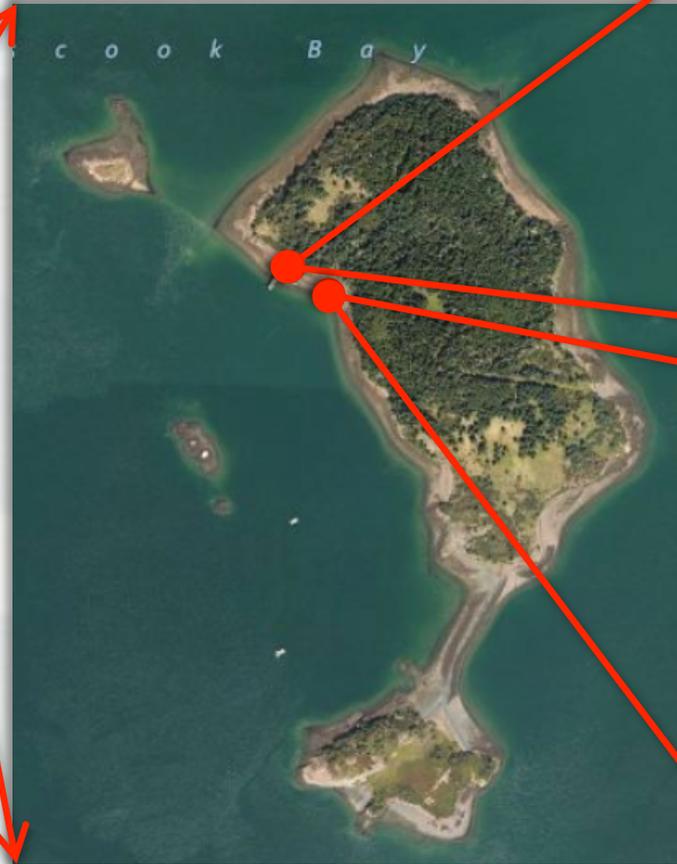
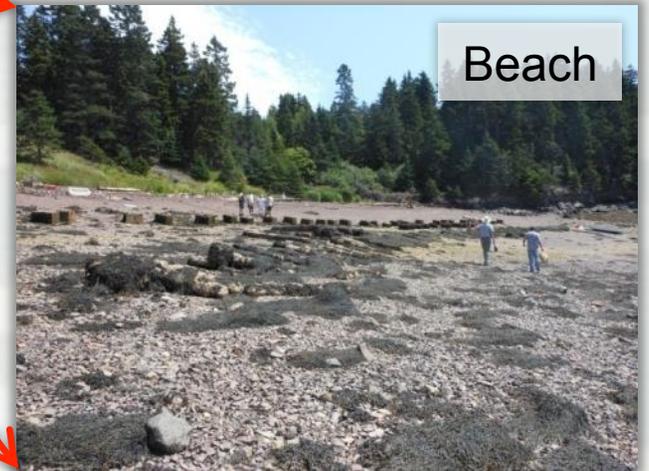
100-160 freeze
thaw cycles per
year of exposure

Approx. 6.7m
(22ft) tidal
elevation change

Treat Island located in the Bay of Fundy
near Eastport, ME, USA.

- Site started in 1936 in conjunction with USACE plans to develop hydropower in the Bay of Fundy.
- Multiple historically-significant concrete-related field durability research programs:
 - Effect of w/c.
 - Air entraining admixtures.
 - Corrosion inhibitors.
 - Effect of size/thermal mass.
 - Fiber-reinforced concrete.
 - Polymer-modified concrete.
 - Roller-compacted concrete.
 - Reactive powder concrete.
 - Supplementary cementitious materials.
 - Prestressed concrete.
 - High-performance concrete.
 - Very-high-strength concrete (predecessor to UHPC).
 - Effect of aggregate size and properties.
 - Many others...

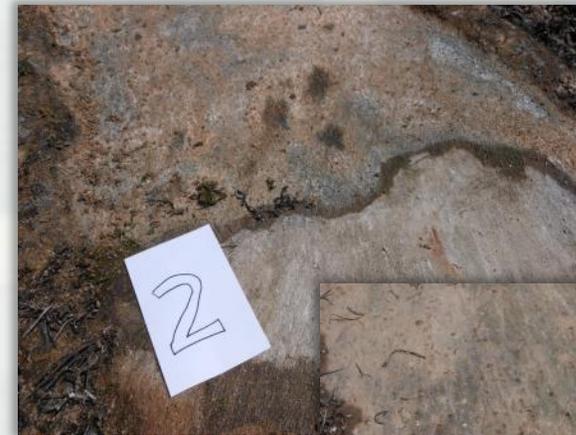
Scaling of polymer modified material

- Higher strength repair materials with lower permeability (e.g., with silica fume addition) were in good condition
- Rapid repair materials were more susceptible to cracking and delamination following placement.
- Fiber reinforcement significantly improved crack resistance.
- Polymer modified systems exhibited increased surface scaling.

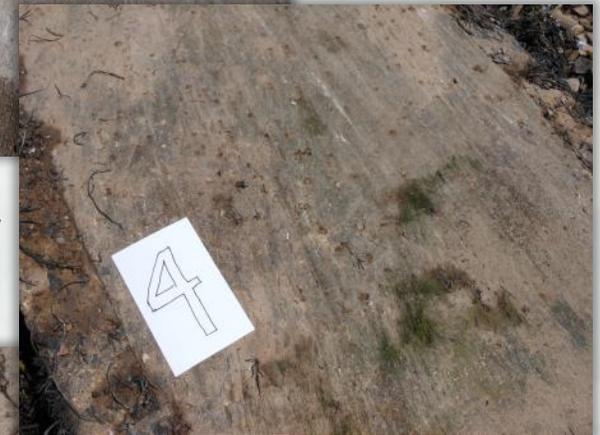
Good quality repair material

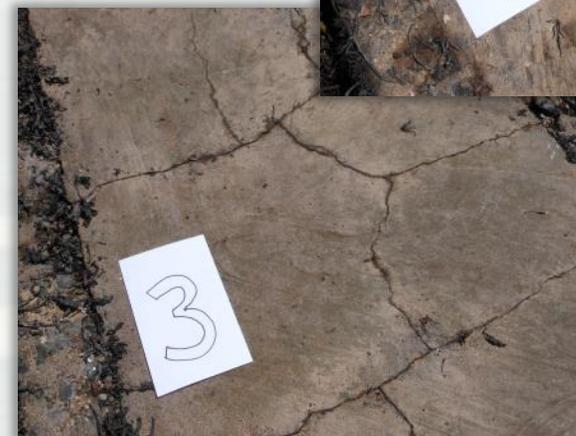
Cracking of rapid repair material

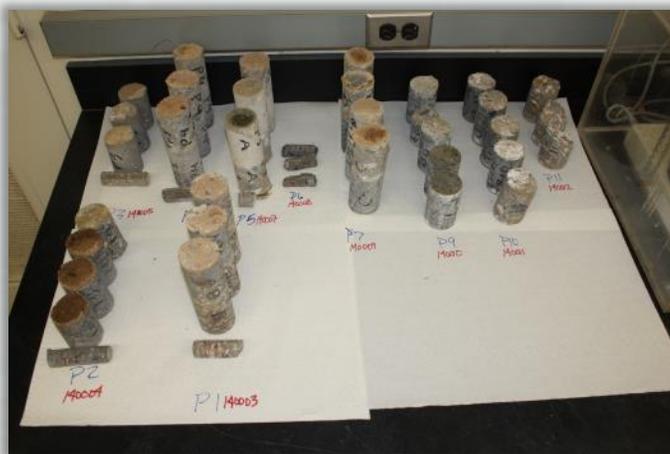
Samples used for strength testing and characterization

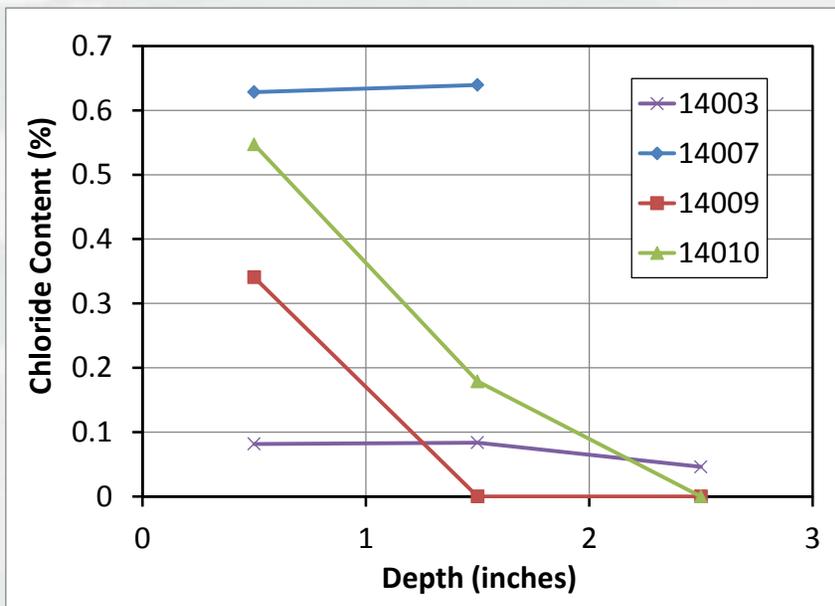
Chloride Penetration:

- Polymer modified and higher strength materials exhibited reduced chloride penetration at cover depths.

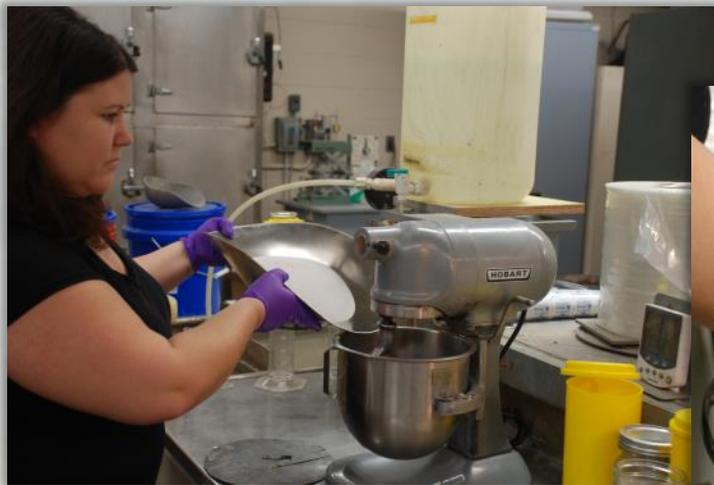
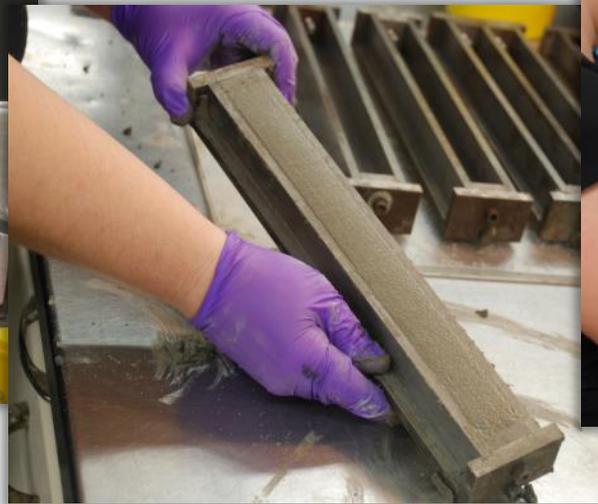
Shrinkage Reduction Studies

- Initial testing performed on mortar bars to “dial in” shrinkage reducing admixture dosage rate:
 - ▶ Three dosage rates of each shrinkage reducing admixture used
 - ▶ Standard and modified test used (28d wet curing vs. 24hr wet curing)
 - ▶ Control samples were also tested to serve as a baseline
 - ▶ Total of 180 mortar samples produced and tested

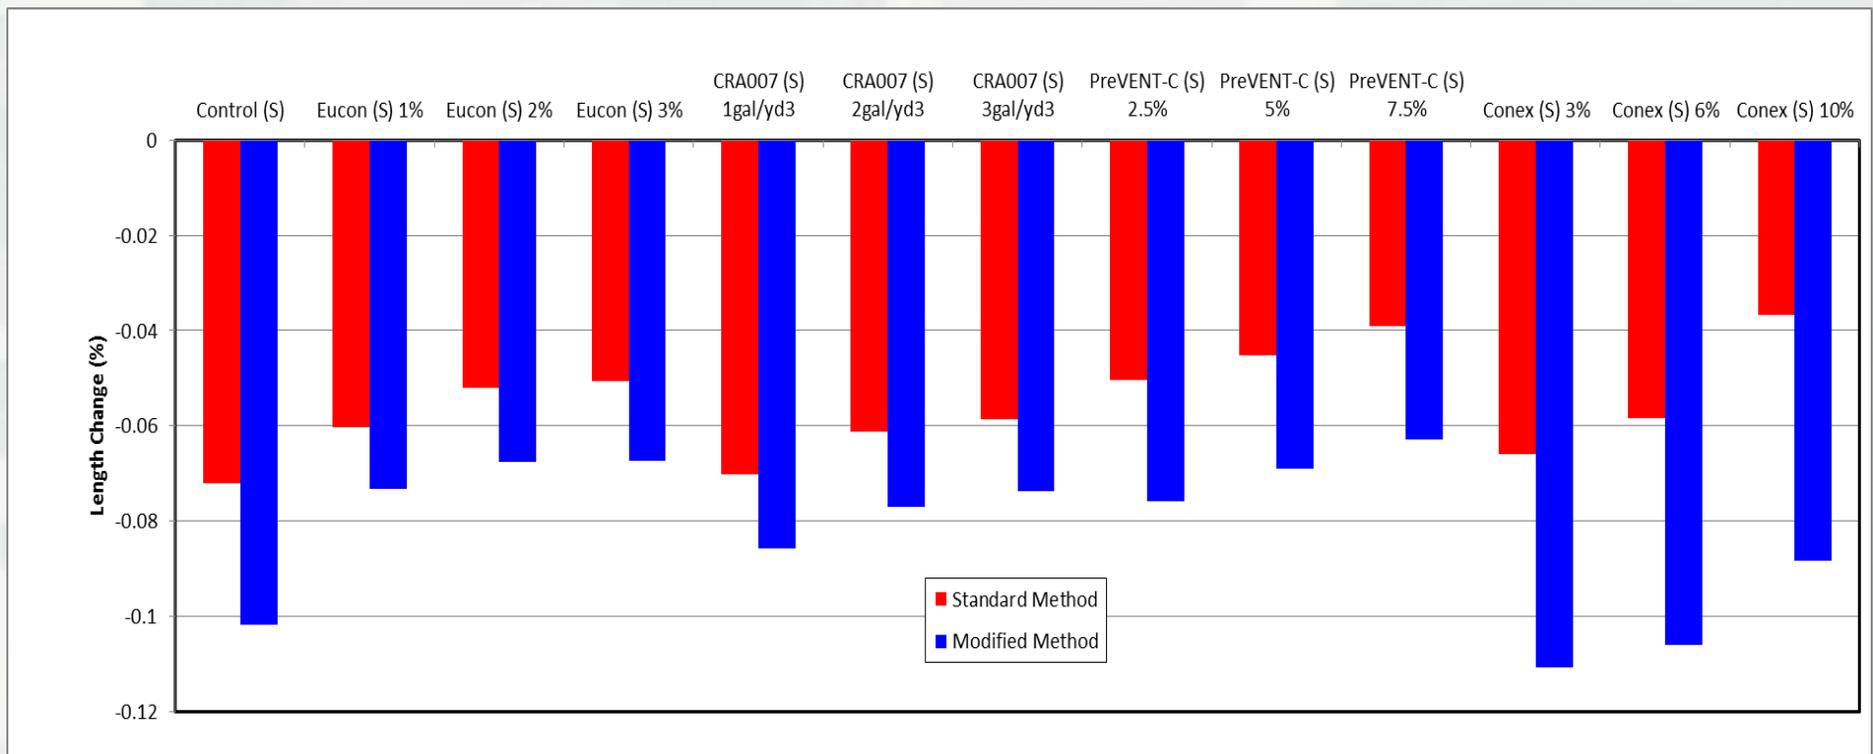
Shrinkage Reduction Studies

- Shrinkage reduction reported by manufacturers of shrinkage reducing and compensating admixtures not achieved.
- Modified testing (i.e., curing) does influence results.

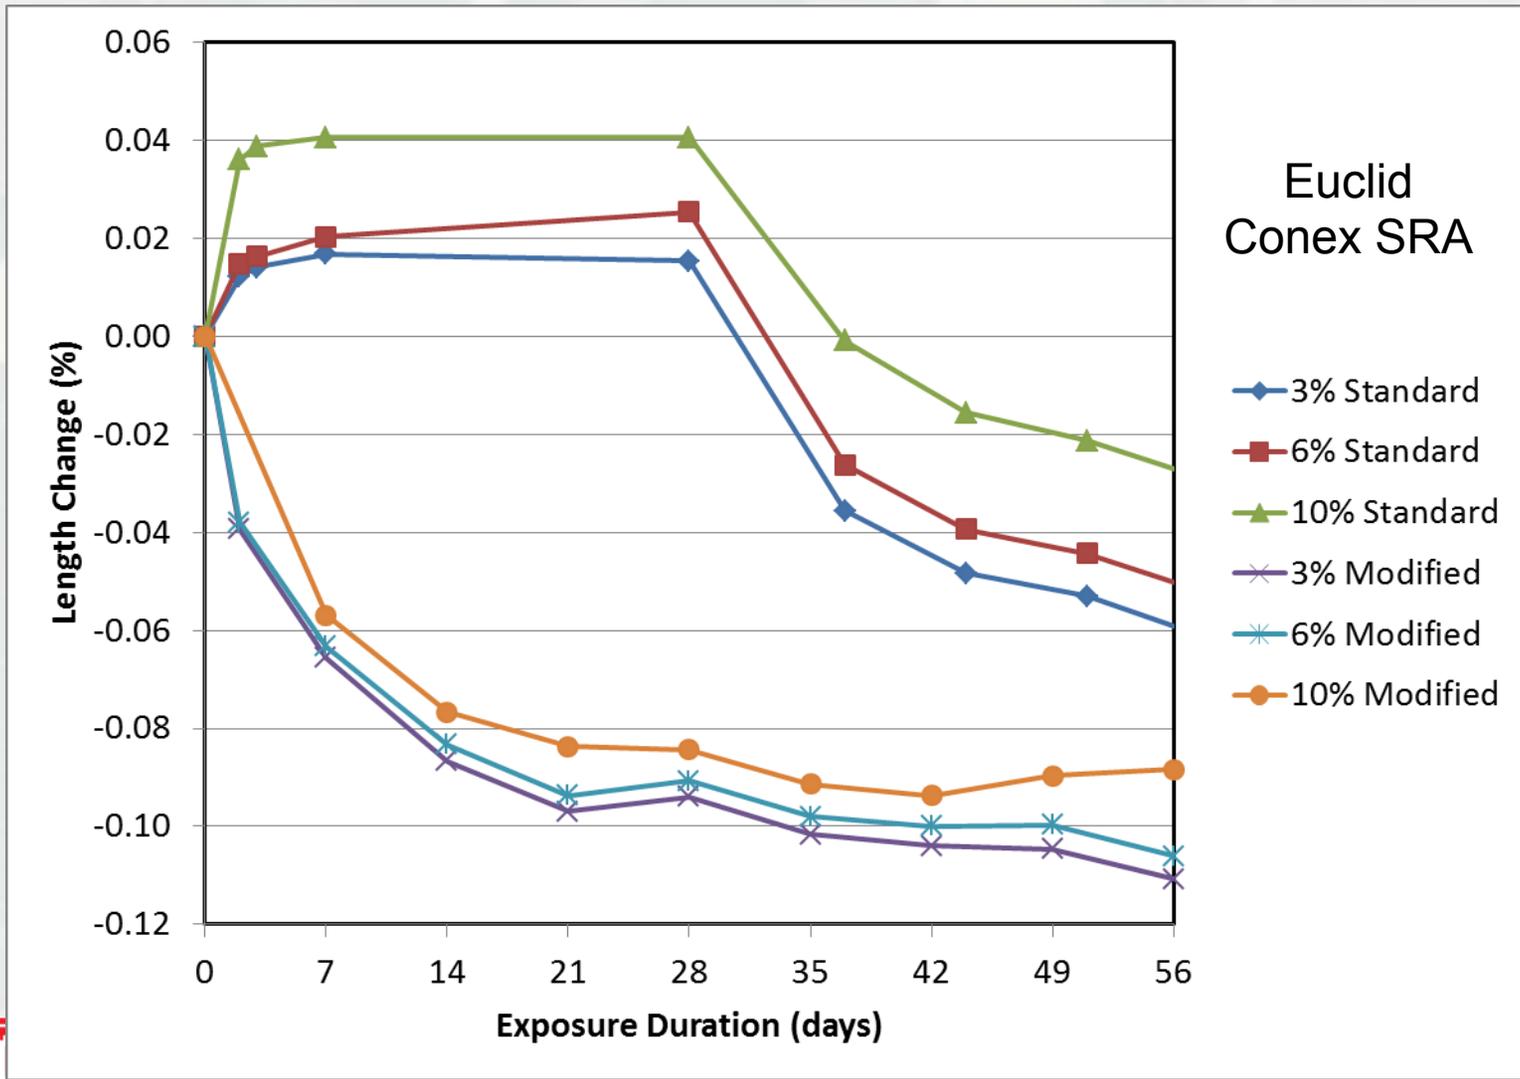
Sub-par Performance of SRAs

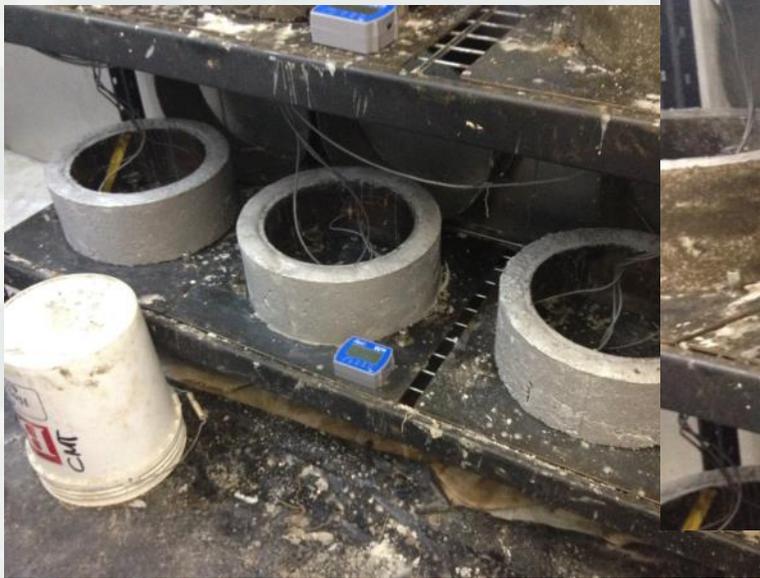
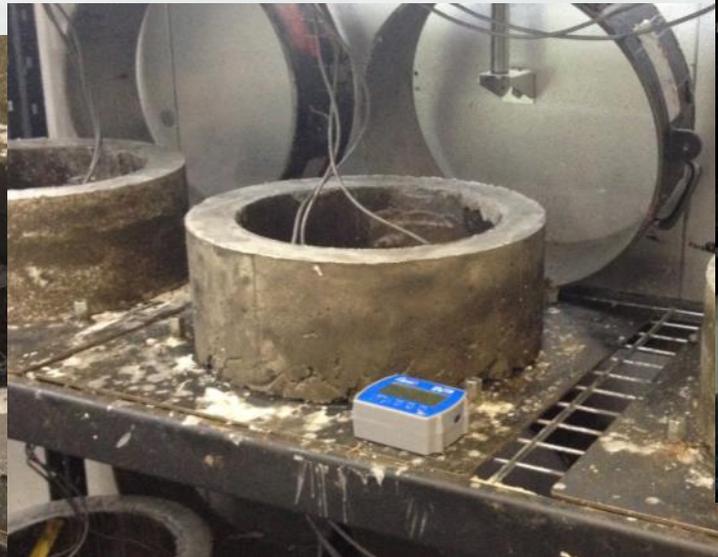
Scaling Up to Concrete

- Extensive trial batching to study admixture interactions
- Typical concrete tests for mechanical properties
- Length change (C157) and restrained shrinkage (C1581)
- Additional durability testing for freeze/thaw, chloride permeability, bond, elastic modulus, CTE, etc.

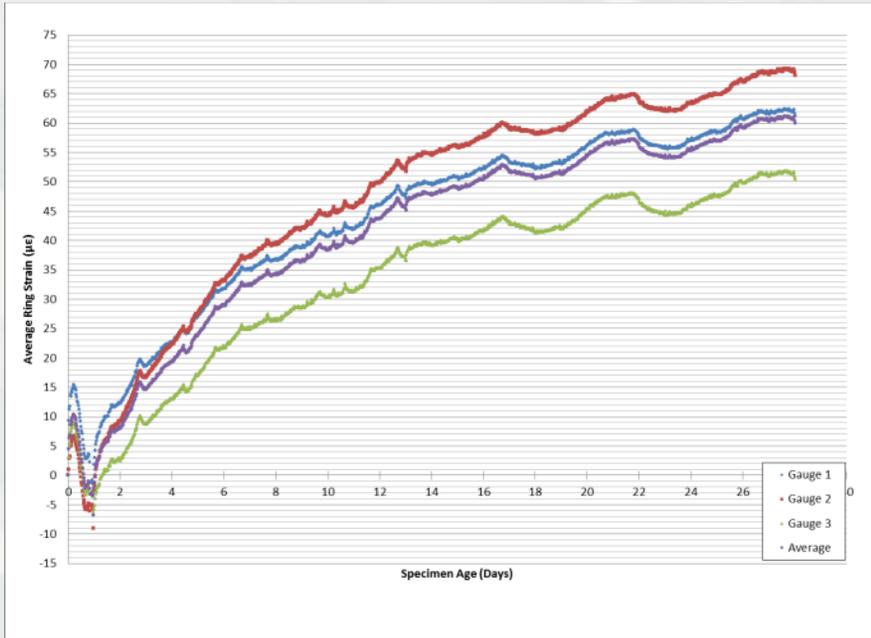
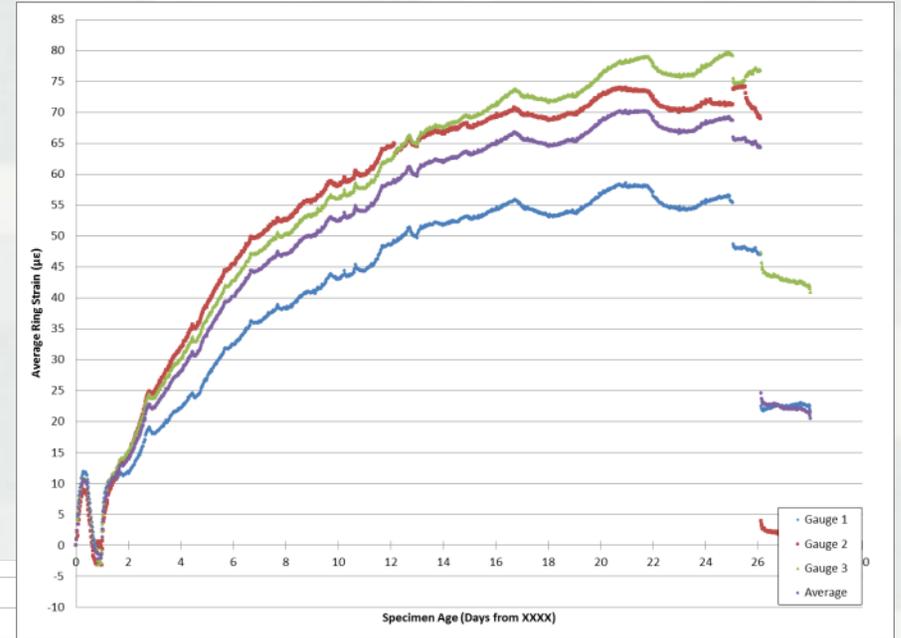
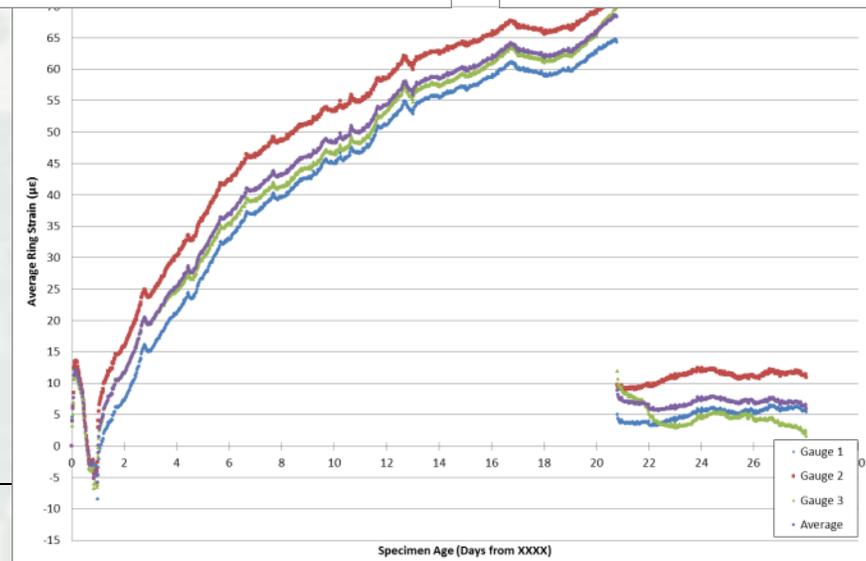
Example Shrinkage Ring Results

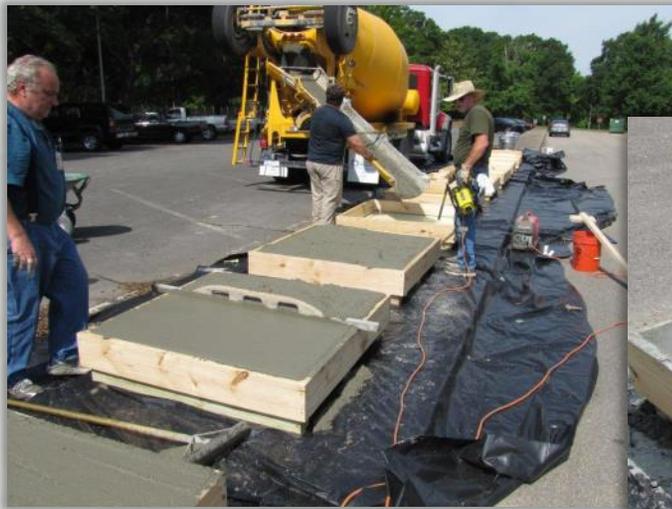
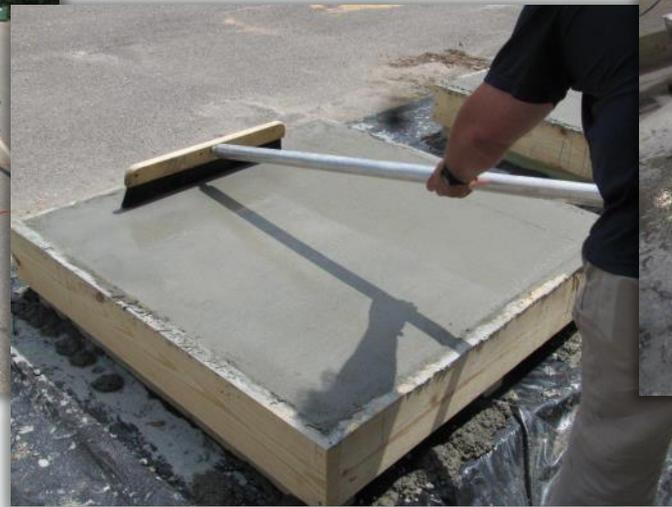
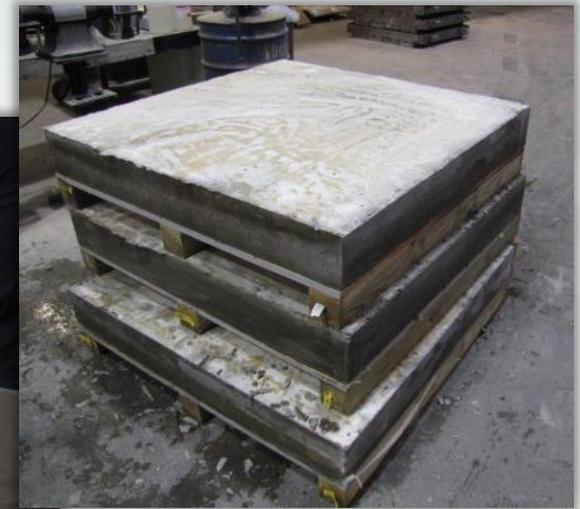
Test Slabs for Laboratory-Scale Repairs

- Fabricated twelve concrete slabs to be used for simulated horizontal concrete repairs.
- Mildly reinforced (#4 bars at 12" centers each way) with 5,000 psi concrete (similar to most CW structures).
- Repairs will be performed with various bonding conditions and materials with measurements of shrinkage and cracking.

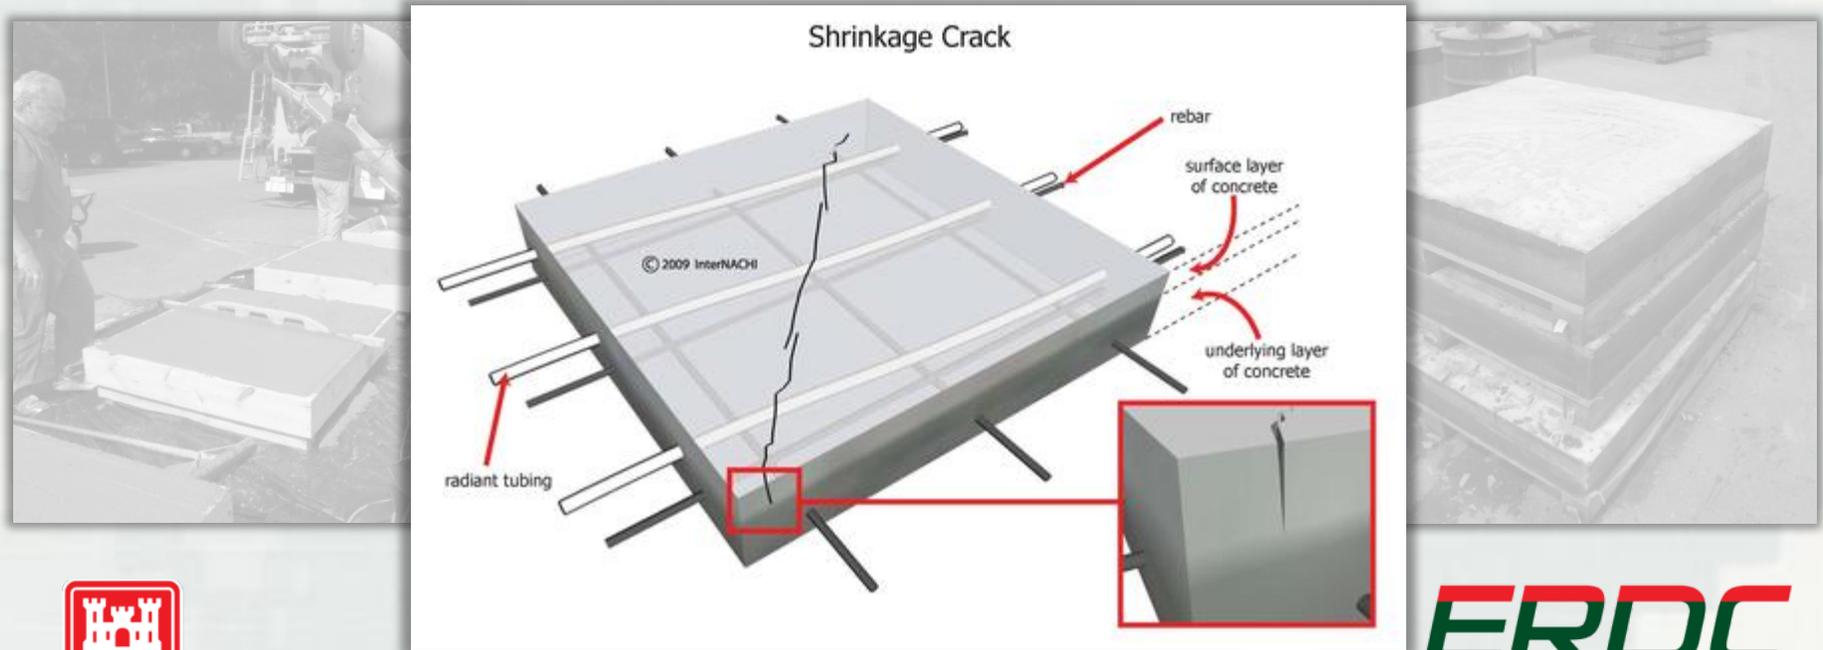
Test Slabs for Laboratory-Scale Repairs

- Fabricated twelve concrete slabs to be used for simulated horizontal concrete repairs.
- Mildly reinforced (#4 bars at 12" centers each way) with 5,000 psi concrete (similar to most CW structures).
- Repairs will be performed with various bonding conditions and materials with measurements of shrinkage and cracking.
