# Technologies to Extend the Life of Existing Infrastructure

Volume 1 • Navigation Infrastructure • March 2016

*Life Cycle Maintenance Management  
Innovative Technologies • Emerging Capabilities*

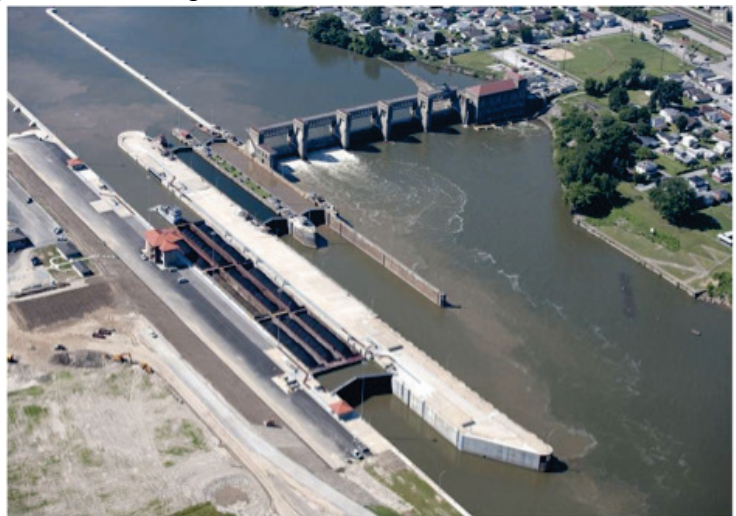
*Figure 1: A new 110' x 800' lock chamber, completed in 2009 at Marmet Locks and Dam, adds vessel handling capacity to the two original 56' x 360' chambers, constructed circa 1933, to help alleviate traffic delays on the Kanawha River.*

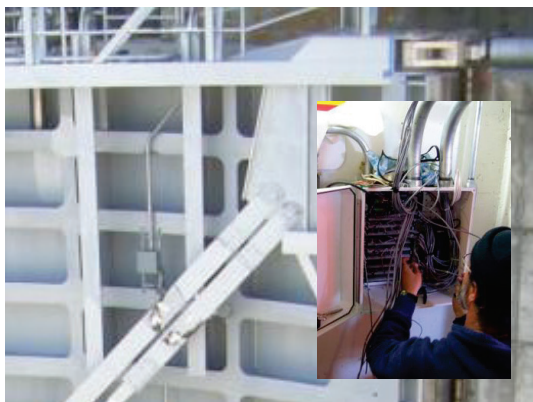
Figure 2: Multiple sensors are installed and wired from the downstream miter gates to a data logger at The Dalles.

Real-time gate monitoring. Monitoring the behavior of structural and electrical-mechanical sub-components, called structural health monitoring, can aid in the prediction and detection of degraded conditions that indicate imminent failure. A real-time navigation lock gate monitoring and warning system detects and reports events like gates dragging debris, barges impacting the gates and degraded quoin-to-wall contact, which are several leading causes of gate failure. The system reports status and warnings to the lock operator through the Lock Operations Management Application (LOMA) interface so actions may be taken when necessary to avoid catastrophic gate failure. The system also automatically emails warnings under specific changes in gate condition. Additionally, USACE personnel may access and analyze

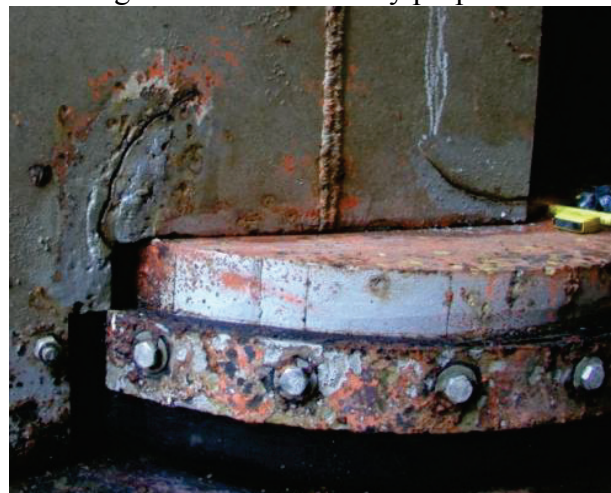
*Figure 3: Cracks in a miter gate near the pintle resulting from improper contact between the gate's contact blocks and the quoin blocks.*

Fracture repair. Maintenance and repair of fatigue and fracture failures on hydraulic steel structures, such as cracks near the pintle socket area of the miter gates, represents a major Operations and Maintenance expenditure for the USACE. Current repair methods have often proven to be ineffective. Carbon Fiber Reinforced Polymer (CFRP) strips, properly adhered and installed at optimal locations, extend the fatigue life of steel members. Engineer guidance provides design guidelines and installation methods for bonding steel and CFRP. ([See: Innovative Repair of Fatigue and Fracture Problems Fact Sheet](#))

Pintle design. Gaps develop between the contact blocks and quoin blocks due to wear, corrosion, installation misalignments or minor movement of the miter gate. Redesigned flexible pintle connections allow proper contact between contact blocks and quoin blocks for proper load transfer without damaging the miter gate or connections. The new design may be used for new gates and for retrofitting existing gates. ([See: Pintle Redesign Fact Sheet](#))

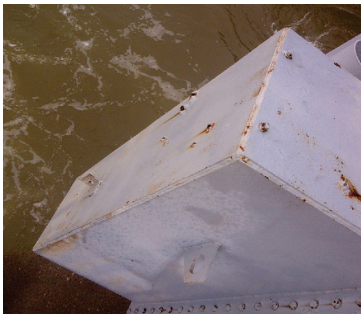
*Figure 5: This trunnion anchor rod cover box indicates multiple rods have failed in the anchorage.*

Nondestructive testing. A major sub-component of spillway Tainter gates is the post-tensioned trunnion rod anchorage system. Many project sites utilize these rods in a design where most of the rod is completely embedded in the structure and only a small portion of the rod is exposed. These rods were normally installed in tubes with either grease or grout for corrosion protection. A number of these rods have broken at a variety of sites around USACE, leaving uncertainty regarding the condition and lifespan of remaining rods.

Historically, lift-off tests have been used to determine if the tension in trunnion anchor rods is at or near the design tension. These tests are expensive (up to \$2,000/rod) and instances have occurred where rods broke during these tests. A non-destructive test (NDT) method alternative to determine the rod tension uses a dispersive acoustic wave technique. The cost is approximately \$250/rod to determine if it has failed and if not, the rod tension. ([See: NDT Rod Tension Testing Fact Sheet](#)) However, simply knowing the tension in the rods does not provide indication of possible future failure. Non-linear acoustic testing may be used on rods to detect corrosion and micro-cracks, a flaw that leads to failure in some rods. ([See: Trunnion Rod Microcrack Detection Test System Fact Sheet](#))

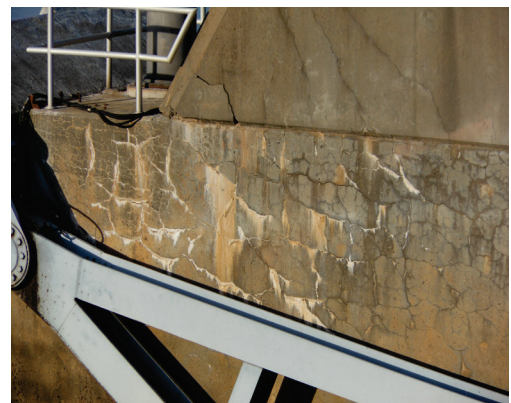
*Figure 6: Severe alkali-aggregate reaction damage at David Terry Lock and Dam, constructed in 1968.*

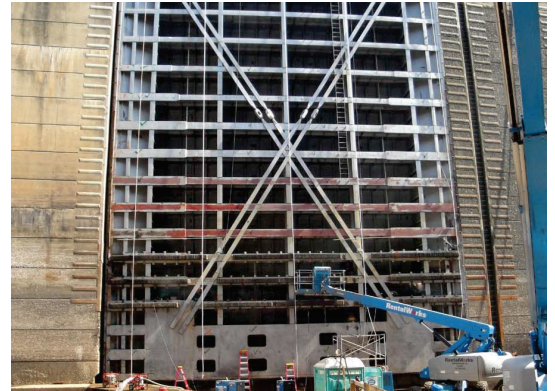
Typical horizontal framed miter gate at Holt Lock

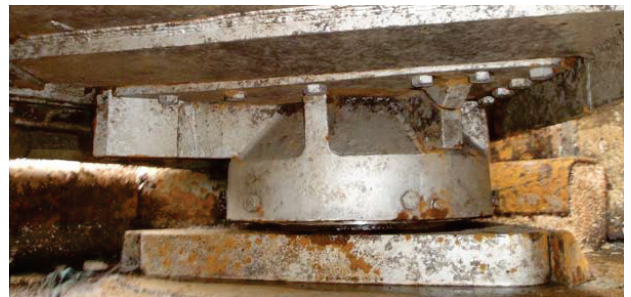
Typical miter gate pintle

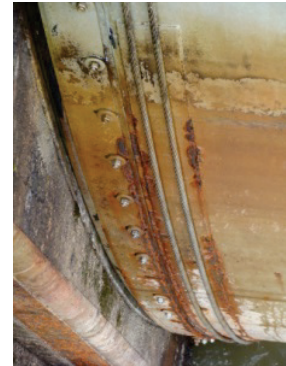
Example of normal breakdown of a coating system on a tainter gate as it ages

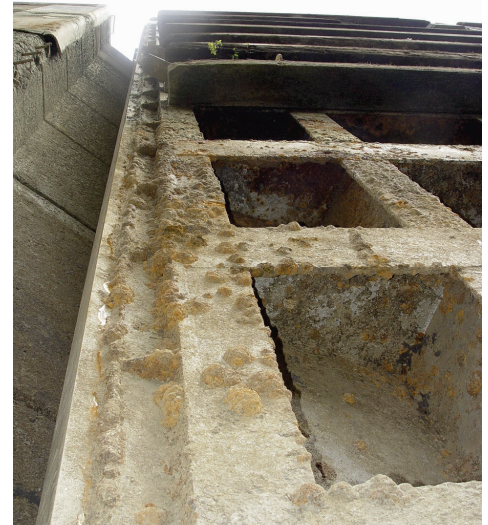
Corrosion on miter gate at Selden Lock, AL

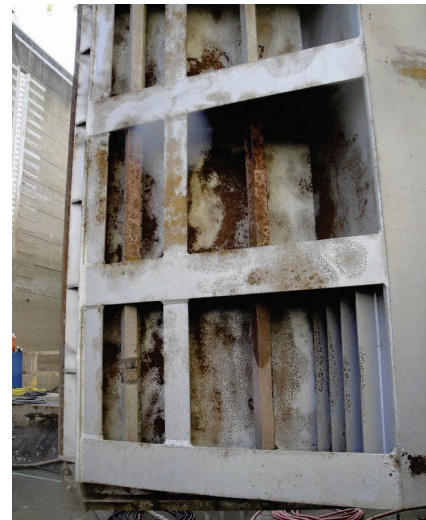
Corrosion on miter gate at Claiborne Lock, AL

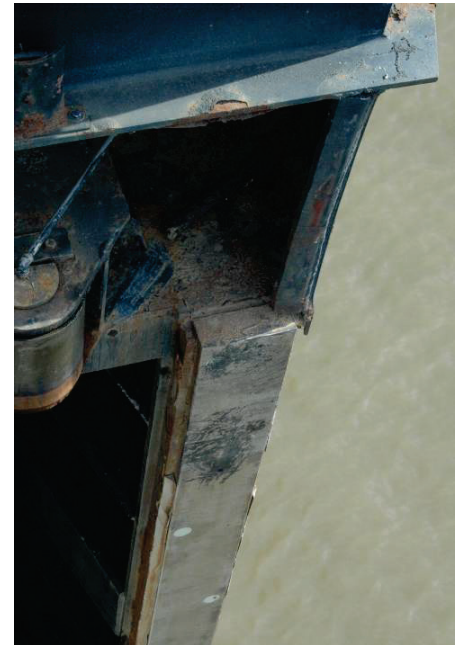
Miter block with epoxy backing material

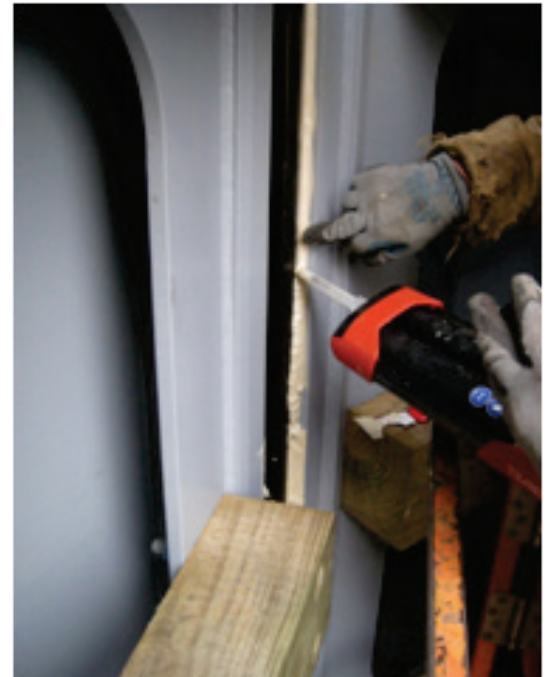
Sealing lock gate quoin block

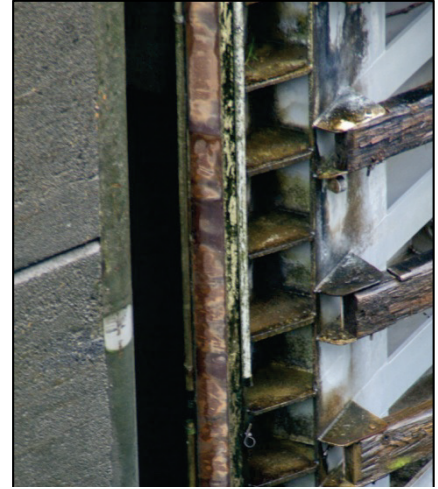
Corroded steel miter blocks

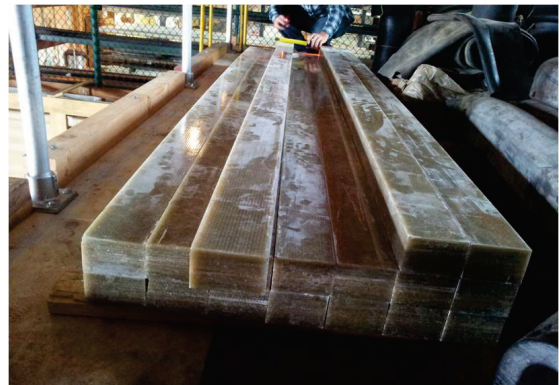
FRP composite miter blocks awaiting installation

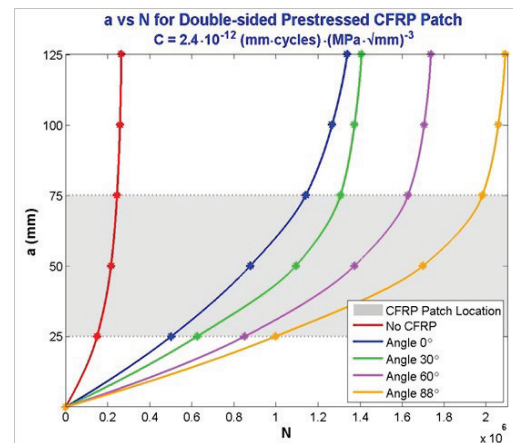
Half crack length (a) vs. number of cycles (N) for double-sided prestressed CFRP patch,  $C = 2.4 \cdot 10^{-12} (\text{mm} \cdot \text{cycles}) (\text{MPa} \cdot \sqrt{\text{mm}})$

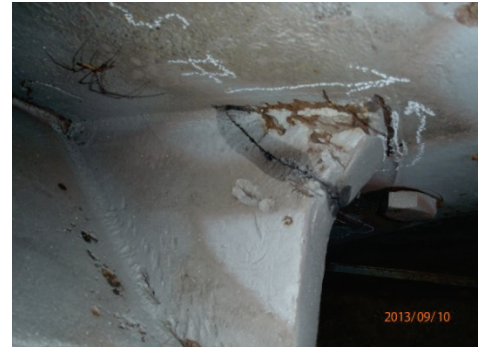
Damaged Pintle Socket, Aberdeen L&D

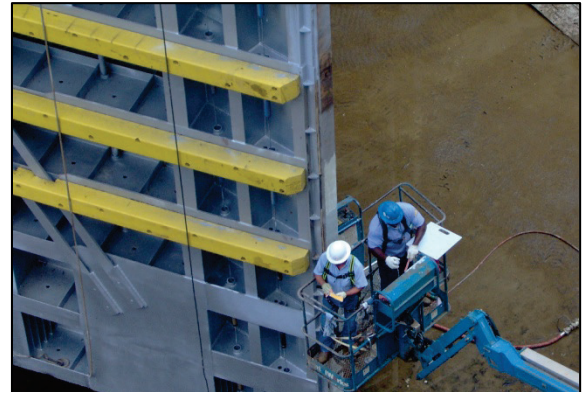
Plastic timbers being mounted on a miter gate

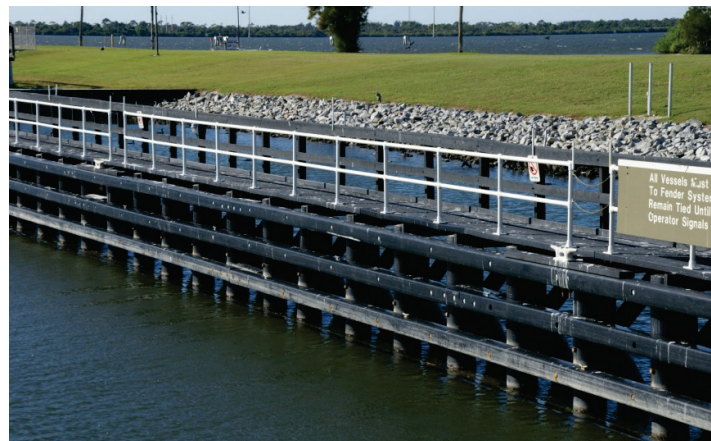
Composite timbers installed on a lock guidewall

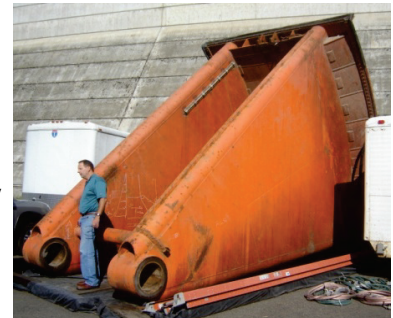
Double-skin plated valve (John Day Lock)

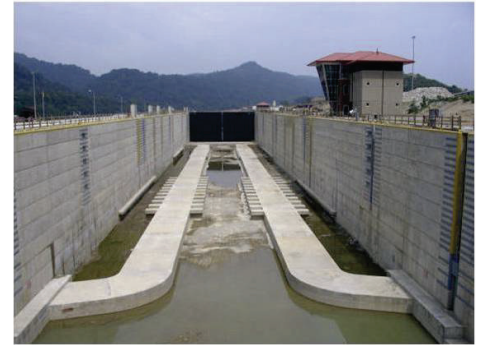
In-chamber longitudinal culvert system;  
Marmet Lock, Kanawha River

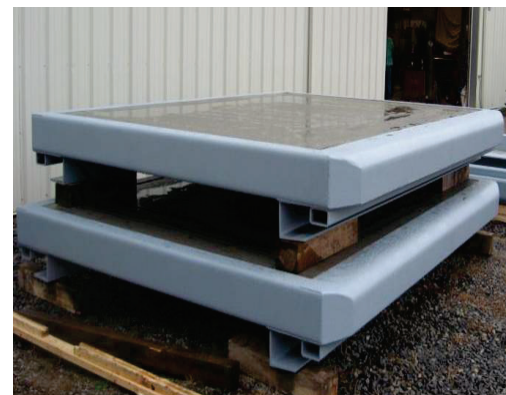
Final Design

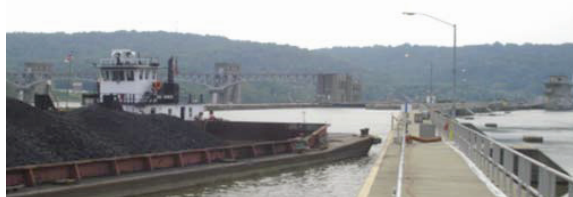
Barge train impacting a flexible approach wall

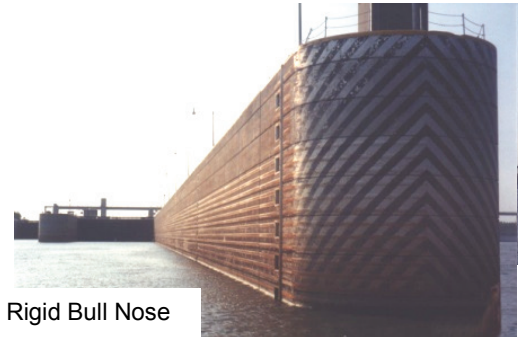
Rigid Bull Nose

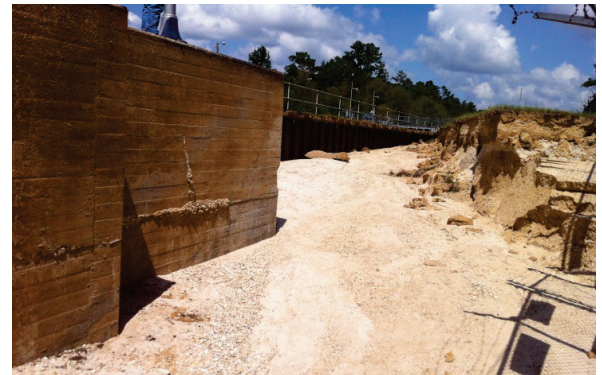
Pearl River Lock, damaged after hurricane surge caused massive erosion during overtopping

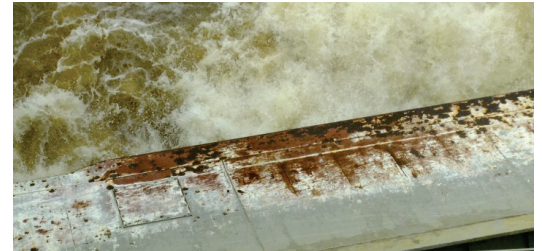
Vinyl coating in poor condition due to abrasive action of debris-filled swirling water

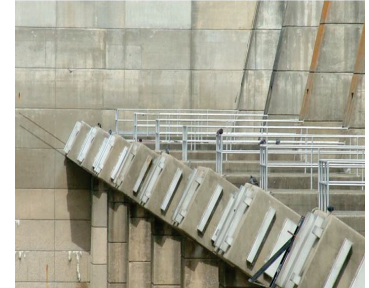
Trunnion rods ejected from pier

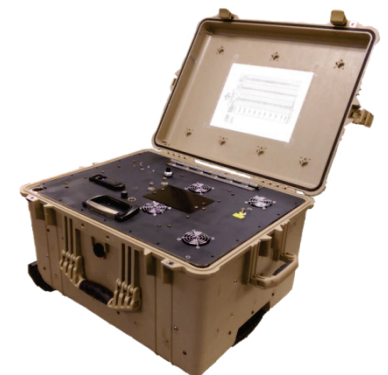
Portable Trunnion Rod Test System

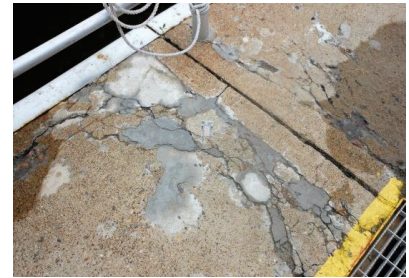
Typical deterioration of horizontal concrete surfaces

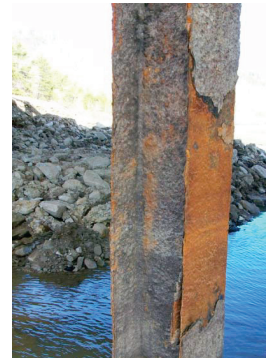
Corroded Steel H-Pile on East Fork Bridge
