FEBRUARY 29, 2012 / Presented by: Darrin Holt/Mark Cesare

Non Destructive Inspection of Existing Trunnion Rod Anchors

2012 LOCKS MAINTENANCE WORKSHOP

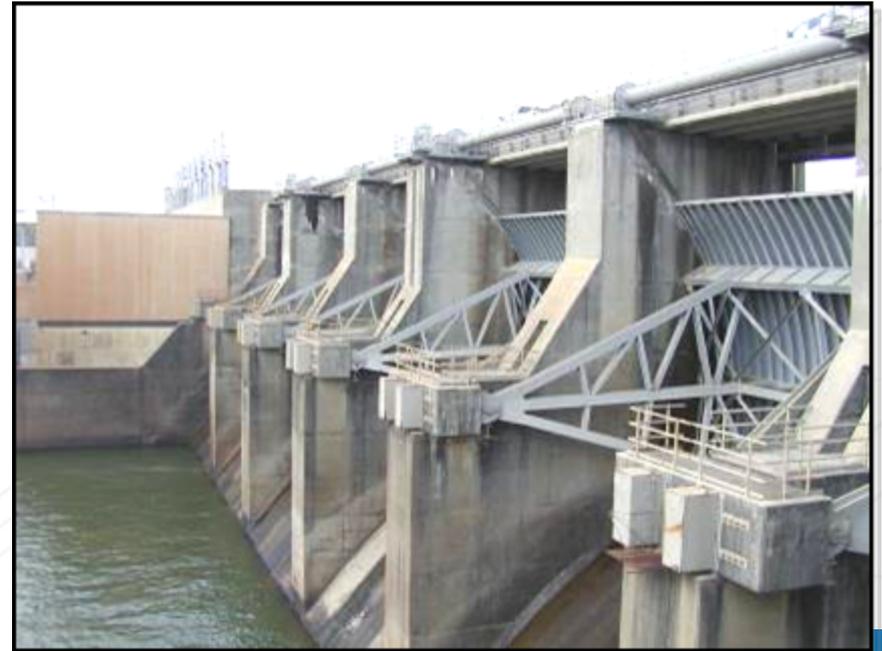
West Point Dam – Rod Failures

- In 2008
 - 5 Failures total
 - 3 on one pier
- Failed rods removed
 - Measured to find failure location
 - Sent for metallurgical testing

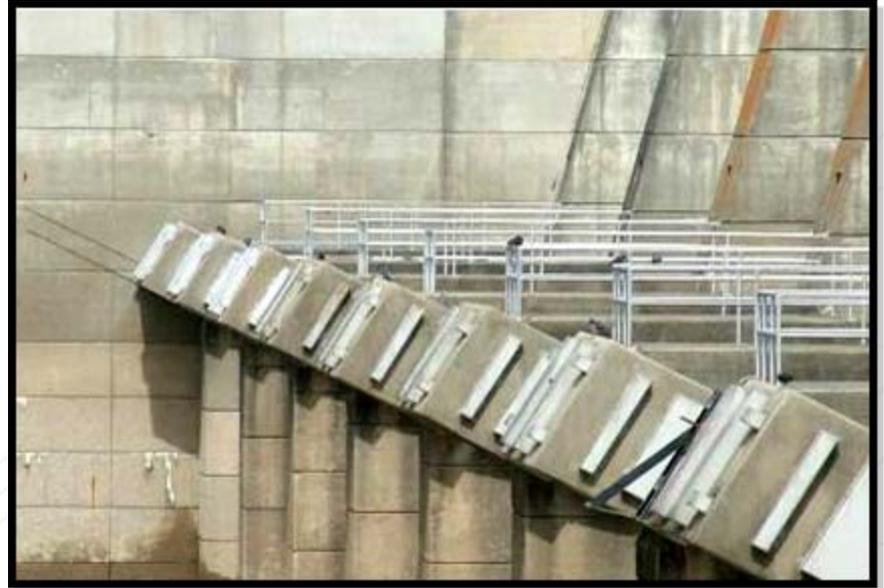
R. F. Henry Dam – Rod Failures

- 4 broken rods found
- Rod removed & sent for testing. Cracks found in material.
- 3 of the failures at threads near Dead End
- 1 rod broke between inspections (a 3 month interval)

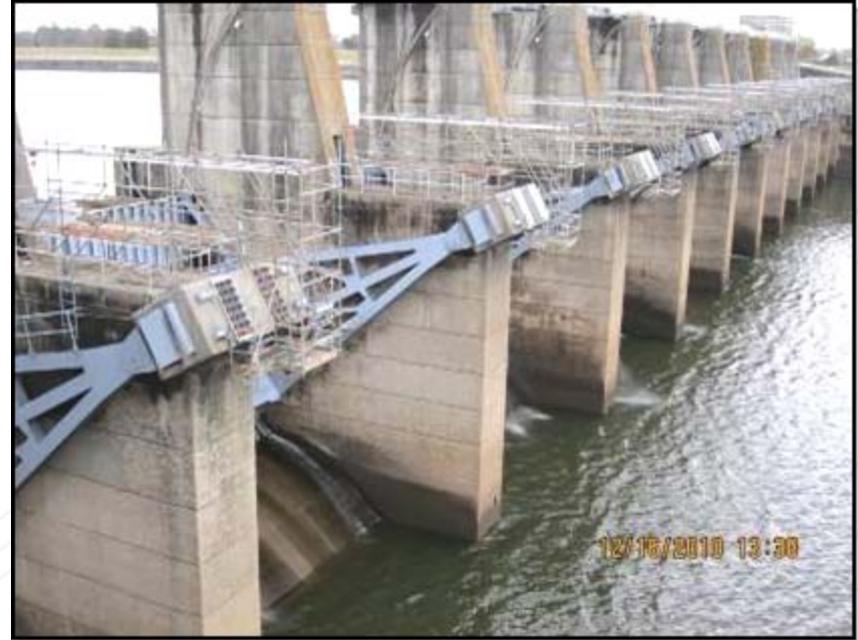
R. F. Henry Dam – Lift-off Testing

- 108 Rods Lifts Attempted
 - 73 lifted
 - 33 did not lift at maximum load
 - 2 were not loaded
- 5 Tested below 100K
 - 3 shimmed to about 106K
 - 2 reseated grip nut at 106K

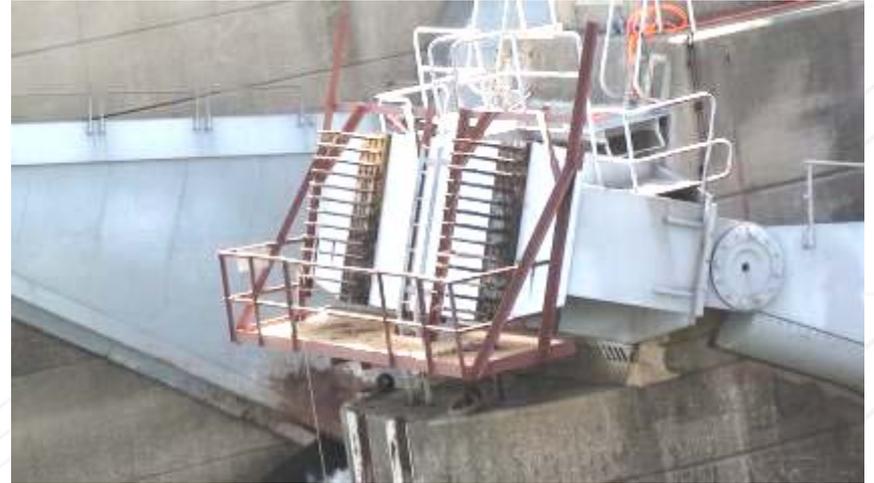
Greenup Dam – Vibration test results

- Broken rod clearly found
- Less scatter than other tests
- Lift-off tests planned but not done yet
- Estimate of tension made by assuming that points near top of this cloud of data are near original lock-off loads

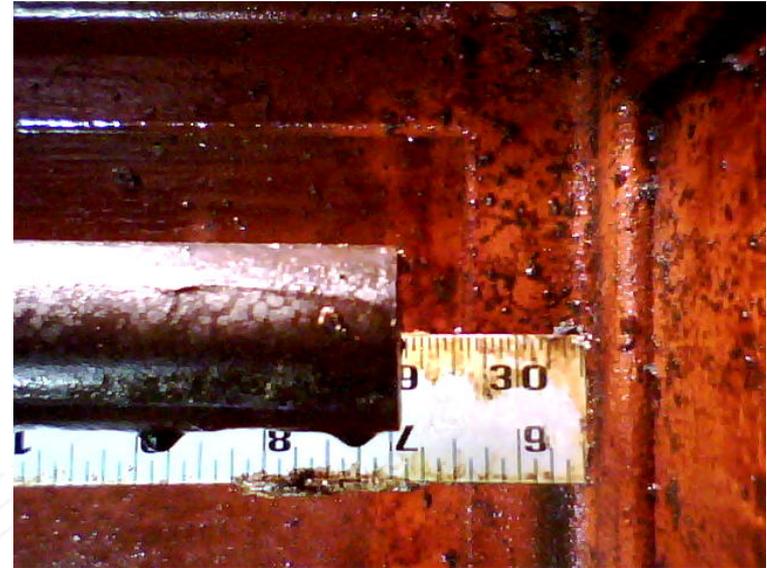
West Point Dam – Measuring Rods

- Accurate measurement of Rods needed
- USB camera and ruler mounted on poles
- Camera read from laptop computer
- Snap shot taken of measurement

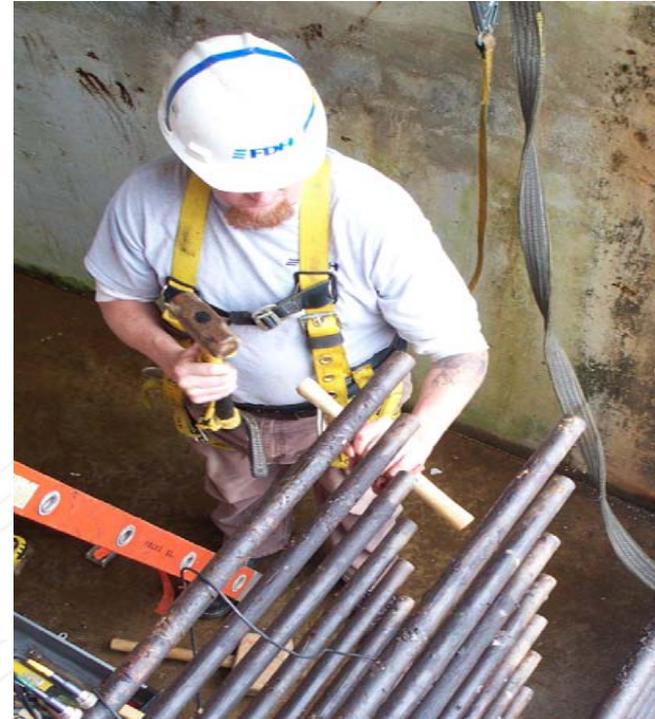
West Point Dam – Proof-of-Concept Tests

- Block E at West Point Dam
 - Easy access
 - 37 Rods tested
- Accelerometers attached to rods
- Rods hit with hammer
- Vibration recorded by Data Acquisition System and laptop
- Time histories sent to office to data processing

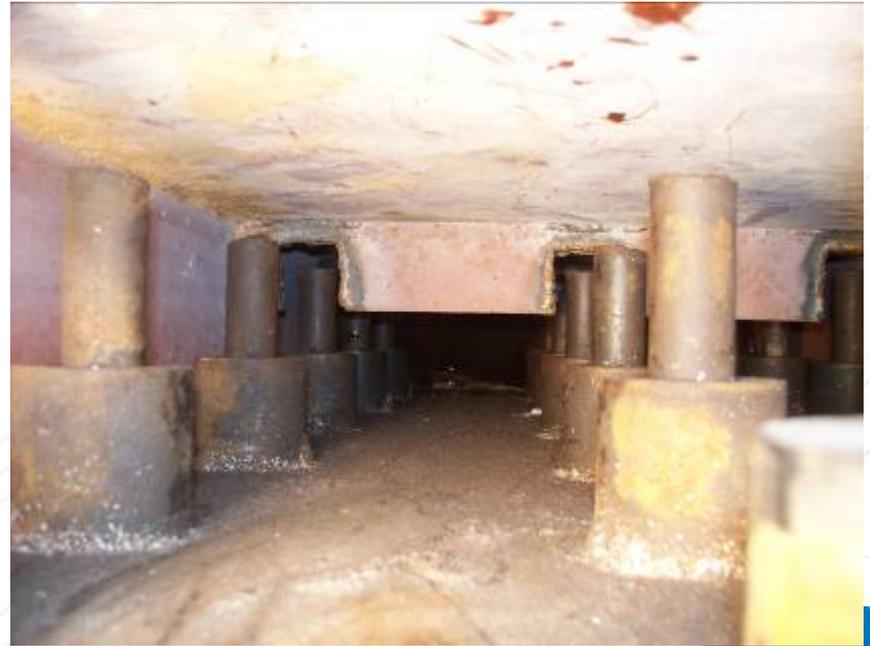
R. F. Henry Dam – Rods with Cover boxes in place

- Much shorter tails left on rods
- As a result the cover boxes very narrow
- NDT testing done thru the access holes in boxes
