Black Rock Lock Bearing Replacement

David Mastriano
Civil Engineer
NY/PA O&M
Buffalo District (LRB)

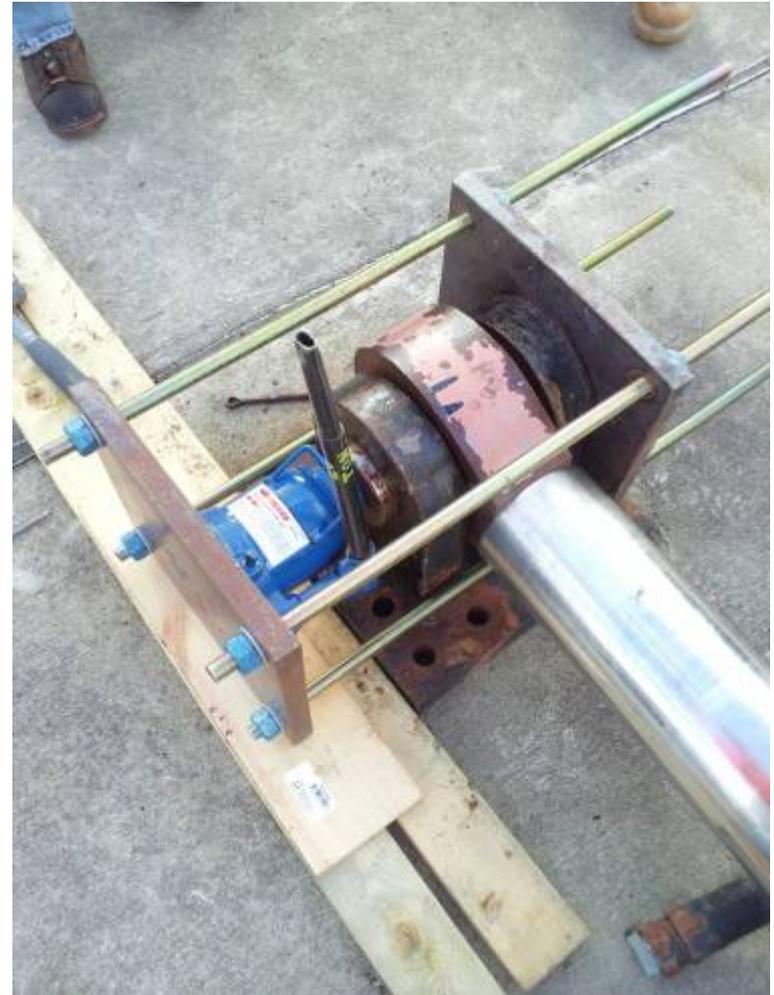
In-House Replacement Attempt

- ▶ This is the old identical assembly which was removed in the late 90's and has been exposed outdoors for several years. Attempt at pressing out with 20 tons of force was unsuccessful, which was the limit of the lock's maintenance capabilities.

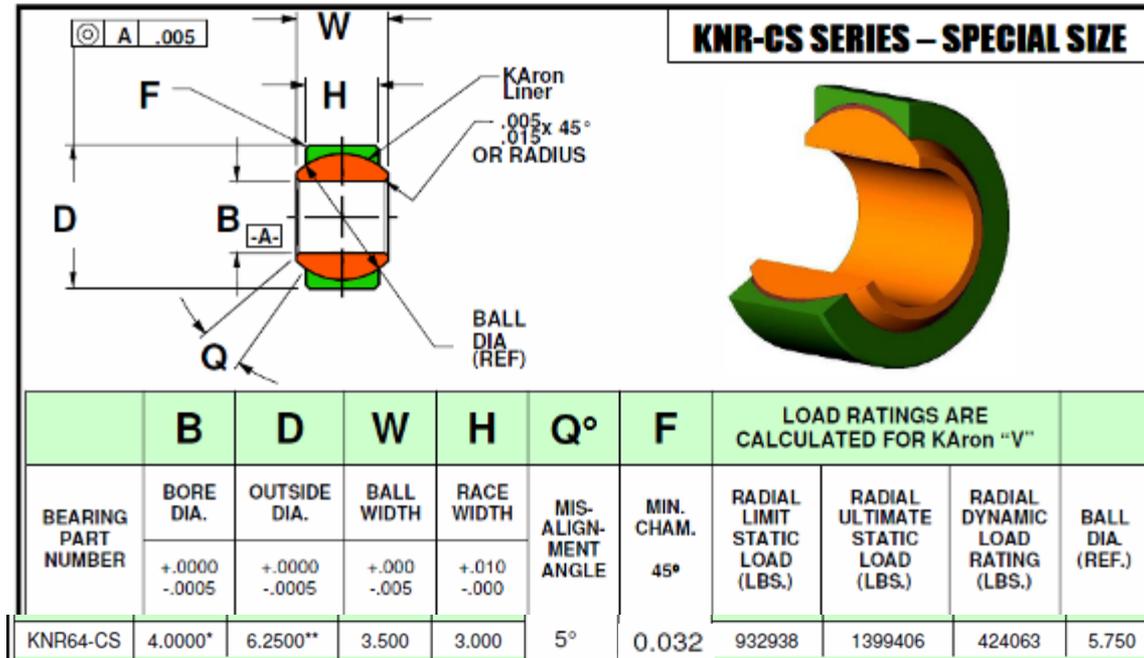
KAron Lined Spherical Bearing

- ▶ KAron liner is maintenance free, self lubricating. The liner is homogeneous in nature, consisting of resin, PTFE, and other special fillers.
 - ▶ No interconnecting fibers that can provide a moisture path to the bonding substrate, which would promote corrosion.
- ▶ Liner thickness typically ranges between 0.010 to 0.015 inches.
- ▶ The inner bore will also be coated in the event there is movement between the pin and bore.

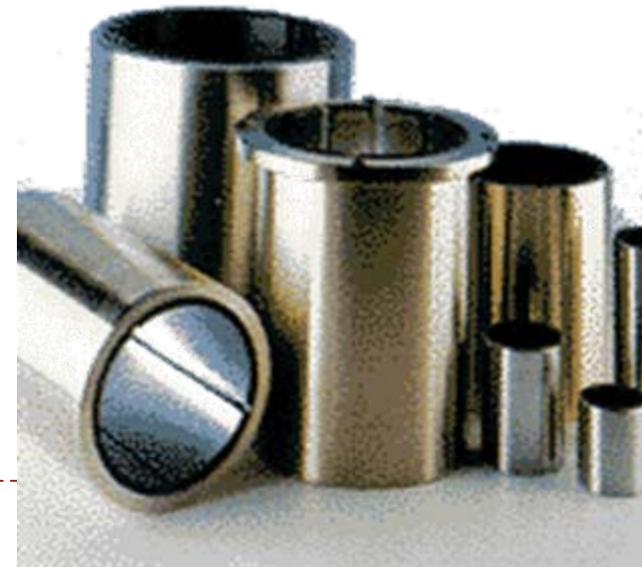
Option 1, New Traxl Bearing

- ▶ Is what is currently in place and has failed on the lower east gate but has been in service on the lower west gate since 1999.
- ▶ Requires good pin and bearing alignment
- ▶ Moderate cost of the bearing
- ▶ Approximate 6 week lead time

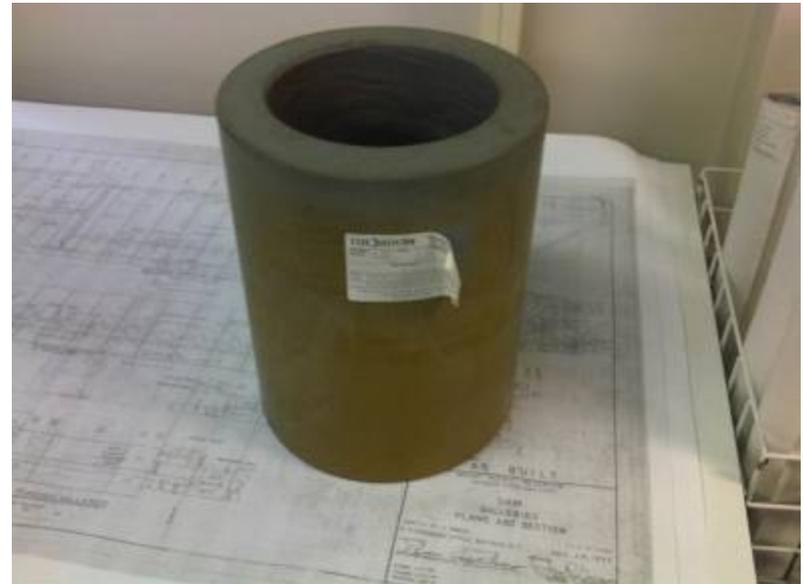
HPSXL Tube

We have a tube of the material on hand from the prior renewal of this bearing. It was a backup bearing in the event that there was difficulty in fitting the Traxl shell to the casting at the lower east gate. It is similar to the SXL tube that had been used for the lower west bearing and failed when the bearing spun in the casting.
