Panama Canal Gate Seal Problems

USACE 2016
Vicksburg, Mississippi

WILFREDO YAU
Locks Overhaul Engineer

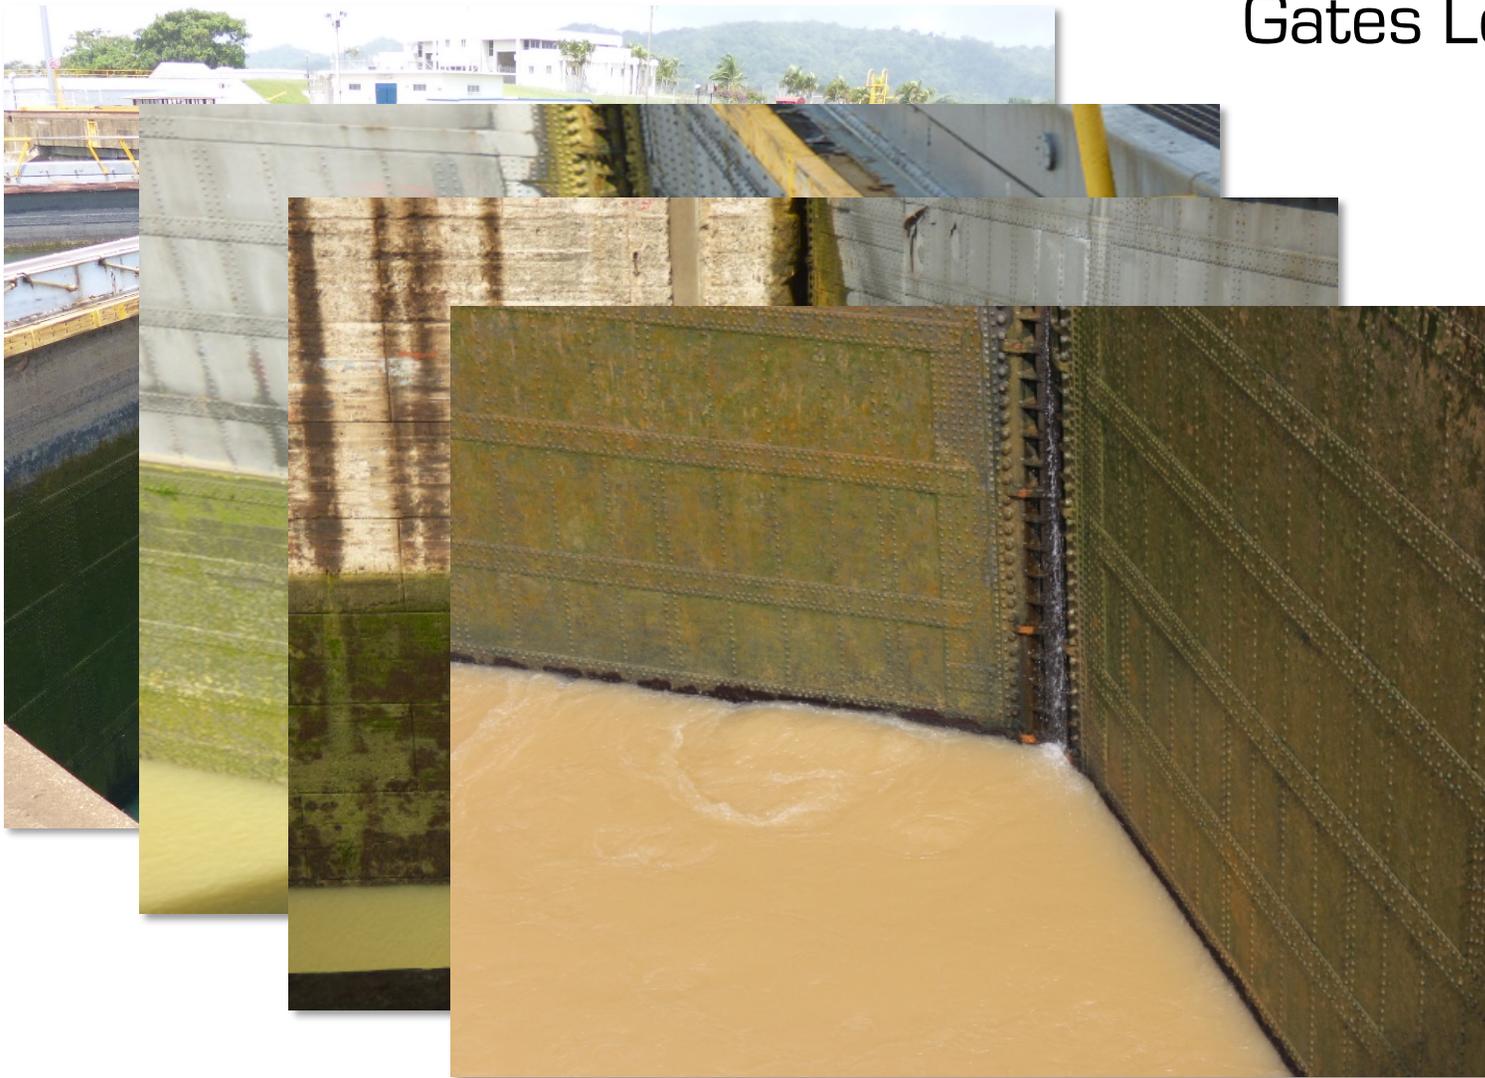
Gates Leaks

Leaks by rubber seals

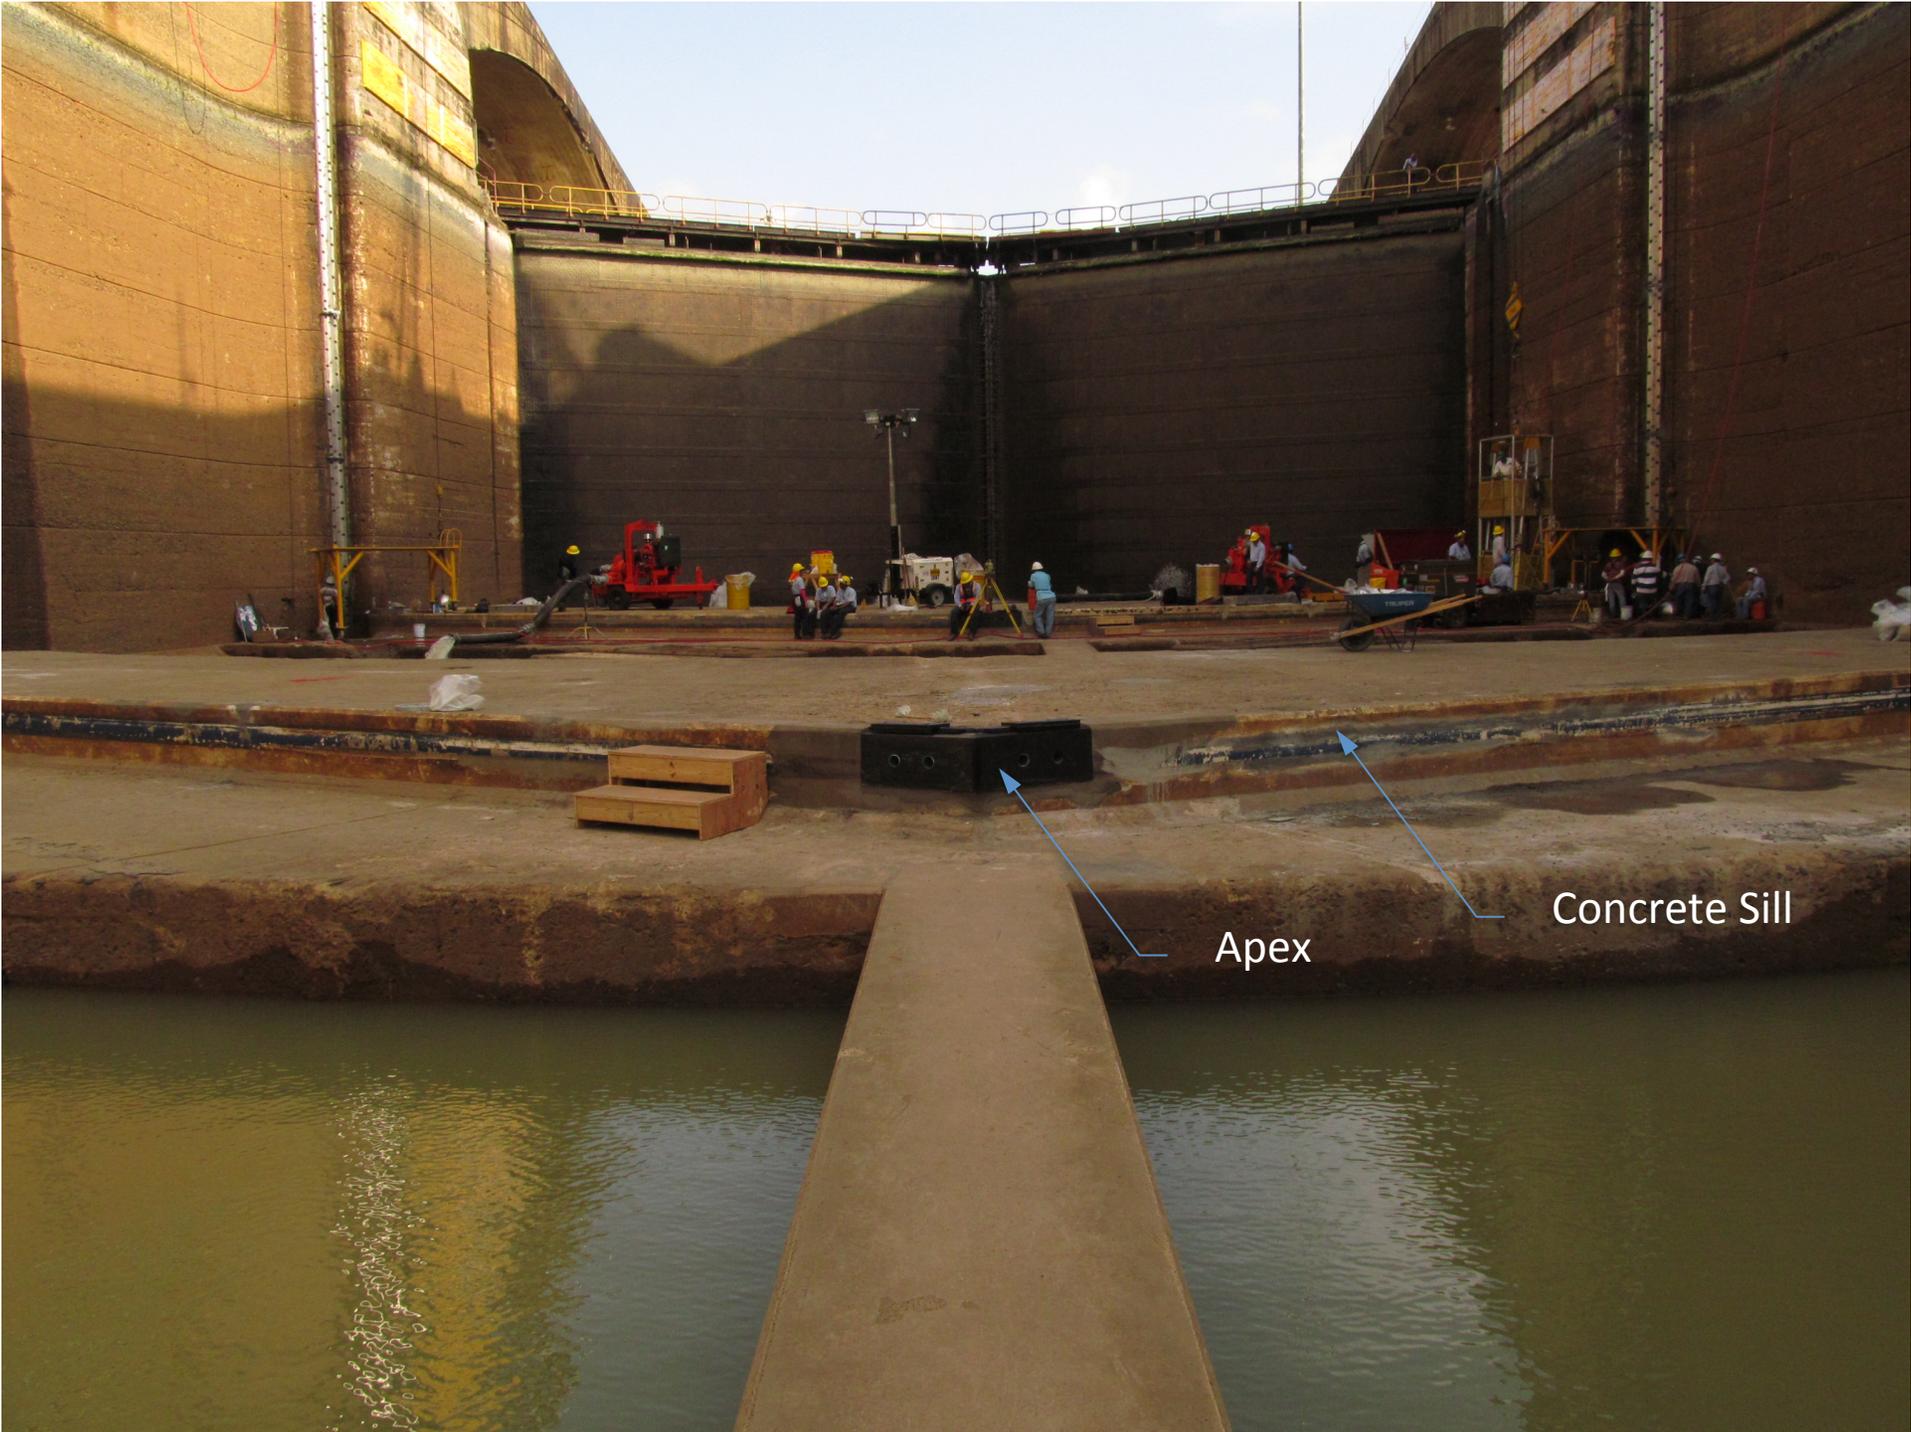
Our main problem:
Important leakages on rubber
seals.

Apex

Concrete Sill

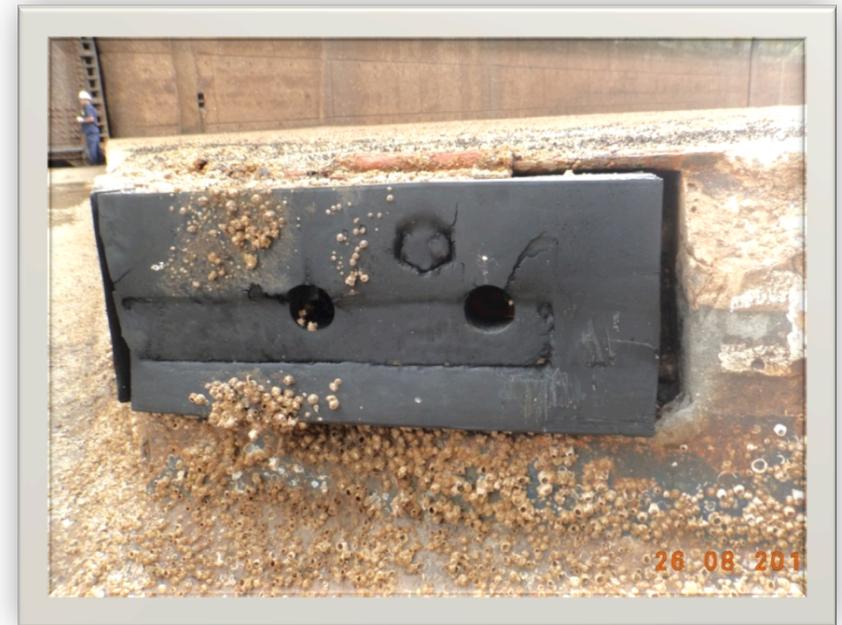
- 432 diving inspections done in Pacific Locks between 2012 and 2015.
- 81 of them with some apex issue relationship, maintenance or repair.
- 18.7% from total amount.

Sill and apex damage exposed during dry chamber works.

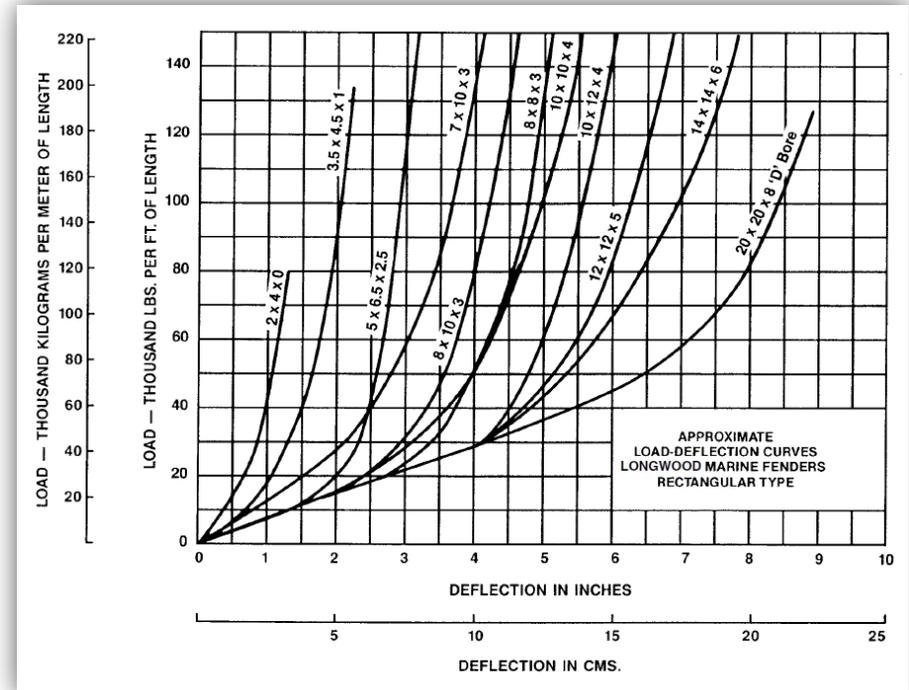
Force-deformation graph.
Square fenders, Longwood Marine

- An apex seal is mainly a commercial rectangular fender with a 10" x 12" section.
- As per fender tables, this section may have a maximum deformation of 6".
- We search different alternatives for increase the loading capacity, minimizing the deformation.
- If we can achieve this combination, we can limit the gate over travel.

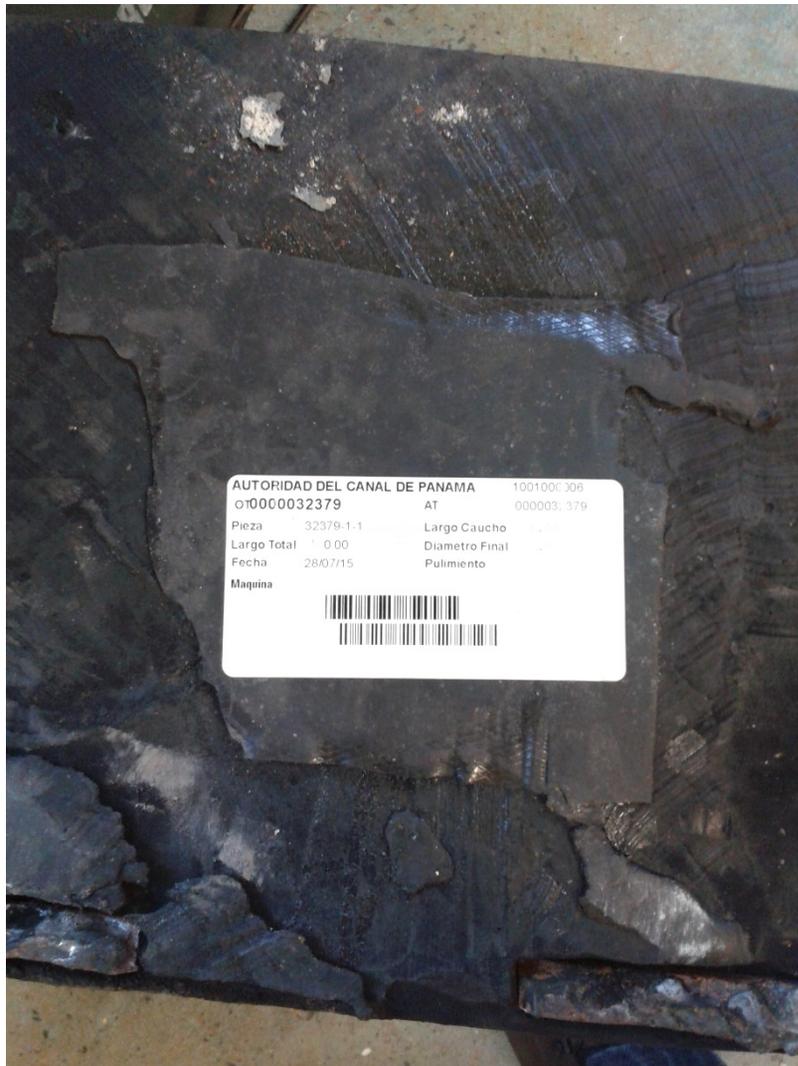
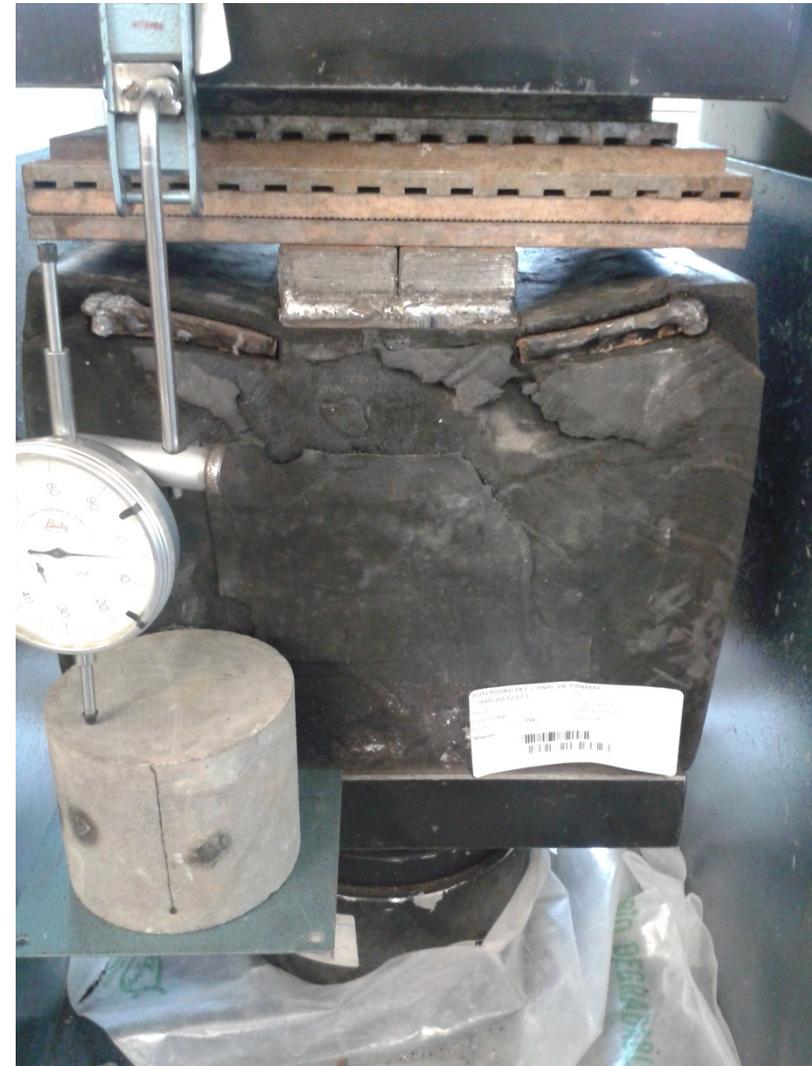
Test with vulcanized rubber fill

- The sample filled with vulcanized rubber, have an increased capacity of 52% if compared with the hollowed section.
- The sample filled with Nordbak®, shows an increased capacity of 180% if compared with the original hollowed section.
- If the gates don't have a perfect mitering and with 1 feet of water head, the gate force over the apex is 870 kg. The gate's movement momentum is not considered in this value.
- A Nordbak® filled apex with 9mm deformation, will have a load capacity of 6,400 kg.

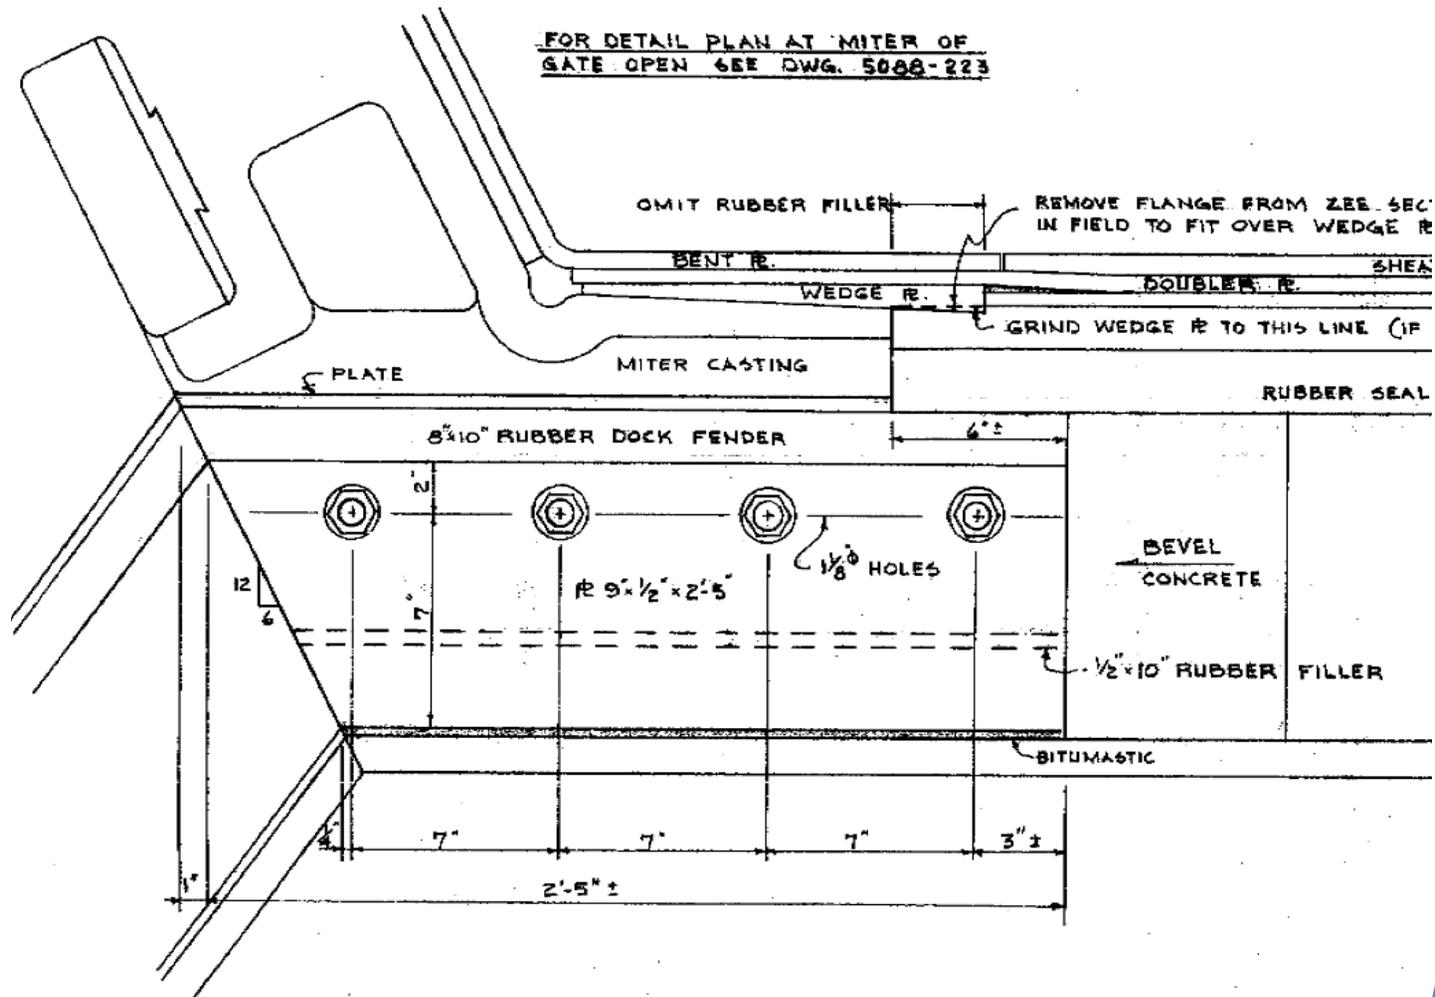
Drawing 5088-222, 3 Sep 1957

- As per current design, two marine brass bolts were used in each section.
- The modified apex was used for its first time.
- The gate works properly for approximately 3 weeks.
- The bolts failed by shear and a big leakage started.
- No damage on apex.
- New question:
 - Why do we have a shear stress?

Vertical gate movement = potential shear failure

- Our divers developed a device for emergency repairs, used for hold the apex, keeping the vertical movement. They named it “saber-tooth”.
- It was modified bringing more vertical capacity, combined with a gate stopper and keeping the original design.
