# Lock 20 Dewatering

Lock and Dam Maintenance  
Workshop 2016

Rock Island District  
Mississippi River Project  
Matt Thurman

# Lock and Dam #20

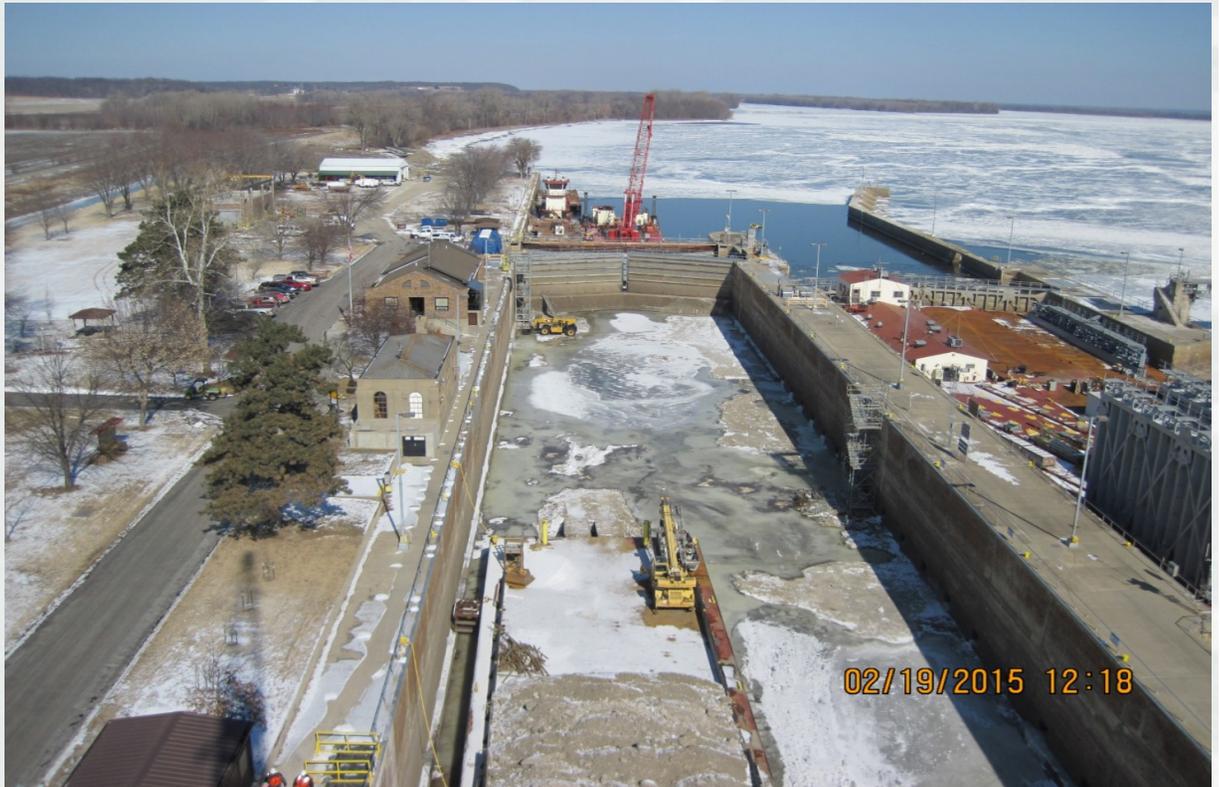
- 5 Jan 2015 through 6 Mar 2015.
- Floating Crane on each end of the chamber.
- Barge with equipment and supplies inside the chamber.

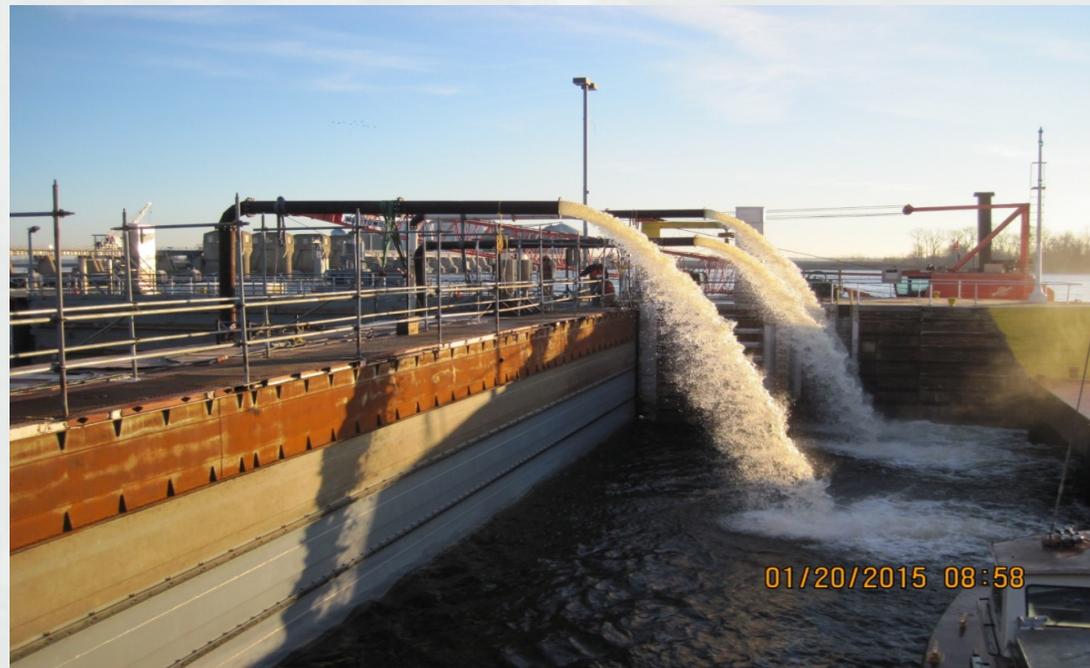
- 3 – 12in submersible pumps
- Condemned Bulkhead for walkway on top.
- Strongback is no longer used.
