Lock 25 Roller Gate Repairs

Lock and Dam Maintenance
Workshop 2011

Lock and Dam #25

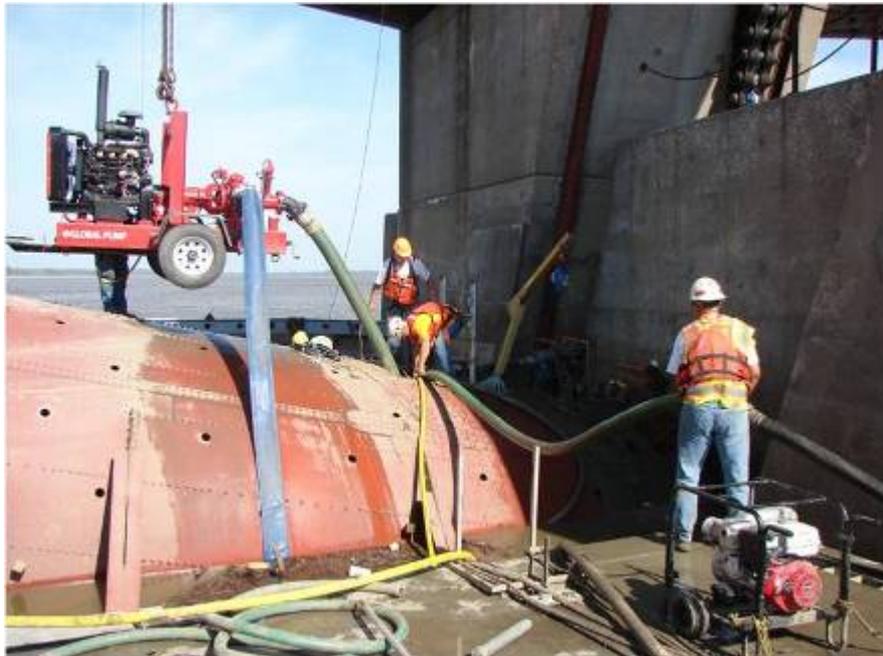
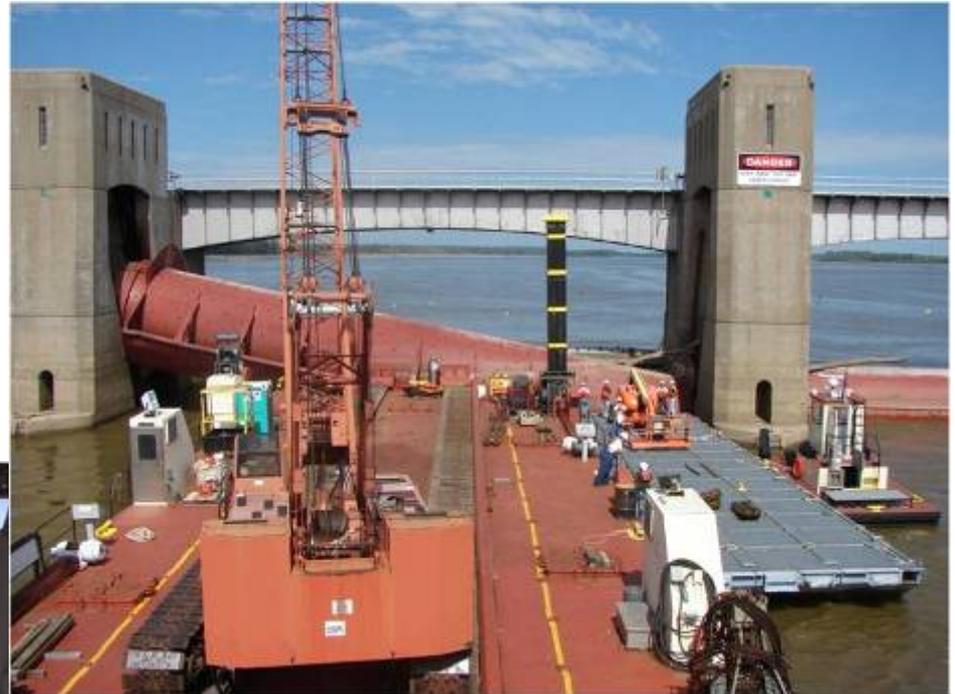
Gate Prep

- Pump out mud, over 6ft.

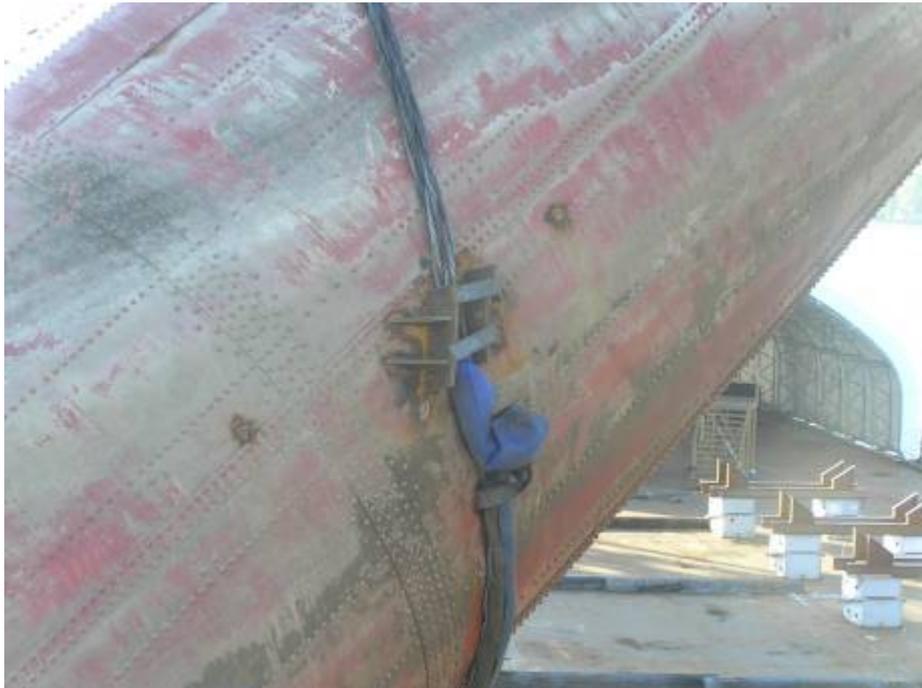
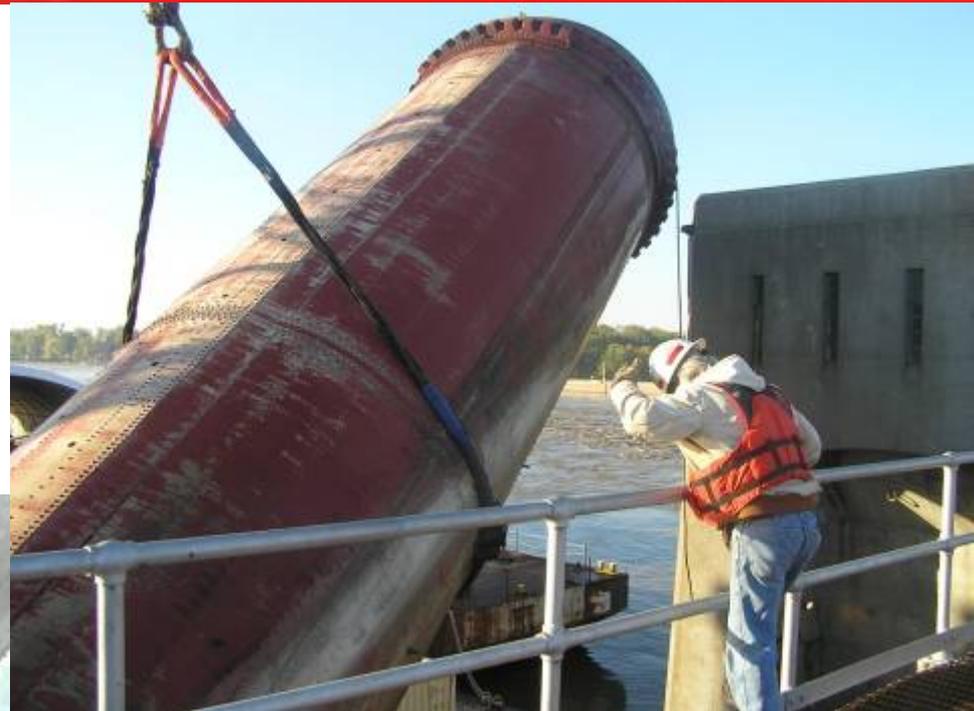
Sling Keepers

- 1 inch plate on a radius with 2 gussets.

- Gate slings were 9pt – 1-3/8” Braided Sling.
- Blue sling protector.

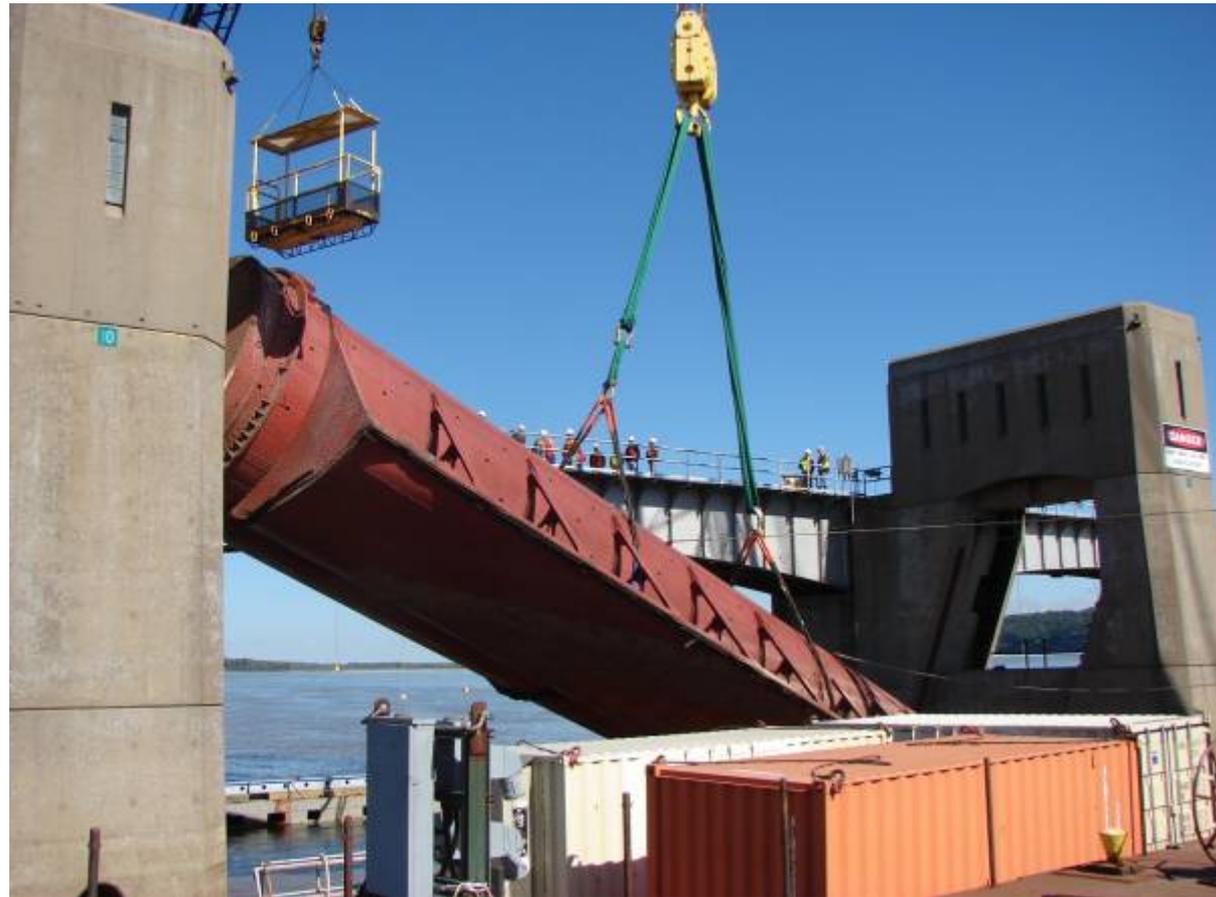
Gate Pull – 1st Try

- Offset Slings to obtain proper angle for removal.
- Distance from pier to pier is 100ft with a gate length of 109ft.
- Wasn't enough angle to clear pier house.

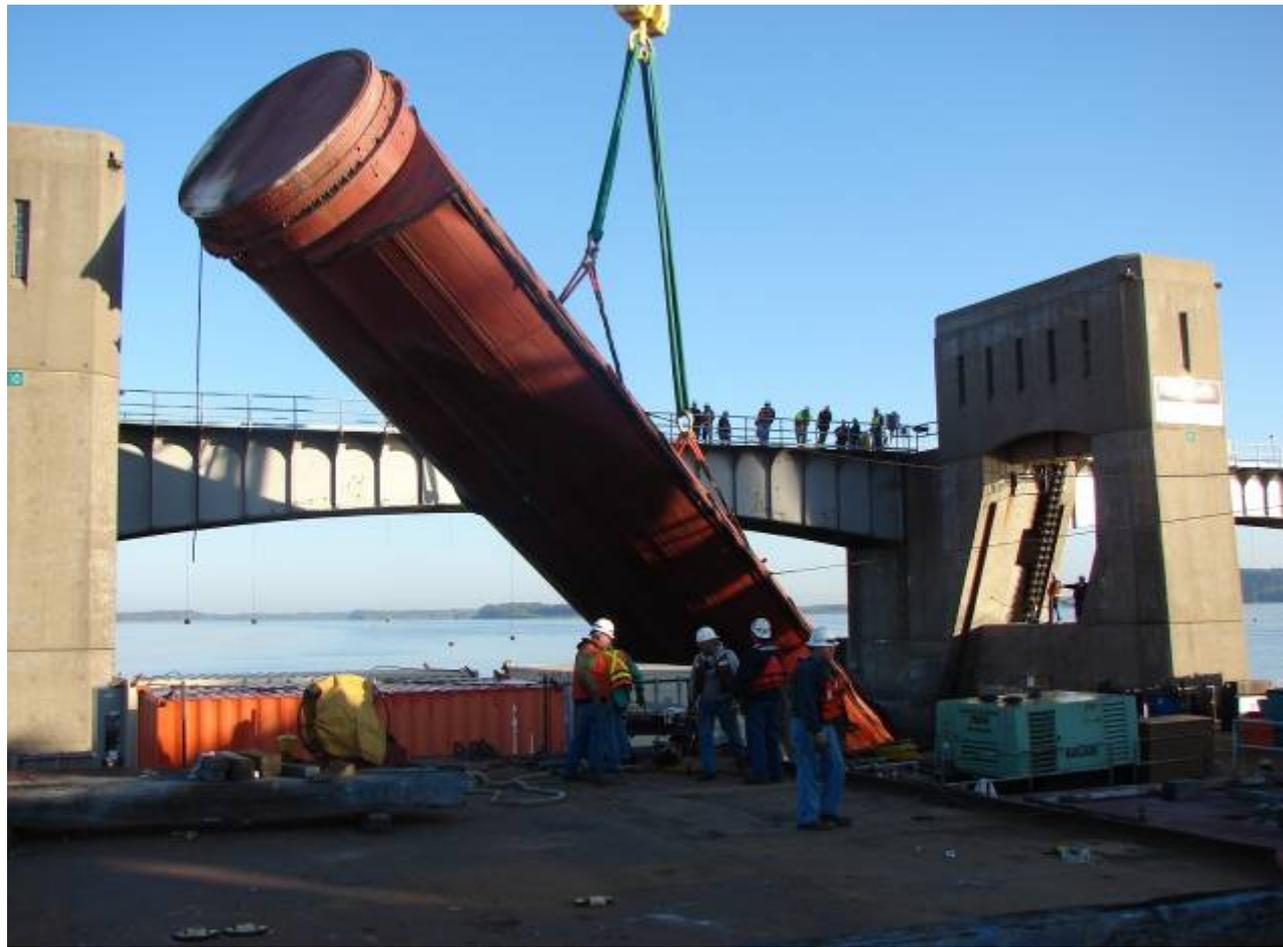
Gate Pull – 2nd Try

- Removed short section of sling to acquire proper gate angle.
- Gate angle was approximately 30 degrees.

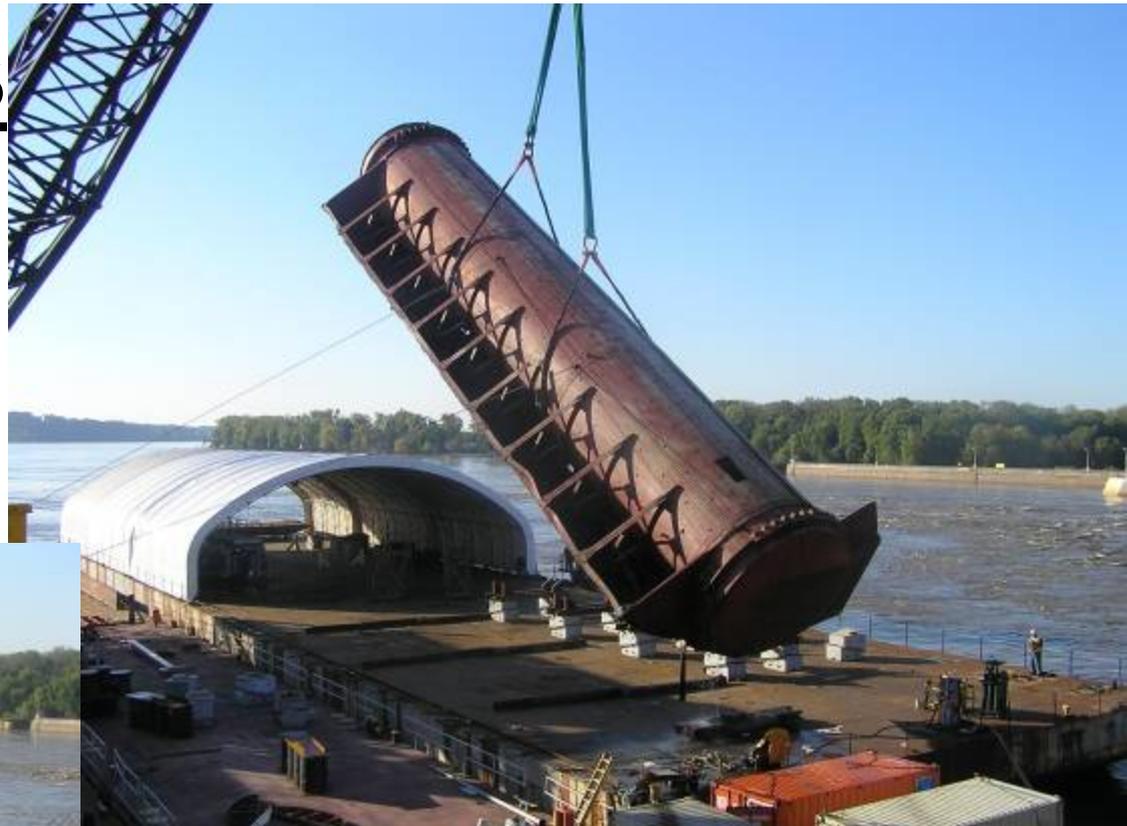
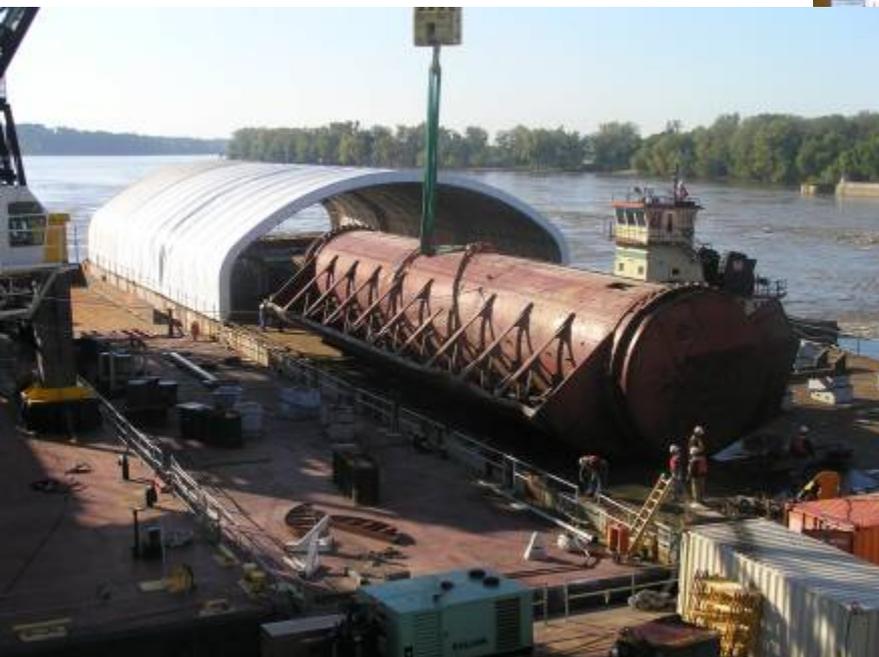
Gate Repairs

- Gate was placed on the Big Top Tent Barge for repairs.

- This was the first time in Corps of Engineers history that a Roller Gate was Removed.

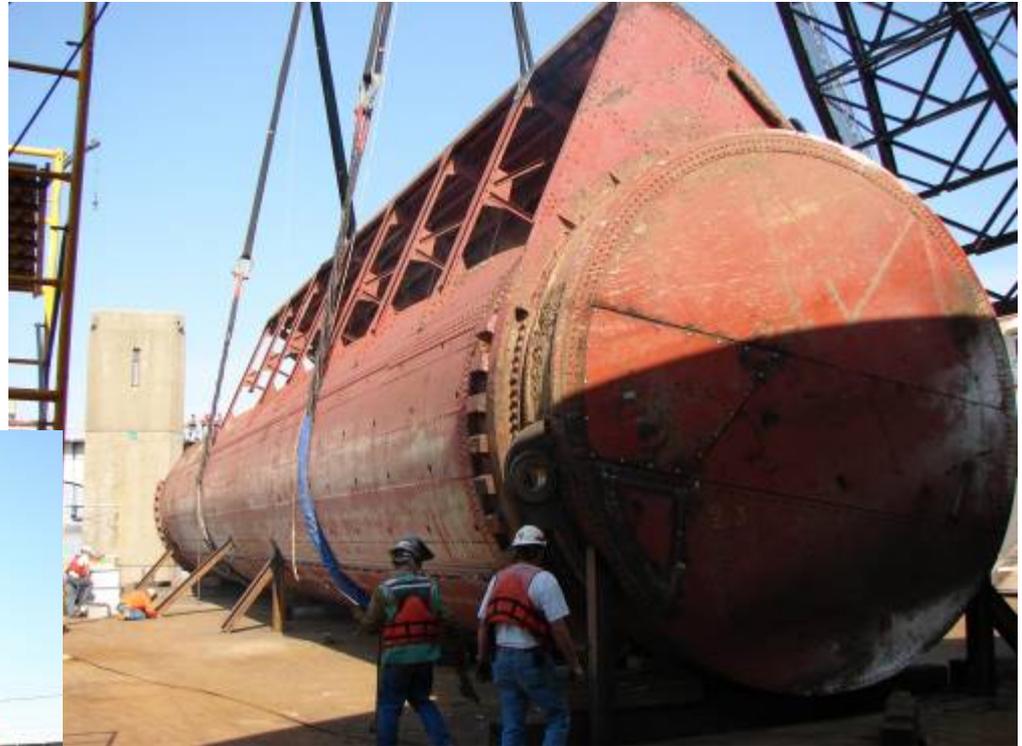
Gate Repairs

- The gate had to be aligned properly for reinstallation. This keeps the gate in time so the apron will seal against the sill.

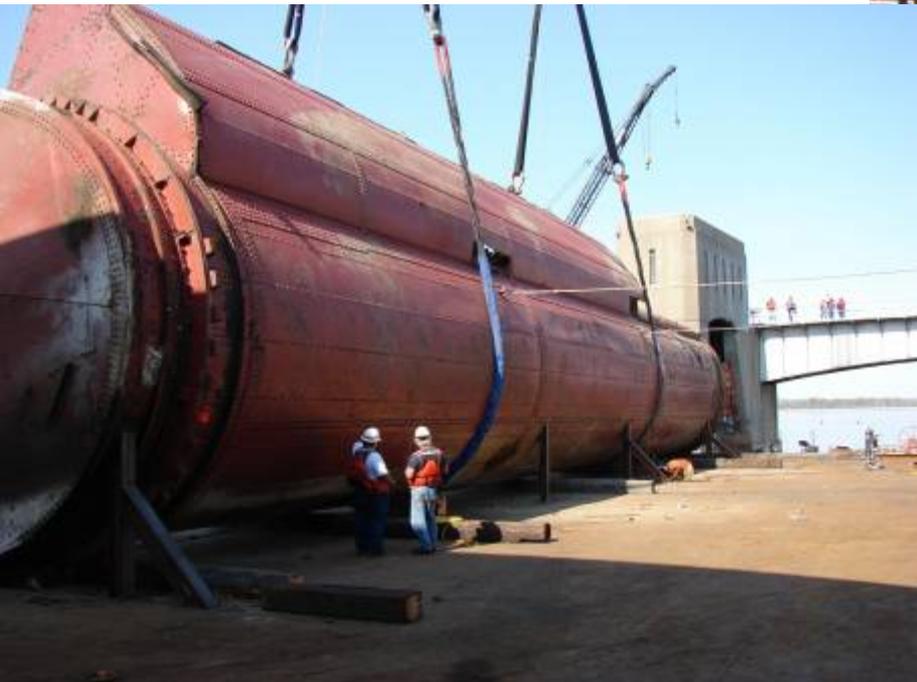
- The angle of apron struts were measured to ensure proper alignment.

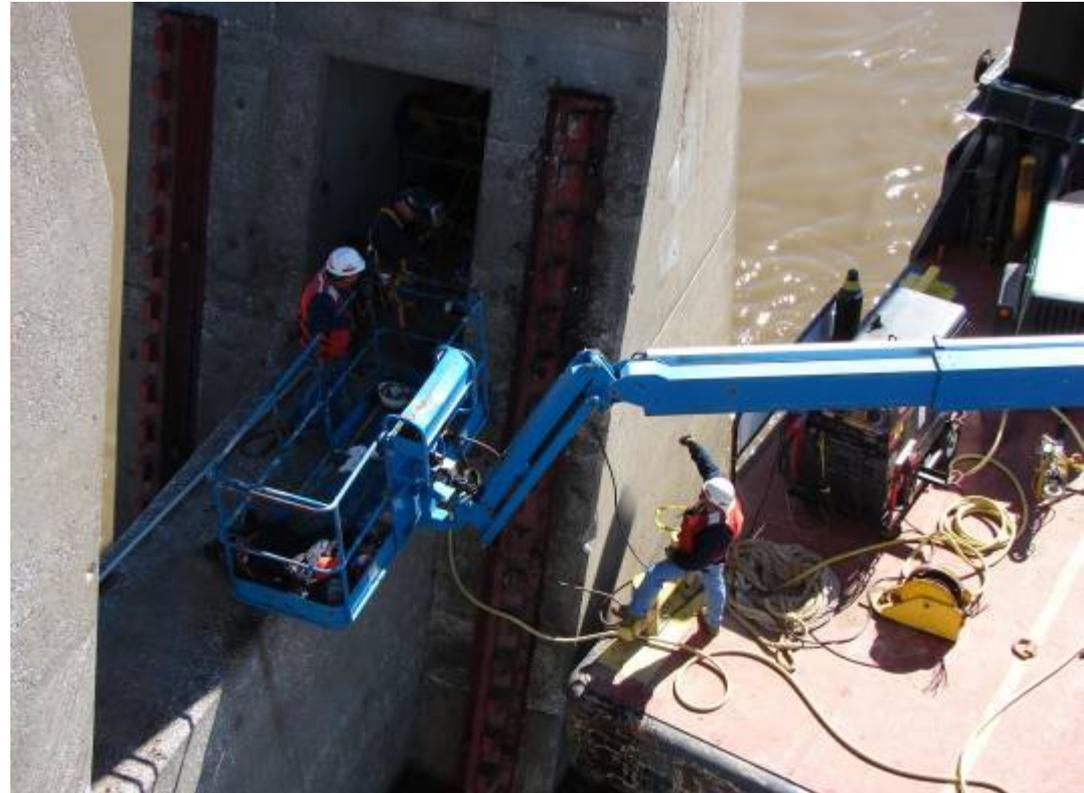
Gate Installation

- Several parts had to be removed on the piers to accommodate the installation.
- EC used lidar and CAD for determining which parts to be removed.
- Parts included top section of kogs, electrical conduits from next gate.
- Approximately 3inch of clearance.

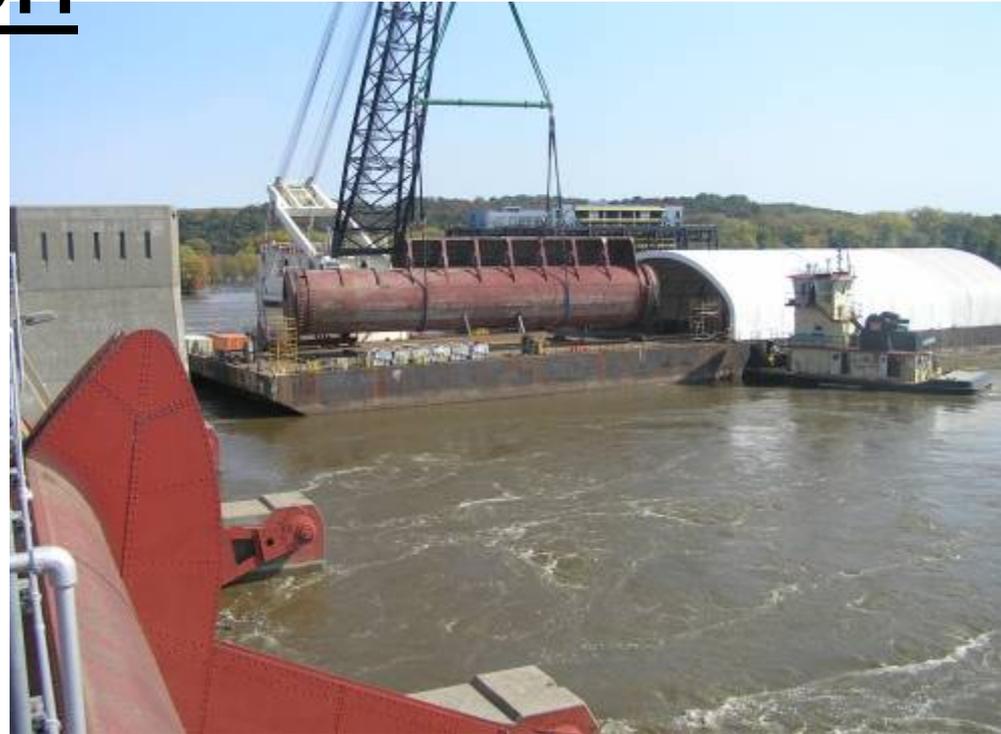
Gate Installation

- For the gate installation, the gate will remain horizontal.
- The Shreve's green spreader beam was used.

- Wire rope slings had to be replaced due to damage during removal.

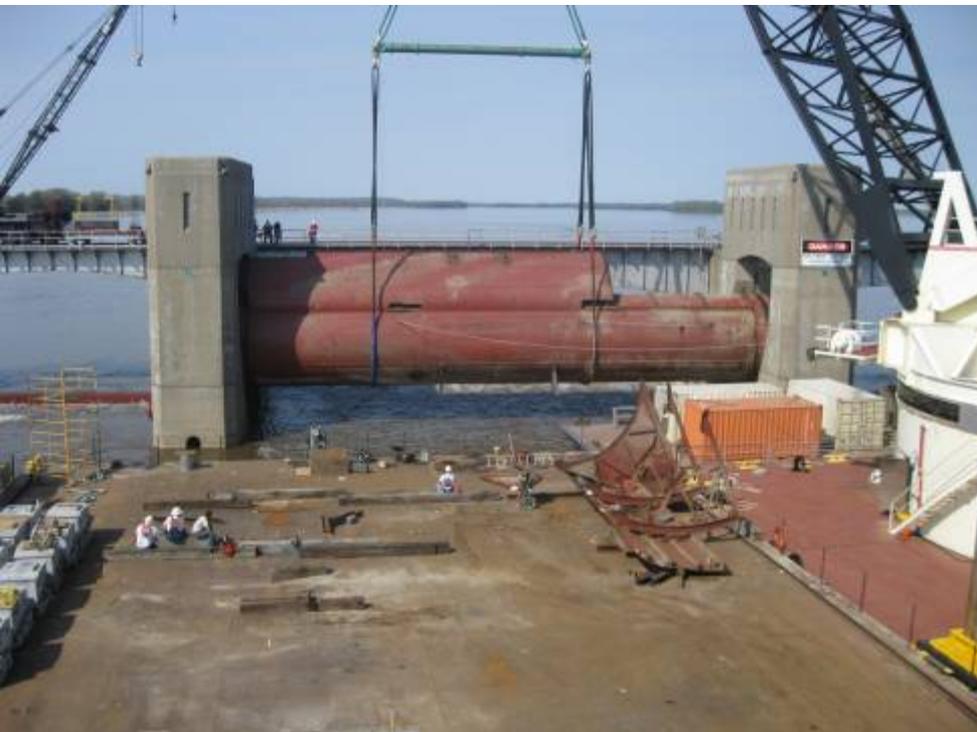
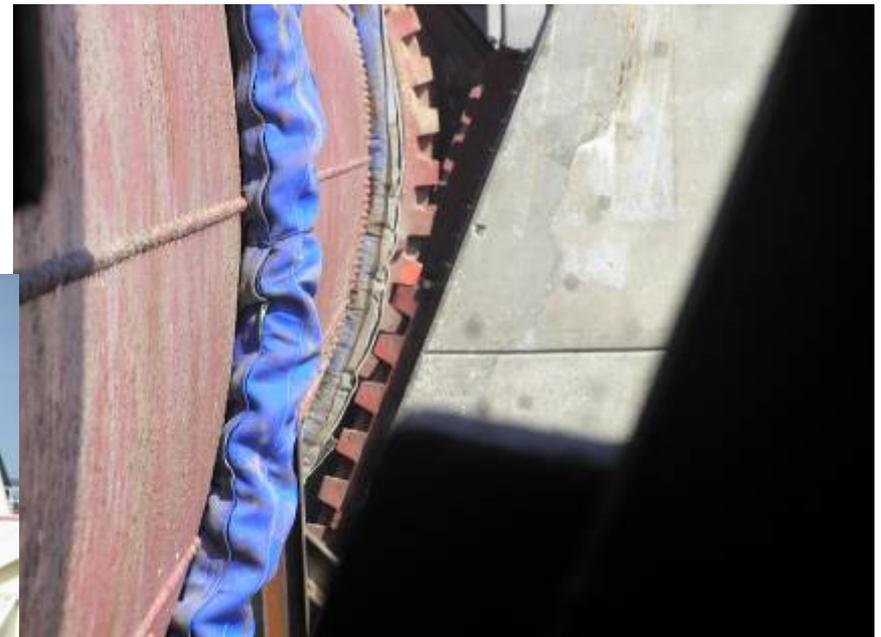
Gate Installation

- Painting the teeth.

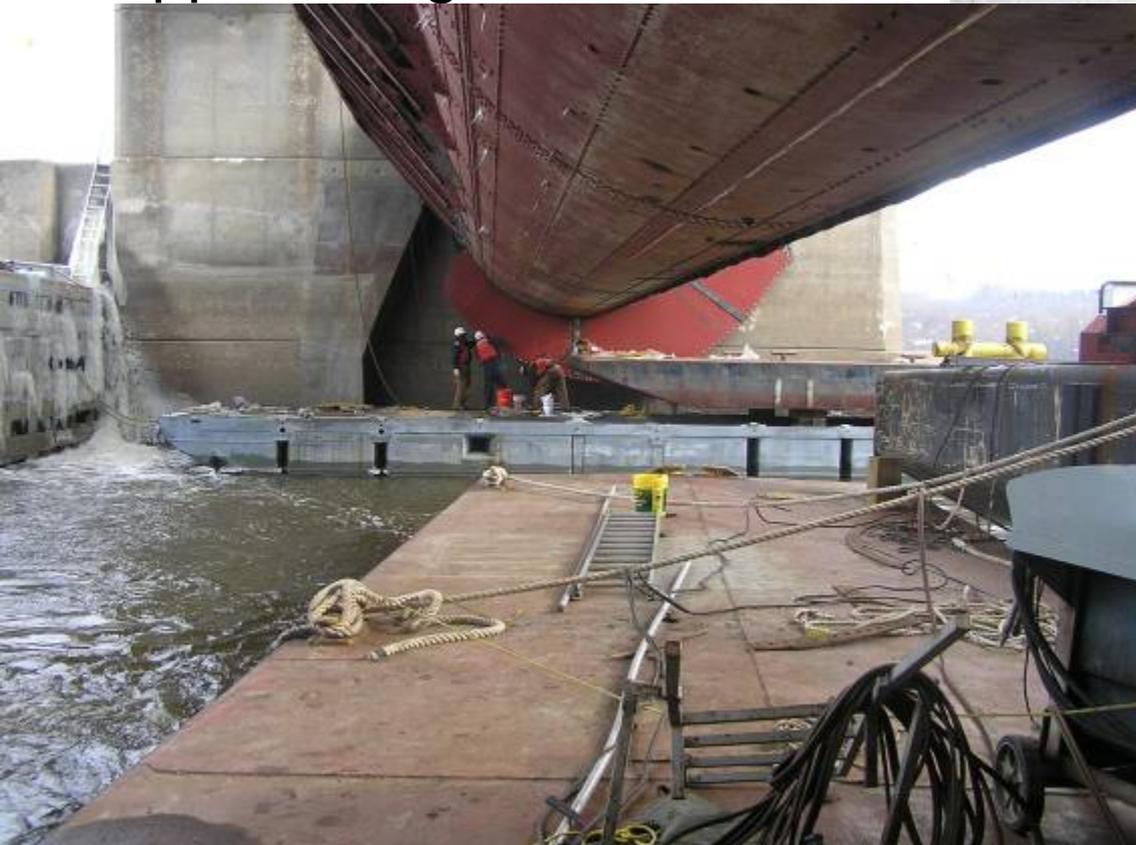
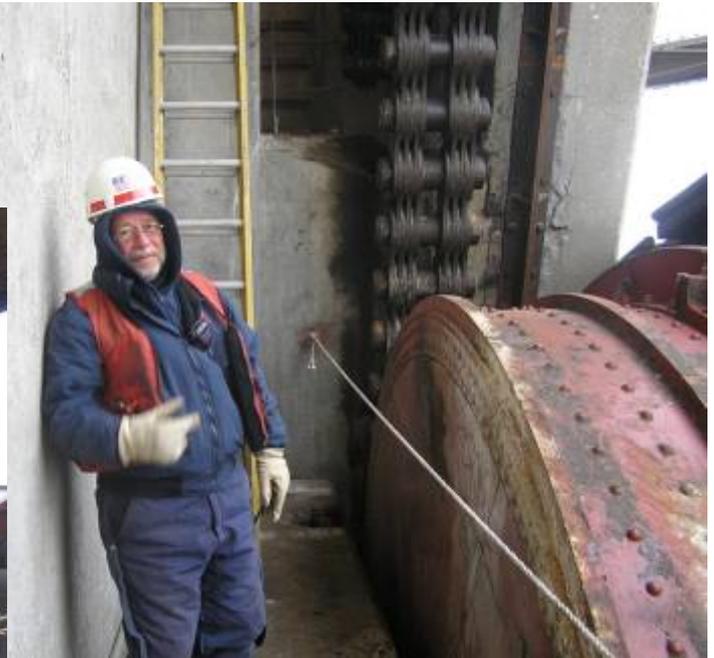
Gate Installation

- The chain helps support the gate.

- Flats to assist in replacing misc parts.
