Miter Gate Pintle Ball Replacement

Chouteau Lock and Dam 17

12 February 2013

21 Day Scheduled Closure

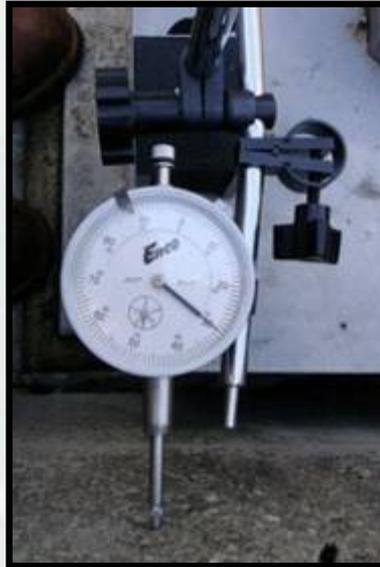
- 2009 Dewater Findings
 - ▶ Ruptured Pintle Grease line
 - ▶ Wear gap over 3/16" (normal under 1/20")
 - ▶ Lubrication attempts unsuccessful
 - ▶ Conclusion grease grooves worn smooth

- 2011 Top Anchorage
 - ▶ Concrete breaking around embedded metal
 - ▶ Measured 1/32" movement during operation
 - ▶ Minimal movement on other Gates

- ▶ Repair worn Miter Gate pintle to prevent future damage to embedded castings, eventual failure and unscheduled outage to navigation
