Navigation Safety Initiatives

Deformable Bullnose Energy Absorbing System (BEAS)

Briefing by: Mr. Tom Hood
7 February 2010

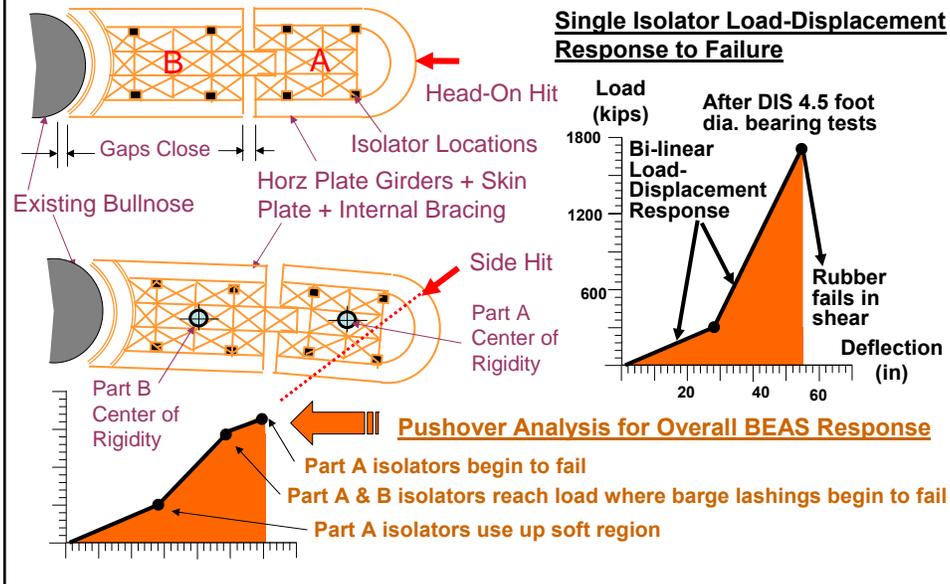
Plan View of Articulated Impact Nosing And Base Isolator Nonlinear Response

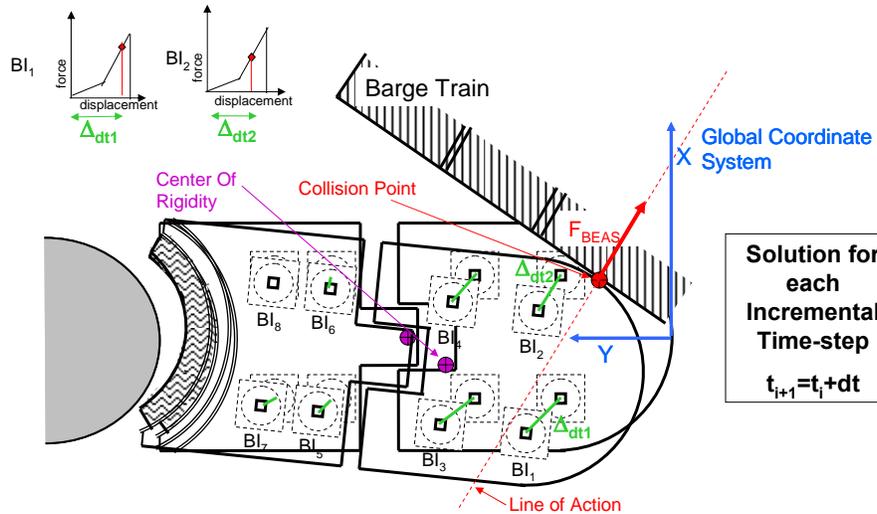
Numerical Solution of Contact between Barge Train and Deformable BEAS

Note: BEAS & Base Isolators shown with incremental base isolator deformations Δ_{dt1} for BI₁ and Δ_{dt2} for BI₂ in the figure at Time = t_i

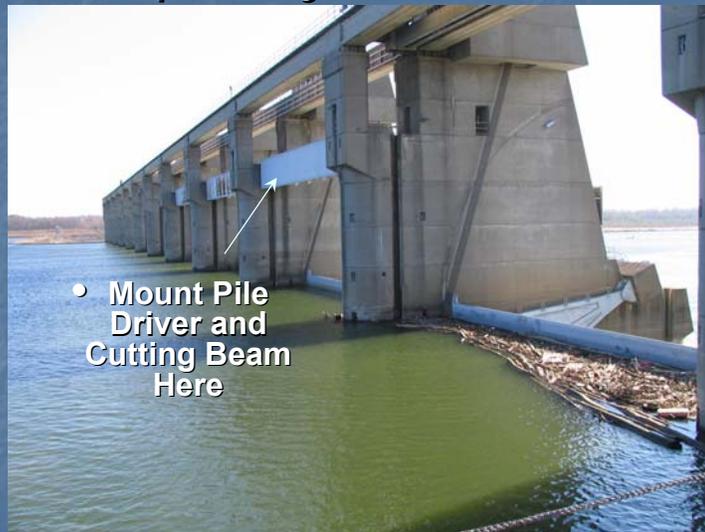
Spillway Bulkhead

- Mount Pile Driver and Cutting Beam Here

- Desired cutting beam would need to be designed for use with some type of pile driver preferably a smaller vibratory type
- Cutting beam and pile driver could be mounted on the end of a crawler crane or excavator arm
- Cutting beam could be designed to fit on the bottom of the gate bay bulkheads

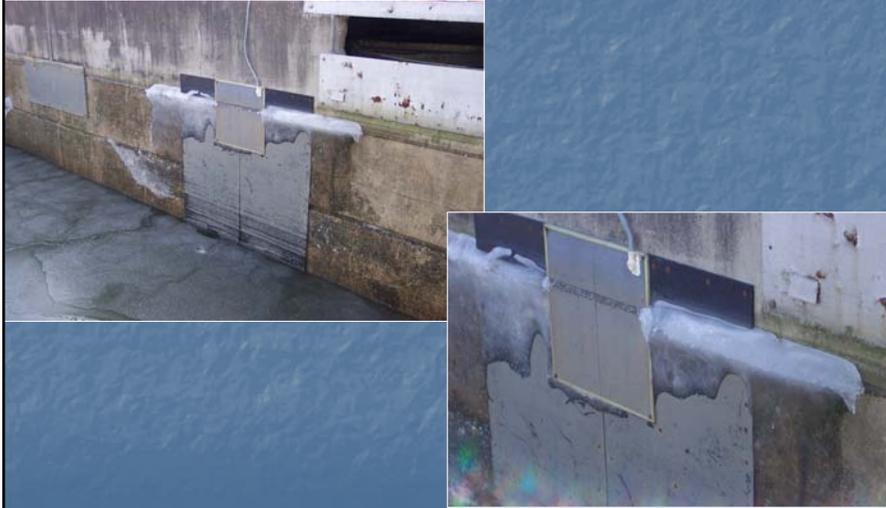
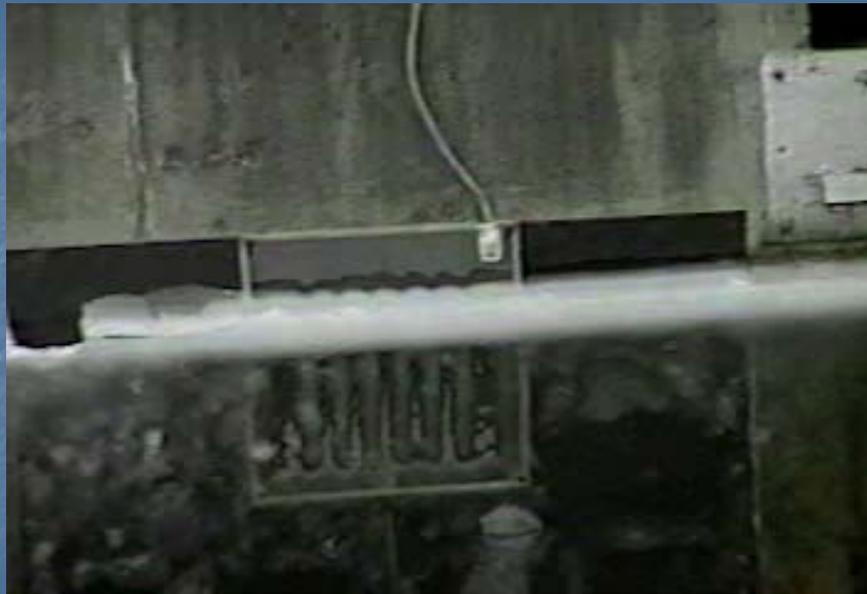
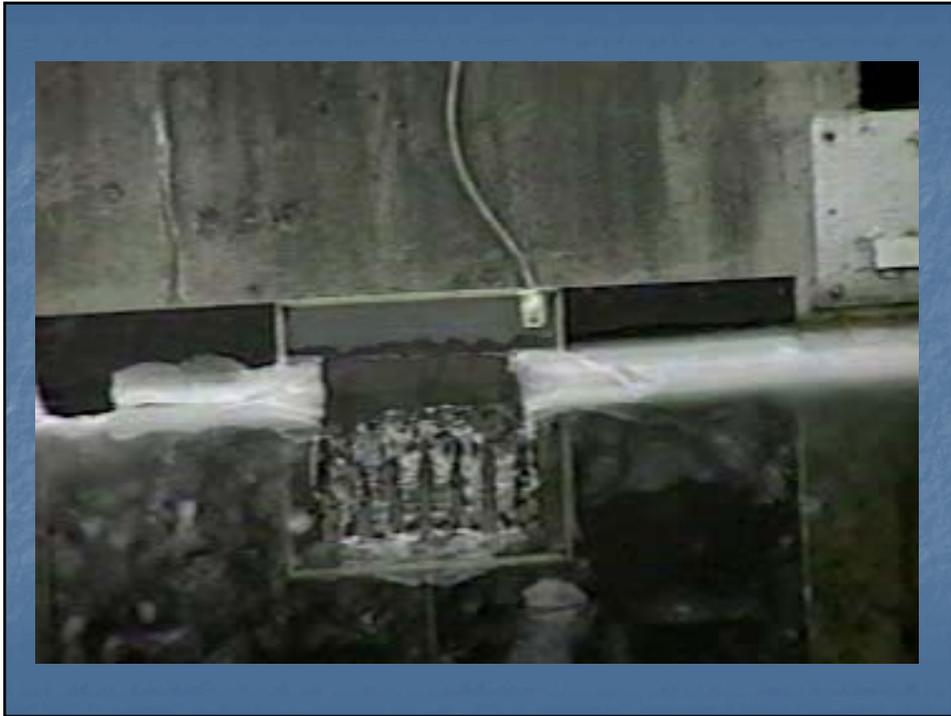
3 ft by 3 ft Electro Expulsion Panel Mounted on Starved Rock Lock Wall

- Meet with Supplier Jan 28 to discuss proposal
- Purchase 9 4-ft high by 7.5-ft wide panels
- Install at Upper Miter Gate Recess at Starved Rock Lock

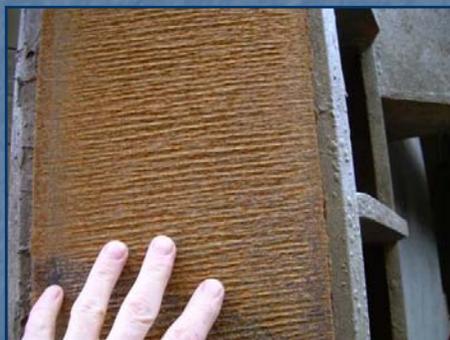
Miter Block Erosion

- Miter gate does not make miter or quoin contact. Load is being transferred through the pintle area
- The gate was not designed for this loading condition

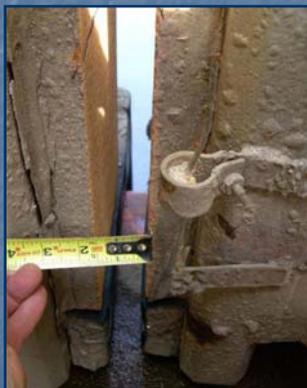
Gate in Closed Position
– No Miter Contact

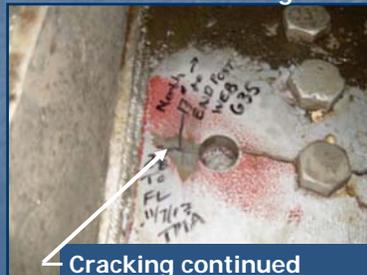
Pintle Area

Location of cracking

Cracking continued through drilled holes

Bolts hold gate to pintle

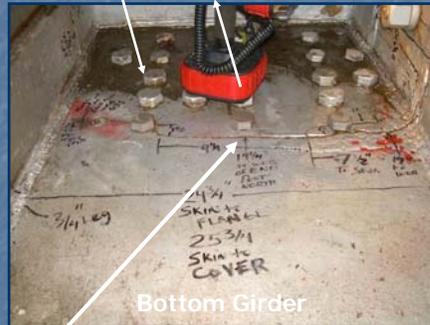
Bottom Girder

Crack running through web and into skin plate

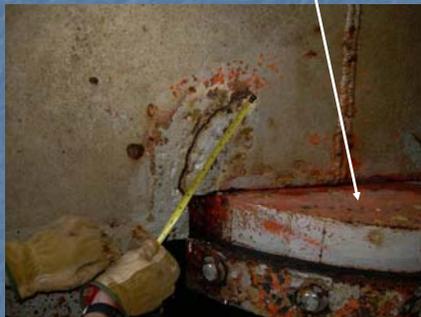
Pintle

Skin plate crack - upstream

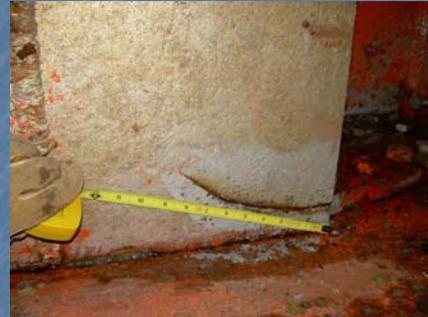
Upstream endpost cracking

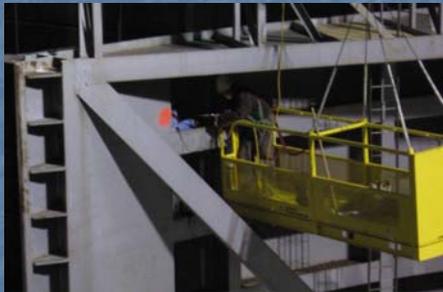
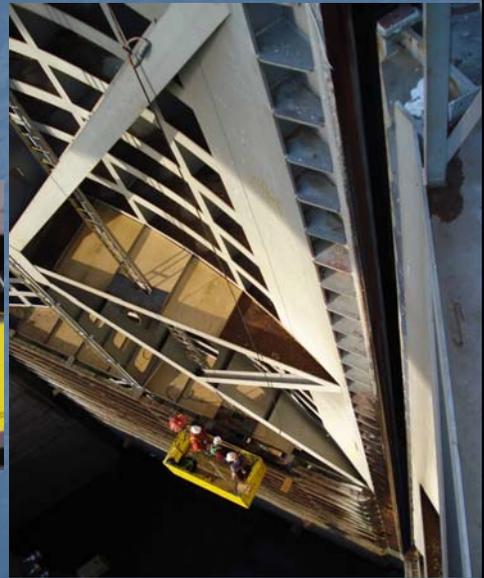
Miter Gate Gage Installation

Install done over a 7-day period with around-the-clock operation.

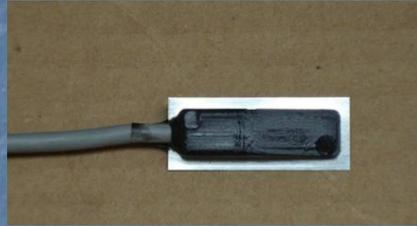
Strain Transducer Used

HiTech Products model HBWF-35-125-6-GP – used on miter gates

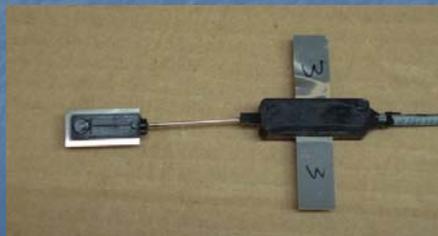
HiTech Products model HBWF-35-125-6-GP-SS similar to above, but with completion resistors removed from weldable area. Used on tainter gates

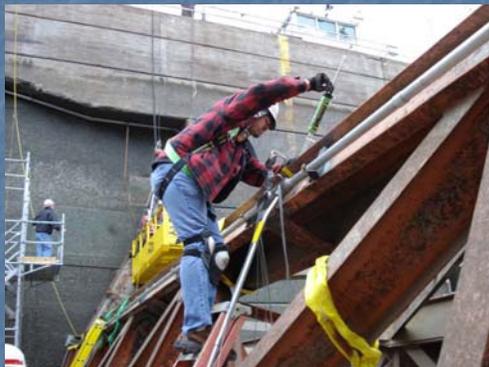
Tainter Gate Instrumentation

Gages Installed on
Tainter Gates:

38 - Full-bridge strain
gage sensors

4 - Tiltmeters

3 - Temp sensors

- Gate damaged from numerous barge impacts
- Unequal load sharing (80% load on north side skews the gate).
- Diagonals continually cracking and requiring repair
- Stress data needed to assist design of new gate scheduled for replacement in 2013

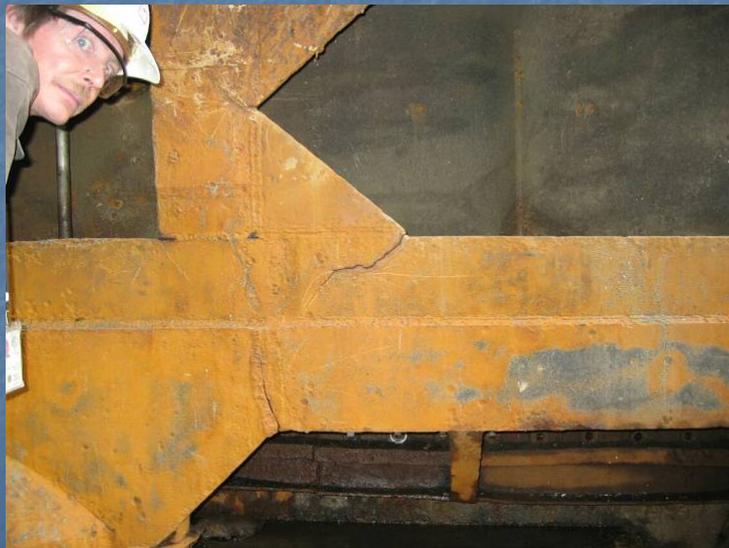
Damage to Reinforcement Flanging

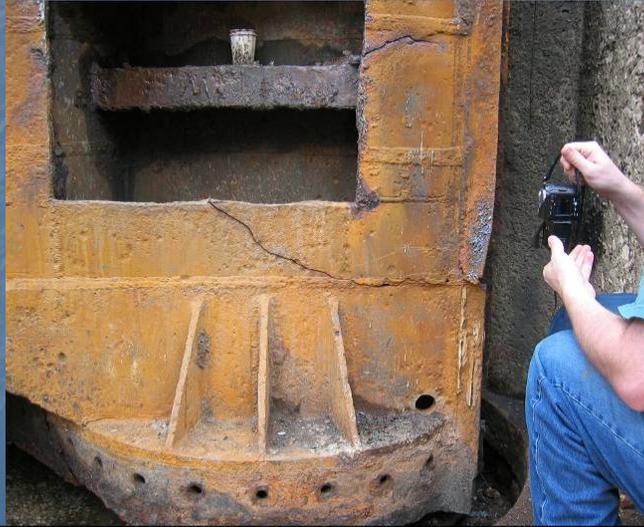
Cracking Around the Pintle Casting

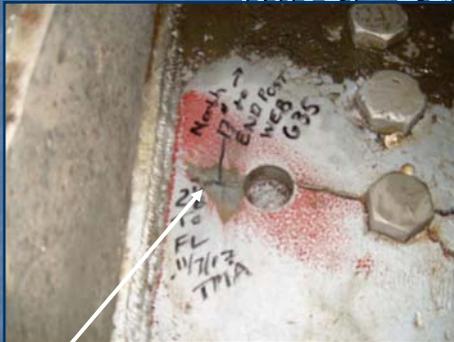
Cracking continued through drilled holes

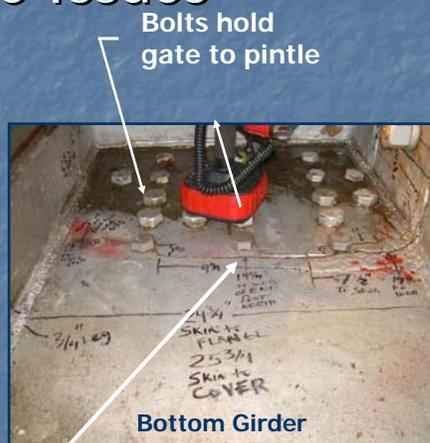
Bolts hold gate to pintle

Bottom Girder

Crack running through web and into skin plate

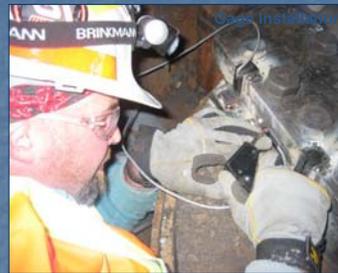
Gages Installed on Miter Gates:

- 97 Full-bridge strain gage sensors
- 10 Bi-axial tiltmeters
- 4 Tri-axial Accelerometers
- 10 Temperature sensors

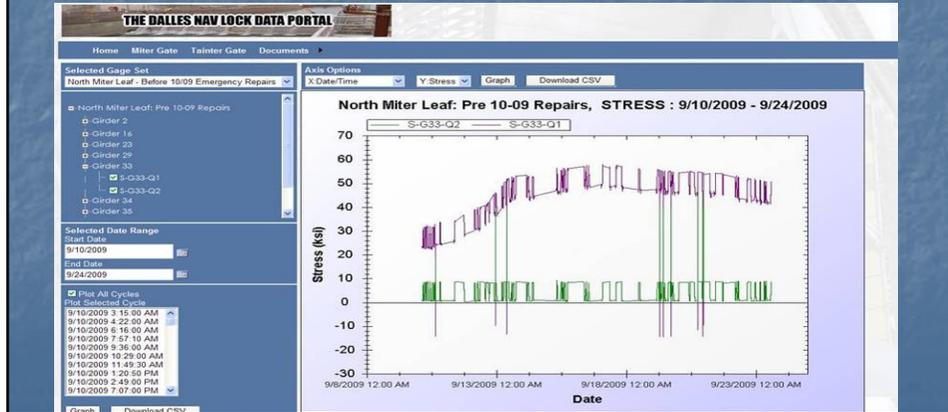
The Dalles Portal Showing Unusual Gate Behavior – Sept 2009

- On 29 Sept 2009 The Dalles nav lock was closed for operation.
- This decision was based largely on strain gage data.**
- Inspection showed substantial damage to the lower girders and diagonals.
- Emergency repairs began on roughly 4 Oct.
- The lock re-opened for normal operation on 12 Oct.

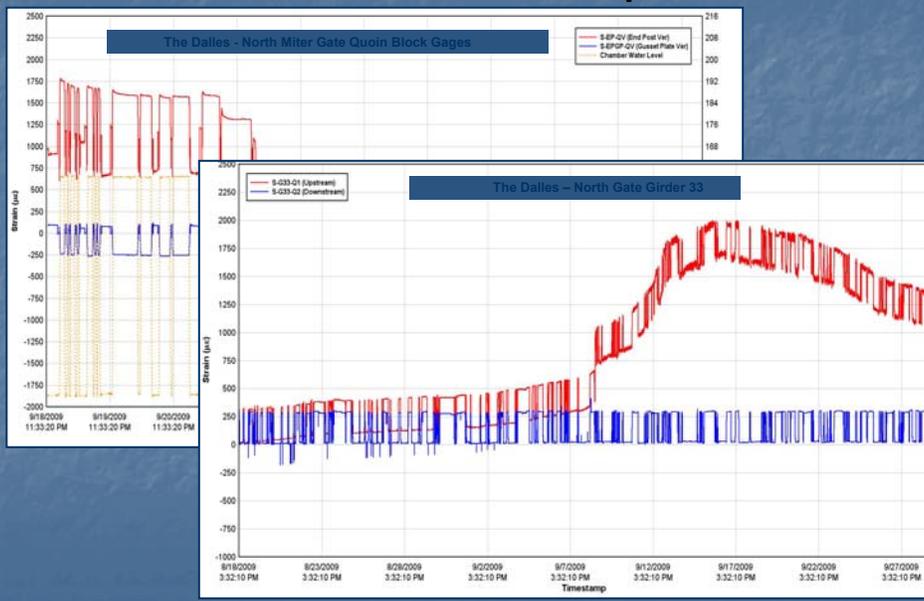
Strain Data from Sept 2009

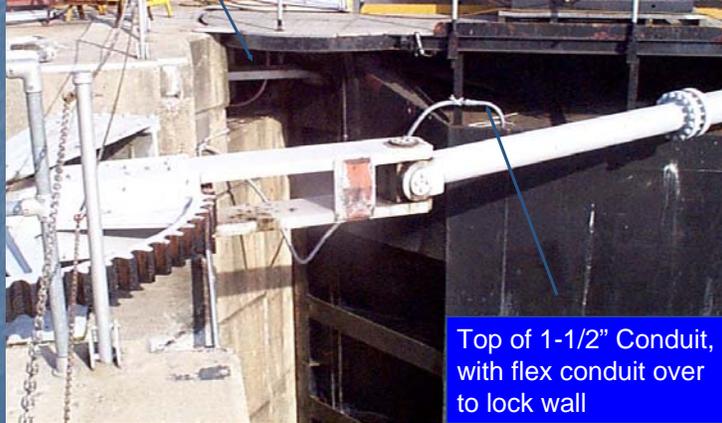
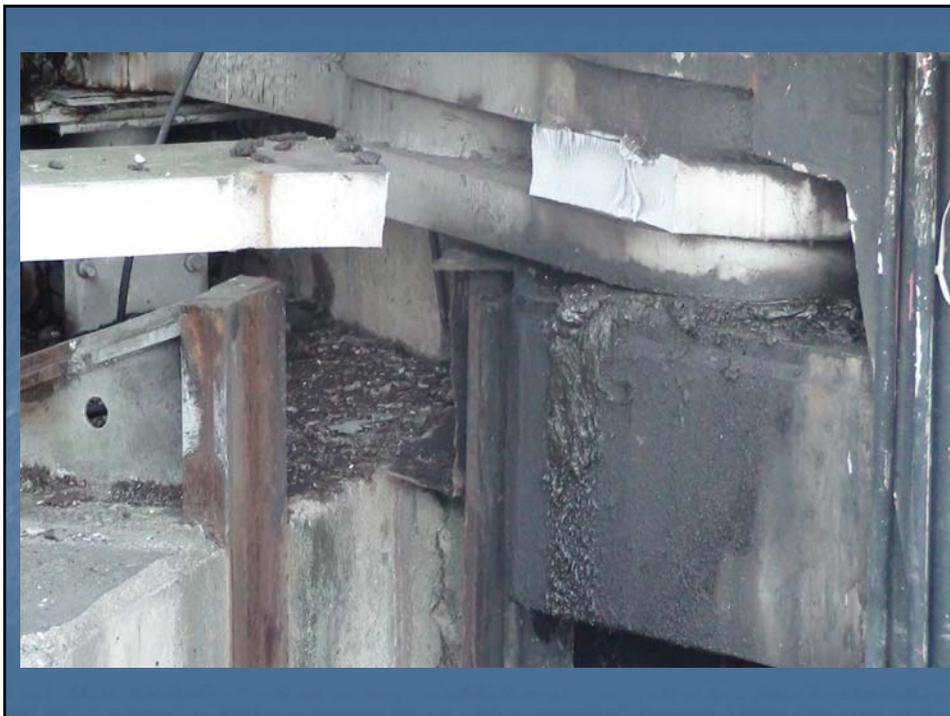
Gage Installation

Greenup L&D Miter Gate

Strain gages also on both the Recessed and Mitered Strut Arm

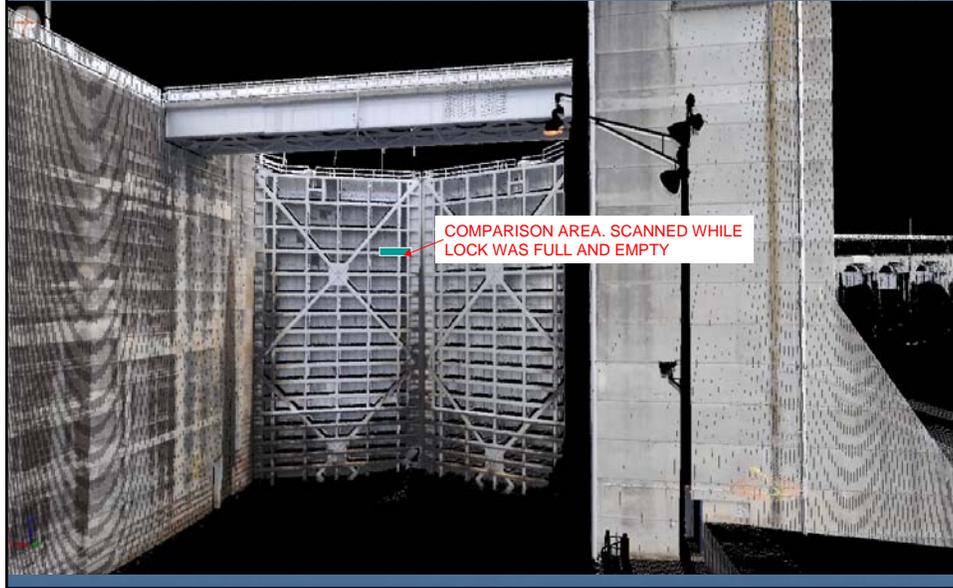
WILSON DAM LOWER GATE SCAN AREA
(1 MINUTE SCAN SHOWN AS COLORIZE POINT CLOUD)

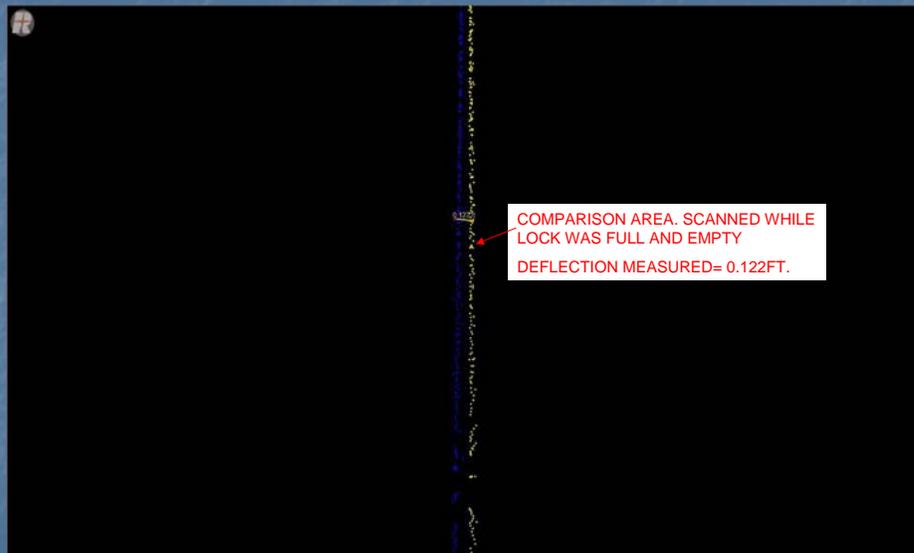
WILSON DAM LOWER GATE COMPARISON AREA
(1 MINUTE SCAN)

Looking strait down from the top of the gate.

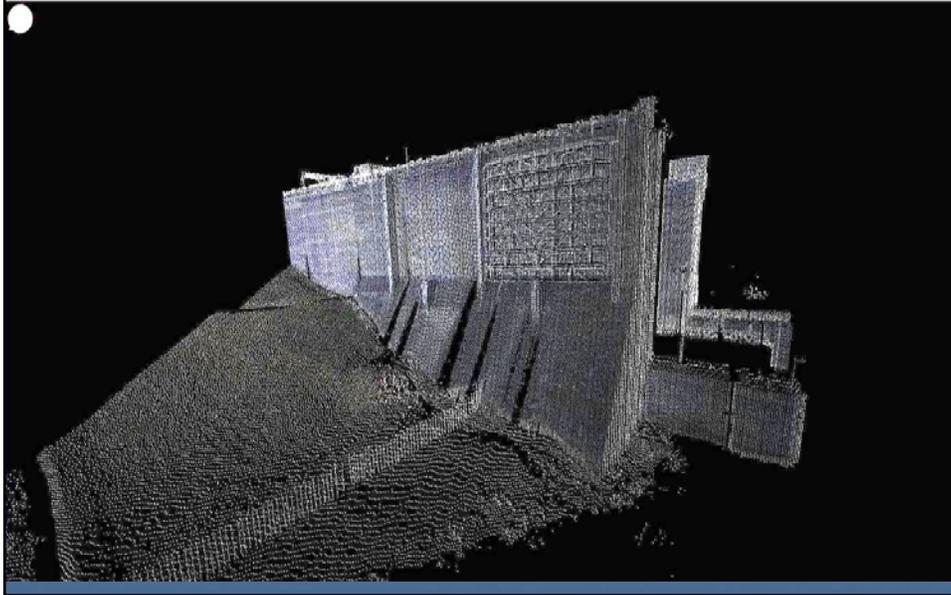
WILSON DAM LOWER LANDSIDE WALL SCAN AREA
(5 SECOND SCAN)
