Acoustical Imaging for Underwater Inspection

James A. Evans

ERDC Information Technology
Laboratory

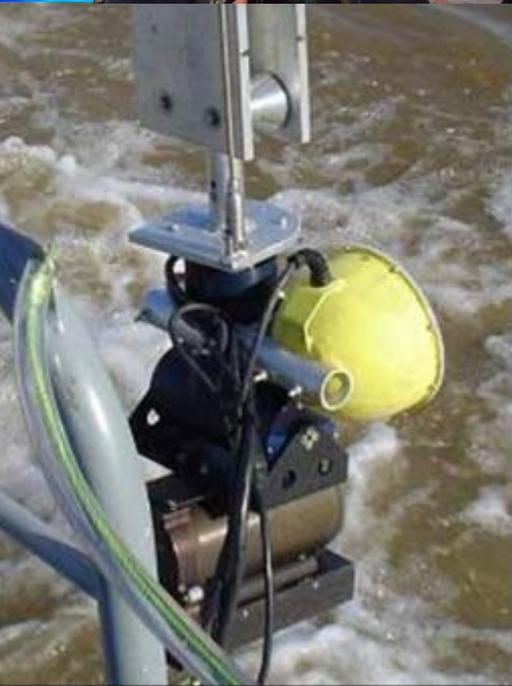
High Resolution Acoustical Imaging

- Mechanical focusing using complex lens system
- Dual frequency (1, 2 Mhz)
- 1-30M range
- Up to 12 frames/second
- Developed for DoD by University of Washington

The acoustic camera offers superior resolution and portability compared to Sidescan and Beam forming approaches

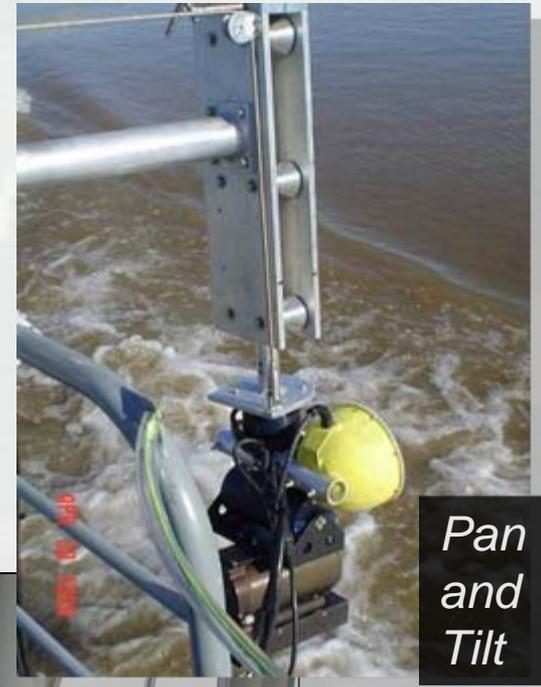
Camera pole
mount

*Pan
and
Tilt*

18 integrated sensors
provide geospatial
referencing

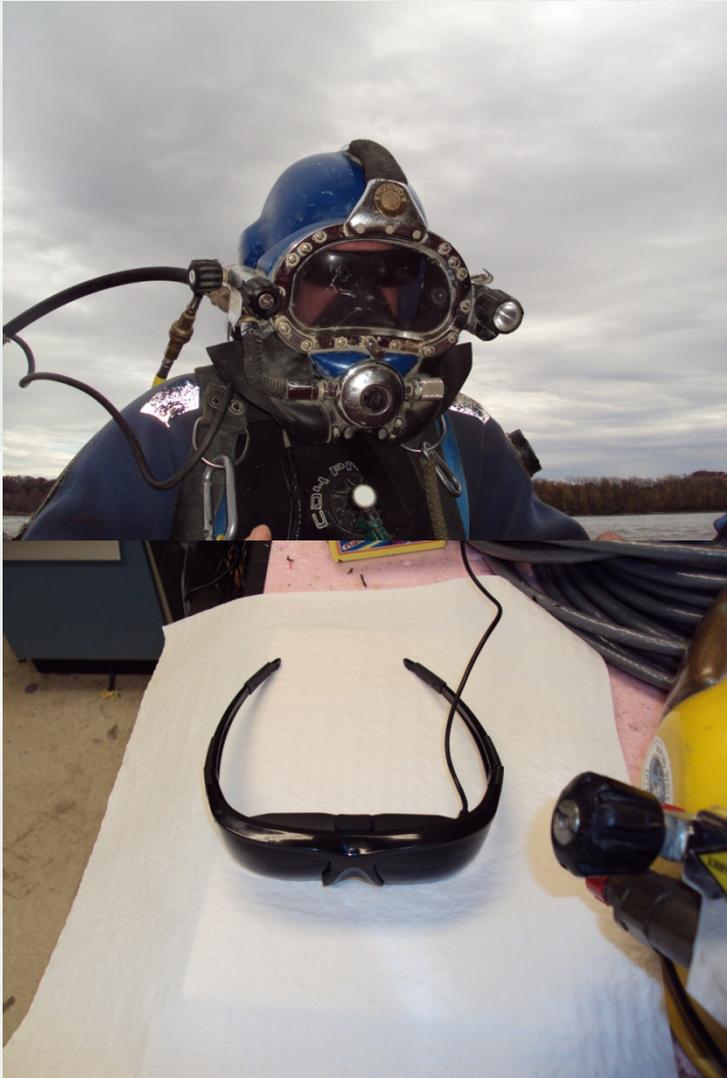
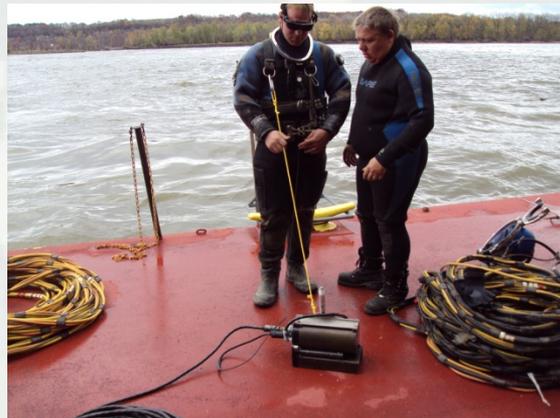
High Resolution Acoustical Imaging Deployment (Continued)

Integration of Video Monitor for Diver Use

- 1) Increases Diver's Involvement of Inspection Process.
- 2) Improves Diver Safety

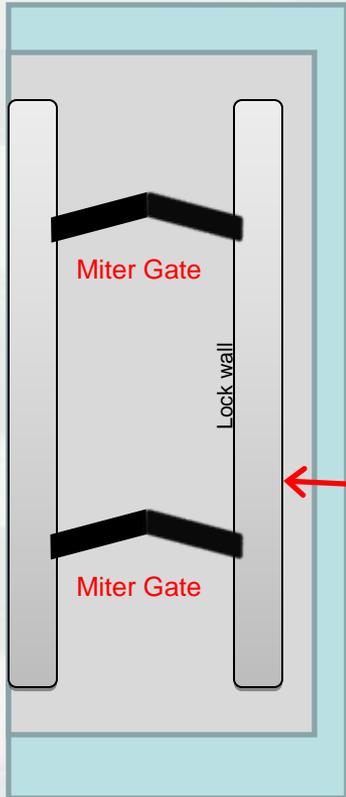
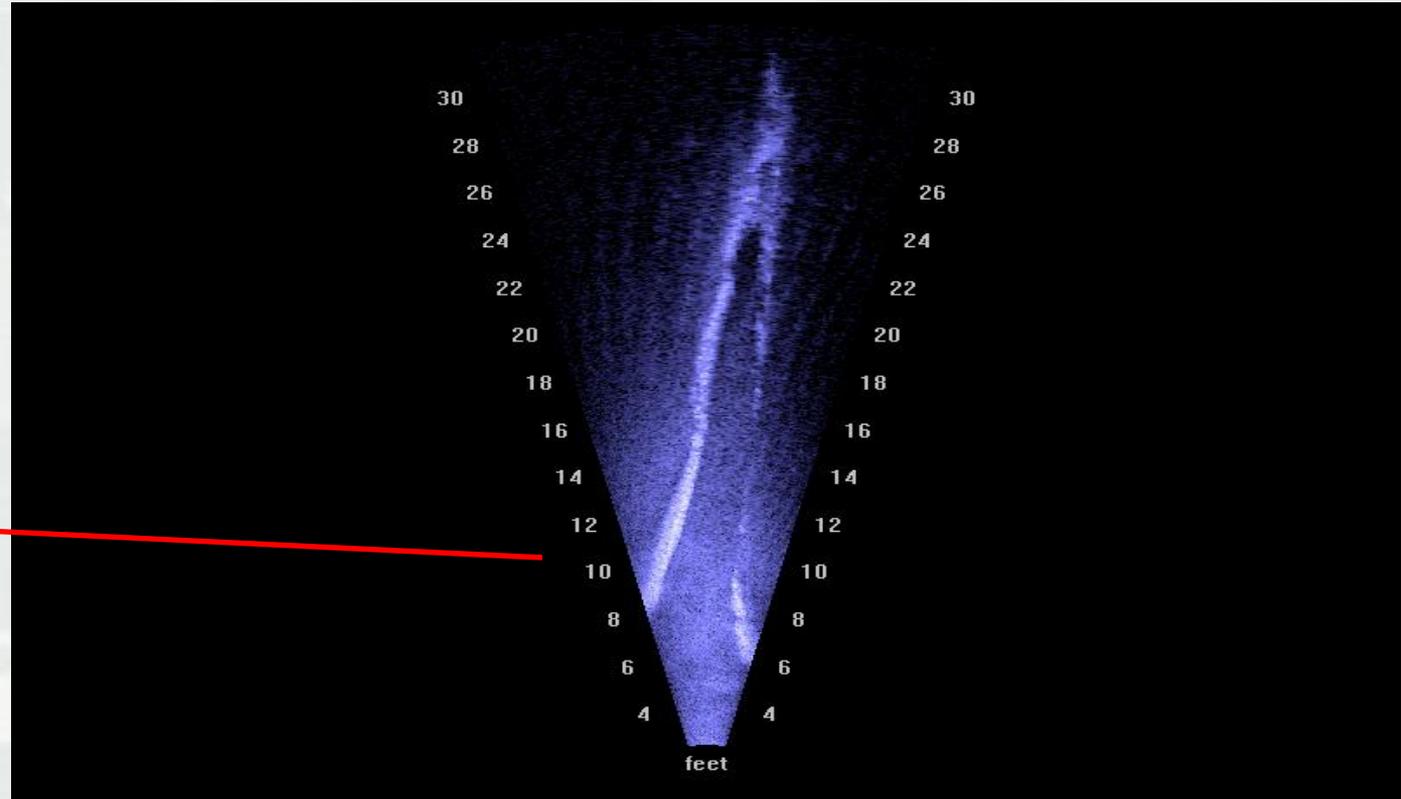
Acoustical Imaging of Lock and Dam #25

Scour Depth approximately 22 feet from edge of existing cracked concrete edge. Scour Depth estimated at 6 feet but could not be viewed directly as the diver was restricted in distance he could back from the target area. Arrow shows approximate location of this scoured area.

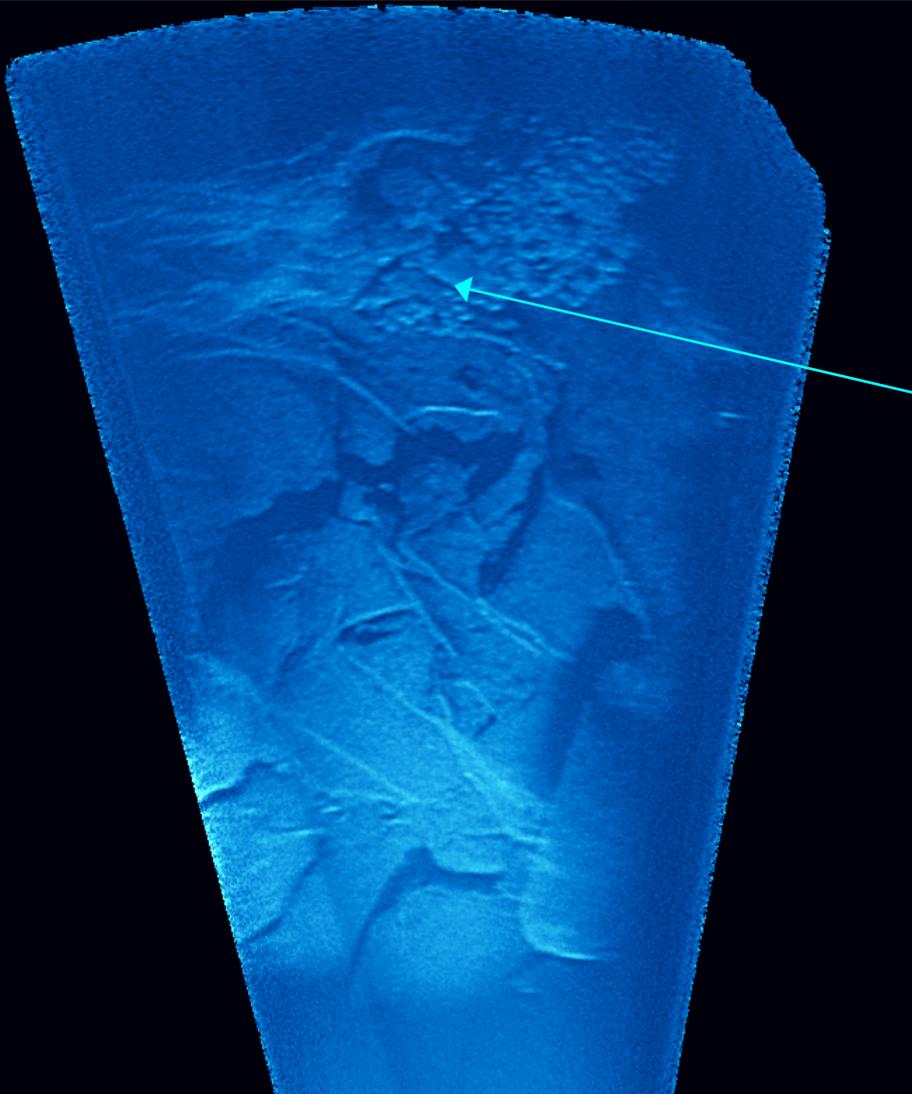
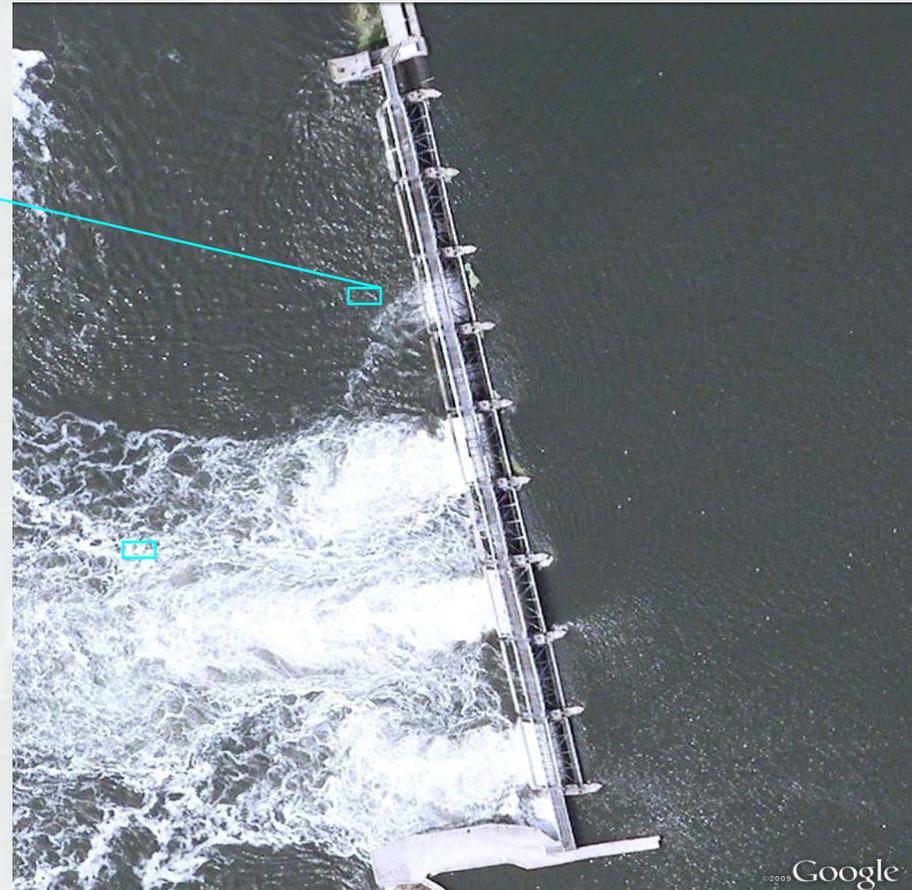
Acoustical Imaging of Dresden Dam Chicago District

**Scour inspection
below the dam.**

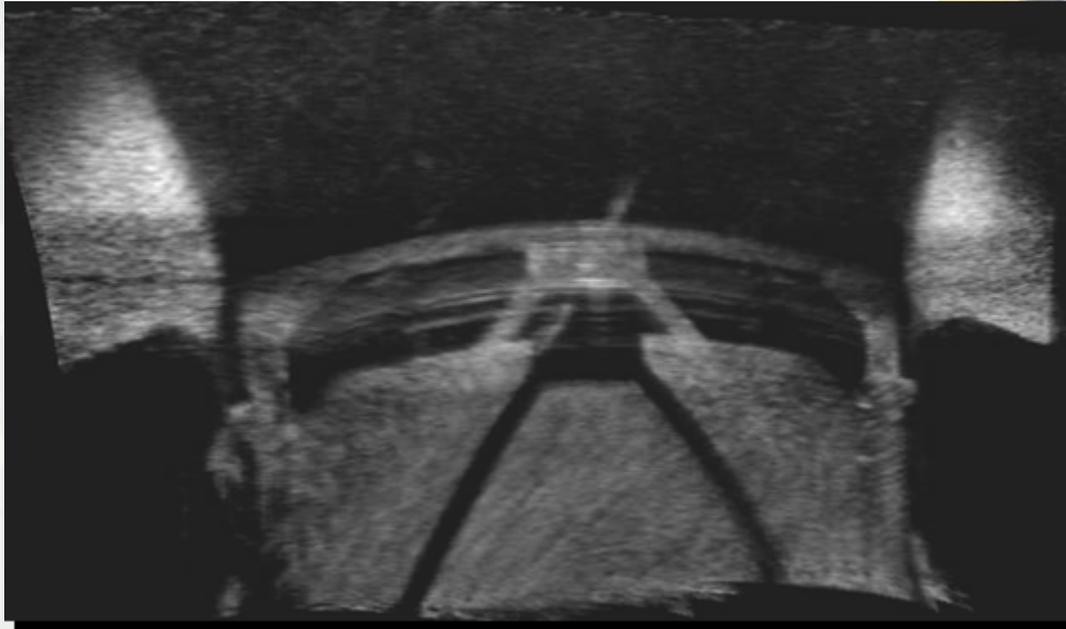
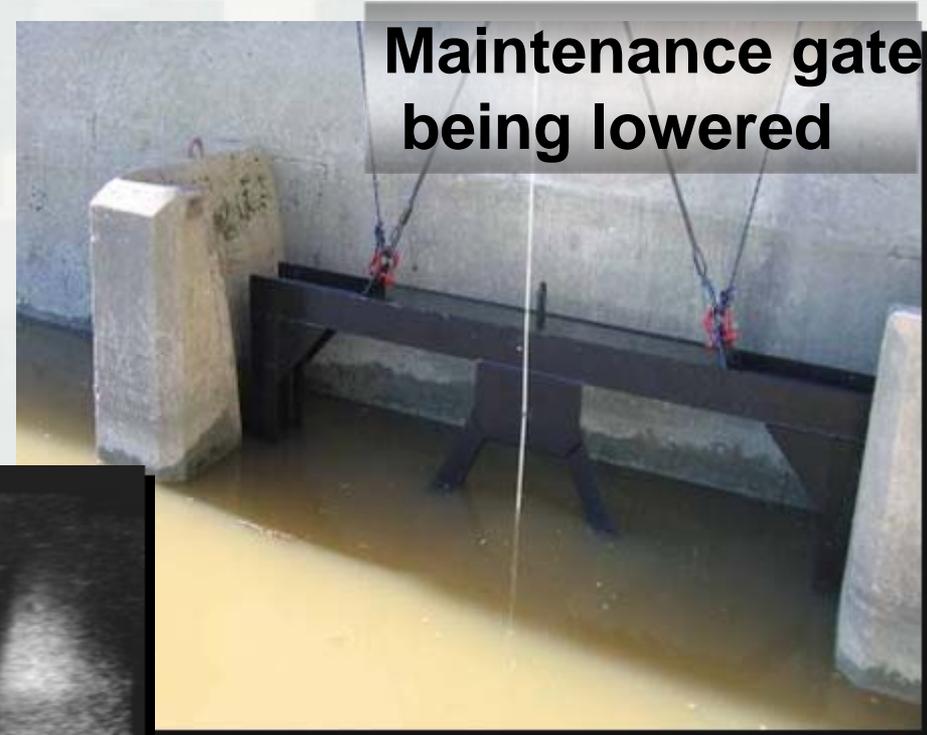
Imaging Structural Elements

Acoustic Camera was used at Delaware Dam, Huntington District to look for obstructions in the gate slots.

- No slot problems were found.

Maintenance gate being lowered

Note water opacity

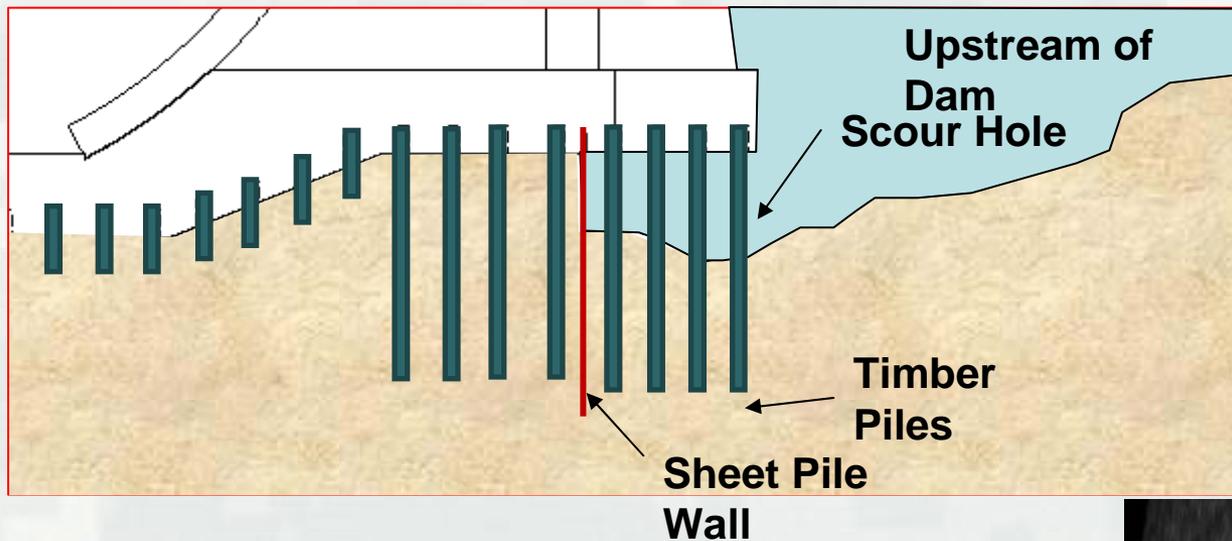
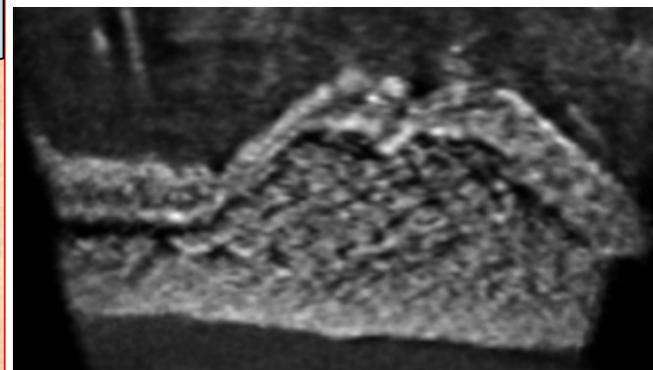
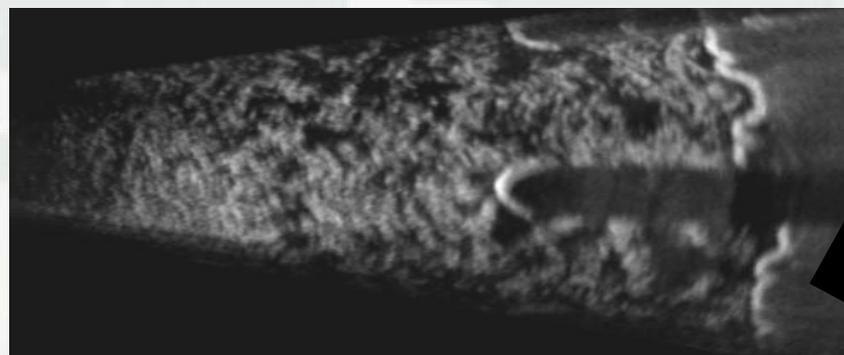
Scour-exposed Timbers

Inspection of Scour-exposed Components Mel Price Lock and Dam

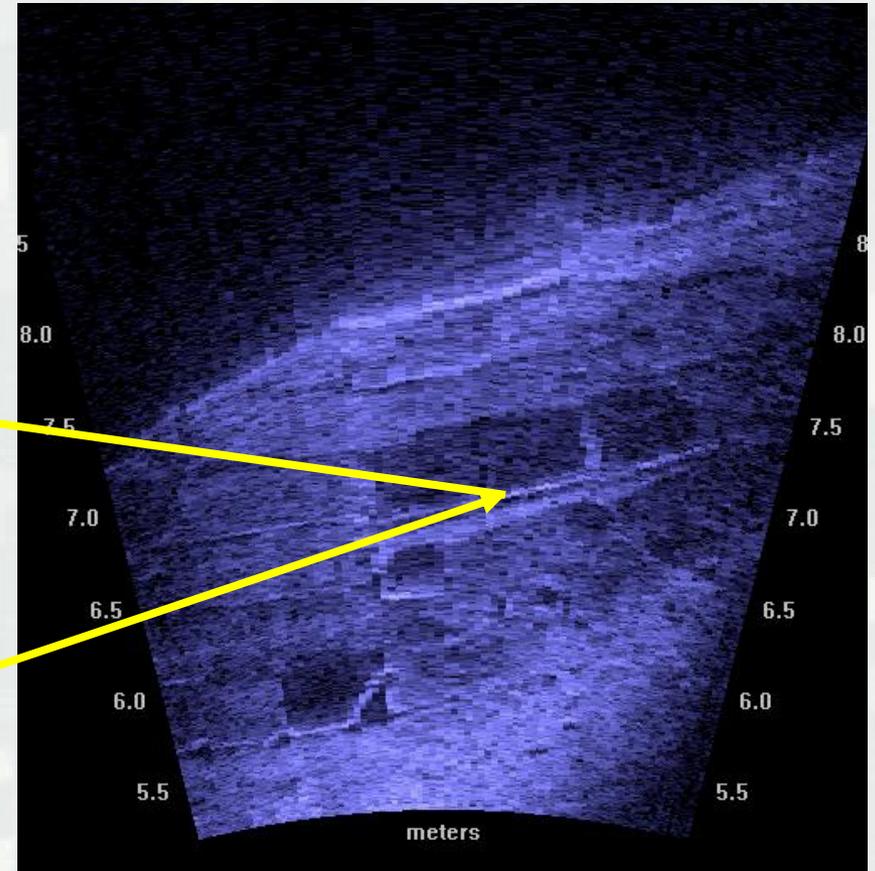
GIS Positional Data

Matting Along Mississippi River Bank
