CHICAGO HARBOR LOCK GATES

Replacement, Lessons Learned, Repairs & Successes

Robert (Bob) Ojala

12 February 2013

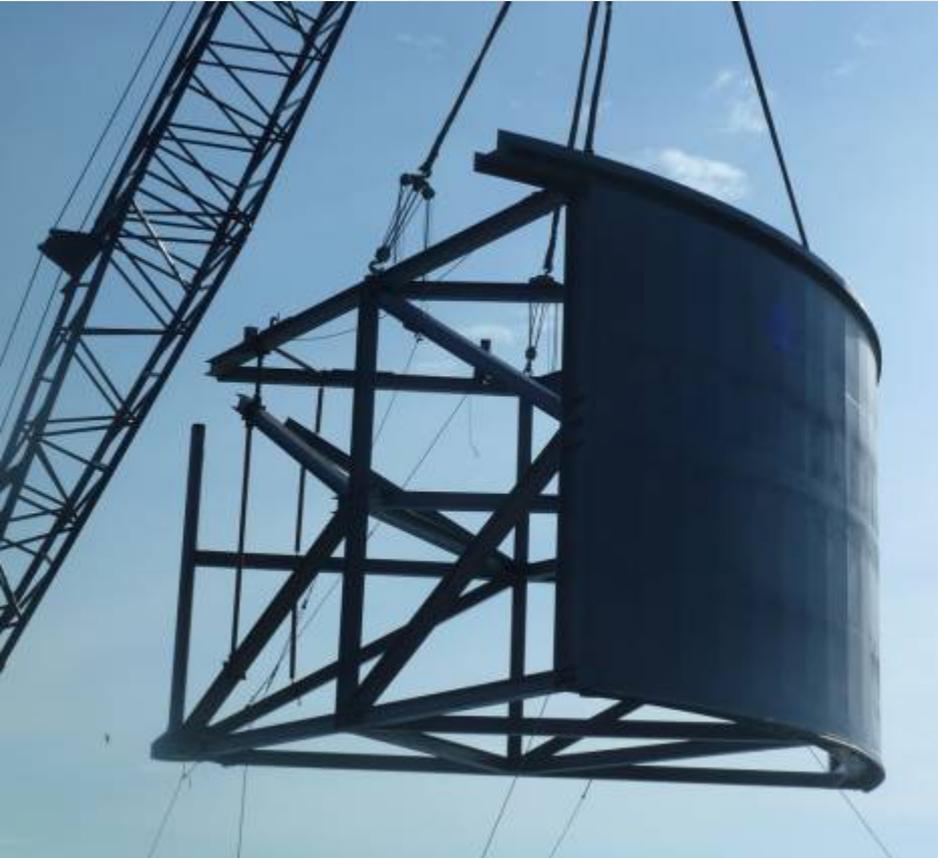
Gate Installation: Installation in two pieces

Gate without upper hinge

- The decision to retain the existing hinge plates created some installation challenges
- The solution was to separate the upper hinge from the gate and to install the gate only on the pintle and temporary blocking
- The upper hinges and fabricated filler plates were installed afterwards
- Following bolt up, all cut members were welded and fully UTed

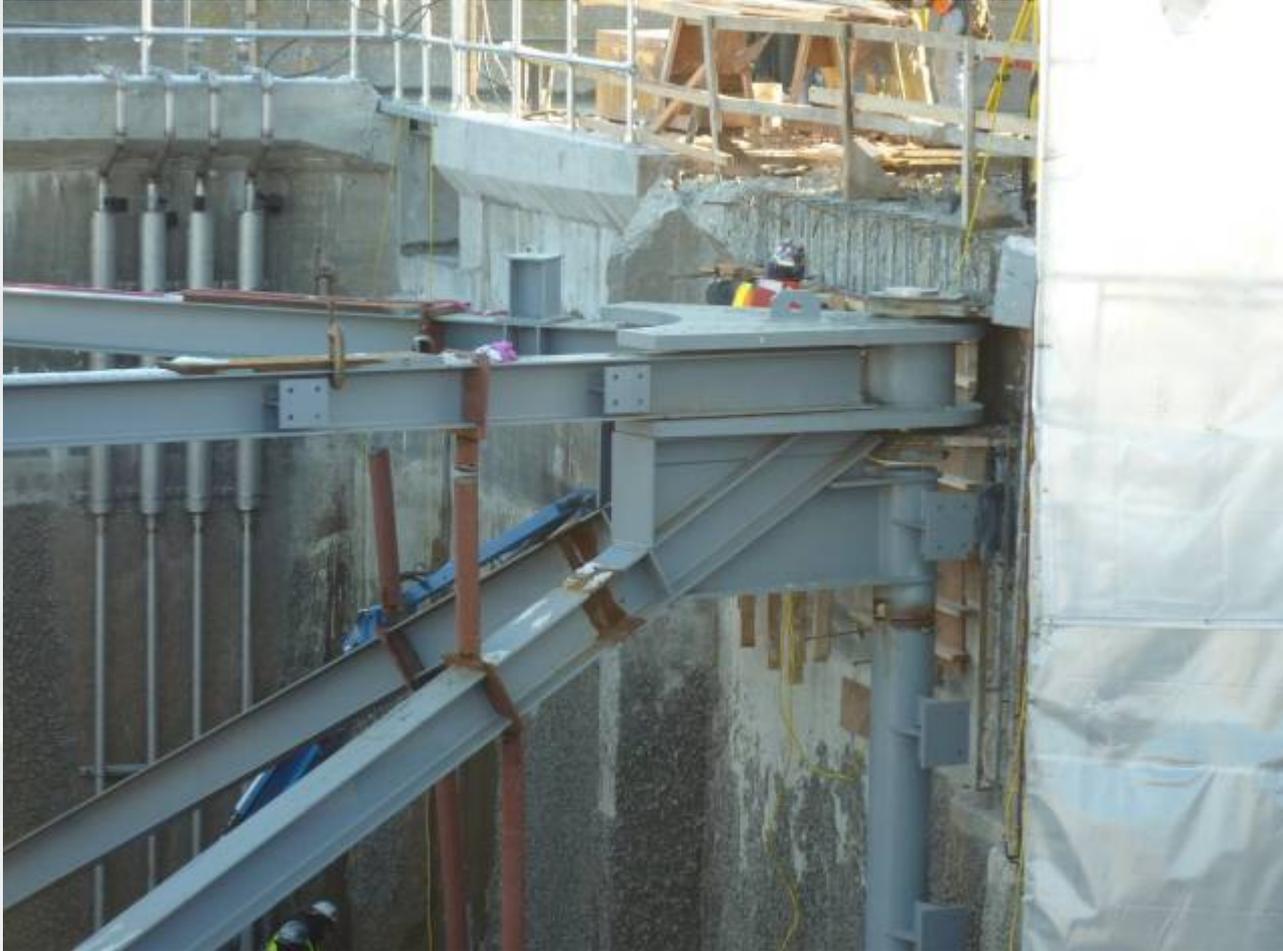
Upper Hinge Installation

Upper Hinge installed with temporary supports cut

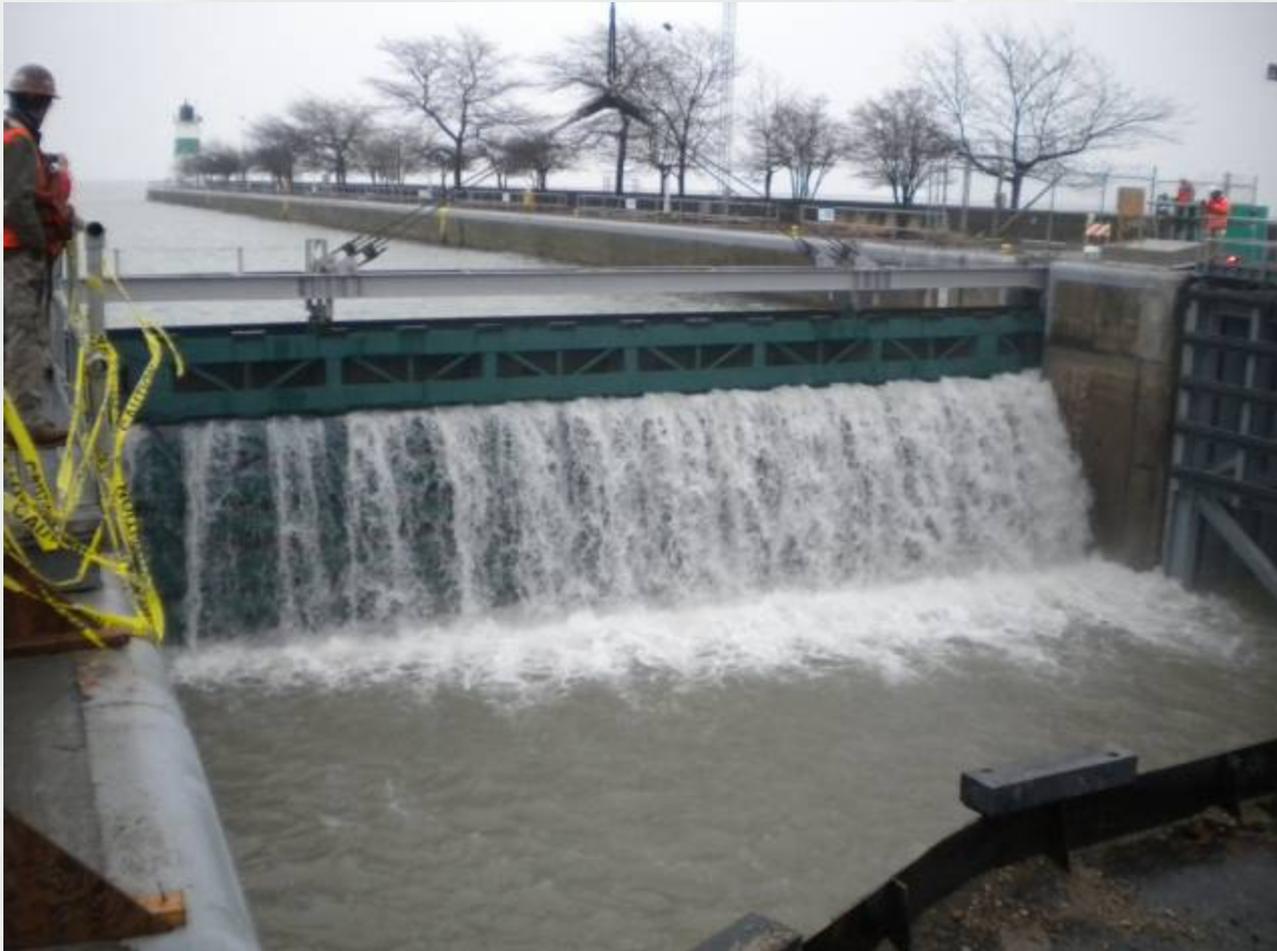
Flooding After Gates Installed

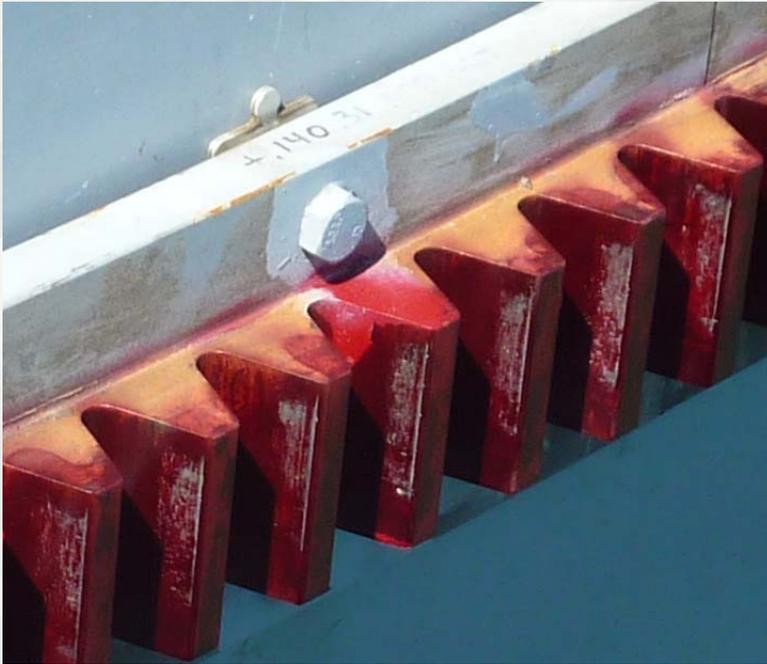
Lessons Learned - Rack Installation

Full Contact at center of rack tooth

This rack misalignment will cause:

- Variable/ Premature wear
- Rounding of Pinion Teeth
- Potential for gate binding

- The plans and specs should have required that field drilling and installation of racks was required. Slotting the holes for field adjustability was also necessary at the worst areas
(Louisville Crew made these repairs)
- Our plans should have specified a tolerance over the entire length of the rack, not just individual sections
- Specs should have required a dye test be performed as a performance test before accepting the gates

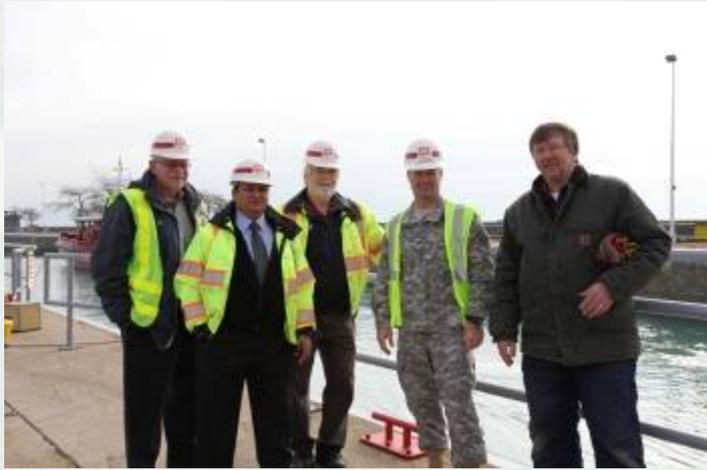
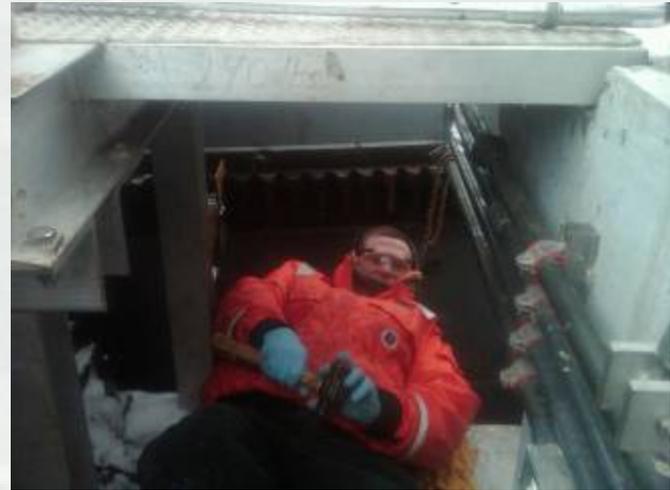
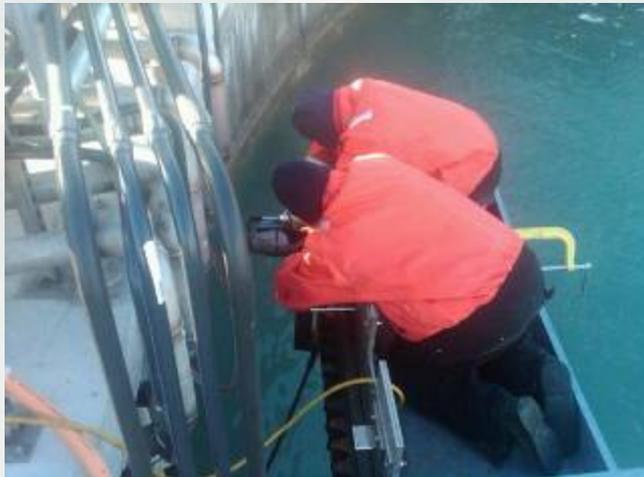
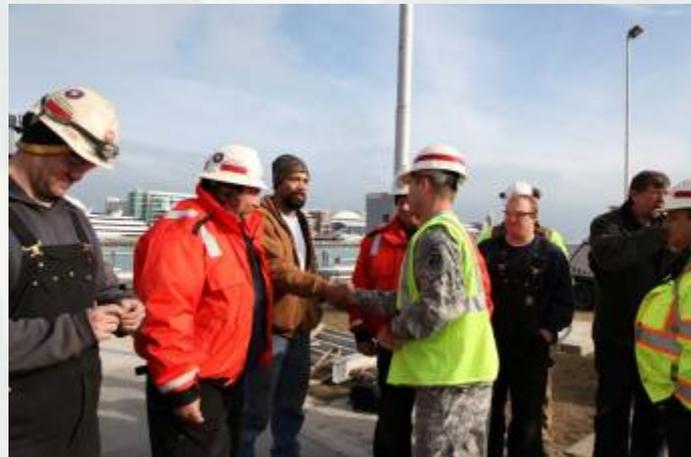
Louisville Crew Working in January Chicago Weather

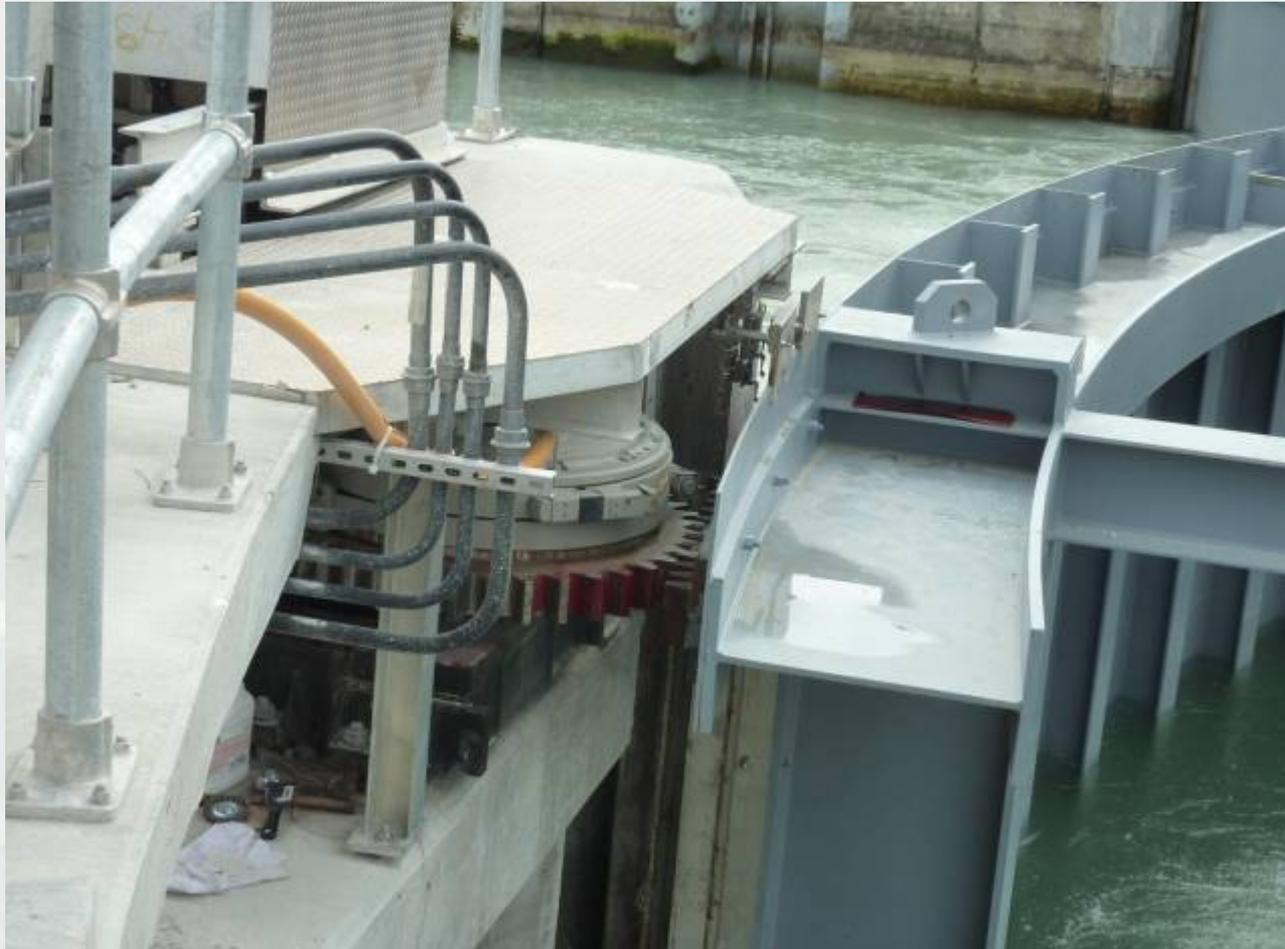
Lessons Learned – HPU Installation/ Pitch-line Separation

Pinion and Rack interface

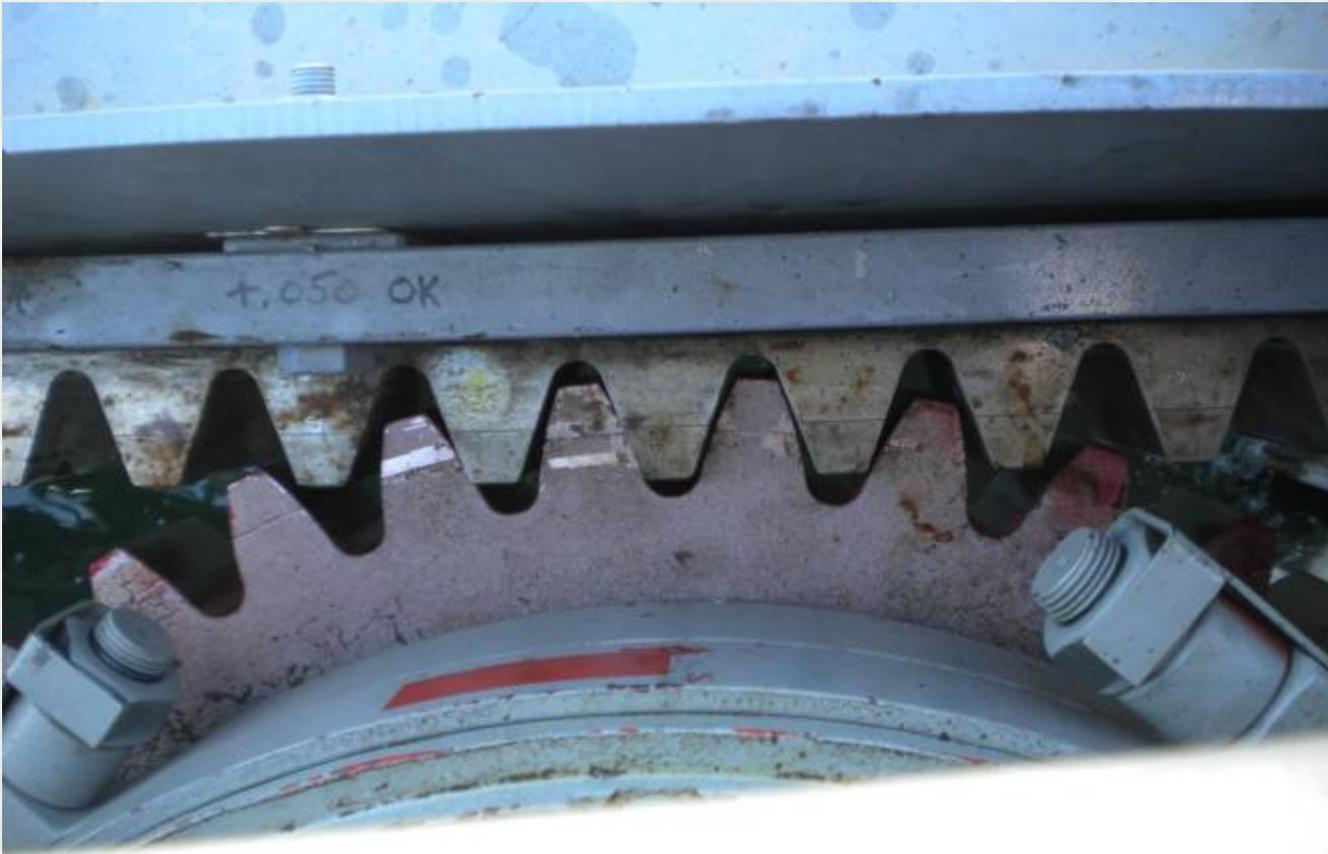
Original Pitch Line Separation

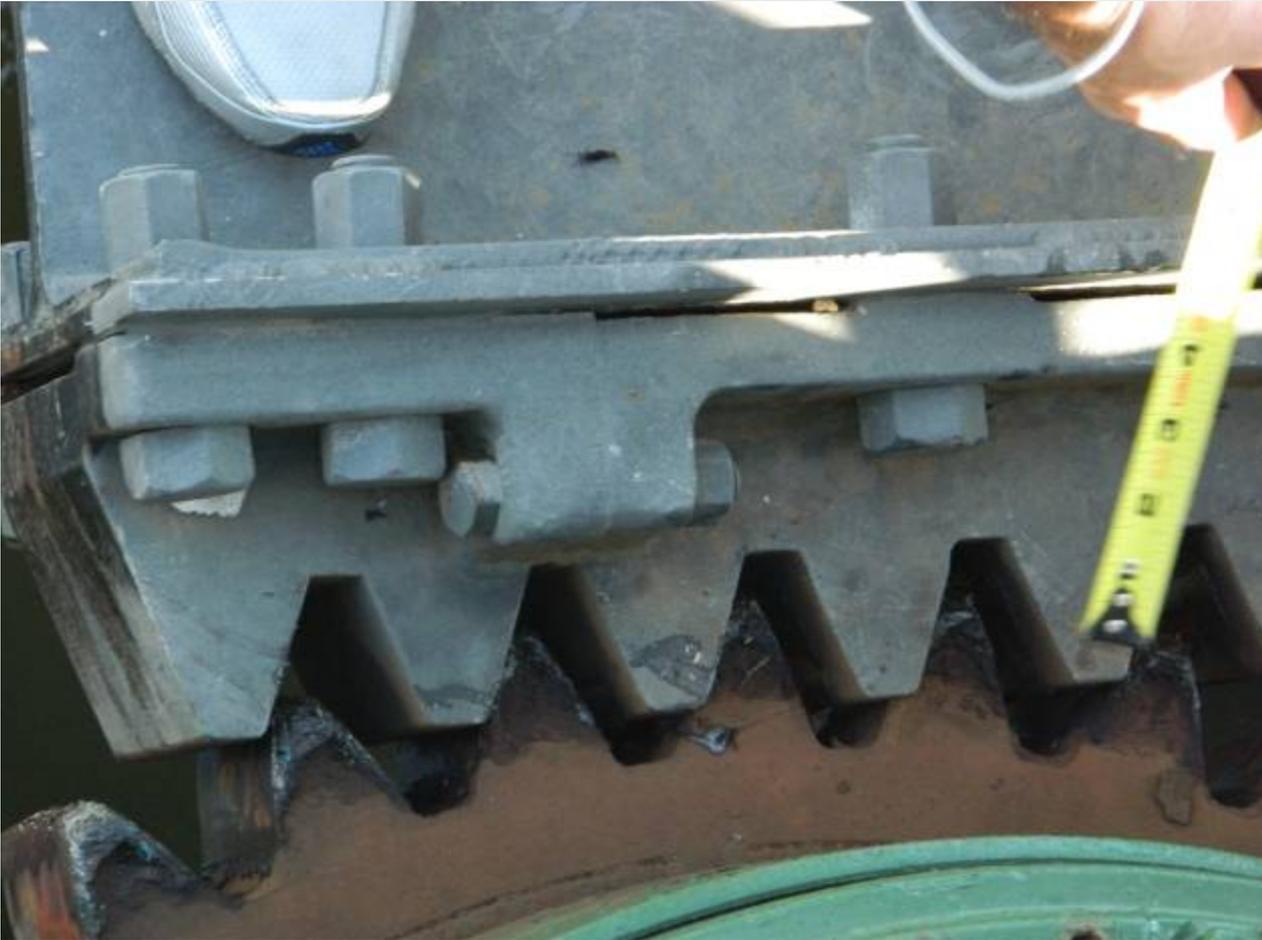
Visit to Calcasieu Lock, Louisiana - Greater Pitch Line Separation Noted

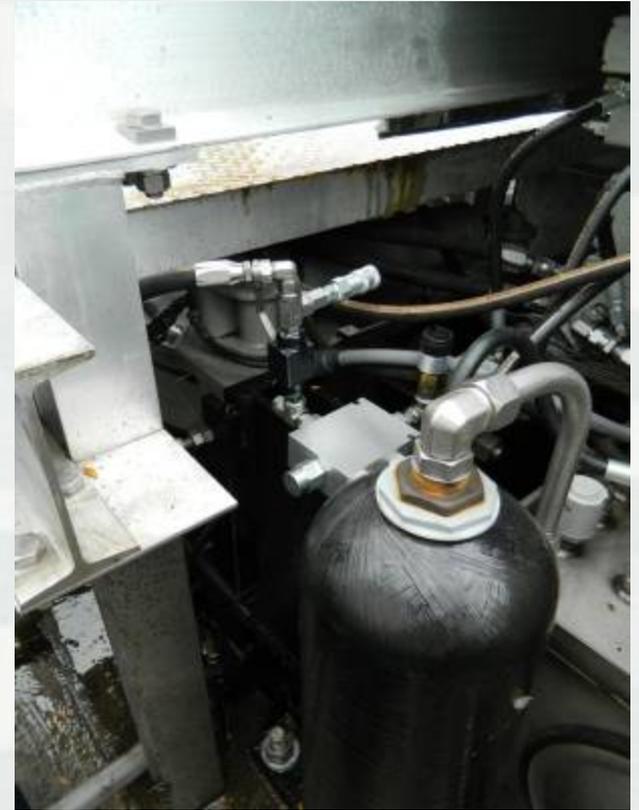
Hose & Fitting Variations Between the four HPU's

HPUs Modified to have Lower Profile and Identical Hoses

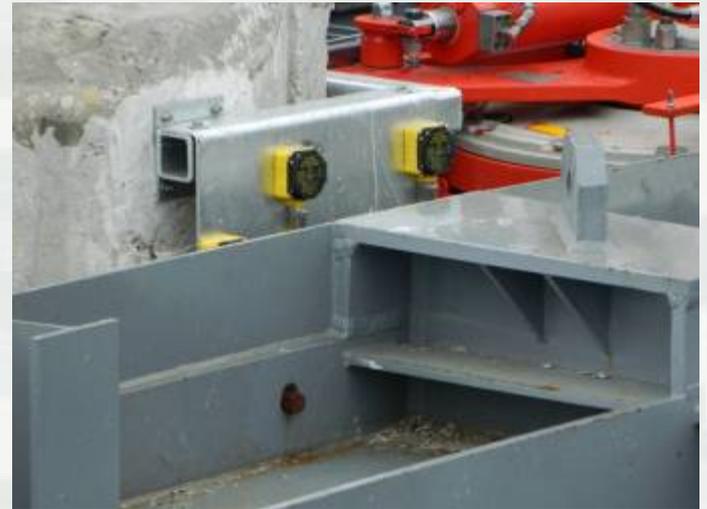
Limit Switches struck by Target, and 17 of 24 switches failed in first season

Conversion to Proximity Switches

Eliminated Physical Contact

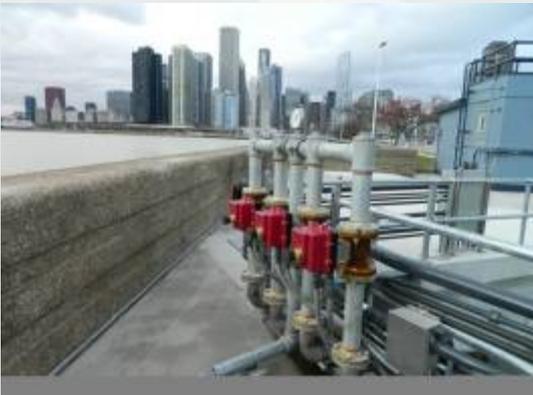
#3 Moved Railing

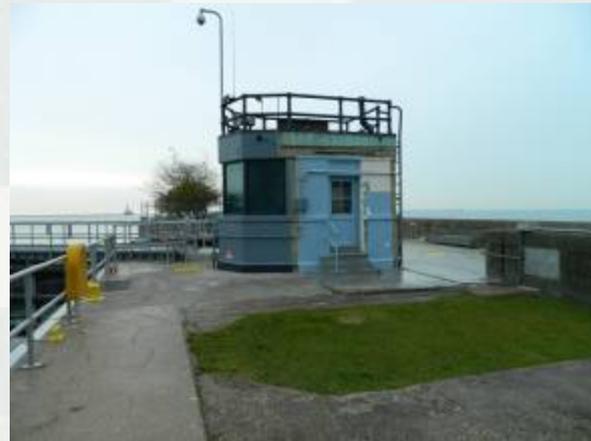
#2 – Problem remains

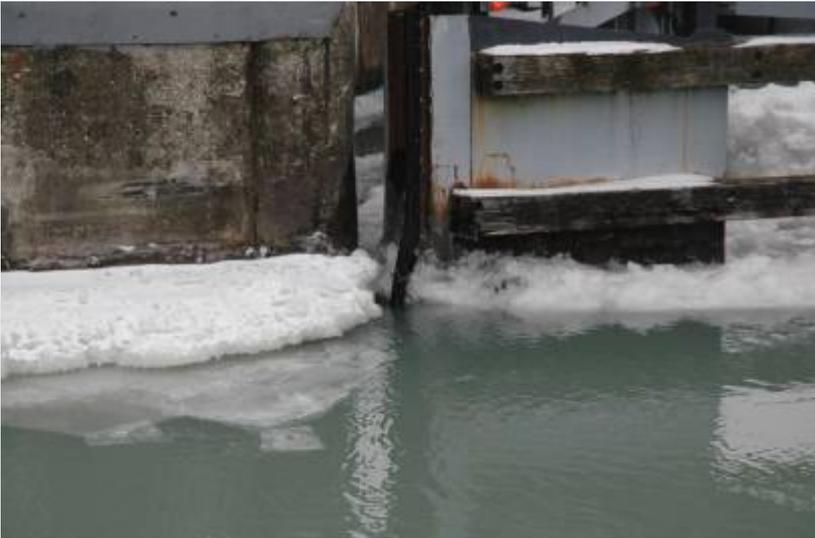
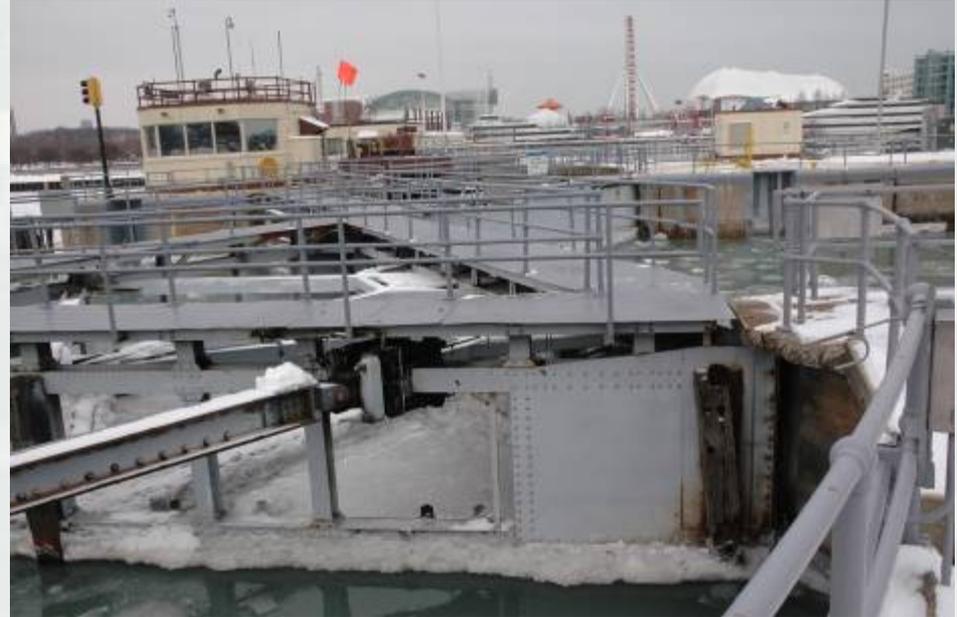
Icing in Old Lock Gates

Eliminated by High Volume Bubbler System

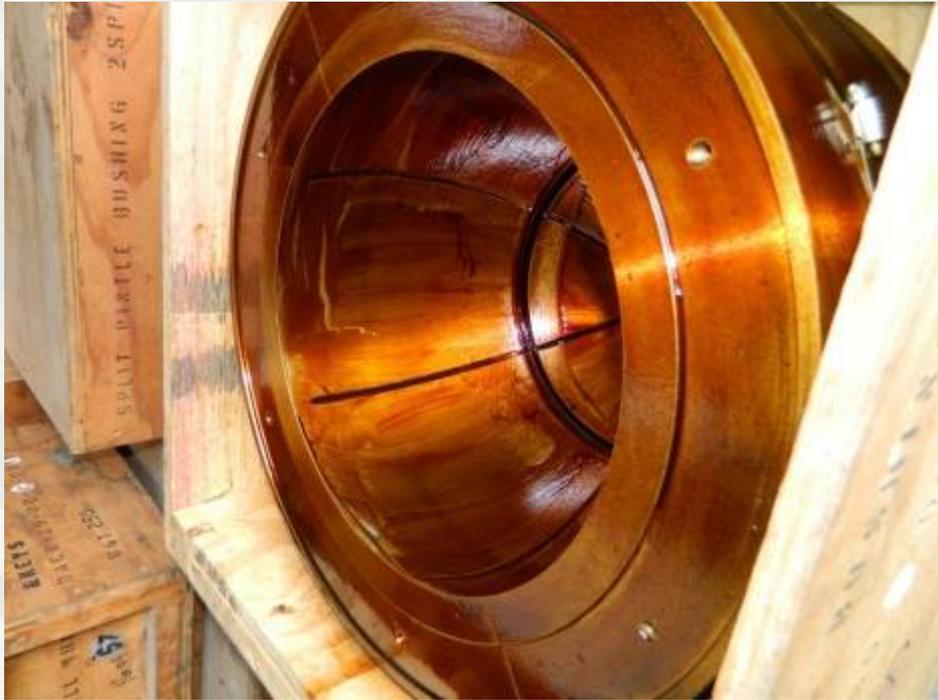
Pintle Greasing Adequate?

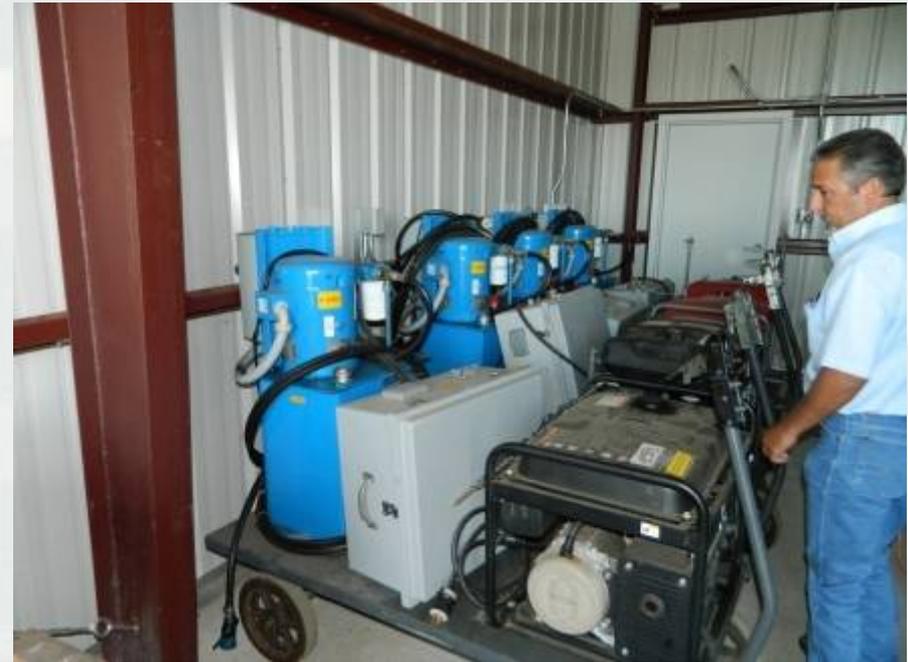
Emergency Operations Adequate?
