2011 Lock Maintenance Workshop

Review of 2010 Lock Closures

Anthony Perkins

Mobile District

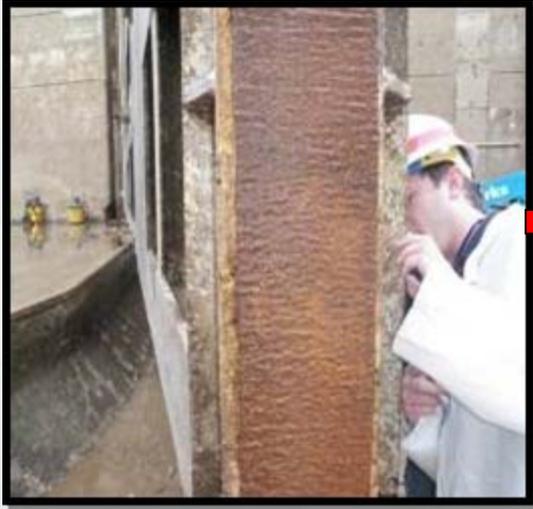
Contact block- Before

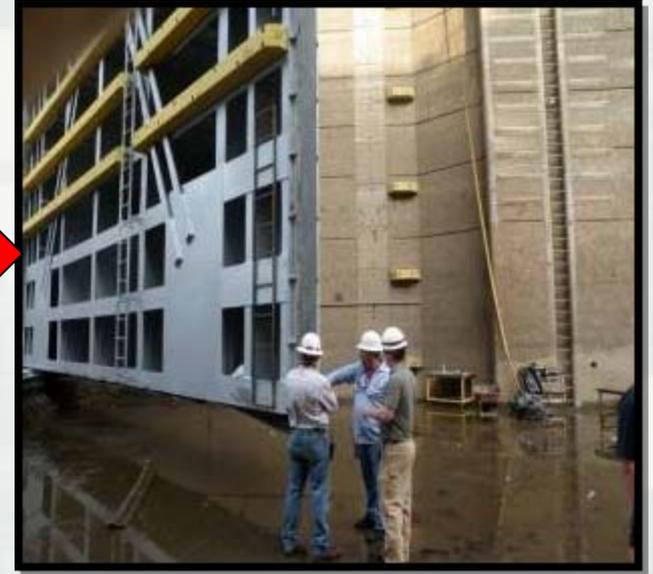
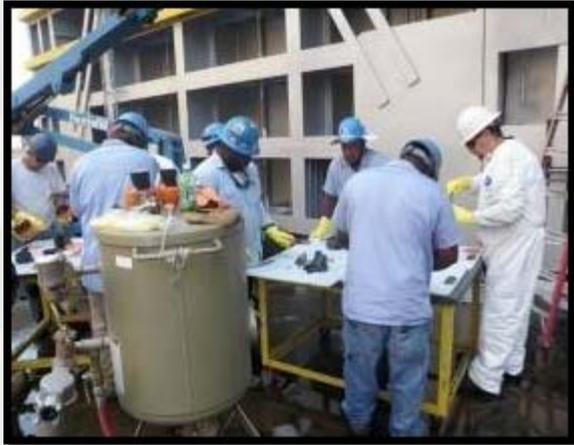
Mixing Belzona

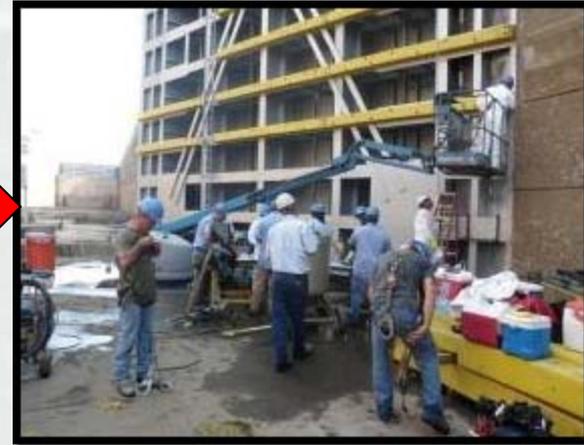
Applying Belzona

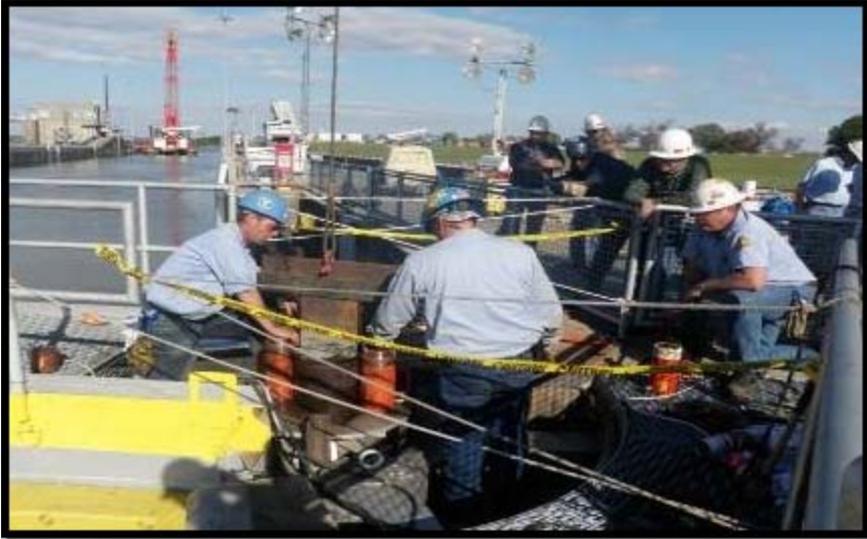
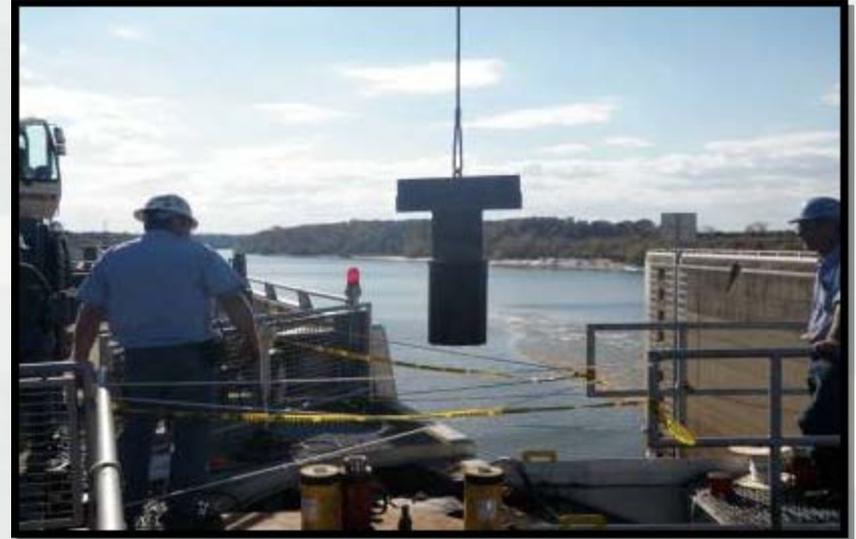
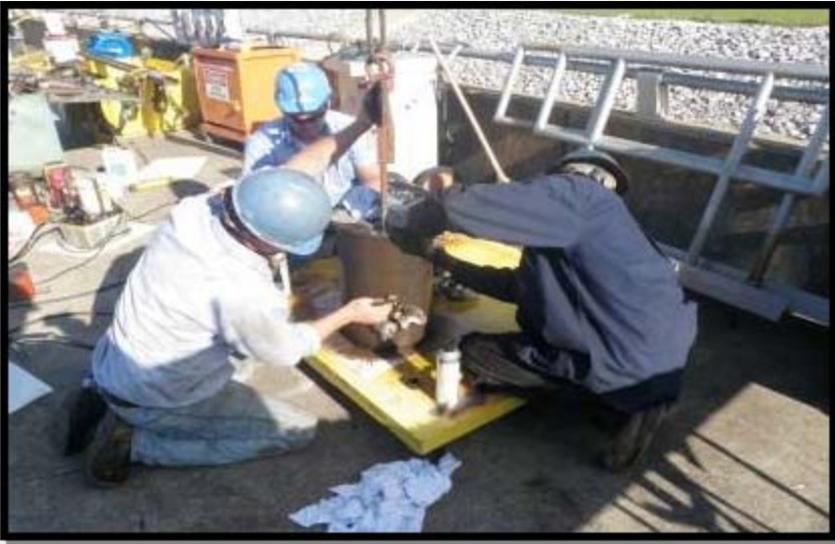
Robert F. Henry Lock

Removed pin from top connection assembly of miter gate (12" dia). Pin was seized in bushing – cleaned pin and re-cut new grease grooves in bushing.

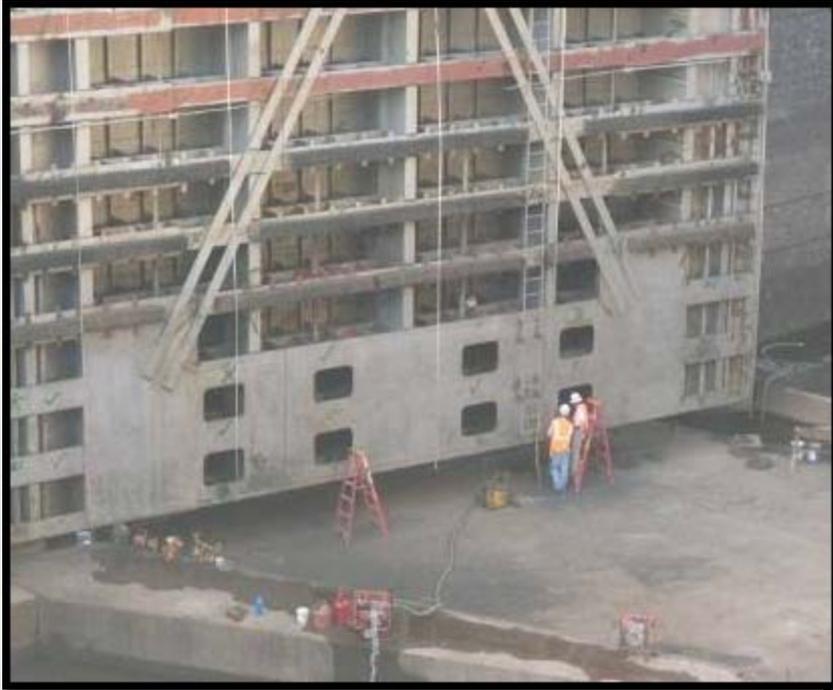
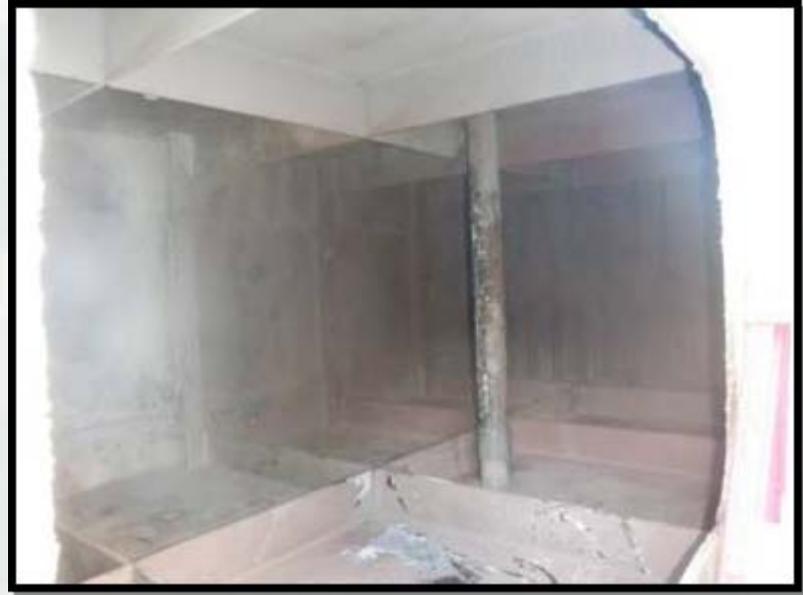
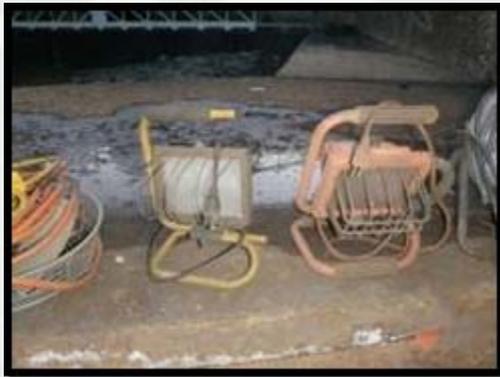
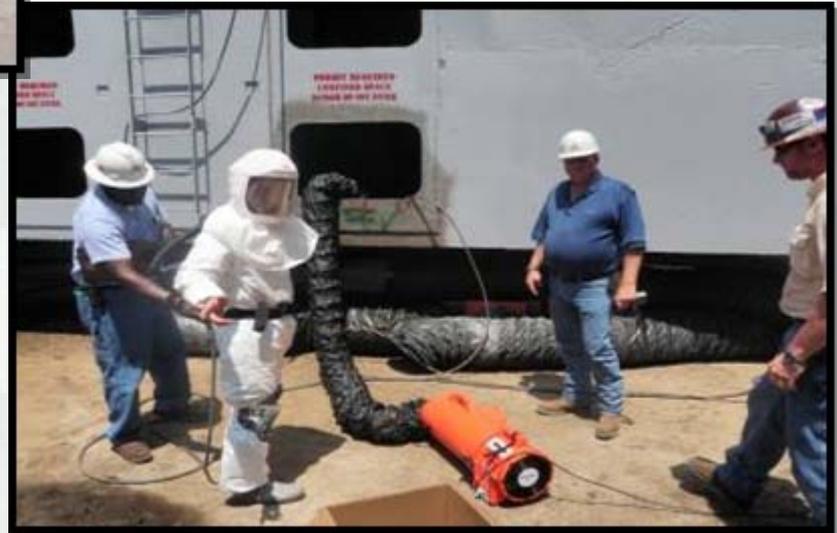
Flash Fire inside lower miter gate bay

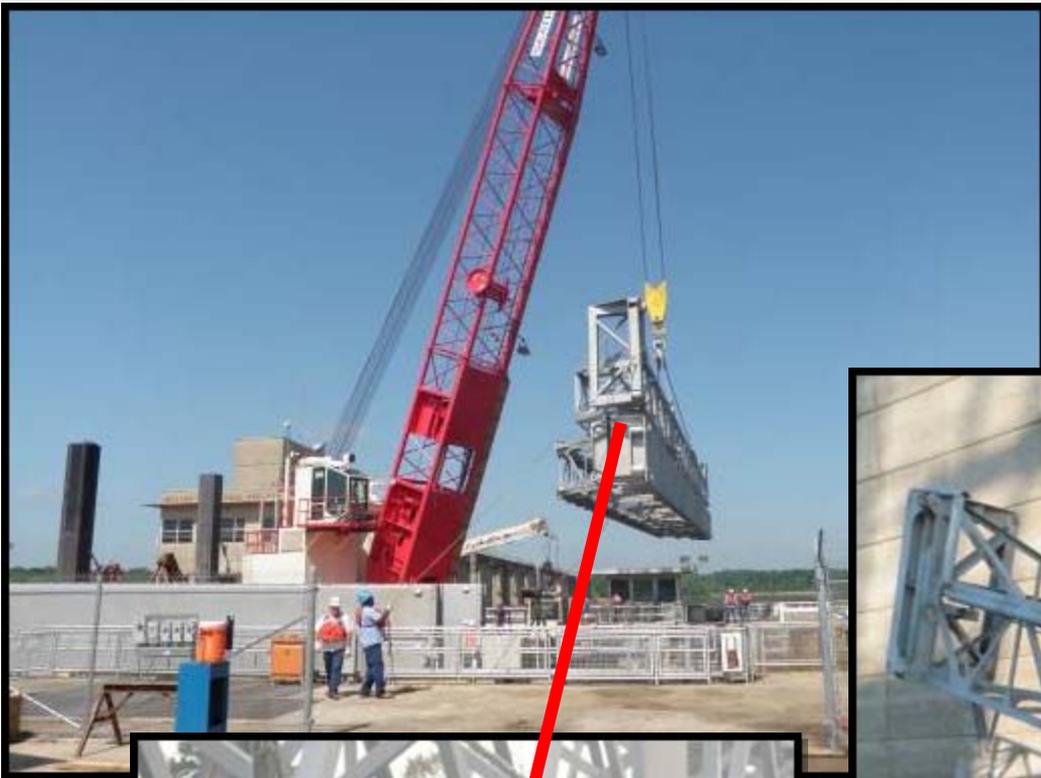
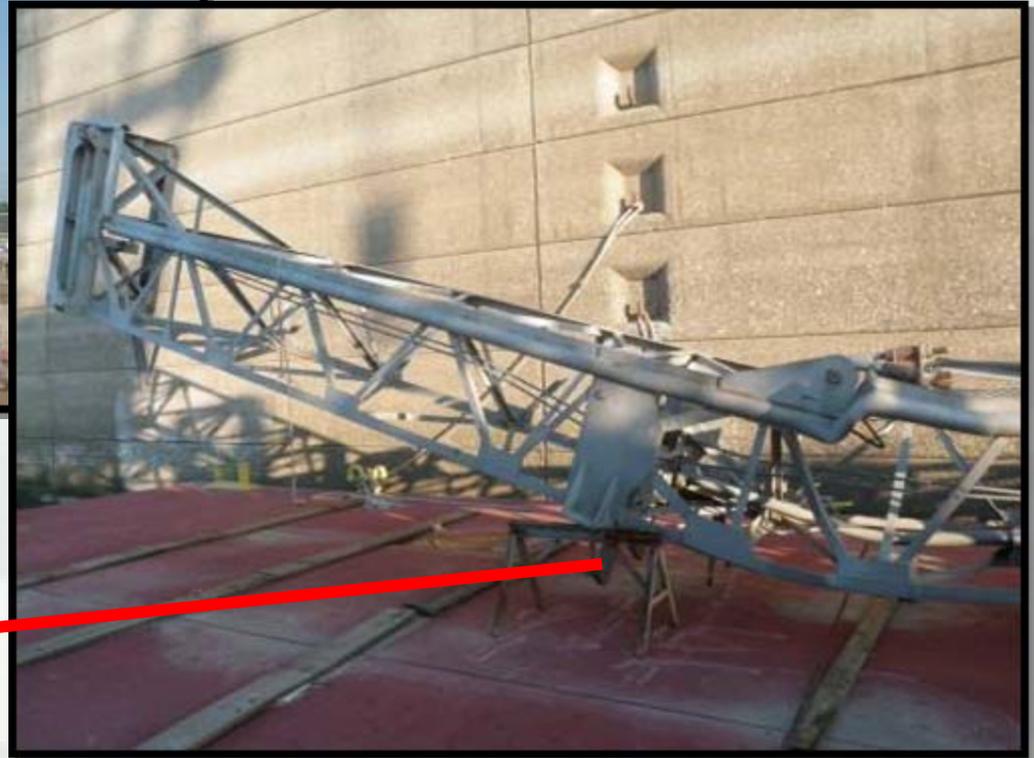
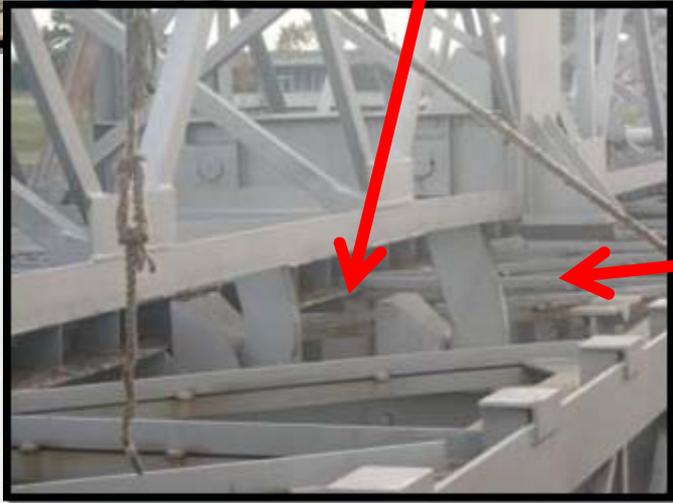
Stoplog Incident – Damaged Lifting Beam & logs.

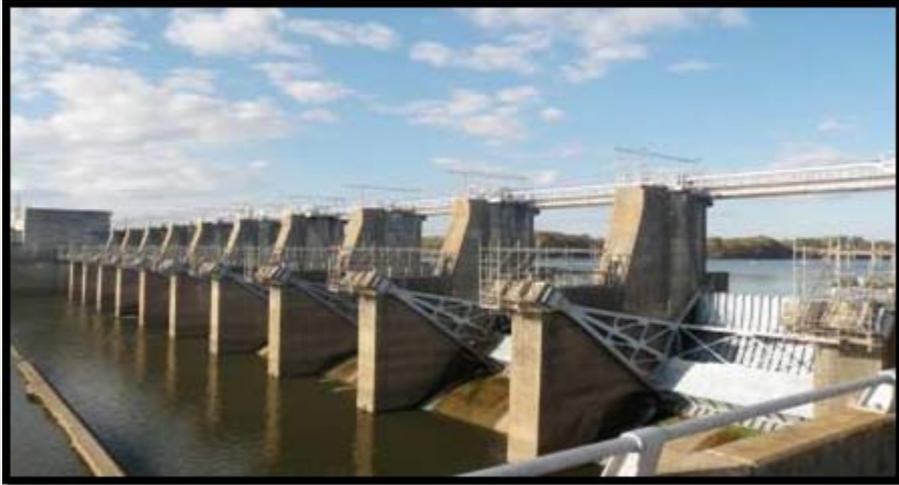
Robert F. Henry Spillway

Spillway gate trunnion rods being load tested. Scaffolding installed for safety and jacks attached to test tension on rods.

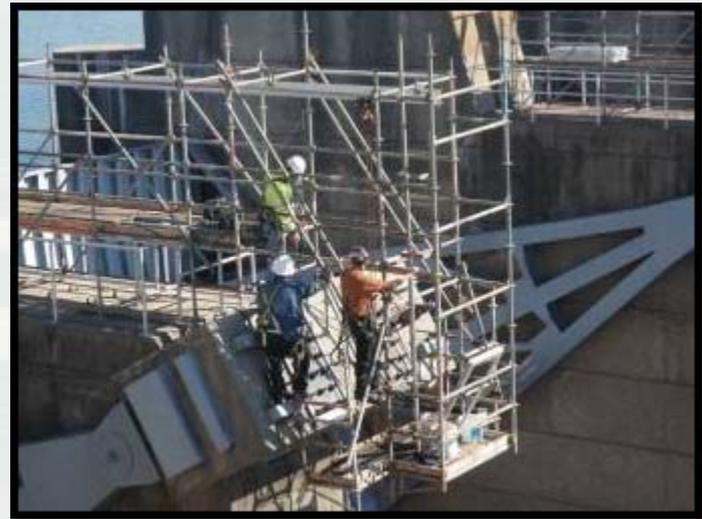
New removal galvanized cover boxes were installed to aid in future inspections.
